MICROWAVE LANDING SYSTEM FLARE SUBSYSTEM TEST

Carl B. Jezierski

FEDERAL AVIATION ADMINISTRATION

DATA REPORT

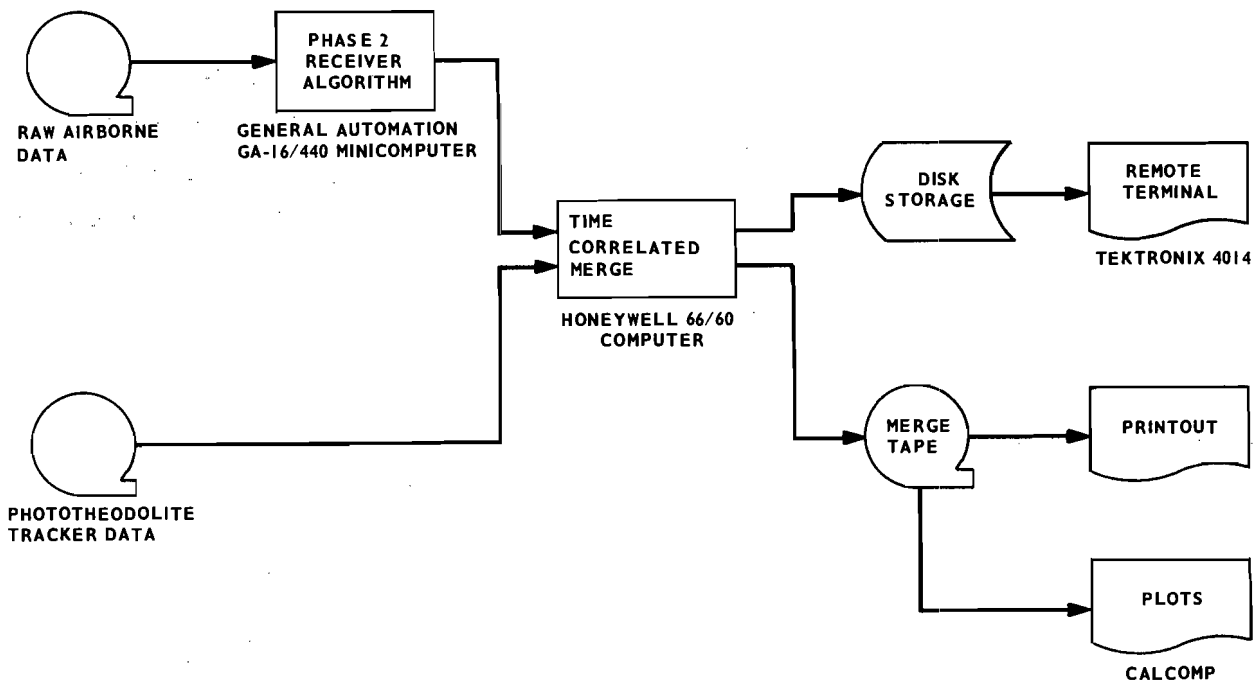
81-61-5

FIGURE 5. MLS FLARE DATA PROCESSING FLOW DIAGRAM

After the filtering operation, the airborne data were time correlated (merged) with the magnetic tape tracking data on the Technical Center's Honeywell 66/60 computer. The merge operation provided a data base on tape for plotting and future processing, and a disk file for immediate analysis on a remote graphics terminal. The flare data processing flow diagram is shown in figure 5.

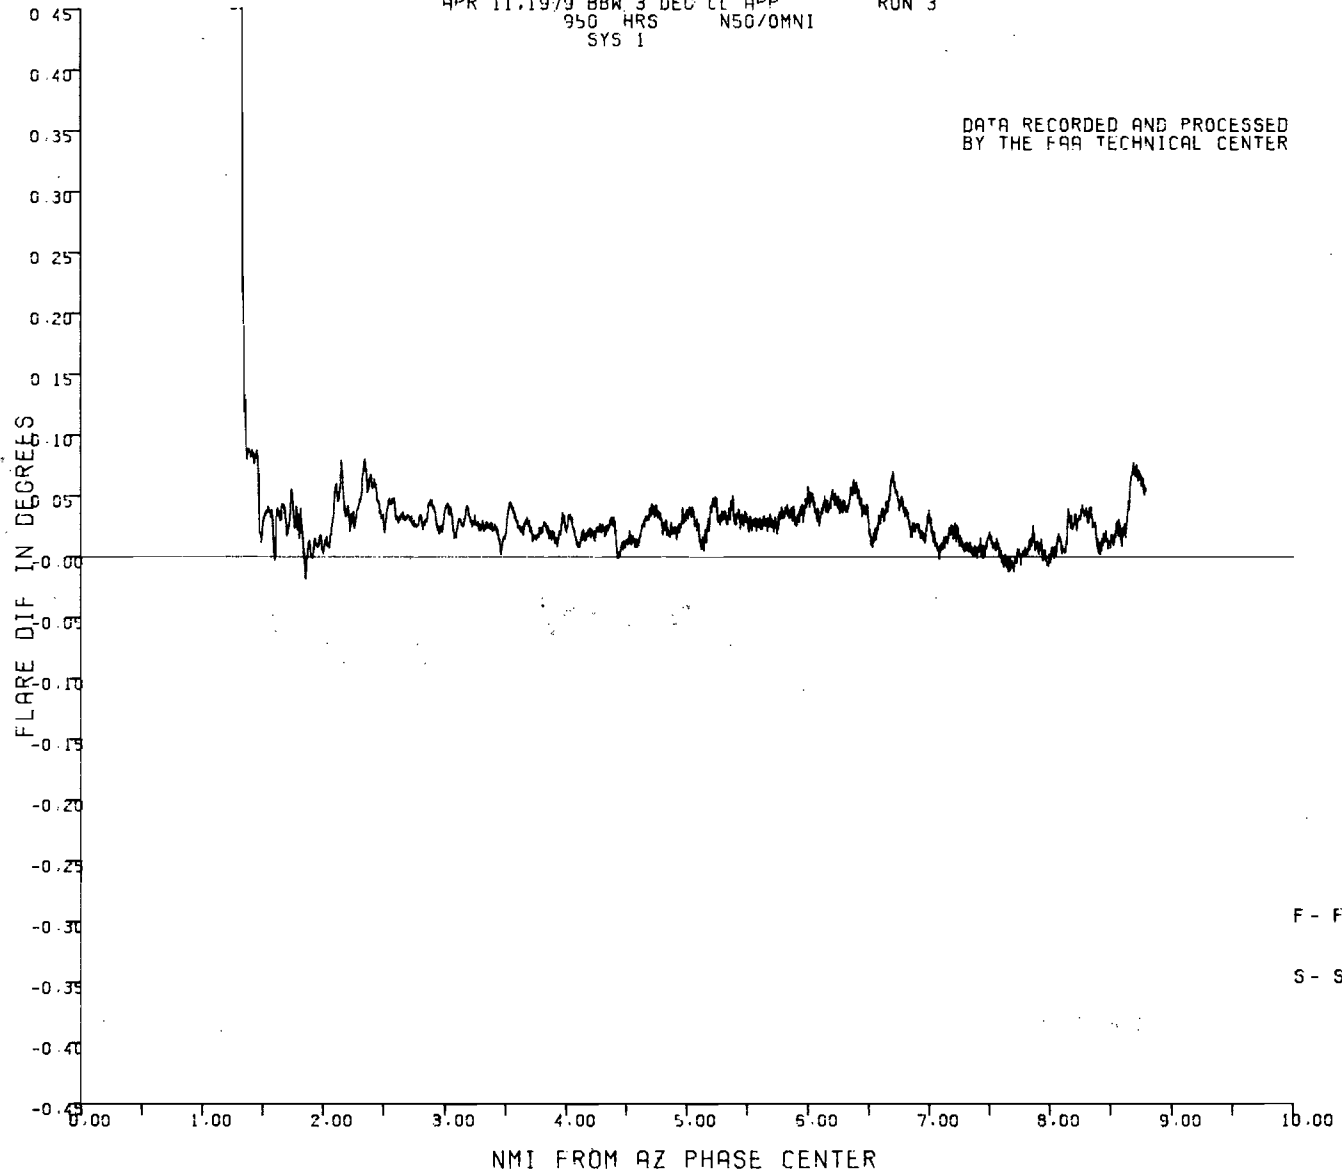
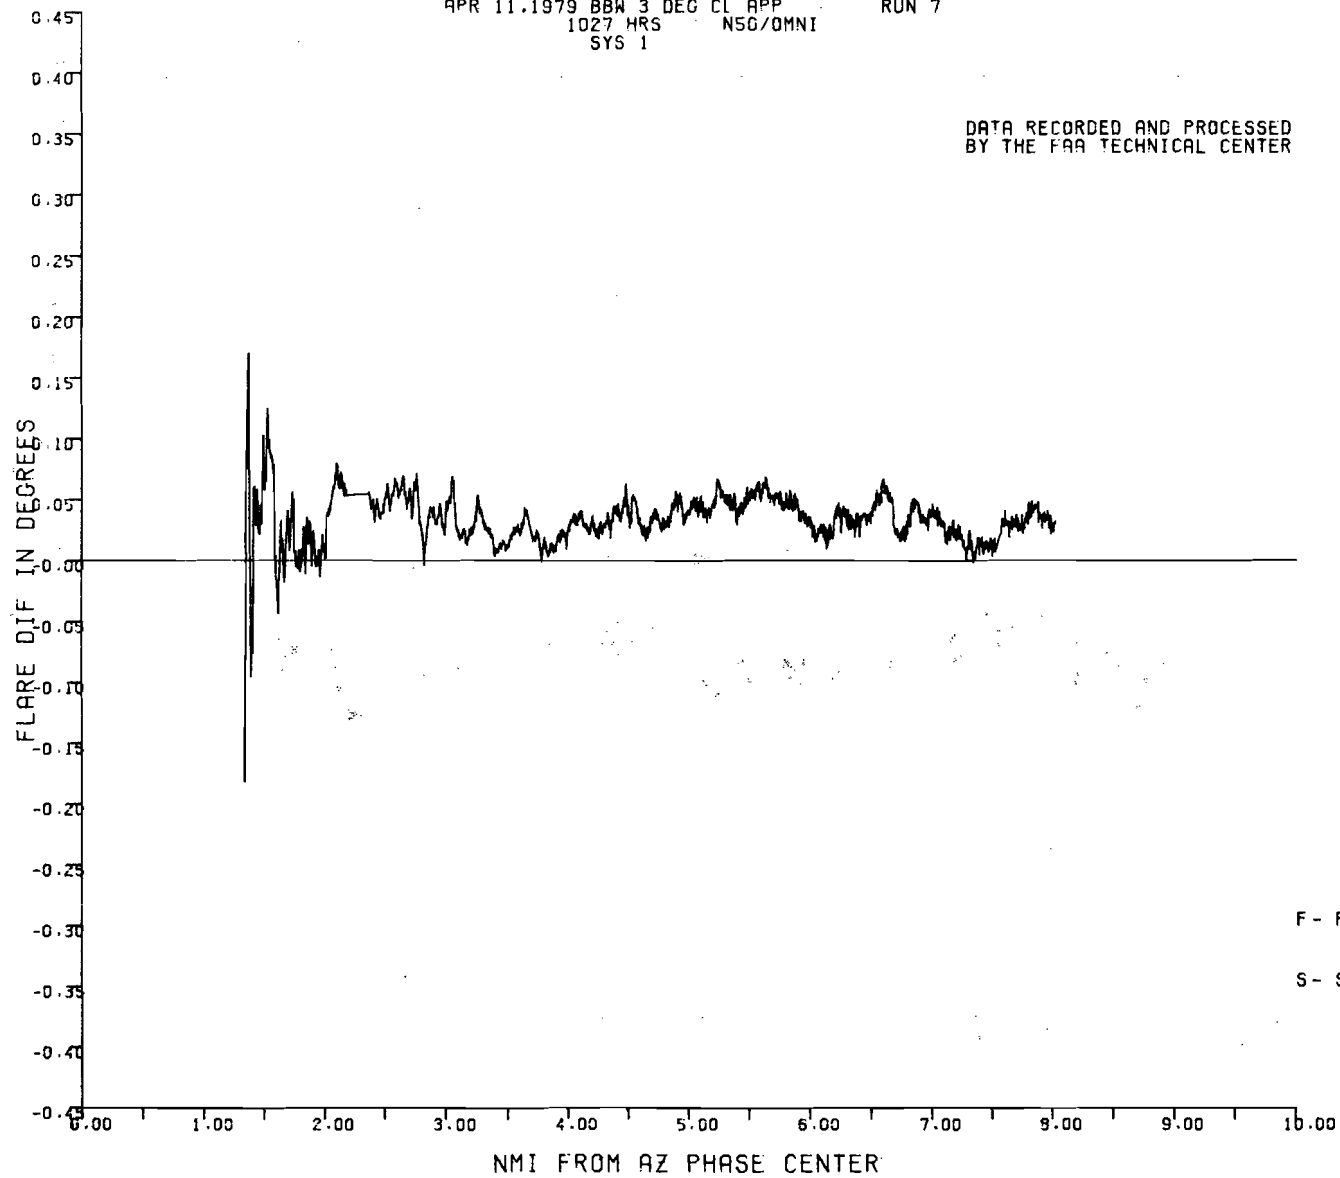
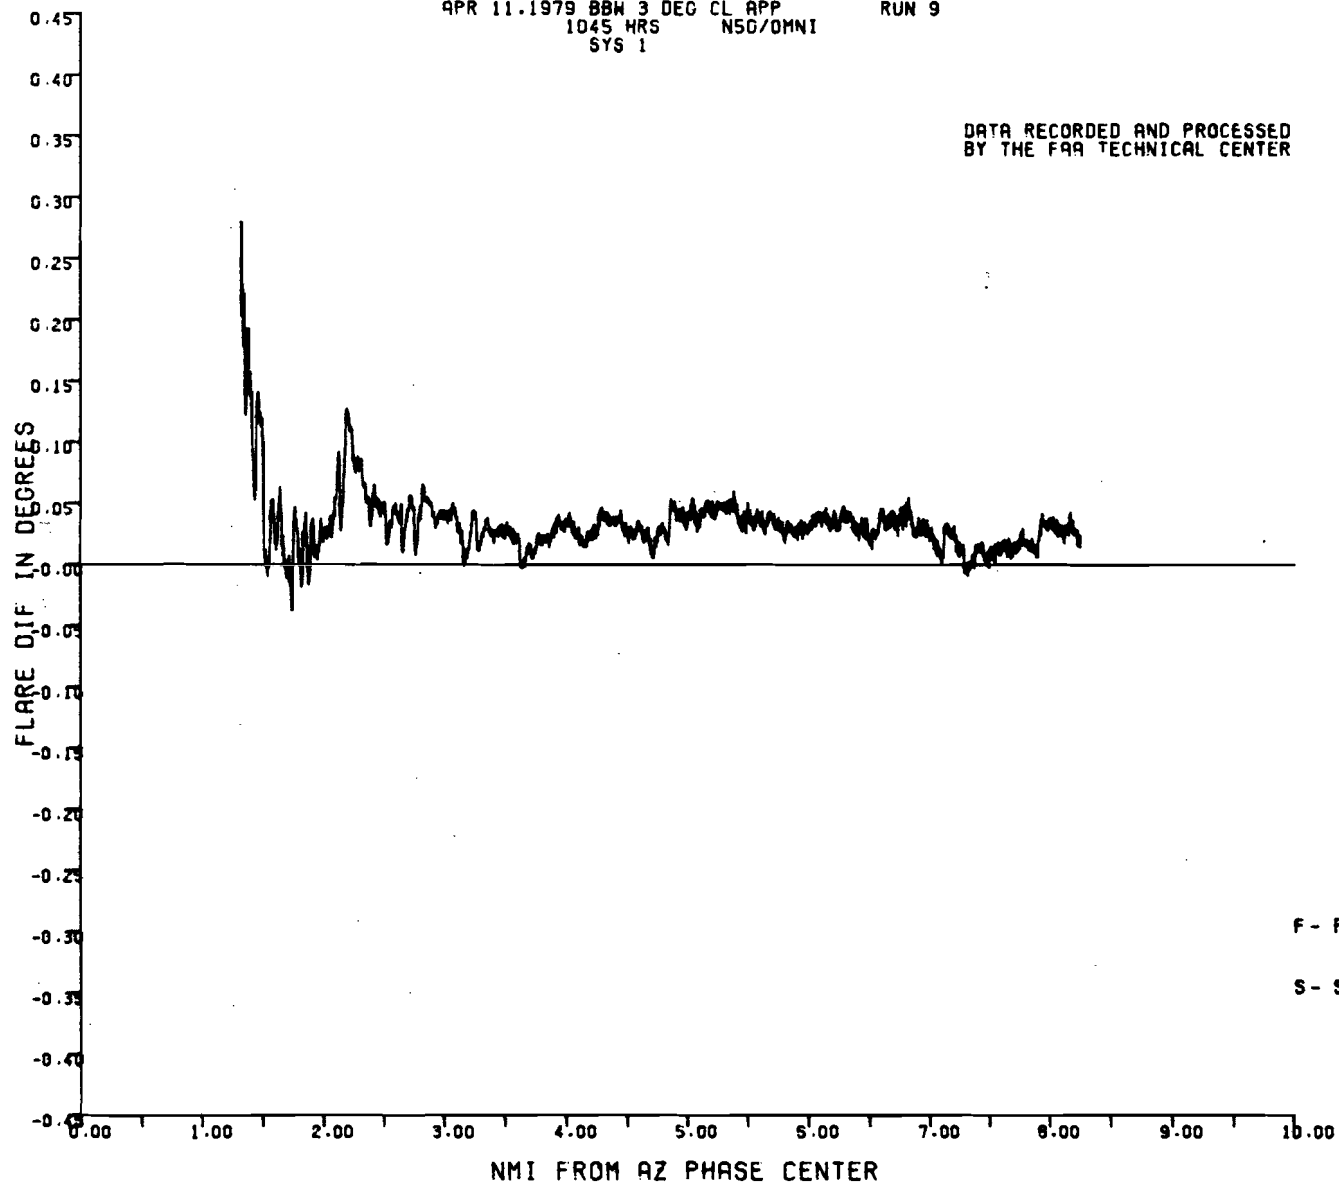
The raw error plots in appendix A show the difference between the receiver angle and the actual angle derived from the ground tracker data and are used to check coverage regions. The 3° centerline approach error plots (figures A-1 through A-5, appendix A) indicate that proportional guidance was provided in the region 2,500 feet inside threshold (1.36 nmi from azimuth phase center) to beyond 5 nmi from threshold. The partial orbit error plots (figures A-6 through A-10, appendix A) show that proportional guidance is provided in an azimuth sector well exceeding $\pm 10^\circ$ about the runway centerline.

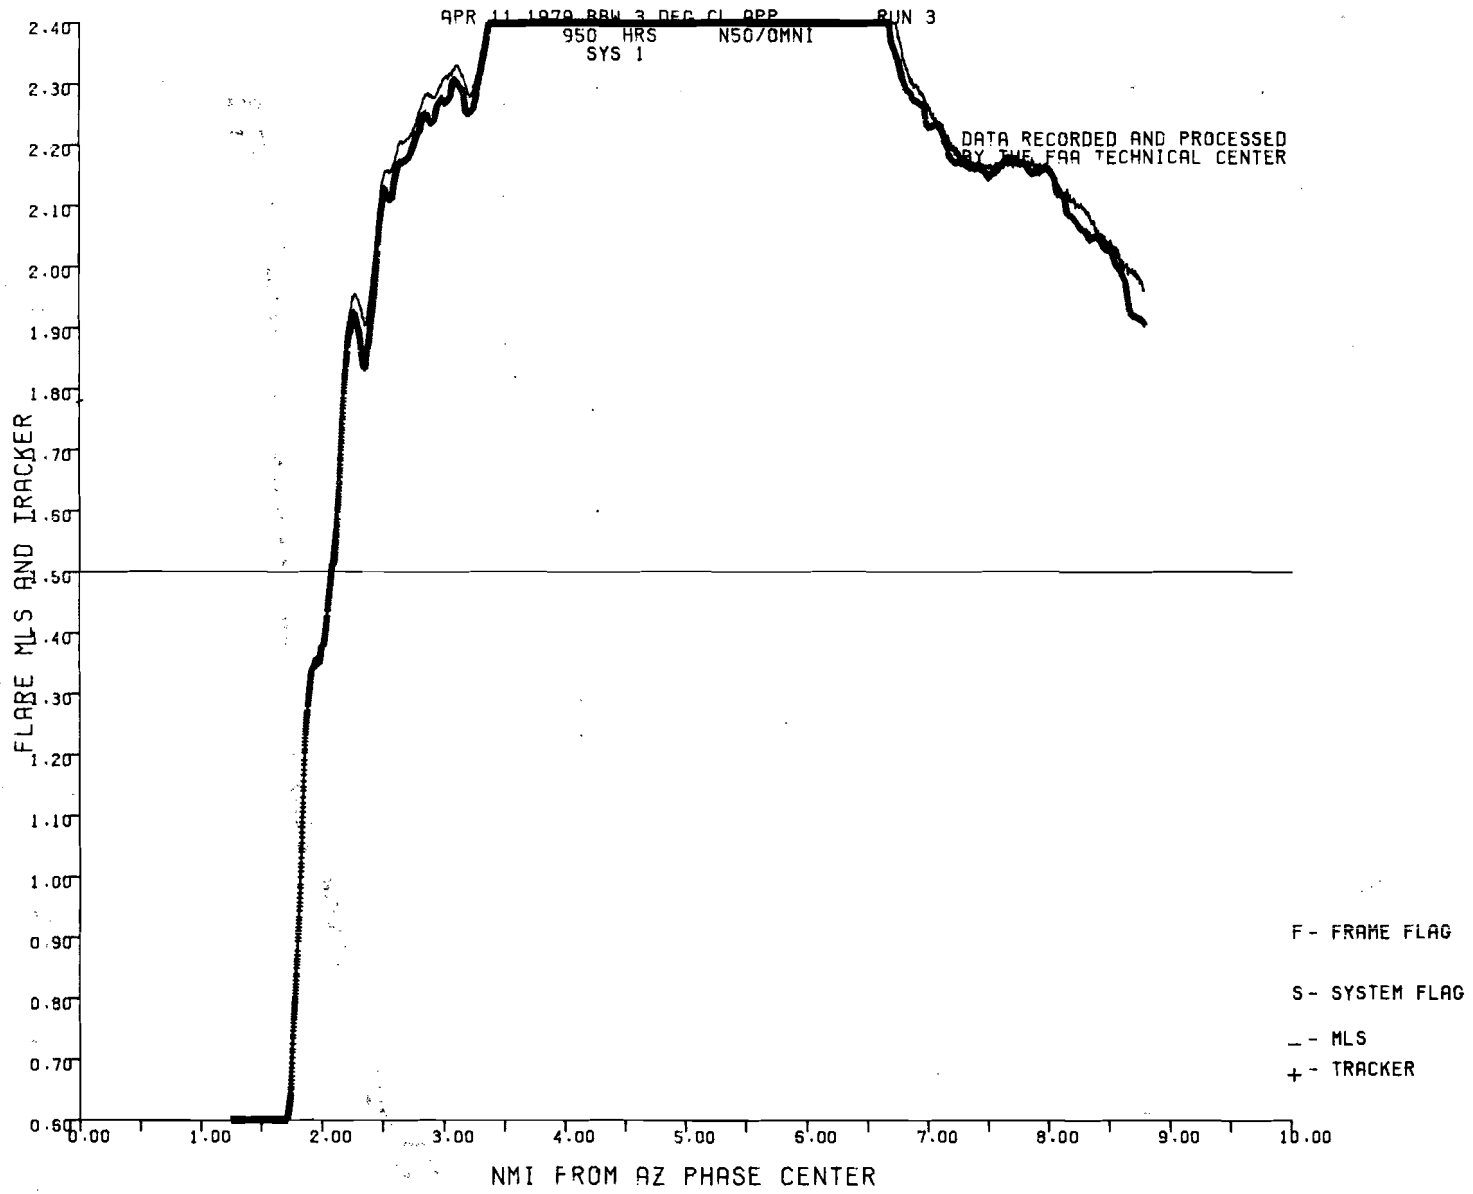
The diagnostic plots in appendix B show the receiver angle data and tracker information used in calculating the error plots. These plots are used only to help identify the source of sudden variations in the corresponding error plots. The

diagnostic plots, figures B-1 through B-5, correspond to the error plots, figures A-1 through A-5, respectively. Diagnostic plots are not provided for the partial orbit flight profiles because the scale factor required to cover a $\pm 10^\circ$ sector rendered the receiver and tracker traces indistinguishable from each other.
