# Summary of Findings from the PIREP-Based Analyses Conducted During the 1988 to 1990 Evaluations of TDWR-Based and TDWR/LLWAS-Based Alert Services Provided to Landing/Departing Pilots

Research and  
Special Programs  
Administration  
John A. Volpe National  
Transportation Systems Center  
Cambridge, MA 02142-1093

Final Report  
July 1992

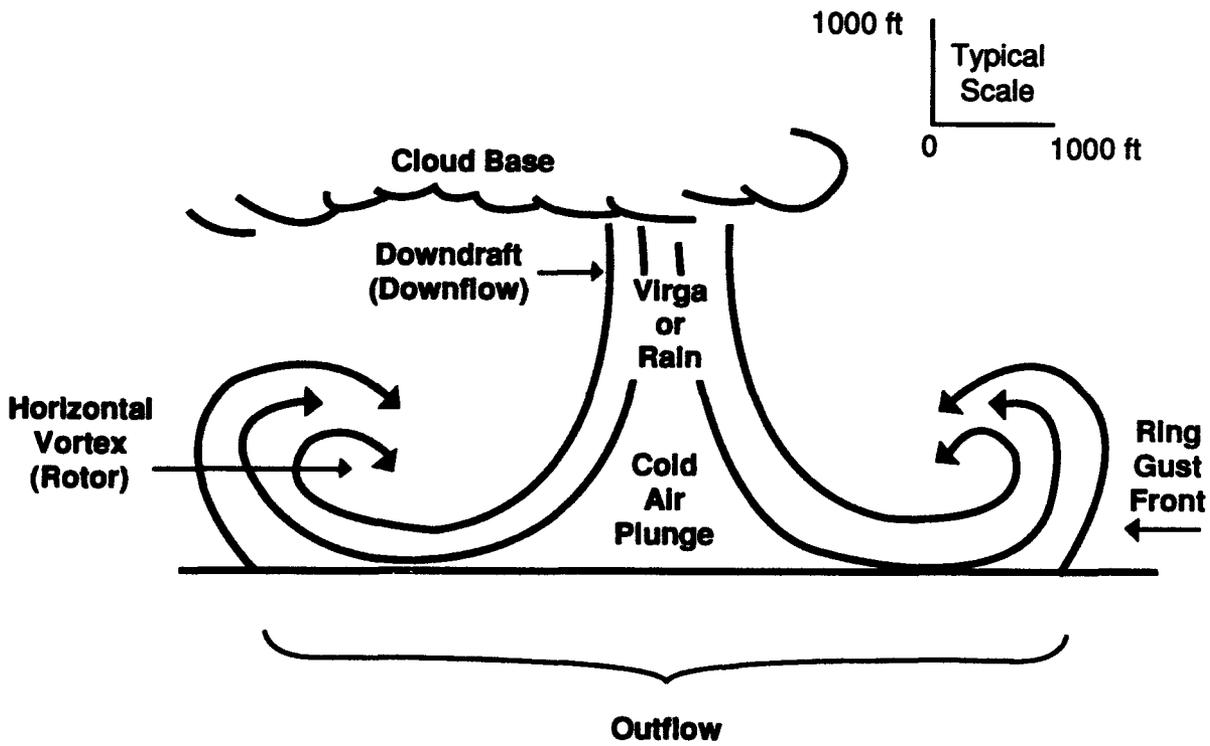
**FIGURE 2-1: BASIC STRUCTURE OF THE MICROBURST SHOWING COMMONLY ASSOCIATED FEATURES**

Figure 2-1 shows the basic structure of a microburst. On occasion, the outer edge of the outflow would travel some distance from the microburst downflow area and was encountered in its own right, as a separate entity. Landing/departing pilots became involved with microburst-generated gust fronts on several occasions.

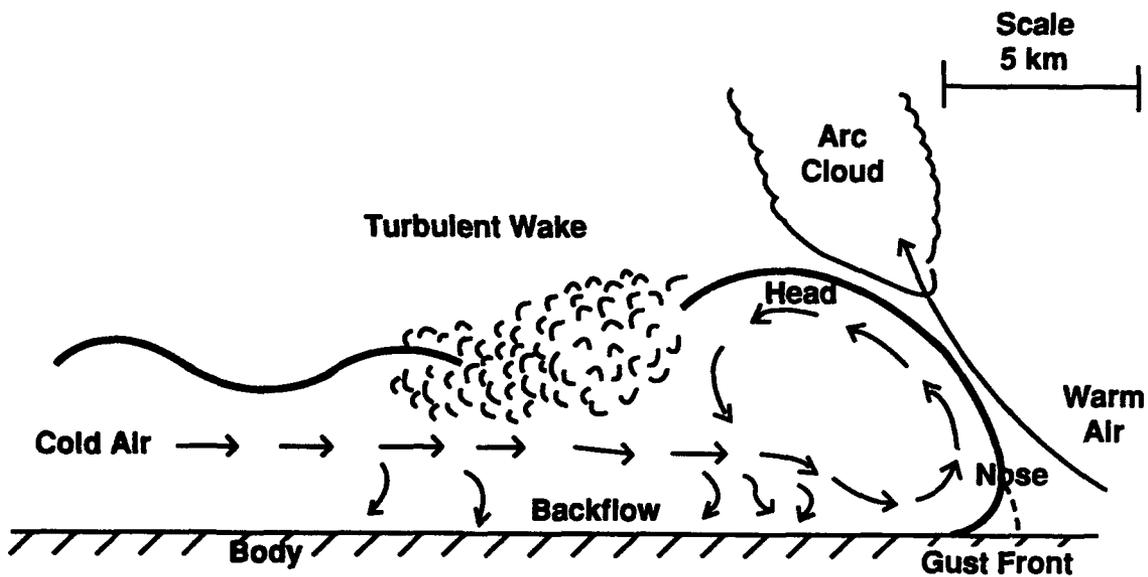
**FIGURE 2-2: BASIC STRUCTURE OF THE GUST FRONT SHOWING COMMONLY ASSOCIATED FEATURES**

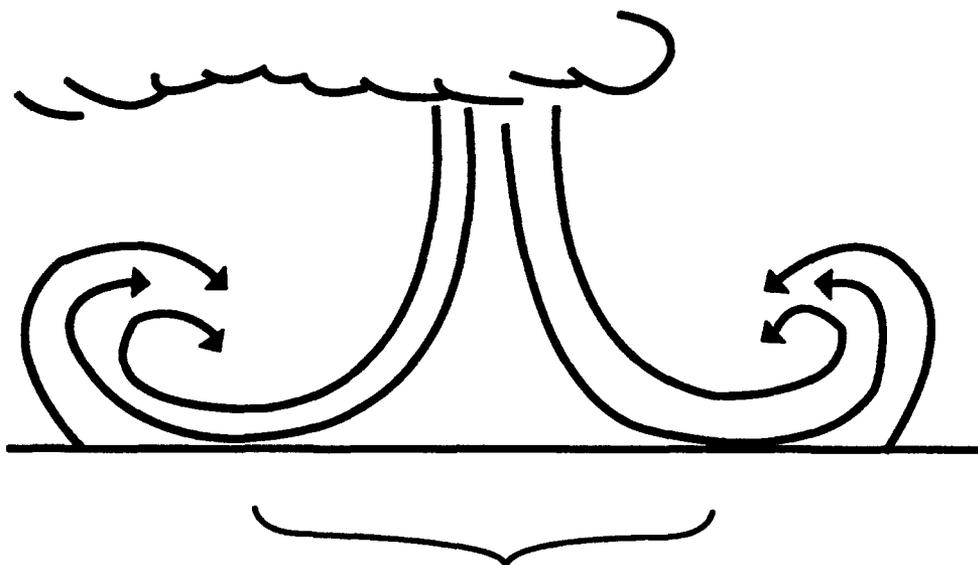
**Alert Area Declared by TDWR**  
(Area of decreasing headwinds that would be experienced by a penetrating aircraft.)

**FIGURE 3-1: THE ALERT AREA DECLARED BY TDWR AS COMPARED TO THE OVERALL MICROBURST STRUCTURE**

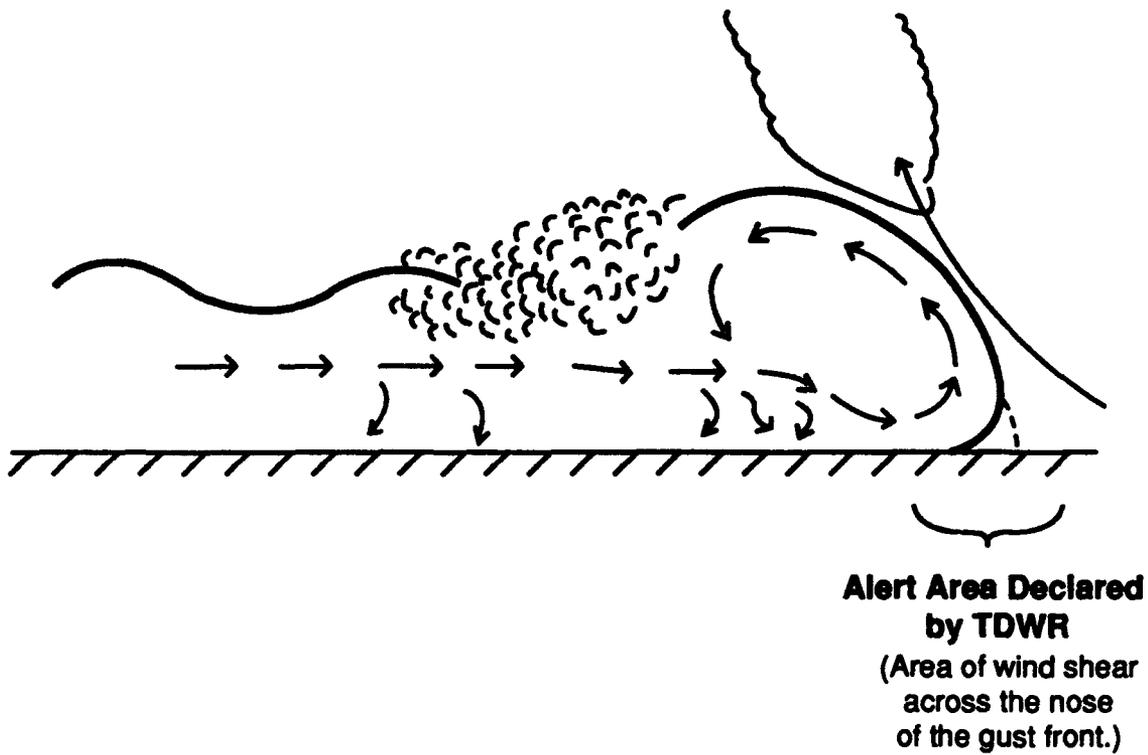
**FIGURE 3-2: THE ALERT AREA DECLARED BY TDWR AS COMPARED TO THE OVERALL GUST FRONT STRUCTURE**

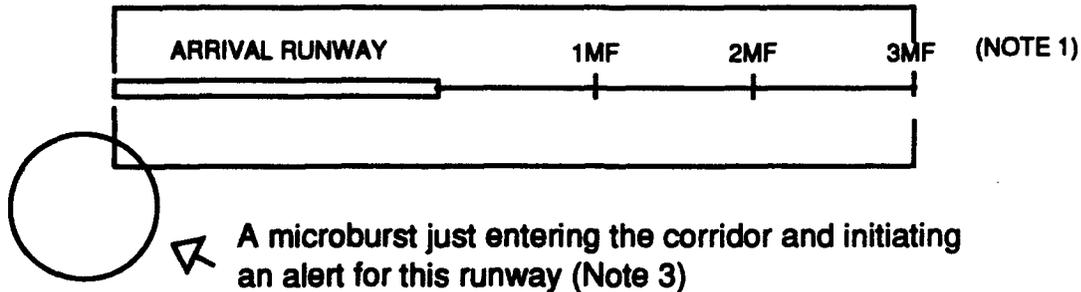
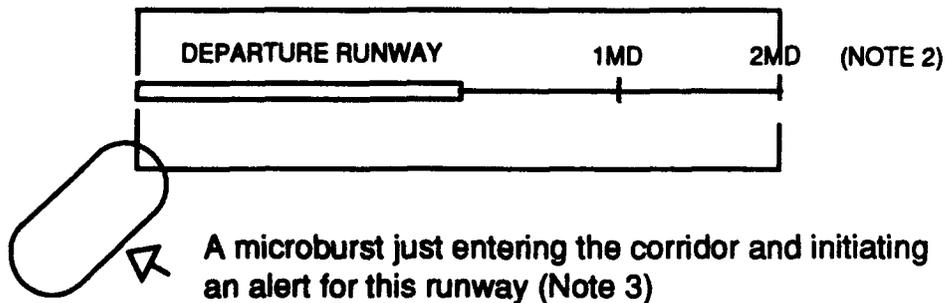
- NOTES:**
- (1) 3MF stands for "3-Mile Final"
  - (2) 2MD stands for "2-Mile Departure"
  - (3) The system software depicted microbursts in either of two shapes: The shape of a band-aid if the software sensed that the microburst's outflow had an elongated axis in some direction or the shape of a circle if it did not.

**FIGURE 3-3: FINAL FORM OF THE SAFETY CORRIDOR GEOMETRIES USED IN THE EVALUATIONS**

Alert coverage was provided to landing pilots for wind shear features inside 3-Mile Final and to departing pilots for wind shear features out to 2-Mile Departure. To increase safety, alert coverage was provided for wind shear features not just on the final approach path and initial takeoff path but for a corridor around these paths (i.e., for 0.5 miles on each side of these paths). Figure 3-3 shows the final form of the safety corridor geometries as of 1990. In the earlier evaluations, the safety corridor for departures extended out to 3-Mile Departure.

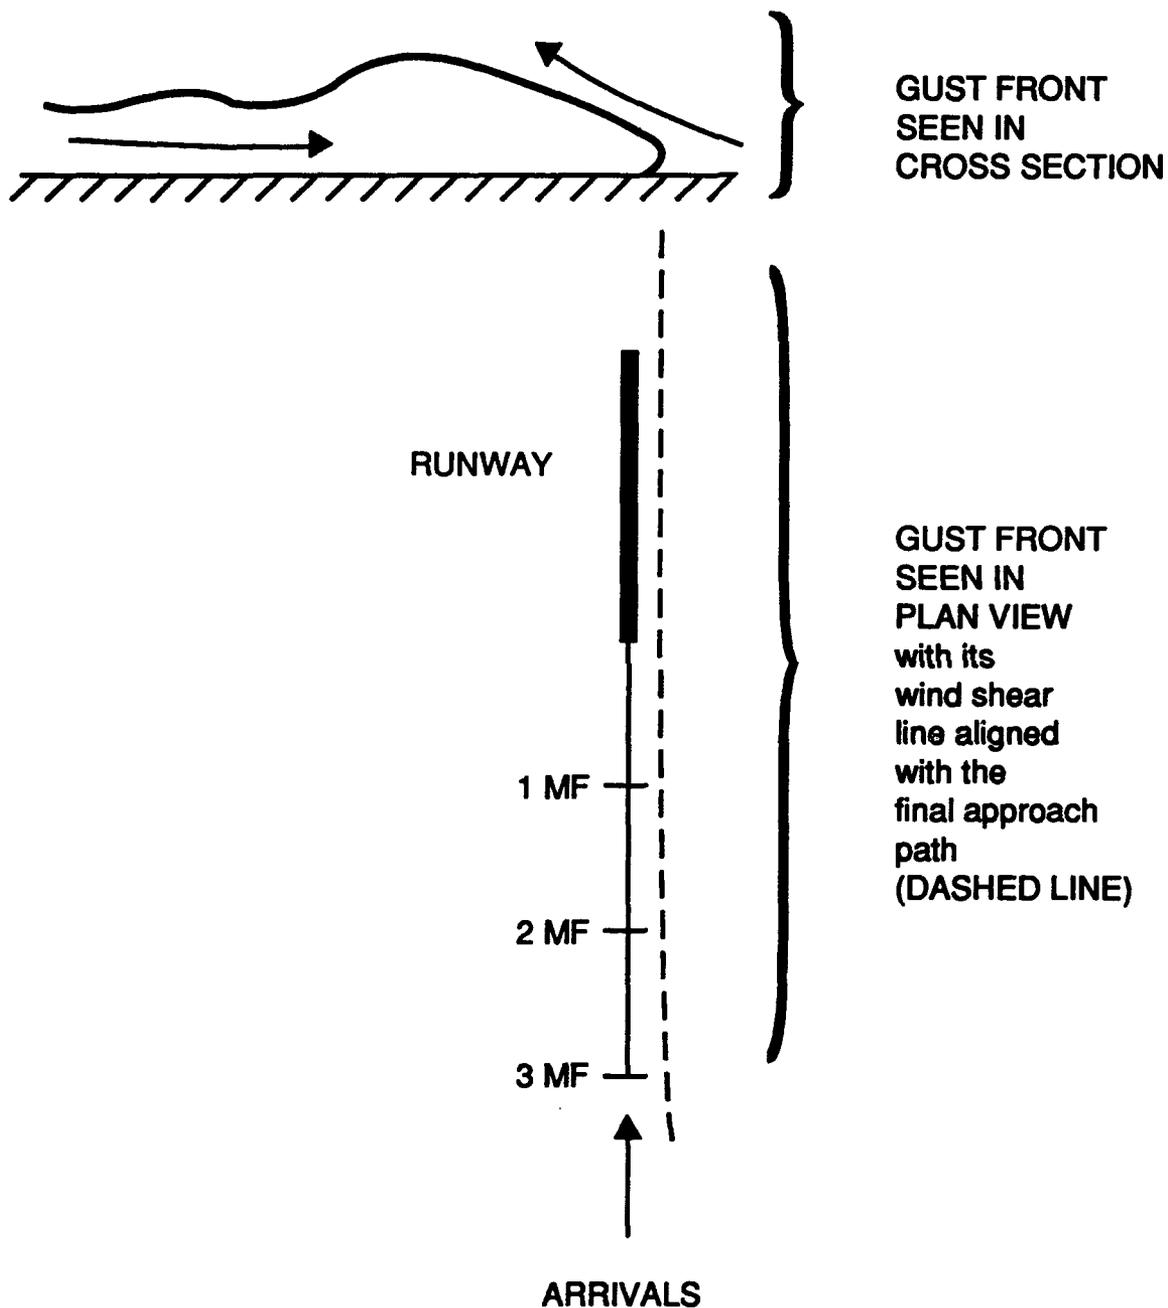
**FIGURE 5-1: GUST FRONT ALIGNED WITH THE FINAL APPROACH PATH - A SITUATION NOT PROVIDED ALERT COVERAGE DURING THE EVALUATIONS BY THE TDWR/LLWAS ALERT SYSTEM**

The end result of this restriction was that TDWR/LLWAS did not provide alert coverage of gust fronts when the head of a gust front, with its turbulence and downdrafts, became aligned with the final approach path and enveloped it. This situation occurred several times and caused numerous pilots to report significant encounters, including: (1) "pretty rough and miserable ride all the way down," (2) "as tough a landing as I have ever made," (3) "pretty large sinker at 50 feet, quite a large airspeed variation; going around," and (4) "15-knot loss and a marked wind shift at 200 feet... really ought to let people know." This was another area identified for consideration of expanded alert coverage in the Conclusions.
