## **Scour Monitoring of Indiana Streams**

FHWA/IN/JTRP-2002/8

Joint Transportation Research Program  
Project No. C-36-62L  
File No. 9-8-12  
SPR-2488

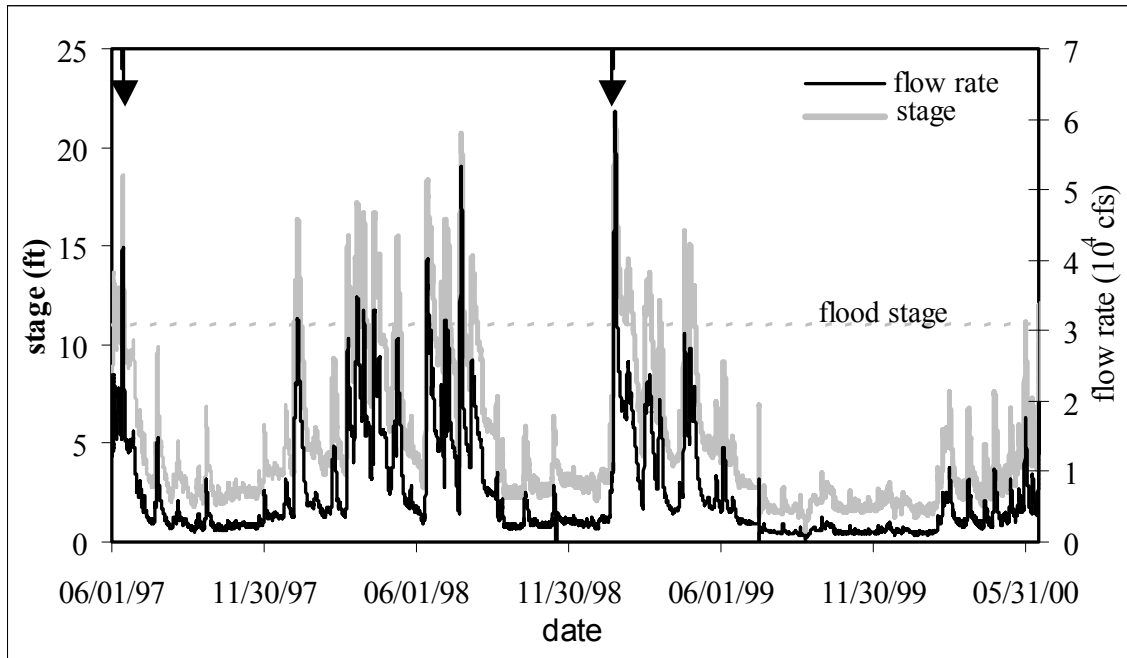
Fig. 1: Time series of stage and discharge for the Wabash River at Lafayette over the previous project period (6/1/97-5/31/00); the arrows indicate the date when the sonar device failed due to damage during a flood event

Hourly flow data used to identify hydrological events were based on data from a nearby USGS gaging station (station no. 03335500) located less than 1 mile downstream of the Wabash River site. Flood stage at the Wabash River station is declared at a stage of 11 ft, corresponding to a discharge of 17,300 cfs. Fig. 1 shows a stage and discharge data for the previous project period (6/1/97-2/1/00) for the Wabash River. The two instances when the device failed due to damage have been indicated, and it is clear that both incidents coincided with flood events. The first failure occurred at a flood stage of 18.6 ft and 41,712 cfs, while the second failure occurred a flood stage of 21.8 ft and a discharge of 61,097 cfs, by far the largest event so far recorded (including the current project period). In spite of this, an examination of the maximum annual flow series for this station (based on 97 years of data from 1901 to 2000) indicates that a discharge of 61,097 cfs corresponds to an average return period of  $\approx 3.5$  years.

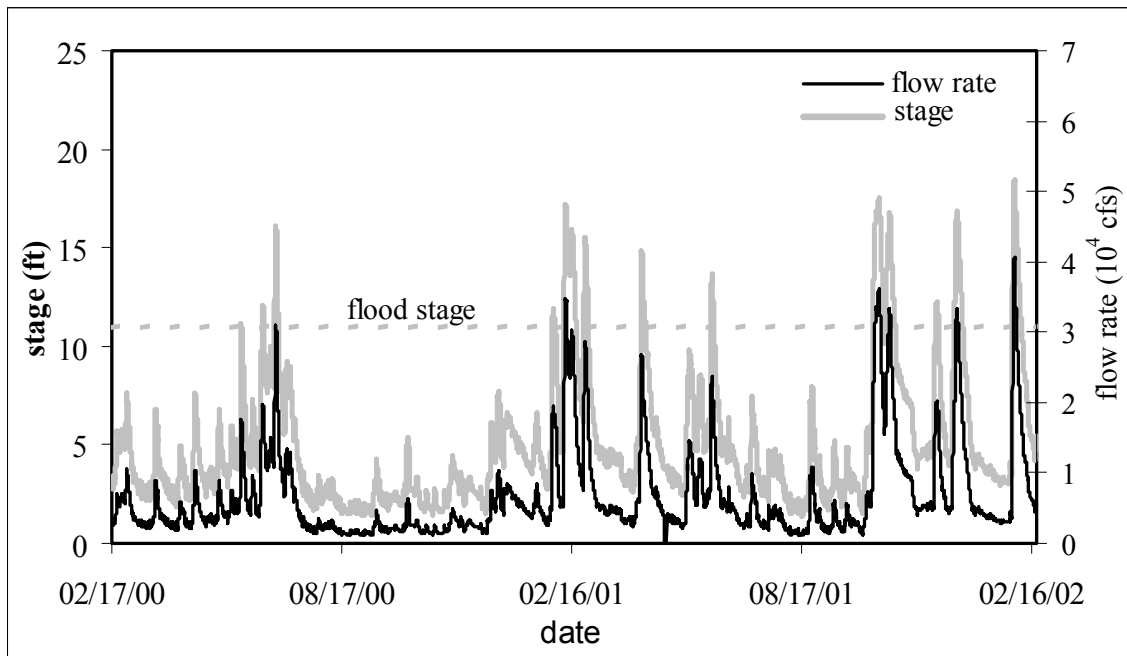
Fig. 2: Time series of stage and discharge for the Wabash River at Lafayette over the current project period (6/1/00-2/16/02)

For comparison, the stage and discharge time series for the current project period (6/1/2000-2/1/2002) are shown in Fig. 2. Several flood events may be identified, the largest of which (a stage of 18.4 ft and discharge of 40657 cfs) was comparable to the event associated with the first failure. Since its last repair, re-design, and re-installation in November 1999, i.e., a period of over 25 months, the sonar device has operated without failure due to damage. Because of the absence of very large events during the project period, a definitive statement concerning the survivability of the device cannot yet be justified. Nevertheless, it is believed that, with the modifications made, the device would survive an event of magnitude at least equal and more likely greater than the event that caused the last failure. That the device has so far operated continuously without damage does give some positive indication that the sonar device can be practically and profitably deployed in the field under appropriate conditions.

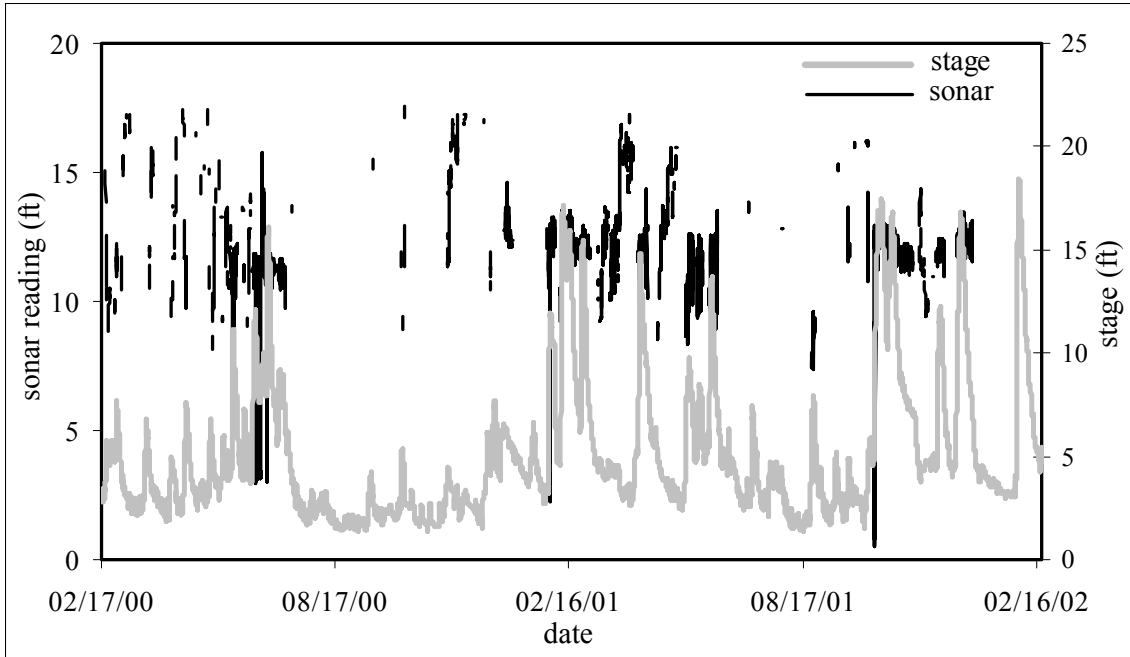
Fig. 3: Sonar device record over project period, compared with corresponding stage record

An overall overview of the data obtained with the sonar device is given in Fig. 3, where the sonar reading is plotted with the stage. As was found in the previous project period, a large scatter can be seen in the sonar data, with fluctuations of 5 ft common in the readings. The sonar operates properly only when it is submerged, and as such the sonar readings at low stage when it could not be submerged should be discarded. This has been done in Fig. 4, where only those sonar readings were retained which corresponded to a

The overall view provided in Figs. 3 and 4 does not give any insight into the relationship between the sonar scour monitoring data and the hydrologic parameters (either stage or discharge) because large flow events last only for relatively short durations, and on a multiyear scale, appear as an undifferentiated blob. In this section, these larger flow events will be examined on a finer scale, thereby allowing a more detailed view of the correlation between flow events and scour-monitor data. An example of a record of flow event (stage) and sonar data is shown in Fig. 6 during the event of 5/28/00-7/12/00. The sonar (hourly) signal exhibits substantial ‘noise’, making it difficult to discern trends. For this reason, a simple 9-point moving-average filter has been applied to the sonar signal. The corresponding smoothed signal is shown in Fig. 7. The smoothing operation does tend to attenuate sharp peaks, which should be kept in mind in interpreting the smoothed data, but longer-term trends are easier to identify.

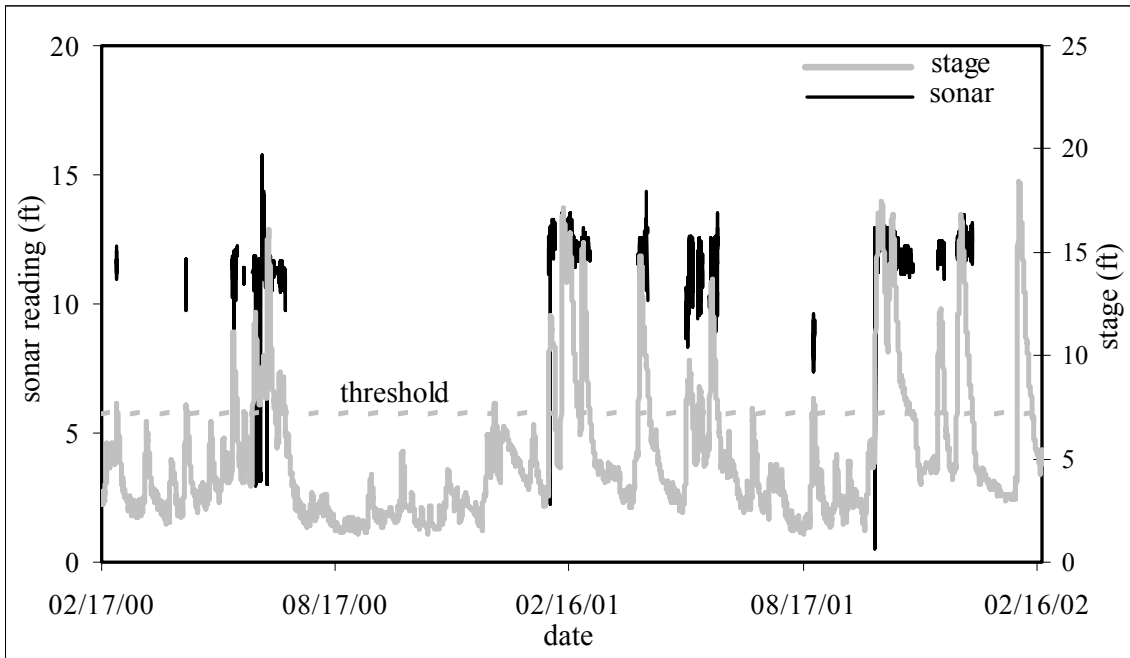
Fig. 4: Sonar readings in which those points that correspond to a stage less than a threshold value (7.25 ft) have been discarded

stage greater than 7.25 ft. A significant reduction in the scatter can be seen, except at isolated instants during the flow events of 6/14/00, 1/31/01, 10/12/01, when erratic spikes in sonar readings are evident. It should also be recalled that the sonar reading *increases* when the streambed *recedes*, presumably as a result of local scour.

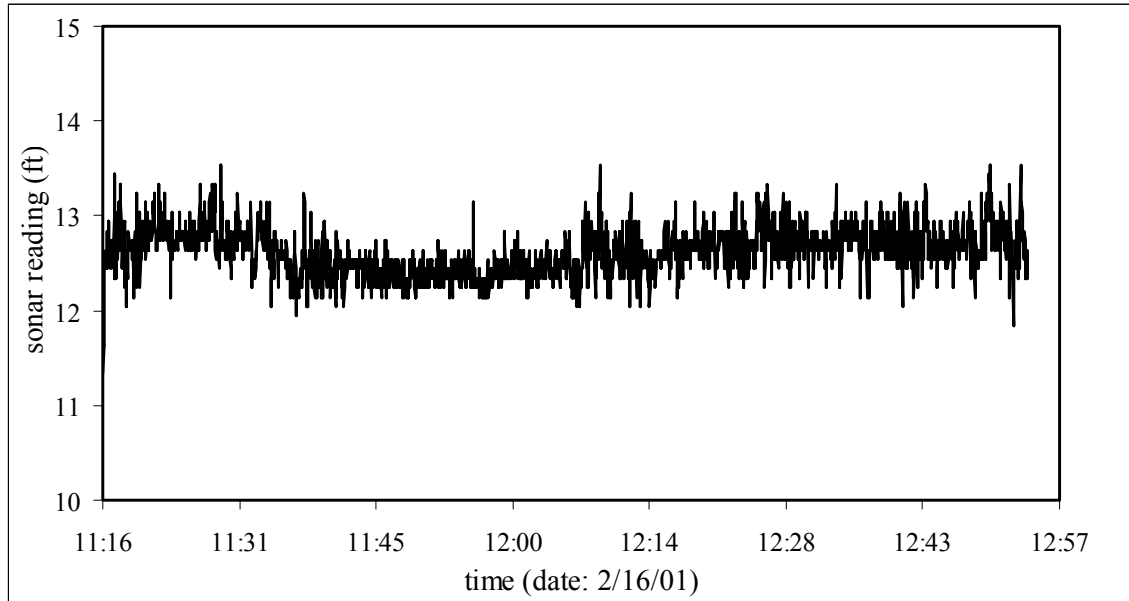
Fig. 5: Record of test of sonar device in which data were taken at a much higher sampling rate to check whether any evidently erratic behavior could be identified

As a further test of the sonar device, a time series with much higher sampling rate (every two seconds instead of every hour) was recorded to check whether the erratic behavior of the data would still be seen. The sonar record over a period of approx. 90 minutes taken during the event of 2/16/01 is shown in Fig. 5. The readings are quite well-behaved,

exhibiting some expected noise, which however is contained within a rather narrow band (note that the scale of the ordinate has been expanded from the previous figures to emphasize the narrowness of the noise band), sufficiently narrow in fact that a physical trend can be discerned in spite of the noise. This suggests that the sonar device is operating as intended.

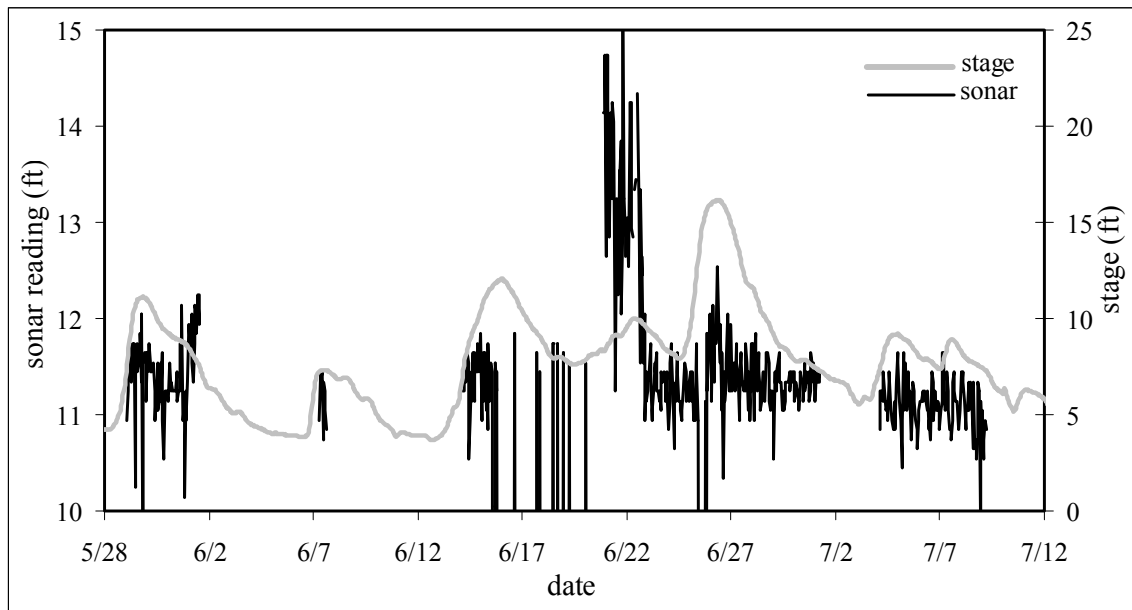
Fig. 6: The hourly sonar signal for the event of 5/28/00-7/12/00 plotted with the hourly stage signal.

In general, a broad positive correlation between stage and sonar reading can be found. Higher stages imply larger discharges and typically larger mean velocities, so that a positive correlation would be expected. Except for Fig. 7, where some erratic behavior is seen (a sharp decrease in sonar reading, followed by a region of rather flat behavior), the other events all exhibit broadly similar longer-term changes in stage and in sonar reading. For the longest continuous sonar reading record (during the event shown in Fig. 8), the

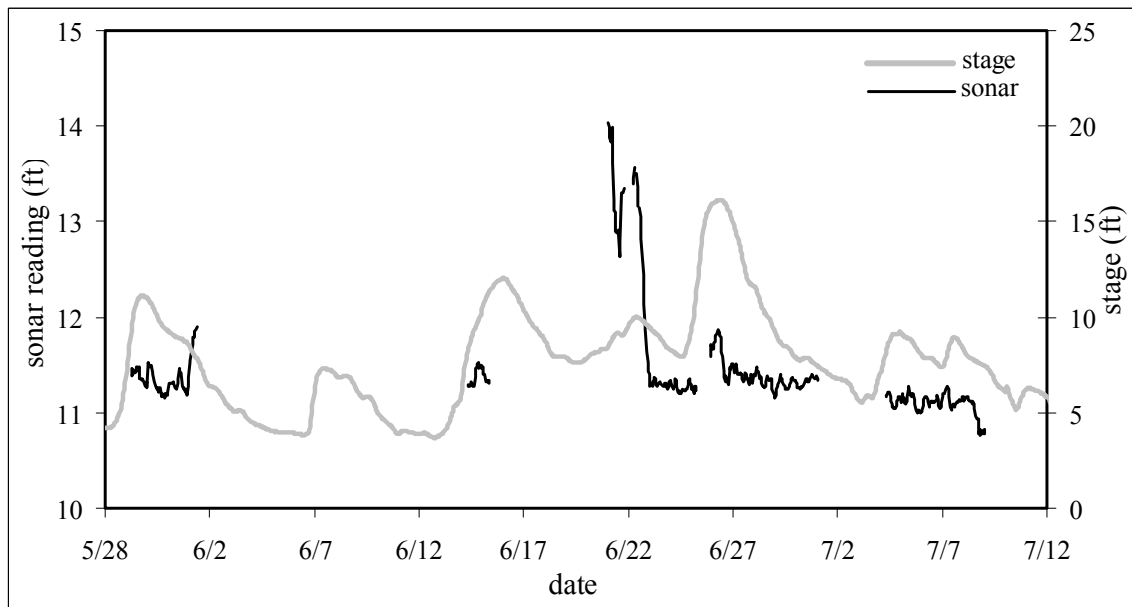
Fig. 7: Filtered signal from sonar scour monitor from 5/28/00-7/12/00, together with the corresponding stage signal

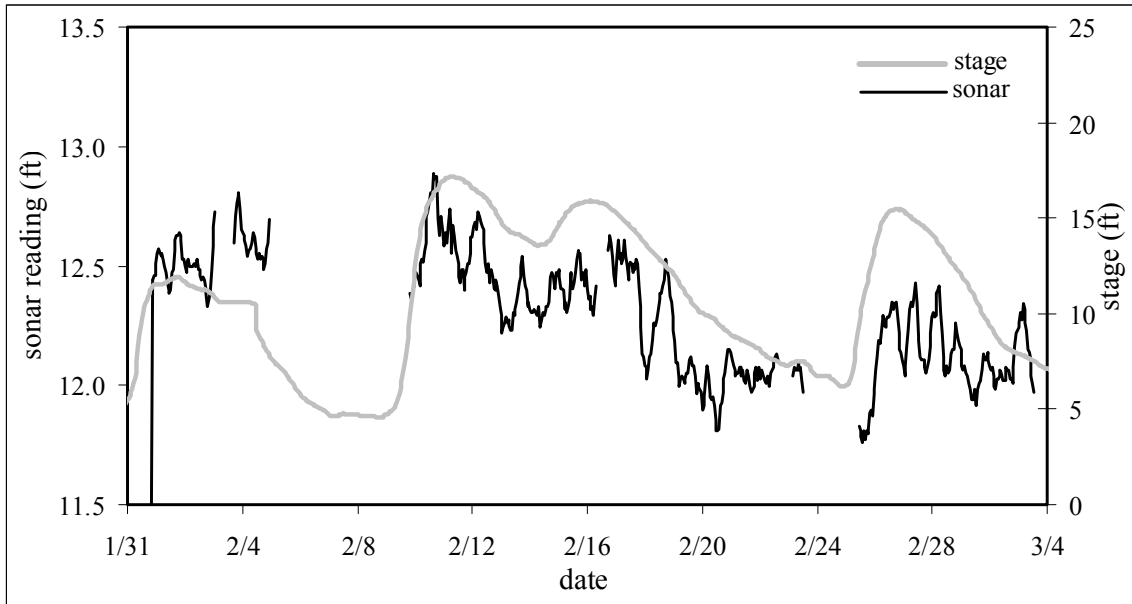
Fig. 7: Filtered signal from sonar scour monitor from 1/31/01-3/4/01, together with the corresponding stage signal

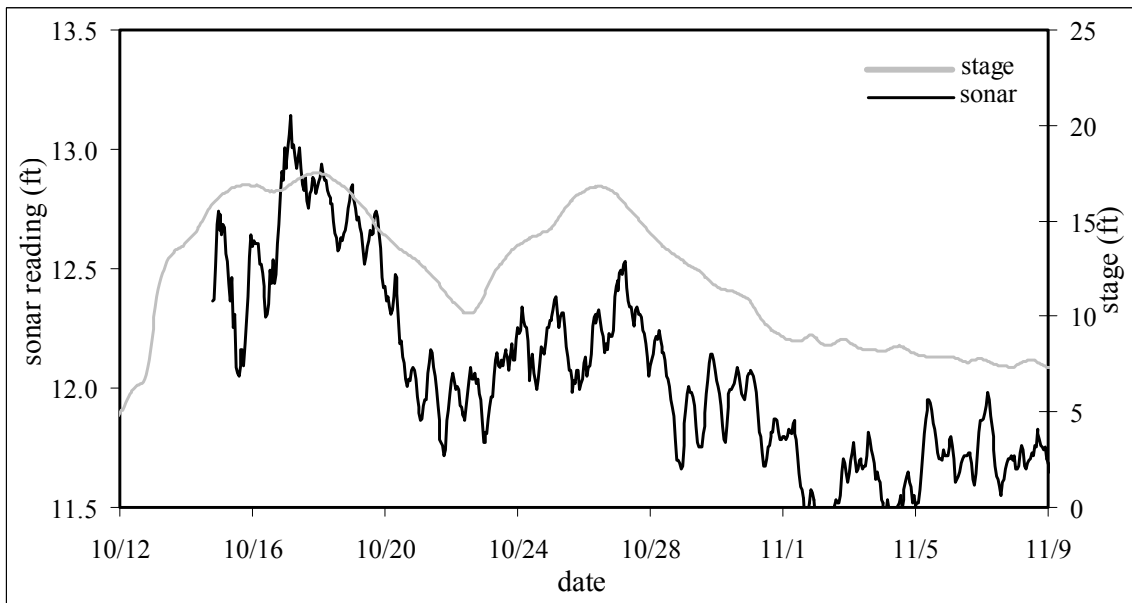
Fig. 8: Filtered sonar scour monitor signal from 10/12/01-11/9/01, together with the corresponding stage signal

sample correlation coefficient,  $r$ , between stage and sonar reading was found to be 0.86, which indicates a reasonably strong relationship between the two variables.

An interesting aspect, especially evident in Figs. 8 and 9, are relatively regular short-term (period of  $\approx 16$  hours) variations of the bed level. While these were hidden in the raw data, they are quite prominent in the filtered data, and do not seem to be strongly correlated with the longer-term variations in stage. It is conjectured that these reflect the pas-

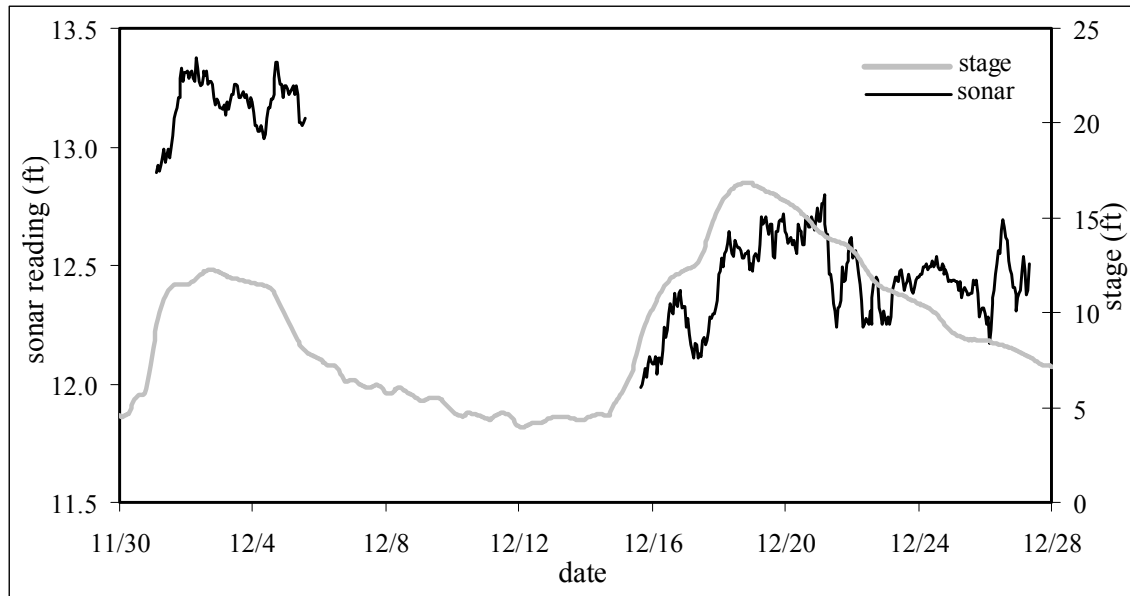
Fig. 9: Filtered sonar scour monitor signal from 11/30/01-12/28/01, together with the corresponding stage signal

sage of trains of bed forms, such as dunes, which would be present for a range of flows, *even in the absence of the pier*. This suggests that some care should be exercised in interpreting the sonar reading, since the scour-and-fill process is not necessarily solely associated with the scour around bridge piers. On the other hand, that the sonar reading is able to track the effects of known physical features such as bed forms gives further support to the credibility of the sonar data.
