Research Report

**EVALUATION OF NDOT'S CONSTRUCTION
STORMWATER DETENTION MEASURES USING
FULL-SCALE TESTING TECHNIQUES**

A Report on Research Sponsored by:
Nebraska Department of Transportation
and
Federal Highway Administration

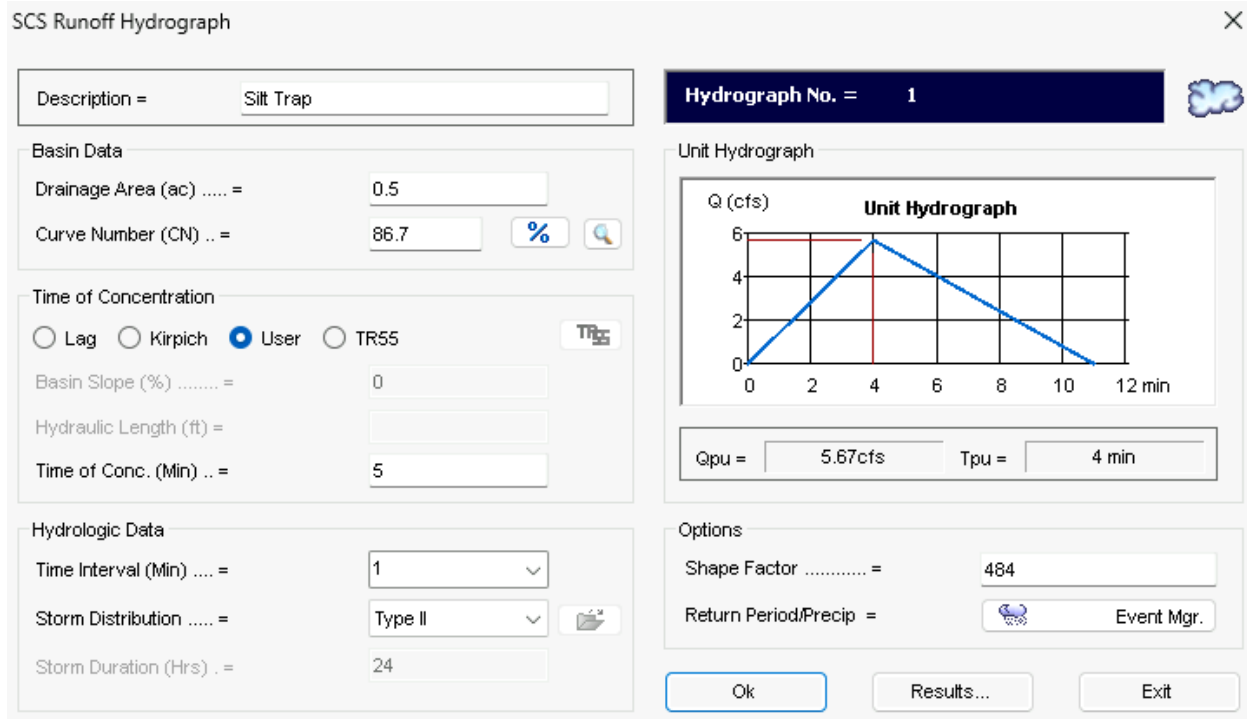
(a) Silt Trap Hydrograph

the smallest possible value at 1 minute to provide greater precision. The storm distribution was a Type II meaning significant rainfall was experienced over a short duration for these storms and was based on the geographic location of Nebraska as depicted in Figure B-2 of the TR-55 manual. The CN, storm distribution, time of concentration, and time interval factors remained consistent for both the silt trap and sediment trap hydrographs. The differing factor for each practice was the drainage area. For the silt trap, an area of 0.5 ac (0.2 ha) was analyzed while an area of 1.0 ac (0.4 ha) was analyzed for the sediment trap. The hydrographs were input and run as seen in Figure 3.4 (a) and (b) for both traps.

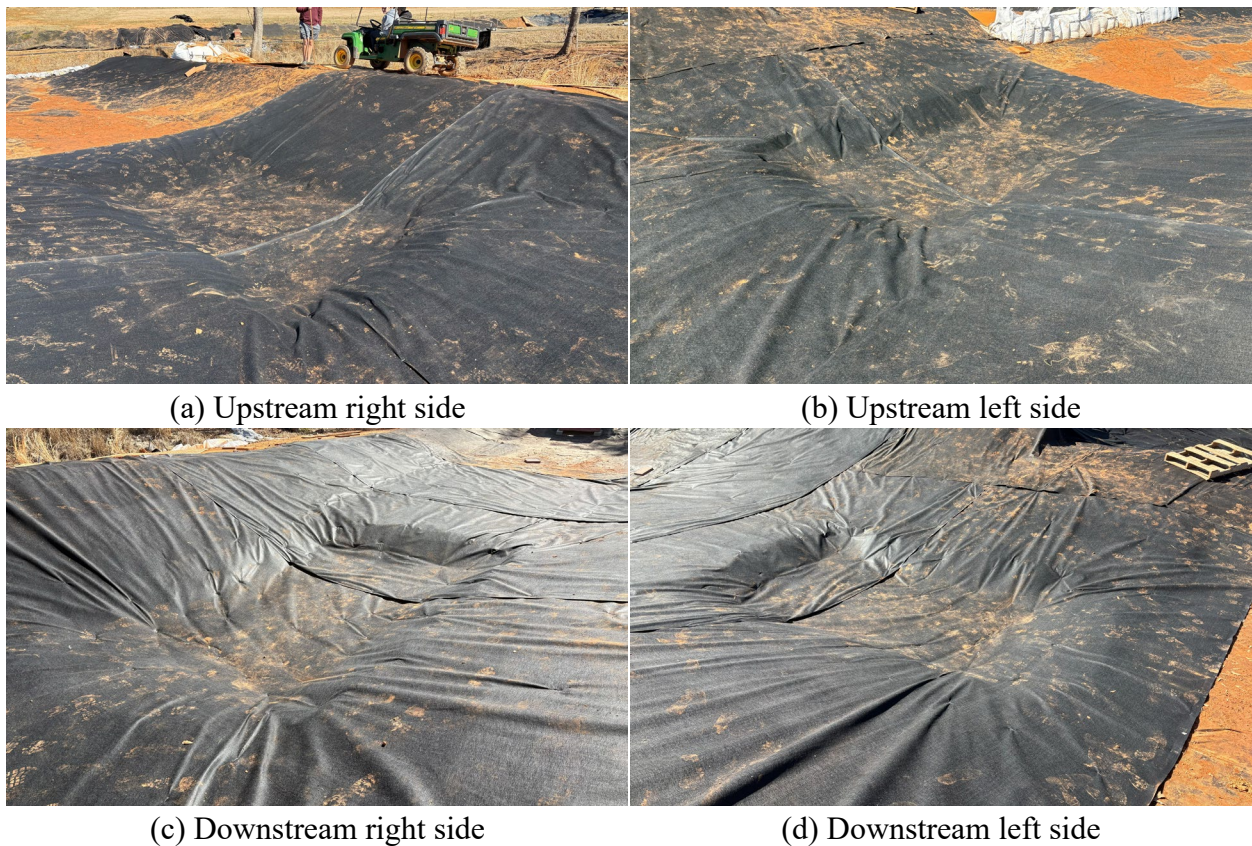
Figure 4.1: NDOT Standard Silt Trap

standard silt trap was 0.3 m (1 ft) deep with 2:1 (H: V) side slopes. The length was twice the width of the excavated trap at 3.66 m (12 ft) and 1.83 m (6 ft) respectively. The top measurements of the trap were 4.88 m (16 ft) in length and 3.05 m (10 ft) in width. The silt trap took the entire width of the channel bottom. The trap was covered in an 8 oz (227 g) geotextile that was securely pinned down with 1 in. (2.5 cm) by 6 in. (15.2 cm) sod staples made of 11-gauge steel wire. The NDOT standard silt trap was considered the control for installation comparisons. Four angles of the silt trap were shown in Figure 4.1 before testing was started.

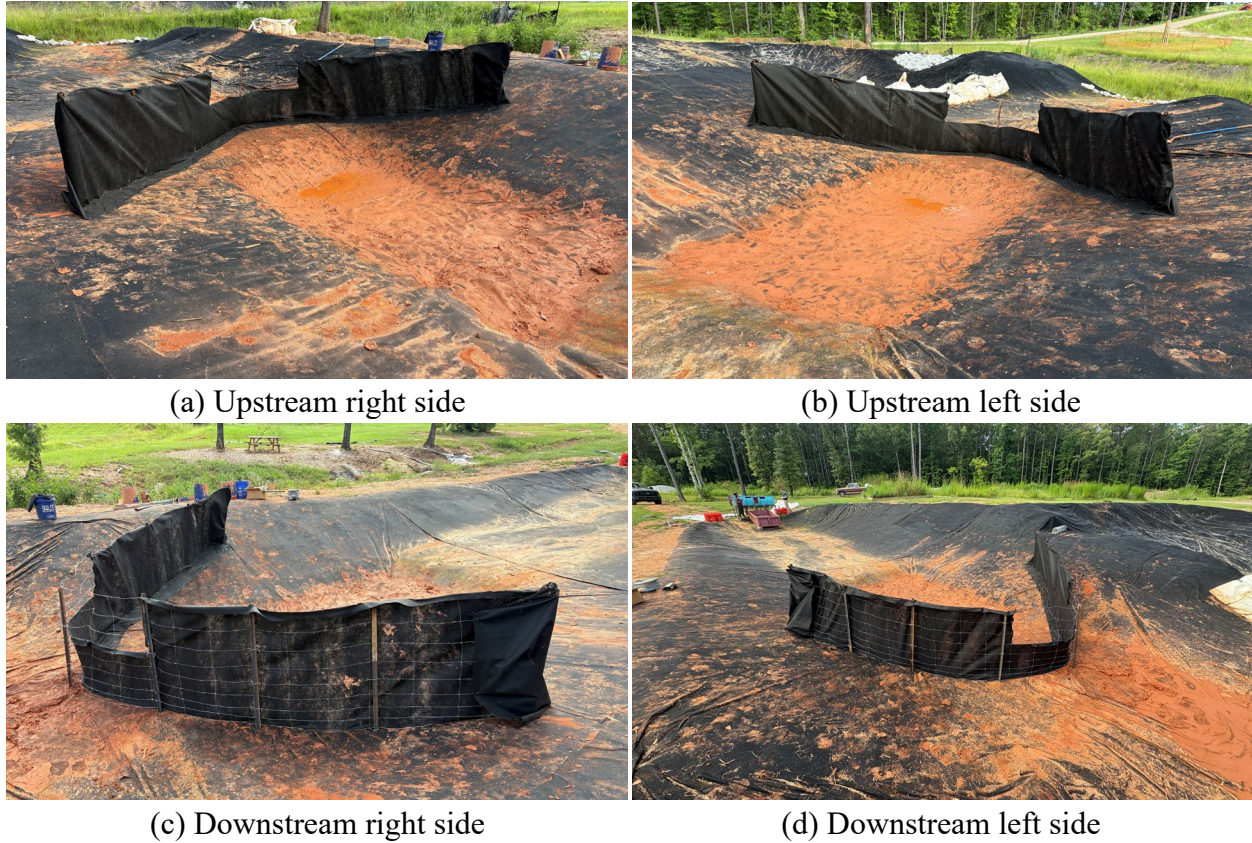
Figure 4.4: Modified Silt Fence

a silt trap. The geotextile was a nonwoven polypropylene weighing 3.5 oz/yd² (118 g/m²). The support backing for the fence was 14.5-gauge steel wire with 12 in. (30.5 cm) spacing between the vertical wire and 3 in. (7.6 cm) horizontal spacing at the bottom up to 8 in. (20.3 cm) horizontal spacing at the top. The geotextile and wire were supported by studded steel T-posts with a weight of 0.95 lb/ft (1.4 kg/m) at a spacing of 3 ft (0.9 m). The center post was positioned 3 ft (0.9 m) from the edge of the center of the silt trap, unlike the typical 2 ft (0.6 m) offset. The next posts on either side of the center post were positioned 1 ft (0.3 m) from the edge of the silt trap with the next posts resting on the toe of the bank. In this manner, the fence posts continued up the side slopes. This created a V-shape fence behind the silt trap, opening toward the upstream side of the channel. The wire backing was attached at the top, middle, and bottom of the T-posts using 6.5 in. (16.5 cm) 11-gauge aluminum tie wire. The fence was then attached along the top of the wire backing using 11/16 in. (1.75 cm) 16-gauge galvanized steel C-ring staples. The height of the fence was 24 in. (61.0 cm). The bottom of the fence – a 6 in. (15 cm) fold upstream – was fastened to the ground using two alternating rows of 1 in. (2.5 cm) by 6 in. (15 cm) 11-gauge steel wire sod staples. The trenching method was not utilized due to the geotextile lining of the channel that prevented scour. In the modified silt fence, a 6 ft (1.8 m) long weir was cut at the center of the channel, spanning the three centermost T-posts. The height of the weir section was 18 in. (45.7 cm), and the edges along the weir were secured with C-ring staples. Four angles of the silt trap and modified silt fence were shown in Figure 4.4 before testing was started.

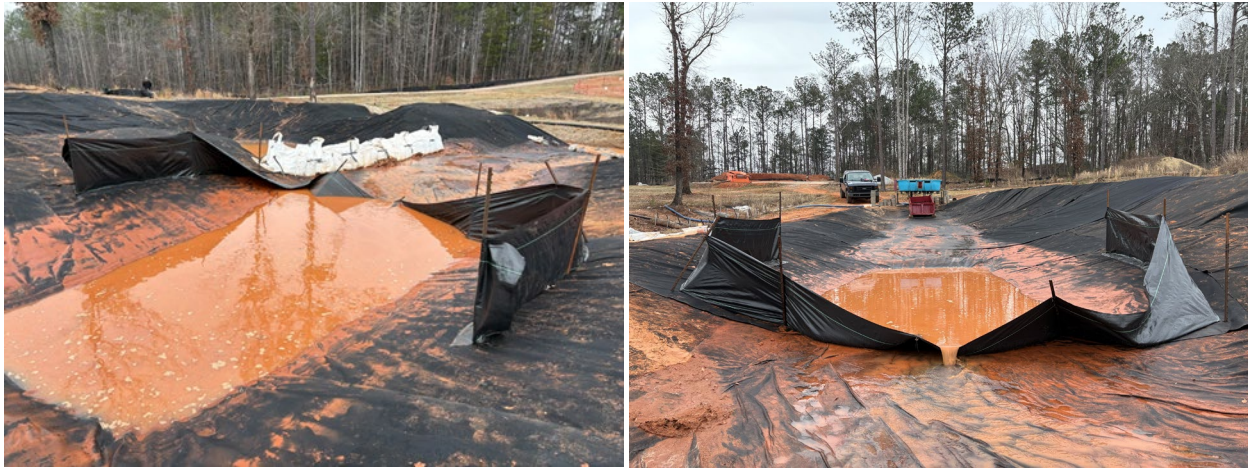
(a) Failure, facing downstream

(b) Failure, facing upstream

Figure 4.17: Low Porosity Silt Fence Failure

was the ripping of the silt fence as the zip ties holding the fence material to the T-posts broke through the fabric. Figure 4.17 highlighted the failure methods mentioned.

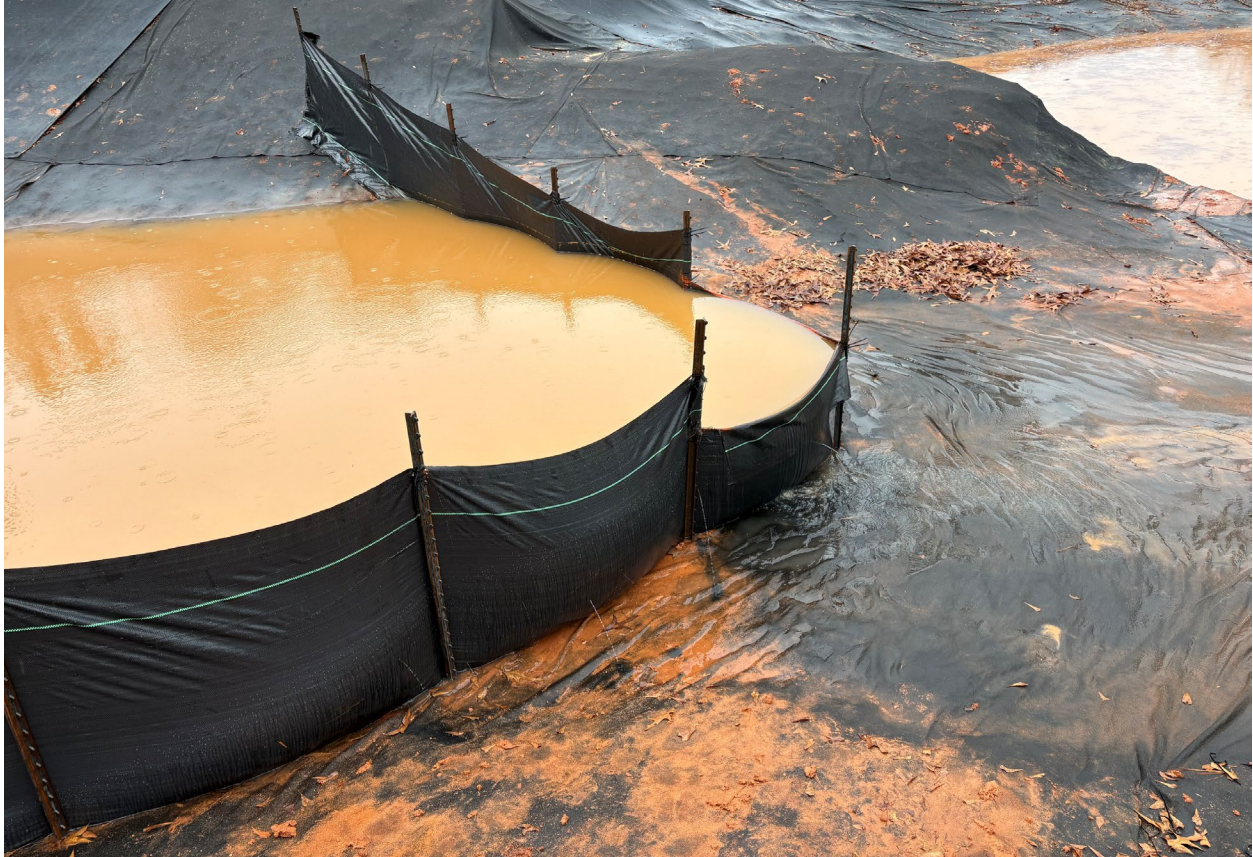
Figure 4.25: Installation 3 After Test C

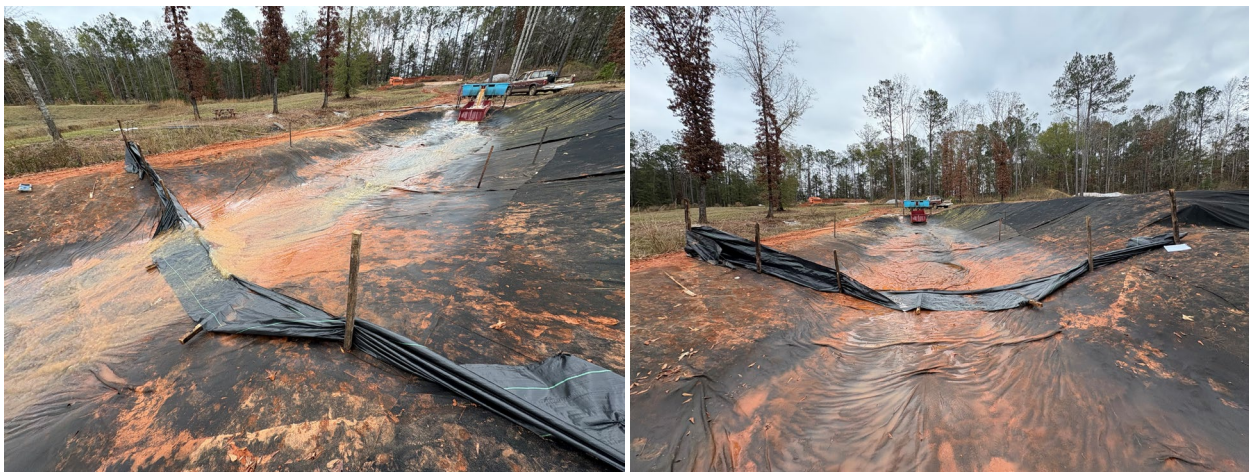
Figure 4.26: Installation 4 Failure

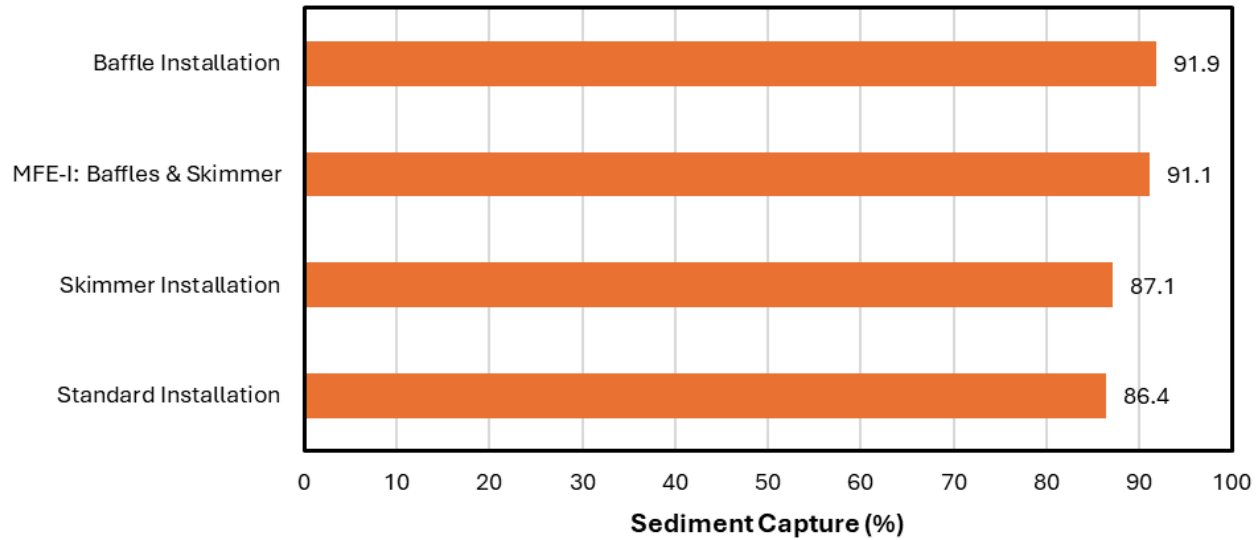
Figure 4.32: Sediment Capture Per Installation

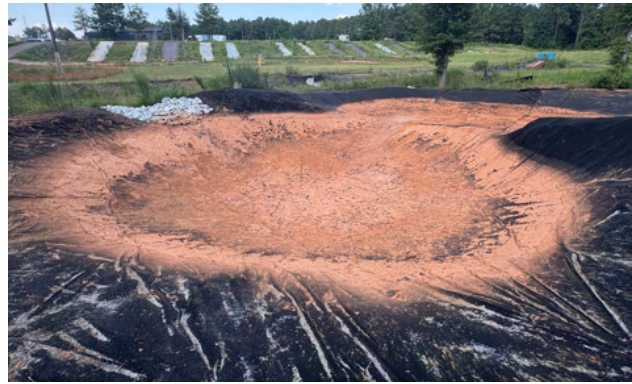
Installation Description & Test Notes: The sediment trap, sized for 1 ac of contributory drainage, was installed according to the NDOT plan set. It had a 4 ft long rock weir that was 1 ft deep built with AL Class 1 riprap as a conservative equivalent for the NE Type A riprap. The trap bottom dimensions were 10 ft wide and 22 ft long. The test notes were that the water did not drain once the level dropped beneath the weir. The 2-yr, 24-hr design storm caused the trap basin to fill and the channel to fill near the mouth of the trap. The trap did not have outflow until 30 min into the test (when the flow was cut). The trap continued to dewater through the weir for three hours after the test flow period.

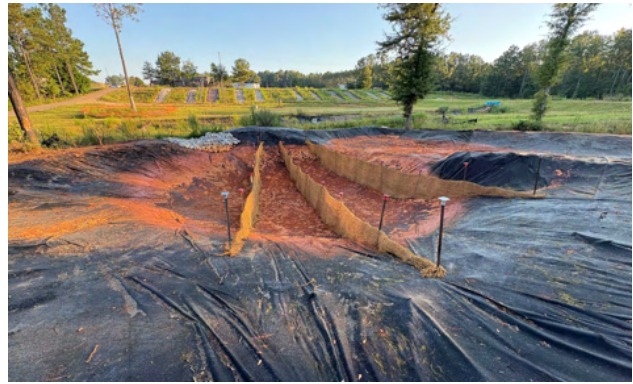
Installation Description & Test Notes: The sediment trap, sized for 1 ac of contributory drainage, was paired with three coir baffles. The baffles were supported with wire attached to steel T-posts. The baffles divided the basin into four nearly equal bays including the channel near the mouth of the trap. The trap did not dewater through the weir until the test reached 25 to 30 min or around when the inflow was stopped. The weir dewatered for around 3 hours after the test inflow period ended then retained the remaining water in the trap. The first baffle was observed to visibly slow inflow from the first bay into the second bay. Any change produced by the third baffle was unnoticeable in testing.

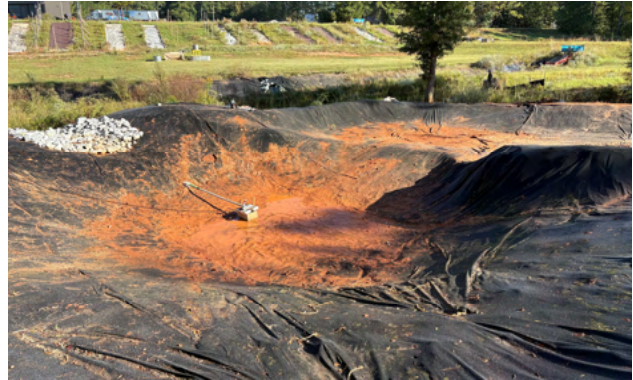
Installation Description & Test Notes: The sediment trap, sized for 1 ac of contributory drainage, was paired with a 1.5 in. skimmer with 100% orifice opening. The skimmer was sized with the Faircloth Estimator's Calculator based on the required volume with a goal of dewatering for a minimum of 48 hours. The skimmer dewatered in around 30 hours due to the spillway height (recommended that the basin dimensions be input into the calculator in the future). The first test was sampled hourly for two consecutive workdays following the test. The TSS and turbidity values decreased consistently over the extended sample period. During the test, inflow was observed pushing the skimmer to the far side of the basin until the trap filled and overflowed into the channel.
