# Alternative Deicer Performance Characterization: Know Before the Snow (Addendum)

Final Report 2026-09

# **Alternative Deicer Performance Characterization: Know Before The Snow**

## **Addendum: On-Pavement Field Comparison, Second Winter**

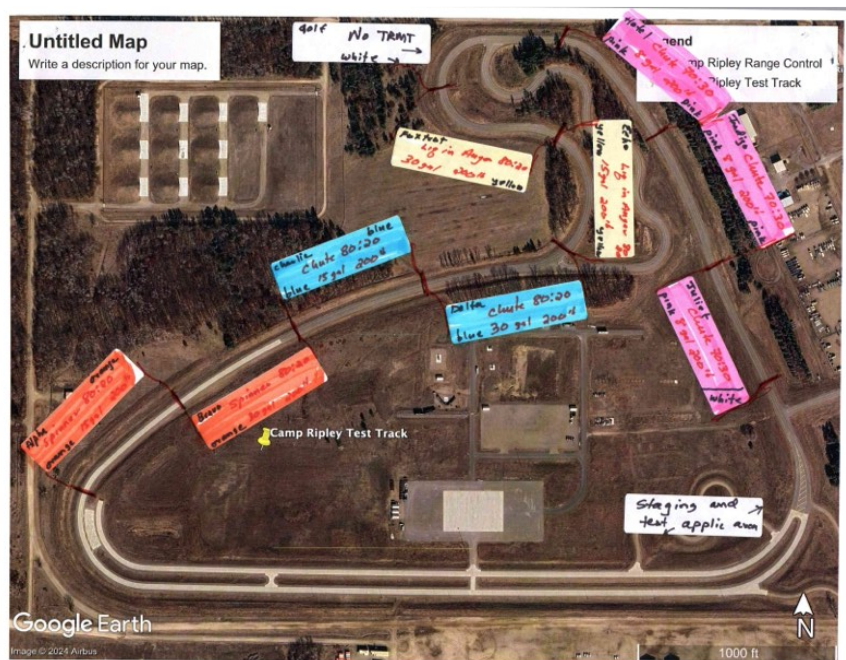
**Figure 1. Test track experimental layout, showing proposed applications.**

The proposed test locations and applications are shown at the locations indicated on the aerial photo of the perimeter roadway (Figure 1) and on the sketch of the skid pad (Figure 2), and listed in Table 1. The colors in the figures represent the field flagging colors of the markers for the test sections. Note that compacted snow and ice on the skid pad did not extend to the full borders as shown, necessitating change during testing such that return lanes were moved outside of the snow and ice area. A return lane on the north (top) side was created for the vehicles on the Romeo, Sierra and Tango lanes, and a return lane on the south (bottom) side for the vehicles on the Oscar, Papa and Quebec lanes.

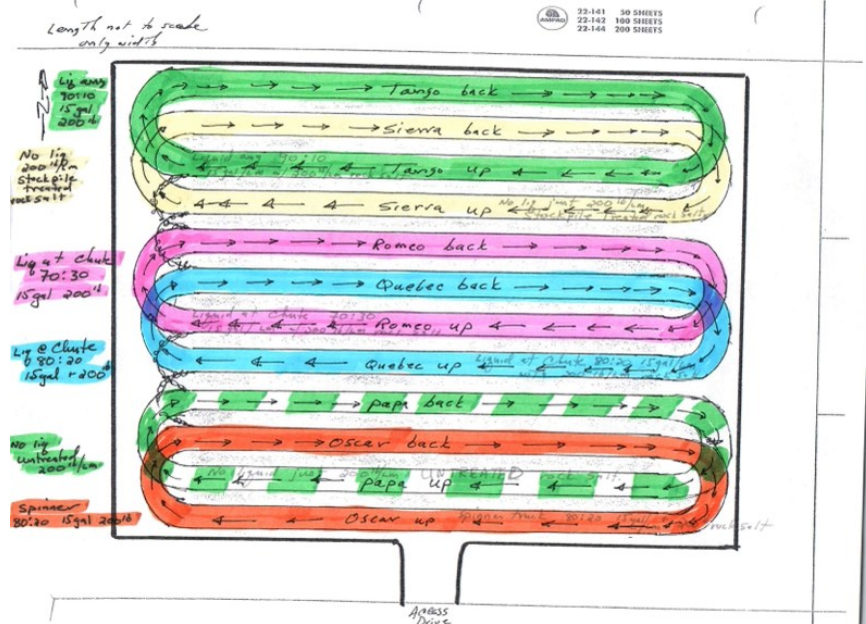
Figure 2. Skid pad experimental layout, showing proposed applications.

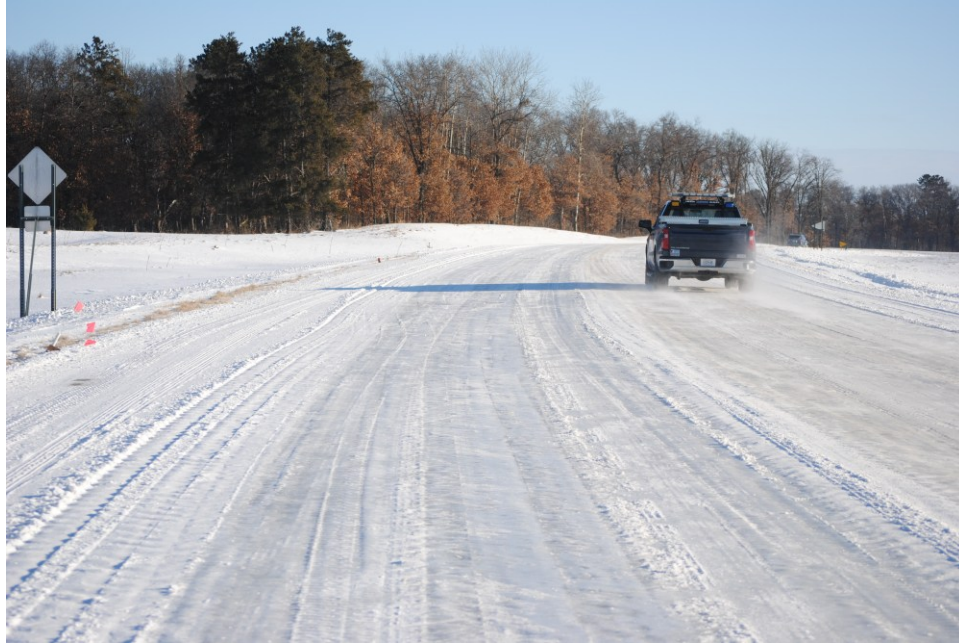
**Figure 3. Conditions on the perimeter roadway section, location Zulu just after the test beginning.**

Conditions on the perimeter roadway section consisted of a dense and hard compaction of snow and ice, some loose granular snow but most as white to gray solid ice with an estimated thickness of 3/8ths of an inch (Figure 3). No additional preparation was done on the day of the testing.

2. No significant difference was observed in the behavior of the snow-ice hardpack between the no-treatment control section that followed 2000 feet of bare lane (Zulu) and the no-treatment control section that followed treated sections (Golf). This lack of difference is interpreted as lack of evidence of deicer “drag through”, bringing deicer from one section to another by the action of traffic through the treated section.

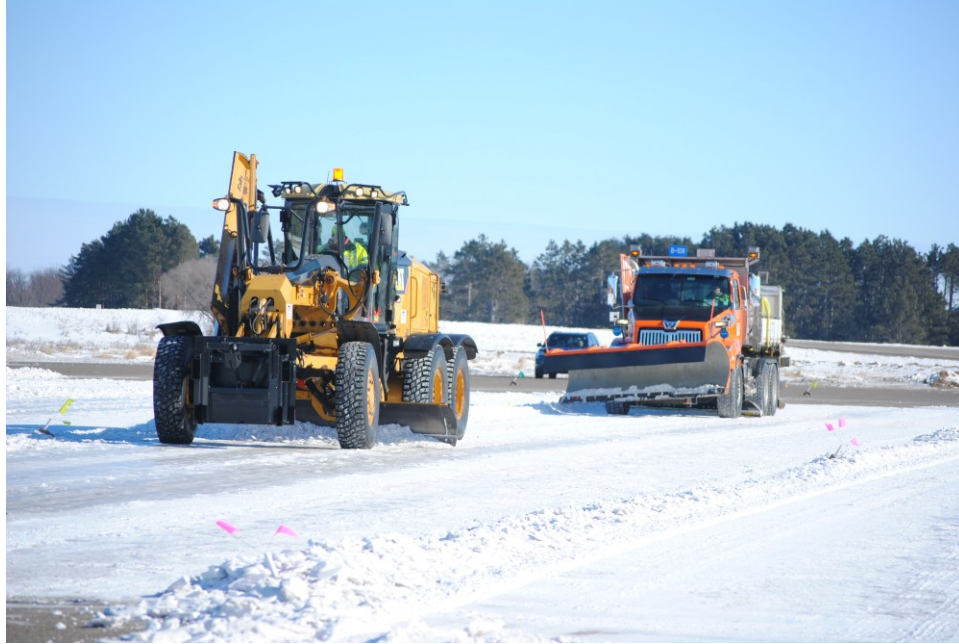
**Figure 4. Motor grader and plow truck using underbody plow to cut and shape lanes at the skid pad prior to testing.**

Conditions at the skid pad were adjusted during preparation for testing by underbody plowing done by a motor grader (Cat 140 AWD; 44,600 pounds weight with a 12-foot blade according to [https://www.cat.com/content/catdotcom/en\\_US/products/new/equipment/motor-graders/motor-graders.html](https://www.cat.com/content/catdotcom/en_US/products/new/equipment/motor-graders/motor-graders.html)) and a plow truck to cut and shape the lanes (Figure 4). It was theorized by Jamie Hukriede of MnDOT District 3 that underbody plow action would crack any hard ice compaction and make the ice more amenable to deicing. This procedure was consistent with MnDOT procedures for deicing compacted snow and ice in near-zero conditions. Conditions at the skid pad lanes consisted of a stiff (but not hard) compaction of snow and some ice with an estimated thickness of 1/4th of an inch (Figure 5).

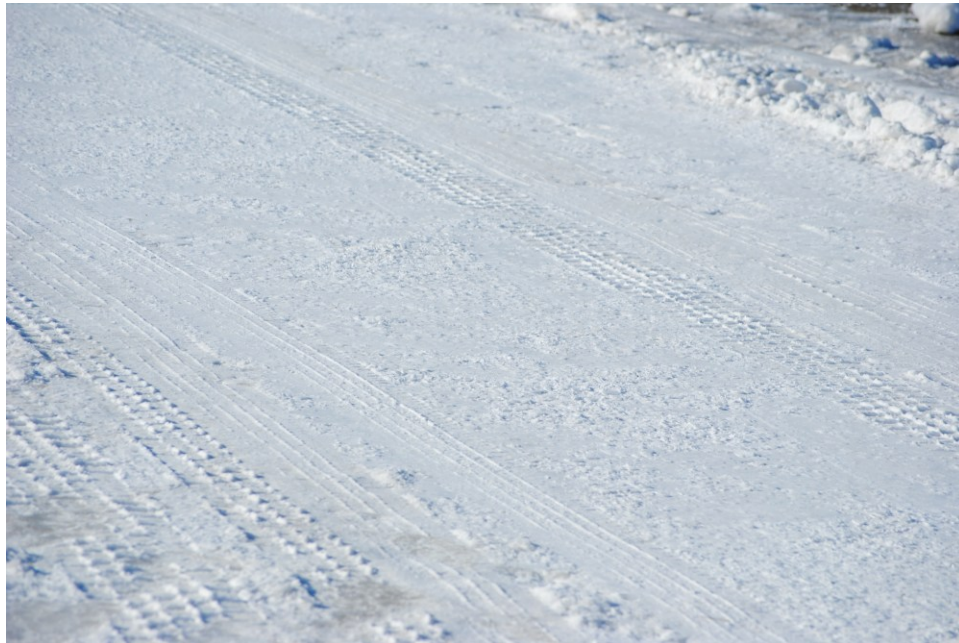
**Figure 5. Conditions at the skid pad, location Uniform just after the test beginning.**

3. The no-treatment no-traffic control section of the skid pad (lane Uniform) shows compact, white colored snow hardpack with some integral ice. Free liquid or melt product was not present at either the beginning of the test just after treatment or after traffic at anytime through the period of the test (out to 57 minutes). With time, no change in the lane surface was noted. This lack of change is interpreted as lack of effect caused by ambient weather conditions, e.g., sun, temperature and wind. Therefore, any effects noted would have been caused by treatment and traffic, not the ambient weather.

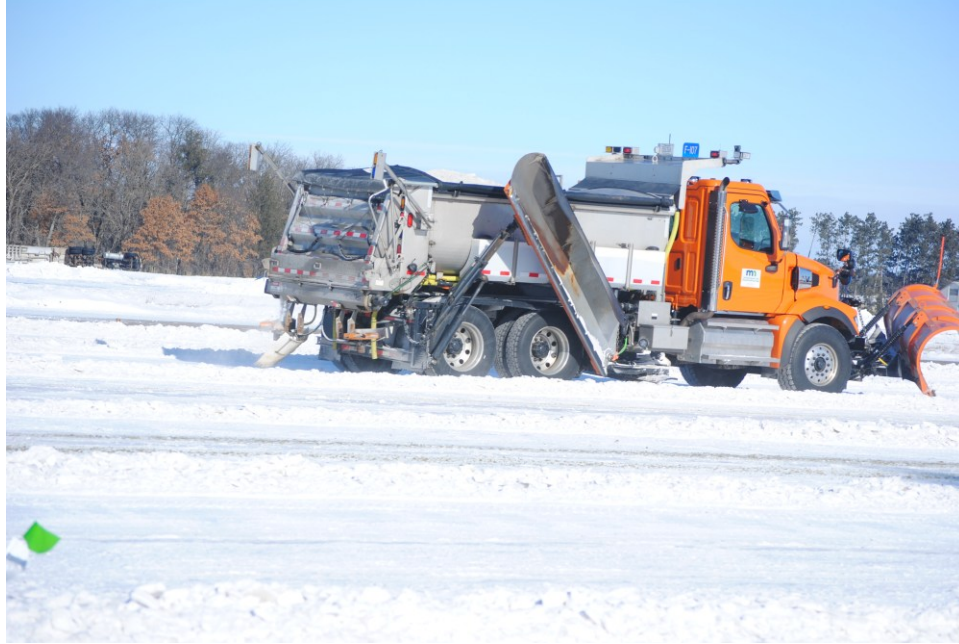
Figure 6. Deicer being applied to a test lane at the skid pad.

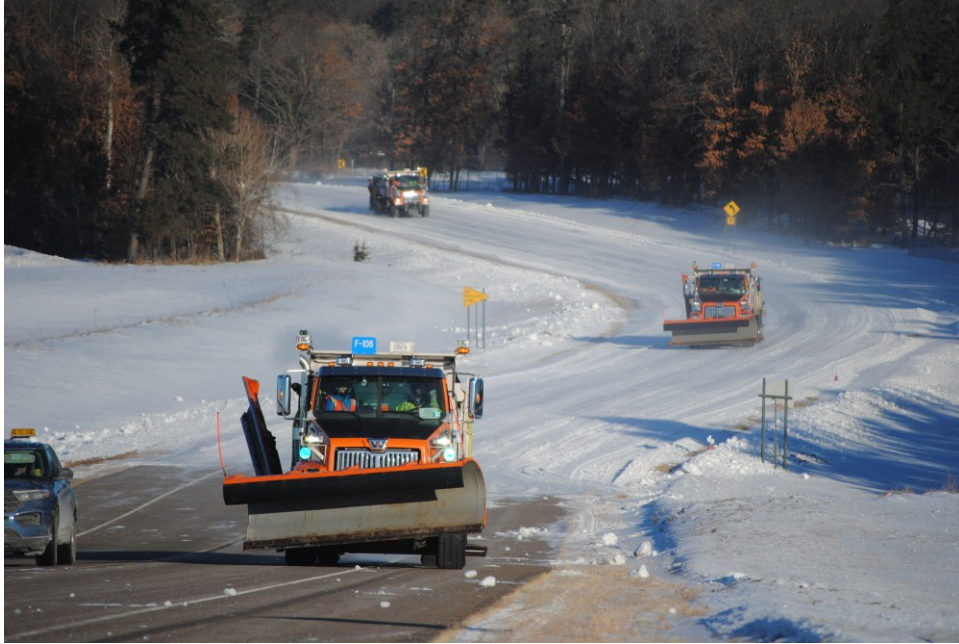
**Figure 7. Plow trucks returning from treatment application on perimeter roadway; note MSU research personnel as passenger “ride alongs” to guide treatment location and confirm rates and amounts.**

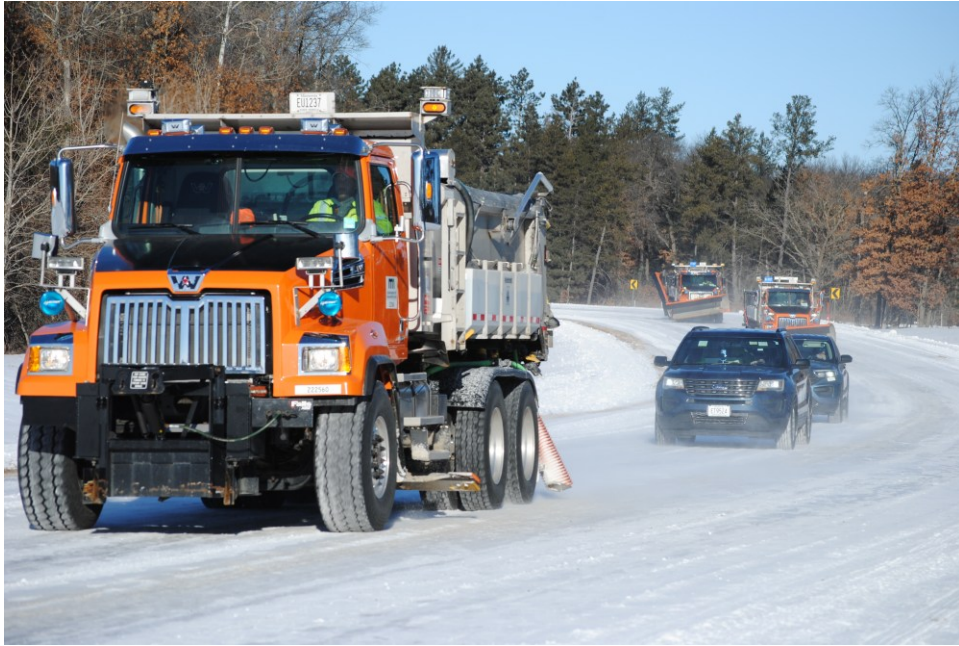
**Figure 8. Typical traffic applied to perimeter track.**

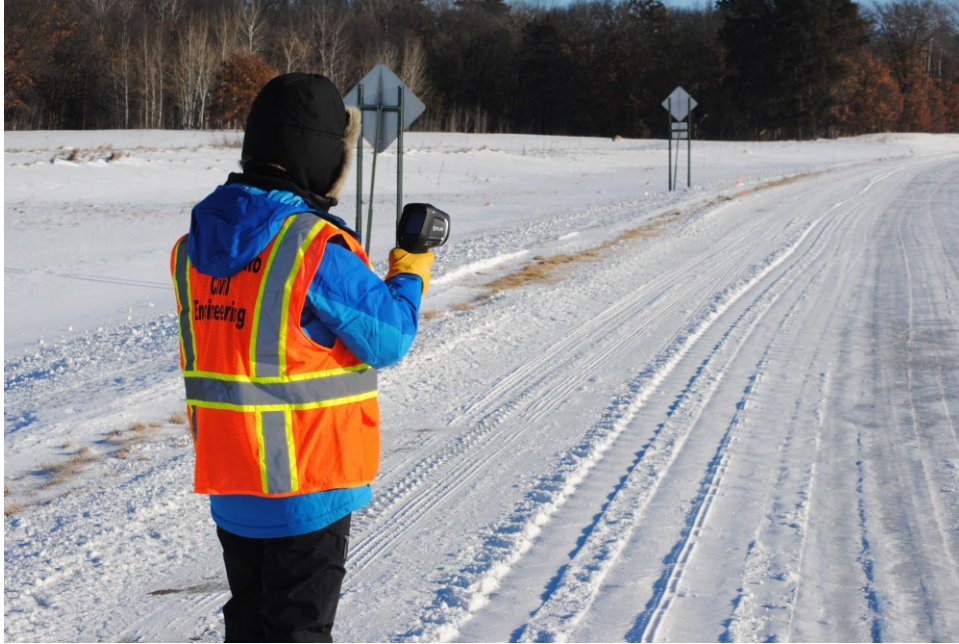
**Figure 9. Observations of roadway surface temperature being collected through thermography. Visual observation of snow and ice condition on the roadway surface were collected separately by photography.**

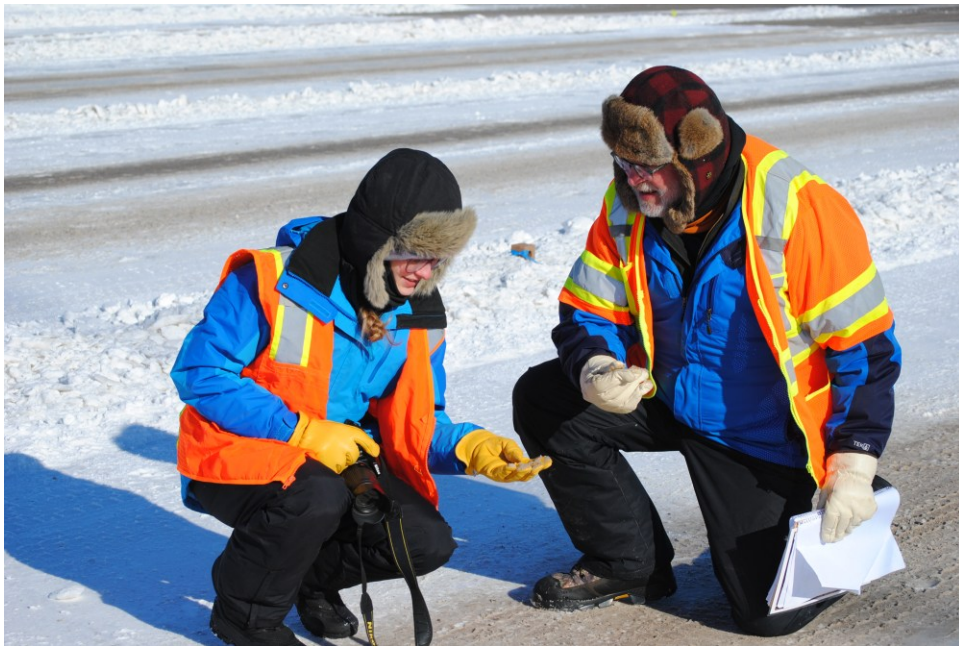
**Figure 10. Evaluating snow strength and consistency.**

Snow strength and consistency were assessed at the skid pad lanes using visual-manual methods (Figure 10). Typical results are shown for a perimeter roadway section (Figure 11) and a skid pad lane (Figure 12).

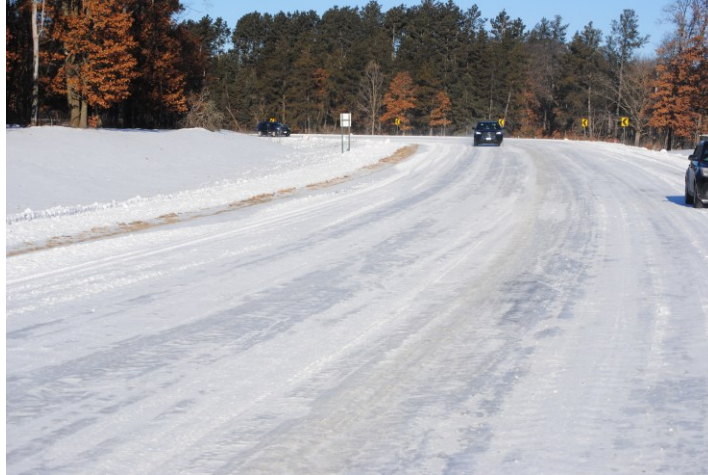
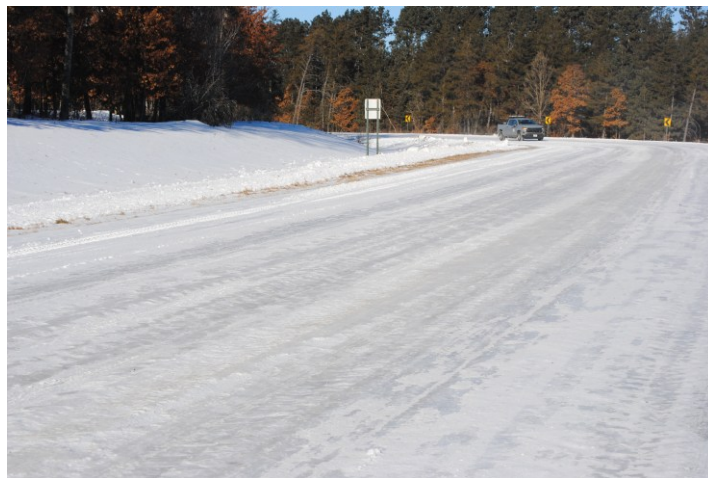
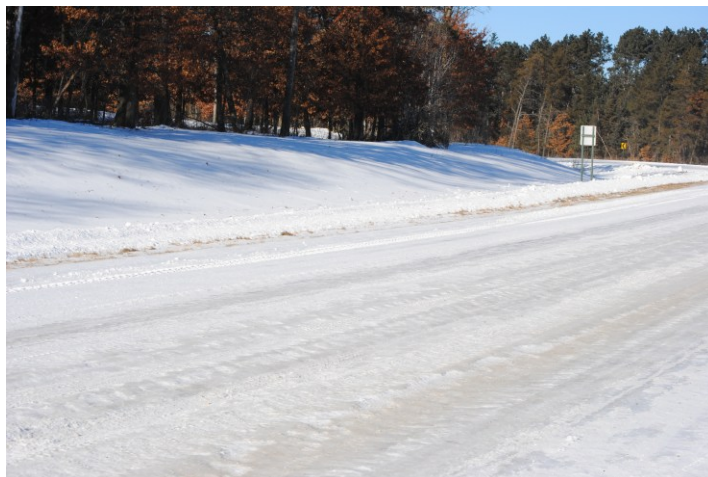
**Figure 11. Typical perimeter roadway testing results (Indigo with 200 lbs/LM rock salt and 15 gal/LM 70:30 prewet delivered as liquid to a spinner). From top to bottom: 23 minutes, 57 minutes, and 97 minutes after initial application.**

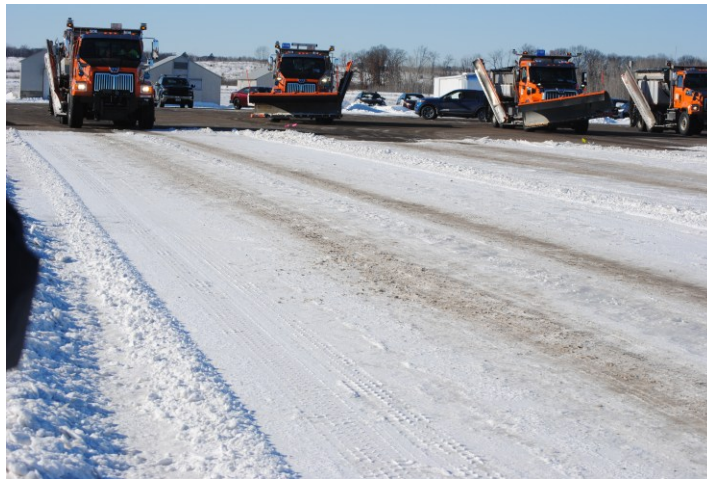
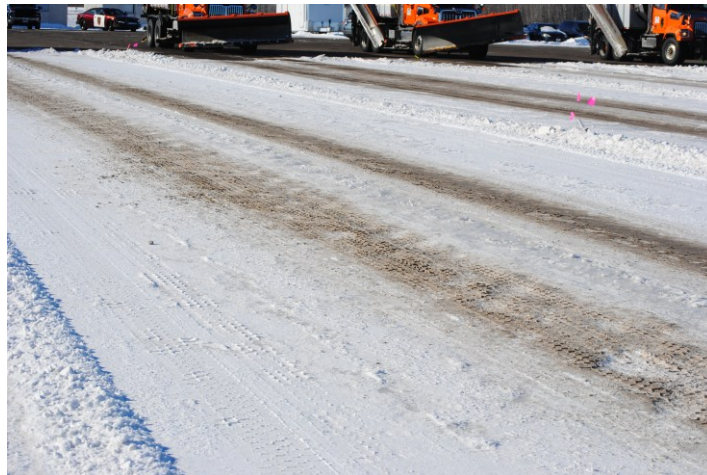
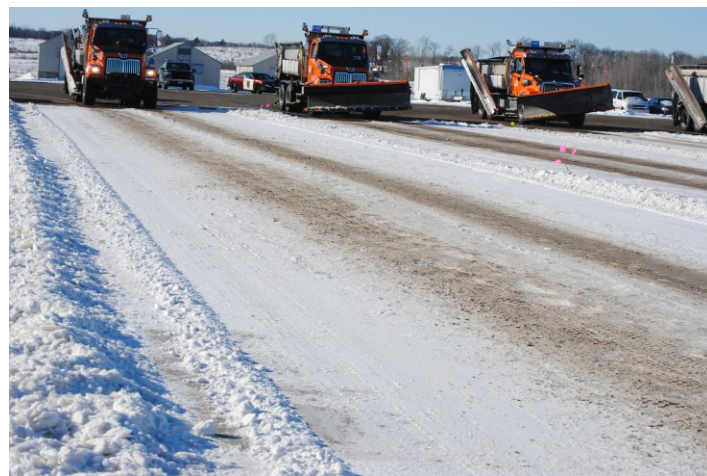
**Figure 12. Typical skid pad lane testing results (Quebec with 200 lbs/LM rock salt and 15 gal/LM 70:30 prewet delivered as liquid to the chute). From top to bottom: 5 minutes, 25 minutes, and 47 minutes after initial application.**

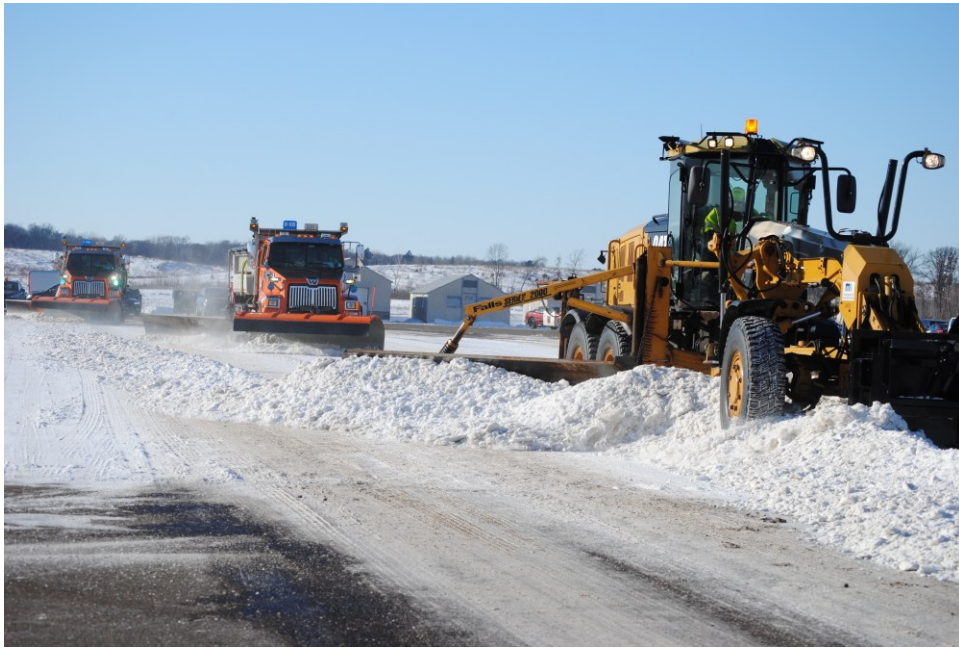
**Figure 13. Clean off of wet skid pad pavement after completion of testing.**

All pavements were plowed clear at the completion of the testing (Figure 13). Once freed from the constraints of the testing protocol, maintenance personnel were able to quickly clear the pavements using motor grader and plow truck underbody plowing combined with deicer rates higher than used during the experiments.

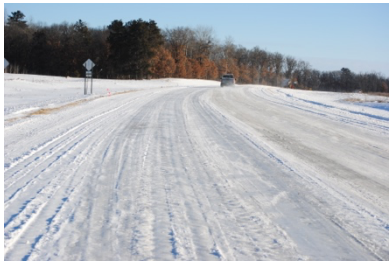
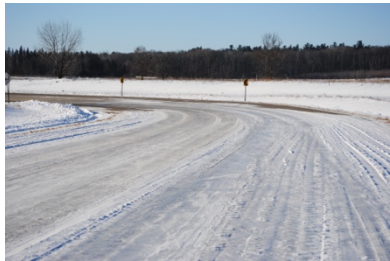
Test Section	Treatment and Distribution System	Forward Photo of Location	Backward Photo of Location
Zulu	None (Control Section)

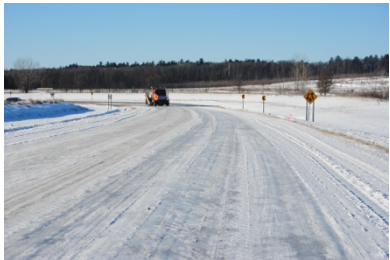
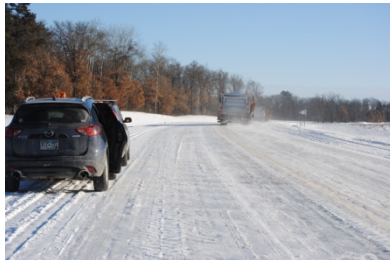
Alpha	15 gal/LM 80% Salt Brine 20% BEET HEET (80:20) and 200 lb/LM rock salt  Distributed with liquid on spinner

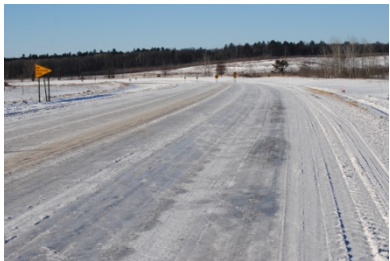
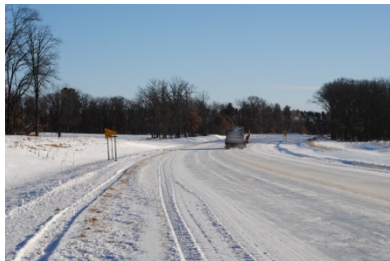
Bravo	30 gal/LM 80% Salt Brine 20% BEET HEET (80:20) and 200 lb/LM rock salt  Distributed with liquid on spinner

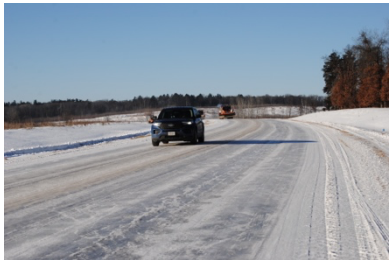
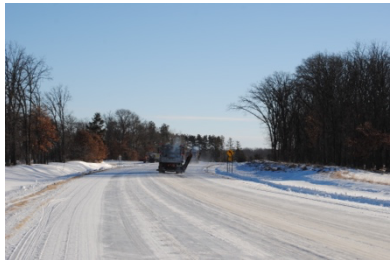
Charlie	15 gal/LM 80% Salt Brine 20% BEET HEET (80:20) and 200 lb/LM rock salt  Distributed with liquid on chute

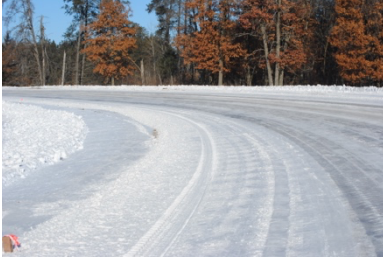
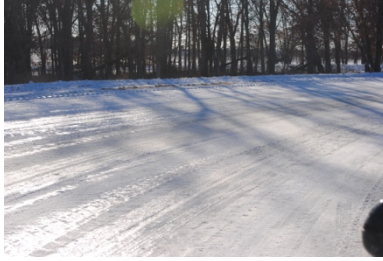
<p>Delta</p>	<p>30 gal/LM 80% Salt Brine 20% BEET HEET (80:20) and 200 lb/LM rock salt</p> <p>Distributed with liquid on chute</p>

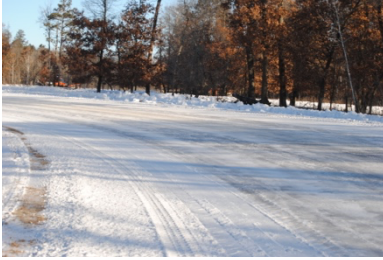
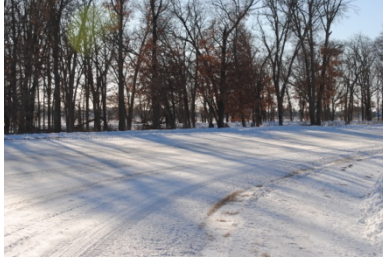
<p>Echo</p>	<p>15 gal/LM 80% Salt Brine 20% BEET HEET (80:20) and 200 lb/LM rock salt</p> <p>Distributed with liquid mixed in auger</p>

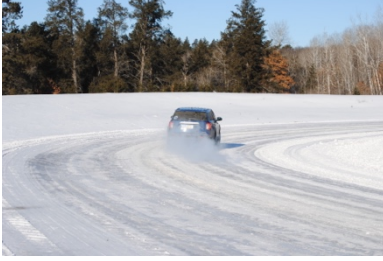
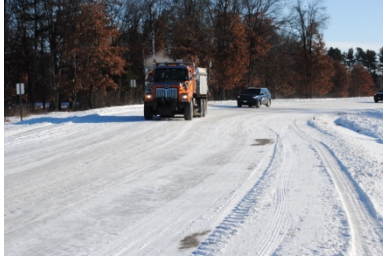
<p>Foxtrot</p>	<p>30 gal/LM 80% Salt Brine 20% BEET HEET (80:20) and 200 lb/LM rock salt</p> <p>Distributed with liquid mixed in auger</p>

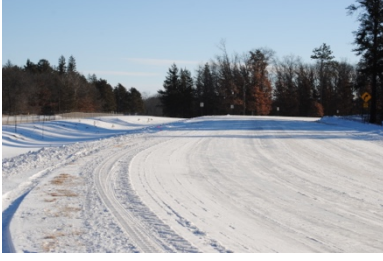
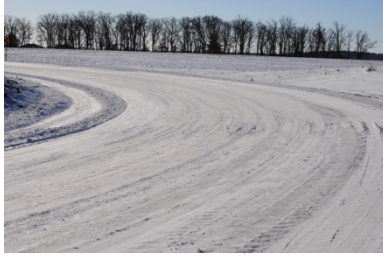
<p>Golf</p>	<p>None (Control Section)</p> <p>Test of deicer drag through</p>

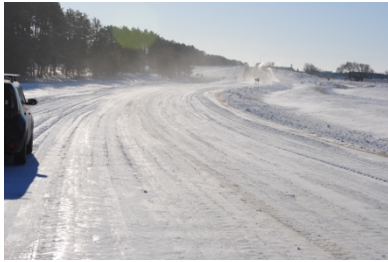
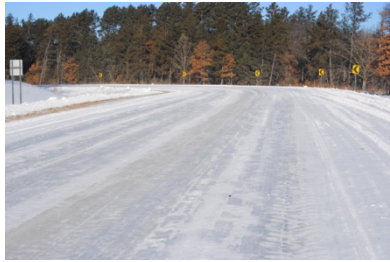
<p>Hotel</p>	<p>8 gal/LM 70% Salt Brine 30% BEET HEET (70:30) and 200 lb/LM rock salt</p> <p>Distributed with liquid on chute</p>

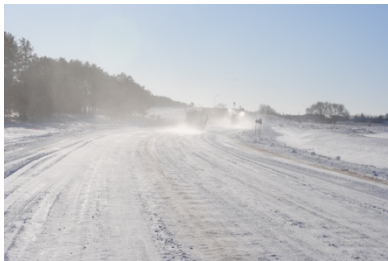
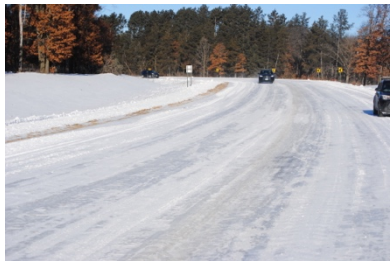
<p>Indigo</p>	<p>15 gal/LM 70% Salt Brine 30% BEET HEET (70:30) and 200 lb/LM rock salt</p> <p>Distributed with liquid on chute</p>

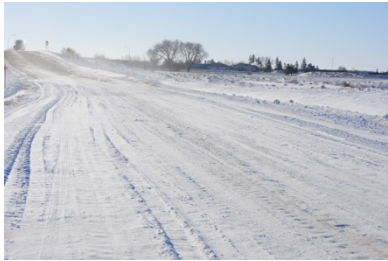
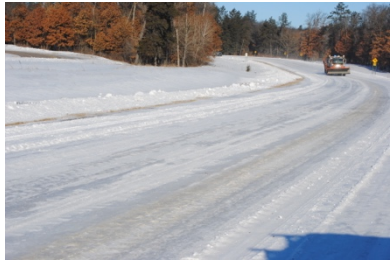
<p>Juliet</p>	<p>30 gal/LM 70% Salt Brine 30% BEET HEET (70:30) and 200 lb/LM rock salt</p> <p>Distributed with liquid on chute</p>

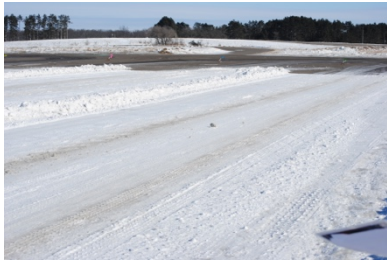
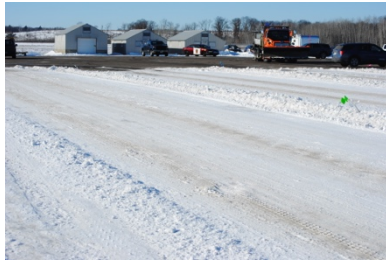
<p>Oscar</p>	<p>15 gal/LM 80% Salt Brine 20% BEET HEET (80:20) and 200 lb/LM rock salt</p> <p>Distributed with liquid on spinner</p>

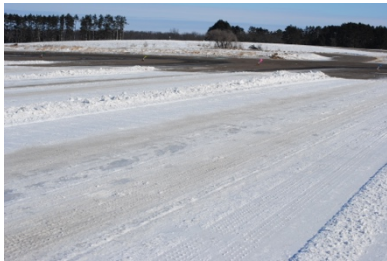
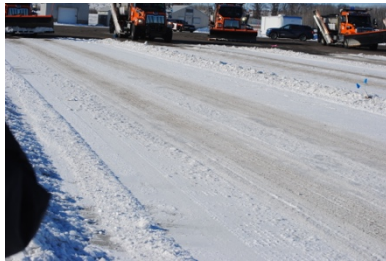
<p>Papa</p>	<p>No liquid; 200 lb/LM rock salt</p> <p>Distributed with chute</p>

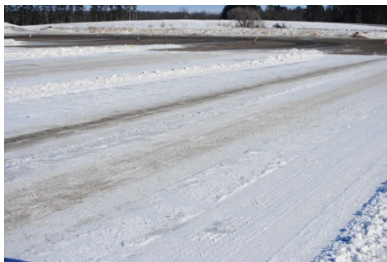
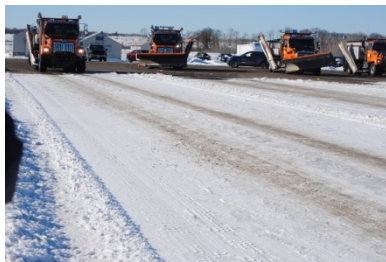
<p>Quebec</p>	<p>15 gal/LM 80% Salt Brine 20% BEET HEET (80:20) and 200 lb/LM rock salt</p> <p>Distributed with liquid on chute</p>

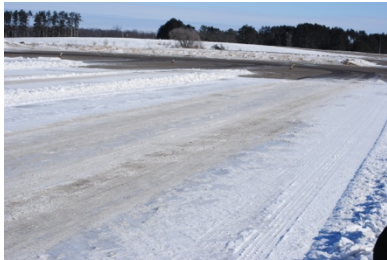
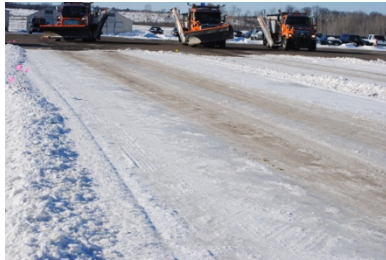
<p>Romeo</p>	<p>15 gal/LM 70% Salt Brine 30% BEET HEET (70:30) and 200 lb/LM rock salt</p> <p>Distributed with liquid on chute</p>

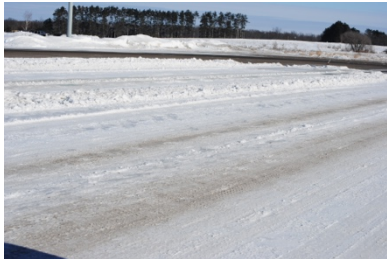
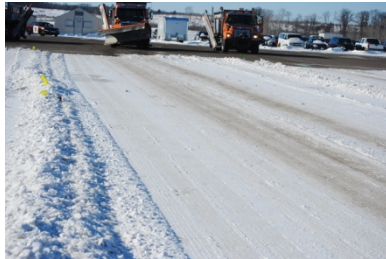
<p>Sierra</p>	<p>15 gal/LM 90% Salt Brine 10% BEET HEET (90:10) and 200 lb/LM rock salt</p> <p>Distributed with liquid on chute</p>

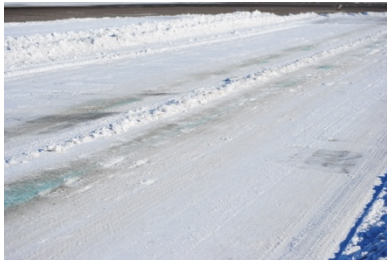
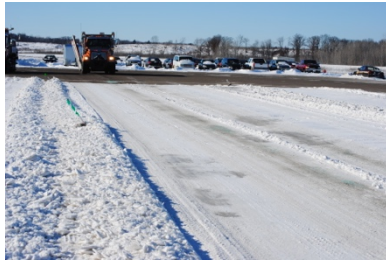
<p>Tango</p>	<p>No liquid; 200 lb/LM stockpile- treated (4 gal/ton) rock salt</p> <p>Distributed by chute</p>

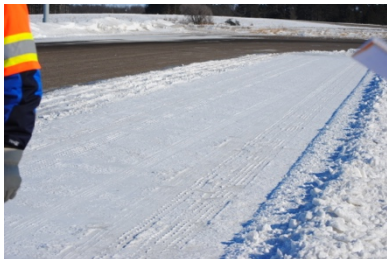
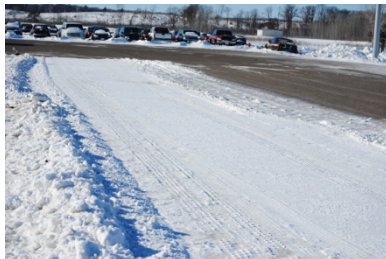
<p>Uniform</p>	<p>No treatment, no traffic.</p> <p>Control.</p>

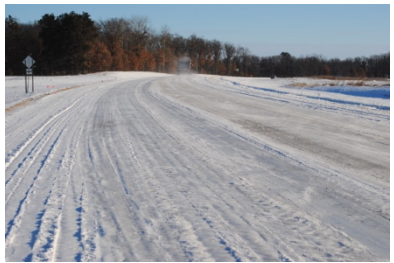
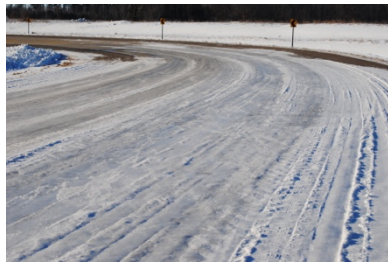
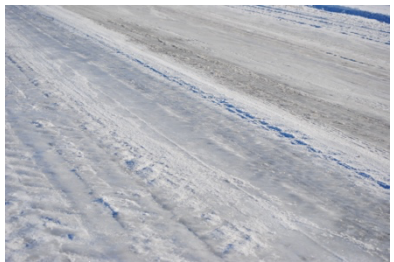
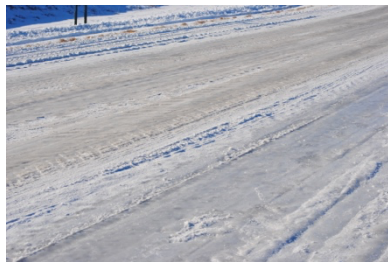
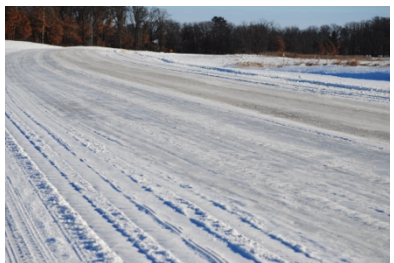
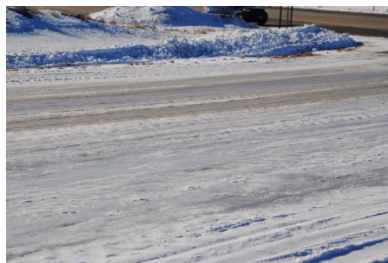
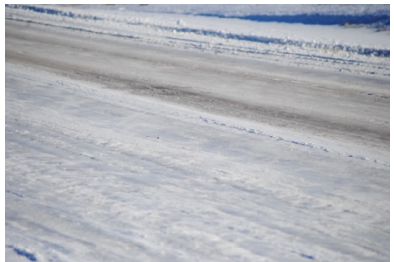
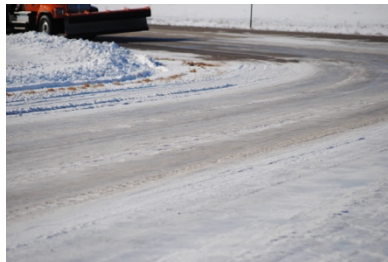
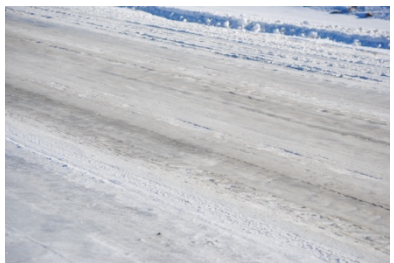
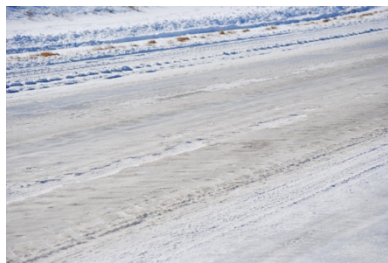
Test Section and Treatment: "Zulu". No treatment; control section. Estimated 2000 veh/d annual daily traffic equivalent.

Time After Treatment	Forward Photo of Location	Behind Photo of Location
12 minutes

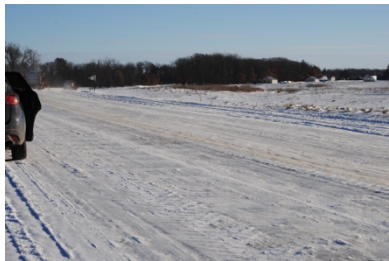
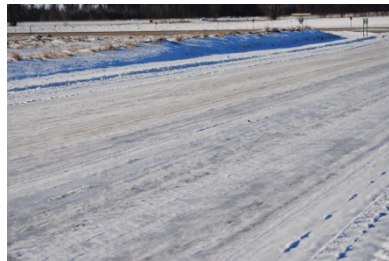
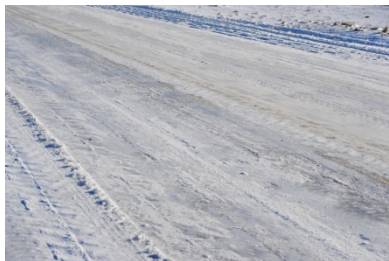
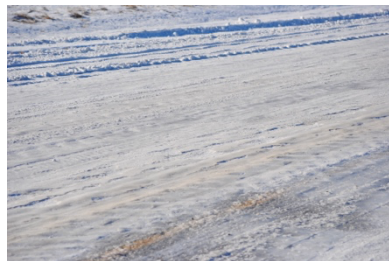
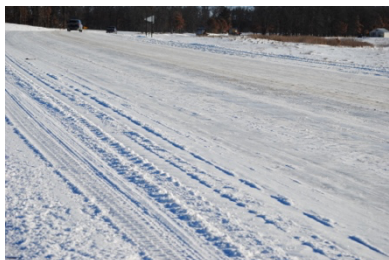
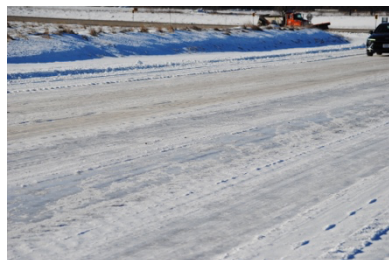
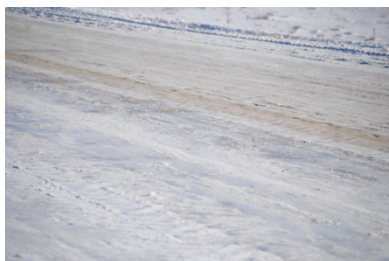
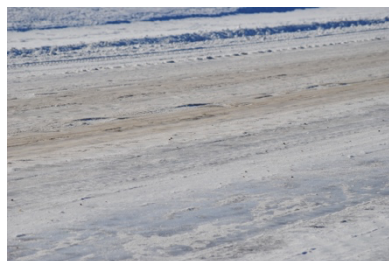
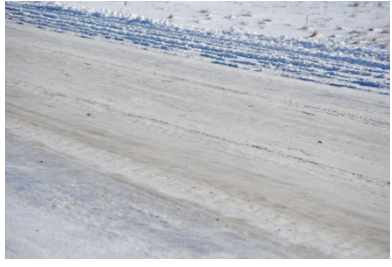
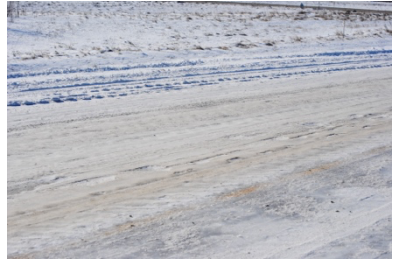
Test Section and Treatment: "Alpha". 15 gal/LM of 80% Salt Brine 20% BEET HEET (80:20) and 200 lb/LM rock salt. Distributed with liquid on spinner. Estimated 2000 veh/d annual daily traffic equivalent.

Time After Treatment	Pavement Forward at Location	Pavement Behind at Location
16 minutes

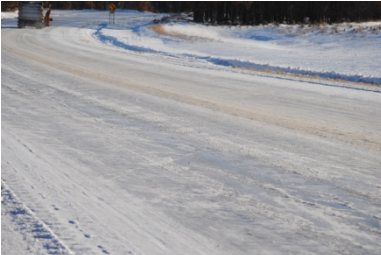
Test Section and Treatment: "Bravo". 30 gal/LM of 80% Salt Brine 20% BEET HEET (80:20) and 200 lb/LM rock salt. Distributed with liquid on spinner. Estimated 2000 veh/d annual daily traffic equivalent.

Time After Treatment	Pavement Forward at Location	Pavement Behind at Location
19 minutes

A photograph showing the pavement surface 19 minutes after treatment. The surface is covered with a thin layer of snow and shows some initial spreading of the treatment material.

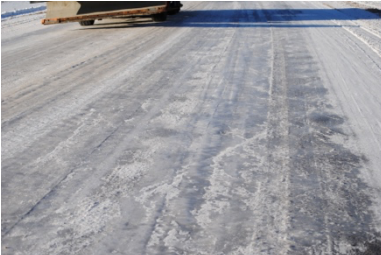
A photograph showing the pavement surface 19 minutes after treatment from a different angle. The surface appears slightly more treated than the forward view.
35 minutes

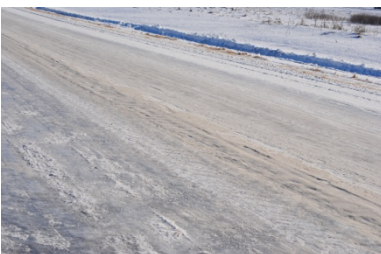
A photograph showing the pavement surface 35 minutes after treatment. The snow layer is more uniform, and the treatment material is more visible.

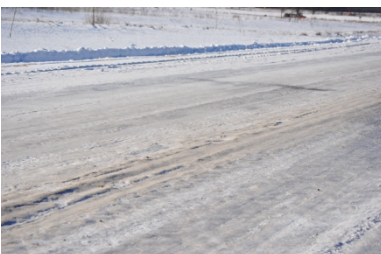
A photograph showing the pavement surface 35 minutes after treatment from a different angle. The surface shows more consistent coverage.
51 minutes

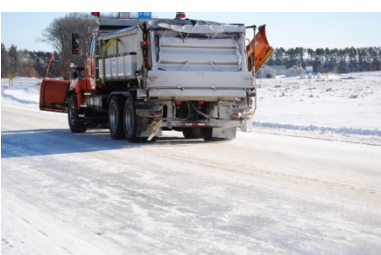
A photograph showing the pavement surface 51 minutes after treatment. A white truck is visible in the foreground, and the pavement shows significant treatment coverage.

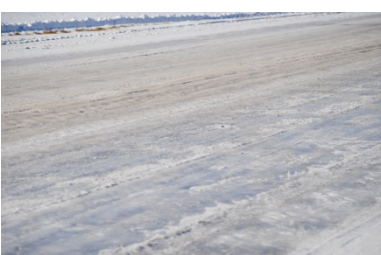
A photograph showing the pavement surface 51 minutes after treatment from a different angle. The surface is well-covered with the treatment material.

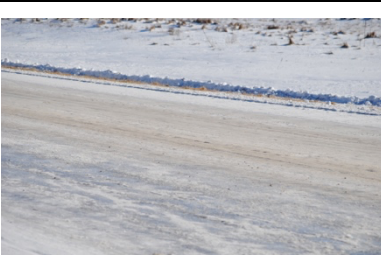
A photograph showing the pavement surface 93 minutes after treatment. The snow is more compacted, and the treatment material is clearly visible.

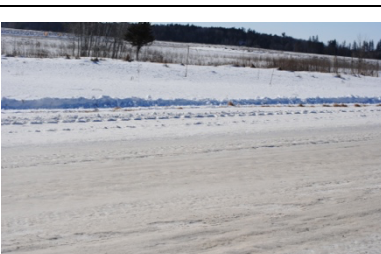
A photograph showing the pavement surface 105 minutes after treatment from a different angle. The surface is well-treated and shows some signs of wear.

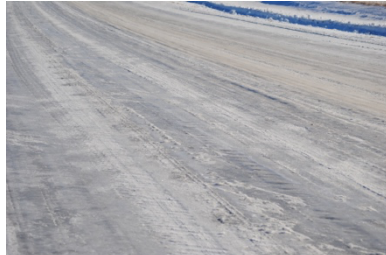
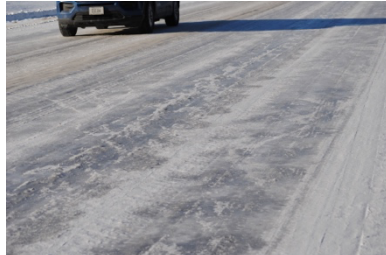
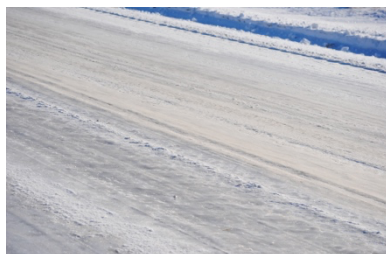
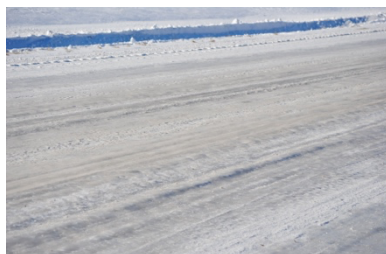
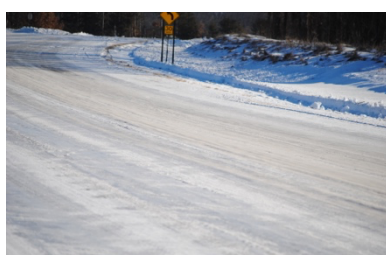
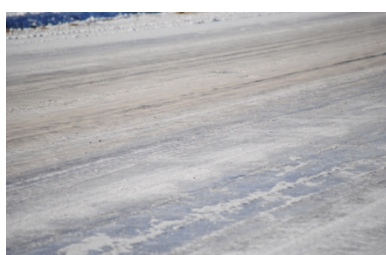
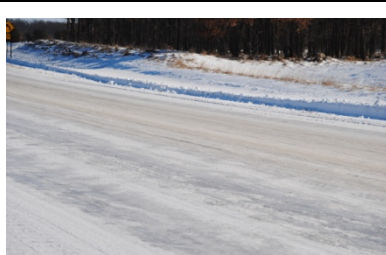
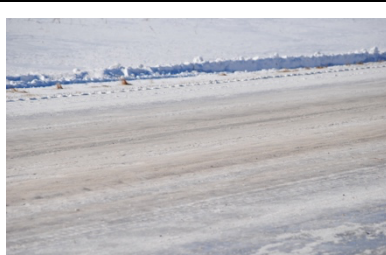
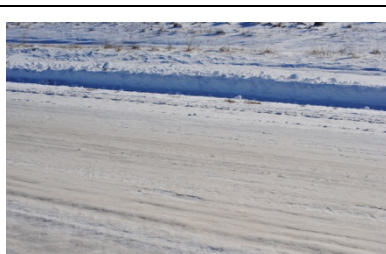
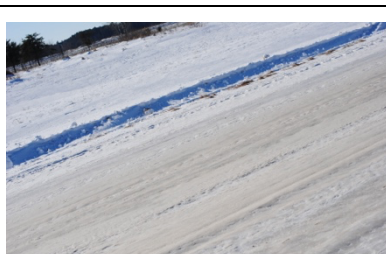
Test Section and Treatment: "Charlie". 15 gal/LM of 80% Salt Brine 20% BEET HEET (80:20) and 200 lb/LM rock salt. Distributed with liquid on chute. Estimated 2000 veh/d annual daily traffic equivalent.

Time After Treatment	Pavement Forward at Location	Pavement Behind at Location
21 minutes

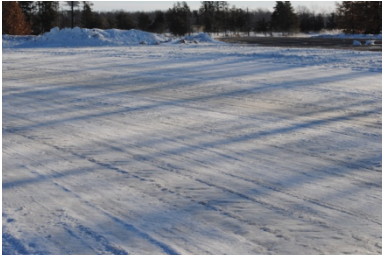
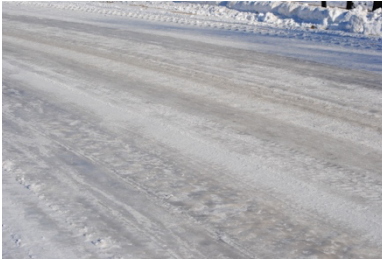
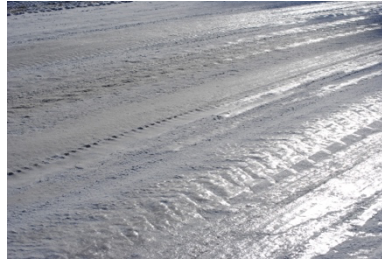
Test Section and Treatment: "Delta". 30 gal/LM of 80% Salt Brine 20% BEET HEET (80:20) and 200 lb/LM rock salt. Distributed with liquid on chute. Estimated 2000 veh/d annual daily traffic equivalent.

Time After Treatment	Pavement Forward at Location	Pavement Behind at Location
26 minutes

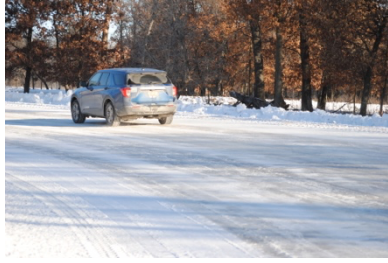
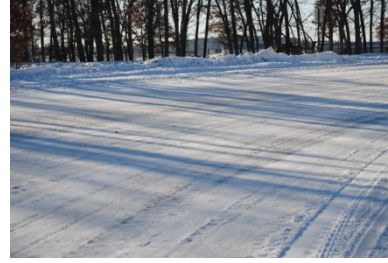
Time After Treatment	Pavement Forward at Location	Pavement Behind at Location
27 minutes

Test Section and Treatment: "Echo". 15 gal/LM of 80% Salt Brine 20% BEET HEET (80:20) and 200 lb/LM rock salt. Distributed with liquid mixed in auger. Estimated 2000 veh/d annual daily traffic equivalent.

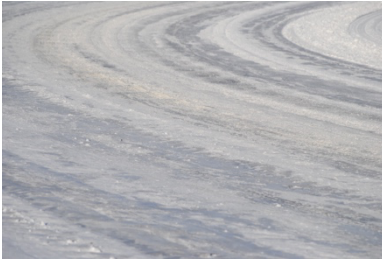
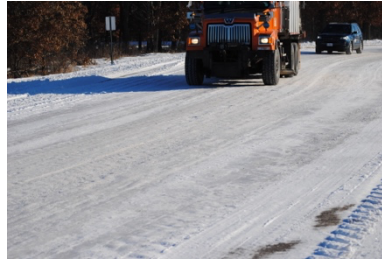
Time After Treatment	Pavement Forward at Location	Pavement Behind at Location
31 minutes

Test Section and Treatment: "Foxtrot". 30 gal/LM of 80% Salt Brine 20% BEET HEET (80:20) and 200 lb/LM rock salt. Distributed with liquid mixed in auger. Estimated 2000 veh/d annual daily traffic equivalent.

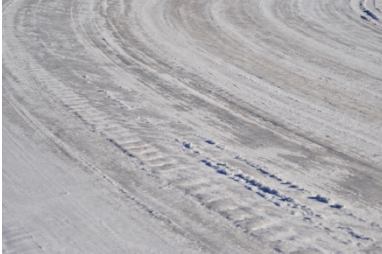
Time After Treatment	Pavement Forward at Location	Pavement Behind at Location
33 minutes

Test Section and Treatment: "Golf". None (Control Section). Test of deicer drag through.  
 Estimated 2000 veh/d annual daily traffic equivalent.

A close-up view of the pavement surface showing distinct, parallel tracks from a deicer machine, with some snow accumulation between the tracks.

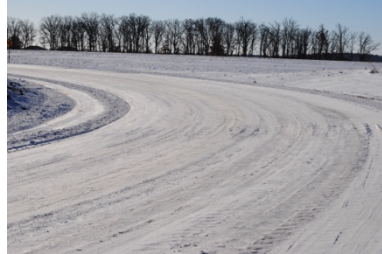
A wide-angle view of a curved road surface covered in snow, showing the same parallel deicer tracks curving along the road.
52 minutes

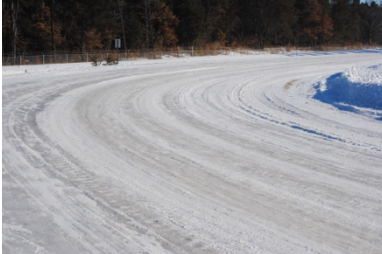
A close-up view of the pavement surface showing the deicer tracks, with a noticeable amount of snow piled up in the center of the tracks.

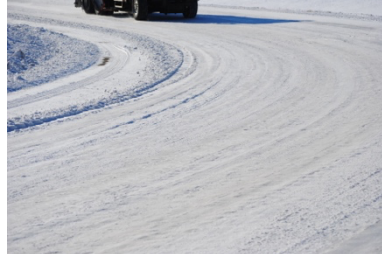
A wide-angle view of the curved road, showing the deicer tracks and the snow accumulation in the center of the curve.
66 minutes

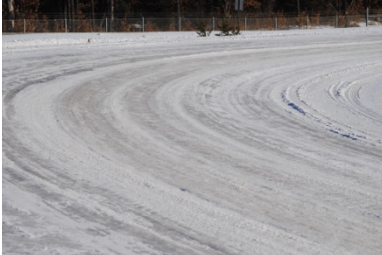
A close-up view of the pavement surface showing the deicer tracks, with significant snow accumulation in the center of the tracks.

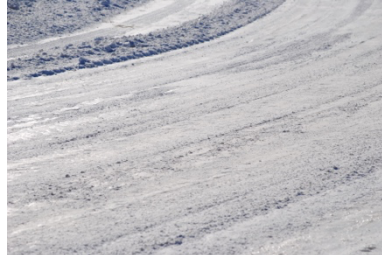
A wide-angle view of the curved road, showing the deicer tracks and the snow accumulation in the center of the curve.

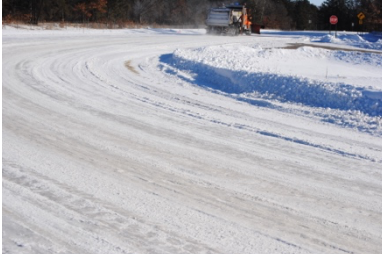
91 minutes

A close-up view of the pavement surface showing the deicer tracks, with a large amount of snow piled up in the center of the tracks.

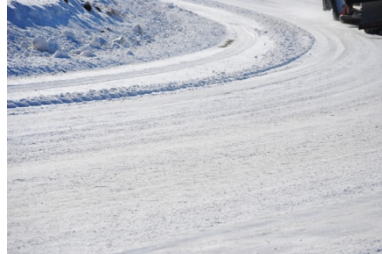
A wide-angle view of the curved road, showing the deicer tracks and the snow accumulation in the center of the curve.
107 minutes

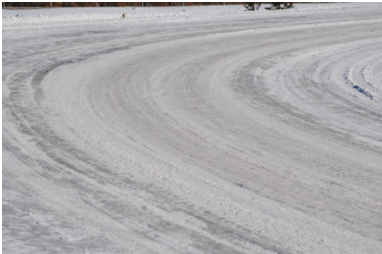
A close-up view of the pavement surface showing the deicer tracks, with a large amount of snow piled up in the center of the tracks.

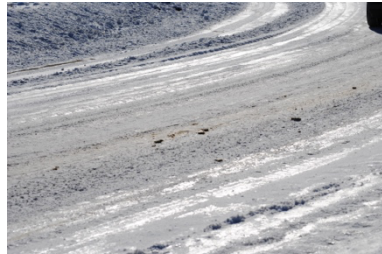
A wide-angle view of the curved road, showing the deicer tracks and the snow accumulation in the center of the curve.

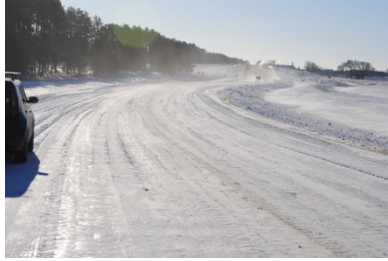
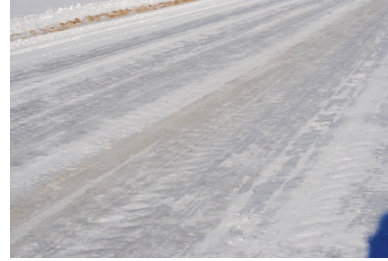
Time After Treatment	Pavement Forward at Location	Pavement Behind at Location
22 minutes

Test Section and Treatment: "Hotel". 8 gal/LM of 70% Salt Brine 30% BEET HEET (70:30) and 200 lb/LM rock salt. Distributed with liquid on chute. Estimated 2000 veh/d annual daily traffic equivalent.

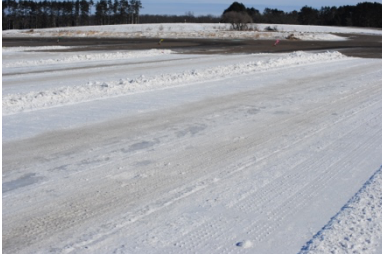
Time After Treatment	Pavement Forward at Location	Pavement Behind at Location
5 minutes

Test Section and Treatment: "Papa". No liquid; 200 lb/LM rock salt. Distributed with chute. Estimated 500 veh/d annual daily traffic equivalent.

A wide-angle photograph of a newly treated road surface. The surface is covered in a thin layer of white rock salt, with some darker patches of pavement visible. The background shows a clear sky and some distant trees.

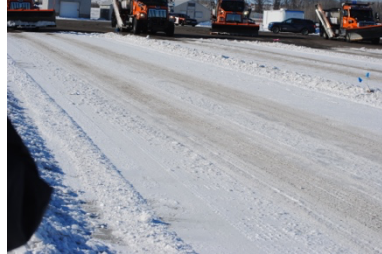
A photograph showing the road surface from a different angle, possibly behind a vehicle. The salt distribution is visible, and there are some orange traffic cones in the background.
15 minutes

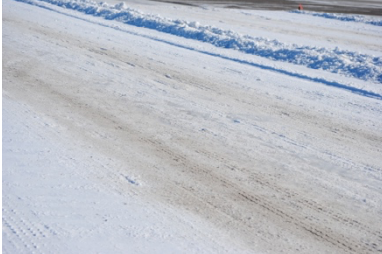
A close-up photograph of the road surface. The salt has begun to settle and is more evenly distributed, though some streaks remain.

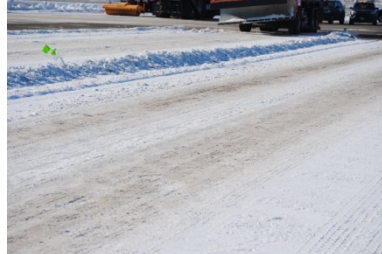
A photograph showing the road surface with a more uniform salt distribution. A yellow traffic cone is visible in the background.
25 minutes

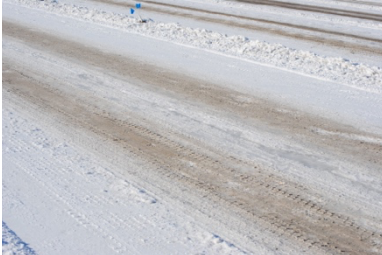
A close-up photograph showing the salt has settled further, creating a more consistent white layer over the pavement.

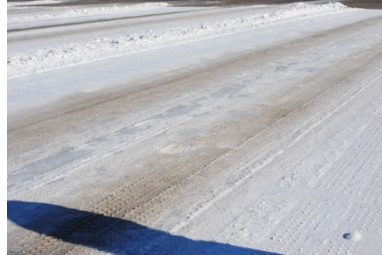
A photograph showing the road surface with a well-settled salt layer. A shadow is cast on the pavement in the foreground.

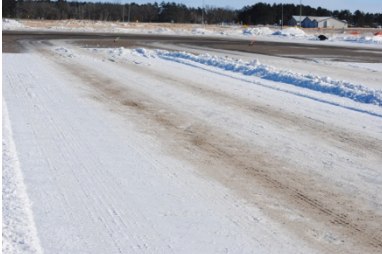
37 minutes

A photograph showing the road surface with a very uniform and thick layer of salt. The underlying pavement is almost completely obscured.

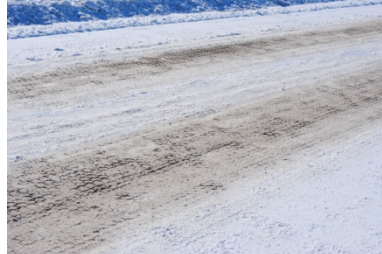
A photograph showing the road surface with a uniform salt layer. The texture of the pavement is still visible through the salt.
47 minutes

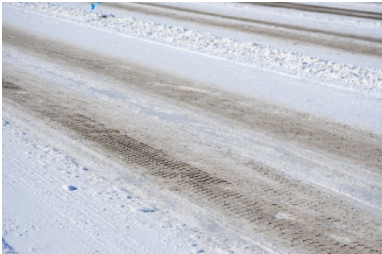
A close-up photograph showing the salt has settled into the pavement texture, creating a very uniform and thick layer.

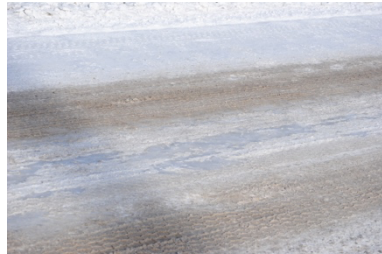
A photograph showing the road surface with a uniform salt layer. The pavement texture is clearly visible through the salt.
