# Alternative Deicer Performance Characterization: Know Before the Snow (Addendum)

Final Report 2026-09

# **Alternative Deicer Performance Characterization: Know Before The Snow**

## **Addendum: On-Pavement Field Comparison, Second Winter**

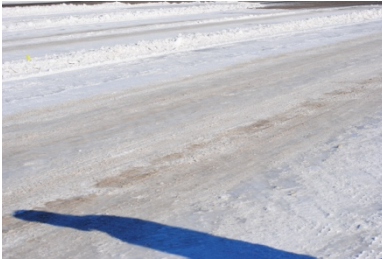
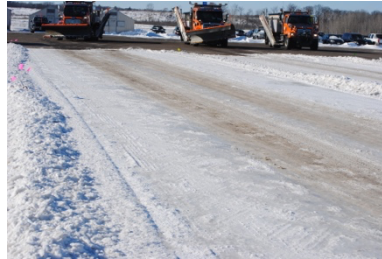
Time After Treatment	Pavement Forward at Location	Pavement Behind at Location
5 minutes

Test Section and Treatment: "Romeo". 15 gal/LM of 70% Salt Brine 30% BEET HEET (70:30) and 200 lb/LM rock salt. Distributed with liquid on chute. Estimated 500 veh/d annual daily traffic equivalent.

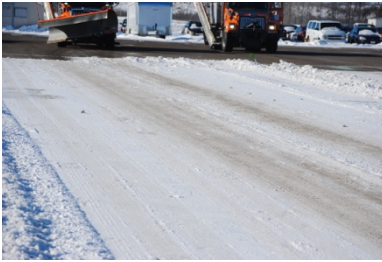
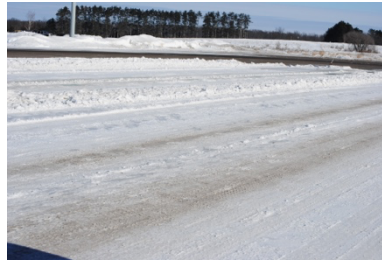
Time After Treatment	Pavement Forward at Location	Pavement Behind at Location
5 minutes

Test Section and Treatment: "Sierra". 15 gal/LM of 90% Salt Brine 10% BEET HEET (90:10) and 200 lb/LM rock salt. Distributed with liquid on chute. Estimated 500 veh/d annual daily traffic equivalent.

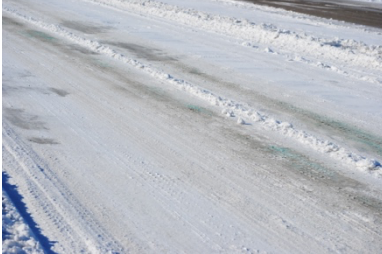
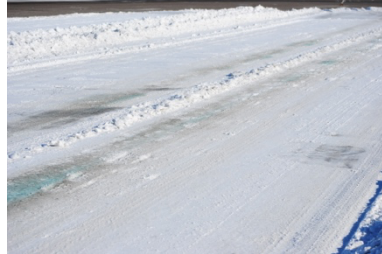
Time After Treatment	Pavement Forward at Location	Pavement Behind at Location
5 minutes

Test Section and Treatment: "Tango". No liquid; 200 lb/LM stockpile-treated (4 gal/ton) rock salt. Distributed by chute. Estimated 500 veh/d annual daily traffic equivalent.

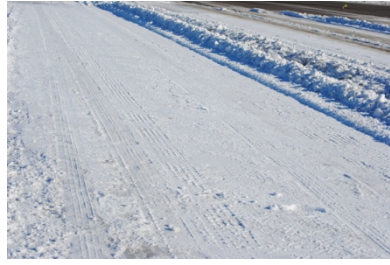
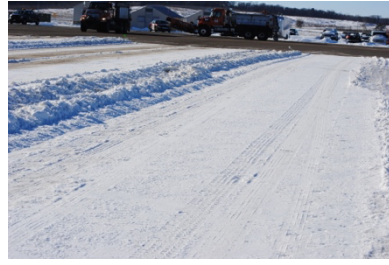
57  
minutes

Test Section and Treatment: "Uniform". No treatment, no traffic; control.
