DOT/FAA/CT-82/147
DOT/FAA/RD-82/77

Braking of an Aircraft Tire on Grooved and Porous Asphaltic Concrete

January 1983

Final Report

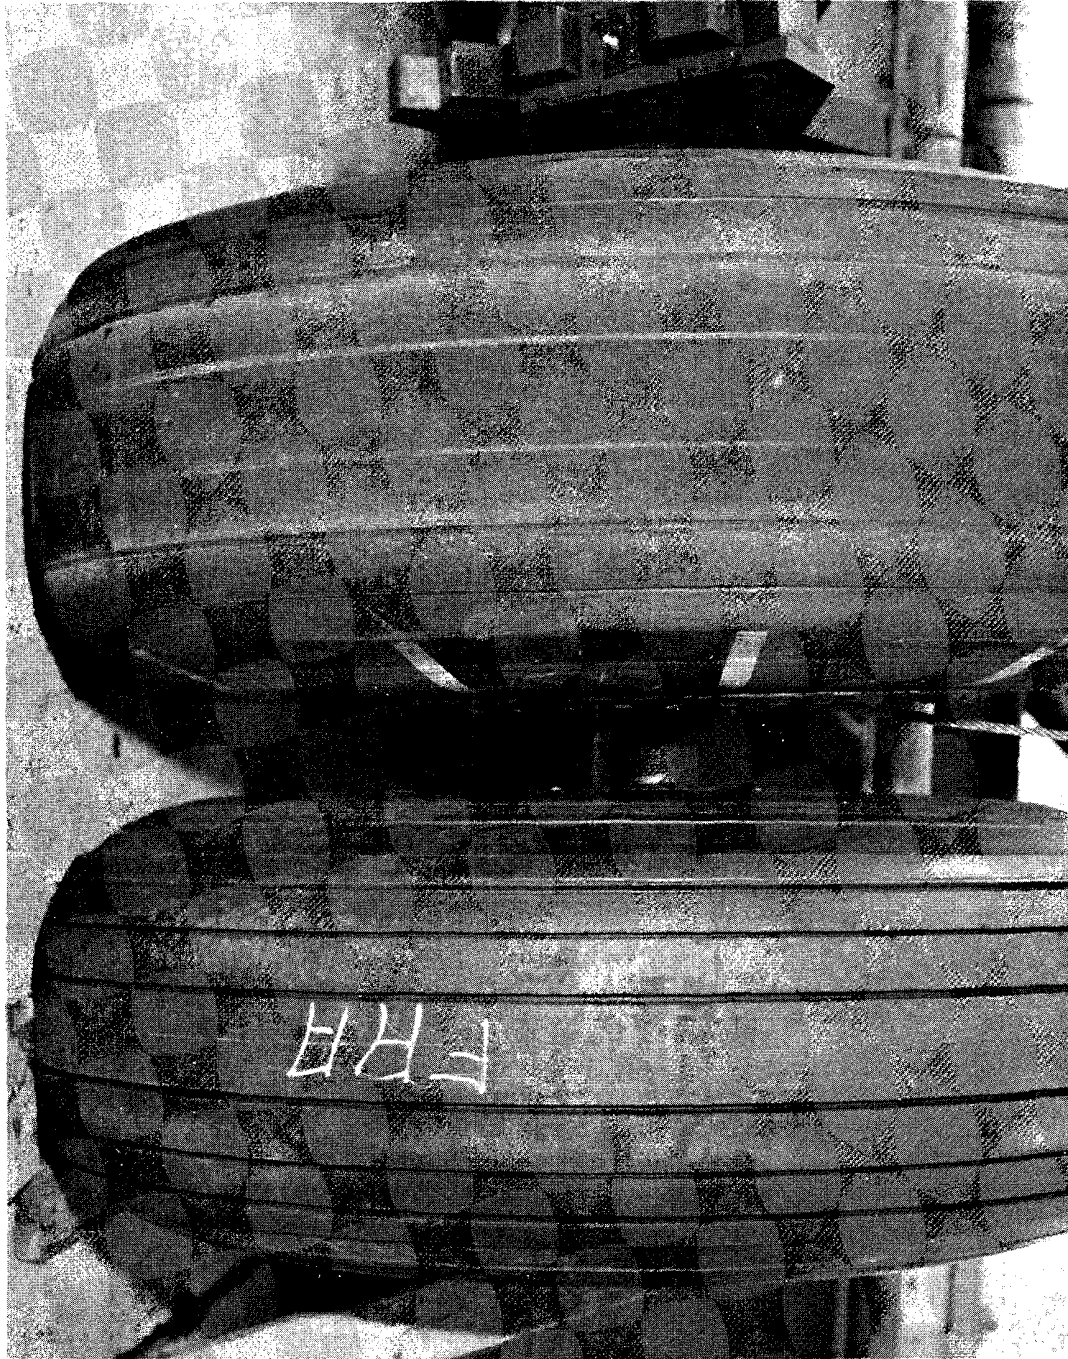
FIGURE 9. A NEW AND COMPLETELY WORN TIRE

Among the various tire parameters, the important ones are: size, vertical load, inflation pressure, and tread design. All the test tires were 49 x 17, 26-ply rating, type VII. These tires are used on both the Boeing 727 and Boeing 747 aircraft and represent a large population of the tires used by the airline industry. To include the effects of tire tread design in terms of tread wear, two extremes were selected - a completely worn tire and a fully treaded tire (figure 9). Both tires were recapped except that the tread rubber was completely worn out on one. The tread wear was representative of the condition at which a tire would

normally be removed from the aircraft and be recapped. The total vertical load on the tire in these tests was 35,000 pounds - a value representing the average load on each landing wheel of a Boeing 727-200 aircraft. The tire inflation pressure was maintained at 140 pound/square inch, which represents the lower limit of the operational range of the Boeing 727 aircraft tires.

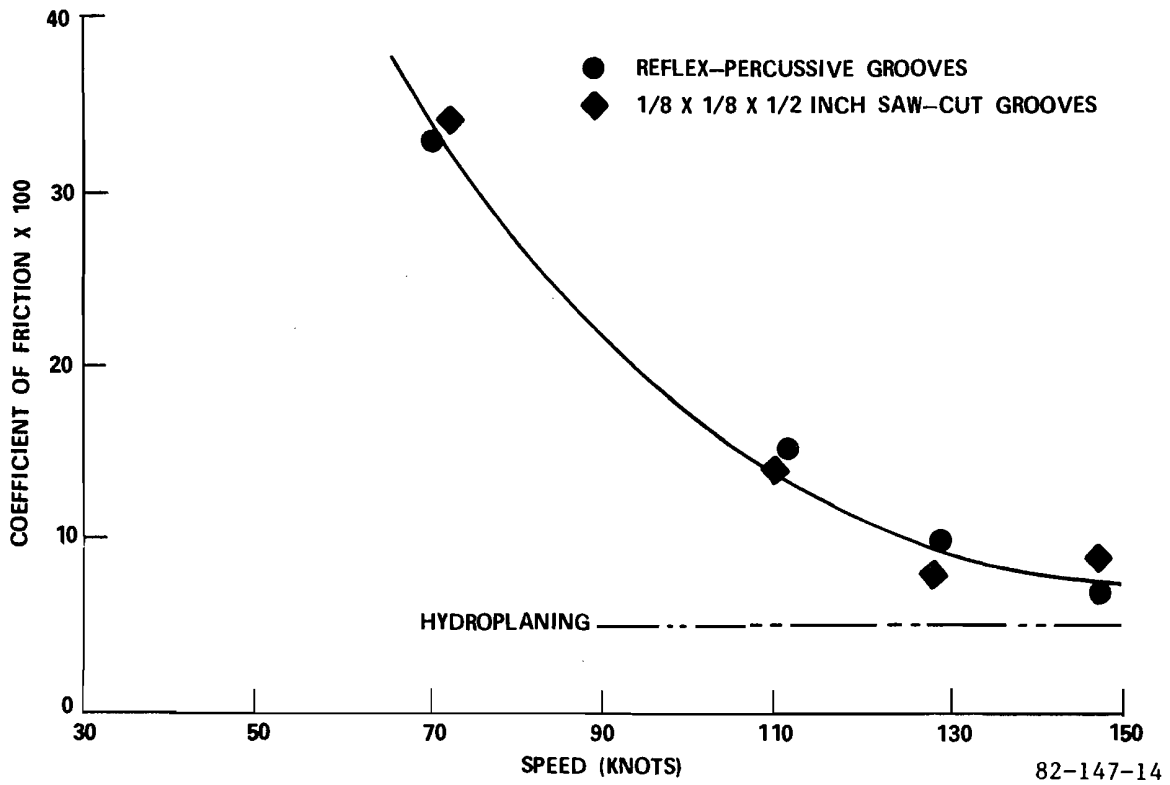
FIGURE 14. BRAKING PERFORMANCE OF A WORN TIRE ON PUDDLED SURFACE

The performance on the reflex-percussive grooves, and on 1/8-inch square saw-cut grooves is shown in figure 14. A single curve adequately represents the average performance of the two treatments. Figure 15 shows a composite of figures 13 and 14 to directly compare the braking performance on all the surfaces tested. The shaded area bounded by two light lines show the performance envelope on the saw-cut grooves. The dark line shows the performance on the reflex-percussive grooves and on the 1/8-inch square saw-cut grooves. In all cases, hydroplaning condition is not reached within the speed range employed in the test program. This figure indicates that the saw-cut grooves spaced 1 1/4 inches apart provide the highest levels of available friction on puddled surfaces with worn aircraft tire. The use of new tires will provide even higher levels of friction coefficients.

The slope of the friction-speed curve is continuously decreasing for all the surfaces — treated or nongrooved. However, although not enough data are available, figures 13 and 18 indicate that the slope is changing assymptotically beyond 140 knots and below 70 knots for treated surfaces. Thus, in a situation where a landing is attempted at a higher than normal speed, the wheel will not immediately experience friction levels corresponding to hydroplaning. Also, as the aircraft is being braked and going through successively lower speeds, it is encountering gradually increasing rate of change of friction level. This enables a shorter overall stopping distance. In comparison, the friction-speed curve for the nongrooved surfaces (figure 11) is uniformly decreasing near the high speed end and a state of hydroplaning will exist should the landing speed be higher than normal.
