**SEAHIVE® solutions to mitigate bridge scour – Phase I**

**Part 1**

**Annual Research Report – Part 1**

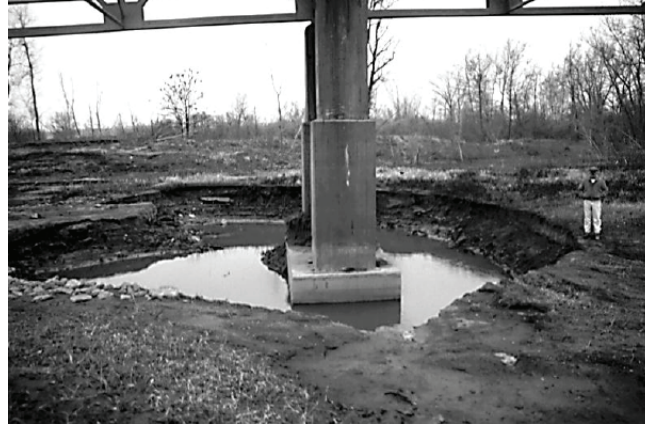
Figure 1 Local scouring a bridge pier after flow event.

The mechanism of local scouring is in a way that the bridge piers impede the flow stream, and this causes large-scale turbulence structures. This turbulence not only exacerbates the turbulence in the flow-down-ward towards the bed which is called horseshoe vortex, but also increases the turbulence behind the bridge pier which is called the wake vortex [16]. It can be concluded that the main root of local scouring is attributed to the hydraulic structures interfering by obstructing the natural flow field [17]. When it comes to general scour, it can be categorized as either prolonged or short-term erosion. The root of this mechanism involves removing the sediments from the bed river and bank river from the width of the channel [18]. As opposed to the local and contraction scour, the bridge pier is not a factor in causing this mechanism. As for the contraction scour, this is attributed to the acceleration of the flow due to the obstruction and contraction, such as a bridge. This type of scouring is narrowed down to the length of contraction [18,19]. To protect the bridge piers from scouring incorporating SEAHIVE® technology is proposed. The presence of perforations on the surfaces of hollow hexagons holds the potential to alter hydraulic flow dynamics in areas surrounding a pile cap, as well as within the interstices between piles, where contraction and local scour may occur [6].

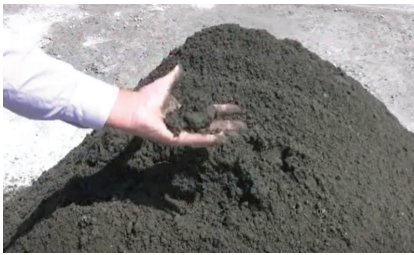
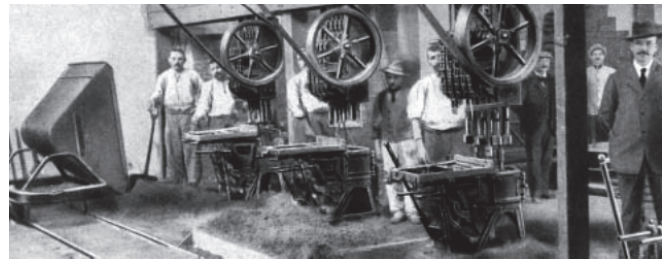
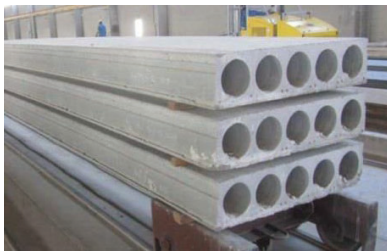
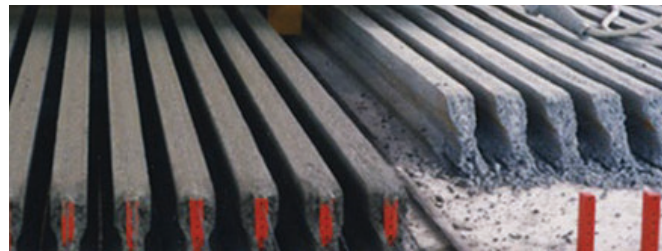
Figure 2 (a) Zero slump concrete; (b) Concrete block production in the early 1900s; (c) Production of T-joist in the 1930s; (d) Prestressed hollow-core slabs in the 1950s

cast concrete consists of using zero slump concrete (See Figure 2 (a)) which is formed with various methods and immediately removed from its forming setup and let to cure. The very first dry-cast product was concrete blocks and concrete pipes at the very beginning of 1900s (See Figure 2(b)), with the method extending to structural applications like T-joists (See Figure 2(c)) in the 1930s and prestressed hollow-core slabs in the 1950s (See Figure 2(d)).

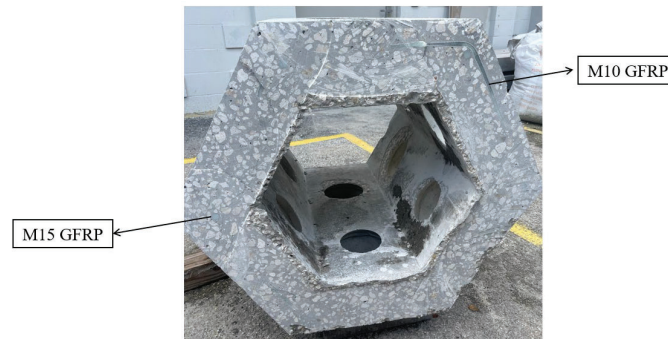
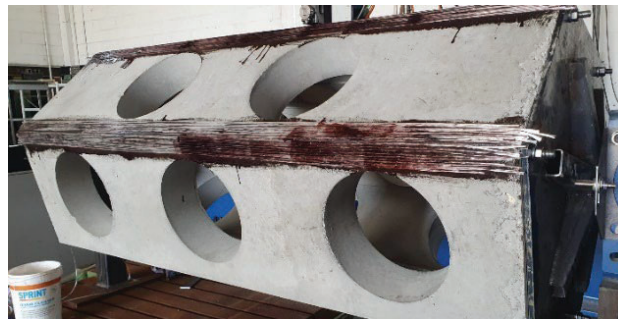
Figure 3 (a) SEAHIVE® with internal reinforcements (b) SEAHIVE® with external reinforcement

portion of the seawalls exposed to tides and waves becomes a weaker link reducing their service life. As an alternative, SEAHIVE® can be reinforced by either external GFRP wraps or internal GFRP bars (See Figure 3) [8,28–34].

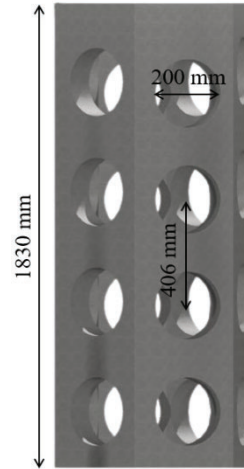
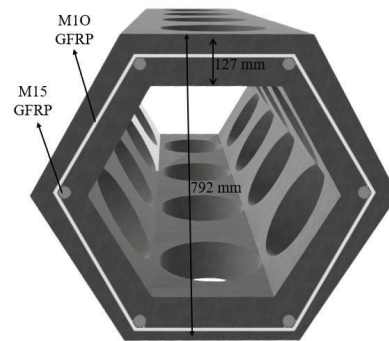
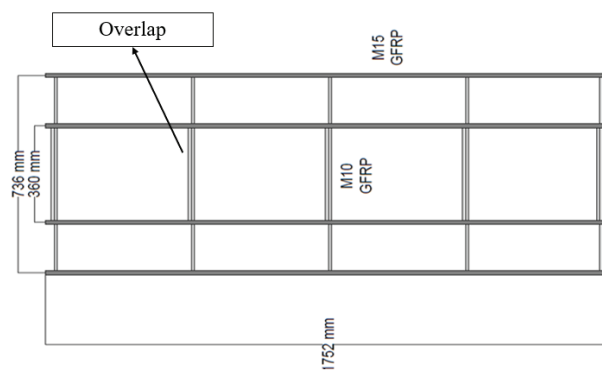
Figure 4 The geometry of the SEAHIVE® unit with reinforcement details

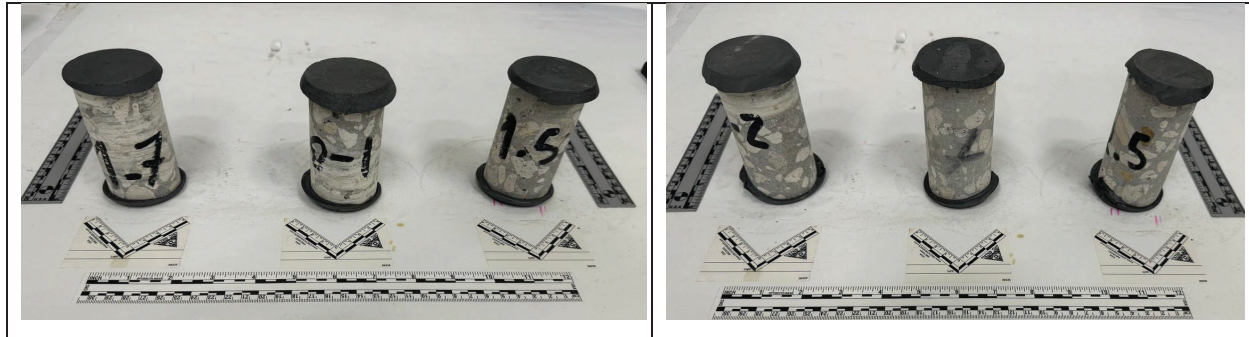
Figure 5 Concrete cores extracted from two different units

Six cores from two different SEAHIVE® units were extracted to obtain the concrete compressive strength used in fabrication. The diameter of the extracted cores was 50.8 mm, and the height after trimming the ends was 101.6 mm. Based on ASTM C39, cores were tested under compression [37]. Before testing, both core ends were sulfur-capped to have planar and parallel surfaces (See Figure 5). The average compressive strength of the concrete cores was 40 MPa with a standard deviation of 2.6. The concrete mix constituents and proportions were not provided by the manufacturer. By inspection, it was observed that the maximum aggregate size was 25 mm corresponding to half the diameter of the core. Ergun and co-workers [38] showed that the

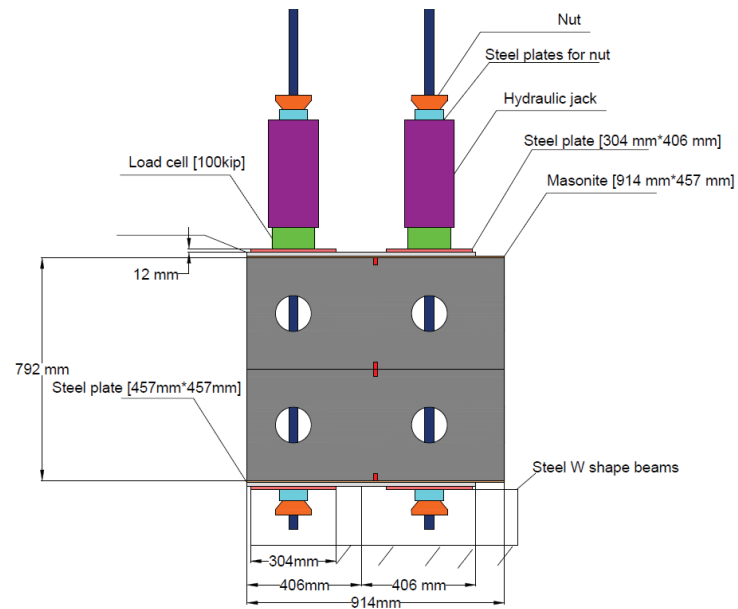
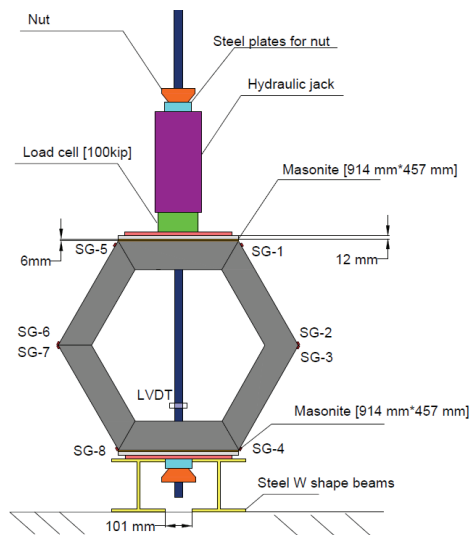
Figure 6 Sketch of compression test configuration: (a) side and (b) cross-sectional views

The experimental setup for the compressive test is shown in Figure 6 for specimens 0.91 m in length. To ensure that the applied load from the two hydraulic jacks was distributed uniformly across the element's surface, two 914 x 457 mm<sup>2</sup> masonite sheets were used on the surface of the element followed by two 305 x 406 mm<sup>2</sup> steel plates. Thereafter, the load cells were placed over the steel plates and the load was applied by means of two hydraulic jacks operated manually.

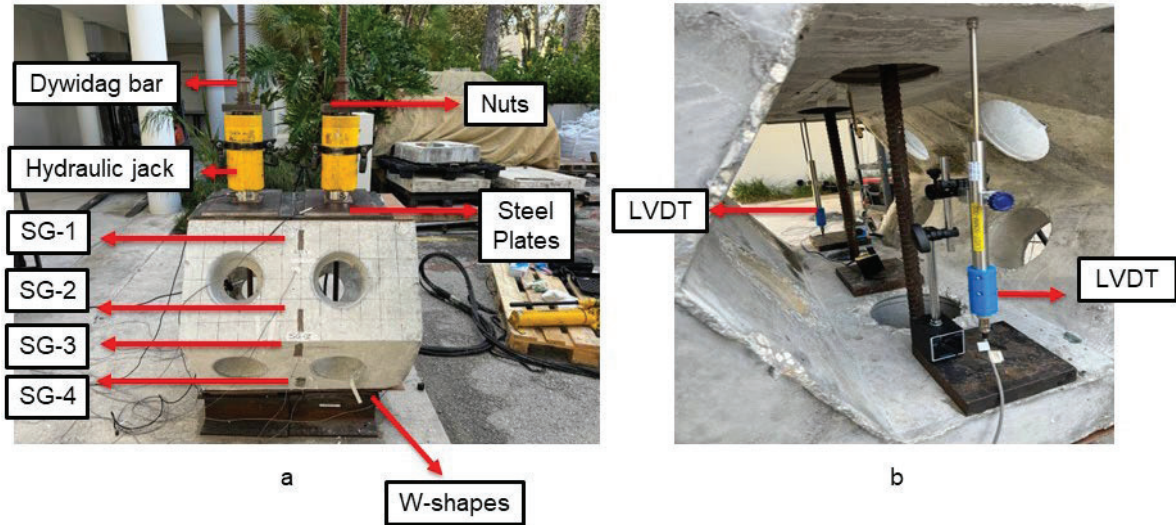
Figure 7 Location of: (a) strain gauges (b) LVDTs

Strain gauges were used to measure strains on the concrete surface, whereas linear variable differential transformers (LVDTs) were used to measure displacements (See Figure 7(a) and Figure 7(b)). The instruments were connected to a data logger to record the applied load, strain, and displacement values.

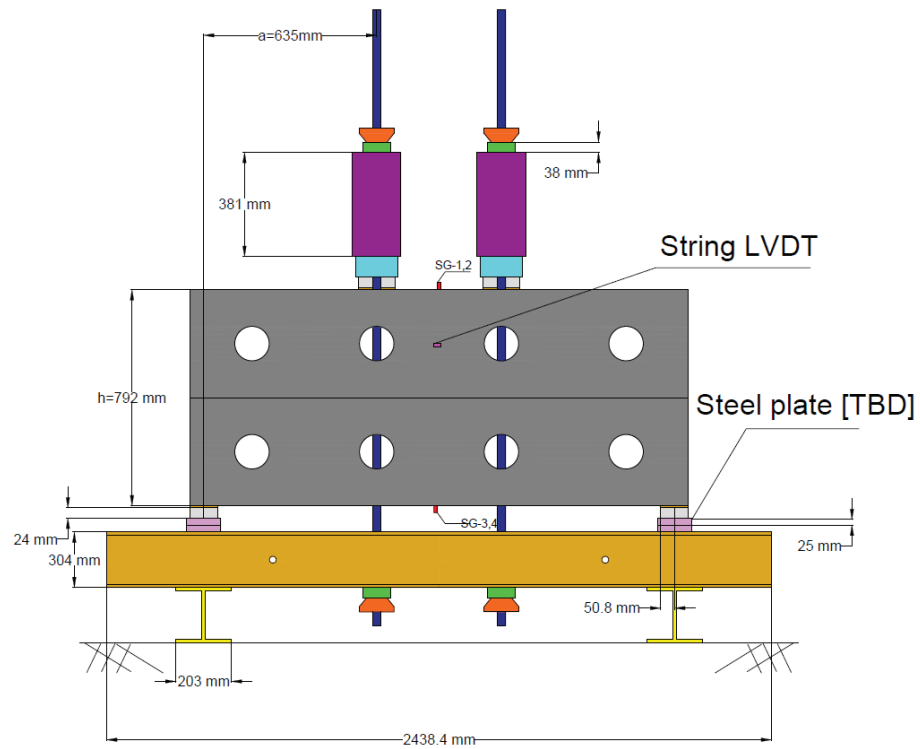
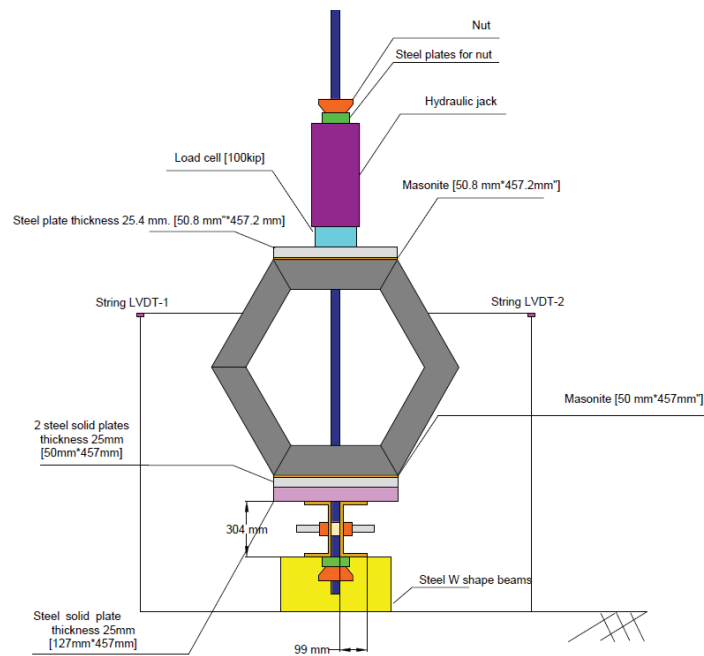
Figure 8 Sketch of the flexural test configuration: (a) side and (b) cross-sectional views

Two full-size units were tested under four-point bending to investigate the flexural behavior of the specimens. As shown in Figure 8, the distance between a support and a loading point (i.e., shear arm= $a$ ) is 635 mm, while the total height of the sample (i.e.,  $h$ ) is approximately 792 mm. The  $a/h$  ratio is about 0.8 (See Figure 8(a)), indicating that the unit being tested can be characterized as a deep beam. Two hydraulic jacks each located at a distance of 686 mm from the end of the specimen were used to apply the load. Masonite sheets were used below steel plates to avoid possible local concrete crushing due to surface imperfections. Strain gauges on one side of the specimen at the mid-length were positioned to measure strain at the top and bottom of the unit. These strain gauges provided valuable data on how strains were generated under the applied flexural load. Figure 9 shows LVDTs positioned mid-depth on both sides of the specimen to measure vertical displacement.

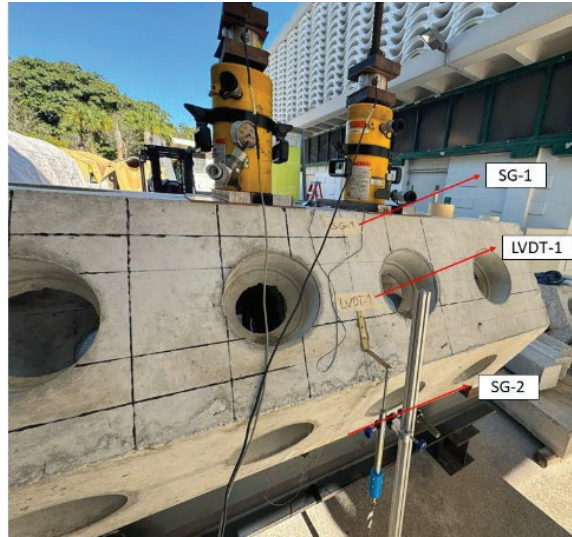
Figure 9 LVDTs on one side of the tested sample under a four-point flexural test

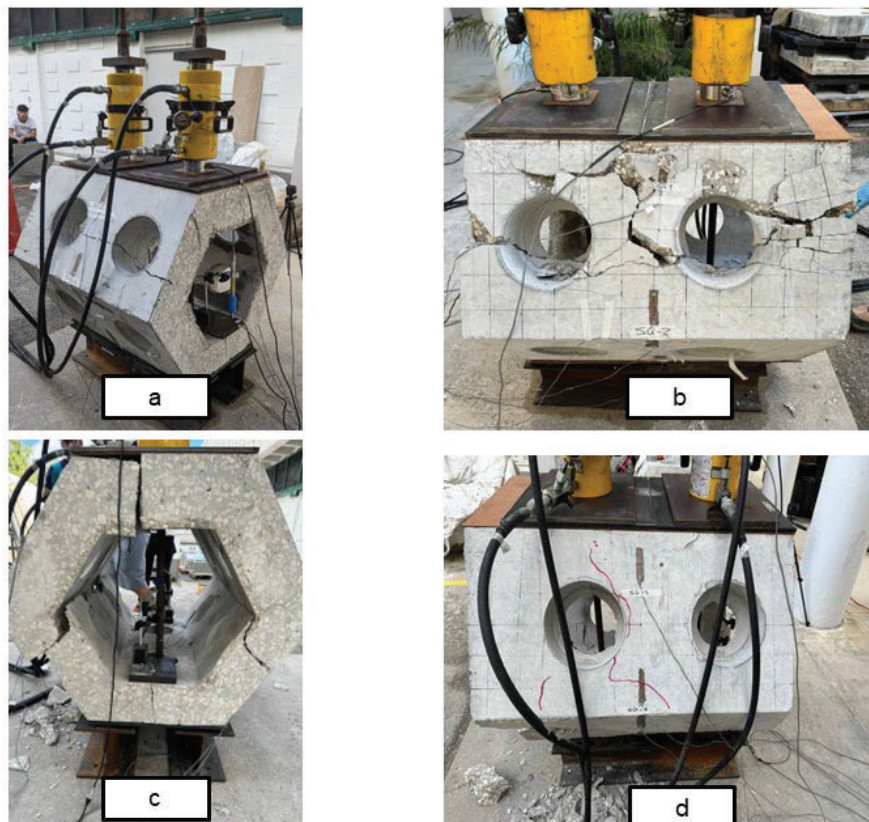
Figure 10(a) and Figure 10(b) show the CB-1 specimen during loading and at failure, respectively. It can be observed that the first crack started at the location of the holes. The crack propagated horizontally along the mid-depth of the leg of the hexagon. Inclined cracks, possibly

due to shear, started after initial horizontal cracks. The failure occurred when the horizontal cracks grew in length, connecting holes in the hexagon.

A similar pattern was observed in the CB-2 specimen (See Figure 10(c) and Figure 10(d)) showing the specimen after failure and after the first loading cycle, respectively. However, in this case, together with horizontal mid-leg cracks others formed at the hexagon corners (See Figure 10(c)).

Figure 10 Cracking pattern in (a) CB-1 failure; (b) CB-1 after failure; (c) CB-2 after failure; and, (d) CB-2 at the end of the first load cycle

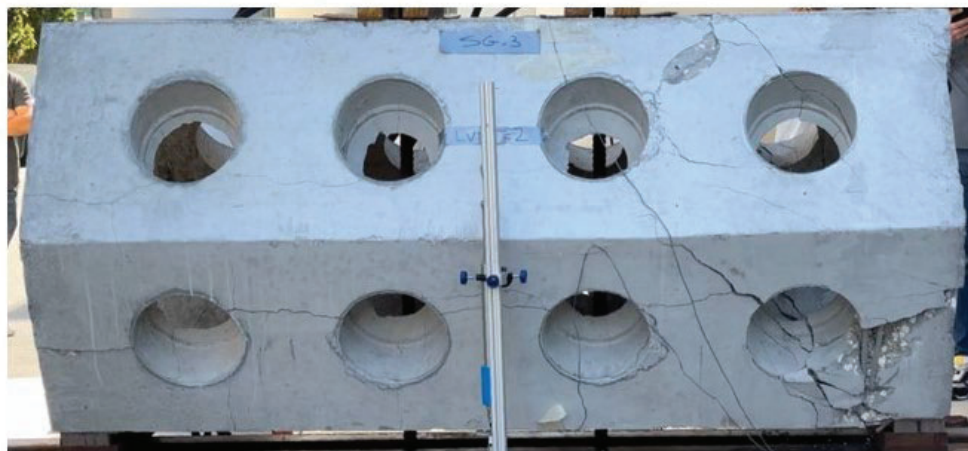
Figure 13 shows the specimens tested under the four-point bending. Similar to specimens under pure compression, a horizontal crack formed at mid-leg between the holes. Figure 13 shows a photograph taken close to the end of the third loading cycle where it is apparent that failure was initiated by arching with a combination of crushing of the concrete toe and slipping of the longitudinal reinforcement not properly anchored.

Figure 13 Cracking pattern of FB-2 near the end of the final cycle

The failure of a SEAHIVE® tested in flexure may be due crushing of concrete in the strut or node, or due to rupture of tie reinforcement, provided it is fully developed. It can be observed in Figure 13 that stress concentrations occurred at the bottom node at the support, and the specimen failed by the propagation of cracks both at the node and horizontal cracks at the center of the leg. The specimen failed at a load equal to 250 kN, which is significantly lower than the strength of the strut and nodes. It may be observed in Figure 13, that there are no signs of concrete crushing in the assumed struts and nodes except at the bottom node. However, the failure at the bottom node may be triggered by stresses in the tie reinforcement. It is worth noting that the required development length for the specimen was calculated equal to 560 mm, however, reinforcement in Tie-2 could only be developed for 50 mm.

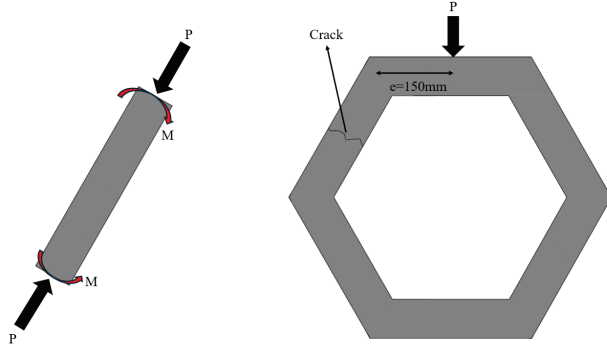
It can be observed in Figure 16 that the first cracks appeared in the middle of the inclined leg of the hexagon. The failure at this location resulted from the combined effect of axial and flexural stresses (See Figure 16). The maximum tensile stress in the leg due to the combined effect of moment and axial load was calculated using conventional analysis (i.e.,  $\sigma_b = -\frac{My}{I} + \frac{P}{A}$ ).

Figure 16 Combined axial force and moment resulted in the inclined leg

The cross-sectional area equals  $A = 64643 \text{ mm}^2$ . The first visible cracks on the specimen appeared at a load between 73 and 79 kN, as per Table 3. Therefore, the load on each leg was equal to about 38 kN. The moment at mid-height of the leg (i.e., location of holes) was calculated by multiplying the applied load with its eccentricity ( $e$ ) assumed to be 150 mm (See Figure 16). The stress at cracking was calculated as shown below:

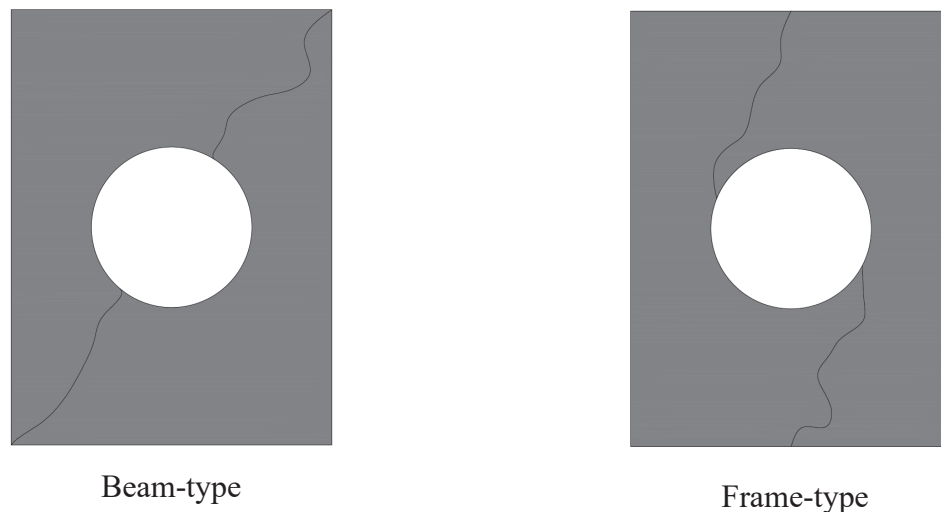
Figure 17 Shear failure modes in concrete beams at the location of the holes

Gohar et al. [40] concluded that when the diameter of the holes on the surface of concrete beams under bending stress exceeds 0.25 times the total depth of the beam, traditional beam theory can no longer be applied. Instead, frame action takes precedence over beam-type behavior, as depicted in Figure 17; thus, using the beam-theory method is not applicable for this condition. In this study, the hole diameter is 200 mm, and there are eight holes on each side of the unit (four holes on the top of each other) so the ratio of the diameter of the holes to the total depth of the concrete exceeds 0.25, surpassing the limit established in the referenced study. The presence of holes on all surfaces of the hexagonal, hollow, perforated specimen makes analysis complex. Moreover, the shear span-to-reinforcement depth ratio of the SEAHIVE® was equal to 0.8; therefore, conventional beam theory is not appropriate for its analysis.

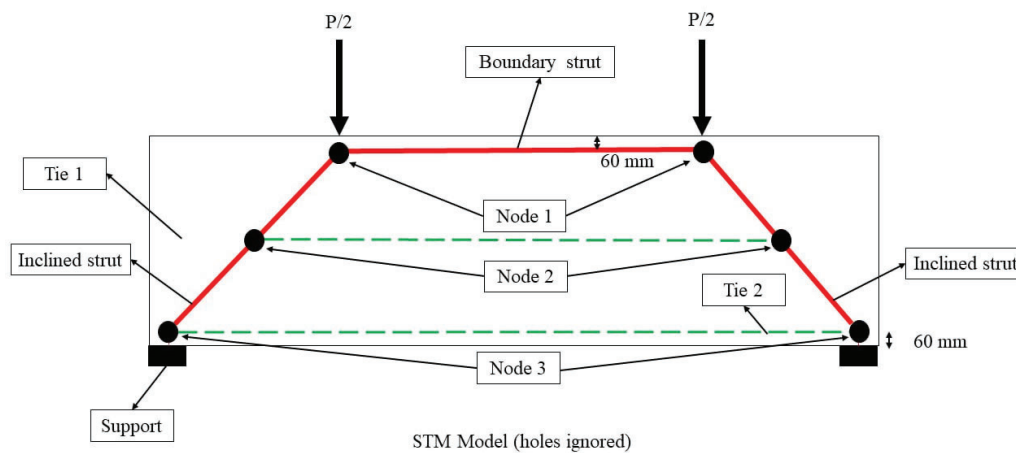
The existing models for analyzing deep members would not be appropriate for SEAHIVE®, as it involves a complex hollow cross-section with holes. It should be noted that due to the presence of these holes, the stress flow will not be uniform, and may result in stress concentrations. For simplicity and in first approximation, the presence of holes was ignored and a model having one chord, four struts, six nodes, and two ties was assumed forming a simplified STM for SEAHIVE® (See Figure 18).

Figure 18 STM model

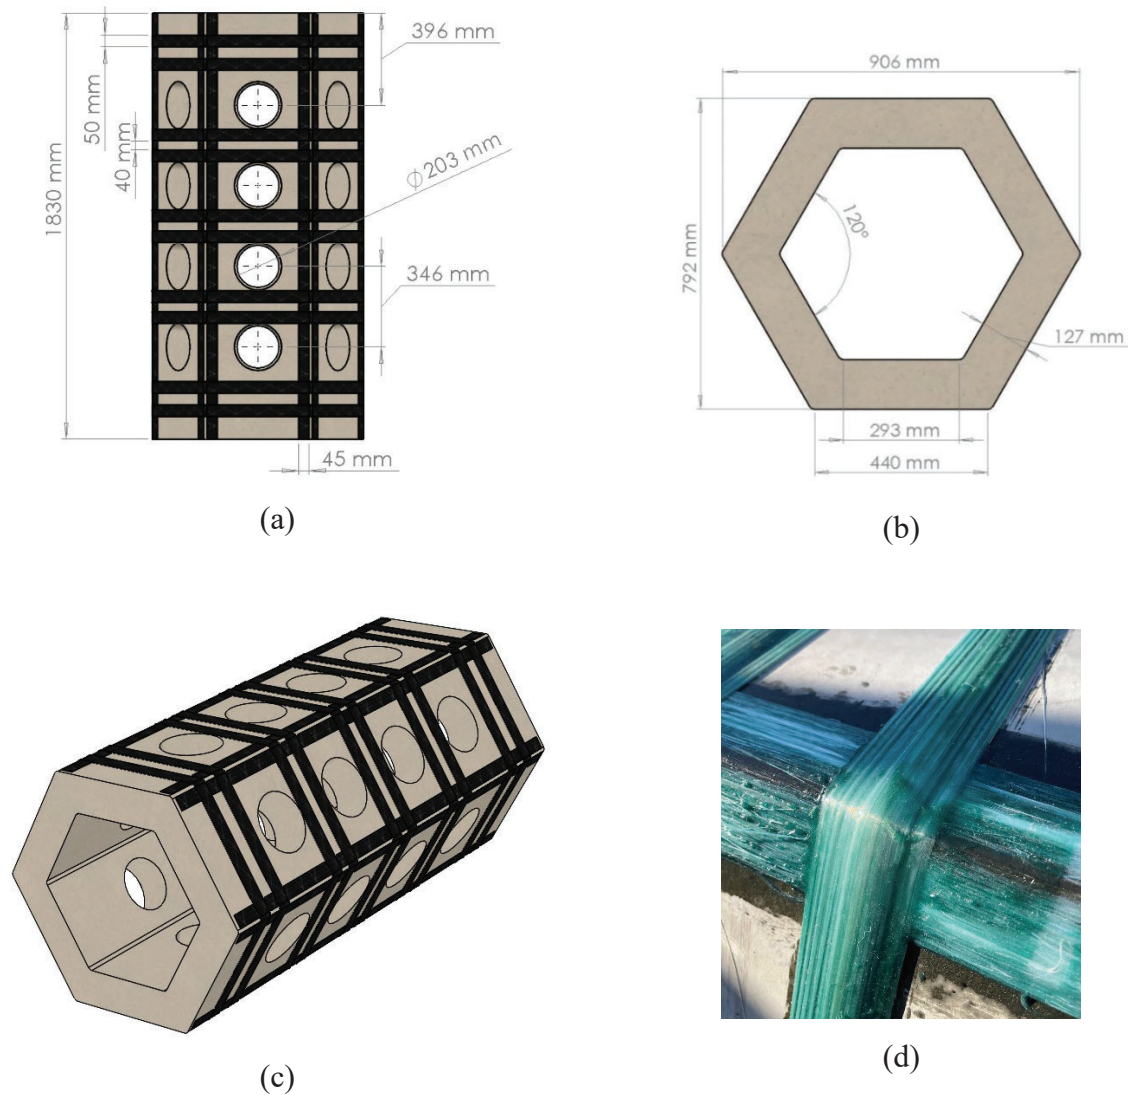
Figure 19 Geometry of the SEAHIVE® unit with reinforcement details

roving during the wrapping process. Each wrap was positioned as close as possible to the holes, to compensate for the lower shear capacity at these locations. In addition to compressing the concrete, these wraps have the function of anchoring the longitudinal strips by enhancing the bond between strip and concrete. This is because the pretensioned wrap creates a compressive force at each corner between strips and concrete thus significantly increasing the shear force capacity between them (See Figure 19(d)). For each wrap, 80 turns of 2400 Tex E-glass roving were applied (about  $80 \text{ mm}^2$  cross section area of GFRP pack), with each wrap tensioned to a total of 20 kN. The 250 N tension applied to each 2400 Tex roving is approximately 25% of its ultimate tensile capacity (refer to Table 5) which is below the limit of creep-rupture for GFRP [44].

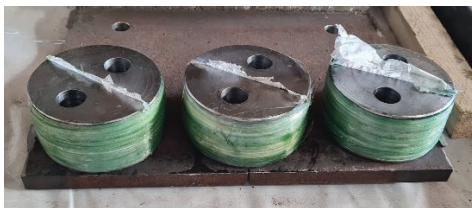
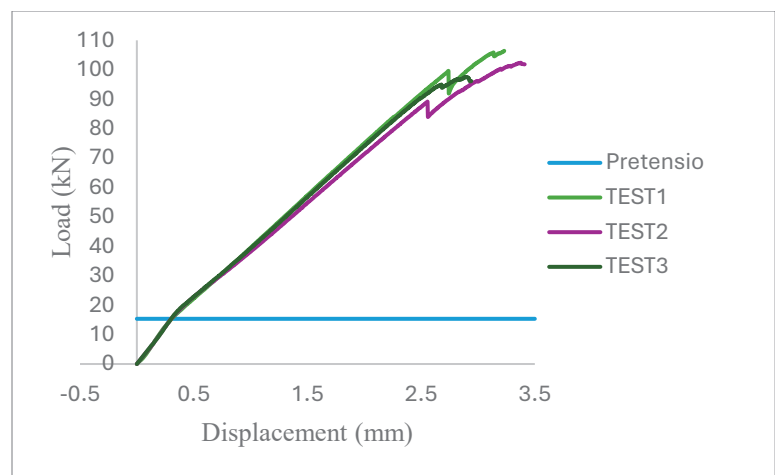
Figure 20 GFRP tensile test: (a) samples and (b) load-displacement results (courtesy of CIRI Edilizia e Costruzioni, DICAM, University of Bologna, Italy; Drs. Anna Rosa Tilocca and Andrea Incerti; Prof. Marco Savoia, Director)

For more accurate data on the mechanical performance of the GFRP strips and wraps, experimental testing was conducted. The tensile properties of the GFRP samples were determined following the provisions of ASTM D2343 [46]. Three cylindrical samples were wrapped with 40 turns of fiberglass roving (see Figure 20(a)), each. subjected to a pretension of 200 N. During the test, the cylinders, separated in halves, were tensioned till GFRP failure. After three tests, the average ultimate tensile strength was approximately 100 kN. The standard deviation of the samples from these tests was found to be 29.3 kN. Given that there were 40 turns, this equates to approximately 1250 N per roving (refer to Figure 20(b)).

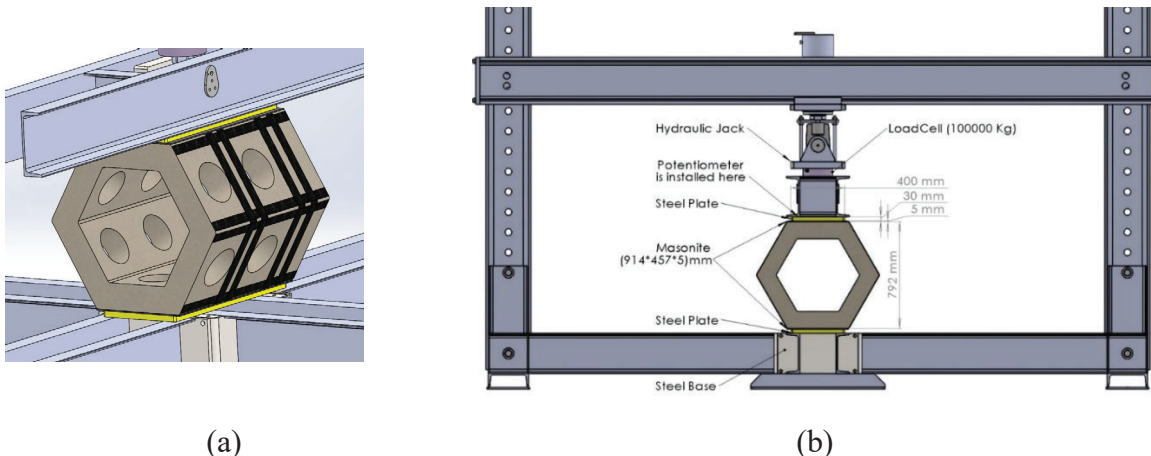
Figure 21 Sketch of compression test configuration: (a) profile and (b) cross-sectional view

The experimental configuration for the compressive test is illustrated in Figure 21(a) and (b), for specimens measuring 910 mm in length. To ensure an even distribution of the applied load from the hydraulic jack across the surface of the element, two masonite sheets measuring 914 x 457 x 5 mm were placed on the element's surfaces. Following this, two steel plates measuring 900 x 400 x 25 mm were positioned one on top and one on bottom of the specimens. Subsequently, load cells were situated over the sample, and the load was applied using a hydraulic jack.

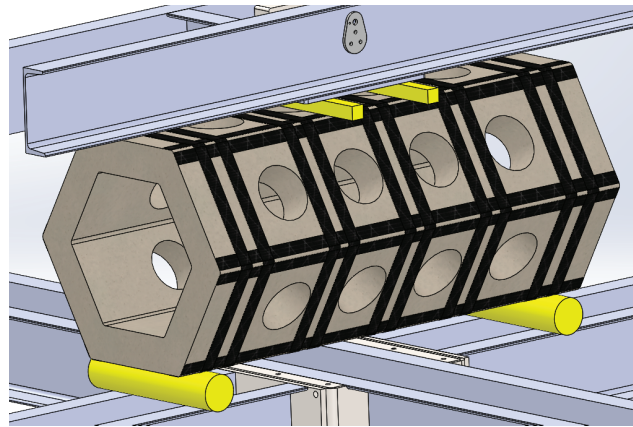
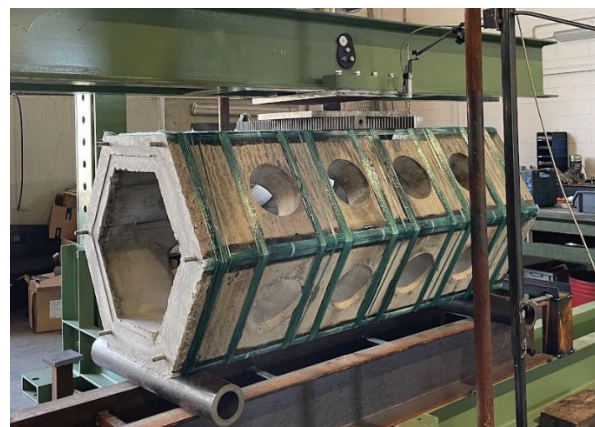
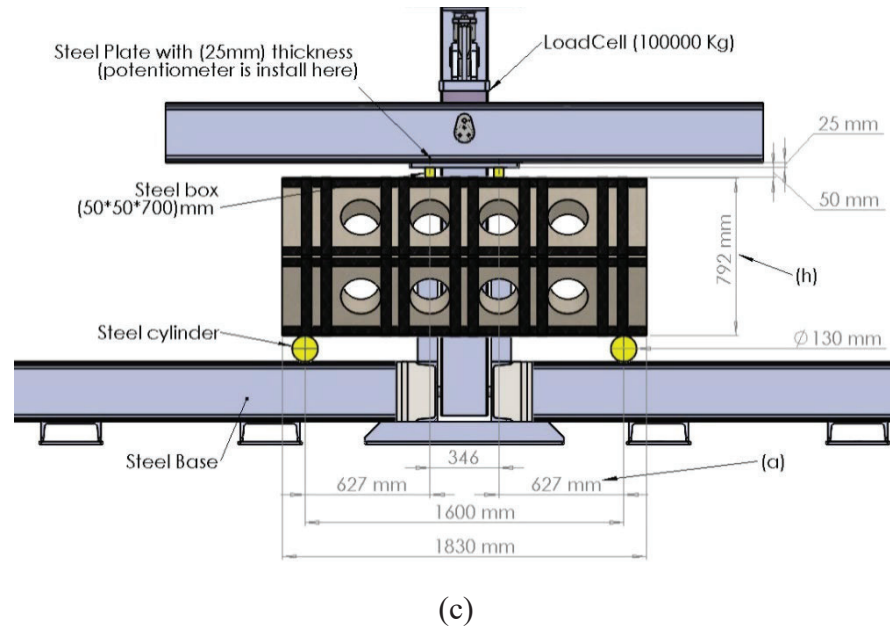
Figure 22 Flexural test configuration: (a) 3D schematic view, (b) specimen photograph; and (b) schematic view of the loading frame with dimensions

Two full-size units were tested under four-point bending to investigate the flexural behavior of the specimens. As shown in Figure 22(a), (b) and (c), the distance between a support and a loading point (i.e., shear arm= $a$ ) is 627 mm, while the total height of the sample (i.e.,  $h$ ) is approximately 792 mm. The  $a/h$  ratio is about 0.8 (See Figure 22(c)), indicating that the unit being tested can be characterized as a deep beam. Two steel plates (25x25x700 mm) were used as the loading knives positioned over the center of the middle holes.

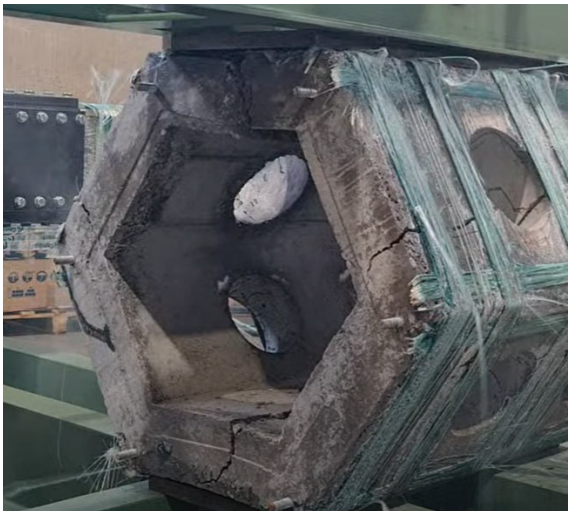
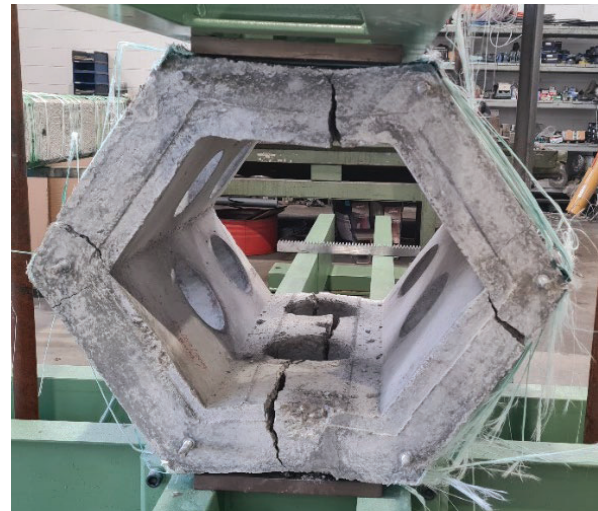
In Figure 23(a), the CS-1 specimen is shown at the point of failure. Cracks are evident along the mid-length of the horizontal section and at the corners of the inclined legs. Initially, horizontal cracks developed, followed by inclined cracks likely attributed to shear. The failure occurred as the horizontal cracks extended, ultimately connecting with the holes in the hexagon. Similarly, the crack pattern observed in the CS-2 specimen (depicted in Figure 23(b)) closely resembled that of the CS-1 specimen.

Figure 23 Cracking pattern at failure in (a) CS-1 (b) and CS-2

The presence of external reinforcement effectively prevented the sudden failure of the samples after the first cracks were initiated. It seems the compressive pressure induced by the external reinforcement significantly increased the strength of the specimens under pure compressive load. The pretensioned wraps created a compressive force along the edges of the SEAHIVE®'s hexagonal structure. This mitigated the effect of tensile stresses on the specimen. As a result, the ultimate strength of the SEAHIVE® became dependent on the GFRP ultimate strength.

During the test, the SEAHIVE® successfully resisted the applied force until some of the glass filaments reached their limit and broke with concrete cracks that began to propagate. The first cracks appeared at the outer points of the SEAHIVE®, where the applied load generated maximum moments. Finally, two additional cracks appeared in the middle of the SEAHIVE® top and bottom legs due to the deformation of the specimen around the center.

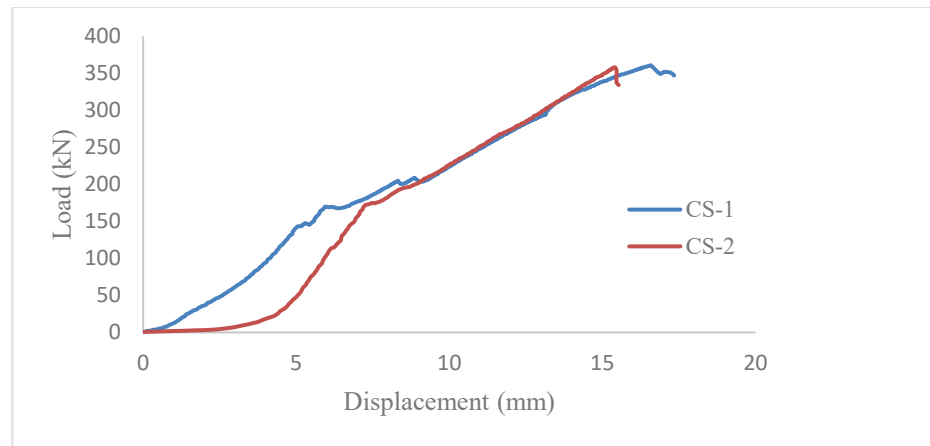
Figure 24 shows the load-displacement diagram of CS-1 and CS-2 tested under pure compression. The horizontal axis indicates the average displacement, and the vertical axis shows the applied load. The first crack occurrence is shown in the diagram by a load drop in both CS-1 and CS-2 around 145 and 172 kN, respectively. After that, the specimens continued to carry the load until GFRP failure (about 358 kN for both).

Figure 24 Load-displacement results of pure compressive tests

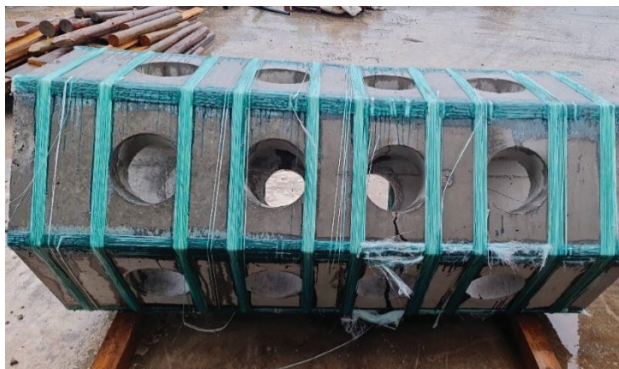
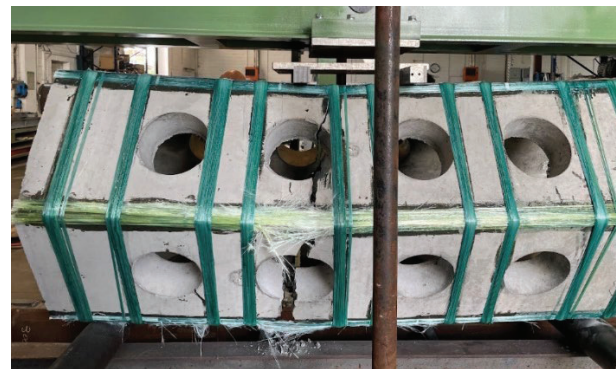
Figure 25(a) and (b) show the failed specimens tested under bending. The cracks started to propagate in the middle of the SEAHIVE® at the holes and extended directly upwards. This crack pattern suggests failure due to bending moment in the area where the moment of inertia is minimal due to the presence of holes. When the longitudinal GFRP strips placed on the bottom (first) and mid-height (second) corners could no longer withstand the tensile stress, they failed and caused the collapse of the specimen.

Figure 25 Cracking pattern at failure of (a) FS-1 and (b) FS-2

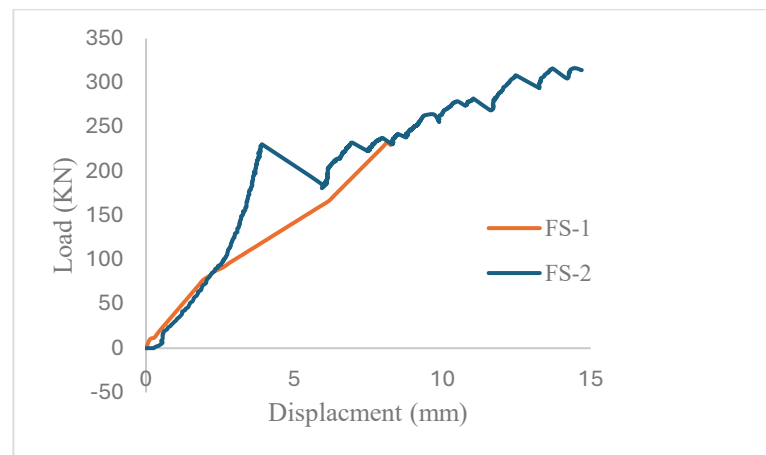
Figure 26 Load-displacement results of FS-1 and FS-2

The difference between the two results is due to the slipping of the longitudinal strips. In the FS-1 test, the GFRP strips held together until 231 kN, but then suddenly slipped due to inadequate anchorage provided by the transverse wraps. Moreover, in this test, the longitudinal strips were adhered using the layup method without any anchors at both ends.

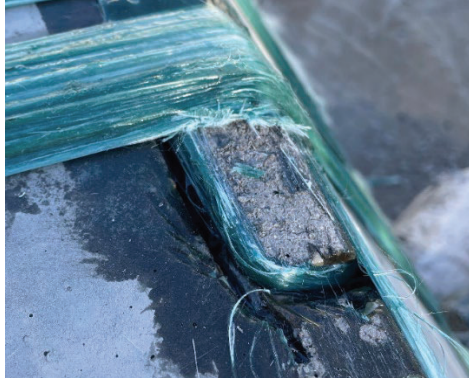
Figure 27 Anchoring fibers on both ends of the longitudinal strips for FS-2

In the FS-2 specimen, to overcome slippage, the longitudinal strips were anchored at both ends of the SEAHIVE®. A slot was created at each end, and during the placement of the longitudinal fibers using the layup method, each fiber filament was wrapped around the slot. As a result, the pack of fibers became securely anchored at each end (See Figure 27). During the test of FS-2 specimen, at 3.9 mm displacement, some of the longitudinal strip partially broke, resulting in a loss of load capacity. However, the remaining strip portions continued to hold, allowing the specimen to sustain a higher load. After a peak load was reached, fibers started to break gradually until sudden failure. Overall, the SEAHIVE® in FS-2 withstood up to 315 kN before complete failure, which is significantly higher than the load in the FS-1 test. Table 6 summarizes the results of the experiments on four tested specimens.

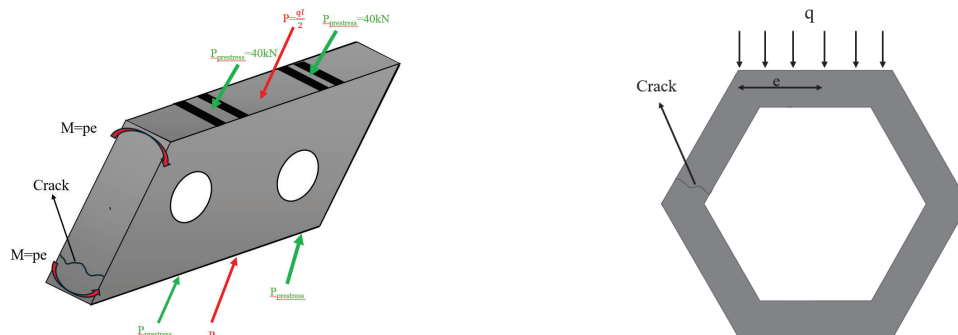
It was observed in Figure 28 that the first cracks appeared at of the end of the inclined leg. The failure at this location resulted from the combined effect of axial and flexural stresses resulting from applying pure compression and prestressing load resulting from the GFRP wraps (See Figure 28).

Figure 28 Loads on inclined leg

$I = 155335710 \text{ mm}^4$ . The corresponding cross-sectional area equals  $A = 115570 \text{ mm}^2$ . The first visible cracks on the specimen appeared at a load between 145 and 172 kN, as per Table 6. Therefore, the load on each leg was assumed to be equal to about 72.5 kN. The moment at the mid-end of the leg was calculated by multiplying the applied load with its eccentricity ( $e$ ) assumed to be  $e=144 \text{ mm}$  (See Figure 28). The stress at cracking was calculated as  $\sigma_b = -4.2 \text{ MPa}$ .

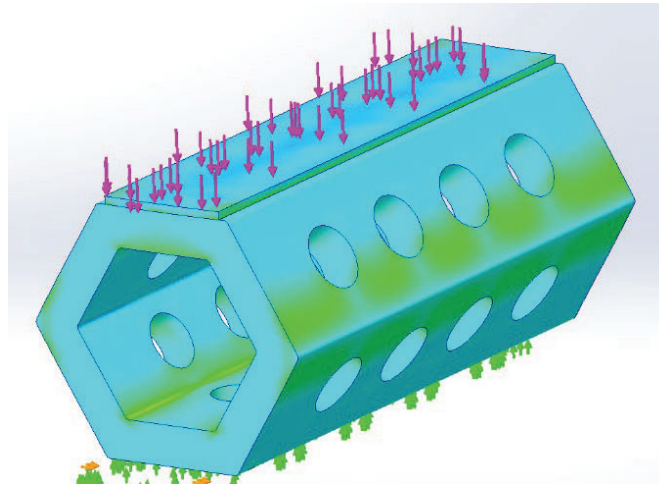
To evaluate the performance of the element under pure compression, a Finite Element Method (FEM) analysis was also performed using the full SEAHIVE®. As shown in Figure 29, the SEAHIVE® under pure compressive load experienced the maximum stress on the outer edge of the inclined legs of the hexagon. These areas correspond with the locations where cracks initiated in the actual specimens during testing.

Figure 29 Stress distribution on the SEAHIVE® under compression load

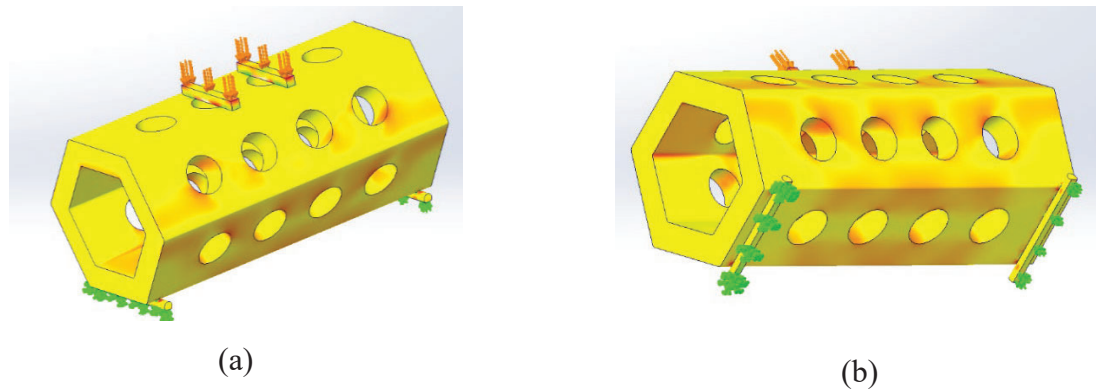
To evaluate the performance of the element under flexural load, a FEM analysis was performed using the full SEAHIVE®. As shown in Figure 30(a) and (b), the SEAHIVE® was modeled under a flexural load while seated on two cylindrical fixtures at both ends, simulating the test conditions. The FEM model displayed maximum tensile stress at the bottom surface of the unit at the location where the bending moments is greatest. Additionally, near the holes, in the direction pointing to the loading knives, maximum stress was observed. These red areas in Figure 30(a) and (b) correspond with the locations where cracks initiated in the actual specimens during testing, illustrating the pattern of crack growth direction in the specimen.

Figure 30 Stress distribution on the SEAHIVE® under flexure (a) 3D view, (b) bottom of specimen view

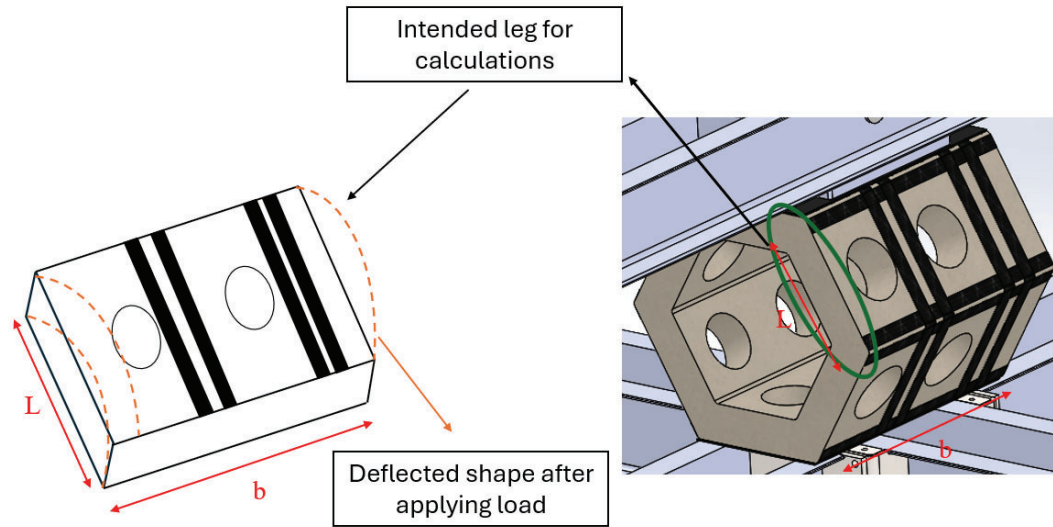
Figure 31 Intended leg for calculations in elements reinforced externally with GFRP wraps

In this research, the modulus of rupture is considered to relate the strength of the element reinforced with GFRP wraps to the element reinforced internally with GFRP bars. As can be seen in sections 2 and 3, the two elements resemble in terms of geometric parameters. The differences between these two elements can be categorized into two aspects, namely, concrete compressive strength and reinforcement amount. It should be noted that the effect of prestressing is considered in the calculation of the modulus of rupture ( $f_r$ ), and the effect of geometry is considered in the moment of inertia ( $I$ ). Figure 31 shows the intended leg in elements reinforced with GFRP wraps for the calculations.

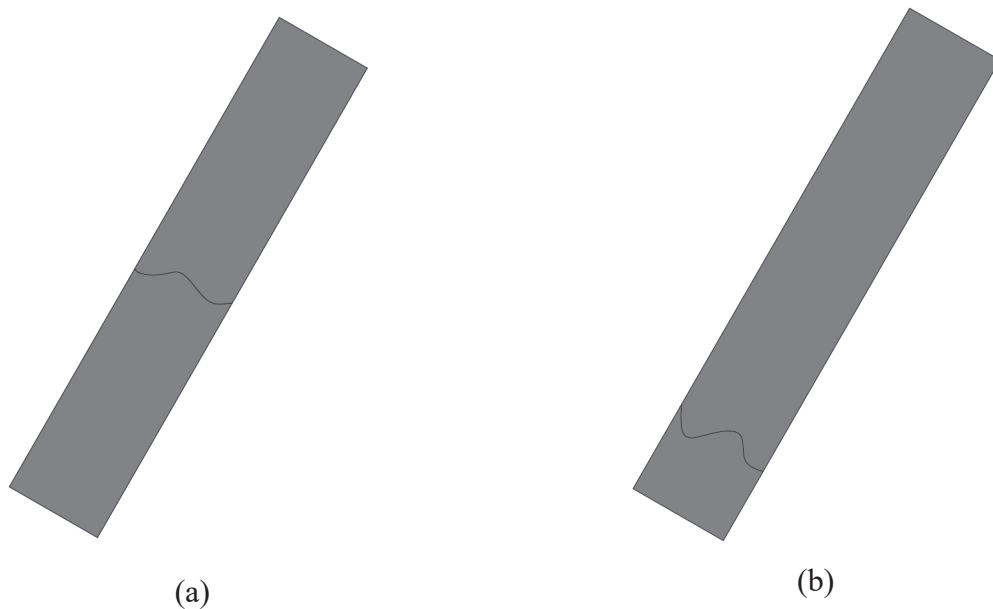
Figure 32 Location of the cracks in (a) elements reinforced with GFRP bars and (b) elements reinforced with GFRP wraps

Where  $f_r$  is the modulus of rupture for elements. It should be noted that the effect of prestressing is considered in the calculation of  $f_r$  as can be seen in section 3.  $C_t$  is the depth neutral axis,  $I$  is the moment of inertia of the element in the location of the crack (See Figure 32), and  $M$  is the cracking moment.

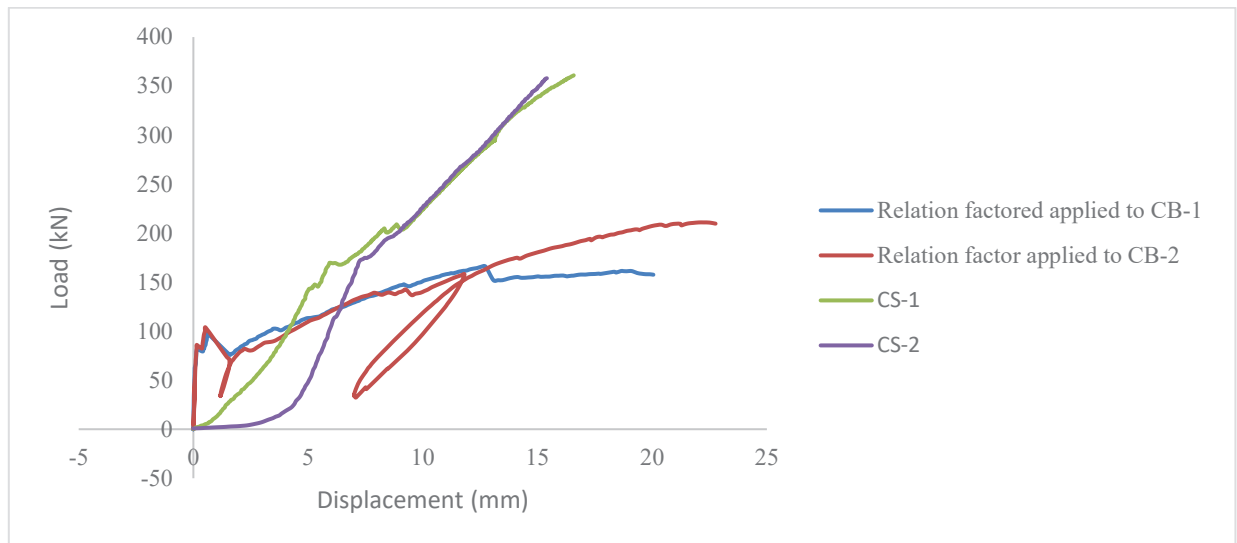
Figure 33 Compression results of experiments after applying relation factors

reinforced with GFRP wraps. Figure 33 shows the experimental results after applying the relation factor.
