U.S. Department  
of Transportation  
**Federal Railroad  
Administration**

## Wheel Failure Investigation Program: Phase 3

| <b>REPORT DOCUMENTATION PAGE</b> | | | | | <i>Form Approved</i><br>OMB No. 0704-0188 | |
|---|---|---|---|---|---|--|
| <b>1. REPORT DATE</b> (DD-MM-YYYY)<br>30 July 2026 | | <b>2. REPORT TYPE</b><br>Technical Report | | | <b>3. DATES COVERED</b> (From - To)<br>September 2020–December 2023 | |

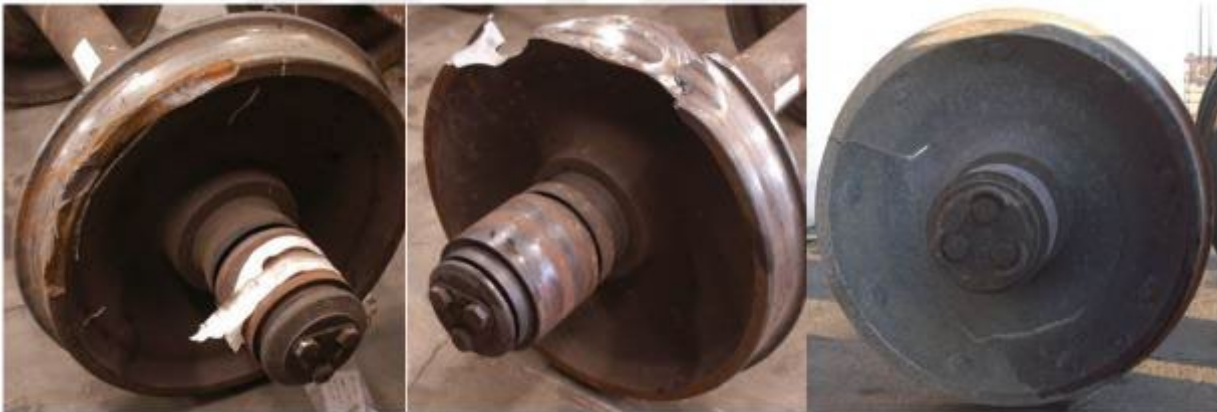
**Figure 1. Example of Vertical Split Rim (left), Shattered Rim (center), and Thermal Crack (right) Failed Wheels [1]**

- **Thermal Crack Extended into Plate:** A thermal crack is a transverse fatigue crack initiated at the surface of the tread or flange that occurs when the rim hoop residual stress is transformed from the beneficial compressive stress that exists following manufacture to the detrimental tensile stress. This stress reversal occurs due to significant tread braking. If the fatigue crack grows during repeated heating cycles to eventually reach the critical size, a large transverse overload fracture will propagate into the plate and can turn to remove a large portion of the rim and plate, or progress to the hub and cause the wheel to become loose on the axle.

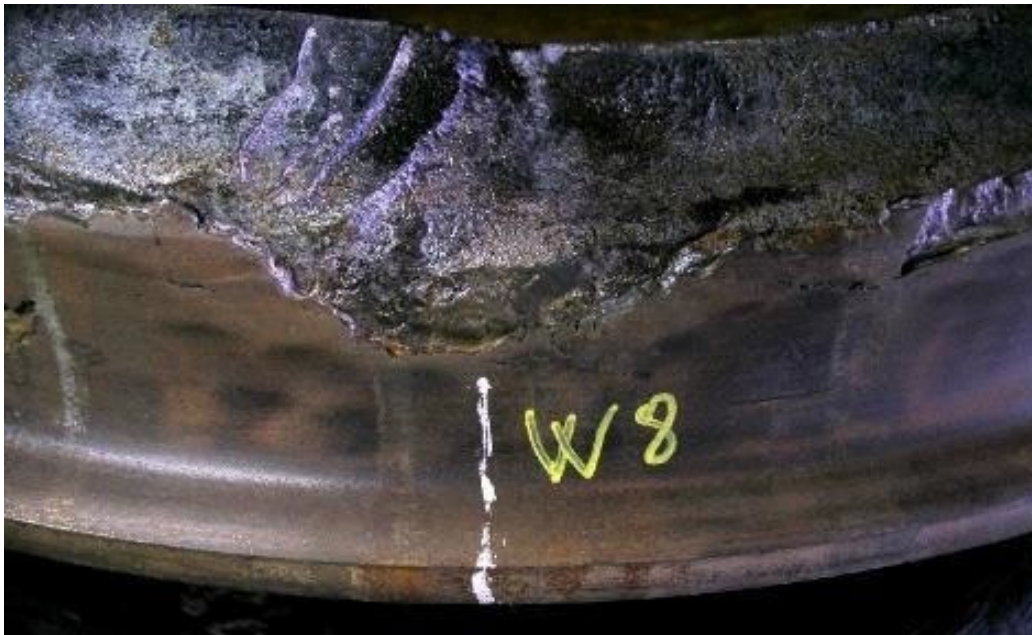
**Figure 3. A VSR failure with deformed steel and purple coloration exhibiting high temperature exposure**

Destructive testing was performed and confirmed that the mode of failure was consistent with the subsurface crack scenario. Additionally, the investigations confirmed significant thermal brake heating had occurred (as seen in [Figure 3](#)). The team found little evidence of false flanges. Fatigue evidence was seen in all subsurface cracks and most turn-in cracks. Some evidence of fatigue was noted in the unstable crack growth area, but in most cases the cracks features found in the region just prior to failure were either shear lips or depicted quasi-cleavage (a non-brittle fracture mode).
