# **PERFORMANCE EVALUATION OF VARIOUS HMA REHABILITATION STRATEGIES**

**Scott Shuler and Christopher Schmidt**

**December 2008**

**COLORADO DEPARTMENT OF TRANSPORTATION  
DTD APPLIED RESEARCH AND INNOVATION BRANCH**

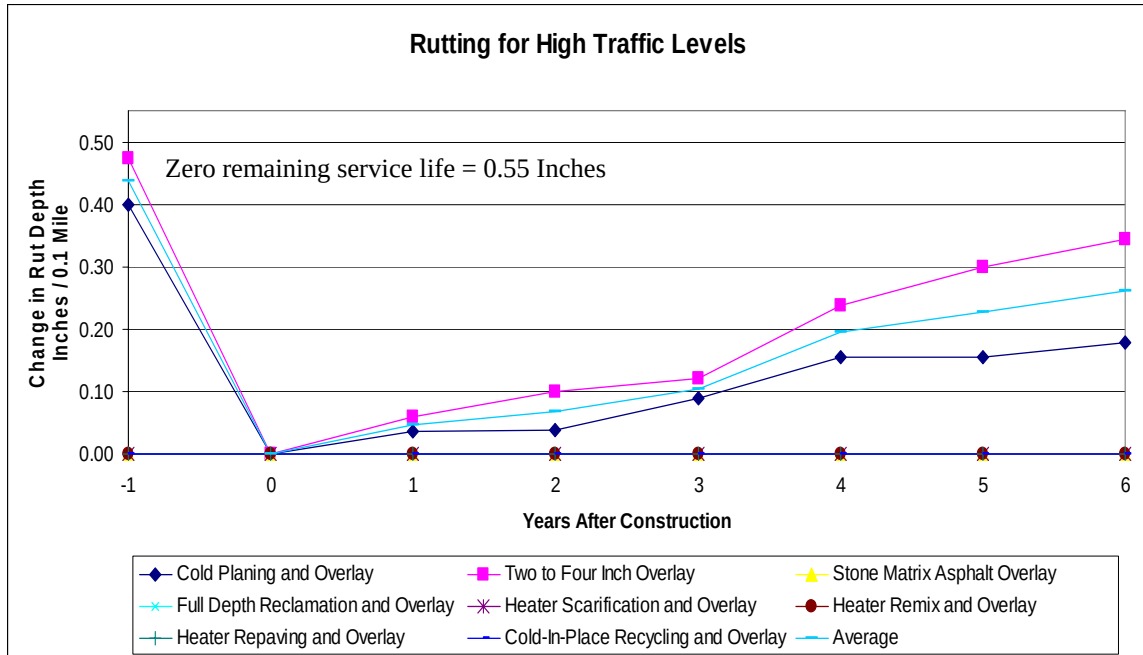
**Figure 24 Permanent deformation performance after six years with relation to traffic counts from 3 to 11 million ESAL**

Stone matrix asphalt overlay, full-depth reclamation and overlay, heater remix and overlay, and cold-in-place recycling and overlay are not represented. Both cold planing and overlay and heater repaving and overlay showed the least amount of rutting per year than the other rehabilitation strategies. Heater scarification and overlay showed the most amount of rutting per year as shown in Table 27.
