# **EFFECTIVENESS OF LEDGES IN CULVERTS FOR SMALL MAMMAL PASSAGE**

**COLORADO DEPARTMENT OF TRANSPORTATION  
RESEARCH BRANCH**

**Report No. 2007-09**

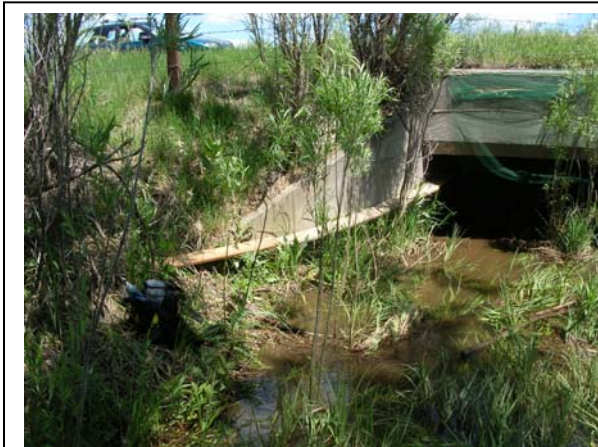
Goodhue Ditch at U.S. 36. Ramp is long and vegetation is well-developed; ledge not visible inside culvert. Note green netting for birds.

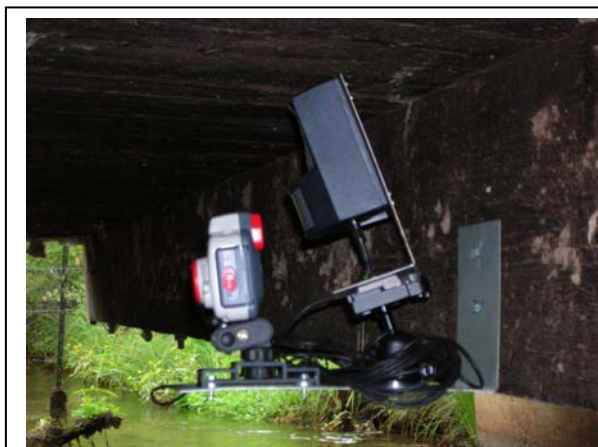
Camera (left) and monitor (right) installation. They are placed on a metal platform attached to the culvert wall.

The cameras were attached to the culvert with the use of 5 x 10.16-cm wooden blocks glued to the sidewall. One culvert required suspension of the camera unit from the culvert ceiling because of its width, and one had a wood beam running through the center that allowed for direct attachment. Metal L-shaped plates were built and used to provide a platform to

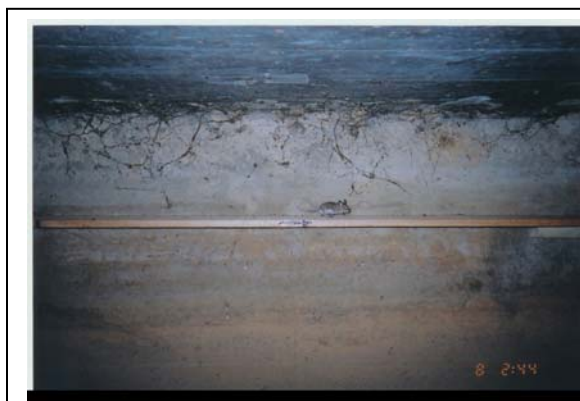
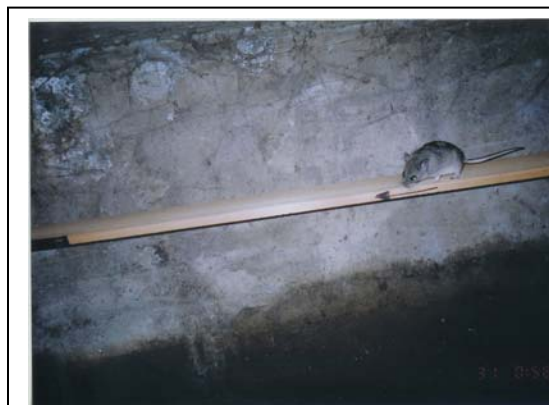
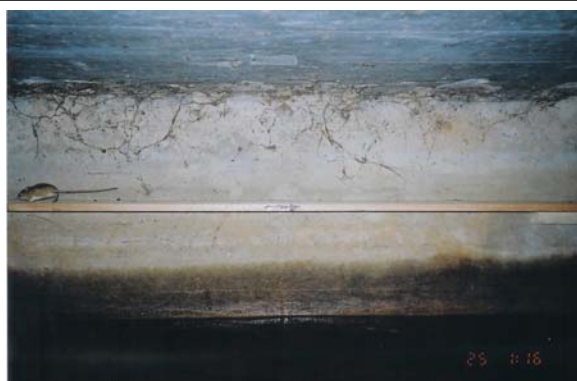
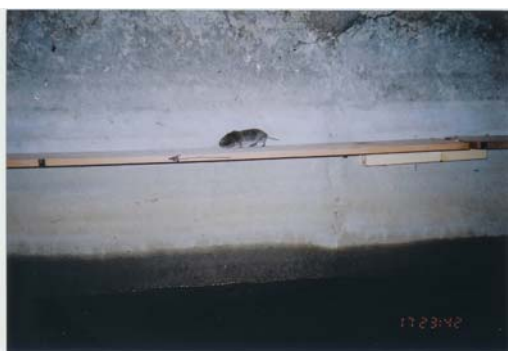
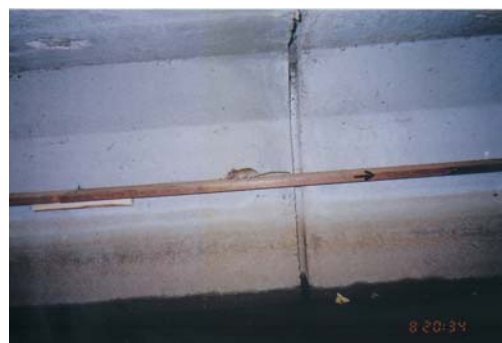
**Figure 2. Photographs of various mammal species captured by remote-sensing cameras in culverts**

Deer mouse on ledge.

Mexican woodrat at Davidson Ditch.

Preble's meadow jumping mouse at Goodhue Ditch during pilot portion of study.

Meadow vole at Davidson Ditch.

House mouse at Marshallville Ditch at Marshall Road.

A total of 3,830 events were recorded by the monitors (the beam was triggered by a movement event) and 2,105 photographs were taken in the six culverts during the 16- and 18-week study over two seasons. Of these, 906 were photographs of animals; the remainder were blank indicating that the monitor was triggered but the camera did not capture anything. Of these 906 animal photographs, 722 were of mammals. Of these, 705 were photographs of mammals on the ledges (Figure 2). Many photographs were triggered by birds flying in and out, and by spiders.

Ditch (Culvert 3) under U.S. 36 (Figure 2). Because of the animal photographed in May 2005, the study was started earlier in 2006 (at the beginning of May). Goodhue Ditch provided excellent habitat, had high overall use of the ledge and low species richness, and was dominated by deer mice. The second photograph was taken July 21, 2005, on Marshallville Ditch at Marshall Road (Culvert 5), under a small two-lane road in a rural residential area where overall activity was low and species richness was high. The third and fourth photographs were from Goodhue Ditch, taken May 28 and June 16, 2006, respectively (Figure 9).

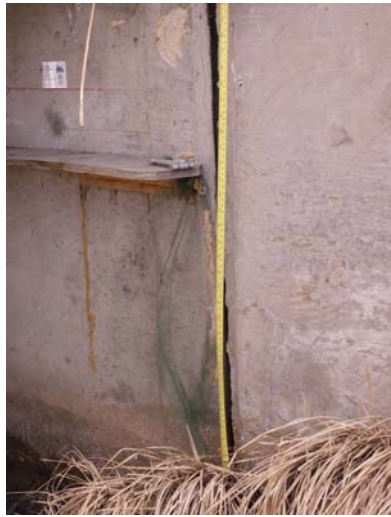
End of ledge at Dry Creek No. 2 Ditch culvert at U.S. 36. Note hinge to connect ramp. Distance from ledge to ground is 54 cm. Bird netting is visible.

solid ground, the lateral distance was 42 to 148 cm. Culvert 1 (Dry Creek No. 2 Ditch) was one of the two culverts with high activity without the ramp and is shown below.

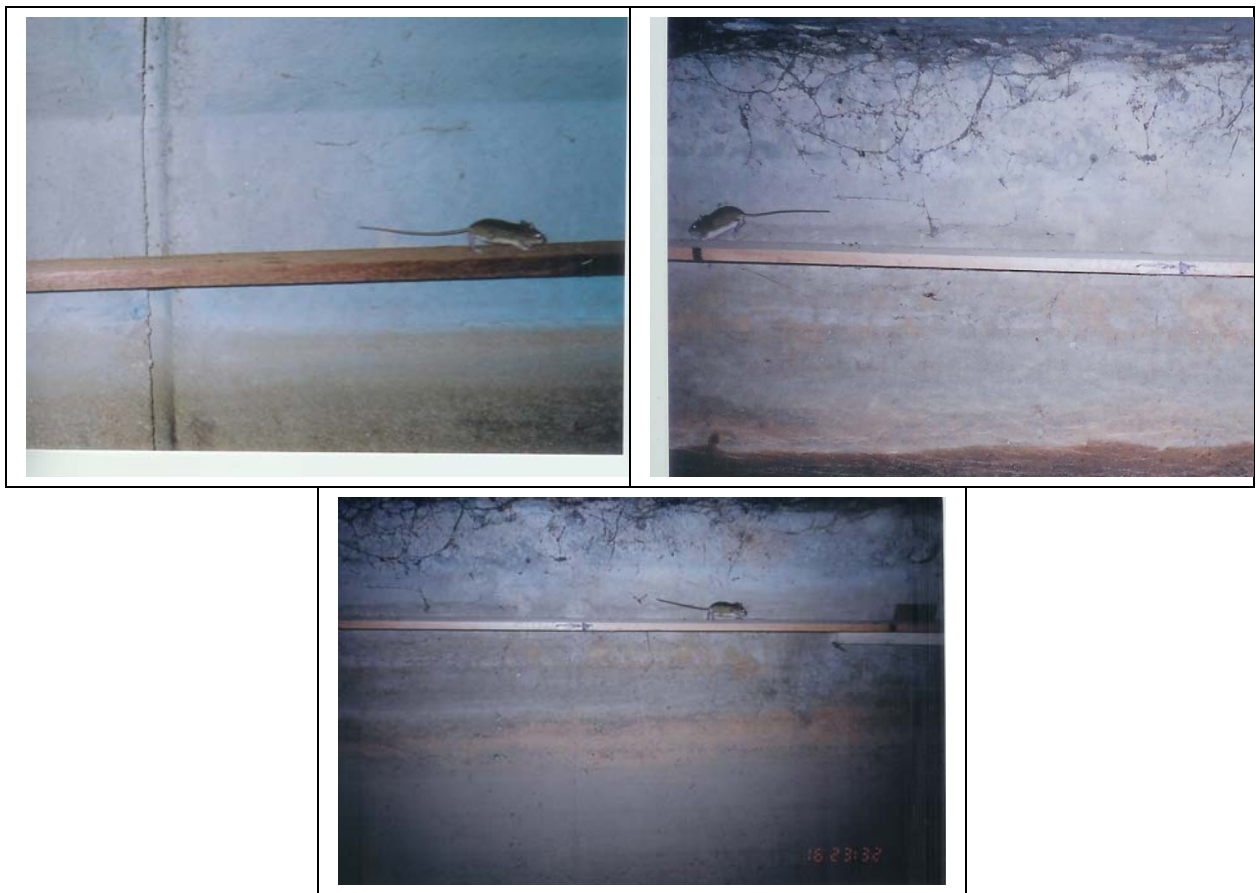
**Figure 9. Three events of Preble's meadow jumping mice on ledges photographed during the study**

*Note: Clockwise from upper left: July 21, 2005 at Culvert 5; May 28, 2006 at Culvert 3; and June 16, 2006 at Culvert 3.*

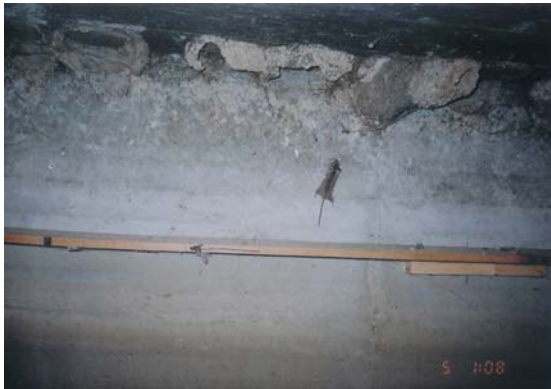
Deer mouse climbing concrete wall toward a cliff swallow nest.

concrete walls. Whether the animals climbed down onto the ledge from above (20 to 80 cm) or climbed up to it from the closest point along the bank (39 to 78 cm) is not known. A few photographs captured animals on the concrete wall of the culvert including a shrew and a deer mouse that was trying to reach a cliff swallow nest above the ledge. It appears that the ledge was of such utility to these small mammals that they made reasonable efforts to get to it.

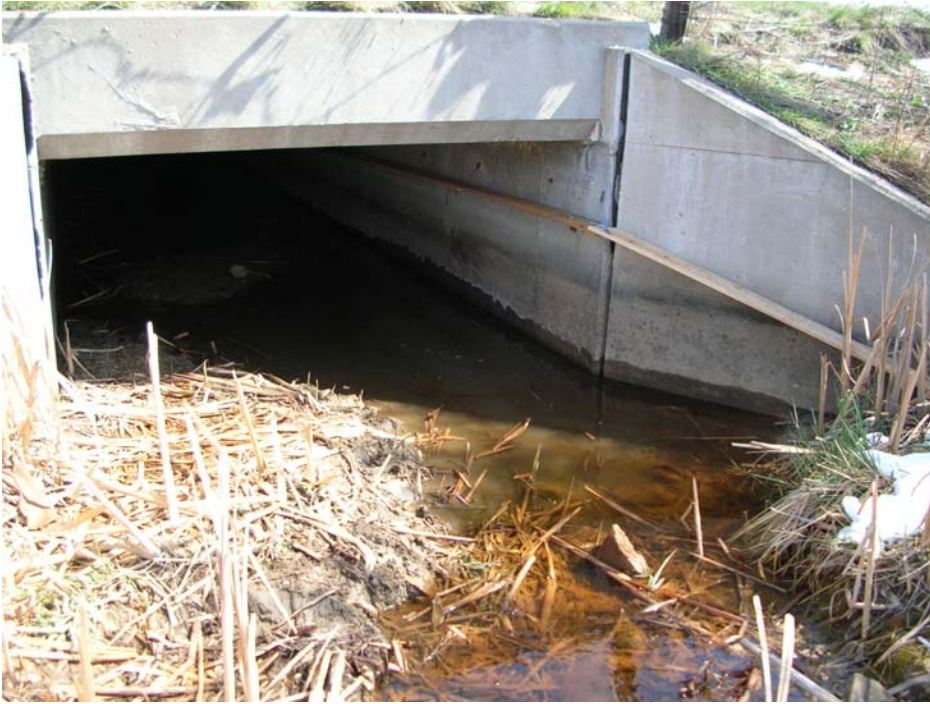
Culvert 1. Dry Creek Ditch No. 2 at U.S. 36.

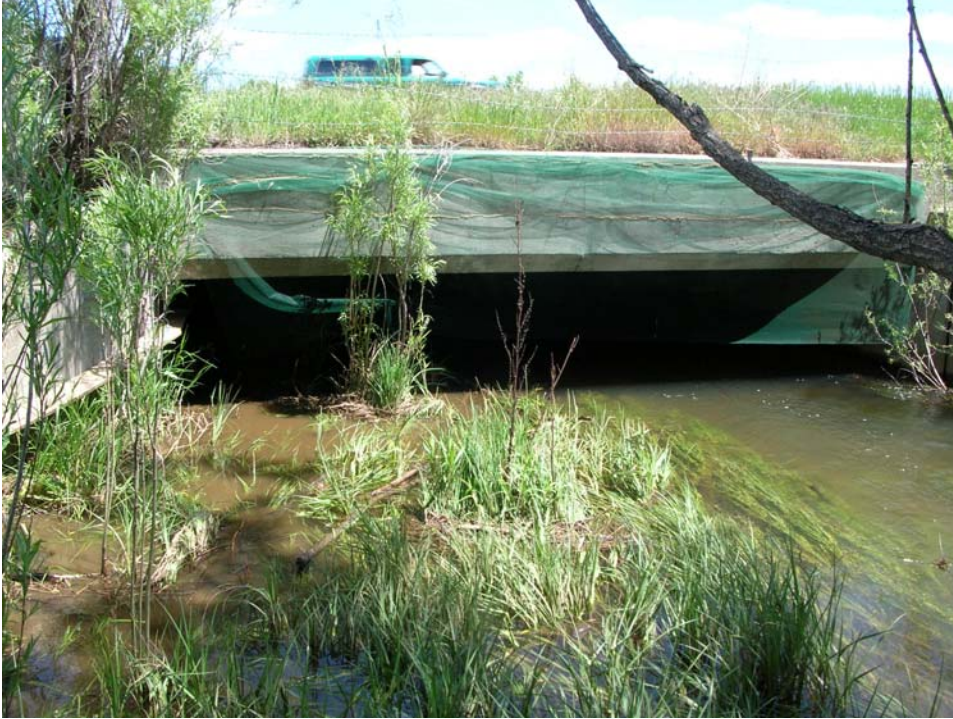
Culvert 3. Goodhue Ditch at U.S. 36. Bird netting visible.

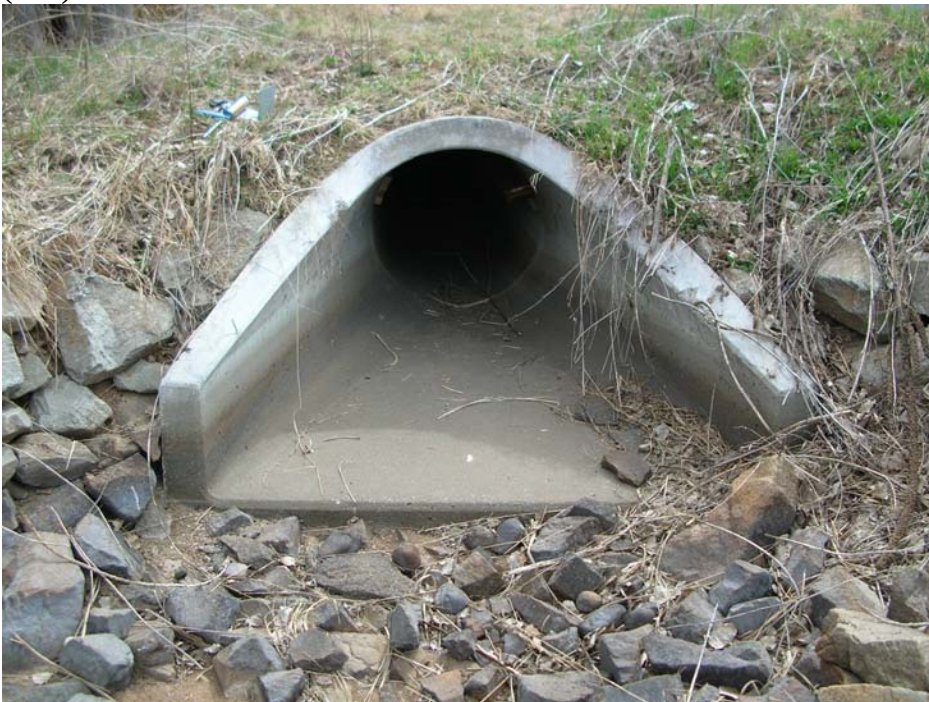
Culvert 4. East Boulder Ditch. This is a round concrete culvert and the smallest diameter (1 m) of all the culverts.

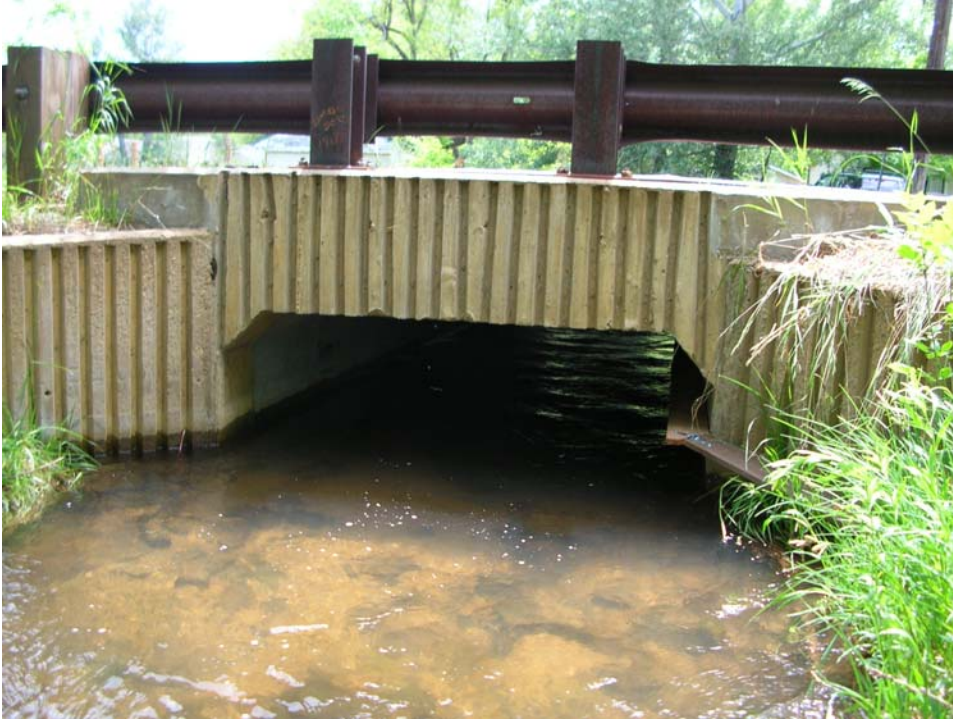
Culvert 5. Marshallville Ditch at Marshall Road. Both ledge and ramp visible at right; note strap hinge to connect them.

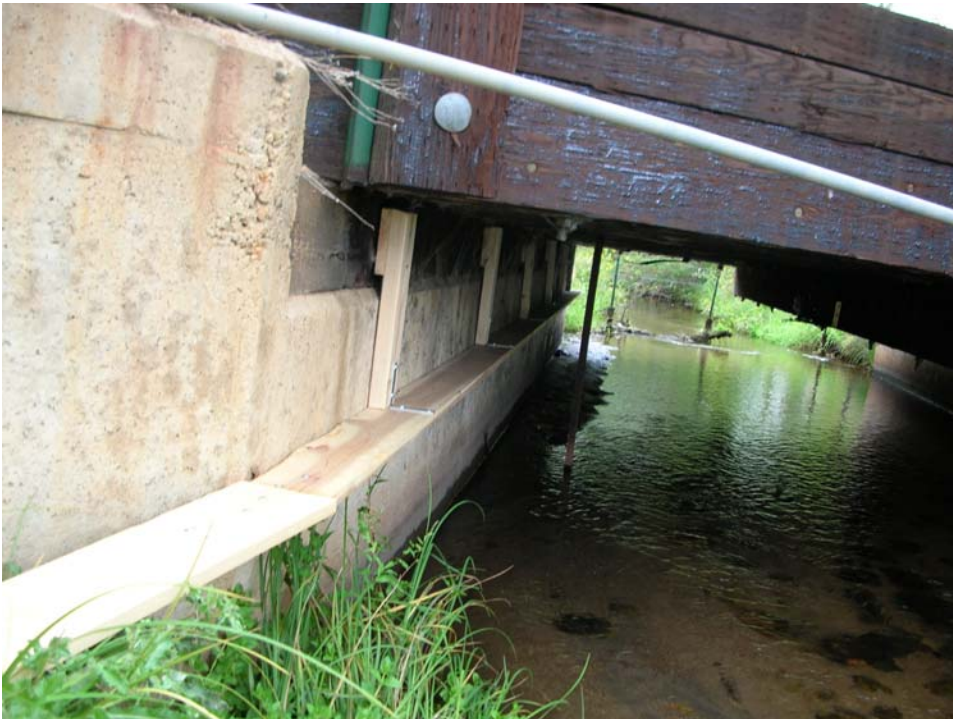
Culvert 6. South Branch of St. Vrain Creek at Crane Hollow Road. This culvert was eliminated from the study (see text). Ledge is inside culvert, ramp is on wing wall.

The seven originally selected culverts are listed in Table A and shown on Figure 1. Photographs of all the culverts, located in Boulder, Colorado, are provided in Appendix A. Culvert 6 (South Branch) was eliminated from the study, leaving a sample size of six, because it was discovered that vehicles driving over the road caused vibrations that triggered the monitor and camera. Although 530 photographs were taken in both years at this culvert, only two were of mammals on the ledge and the remainder were blank.

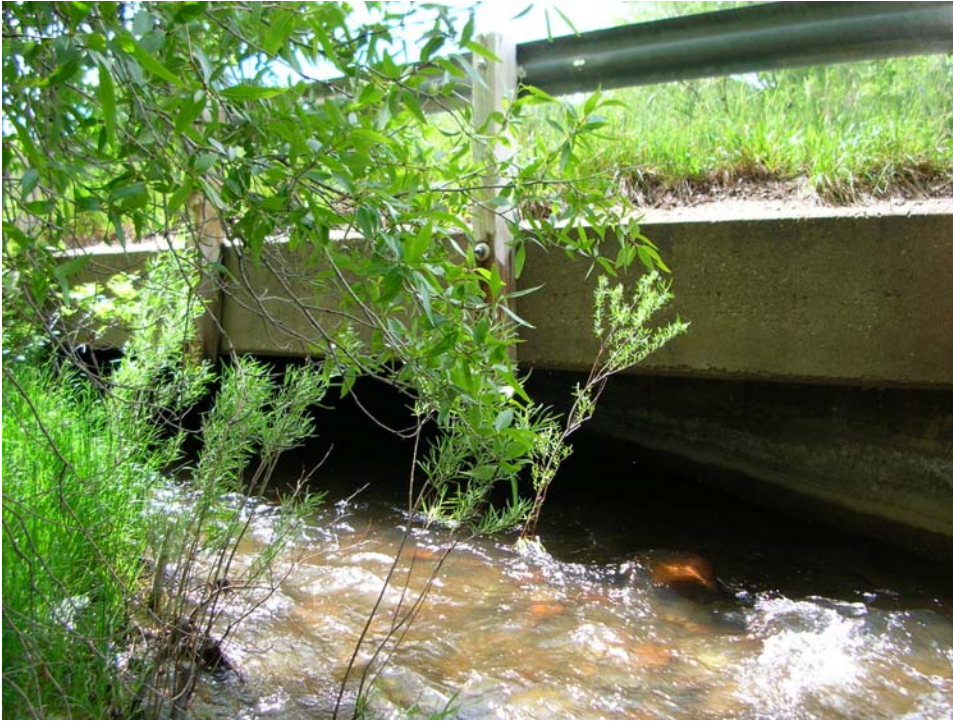
Culvert 7. Davidson Ditch at State Highway 170 in Eldorado Springs.
