# **FACTORS IMPACTING THE HEALTH OF ROADSIDE VEGETATION**

**Nichole A Trahan and Curt M. Peterson**  
**University of Northern Colorado**

**April 2007**

**COLORADO DEPARTMENT OF TRANSPORTATION**  
**RESEARCH BRANCH**

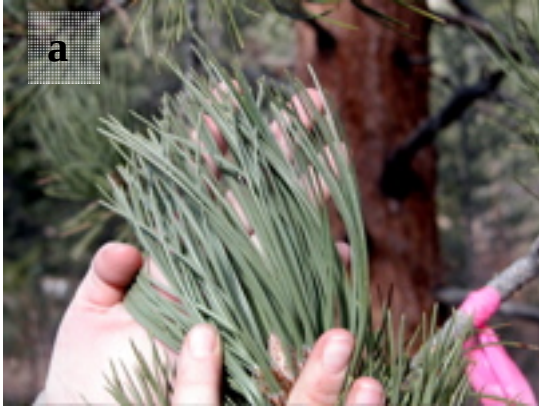
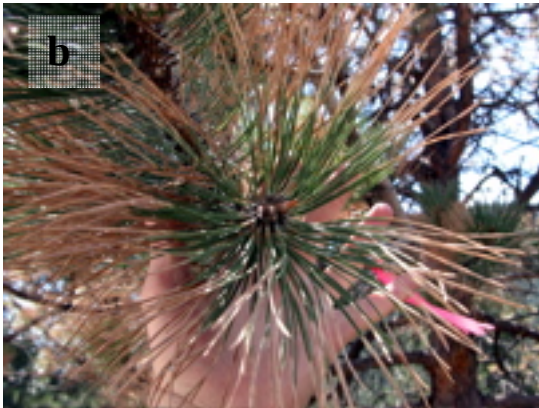
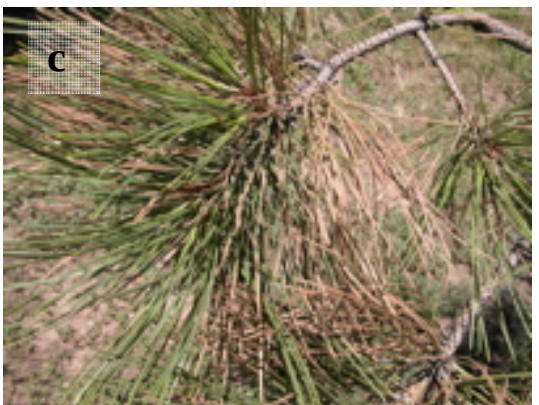
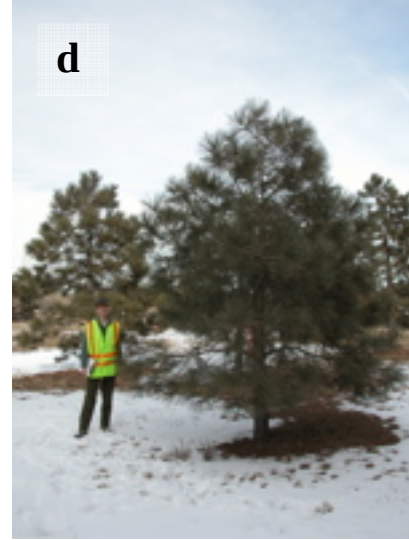
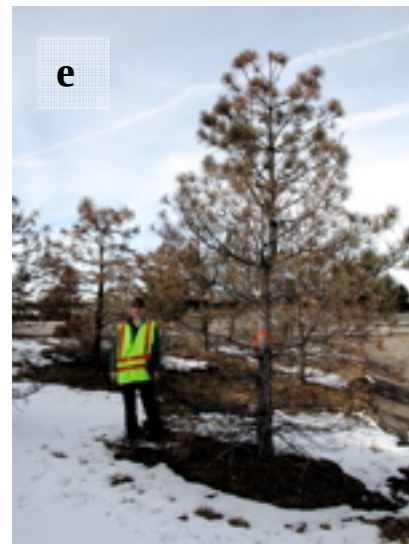
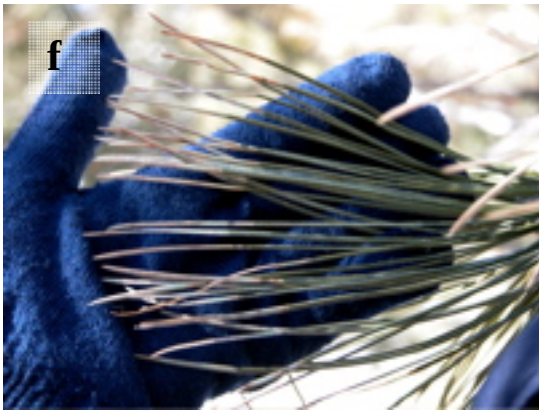
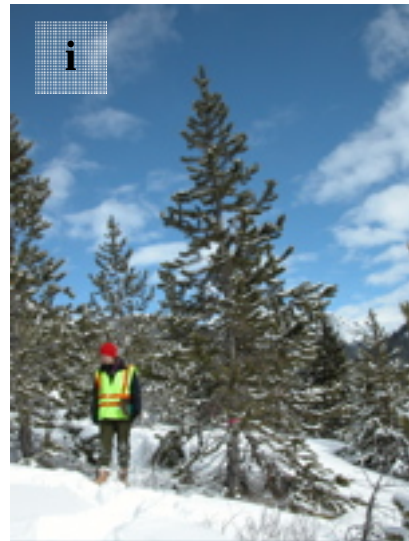
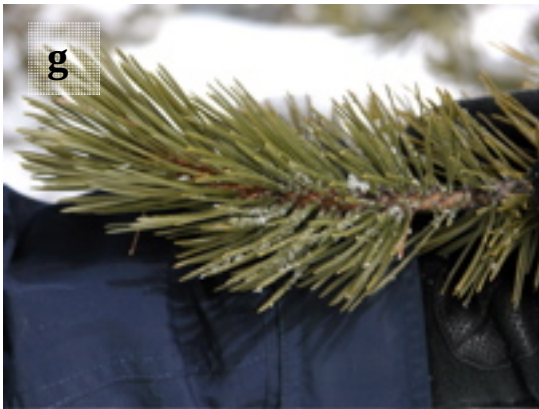
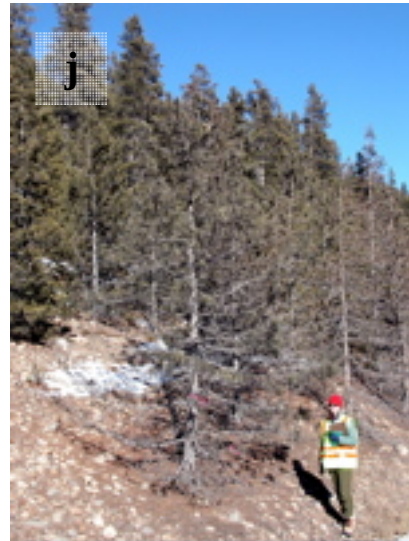
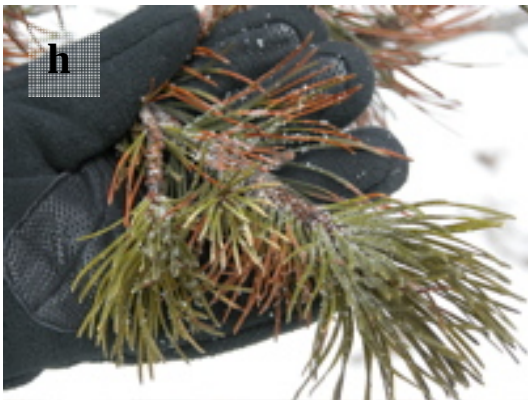
**Figure 2. Comparisons of foliage health in studied conifers adjacent and distant from the roadside. *a:* *P. ponderosa* needles away from roadside, site 121H. *b:* *P. ponderosa* needles adjacent to the roadside exhibiting necrosis from the tips, site 122D. *c:* *P. ponderosa* needles adjacent to the roadside exhibiting necrosis primarily in previous years (older) needle tissues, site 132D. *d:* *P. ponderosa* off-road, site 132D. Note density of foliage. *e:* *P. ponderosa* adjacent to roadside, site 132D. Note scarcity of foliage. *f:* *P. ponderosa* needles adjacent to the roadside exhibiting tip necrosis and banding, site 121H. *g:* *P. contorta* needles from off-road tree, site 111D. *h:* *P. contorta* needles adjacent to roadside exhibiting necrosis in older growth, site 111D. *i:* *P. contorta* away from roadside, site 111D. Note foliage density. *j:* *P. contorta* adjacent to roadside, site 114D. Note foliage scarcity on trees facing the roadside.**

In general, damaged needles characteristically displayed necrosis and chlorosis in their tips first, with tissue death advancing to the needle base. In addition, occasional banding in ponderosa pine needles was noted. Observed damage was in all cases concentrated in older needle growth, and was frequently more severe on the side of the tree facing the roadway. Figure 2. displays characteristic foliage damage in roadside ponderosa and lodgepole pines, and provide a comparison with off-road undamaged conifer foliage.

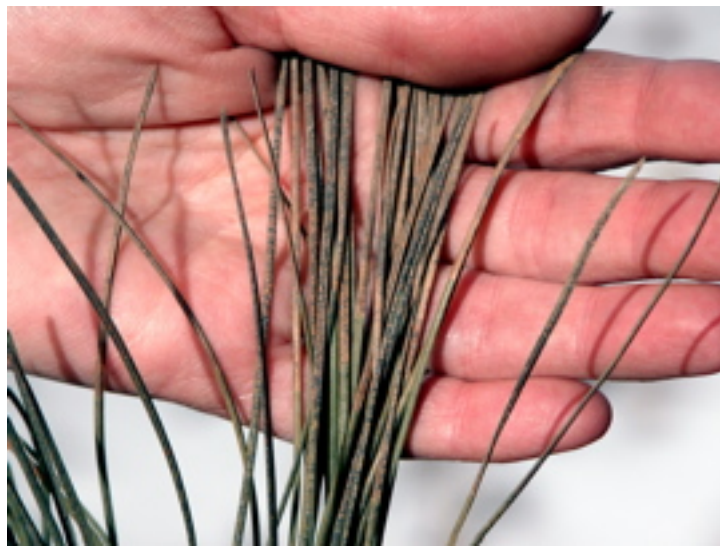
**Figure 6. *P. ponderosa* needles from site 132D (Denver) displaying a dark mottling of surface deposits on needle tissue.**

*Conifer Foliage Exposure to Aerosolized Salts:* After field work revealed the presence of a deposited coating on the foliage of roadside conifers (Figure 6.), needle samples from each study site were collected in the winter of 2004 and analyzed through scanning electron microscopy (SEM) for the presence and characteristics of surface deposits. From these analyses, it becomes apparent that trees in proximity to the roadside are more likely than trees further away to exhibit coating on needle surfaces. Presence of needle coating was significantly ( $p < 0.0001$ ) negatively correlated with distance from the roadside,  $R^2 = 0.215$ .
