# **STUDY ON THE USE OF SELF- CONSOLIDATING CONCRETE FOR THE REPAIR OF THE MEAD BRIDGES ON I-25**

**COLORADO DEPARTMENT OF TRANSPORTATION  
RESEARCH BRANCH**

Report No. CDOT-2007-1  
Interim Report

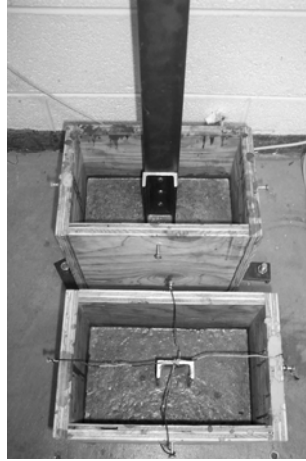
A series of experiments were developed to simulate the vibrations of the steel bridge girders in wet concrete under normal traffic conditions. These experiments are used to quantify the deterioration of bonding strength between the girder and the concrete that result from the vibratory motion of the girders in the freshly mixed SCC. The experiments consisted of steel channel sections of various sizes placed vertically in rectangular forms as shown in Figure 6. SCC was placed around the steel channels to a depth of seven inches. For each experiment, two blocks were cast. Each block had identical channels and depths of SCC. The channel in one block was vibrated for 24 hours, starting immediately after the concrete placement, while the channel in the second block remains perfectly still for the same period. Figure 6 presents a picture of a pair of tests with channels in fresh SCC.

**Figure 6: Steel channels in fresh SCC**

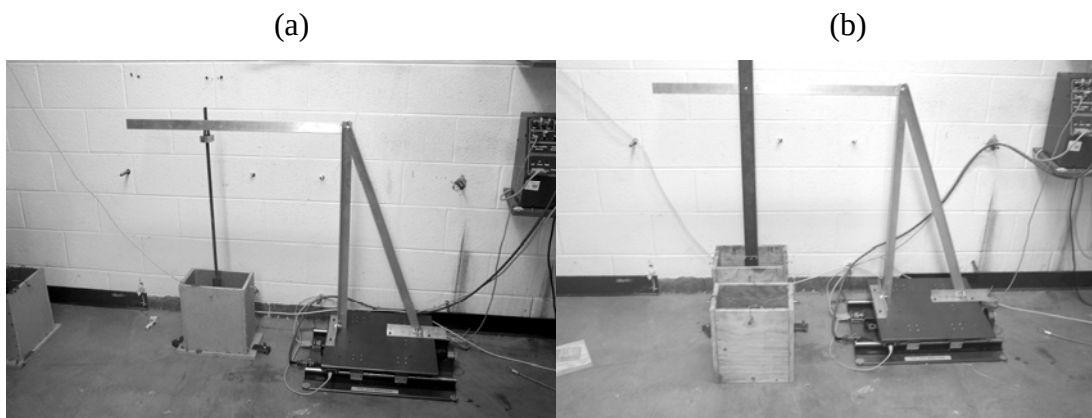
To simulate the vibration of the steel girders, the measured Mead bridge displacement history was applied to the top of the channel using a small shake table. The vibrations were proportioned as necessary and applied as shown in Figure 7. The movement of the shake table is transferred to the channel in the fresh SCC, therefore vibrating the channel as the SCC cures. The steel channels pivot about the bottom of the form, where a 1/8 inch deep groove was cut to prevent the channels from moving laterally during casting and testing. Figure 7(a) demonstrates the configuration used to vibrate the 1.25in channels and Figure 7(b) demonstrates the configuration used to vibrate the 2.0in and 3.0in channels.

A wider steel blade was used for the larger channels to avoid deflection in the connecting arm and assure movement of the channels as the concrete sets. A smaller bar was sufficient to vibrate the 1.25in channels because their 0.5in flanges do not produce significant bearing pressures. To better simulate the actual bridge girders, channels with larger flanges were tested. The Mead vibration record was placed in a continuous loop for 24 hours. After that time, the concrete has sufficiently hardened and the specimens were removed from their forms and tested for bond strength.

**Figure 7: Shake table connected to steel channel in fresh SCC**
