DOT/FAA/CT- 89/32

# Fire Hazards of Aerosol Cans in Aircraft Cargo Compartments

David R. Blake

December 1989

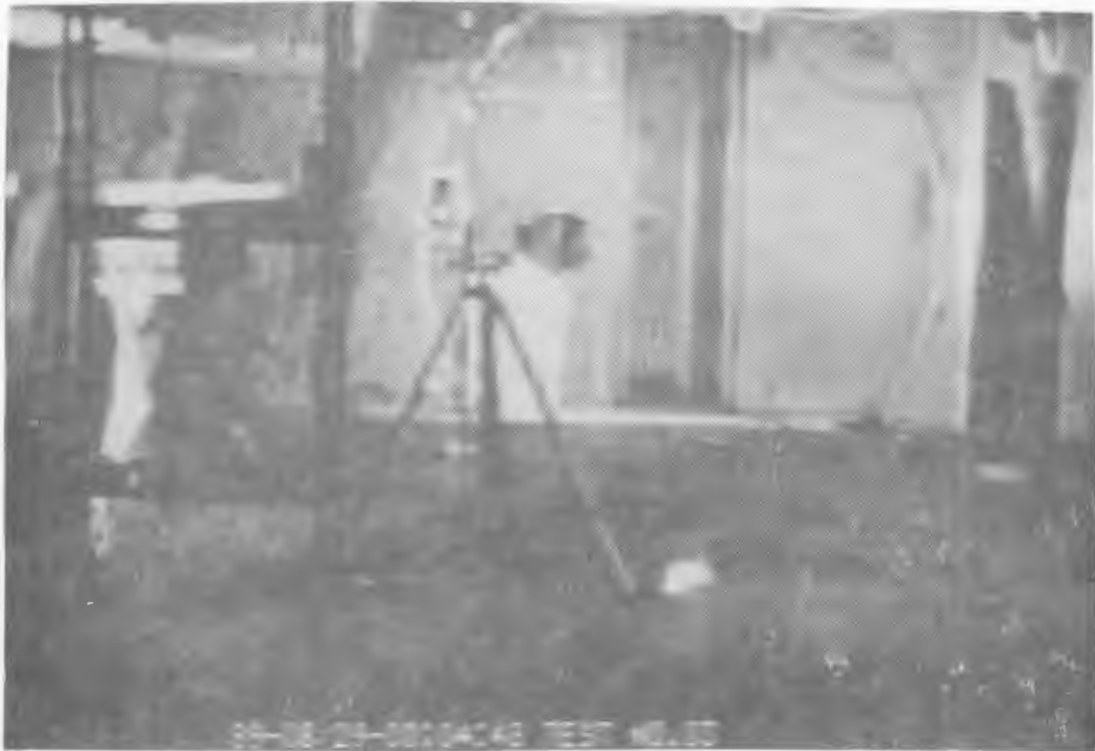
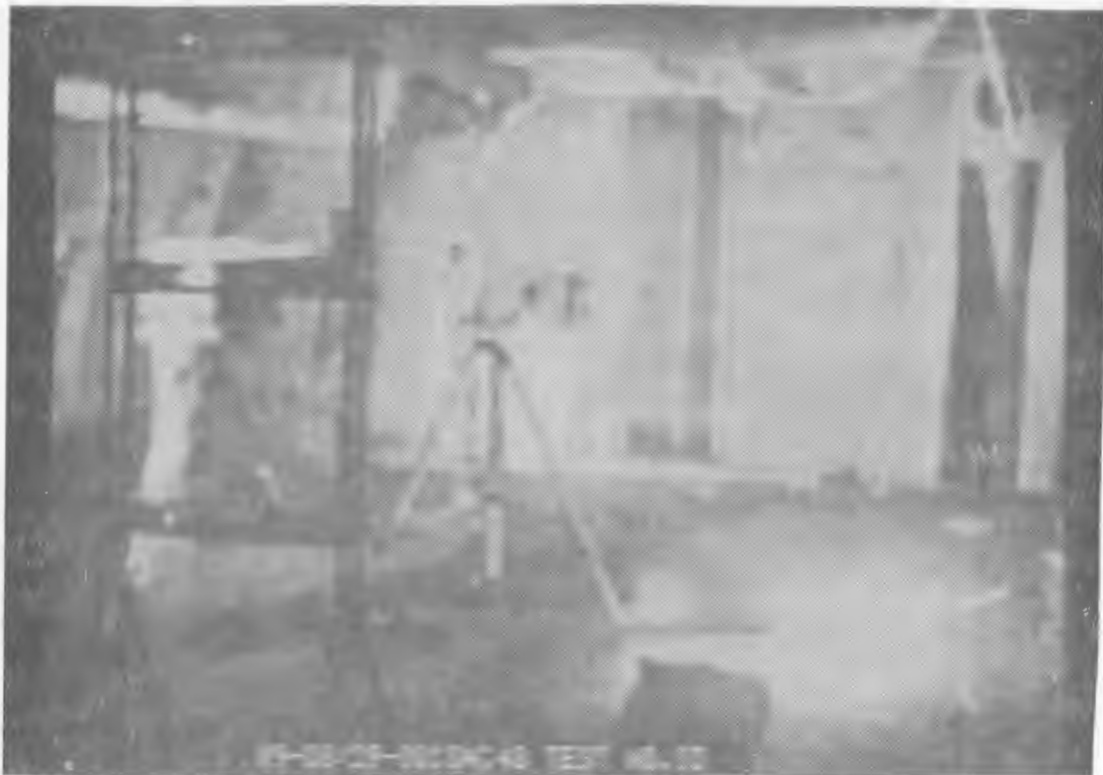
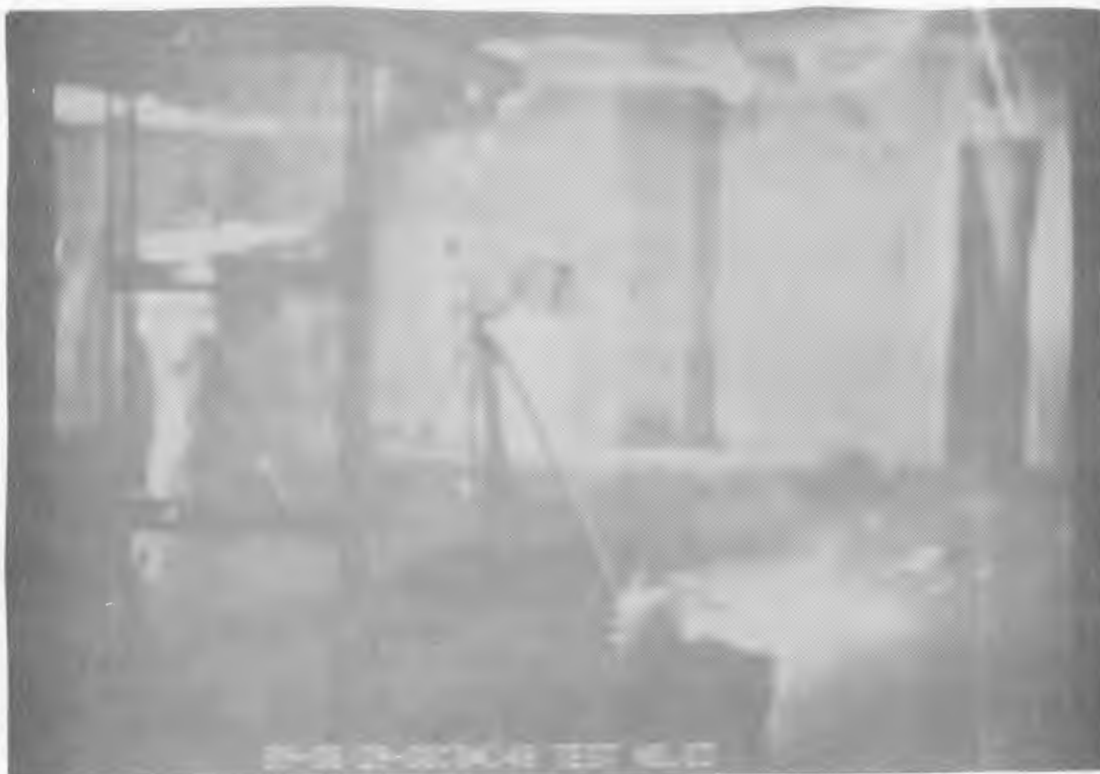
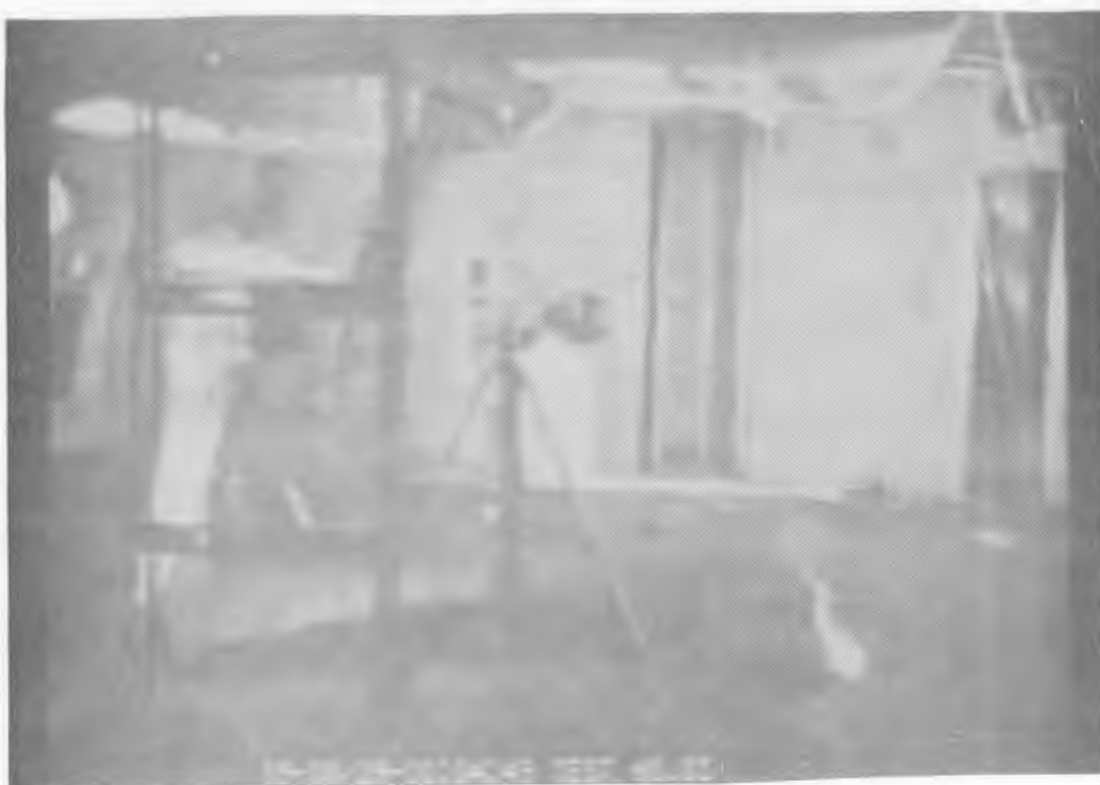
FIGURE 4. CABIN VIEW OF EXPLODING CAN - TEST 3 (1 of 2 Sheets)

Test 3. One 9-ounce hair spray can and one 4-ounce deodorant can in burning suitcase. The smoke detector alarmed at 45 seconds. The first can exploded at 4:49 with an overpressure of 0.52 psi. The second can exploded at 5:17 with an overpressure of 0.08 psi. CO<sub>2</sub> was used to extinguish the fire at 5:57. There was extensive smoke in the cabin at that time. Approximately 1.5 square feet of ceiling liner was forced out of its holder. The test article was damaged in several areas as a result of this test. A section of cabin floor was blown out, and a fireball was visible in the cabin. A door to the cargo compartment was blown open, and the aluminum structure that was used to close off the end of the fuselage was forced open in several places. Figure 4 shows the initial explosion in the cabin. The frames are 1/8th of a second apart.

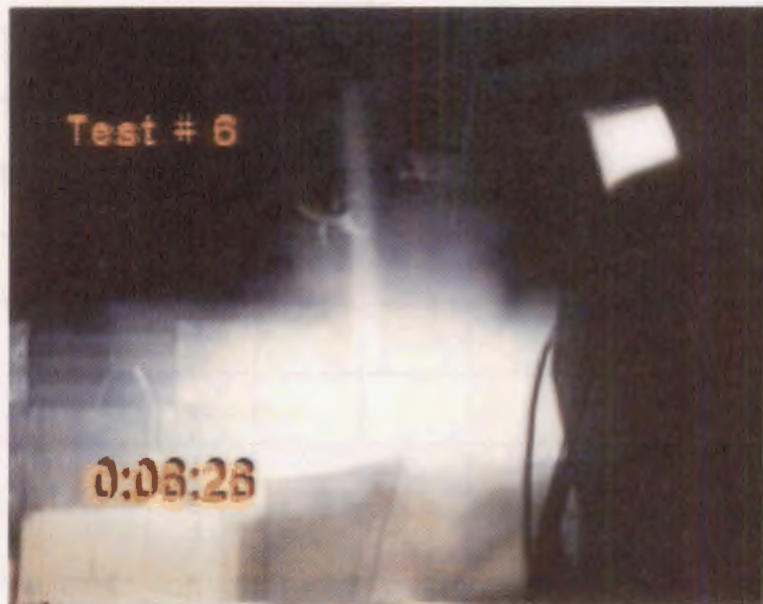
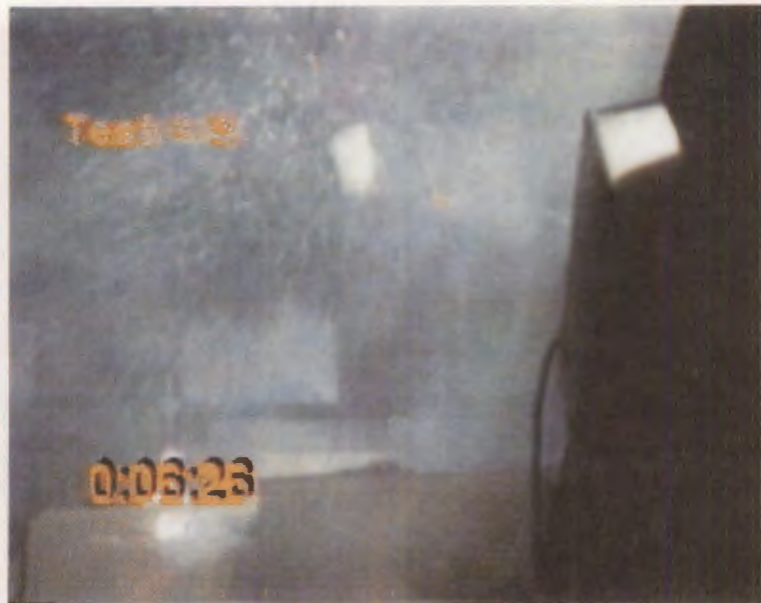
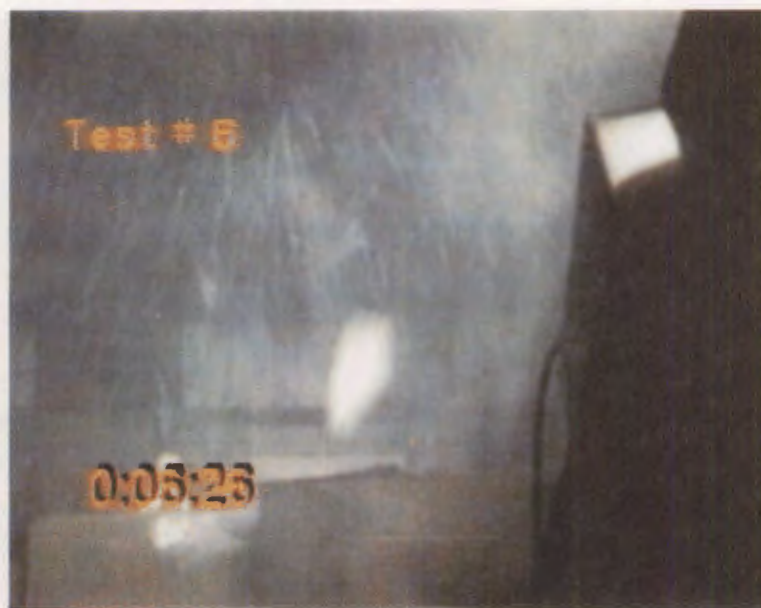
FIGURE 8. CAN RUPTURE - TEST 6 (1 of 2 Sheets)

Test 6. One 7-ounce can of air freshener exposed to 400-degree Fahrenheit (°F) air from a heat gun. Halon was discharged into the compartment at 3 minutes. The can burst at 6:26, but the contents did not ignite and no overpressure was recorded. The halon concentration at the time the can burst was approximately 4.5 percent. The oil burner electrodes were energized for the entire test.

Test 6 shows that should a can rupture after halon discharge, due to a smoldering fire for example, the halon would prevent the ignition of the escaping propellant. Figure 8 shows the rupture of the aerosol can during test 6.

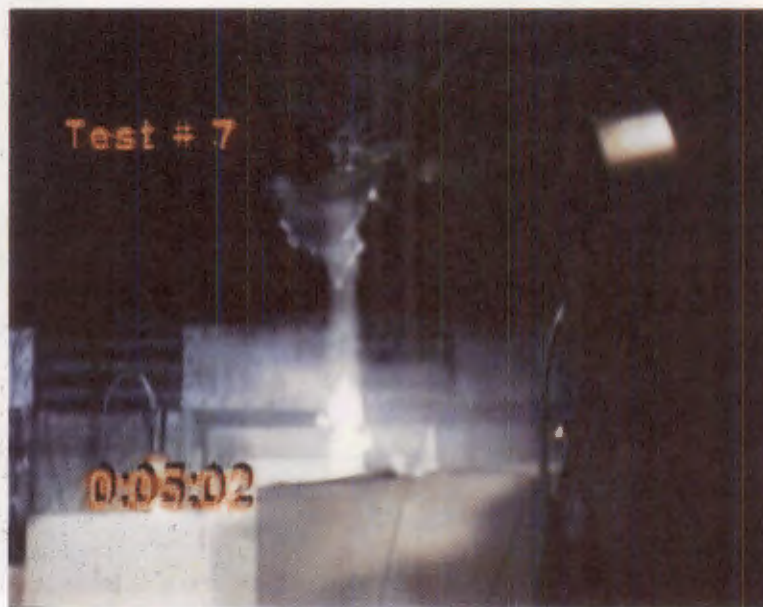
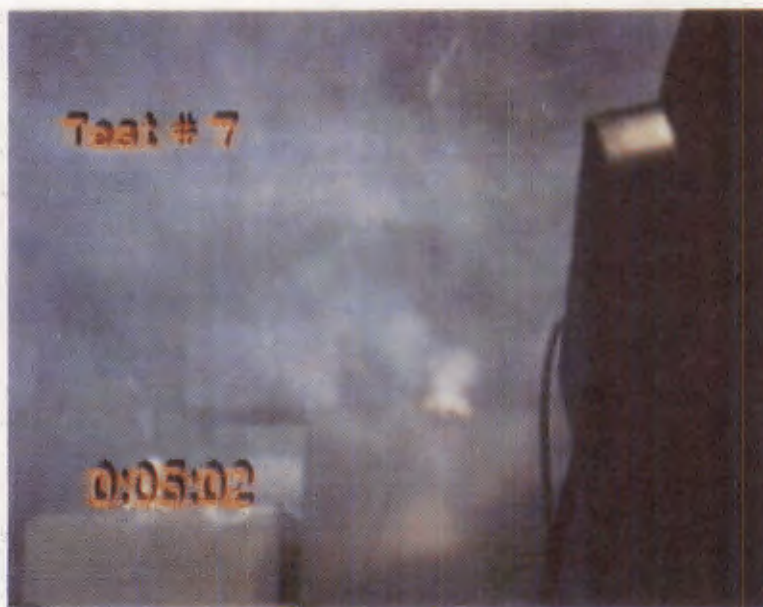
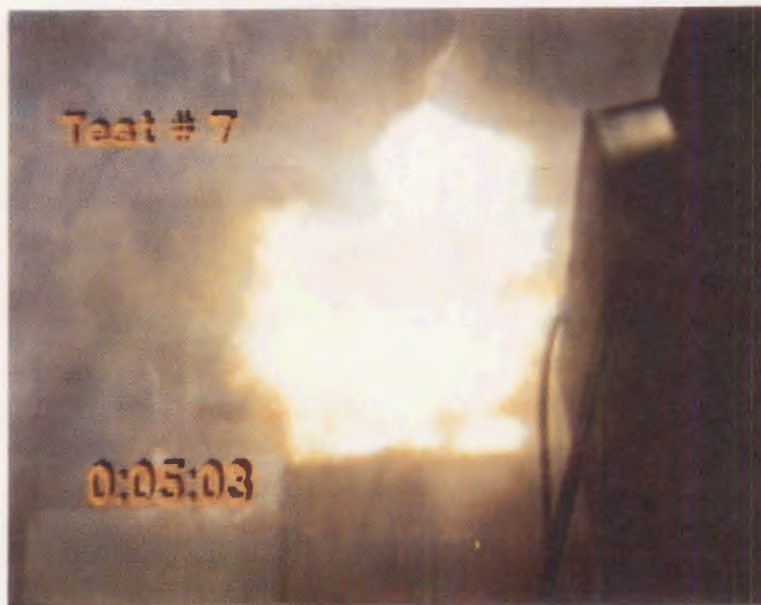
FIGURE 9. CAN RUPTURE - TEST 7 (1 of 2 Sheets)

Test 7. One 7-ounce can of air freshener exposed to 400 °F air from a heat gun. Halon was not discharged into the compartment for this test. The can burst at 5:04 and the contents ignited in a fireball. The ignition point of the escaping gas was near the bottom of the can and not at the oil burner electrodes. No overpressure was recorded. The boxes near the can burned briefly after the fireball subsided and then self-extinguished.

In test 7 the can was heated in the same manner as test 6 but halon was not used. The can ruptured and the contents ignited in a fireball. The ignition point was near the can and not at the location of the oil burner electrodes. Figure 9 shows the rupture and ignition of the can in test 7. This test demonstrated that an external ignition source is not needed to ignite the propellant; the heat from the ruptured can was sufficient to ignite the contents.
