**DOT/FAA/CT-92/14**

**FAA Technical Center**  
Atlantic City International Airport,  
N.J. 08405

# **Rotorcraft Ditchings and Water-Related Impacts that Occurred from 1982 to 1989 - Phase II**

| 16. Abstract<br><br>This report documents Phase II of a two-phase effort to examine rotorcraft ditchings and water-related impacts for rotorcraft, that occurred between the years 1982 through 1989. The main tasks performed for this phase of the investigation were assessment of the effects of structure on occupant injury, determination of the specific modes of structural failure, identification of the potential means to alleviate injury, and evaluation of available analytical methods for modeling rotorcraft water impacts. The Phase II analysis examined specific aspects of the Phase I data for accidents that fulfilled the criteria for the three impact scenarios. The main impact injuries were from flailing and excessive acceleration and resulted from occupant interaction with the rotorcraft interior and insufficient energy absorption. Drowning and exposure were found to be the main post-impact hazards and other post-impact injuries were minor in severity. Structural failures of the rotorcr

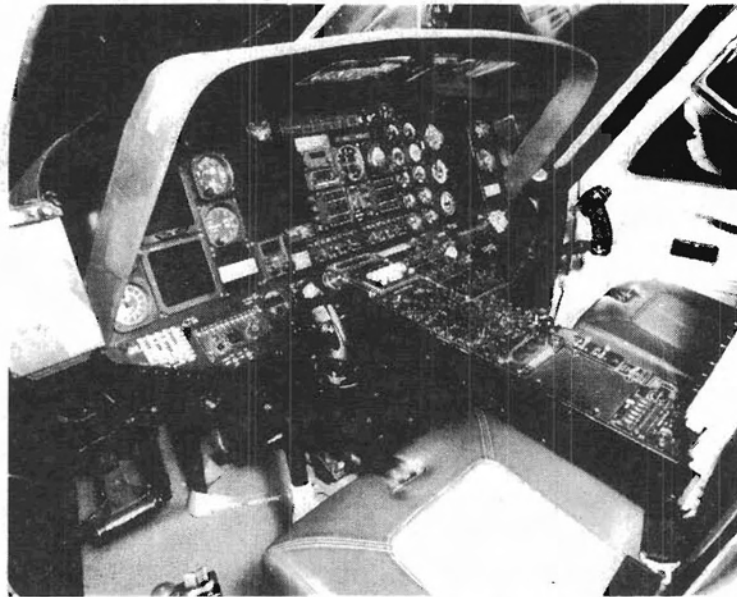
FIGURE 8. TYPICAL CURRENT INSTRUMENT PANEL

Other areas requiring delethalization may not be able to accommodate a padded surface or a padded surface may not provide sufficient delethalization. An example would be the instrument panel glare shield in which padding could cause difficulty in viewing gauges. A typical current instrument panel (figure 8). If occupant strike is anticipated to be a problem, the panel may be of frangible design so it will break before the occupant strike causes severe injury. Additionally, gauges and switches should be mounted flush with the panel to preclude severe facial injury should a strike occur.
