**Report No. CDOT-DTD-R-2002-5**  
**Final Report**

## **Cost of Sanding**

**Prof. Nien-Yin Chang**  
**Adj. Prof. Brian Brady**  
**University of Colorado at Denver**

**June 2002**

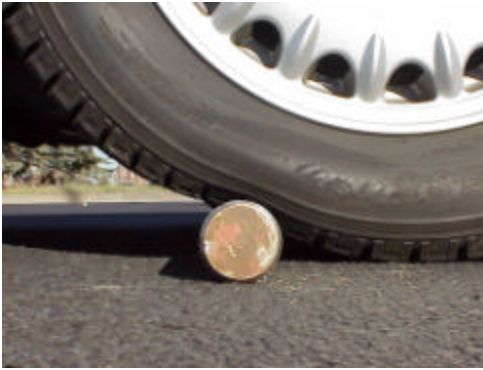
Figure 6.1a

the same phenomenon was expected to happen for the small particle of sand or gravel. The deformed shape of the tire was recorded with digital camera presented in Figure 6.2.1 and figures in Appendix E. Three different types of rods were used in the tests, 2-in steel rod, 1-in wooden rod, and  $\frac{3}{4}$  inch aluminum pipe. A Michelin tire from a regular passenger car was used in the test. The test was carried out on the R Parking Lot at the University of Colorado at Denver, Auraria Higher Education Center.

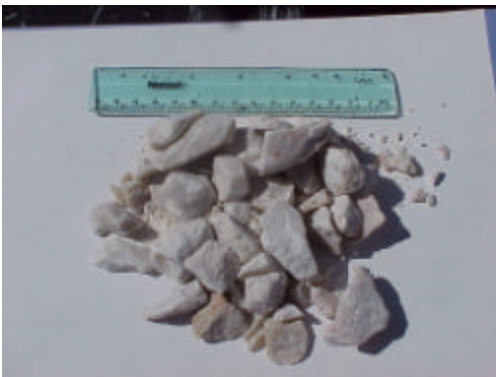
e) Dolomite sample used in Test A

**Figure 8.3.2 Test Samples Used to Determine the Extent of Damage When Impacted with Windshield. Varieties of Rock Types Were Chosen for Damage Comparison**

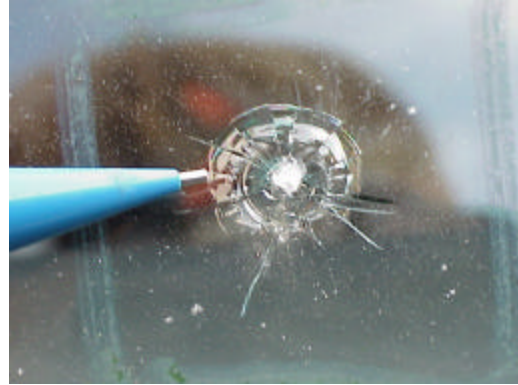
**Figure 8.3.4 Radial Crack Fracture "Star" from Particle Impact**

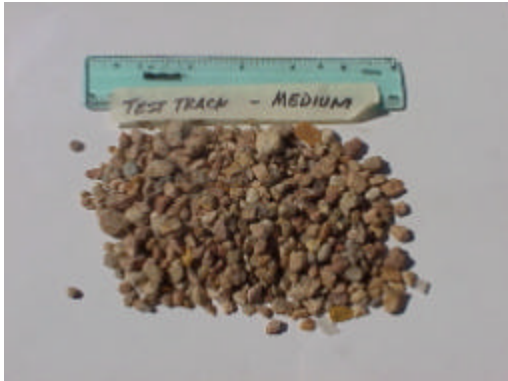
submerged in a graduated flask filled with a known volume of water to measure its volume by the volume of water displaced by sample submergence. The density of the sample was then obtained by dividing the weight by its volume. The above particle characteristics are recorded in Table 8.3.1.

a) Medium sample used on test track.

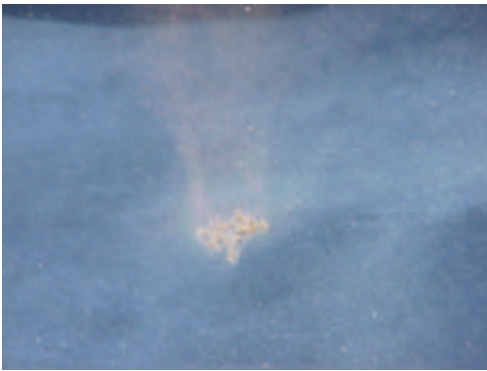
Figure 5 Damage pattern

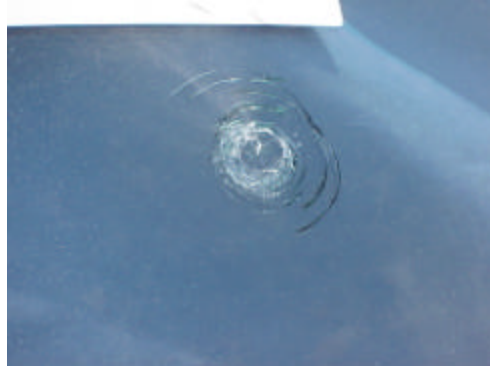
Figure 10 Bulls-eye pattern damage

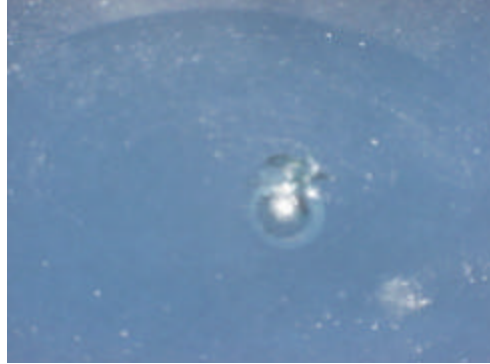
Figure 12 Chip fracture

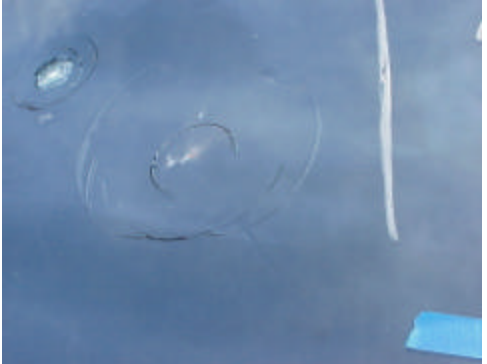
Figure 13 Bulls-eye pattern damage

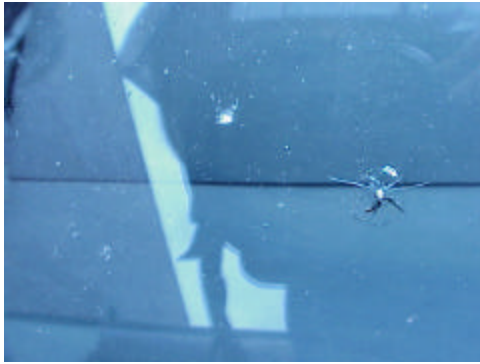
Fig 9 Fractures

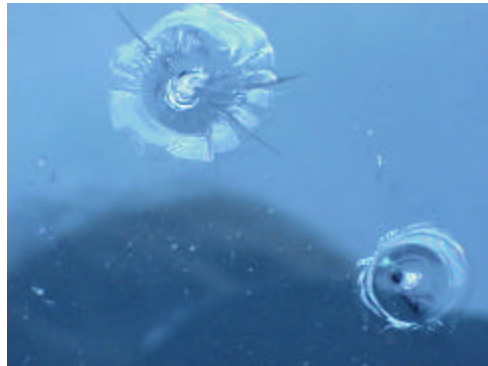
Fig 12 Star fracture

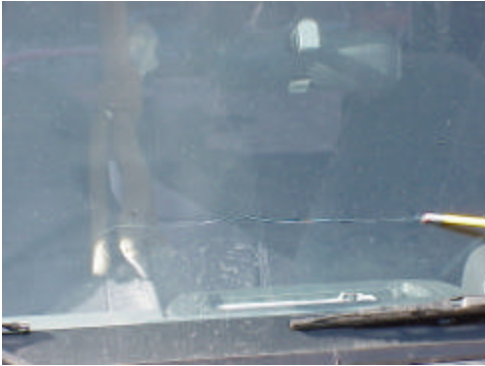
Fig 9 Crack propagation

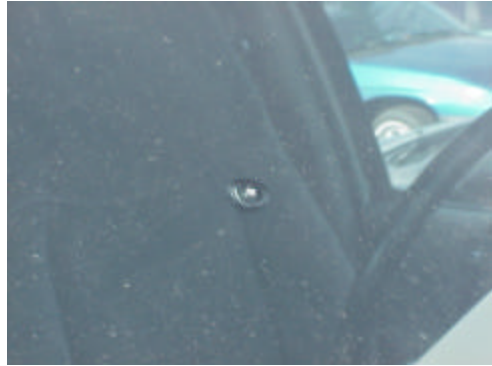
Fig 10 Conchoidal fracture

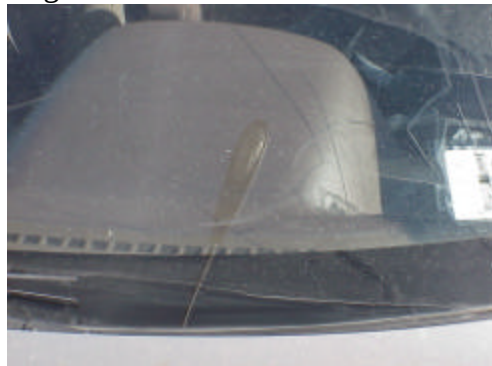
Fig 12 Random cracking

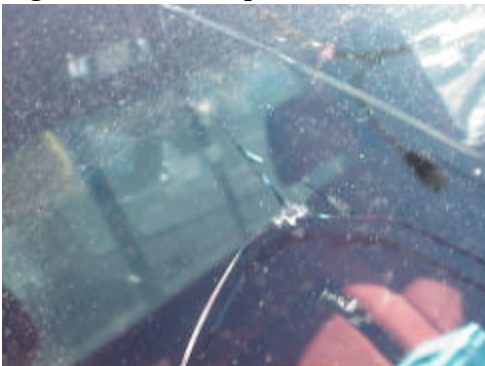
Fig 13 Crack propagation

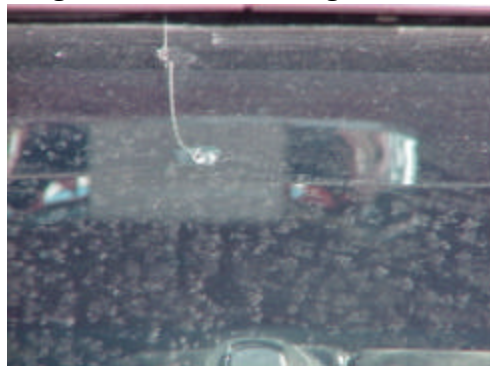
Fig 14 Crack propagation

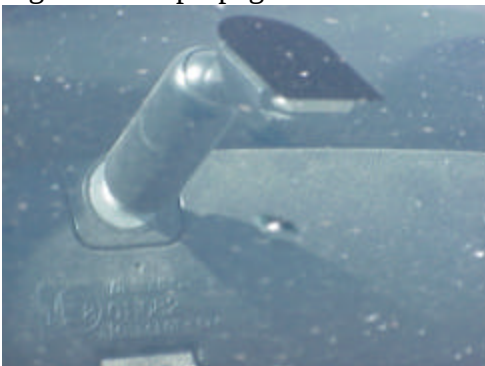
Fig 15 Surface chips

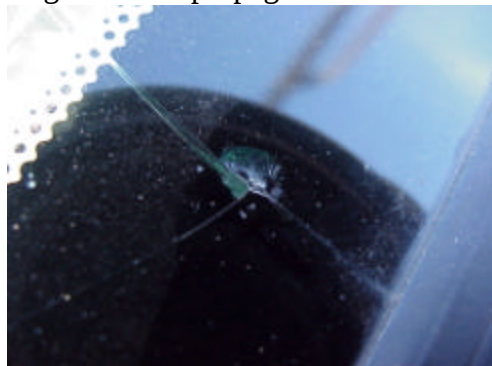
Fig 16 Crack propagation

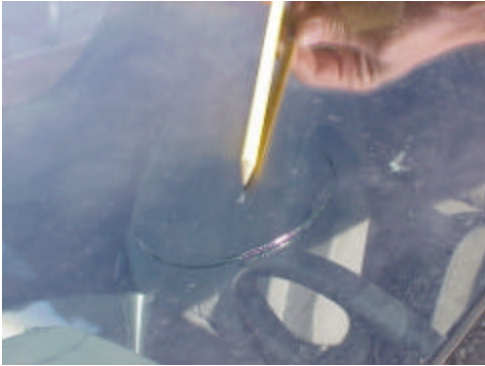
Figure 19 Bulls-eye fracture pattern

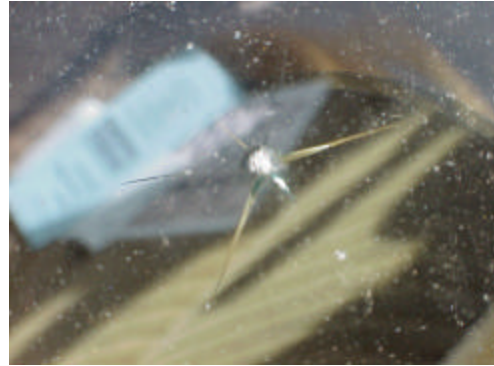
Fig 20 Star fracture pattern
