**DOT/FAA/CT-94/79**

# **Evaluation of Scanners for C-Scan Imaging for Nondestructive Inspection of Aircraft**

**October 1994**

**Final Report**

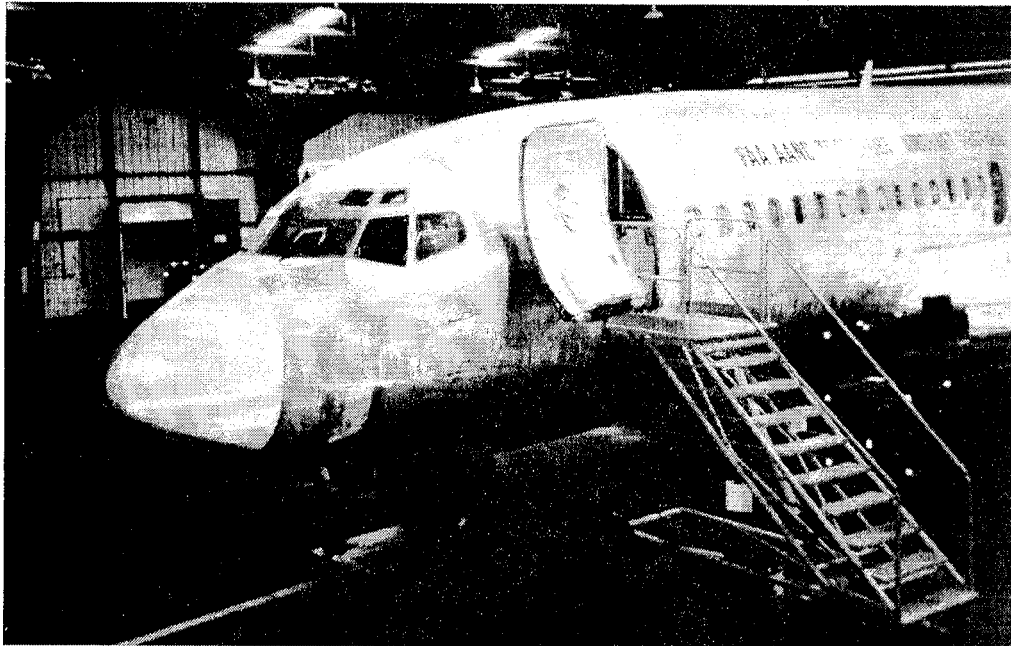
## 5. B737 Airplane Locations (AANC Test Specimen Library Number 100)

The full scale B737 aircraft was received by AANC on October 9, 1992. The aircraft is being used as a commercial transport aircraft test specimen that provides a means to assess human factors issues, accessibility issues, and hangar environment for evaluating NDI inspection requirements.

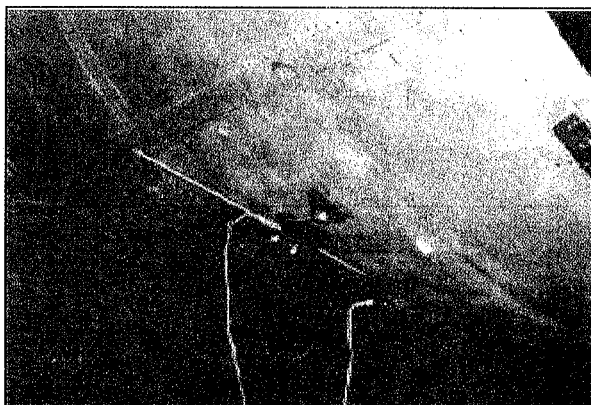
Infometrics manual scanner attached to the B737 at BS 877. The C-scan eddy current image for BS 877 and BS 887 is shown to the right where corrosion is indicated in light green and yellow.

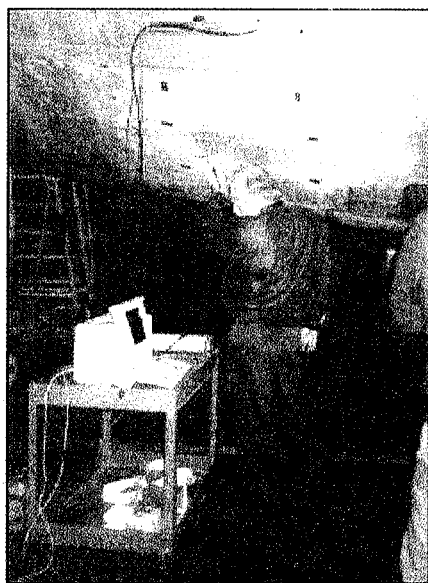
SmartEDDY Systems acoustic triangulation manual scanner shown at left is being articulated by Duane Johnson to obtain the above C-scan image at BS 877 and 887. Corrosion is shown in dark green and yellow.

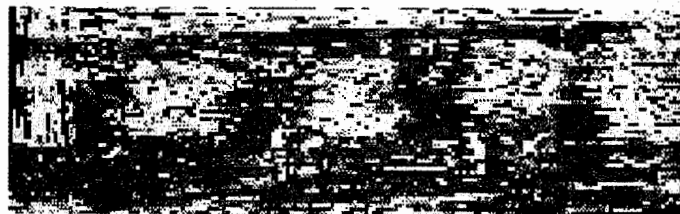
Infometrics manual scanner image of the defects in the six ply region of the sample. The defects are in yellow.
