# **Demonstration of the Placement of Stone Matrix Asphalt in Colorado**

**Colorado Department of Transportation**

**Interim Report**

**March, 1995**

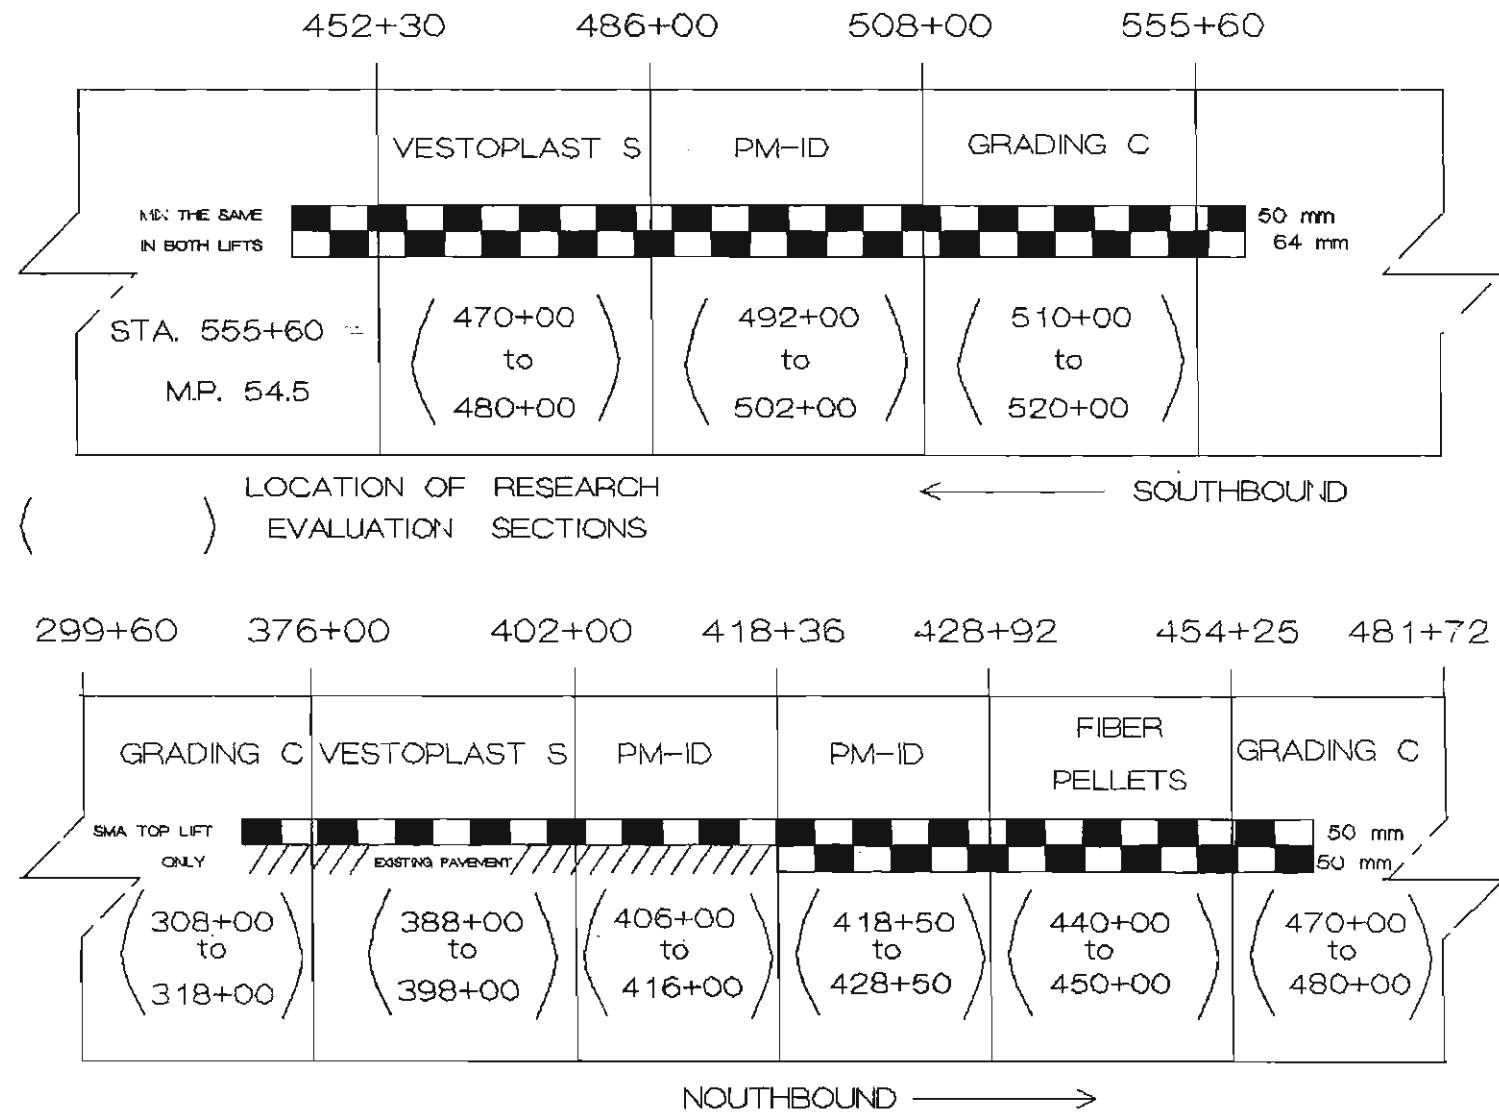
**Figure 3. Overview of Existing Pavement Condition Prior to Construction.**

Crack maps were prepared for each of the evaluation sections. Cracking in the sections was fairly uniform. On the average, transverse cracks could be found every 5-m (15 ft) throughout the sections. Load associated longitudinal cracking was found in the wheel paths of the driving lane. In some areas the longitudinal cracking had deteriorated into block cracking and in other areas alligator cracking. The cracks were wide (up to 25 mm) and many had begun to deteriorate on the edges. Although the pavement in the southbound lanes on the north end of the project had been covered by a thin maintenance blade patch the severity and amount of distress in all the evaluation sections prior to construction were considered to be equal for evaluation purposes. Typical distress found in the existing pavement is shown in Figures 3 and 4.

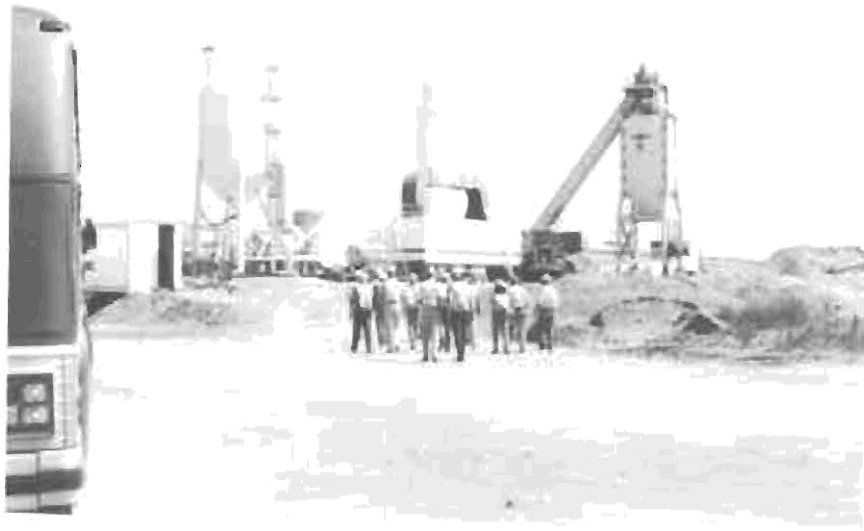
**Figure 5. Plant Layout.**

Photographs from plant and laydown operation taken during the open house are shown in Figures 5 and 6.

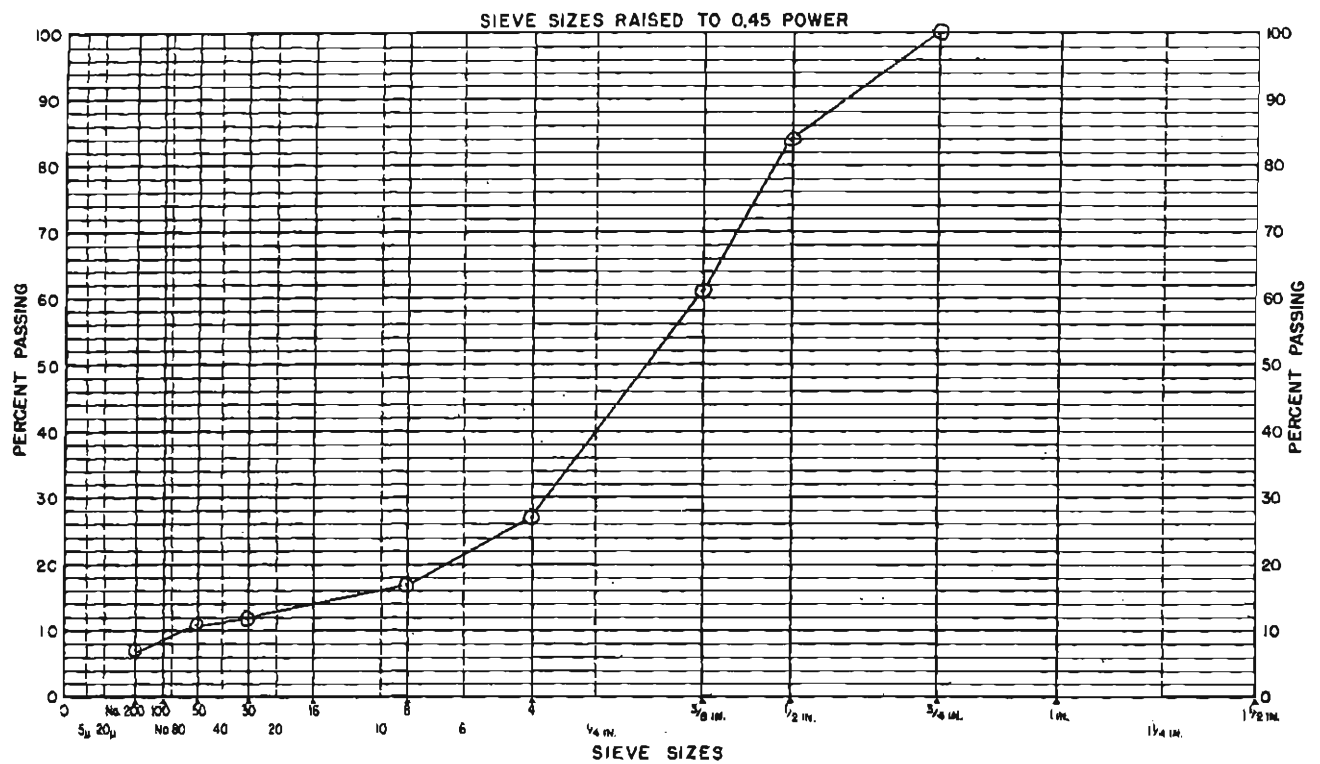
**Figure 7. Gradation of Trial Blend #2.**

The gradation for Trial Blend #2 was slightly out of the Master Range on the 4.75 mm, 2.36 mm, and 75  $\mu$ m sieve sizes. This was considered acceptable for two reasons. First, the Master Range specification for this project was developed based upon recommendations by the FHWA in 1992. Since that time, the FHWA recommendations have been modified with the experience of many projects throughout the country. The gradation of Trial Blend #2 is within the Master Range currently recommended by the FHWA (6). Second, the VMA of Trial Blend #2 was higher than Trial Blend #1. The project specifications were modified on the job. The gradation of Trial Blend #2 is shown in Figure 7.

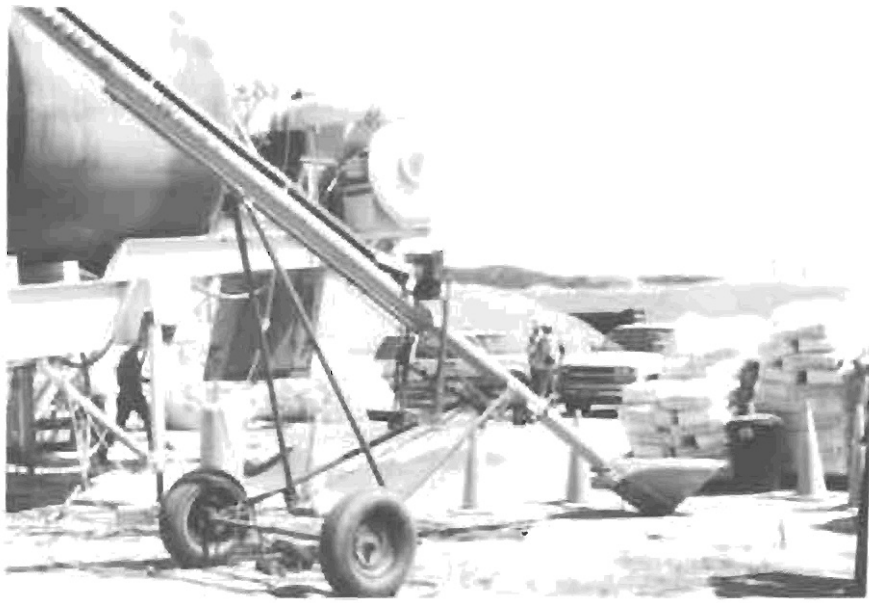
caking of the Vestoplast S, the blades of the auger were sheared from the shaft. The auger that fed the Vestoplast S was then modified to be an open-troughed auger with a plate on top. This auger was also unsuccessful. Finally, a shingle conveyor was used to transport the Vestoplast S to the RAP collar. The shingle conveyor had slats on the belt to prevent the Vestoplast S from sliding down the conveyor. This method worked well (except in high wind conditions) and was used for the remainder of the project. The fiber pellets were added only with the shingle conveyor.

**Figure 8. Auger System Initially Used for Vestoplast S.**

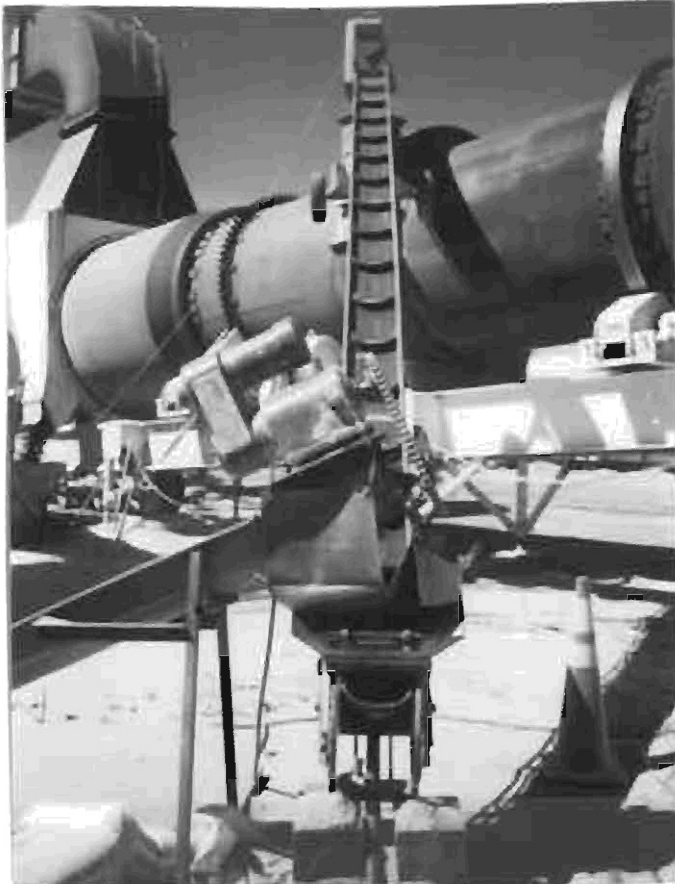
**Figure 9. Conveyor System Used to Add Vestoplast S and Fiber Pellets at the RAP Collar.**

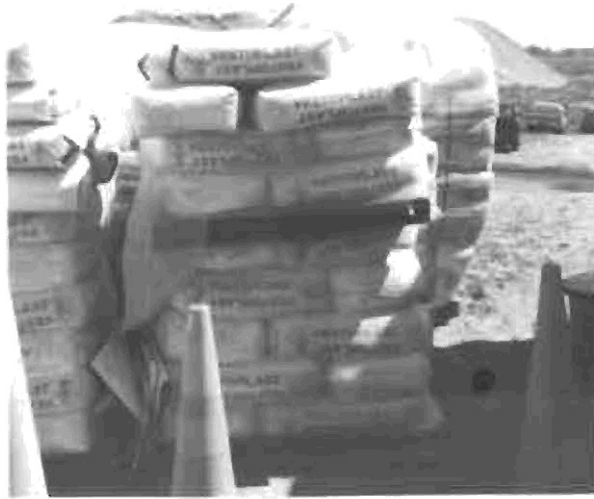
**Figure 10. The Vestoplast S Was Supplied in 20 kg (45 lb) Bags.**

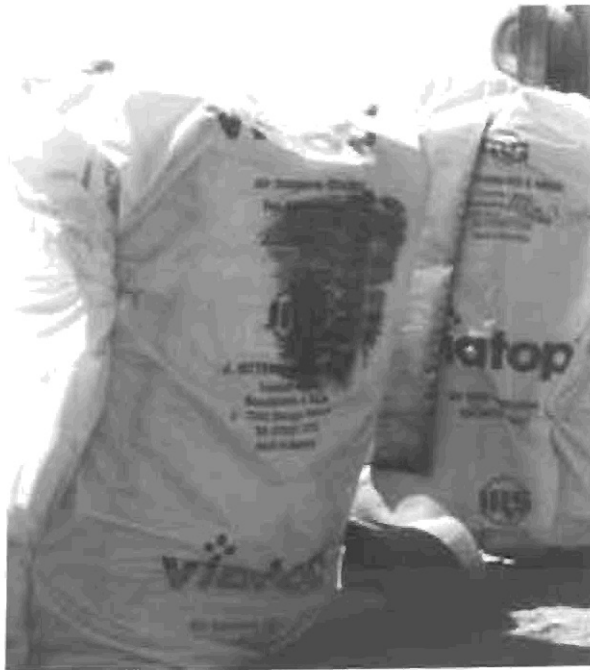
**Figure 11. The Fiber Pellets Were Supplied In 1000 kg (2200 lb) Bags.**

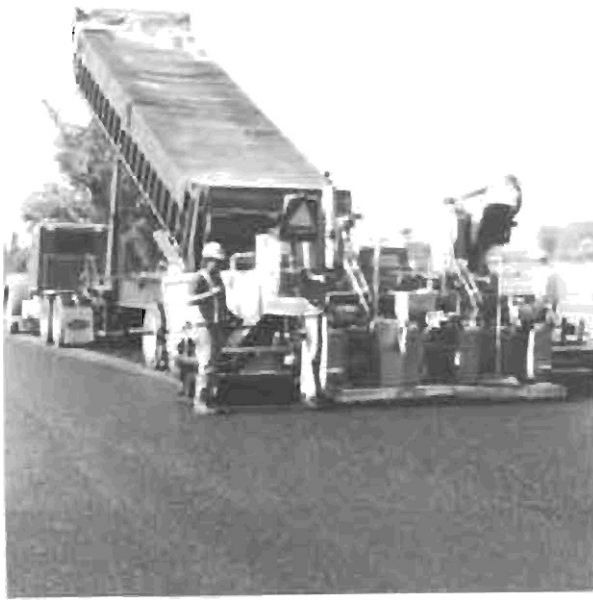
One Blaw-Knox 510 paver with a variable width screed and extended augers was used. Paving widths ranged from 3 to 5 m (10 to 16 ft). Three rollers were used to compact the SMA. Because SMAs perform differently during the compaction process, a roller pattern were difficult to establish. The final roller pattern that was established used two steel-wheeled rollers for breakdown (Caterpillar 534B) and one steel-wheeled roller for finishing (Hyster 766). The first roller used for breakdown was a 10 tonne roller which made one pass in the vibratory mode and one in the static mode. The next roller (10 tonne) made two passes in the vibratory mode and two passes in the static mode. A 7 tonne steel-wheeled roller operated in the static mode as the finish roller. A pneumatic roller was not used on the SMA pavement. It is very critical that rollers are kept close to the laydown operation. Photographs of construction are shown in Figures 12 through 15.

**Figure 12. Typical Laydown Operation.**

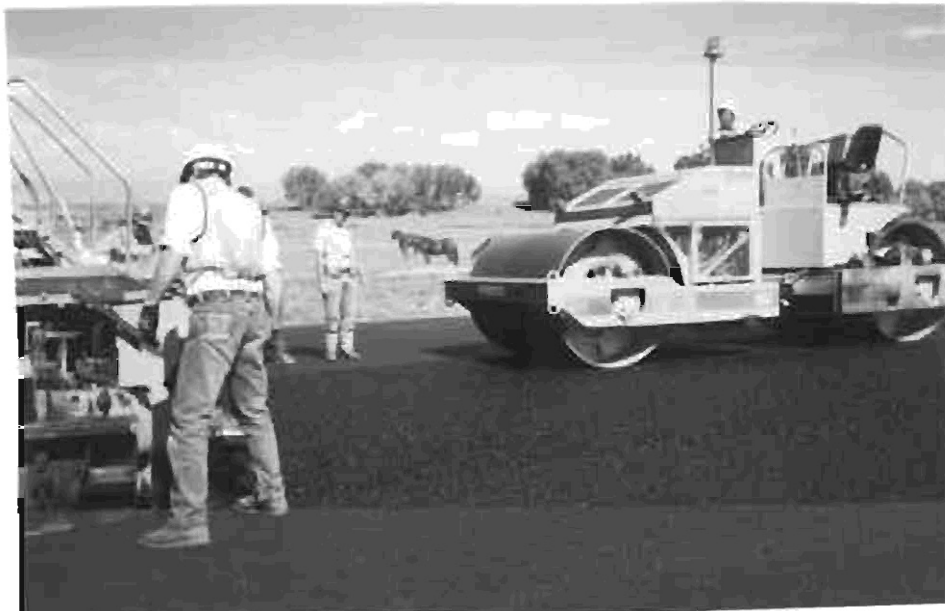
**Figure 13. The Breakdown Roller Was Kept Close to the Laydown Machine.**

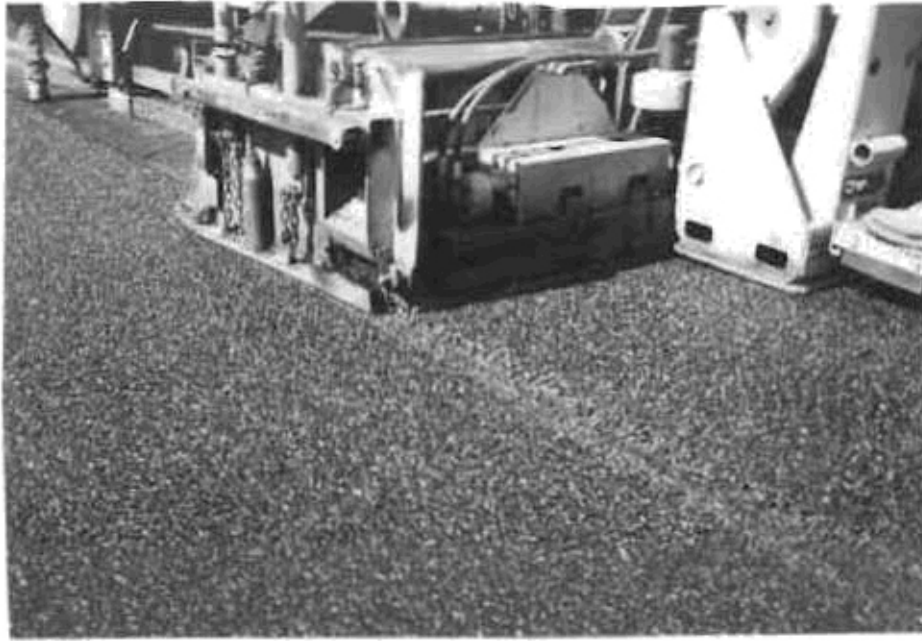
**Figure 14. SMAs Allow for Neat Line Joints.**

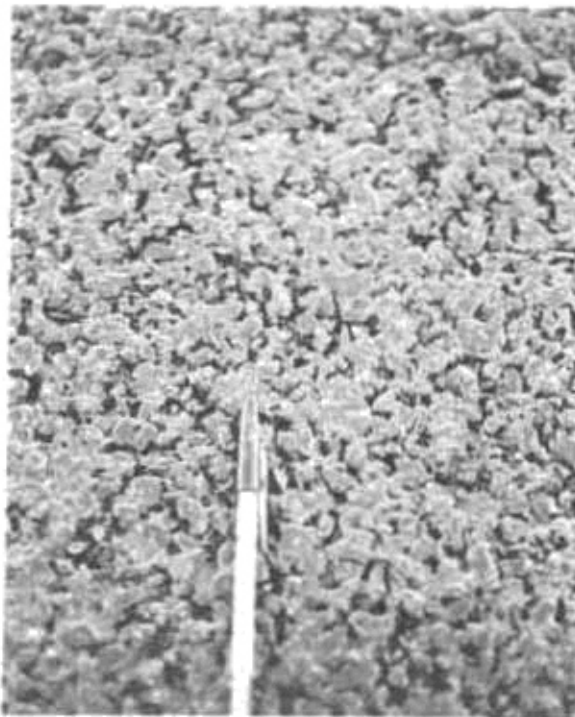
**Figure 15. Surface Texture of the Finished Mat.**

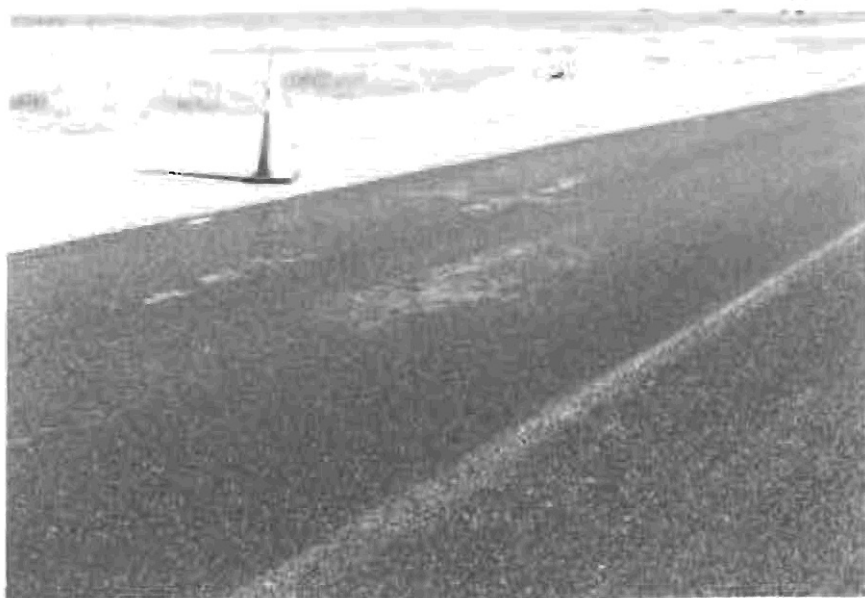
**Figure 16. Limited Problems With Dralndown Were Encountered.**

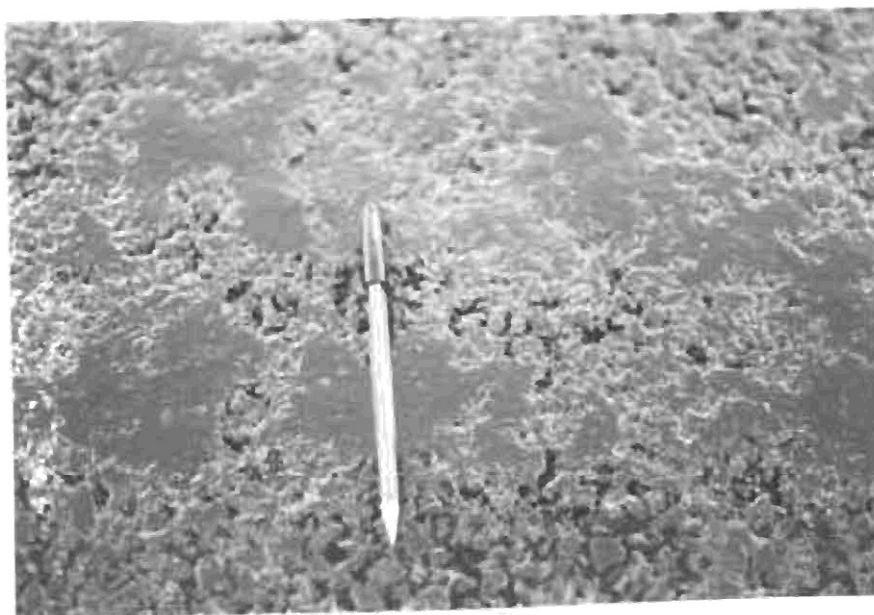
**Figure 17. Close-Up of Flushing Area.**

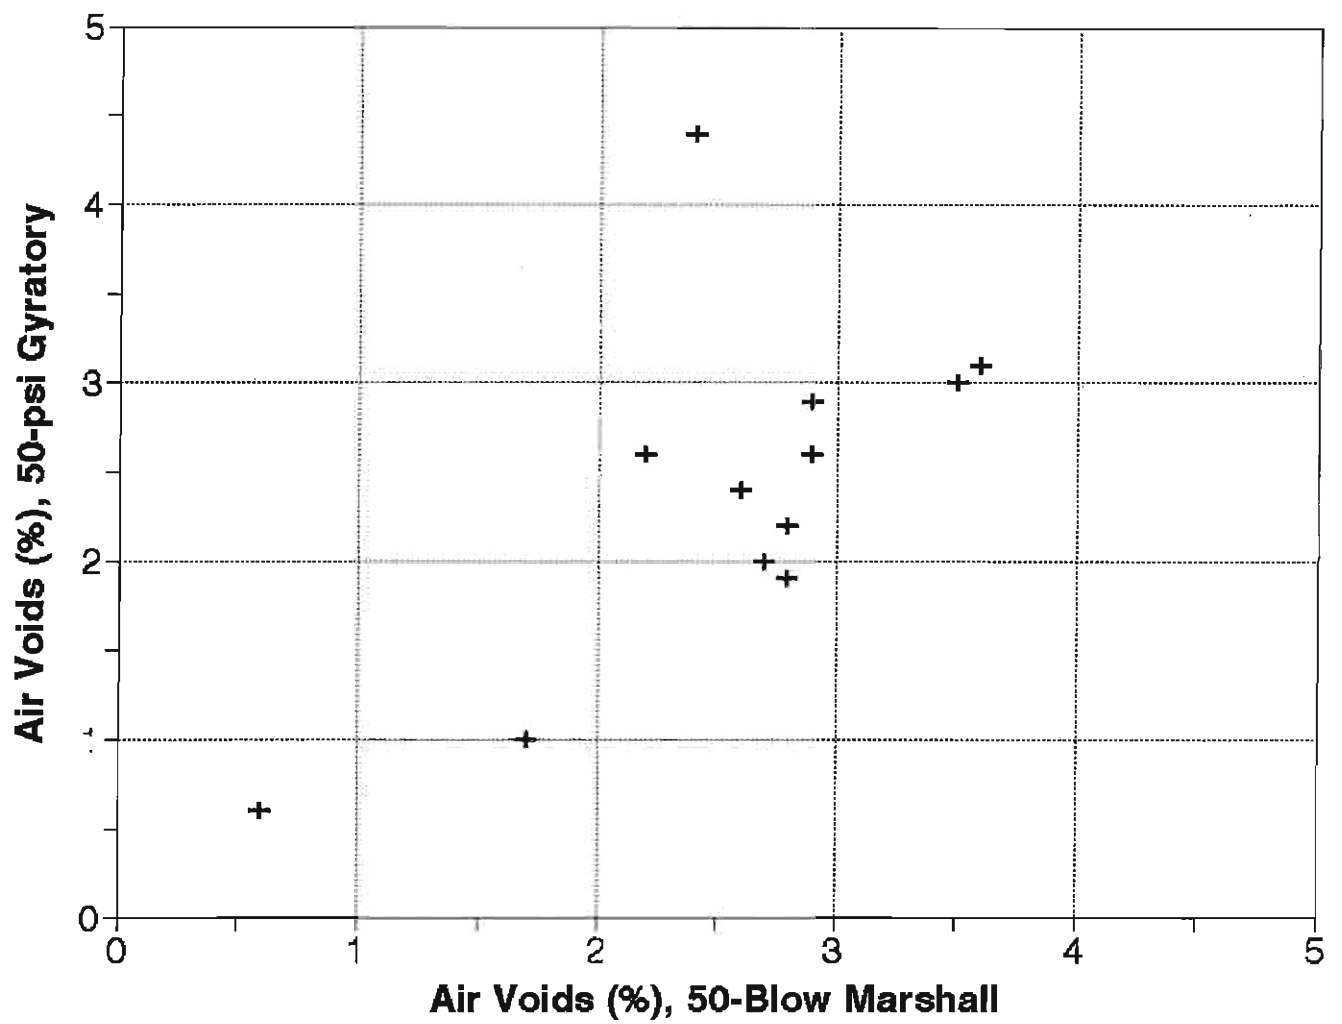
$$y = 0.93 x + 0.51$$

It should be recognized that any attempt to replace the Marshall hammer with the gyratory compactor will not yield an ideal conversion. If the gyratory is used as a matter of convenience to replace the Marshall hammer, the 340 kPa (50 psi) end point stress appears reasonable. More data should be gathered before making this a specification change for SMA mixtures.

Figure 18. Comparison of Air Voids from Texas Gyratory and Marshall Compaction.

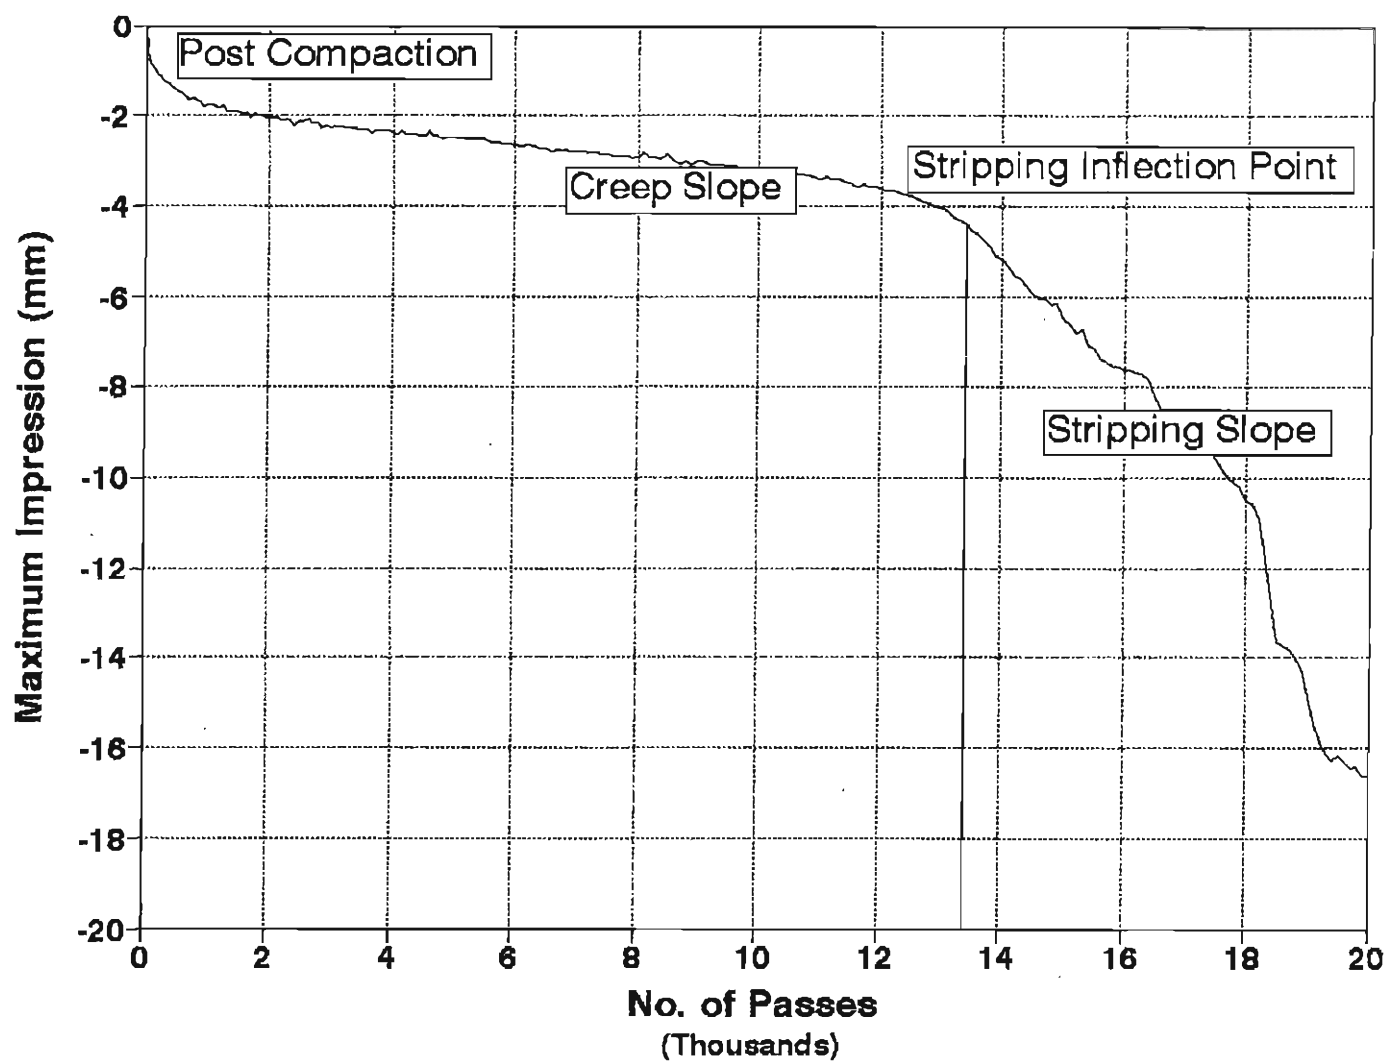
The results from the Hamburg wheel-tracking device include the creep slope, stripping slope and stripping inflection point as shown in Figure 21. These results have been defined by Hines (10). The creep slope relates to rutting from plastic flow. It is the inverse of the rate of deformation

Figure 21. Typical Results from the Hamburg Wheel-Tracking Device.

in the linear region of the deformation curve, after post compaction effects have ended and before the onset of stripping. The stripping slope is the inverse of the rate of deformation in the linear region of the deformation curve, after stripping begins and until the end of the test. It is the number of passes required to create a 1 mm impression from stripping. The stripping slope is related to the severity of moisture damage. The stripping inflection point is the number of passes at the intersection of the creep slope and the stripping slope. It is related to the resistance of the HMA to moisture damage.

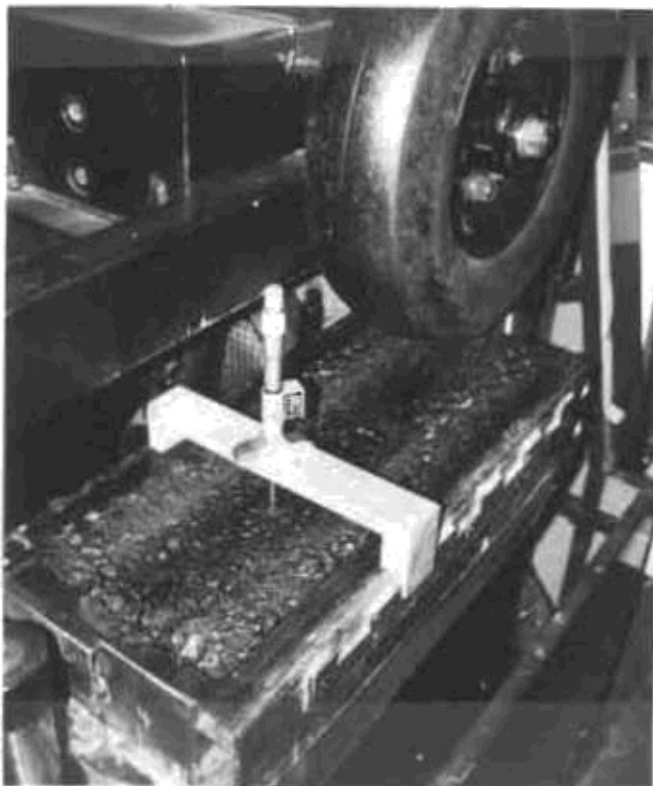
**Figure 23. Close-Up of the French Rutting Tester.**

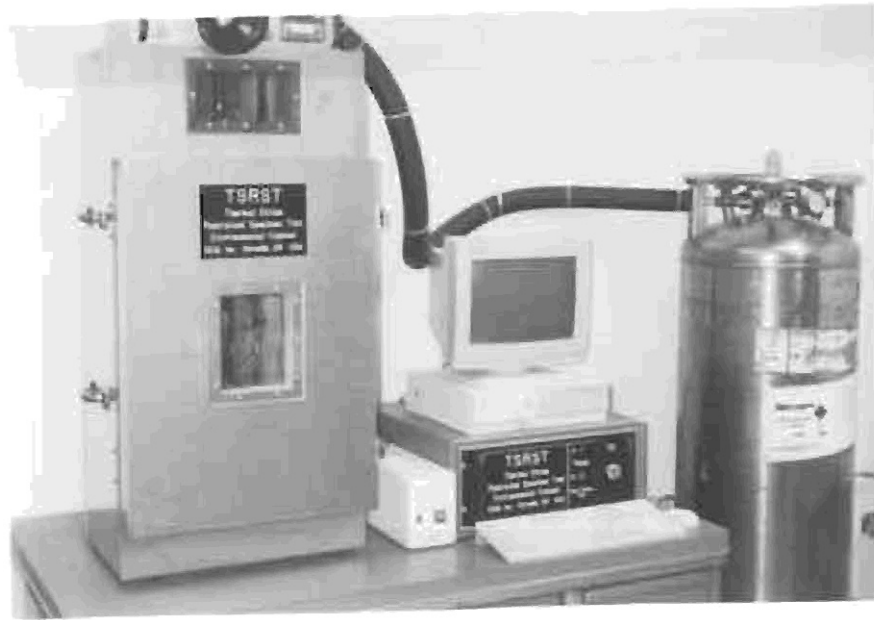
The thermal stress restrained specimen test (TSRST) is used to evaluate the resistance of the HMA to low temperature thermal cracking. The TSRST was developed at Oregon State University as part of SHRP. The TSRST is manufactured by OEM, Inc. in Corvallis, Oregon.

Figure 24. The TSRST Device.

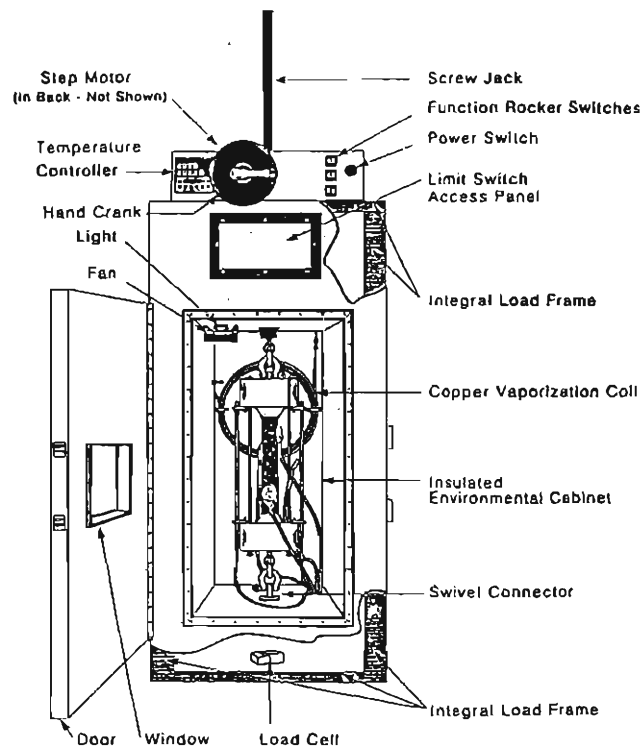
After a sample is mounted in the TSRST, it is cooled at a rate of 10°C (18°F) per hour. Liquid Nitrogen is used to provide the cooling. The sample is not allowed to contract during the cooling period. The sample length is monitored with LVDTs and the use of Invar steel rods. Since the sample is not allowed to contract as it cools, stresses develop within it. A closed-loop system keeps the sample at a constant length. When the developed stress exceeds the strength of the sample, the sample breaks. The temperature and stress at fracture are recorded. A typical plot of the test results is shown in Figure 27.

Figure 25. Schematic of the TSRST Device.

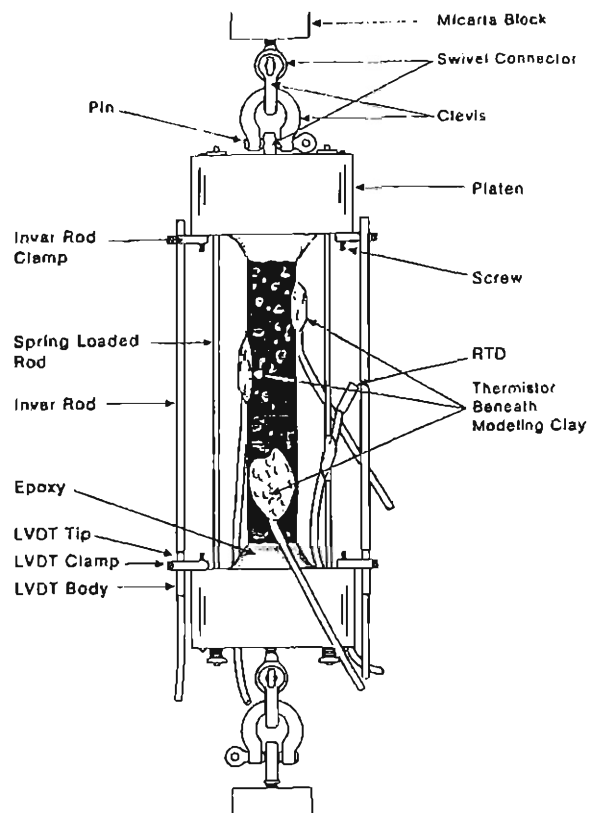
The loose HMA was short-term aged for 4 hours at 135°C (270°F) and then compacted. Samples were compacted in the linear kneading compactor for this study. The compacted HMA was then long-term aged for 120 hours (5 days) at 85°C (185°F) in a forced draft oven. Samples tested were 50-mm (2-in.) diameter and 250-mm (10-in.) long.

Figure 26. Schematic of the Test Sample.

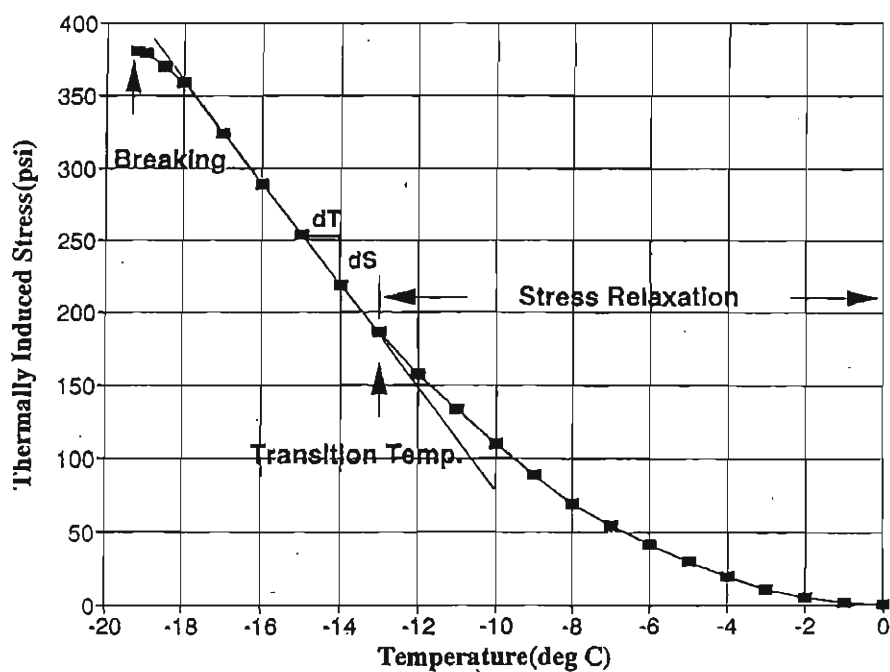
Figure 27. Typical TSRST Test Results.
