**DOT/FAA/AR-99/44**

# **Development of Improved Flammability Criteria for Aircraft Thermal Acoustic Insulation**

Timothy Marker

Final Report

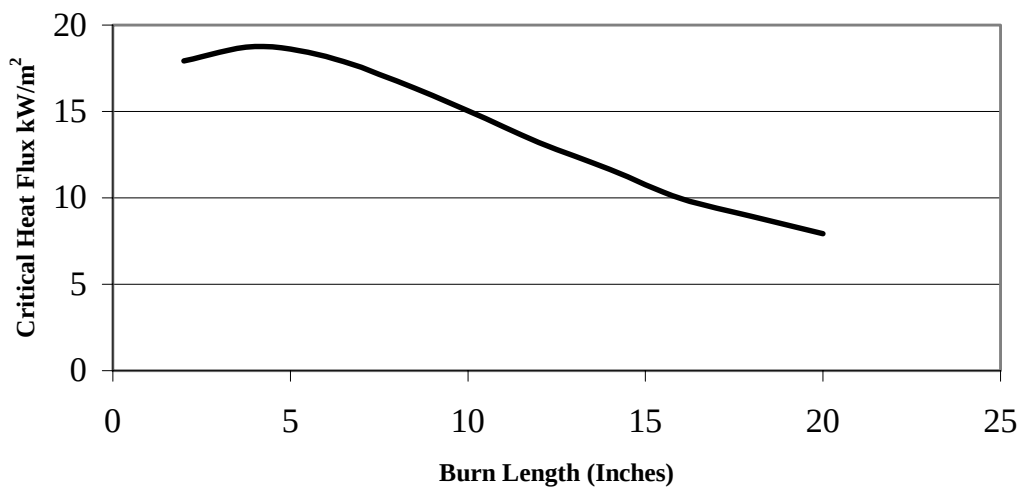
FIGURE 21. INVERSE RELATIONSHIP BETWEEN FLAME PROPAGATION AND CRITICAL RADIANT FLUX

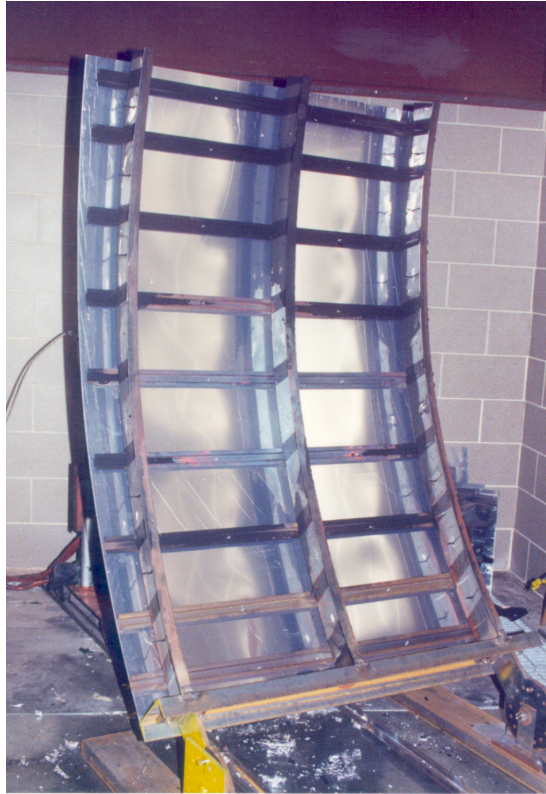
Because of the problems associated with the sample holder and the attachment process in the initial box tests, a larger surface area rig was constructed to more closely resemble a generic aircraft structure. The new steel rig incorporated curved “Z” section formers oriented vertically and hat-shaped lateral stringer pieces (figure 31). This enabled the attachment of the insulation to the test rig using in-service type fasteners. The entire test frame was capable of being rotated to produce a variety of impact angles by the burner flame. Since an actual crash fire situation could result in an infinite number of possibilities regarding the location of the fire with respect to

FIGURE 31. CURVED TEST RIG
