# Develop Best Practices for Flexible Pavement Repairs

Technical Report 0-7175-R1

TEXAS A&M TRANSPORTATION INSTITUTE  
COLLEGE STATION, TEXAS

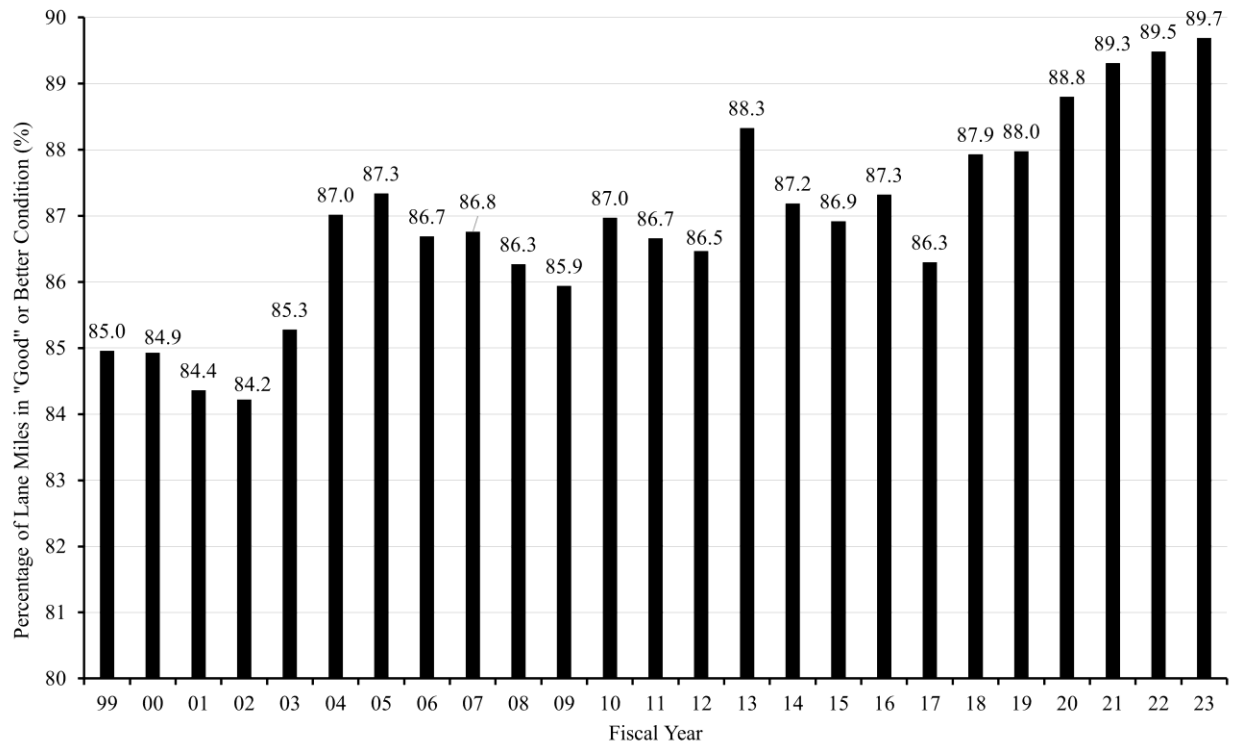
**Figure 1. Statewide Percentage “Good” or Better and Maintenance Expenditure in FY 2008–2023.**

Texas faces significant challenges in maintaining its extensive roadway network. Since 2001, the Texas Department of Transportation (TxDOT) has aimed to keep at least 90 percent of the system in good or better condition. Figure 1 illustrates the percentage of roads rated “good” or better alongside maintenance expenditures from fiscal year (FY) 2008 to FY 2023 (TxDOT 2021b).

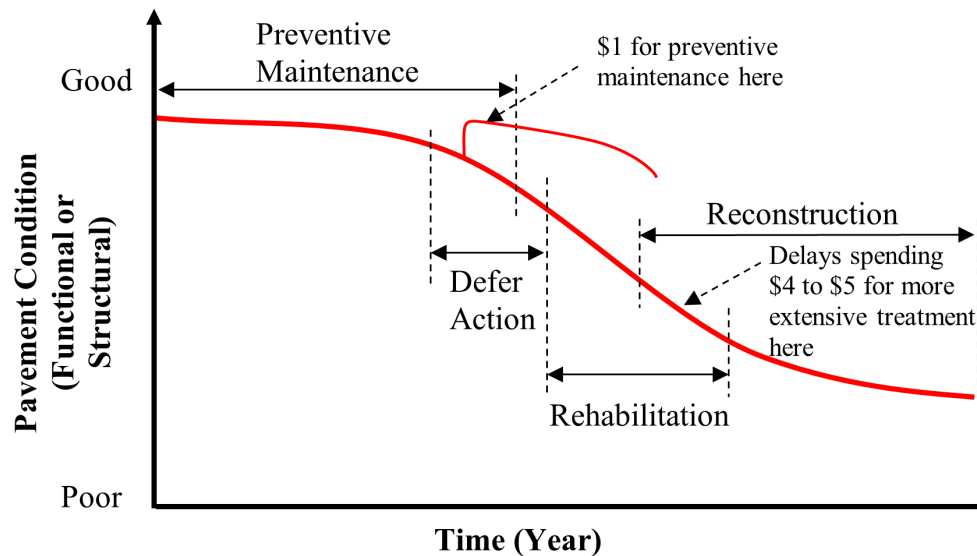
**Figure 2. Theoretical Pavement Performance Curve for Different Maintenance and Rehabilitation Strategies.**

good condition slow deterioration and prolong service life. This strategic approach goes beyond immediate concerns; it involves implementing measures specifically aimed at preventing future distress within pavements (Figure 2). PM treatments are strategically applied when the pavement surface is still in good condition. This proactive approach aims to prevent accelerated damage, effectively extending the pavement's service life.

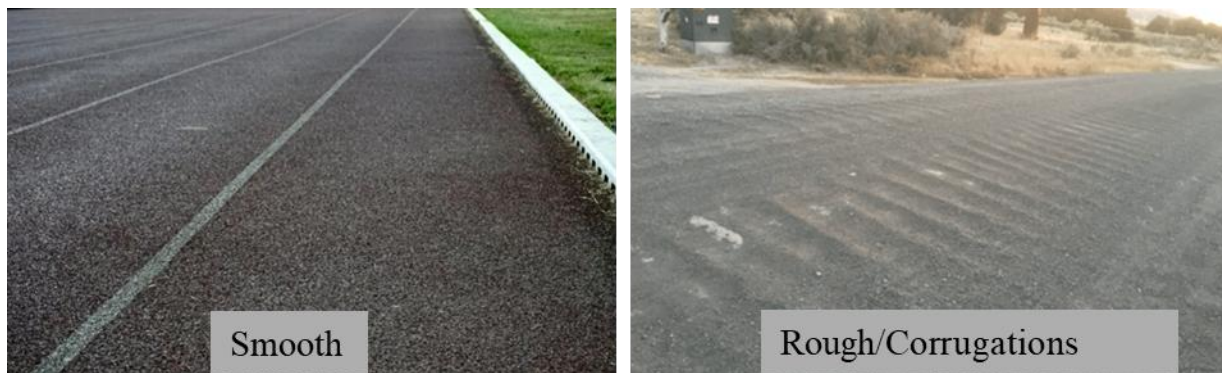
**Figure 3. Ride Quality.**

TxDOT monitors both flexible and rigid pavements for ride quality using the International Roughness Index (IRI) and visual ratings for distress. *The Pavement Management Information System (PMIS) Rater's Manual* (TxDOT 2016) defines distress types and scoring methods. Combining distress and ride scores provides an overall condition score for each roadway section. TxDOT employs automated and semi-automated data collection methods using 3D laser technology and high-resolution cameras. Figure 3 and Figure 4 show examples of the ride quality and visual distress, respectively.

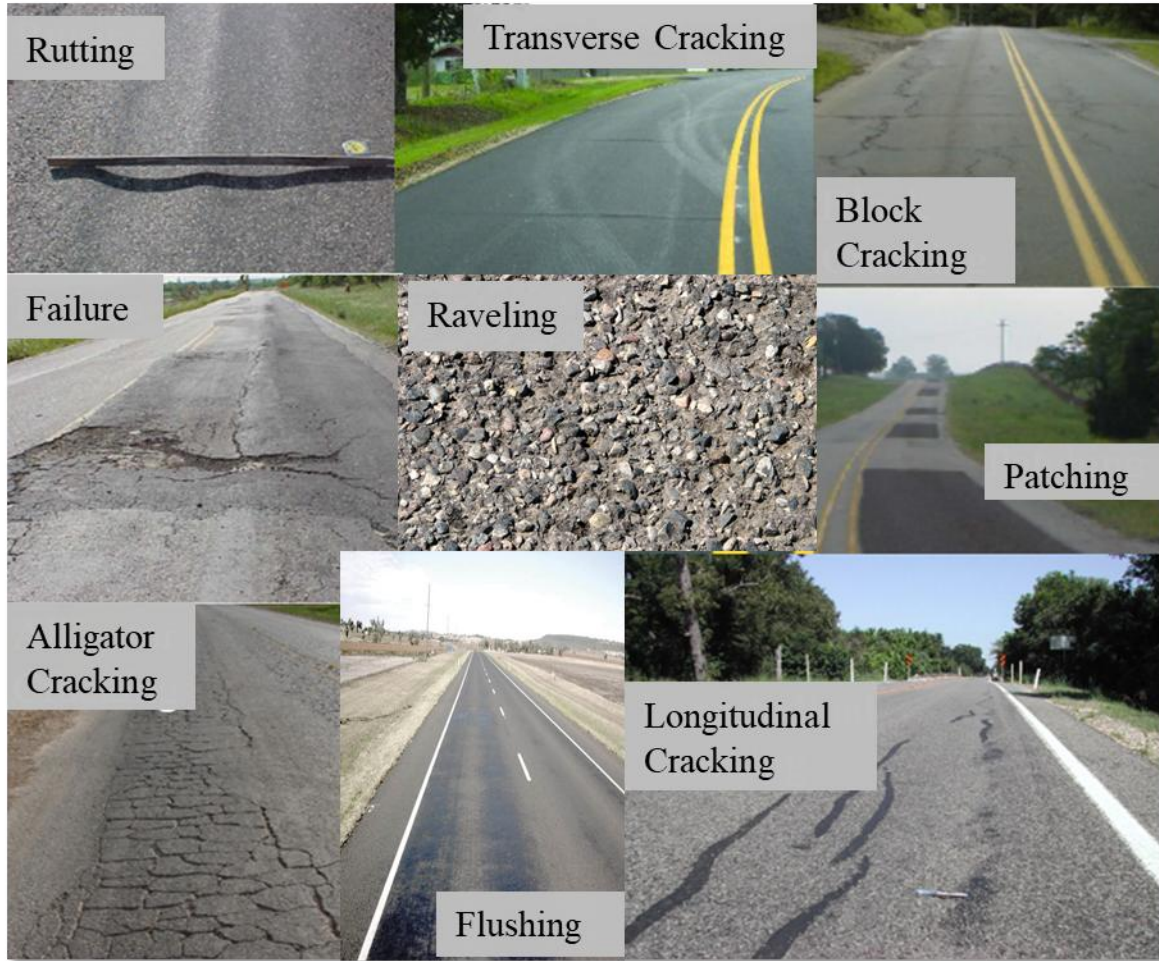
**Figure 4. Flexible Pavement Distresses.**

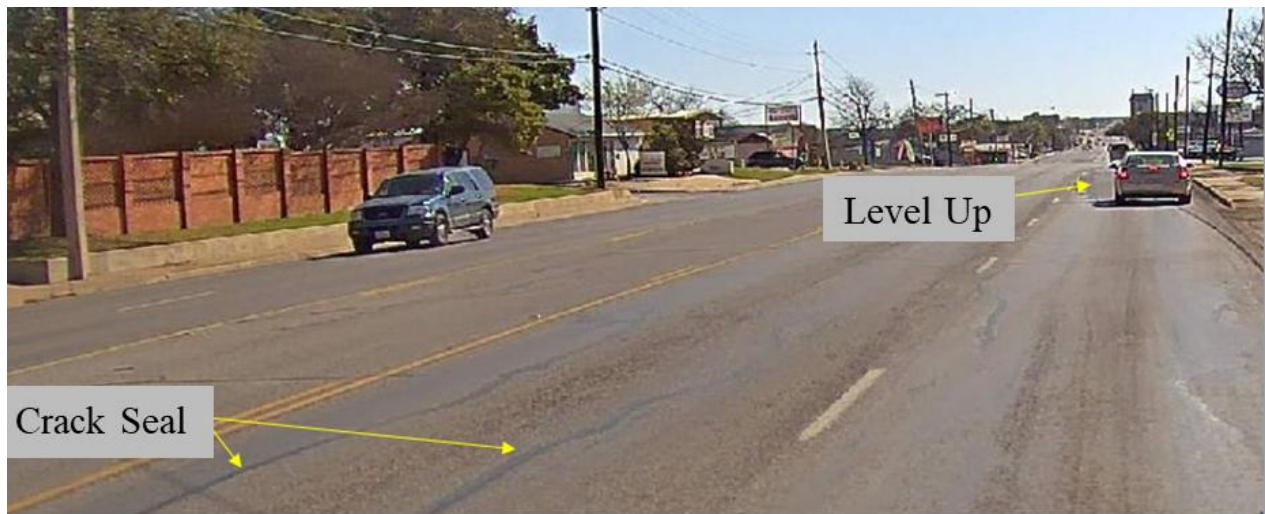
**Figure 5. Example Preparatory Work.**

Multiple repairs may be combined before applying a seal coat PM treatment (Figure 5).

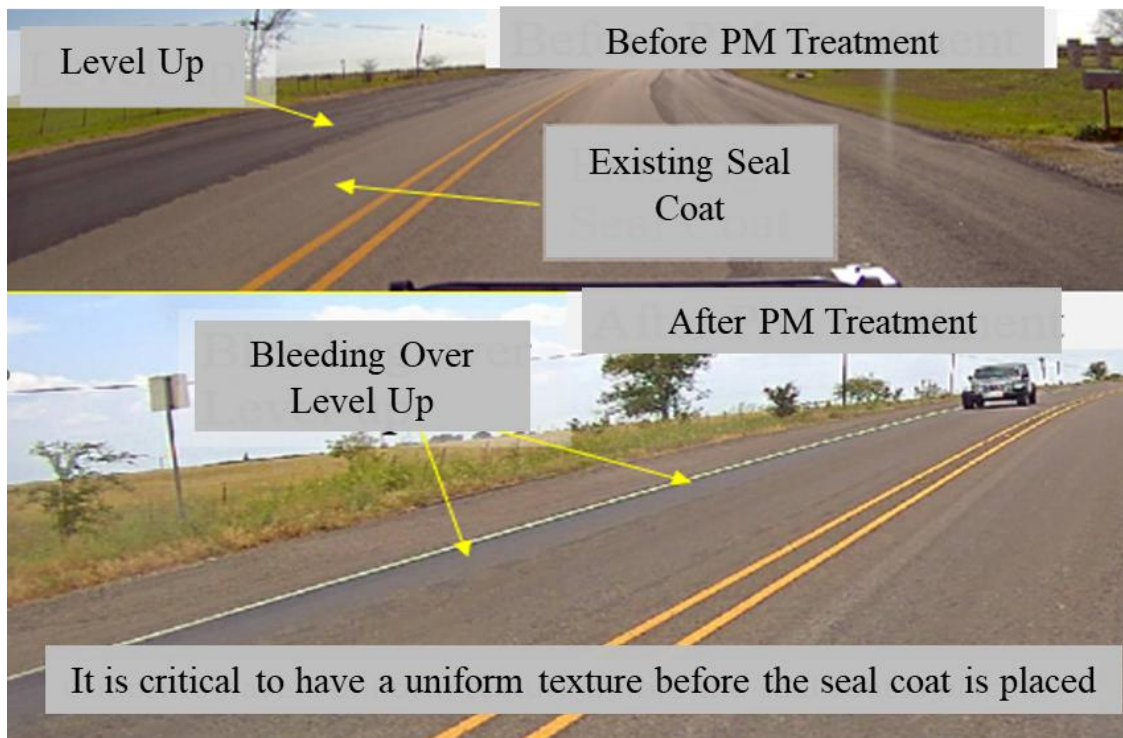
**Figure 6. Repair Effect on Seal Coat.**

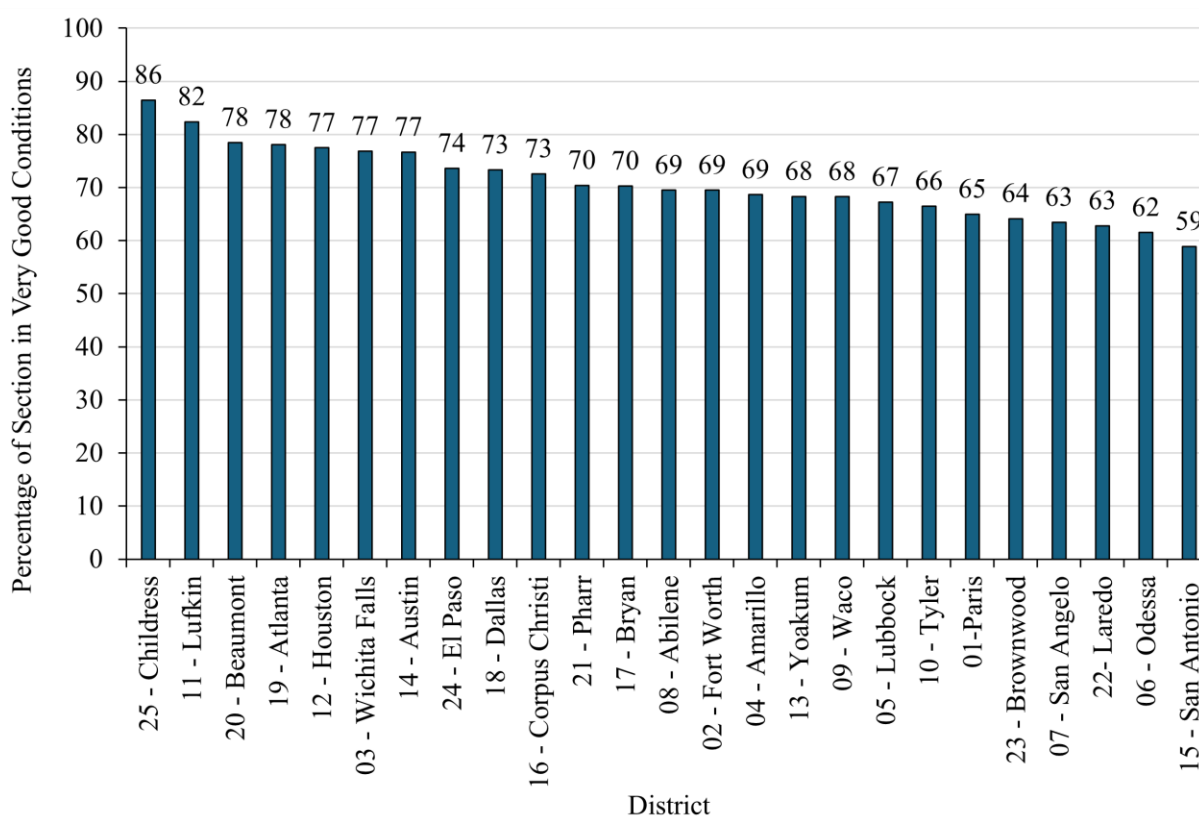
**Figure 8. Percentage of Section (0.5 mile) with Very Good Distress Score.**

- Rural districts such as **Childress, Lufkin, and Atlanta** maintain a high percentage of sections with high distress scores ( $> 90$ ), likely due to lower traffic volumes and smaller networks (Figure 8).
- Large metropolitan districts such as **San Antonio, Dallas, Houston, and Fort Worth** show higher percentages of sections with relatively poor pavement conditions, primarily due to heavy traffic and complex maintenance demands (Figure 9).
- **Odessa**, a smaller district with significant oil and gas traffic and limited asphalt plants, also exhibits a higher percentage of sections with poor conditions (Figure 9).

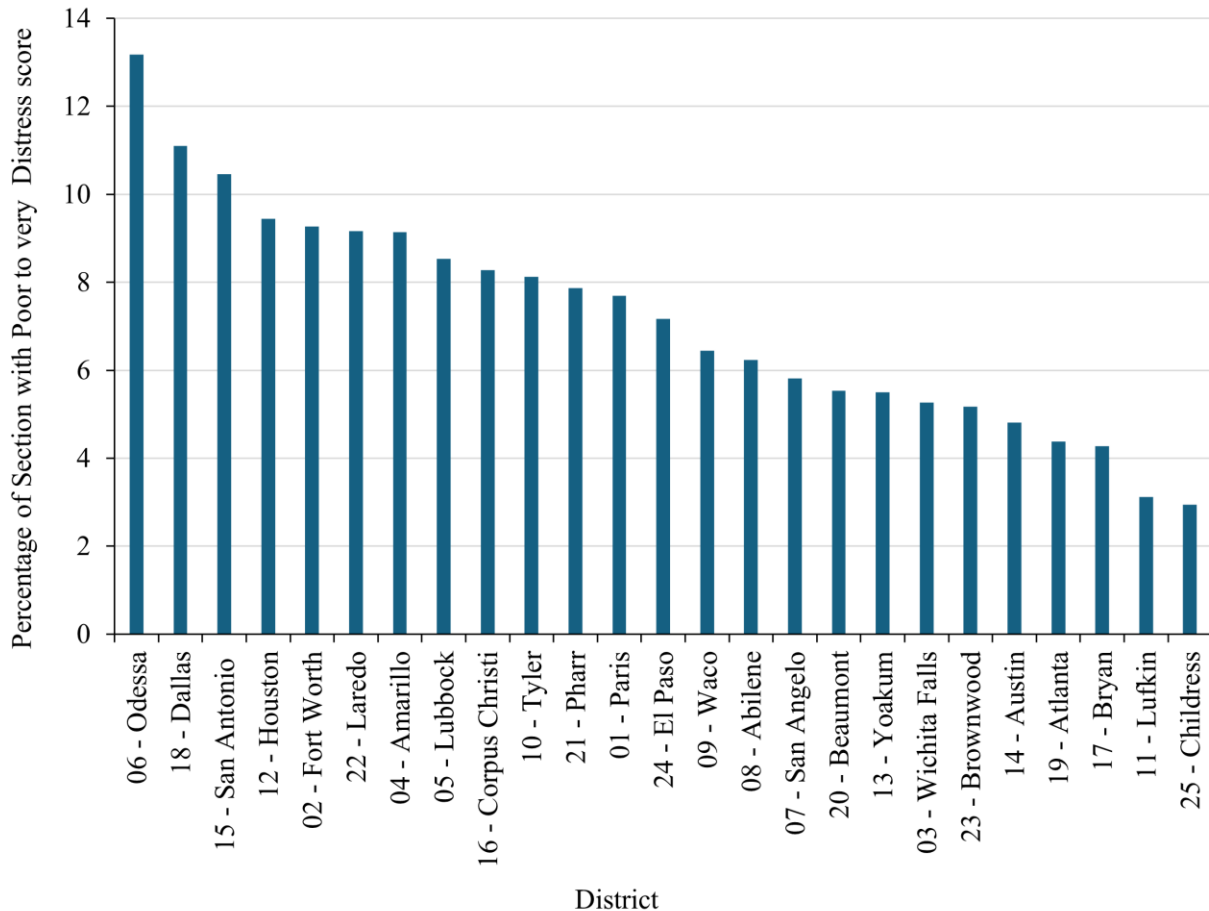
**Figure 9. Percentage of Section (0.5 mile) with Poor Distress Score.**

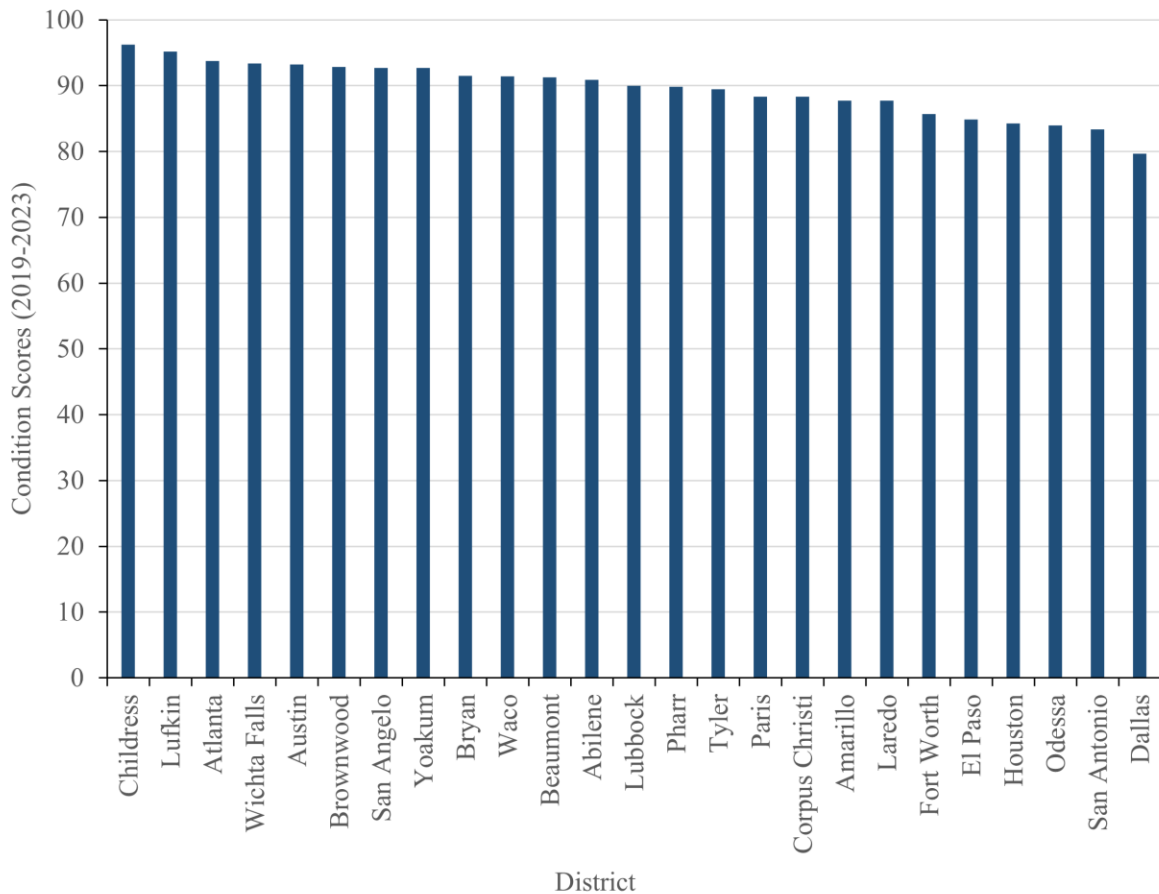
**Figure 10. TxDOT District Ranking According to Condition Scores 2019–2023.**

The Texas PMIS Annual Report 2020–23 echoes a similar finding, this time using the condition score (distress and ride scores) (TxDOT 2023). Figure 10 shows that rural districts, such as Childress, Lufkin, Atlanta, and others, have high condition scores. In contrast, Odessa and large metro districts (i.e., Houston, Dallas, etc.) have relatively lower scores. However, on average, all districts have good condition scores (Figure 10).

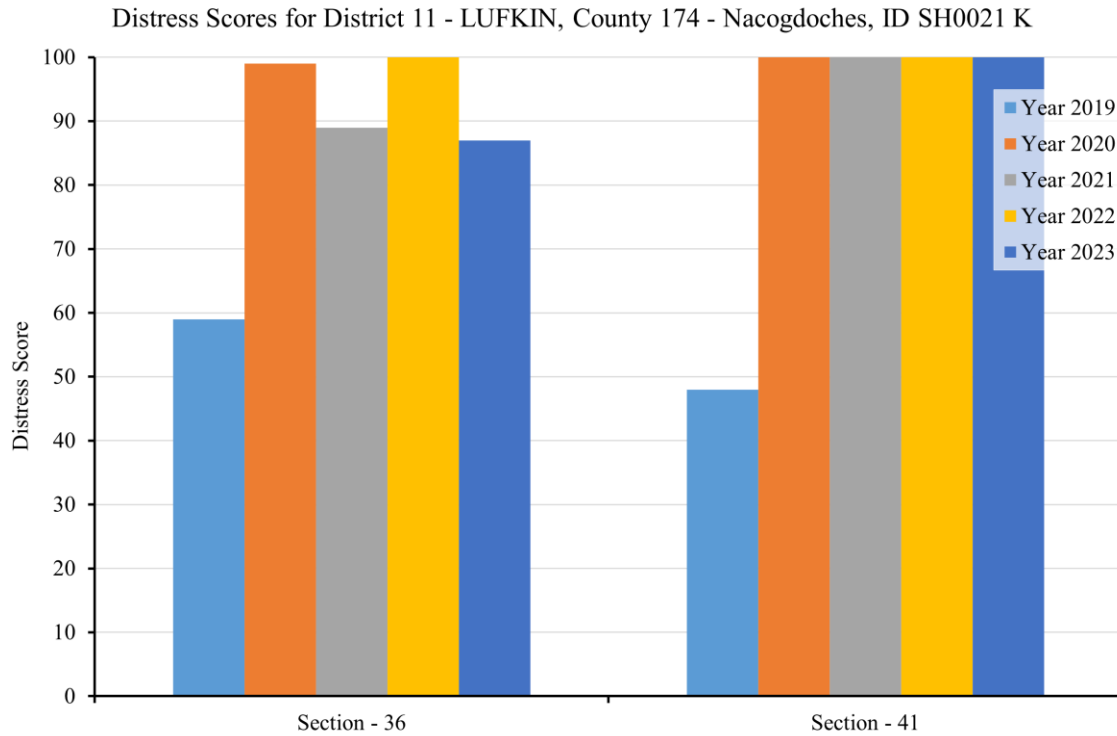
**Figure 12. Sample of the Well-Fixed Sections in Lufkin.**

To evaluate maintenance trends, the research team developed customized code to extract and plot distress scores annually, since the volume of data required automated processing. The core of the computing code is shown in Figure 11. This approach allowed identification of sections that improved or deteriorated significantly after repairs. Sections with scores above 98 (very good; relatively new) and below 70 (poor; need maintenance) were prioritized for further evaluation. Figure 12 to Figure 18 show examples from Lufkin and Odessa, highlighting contrasting outcomes:

- Some repaired sections remained in good condition for years. For example, Figure 12 and Figure 13 show a distress score trend for Lufkin, one of the districts with the most sections with good scores. Once repaired, most of the sections in this district stayed in good shape for a relatively long period.
- Some sections failed within a year, raising questions about repair practices and material performance. For example, Figure 14, Figure 15, and Figure 16 show sections from Odessa with a relatively high proportion of poor-scoring sections.

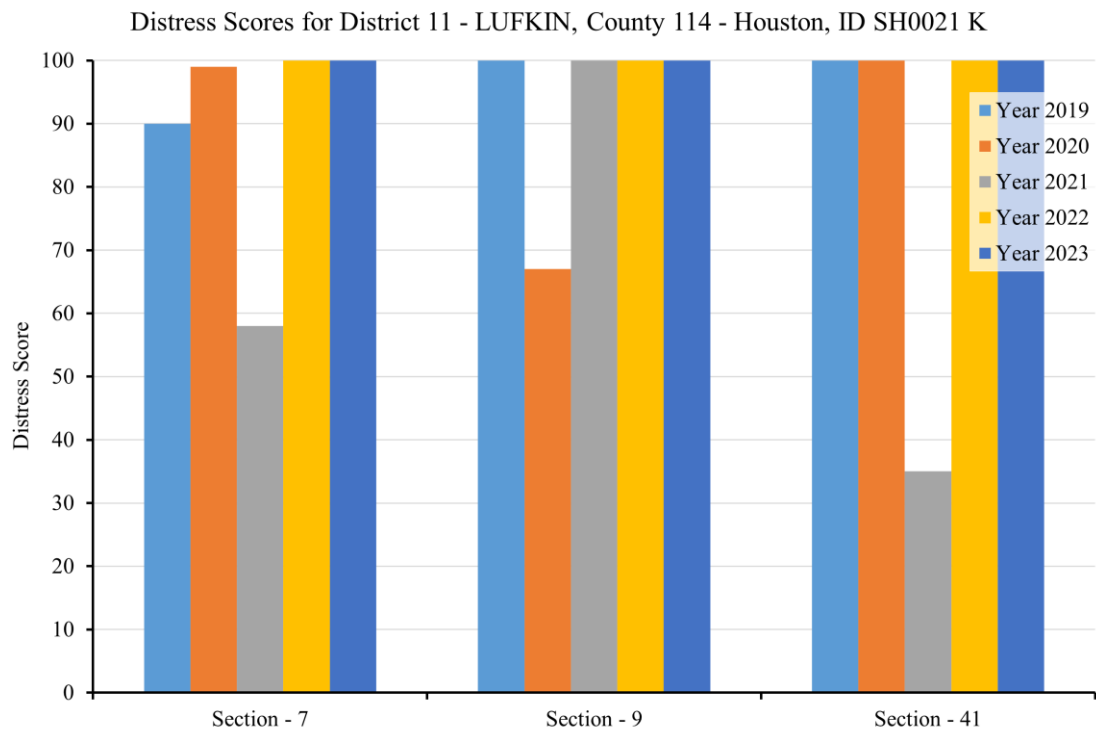
**Figure 13. Sample of the Well-Fixed Sections in Lufkin: Fixed and Remain in Good Condition.**

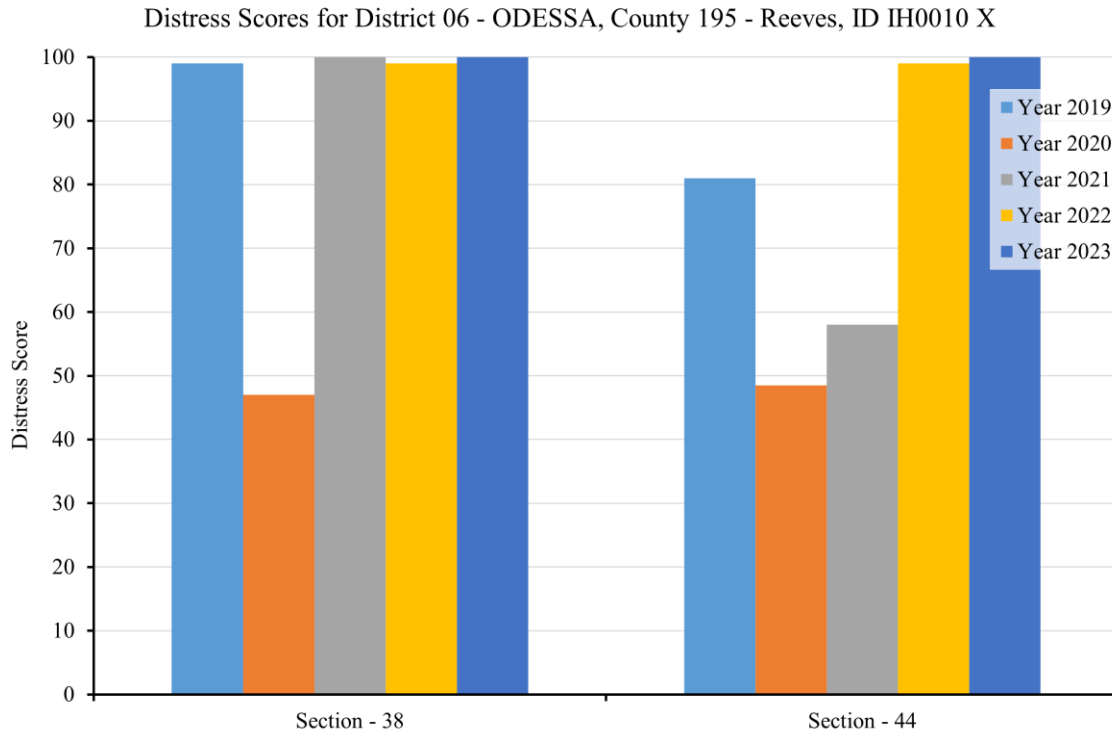
**Figure 14. Sample of Well-Fixed Sections in Odessa: Fixed and Remain in Good Condition.**

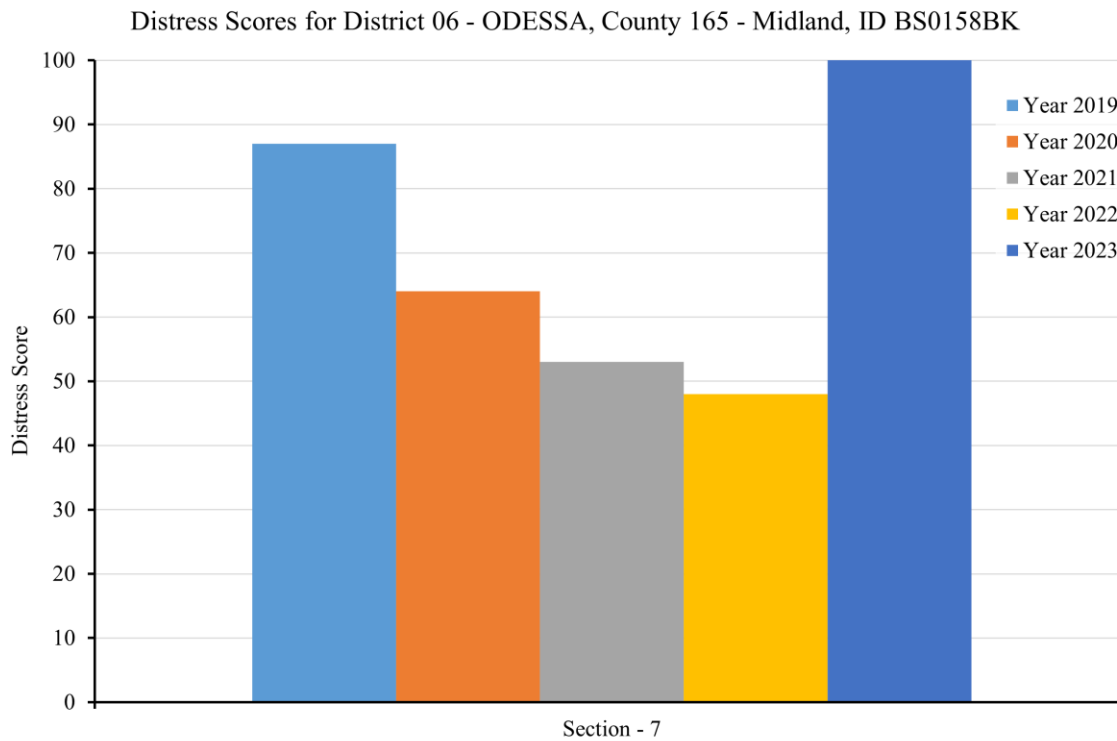
**Figure 15. Sample of a Section in Odessa: Left to Deteriorate for Years Before Fixed 2023.**

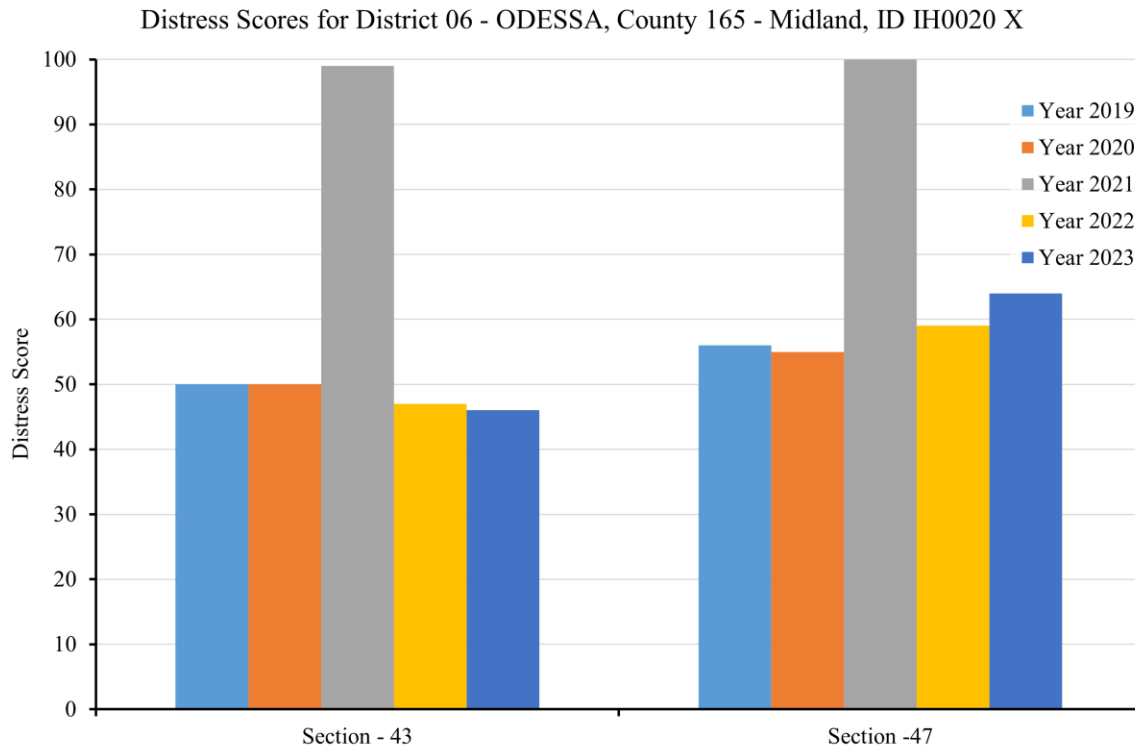
**Figure 16. Sample of Poor Sections in Odessa Fixed and Failed.**

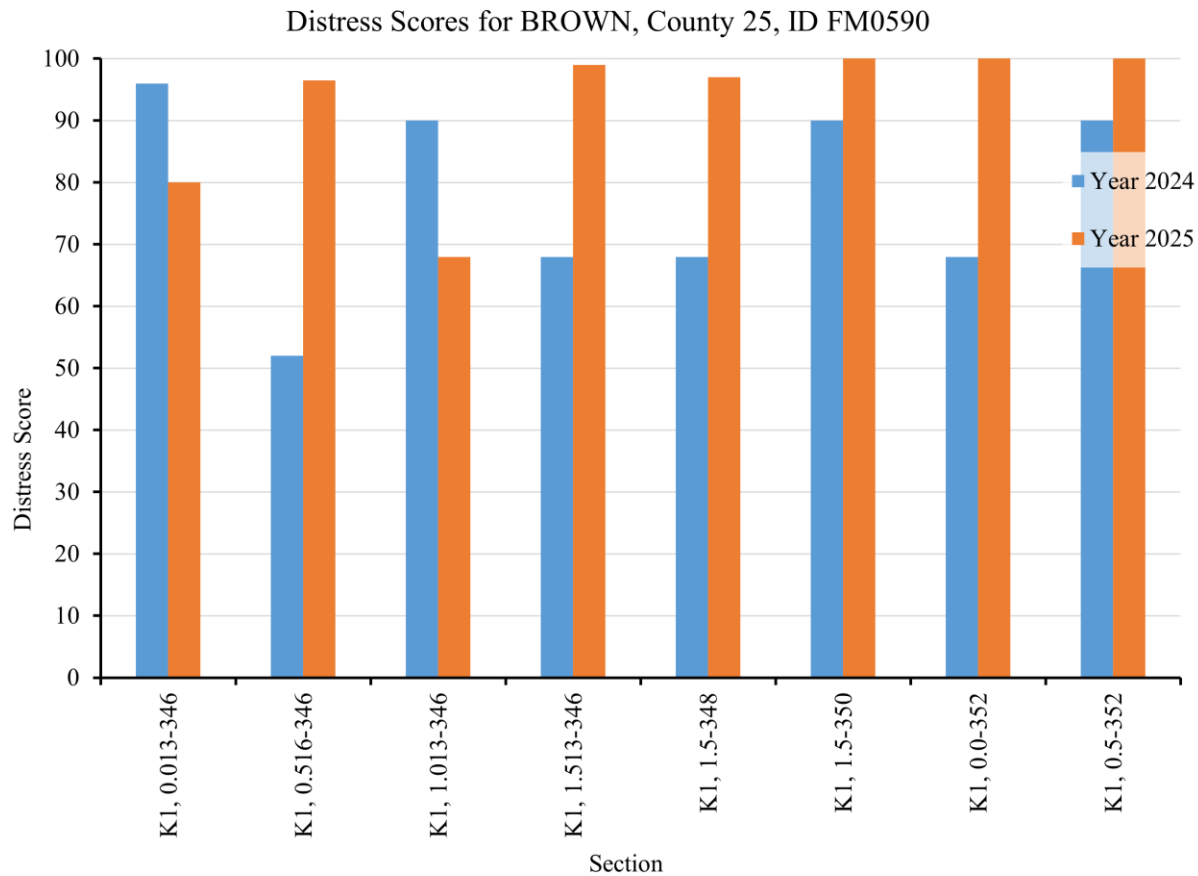
**Figure 19. Distress Score for FM 0590 Brown County in Brownwood.**

As noted in the literature review, PMIS is a vital database that collects and maintains distress and condition scores for Texas pavements. Analyzing these data enables TxDOT to identify roads that need repair and develop suitable strategies. Some districts use GIS (or TxDOT's internal dashboard) to overlay pavement condition and distress scores on maps for visualization and to prioritize repairs. Others analyze PMIS data with Microsoft Excel, but the process can be overwhelming because the data are collected every 0.5 mile. To enhance the effectiveness of PMIS data, the research team has developed an algorithm that uses PMIS scores to assist districts in reviewing their data and prioritizing repair projects. The algorithm evaluates the performance of different pavement sections within counties. For example, the Brownwood District used the algorithm to review PMIS data across all counties by plotting and comparing 2024 and 2025 inputs; sections with a difference of 10 or more in condition or distress scores prompted further review (Figure 19). If no treatment or repair was performed on a section that showed a significant change over consecutive years, personnel were dispatched to verify the actual conditions or determine whether it was a data-collection error.

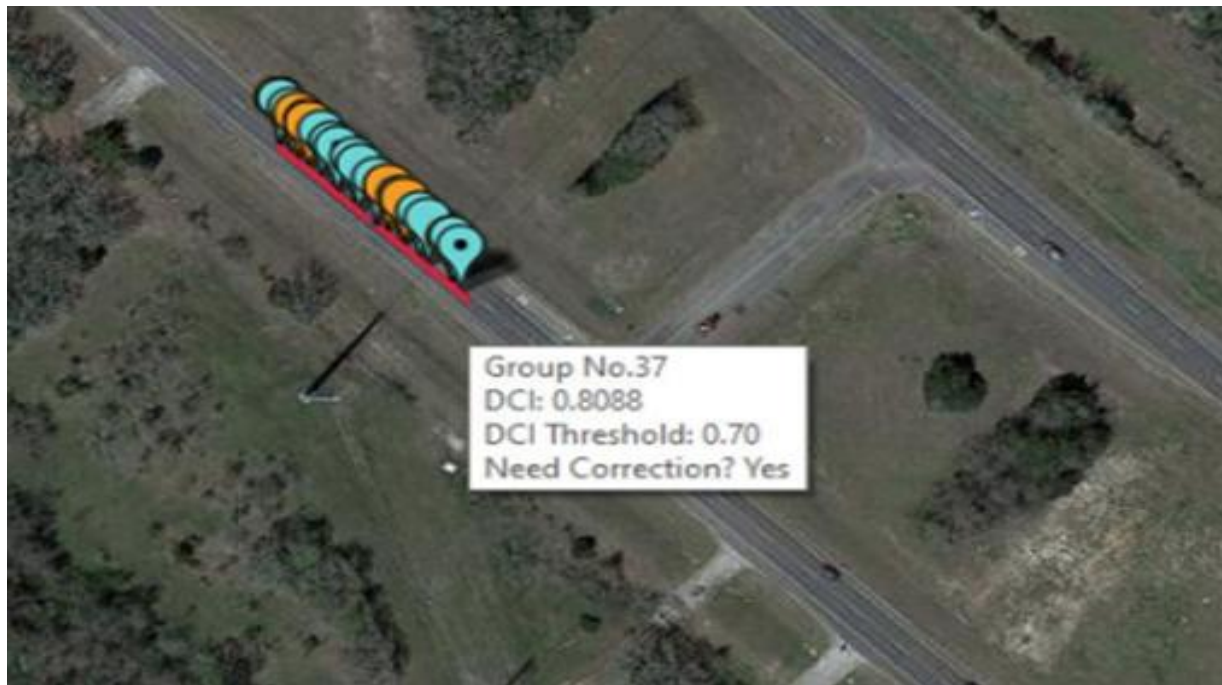
**Figure 20. DCI Analysis Map.**

Table 7 shows a demo summary of the repair options and their price. Grind Diagnostic includes a mapping utility to output maps of the results from the DCI (Figure 20) and cost analyses. The map more effectively communicates the locations of defects and whether corrections are

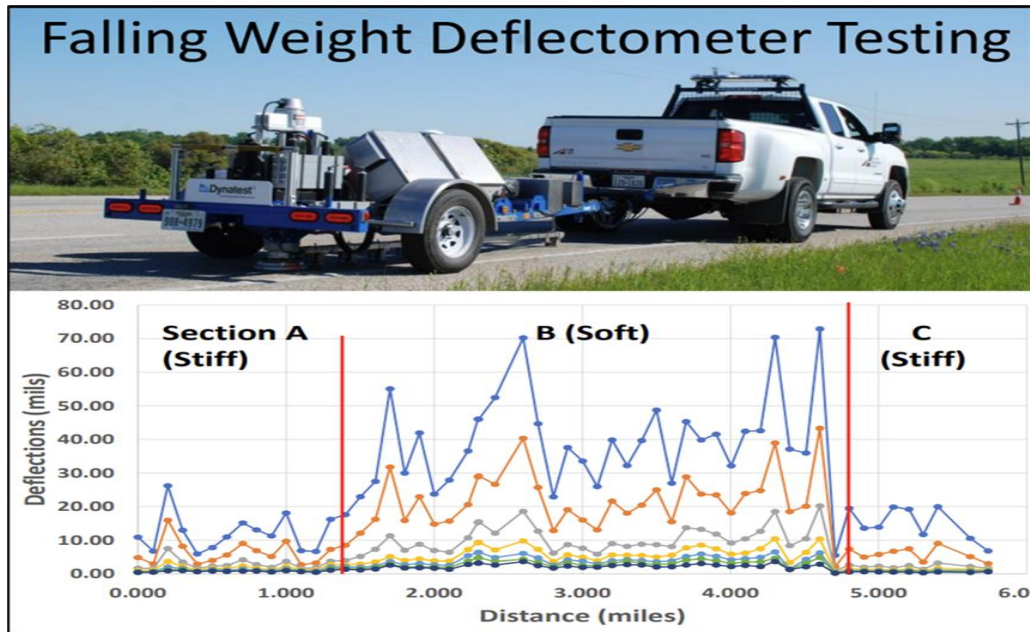
Figure 21. FWD Testing.

**FWD and Dynamic Cone Penetrometer (DCP).** If structural deficiencies are suspected, the FWD should be used. The FWD uses the deflection of pavement (due to dropping a weight onto a pavement surface) to determine the pavement's structural integrity. The FWD measures the stiffness of pavement layers. Figure 21 shows a road project with a significant variation in strength (Liu and Scullion 2001). Another piece of equipment that can measure stiffness is the DCP. DCP tests often complement the FWD to verify the base/subbase and subgrade moduli. The DCP uses the penetration depth per blow to assess the in-situ strength of undisturbed soil or compacted materials. Figure 22 shows a typical DCP test and its results.

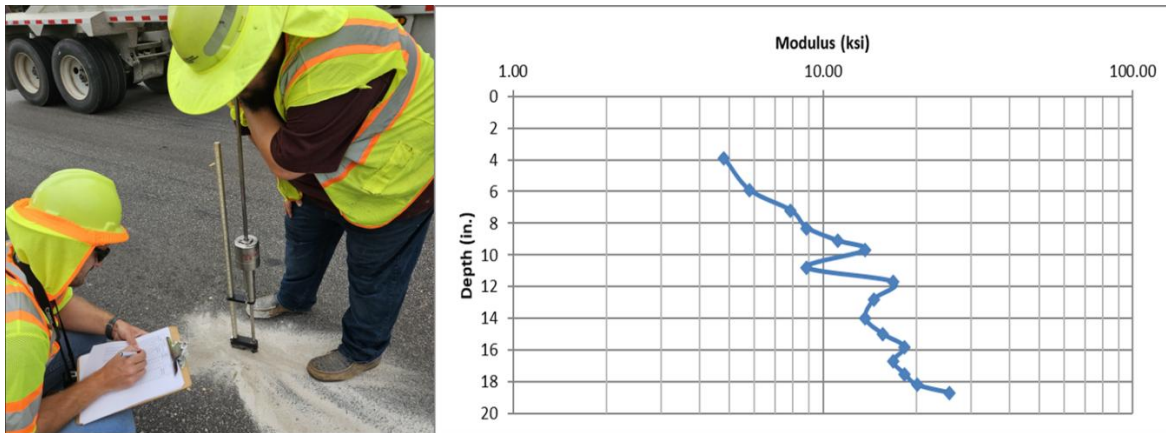
Figure 22. DCP Testing.

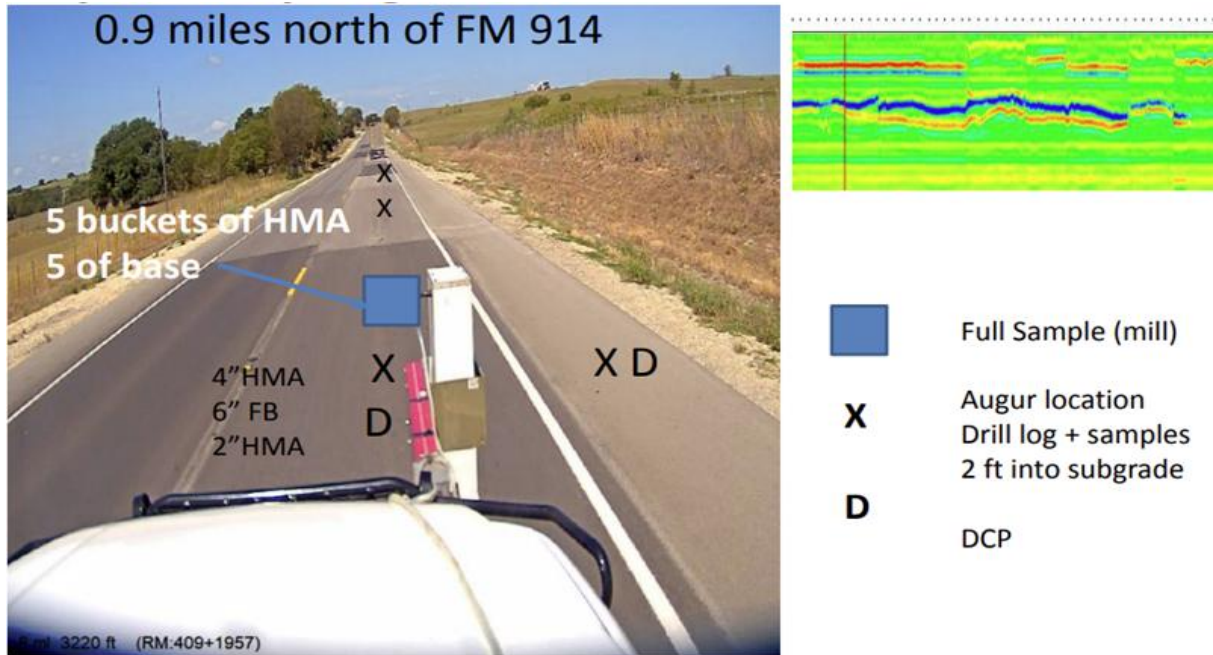
Figure 23. GPR.

**GPR.** The GPR is used to identify pavement layer thicknesses, potential areas of deterioration, and the limits of the defects. The GPR can estimate the density within HMA layers and identify existing moisture and defects in HMA, such as stripping and segregation. A data-integrating analysis software, PaveCheck, is used to communicate the GPR data to users. The software integrates a video with a color plot of the waveforms. Through GPR data, engineers can identify poor sections along the road and deploy FWD tests and coring at specific points (Figure 23) (De Carteret 2009).

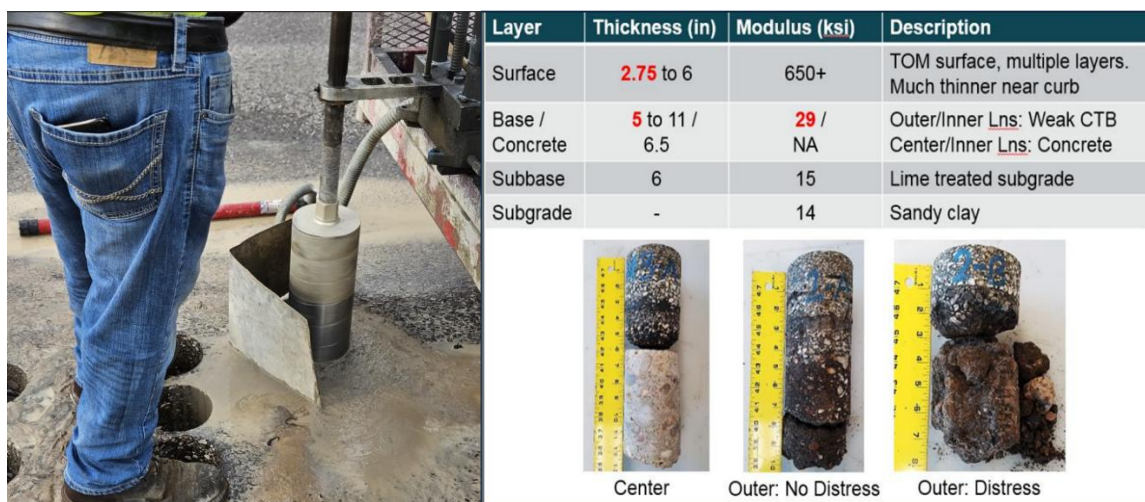
Figure 24. Coring Process and Report.

**Coring.** The pavement and subgrade sampling coring device is typically mounted to the back of a truck to gain support and perform heavy-duty coring. Pavement cores are typically extracted to assess the extent of damage or verify NDT findings (e.g., GPR). Core inspection can identify the extent and size of cracks, as well as determine the composition of the pavement layers and materials. Figure 24 shows the coring process and reported examples from previous projects (Goehl et al. 2021).

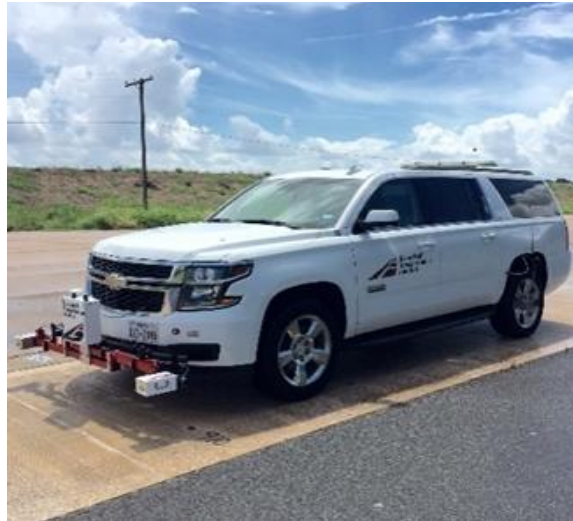
**Figure 25. Inertial Profiler.**

**Inertial Profiler.** The inertia profiler can be used to determine the pavement's functional properties. It measures the longitudinal and transverse roughness statistics at highway speeds. The measurements are taken in real time and quantified into two indices: the serviceability index

(SI) and the IRI. This equipment can also identify locations of localized roughness, bumps, and dips. The SI is an input into the flexible pavement design software FPS-23. The inertial profiler is shown in Figure 25.

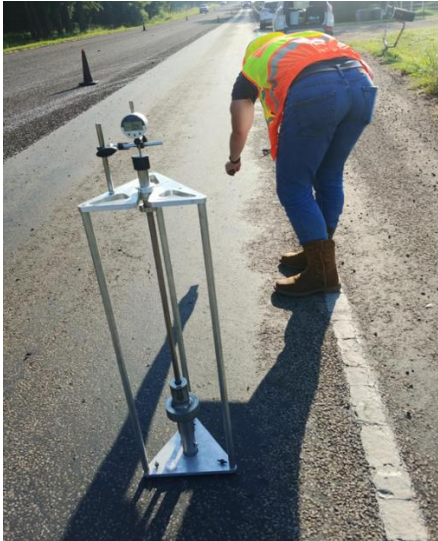
| | Ball Penetration Test Result | Corresponding Action |
| | $\leq 0.039$ inches (1 mm) | 0.039 inches (1 mm) adjustment to mat thickness for application rate on new seal coat. |
| | $> 0.039$ inches (2 mm) to 0.118 inches (3 mm) | No adjustment. |

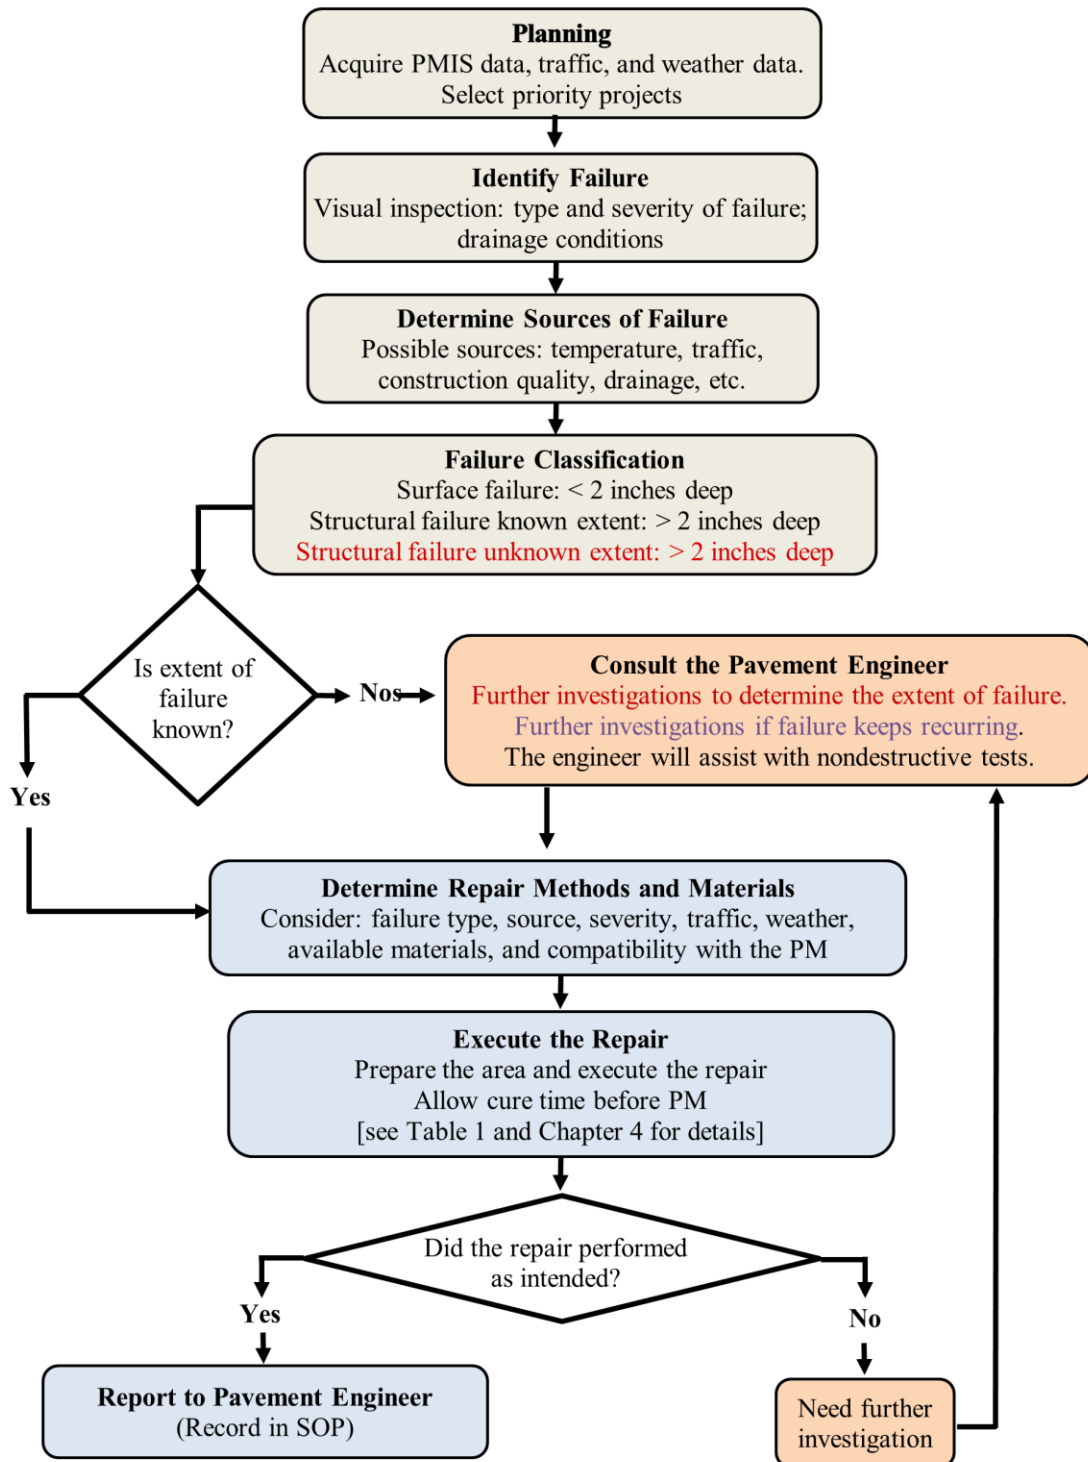
**Figure 28. Decision Flowchart Before PM.**

The flowchart shown in Figure 28 outlines the steps for effective asphalt pavement repair strategies before PM.

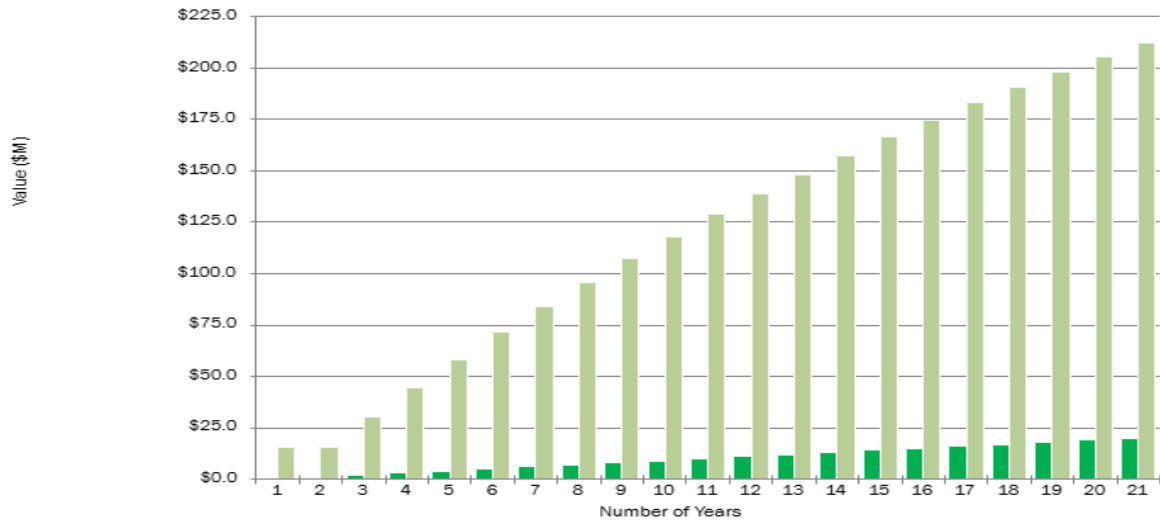
**Figure 29. VOR Over Time Expressed as NPV.**

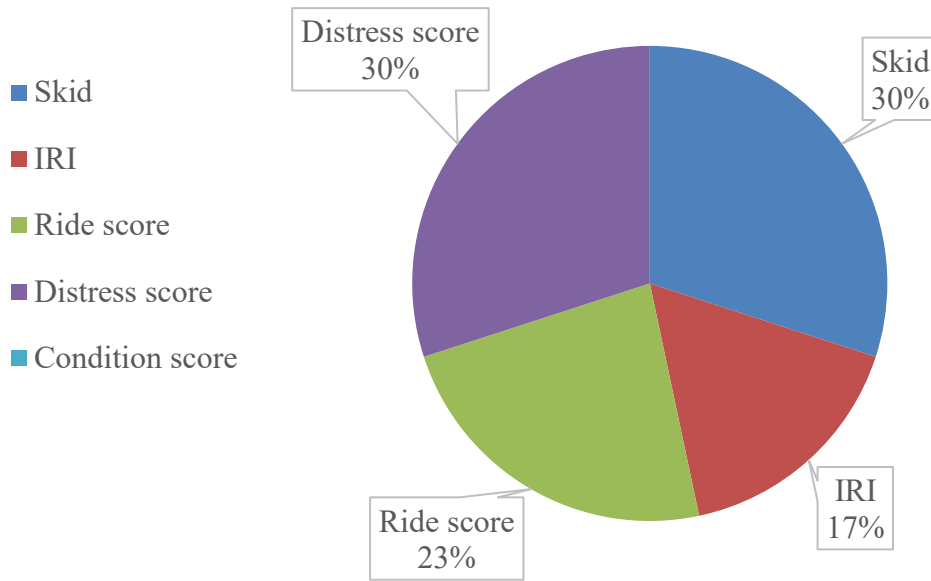
*In response to this question, 60 percent of the selections indicated skid and distress scores are always the PMSI data used to help plan repairs (see Figure A2). Ride score and IRI are also used.*

**Figure A2. PMIS/PA Data Always Used to Plan Repairs.**
