# Develop Best Practices for Flexible Pavement Repairs

Technical Report 0-7175-R1

TEXAS A&M TRANSPORTATION INSTITUTE  
COLLEGE STATION, TEXAS

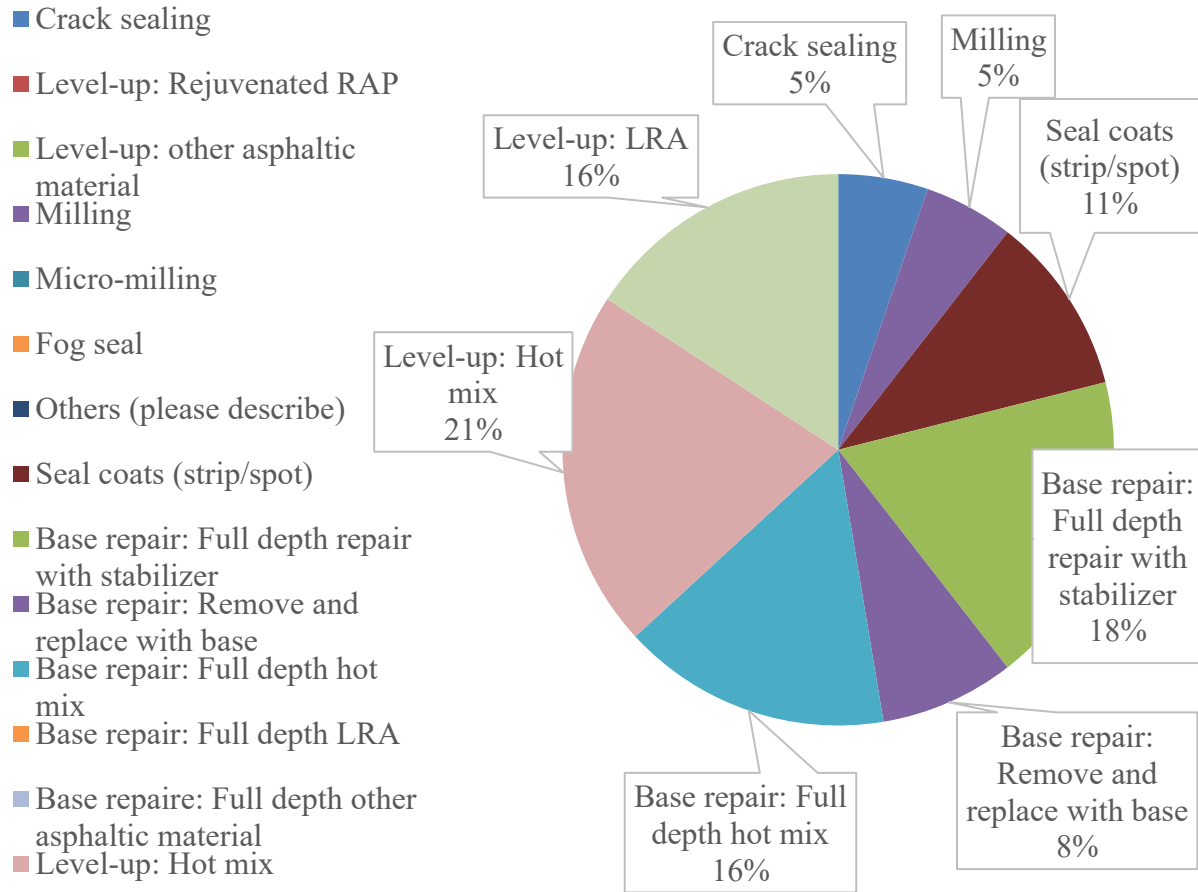
*The responses indicate that Level Up (Hot Mix and LRA) and Base Repair (Full Depth with Stabilizer and Full Depth Hot Mix) are the major FLEXIBLE PAVEMENT preparatory work types that are typically used in most represented districts in the survey (see Figure A6).*

**Figure A6. Flexible Pavement Preparation for Main Repair.**

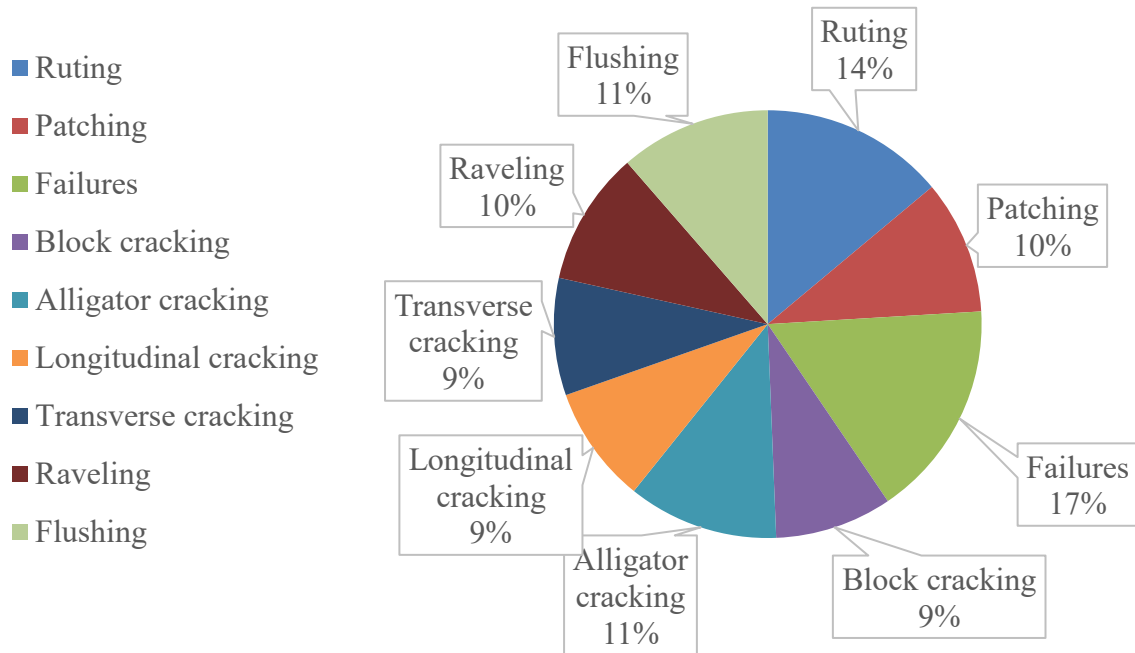
*To a certain level, the effect of any repair problem on the new seal coat is always considered, with rutting and failure being considered most of the time (14 percent and 17 percent, respectively) (Figure A10). One respondent reported never considering block-cracking effects on the new seal coat surfaces.*

**Figure A10. Respondent Considerations of Effects of Repair Problems on New Seal Coat Surface.**

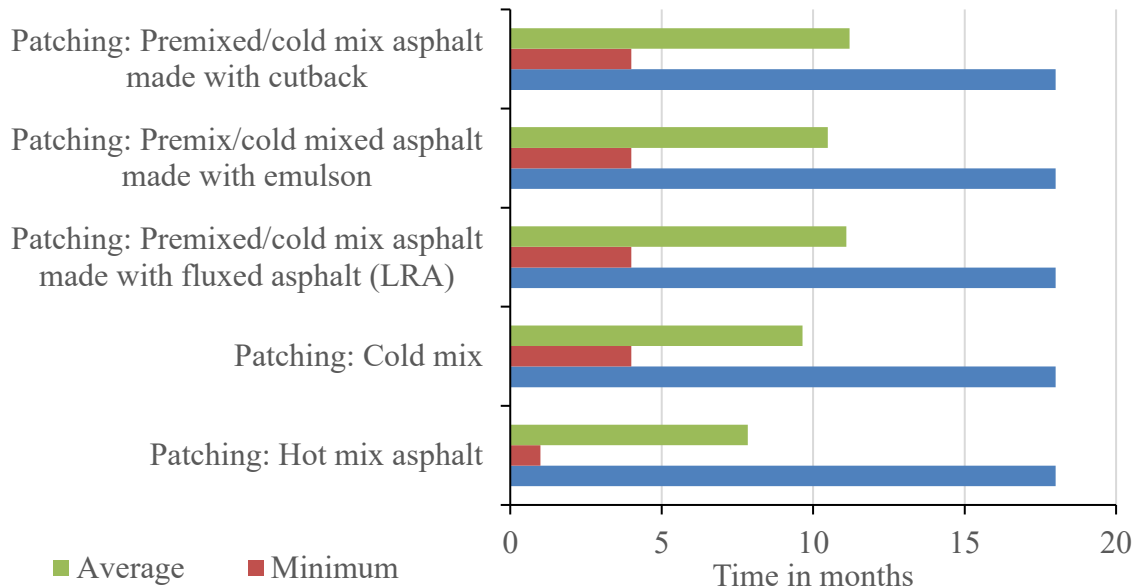
- What is the best repair timeframe to cure crack sealing before constructing the PM project?  
*All respondents suggested that the repair timeframe before the PM was considered to range from 0 to 18 months.*
- What is the best repair timeframe to cure patching material before constructing the PM project?  
*All respondents suggested that the timeframe to cure patching materials before the PM was constructed ranged from 4 to 18 months for all materials except for HMA, which could range from 1 to 18 months (Figure A11).*

**Figure A11. Timeframe to Cure Patching Material Before Constructing the PM Project Surface.**

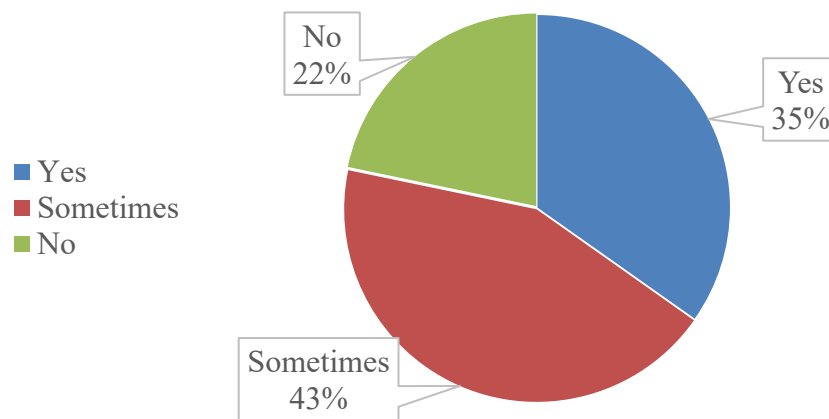
About 80 percent of responses indicate that fog seal is typically applied to repairs before constructing the PM project (Figure A14).

**Figure A14. Fog Seal Application on Repairs.**
