Structural Steel Coatings for Corrosion Mitigation

**NUTC
R233
R238**

Prepared for
Missouri Department of Transportation
Organizational Results

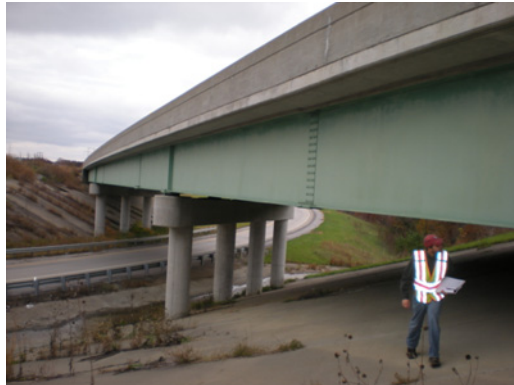
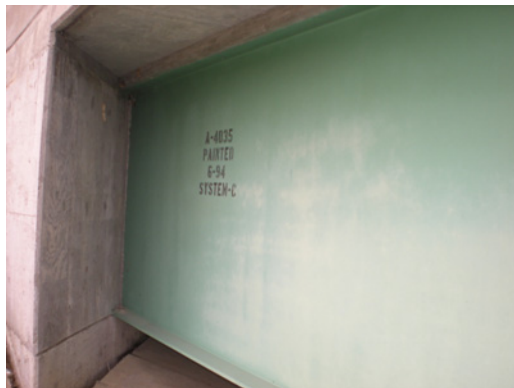
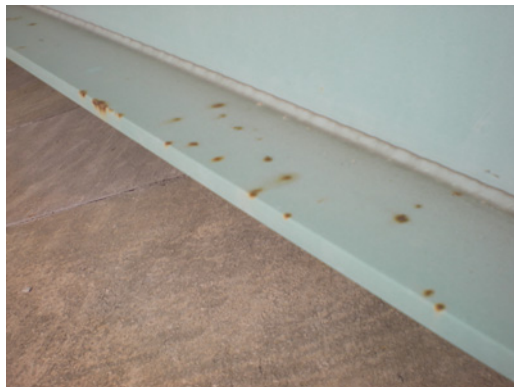
However, rating of the beam-ends as suggested here does adapt the philosophy that the worst beam-end condition should be reported. Based on the field survey, multi-span simply supported structures frequently have common condition characteristics at the beam ends. In some cases these beam ends may have very different conditions, if, for example, the drainage on the bridge is such that one beam end is exposed to very little run-off from the deck while another beam end is exposed to significant run-off from

the deck. In such a case, one beam-end may have a general condition of “good” while the other has a general condition of “poor.” In such cases, inspector may assign a condition rating of “Fair.” We feel that the appropriate rating for the condition is “poor,” and as such have included the direction that the worst beam-end be reported, such that the rating suggests accurately the need for maintenance painting (overcoating) to improve corrosion protection at the bearing area, where section loss is a typical, though sometimes localized to the beam end, damage mode.

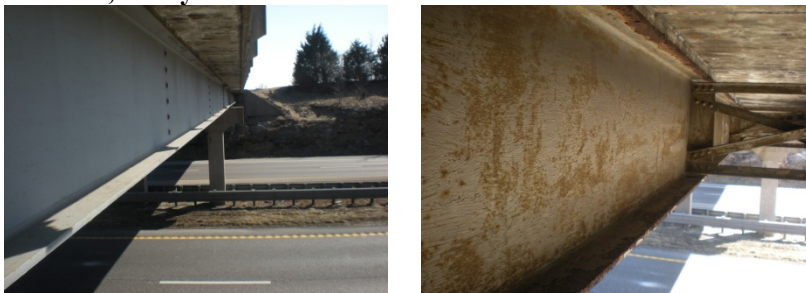
SYSTEM S					
Coating less than 5 years					
Bridge Number	Paint Year	TMS Condition	End- Span Field Rating	Mid-Span Field Rating	Overall Field Rating
A0048	2006	Good	Fair	Good	Fair
A0095	2006	Good	Good	Good	Good
A0491	2006	Good	Very Poor	Very Poor	Very Poor
A0491: Facia girders were in good condition, mid- span was in very poor condition, partially recoated, old system is not available.

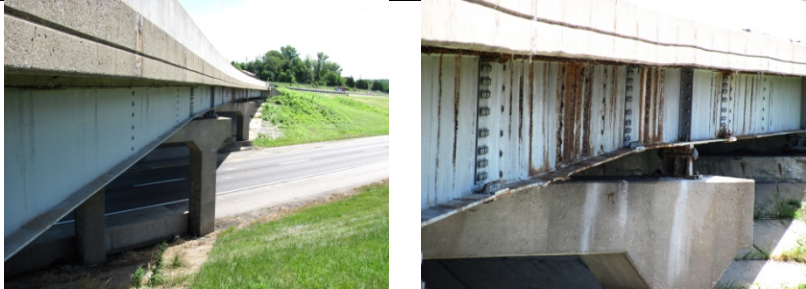
A0557	2006	Good	Fair	Poor	Poor
A1256	2006	Fair	Fair	Fair	Fair
G0519	2006	Good	Fair	Good	Fair
L0928	2006	Good	Poor	Poor	Poor
L0928: One end of the facia girder was in good condition, the other end was in very poor condition. Partially recoated.

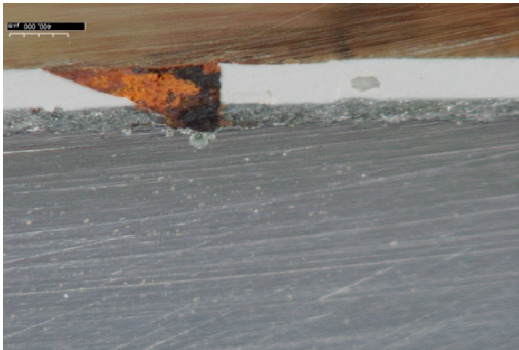
easy peeling of the primer from the substrate. The epoxy primer was not effective and durable in the salt induced corrosion environment. The primer for system A1-01 provided cathodic / sacrificial protection to the bare steel even over 3000 hr salt fog test. The corrosion was limited within an area shown in the image (see Fig. 5.8) by synergic action of micaceous iron oxide and zinc. Systems N1-0# did not perform as well as system A1-01. The rust creepage developed underneath the primer within a limited range. The zinc primers for systems N1-0# were not sacrificial enough. System G performed very well as expected. Observed for system A1-01, the inorganic zinc primer of system G acted as a cathode to protect the steel substrate from corrosion. Systems I1-0# used urethane primers. They did not perform very well in salt fog test. The rust creepage grew fast underneath the coating systems.

System A1-01 1500-hr & 3000-hr interface characterizations

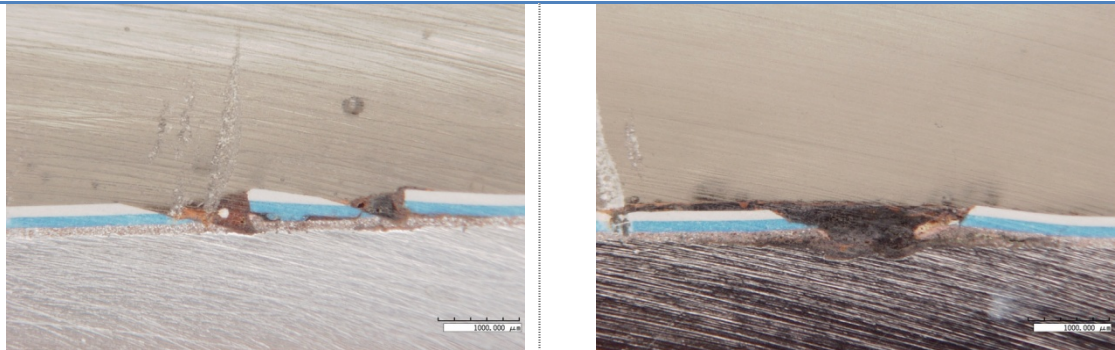
System N1-01 1500-hr & 3000-hr interface characterizations

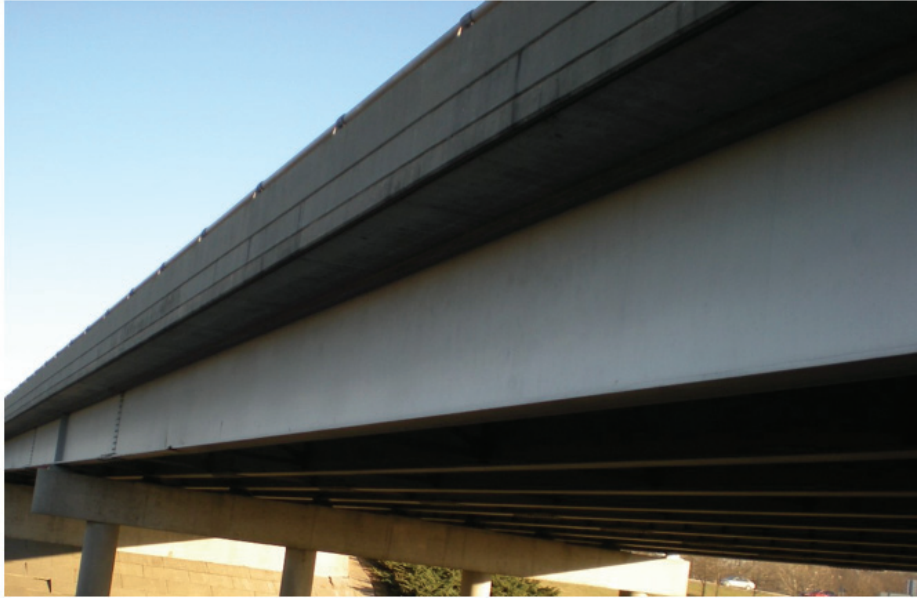
Description: Perfect, new condition. The coating is a new coating system with very little or no damage. This condition correlates to the SSPC rating 10, less than 0.01 % rust and SSPC-9 (Greater than 0.01 up to 0.03%).

Very Good Condition – Facia Girder Mid-Span

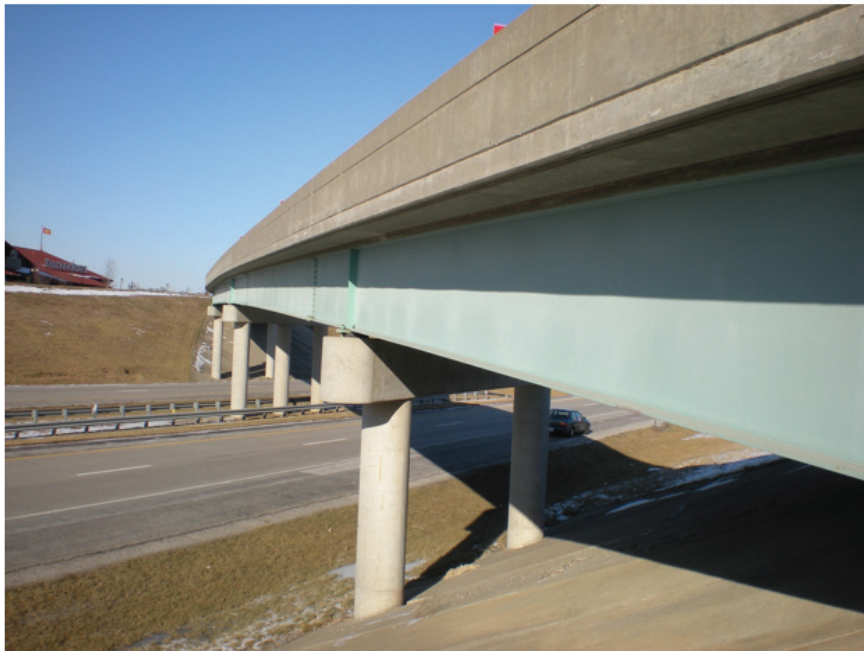
Very Good Condition – Facia Girder Mid-Span

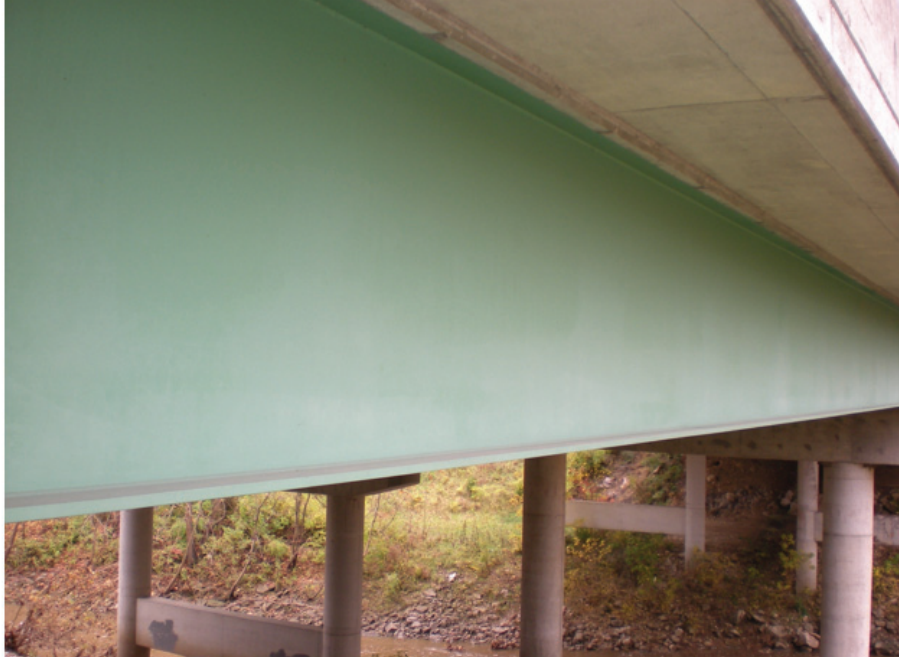
Very Good Condition – Facia Girder Mid-Span

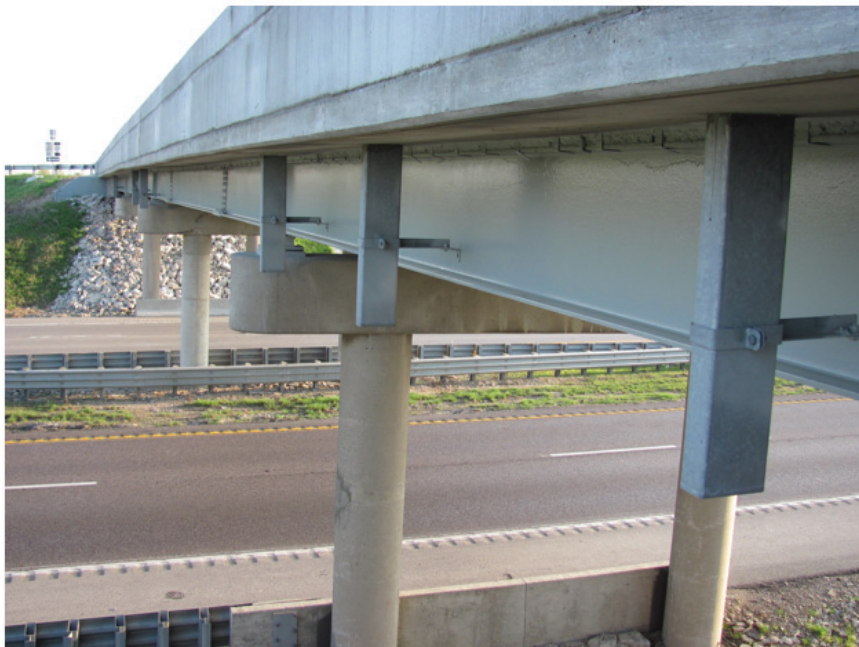
Very Good Condition – Facia Girder Mid-Span

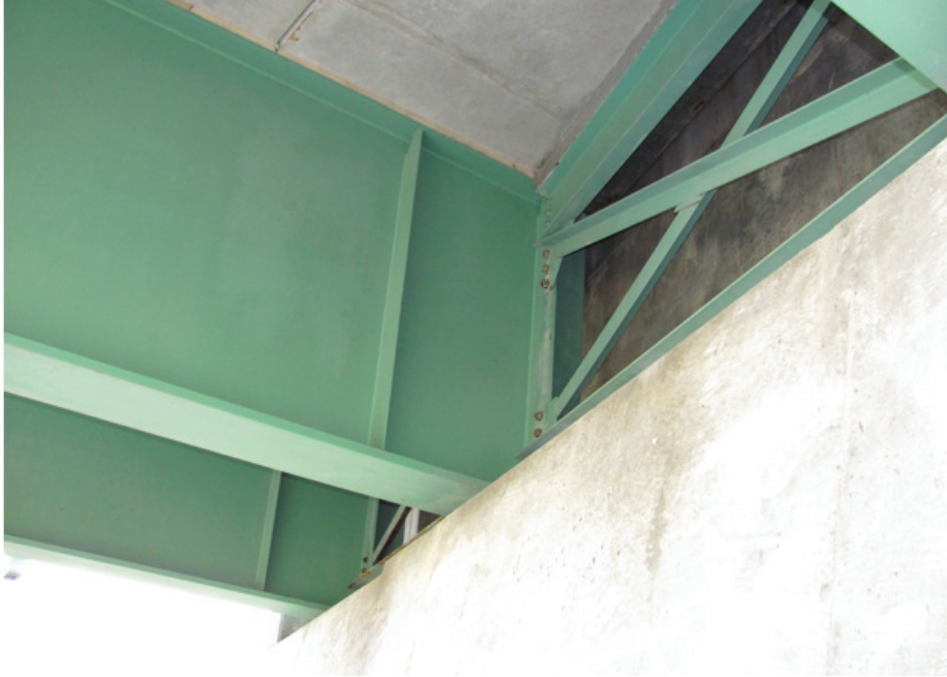
Very Good Condition – Interior Beam End-Span

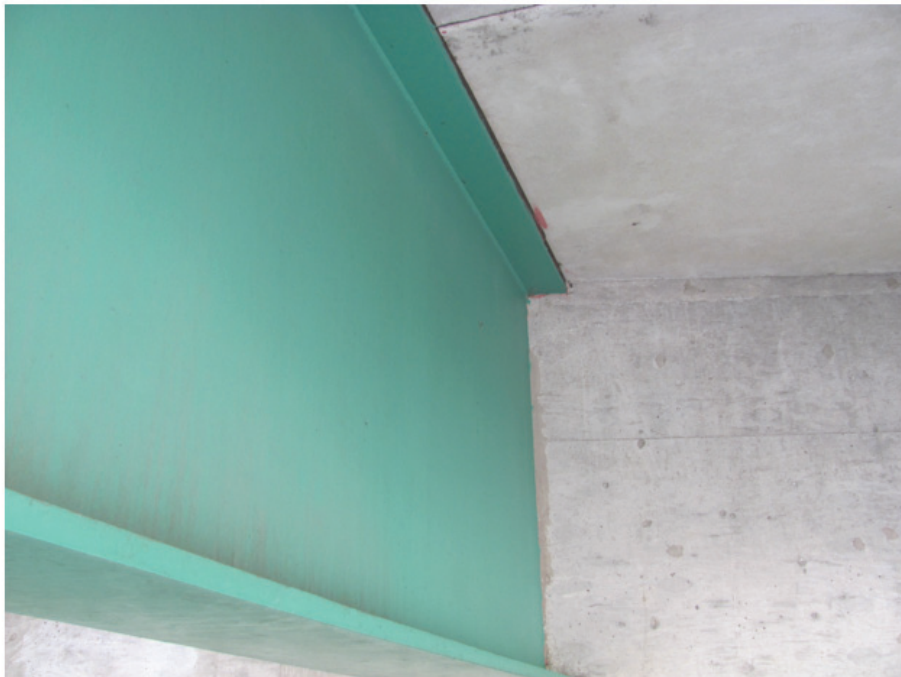
Very Good Condition – Interior Beam End-Span

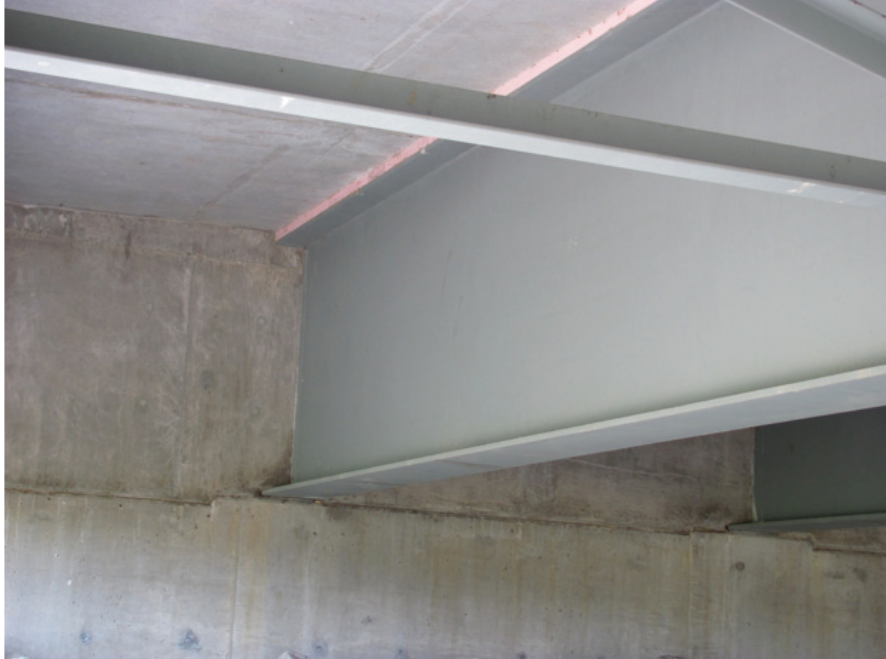
Very Good Condition – Interior Beam End-Span

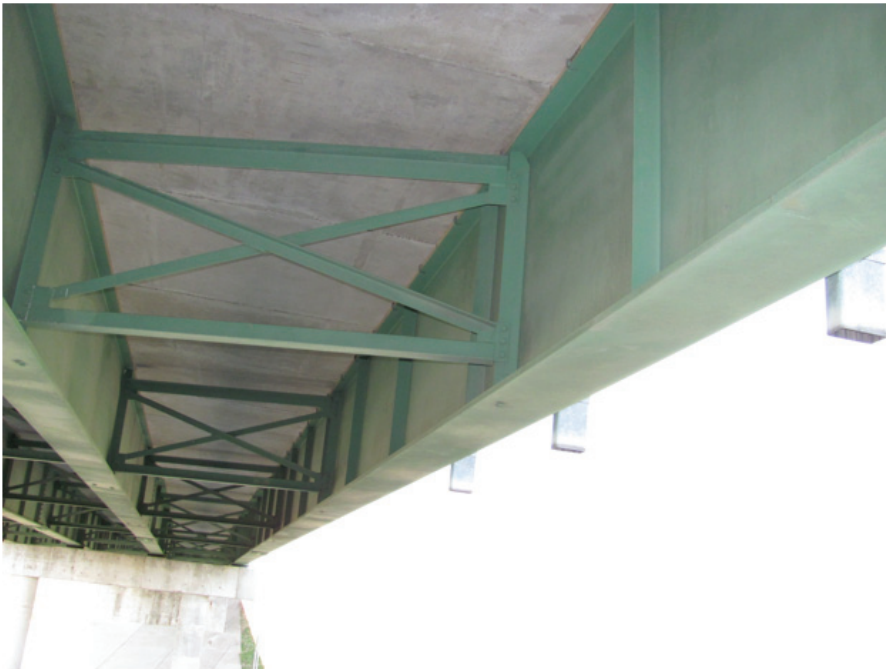
Very Good Condition – Interior Beam Mid-Span

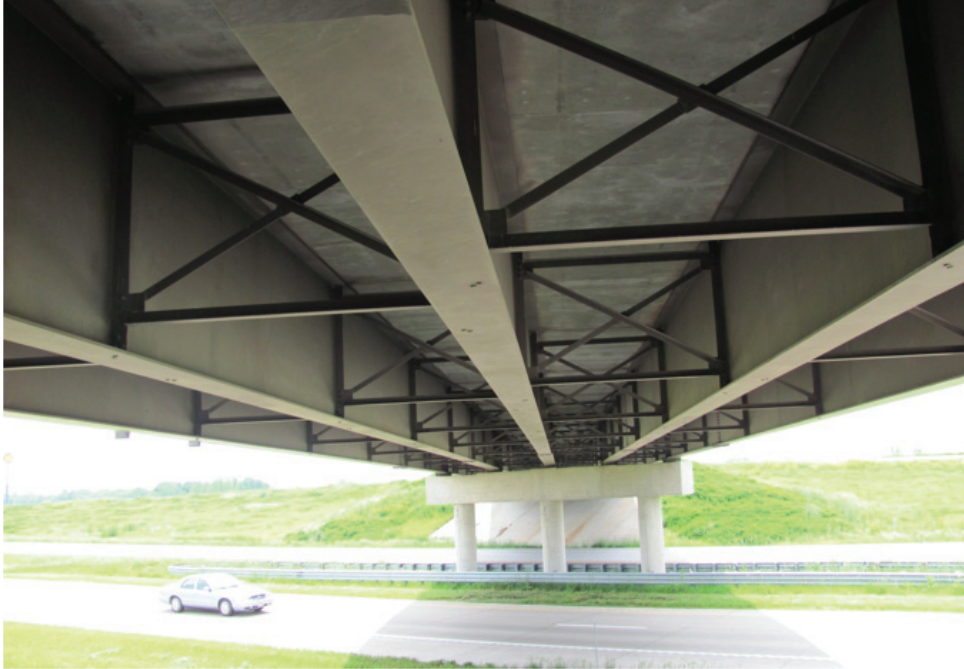
Very Good Condition – Interior Beam Mid-Span

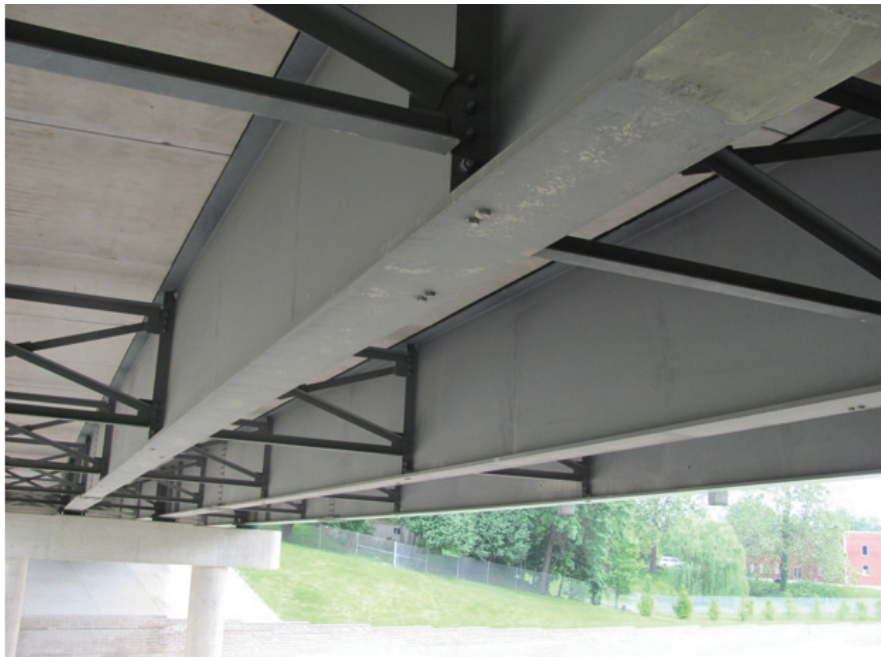
Very Good Condition – Interior Beam Mid-Span

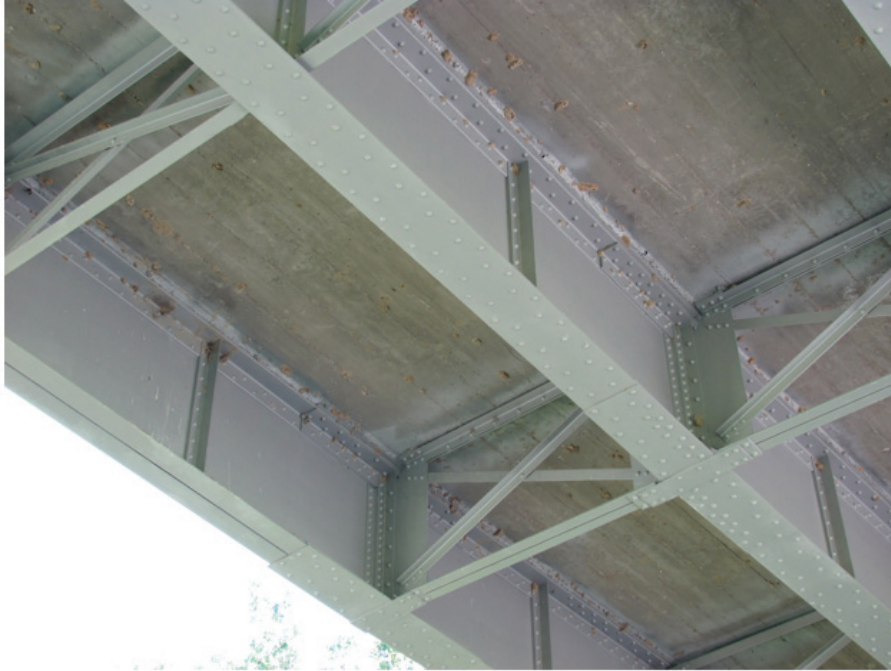
Very Good Condition – Interior Beam Mid-Span

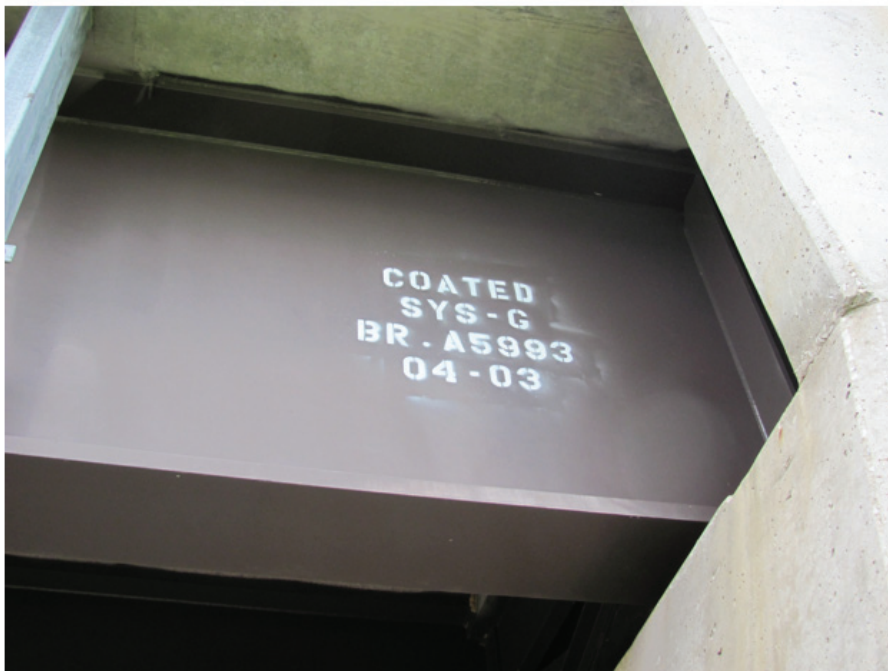
Very Good Condition – Exterior Beam End-Span

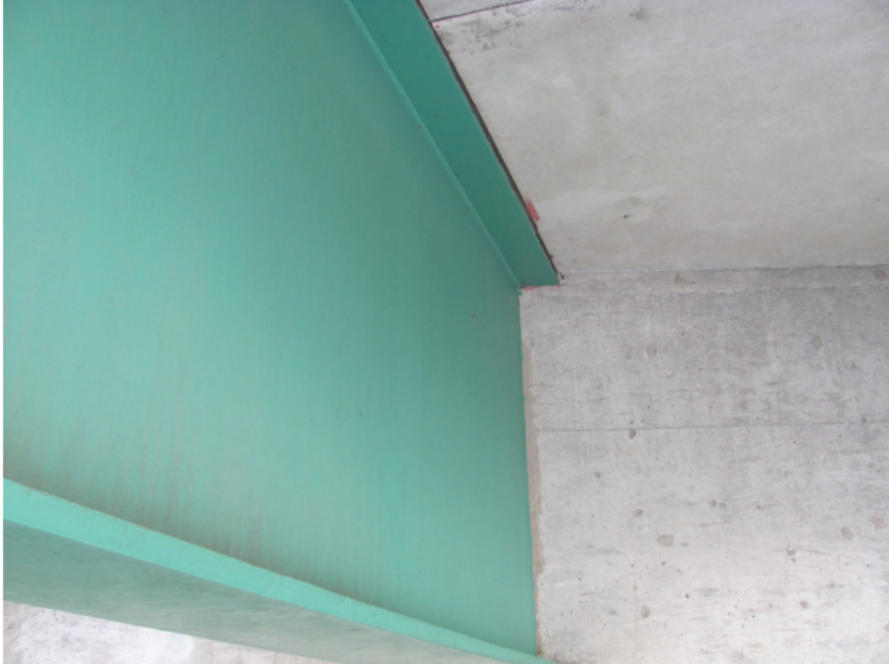
Very Good Condition – Exterior Beam End-Span

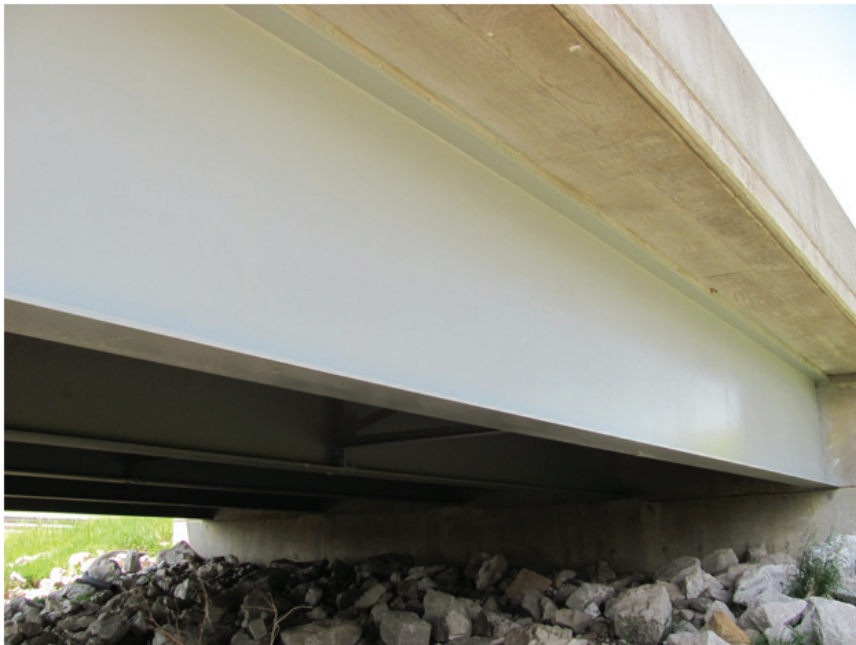
Very Good Condition – Exterior Beam End-Span

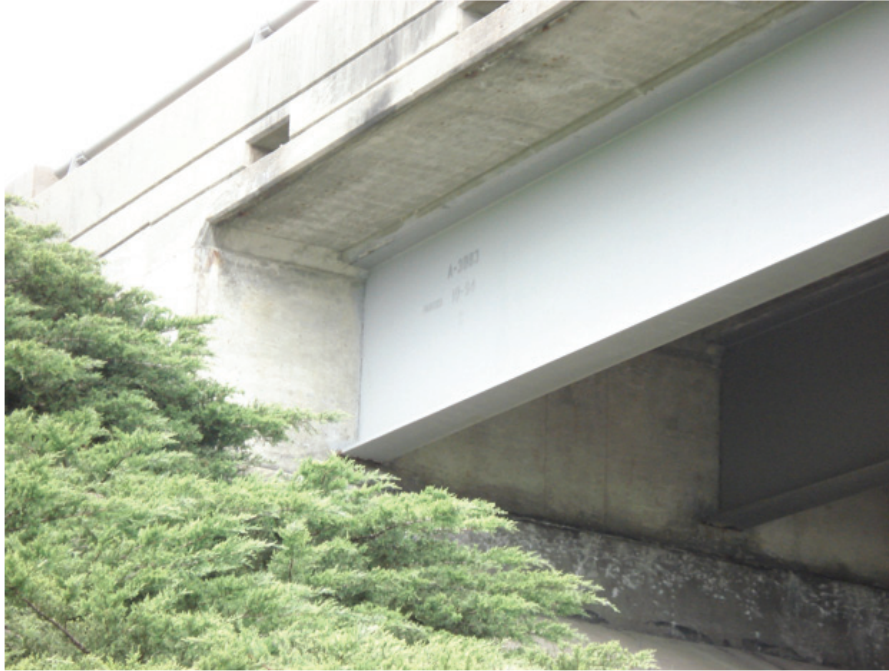
Very Good Condition – Exterior Beam End-Span

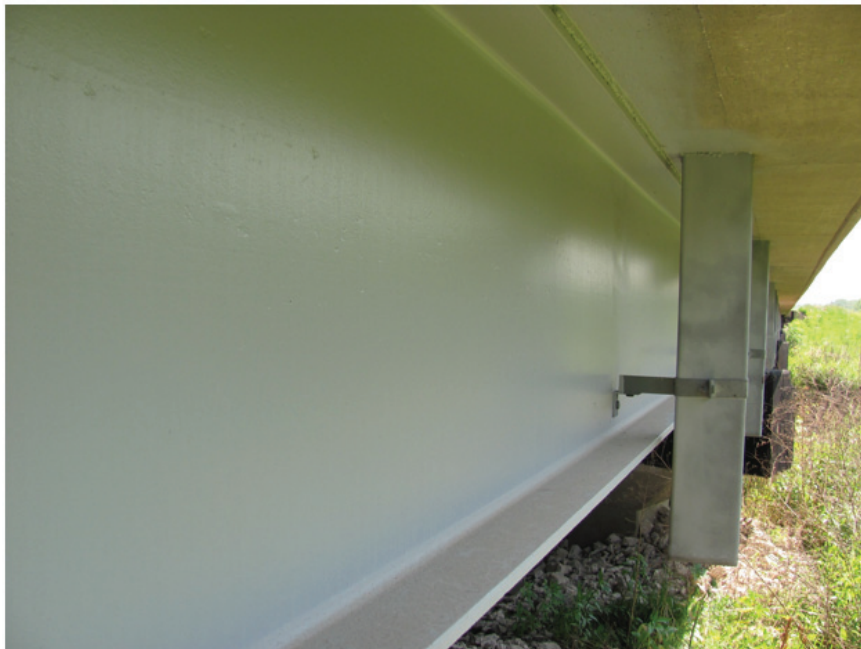
Very Good Condition – Close-up

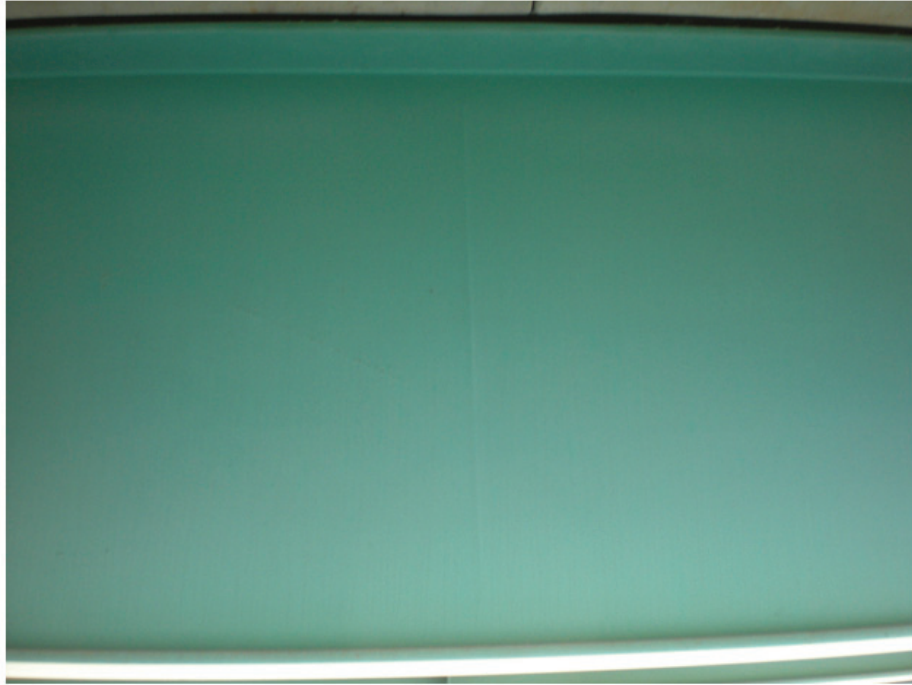
Very Good Condition – Close-up

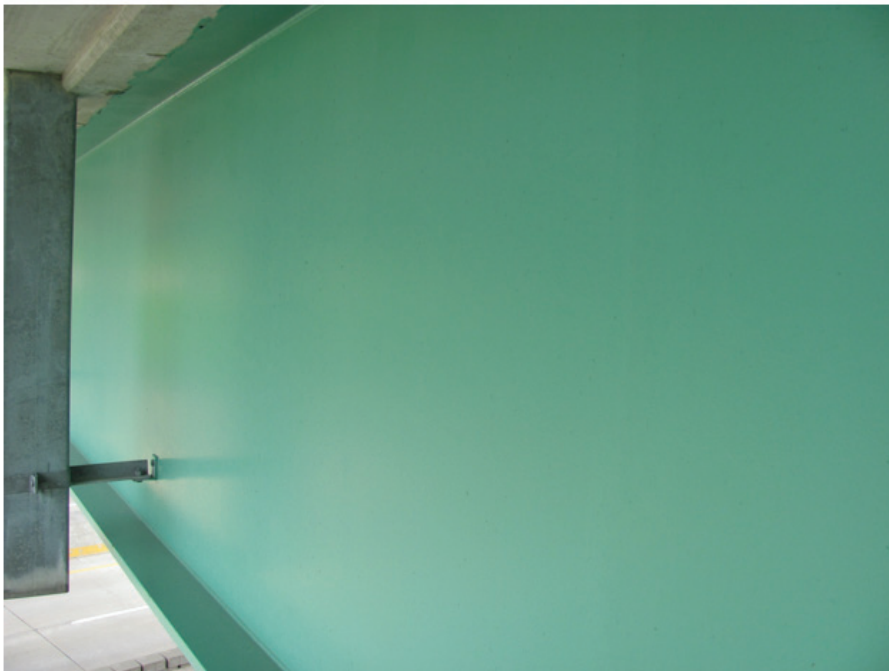
Very Good Condition – Close-up

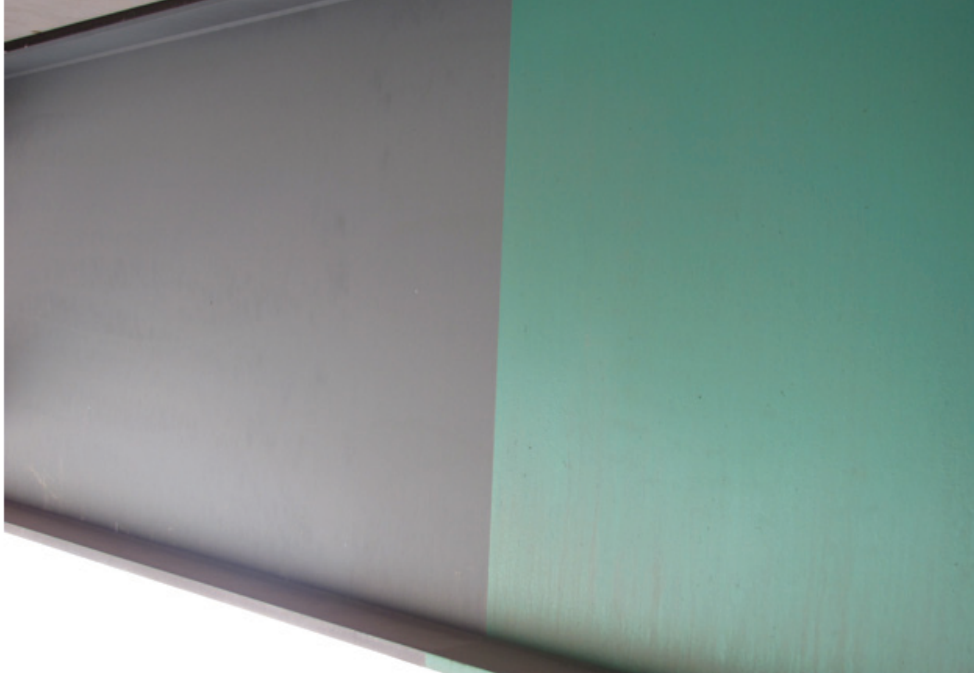
Very Good Condition – Close-up

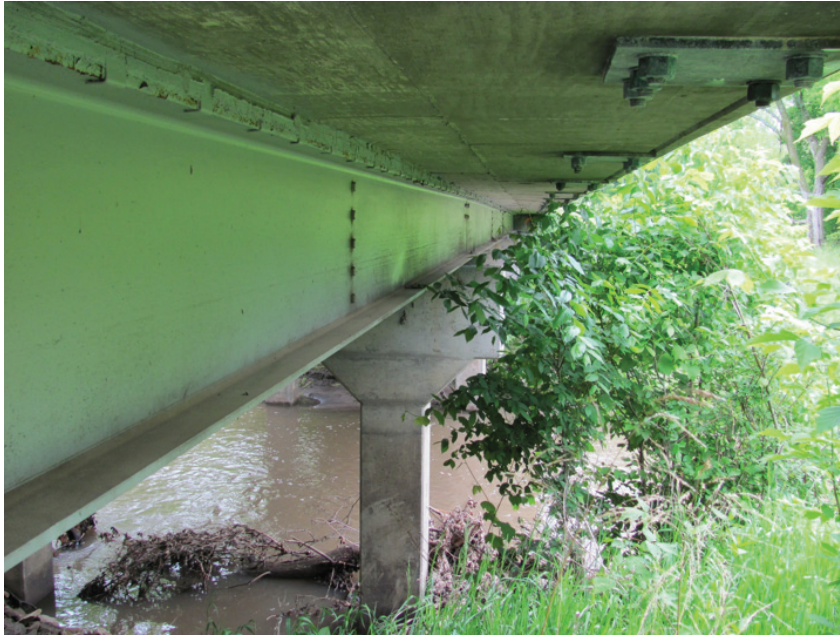
Some very minor corrosion: The coating system is in good condition, with little overall corrosion/rust corresponding to SSPC 8 (greater than 0.03 and up to 0.1 %).

Good Condition – Facia Girder Mid-Span

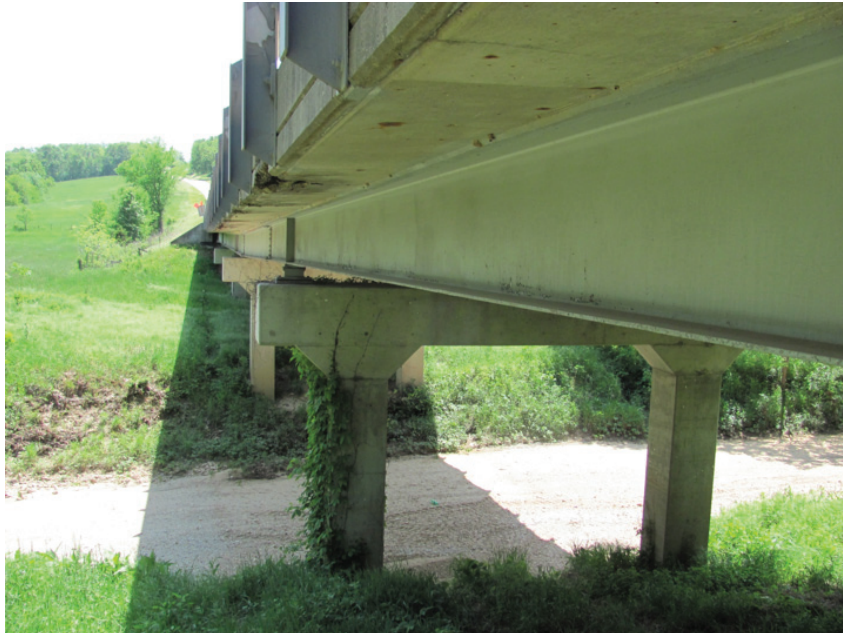
Good Condition – Facia Girder Mid-Span

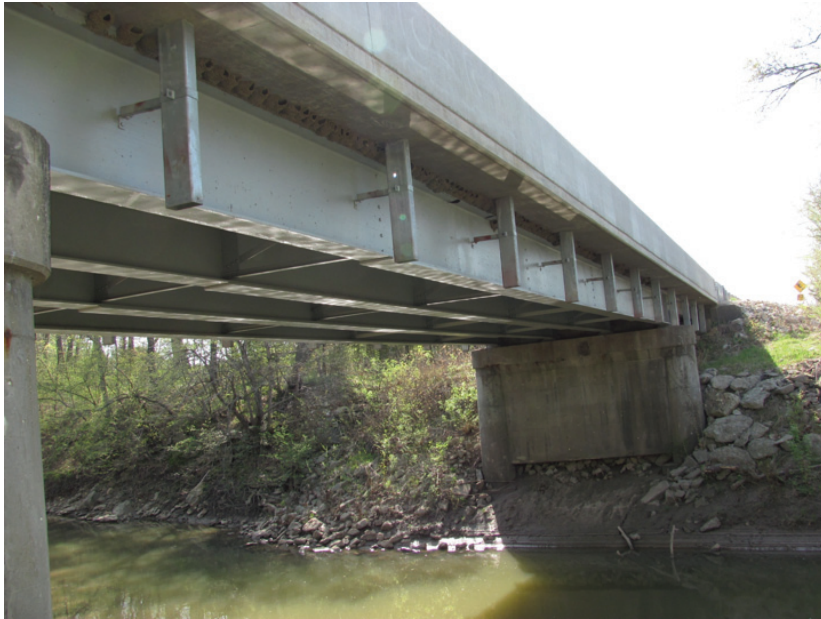
Good Condition – Facia Girder Mid-Span

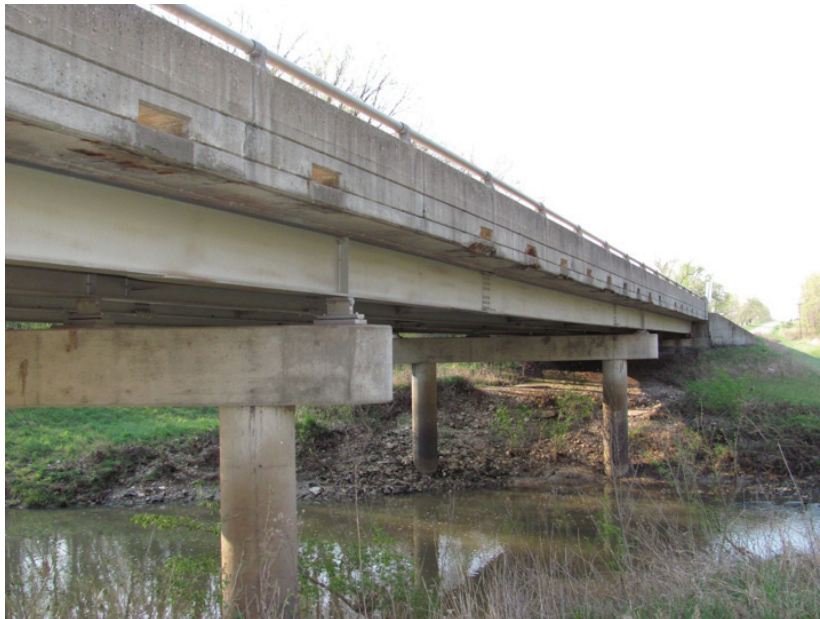
Good Condition – Facia Girder Mid-Span

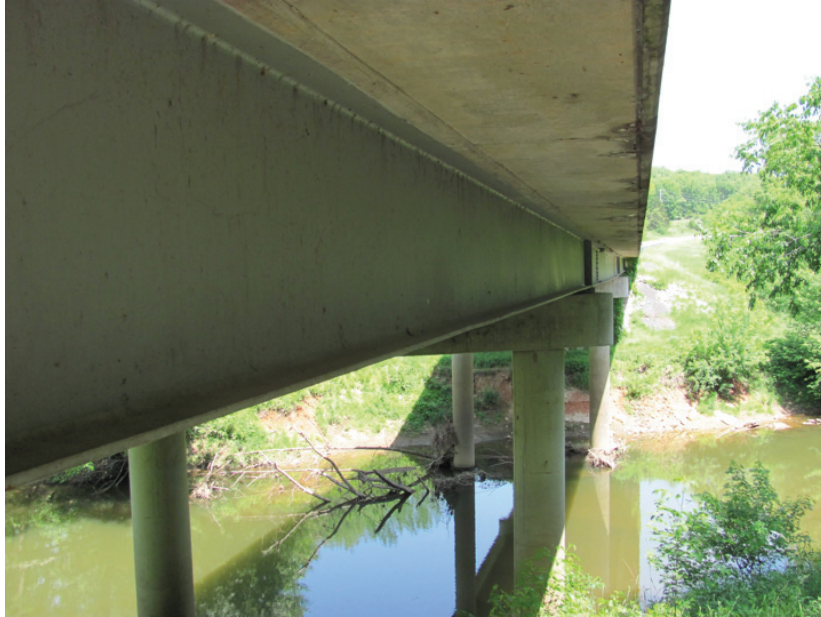
Good Condition – Facia Girder Mid-Span

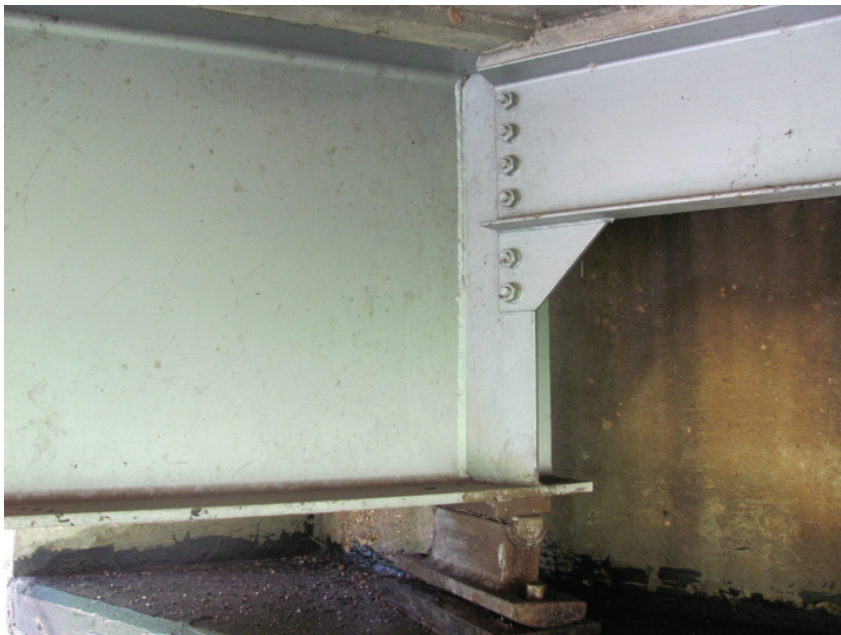
Good Condition – Interior Beam End-Span

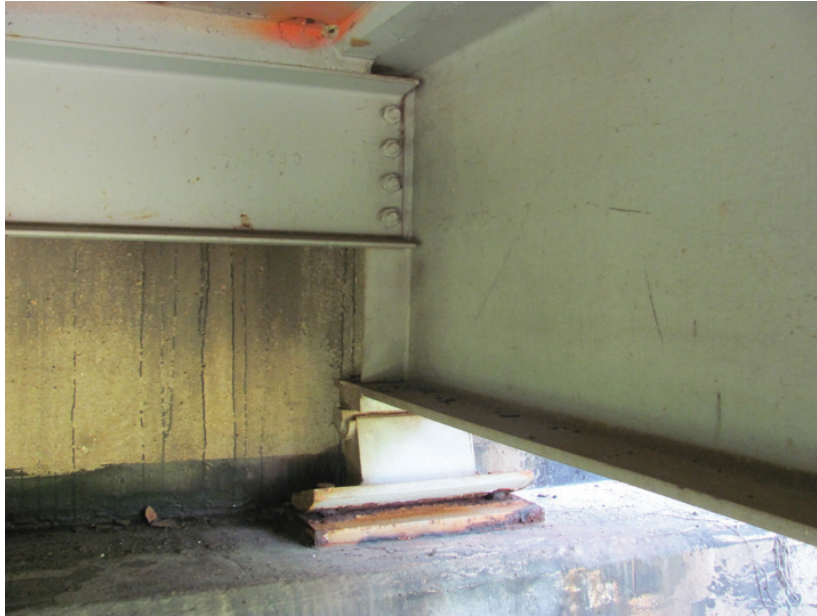
Good Condition – Interior Beam End-Span

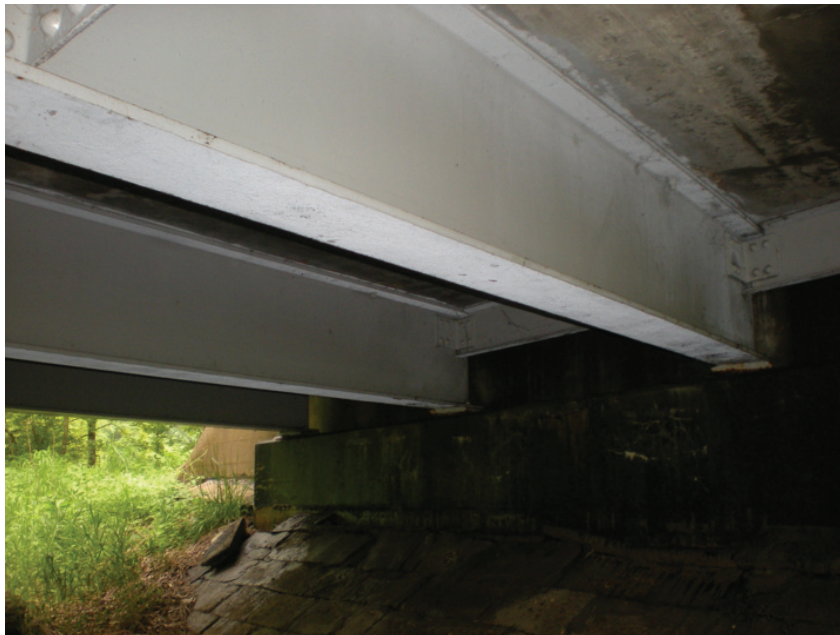
Good Condition – Interior Beam End-Span

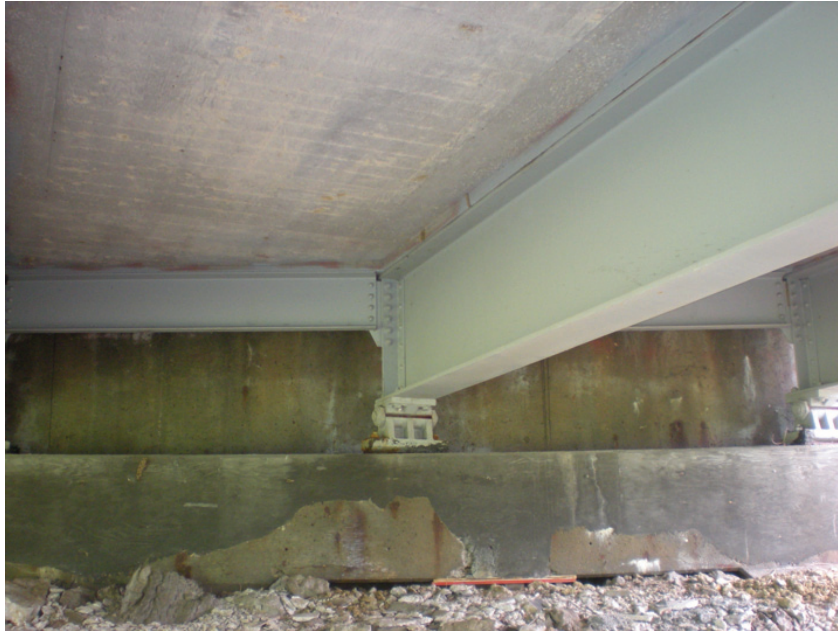
Good Condition – Interior Beam End-Span

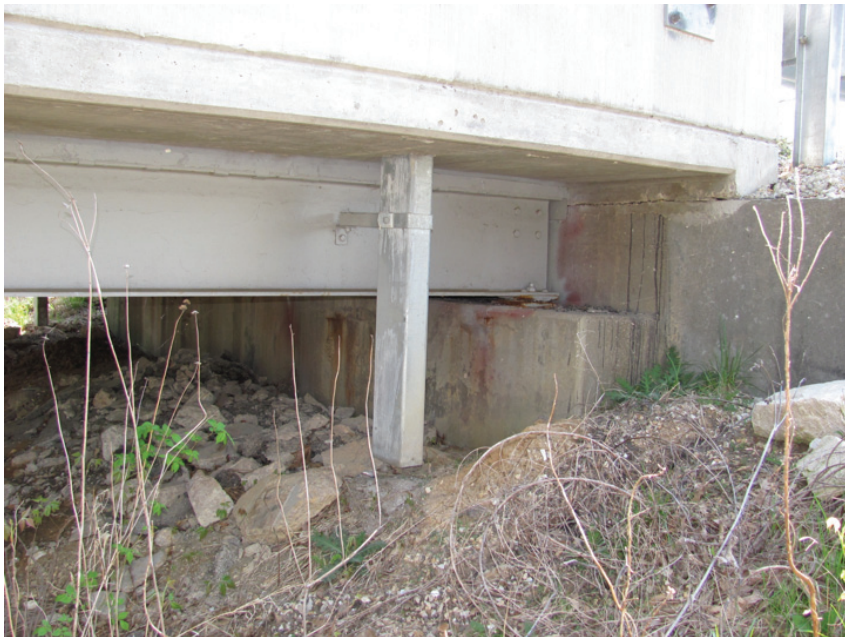
Good Condition – Exterior Beam End-Span

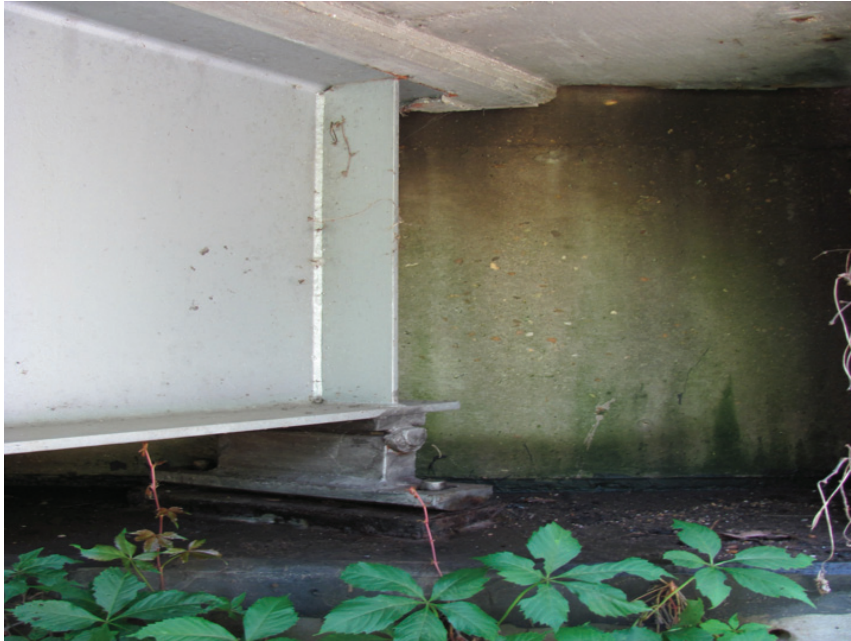
Good Condition – Exterior Beam End-Span

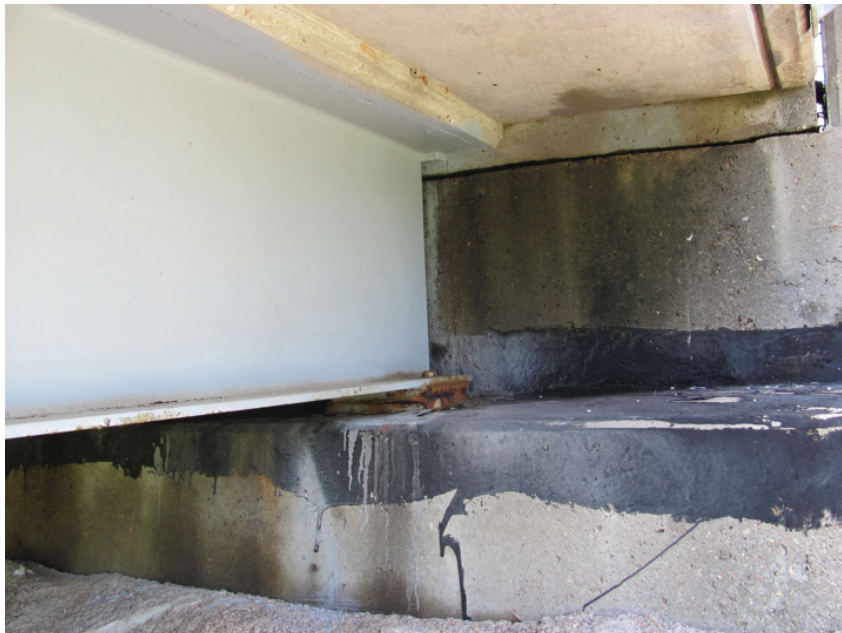
Good Condition – Exterior Beam End-Span

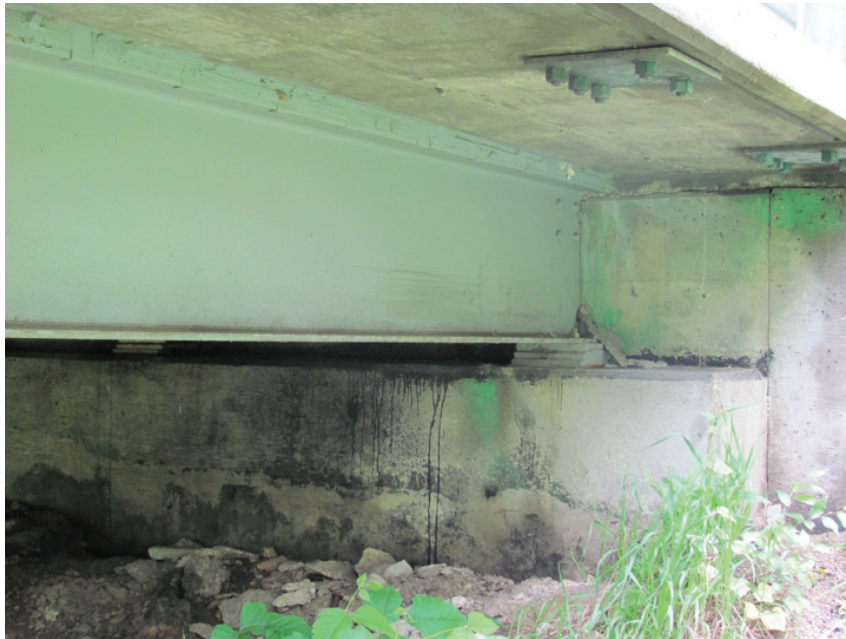
Good Condition – Exterior Beam End-Span

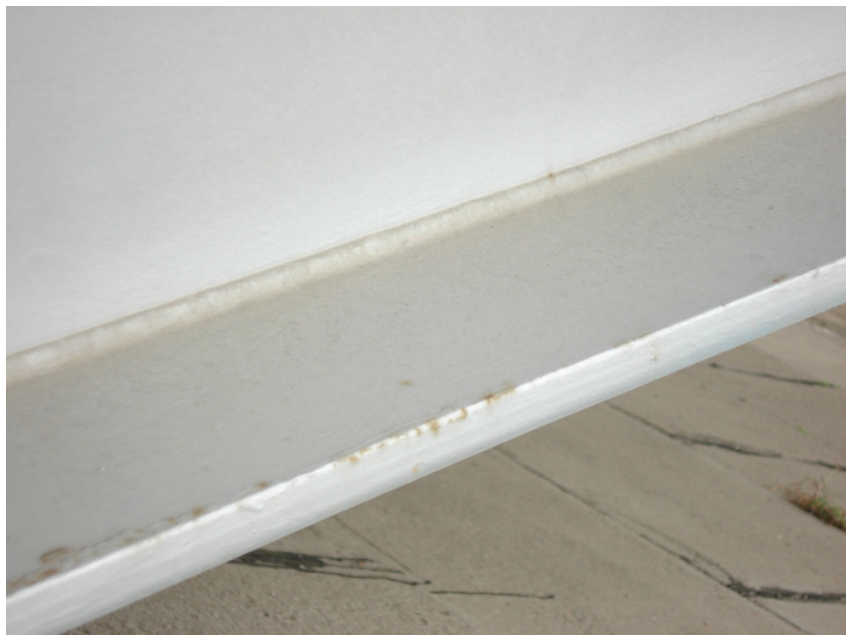
Good Condition – Close-up

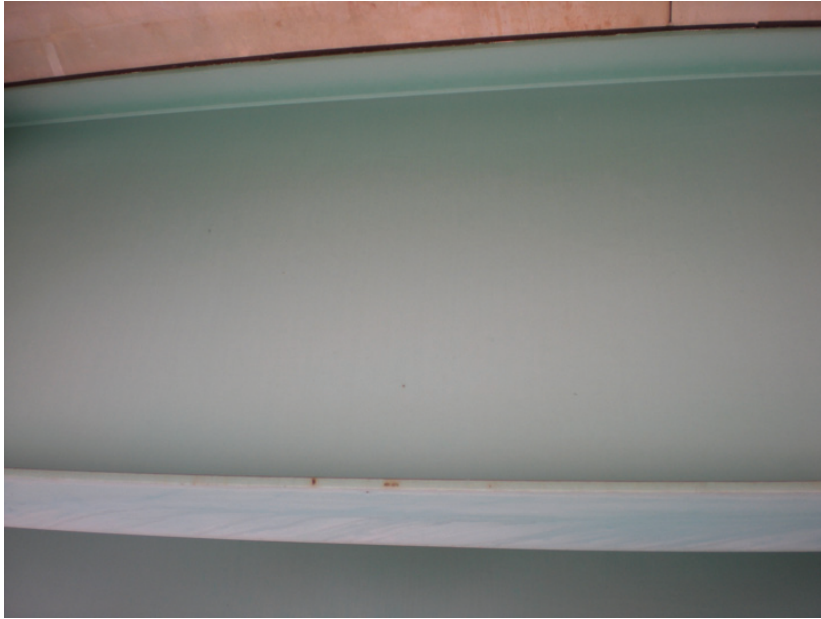
Good Condition – Close-up

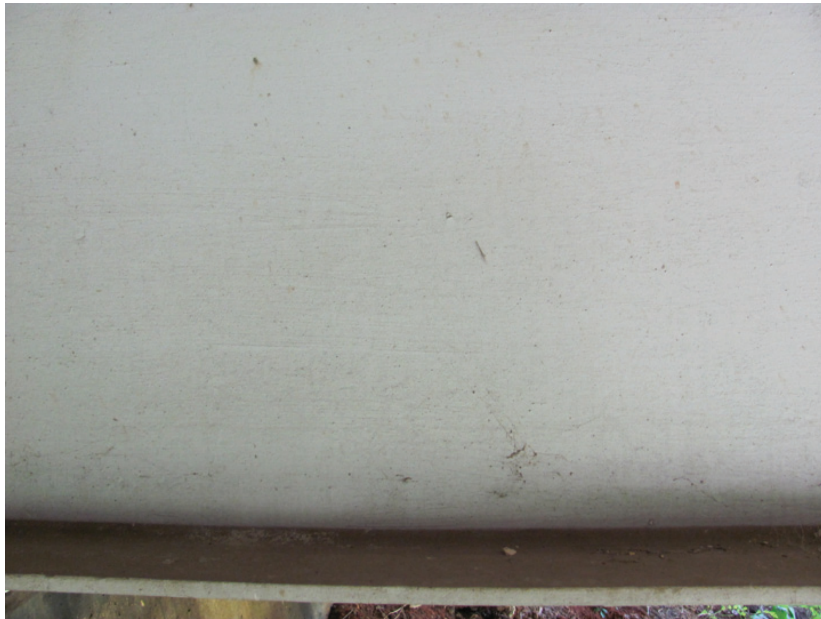
Good Condition – Close-up

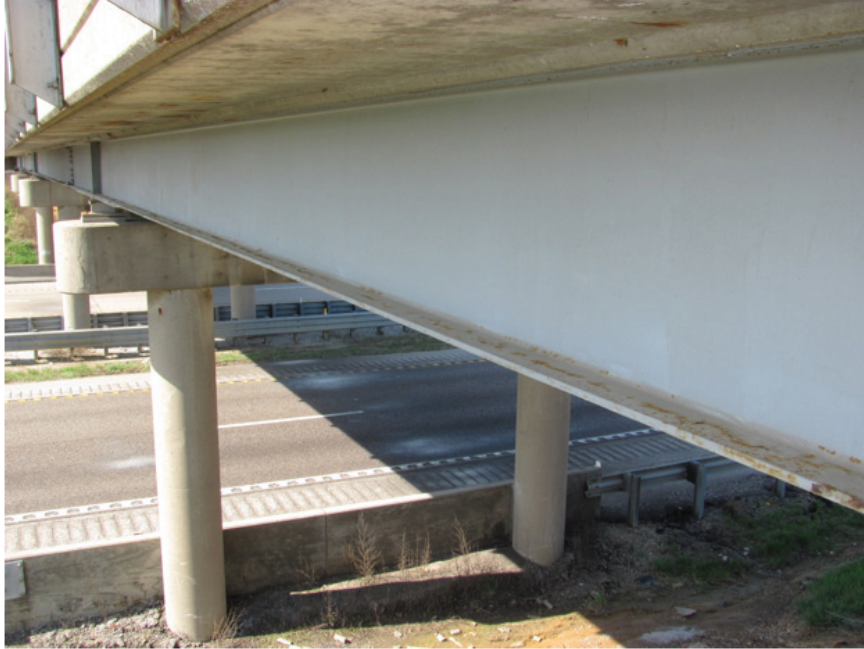
The coating has observable damage corresponding to SSPC-7 (greater than 0.1 and up to 0.3 %) to SSPC-6 (Greater than 0.3% up to 1%).

Fair Condition – Facia Girder Mid-Span
