Structural Steel Coatings for Corrosion Mitigation

**NUTC
R233
R238**

Prepared for
Missouri Department of Transportation
Organizational Results

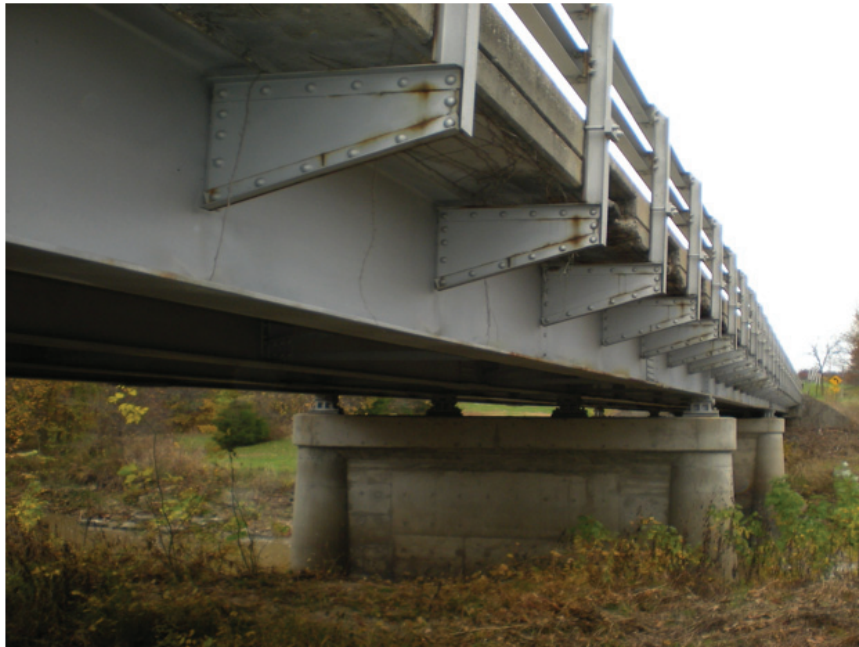
Fair Condition – Facia Girder Mid-Span

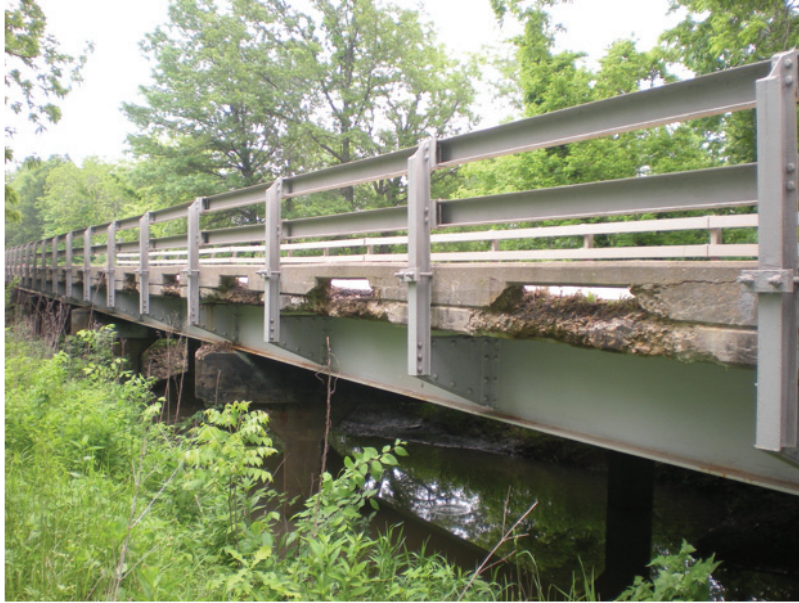
Fair Condition – Fascia Girder Mid-Span

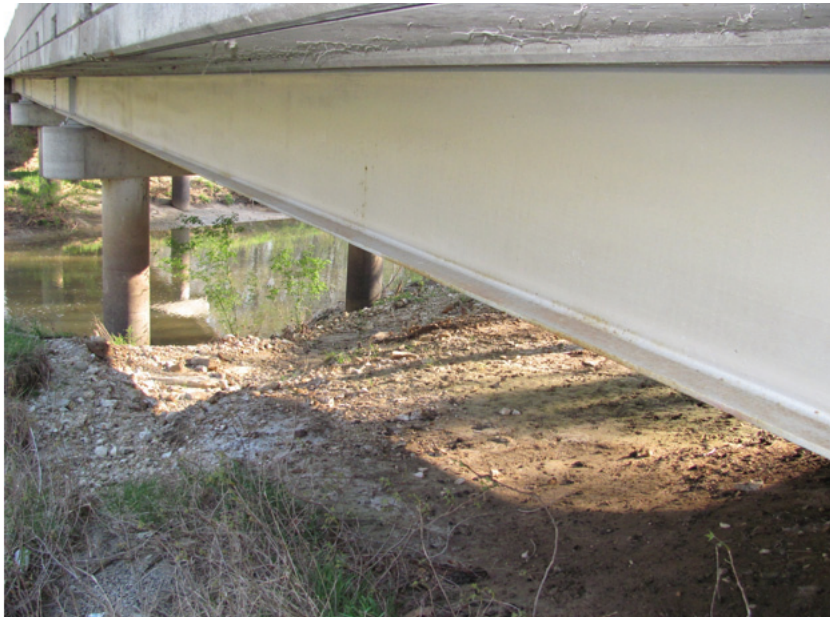
Fair Condition – Fascia Girder Mid-Span

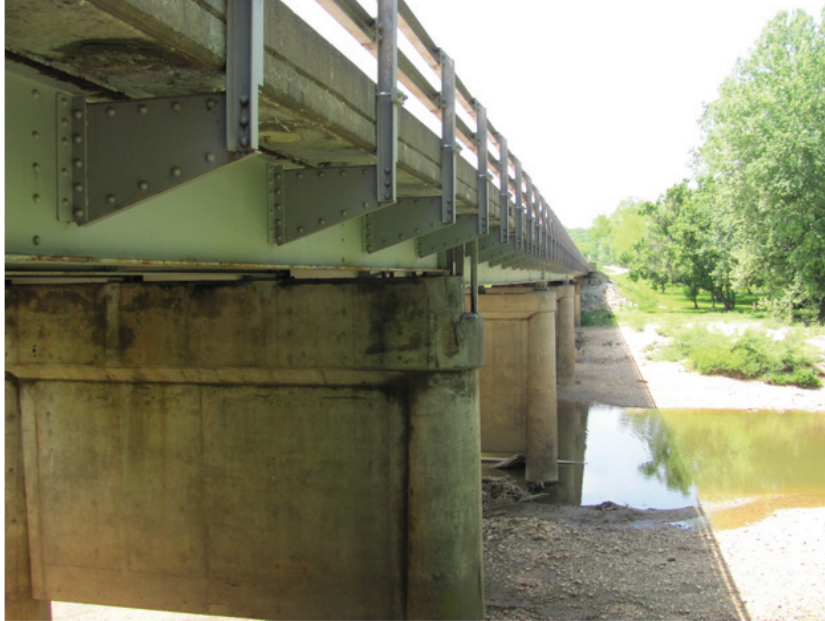
Fair Condition – Fascia Girder Mid-Span

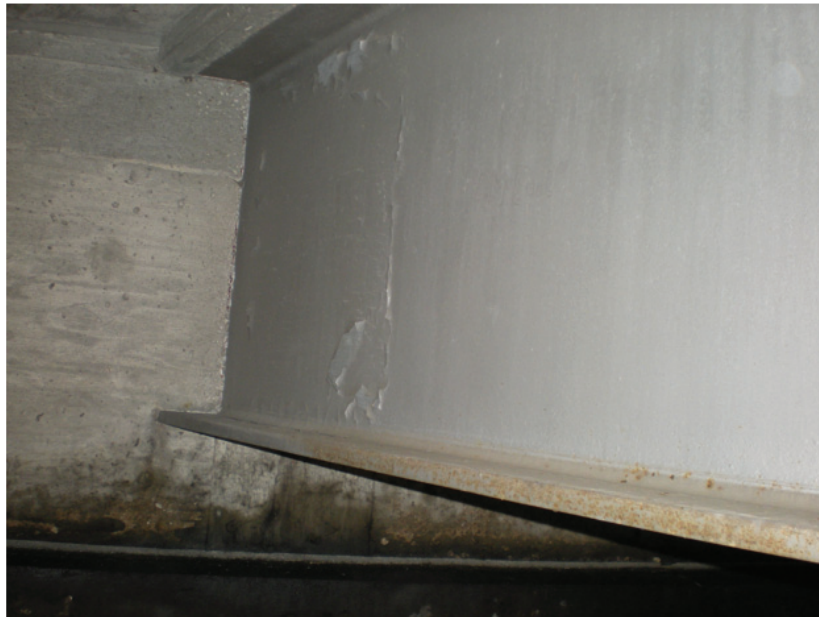
Fair Condition – Interior Beam End-Span

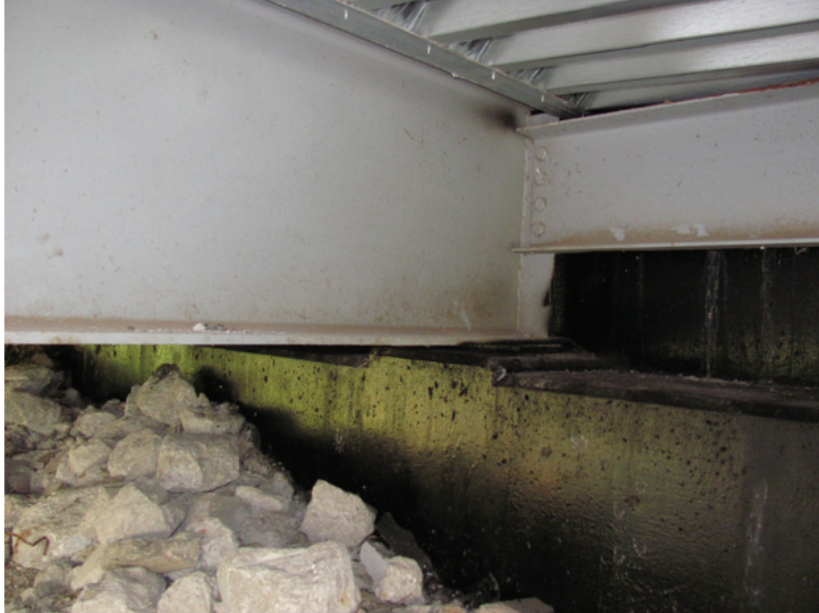
Fair Condition – Interior Beam End-Span

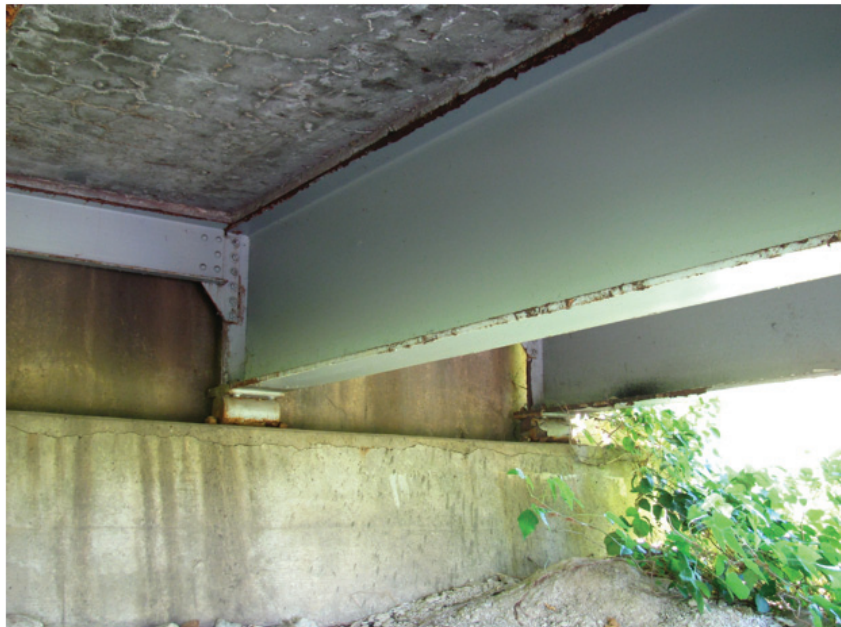
Fair Condition – Interior Beam End-Span

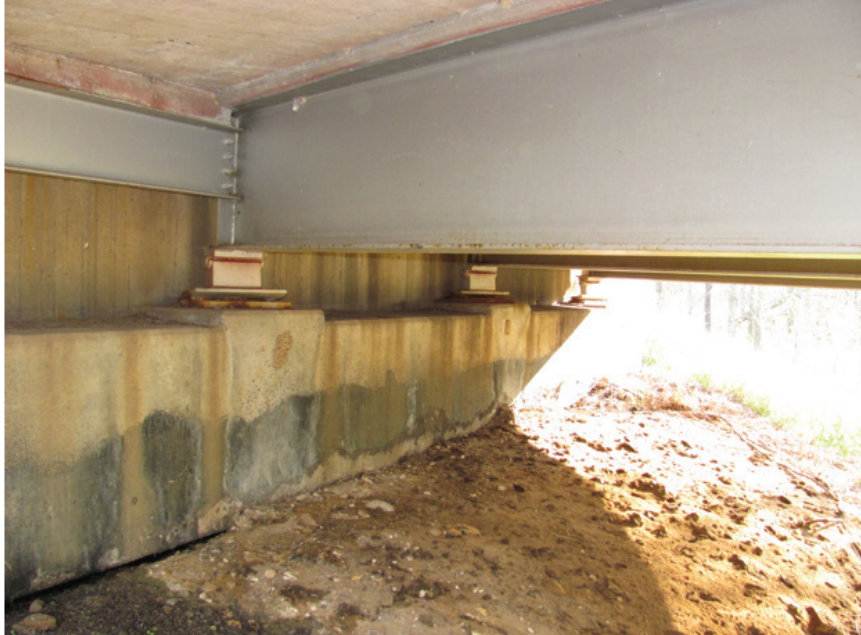
Fair Condition – Interior Beam End-Span

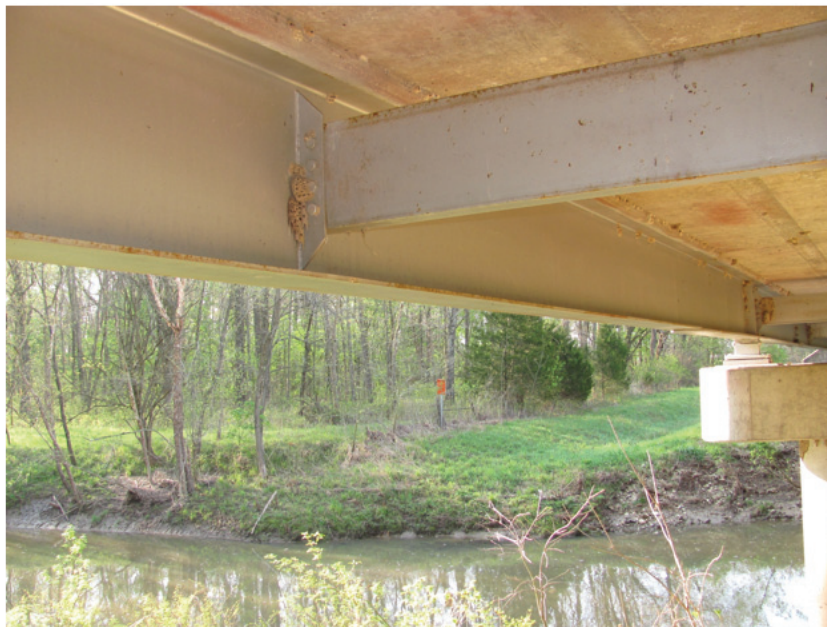
Fair Condition – Interior Beam Mid-Span

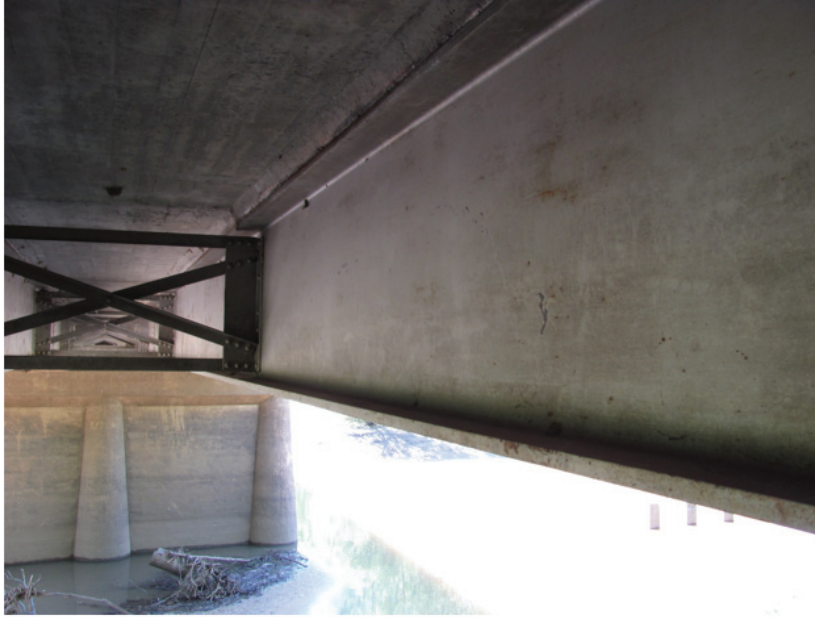
Fair Condition – Interior Beam Mid-Span

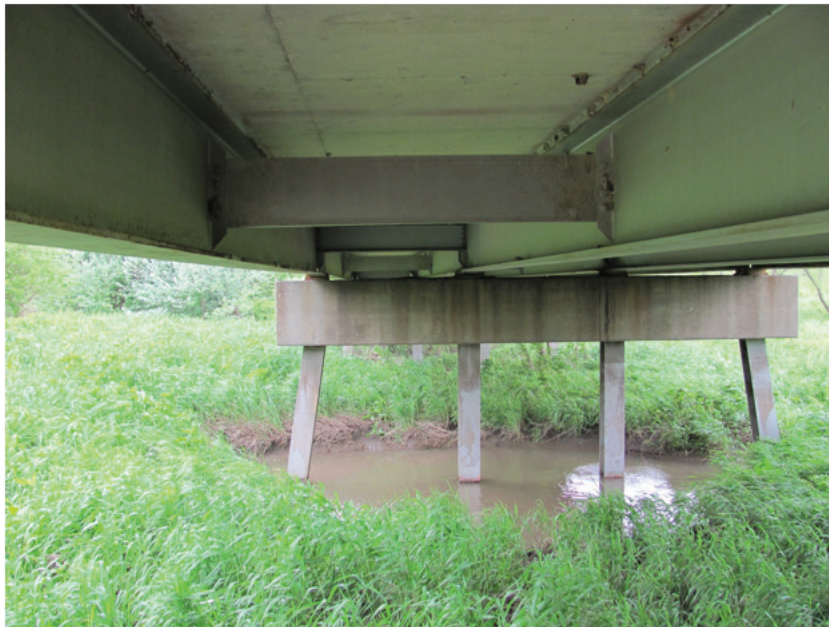
Fair Condition – Interior Beam Mid-Span

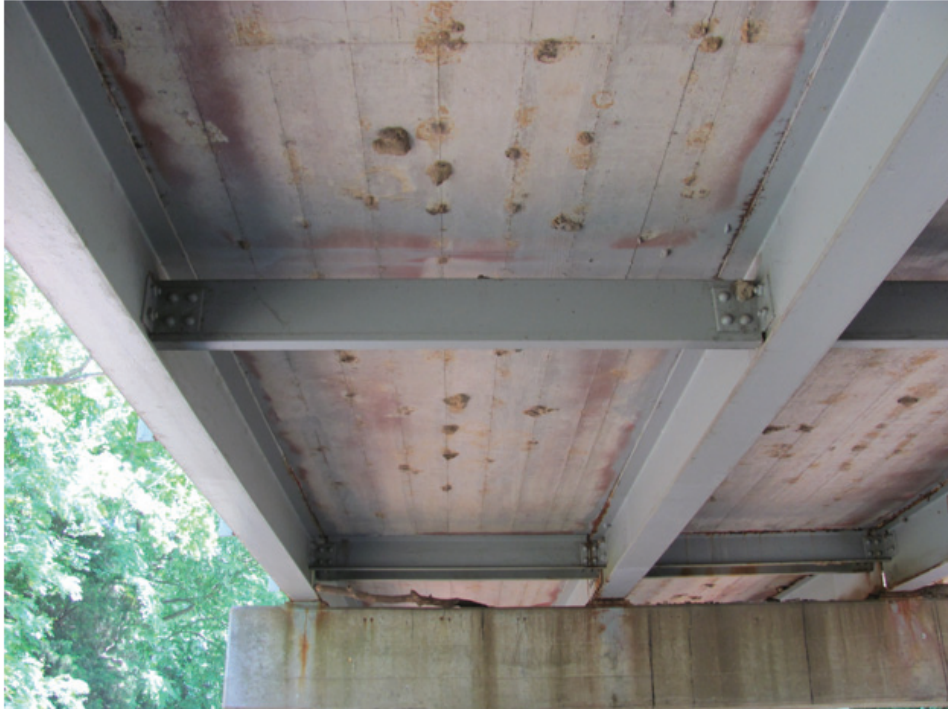
Fair Condition – Interior Beam Mid-Span

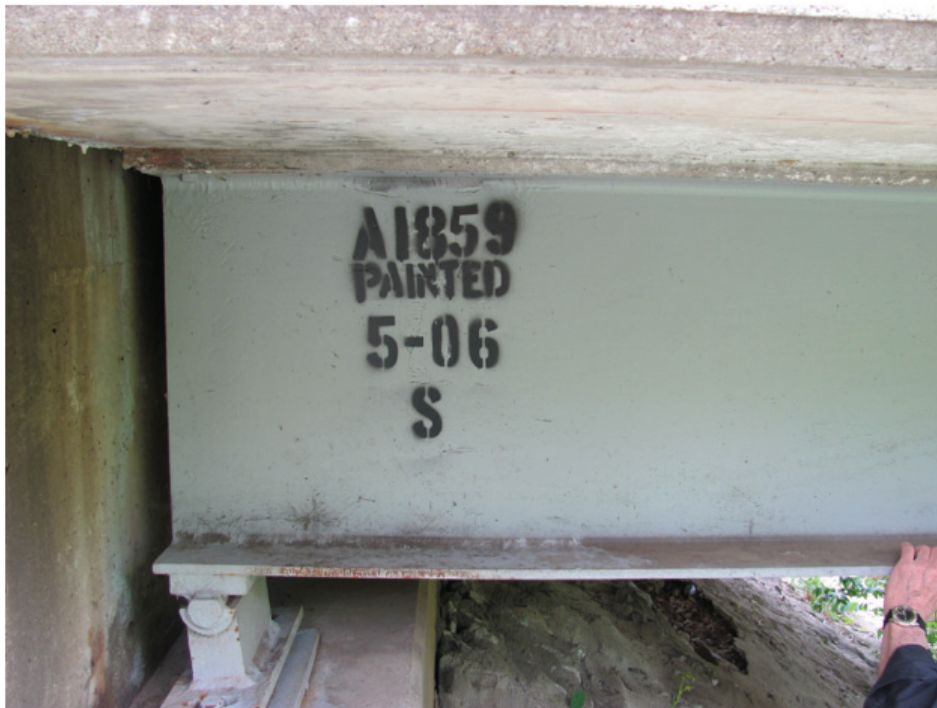
Fair Condition – Exterior Beam End-Span

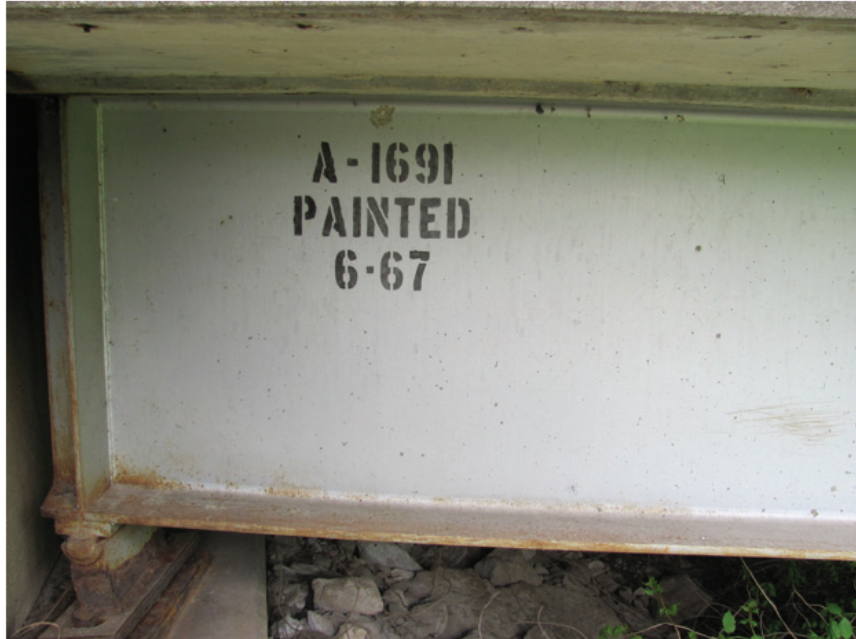
Fair Condition – Exterior Beam End-Span

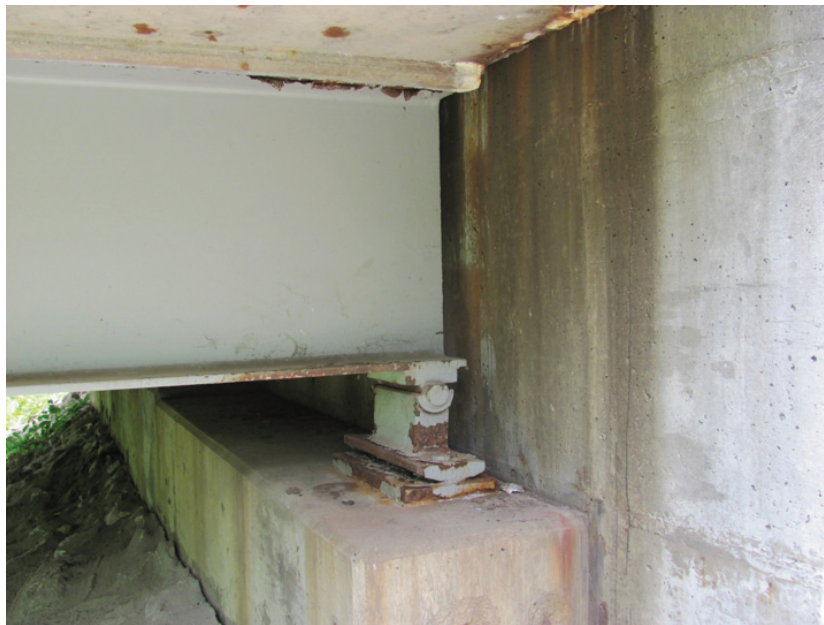
Fair Condition – Exterior Beam End-Span

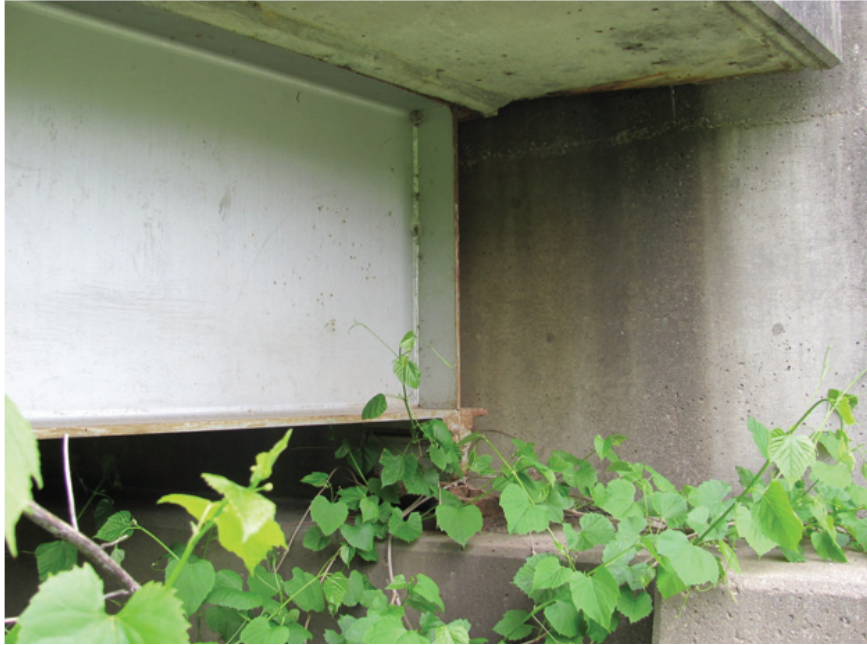
Fair Condition – Close-up

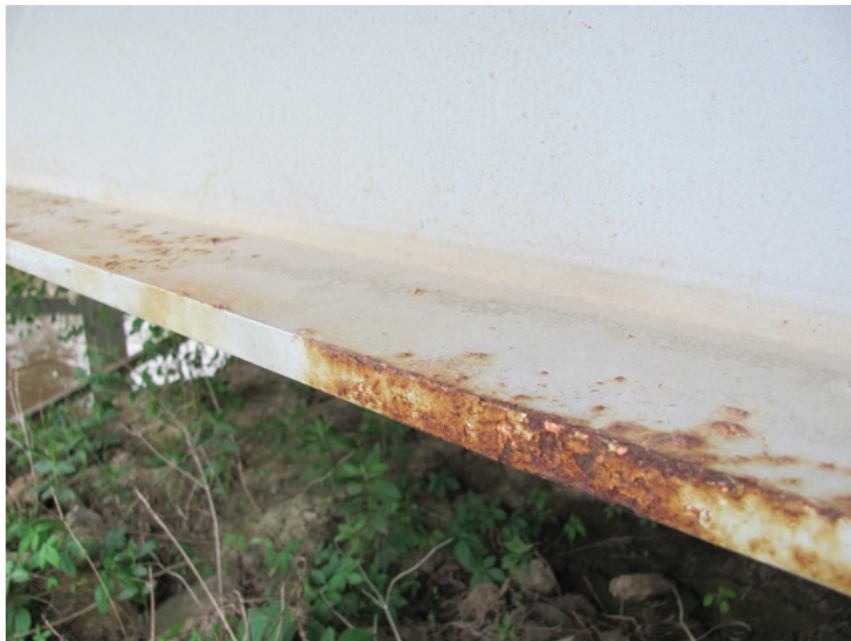
Fair Condition – Close-up

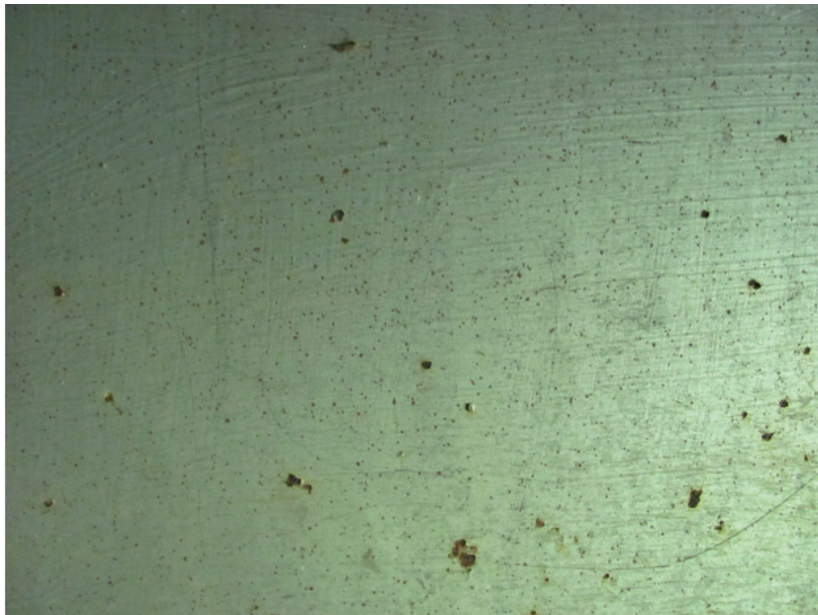
Fair Condition – Close-up

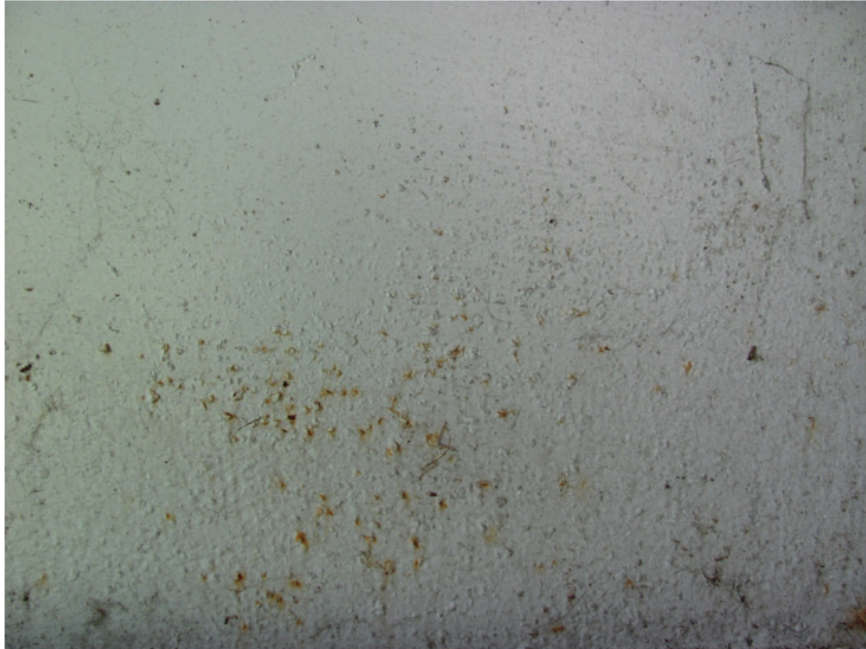
Fair Condition – Close-up

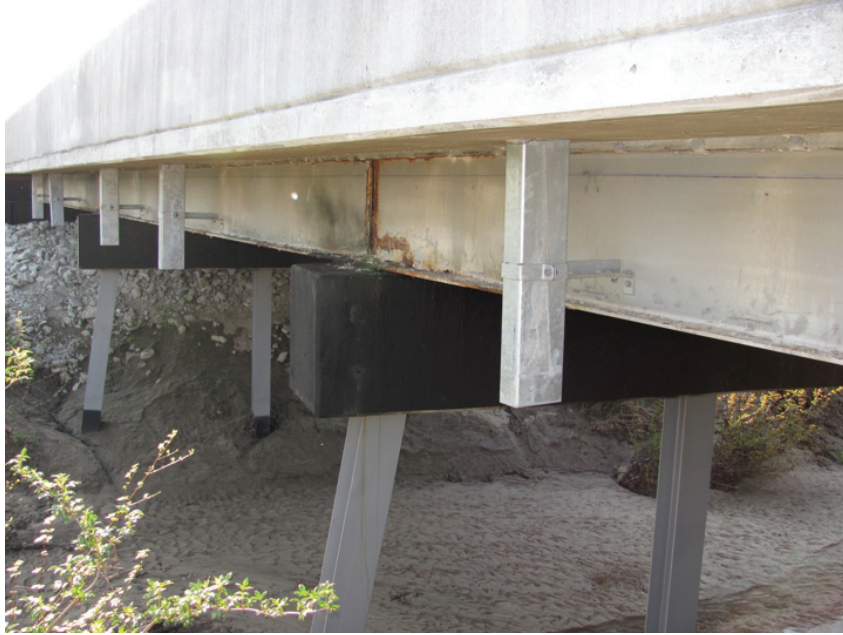
The coating has widespread corrosion corresponding to SSPC-5 (Greater 1% up to 3%) to SSPC-4 (Greater than 3% up to 10%).

Poor Condition – Facia Girder Mid-Span

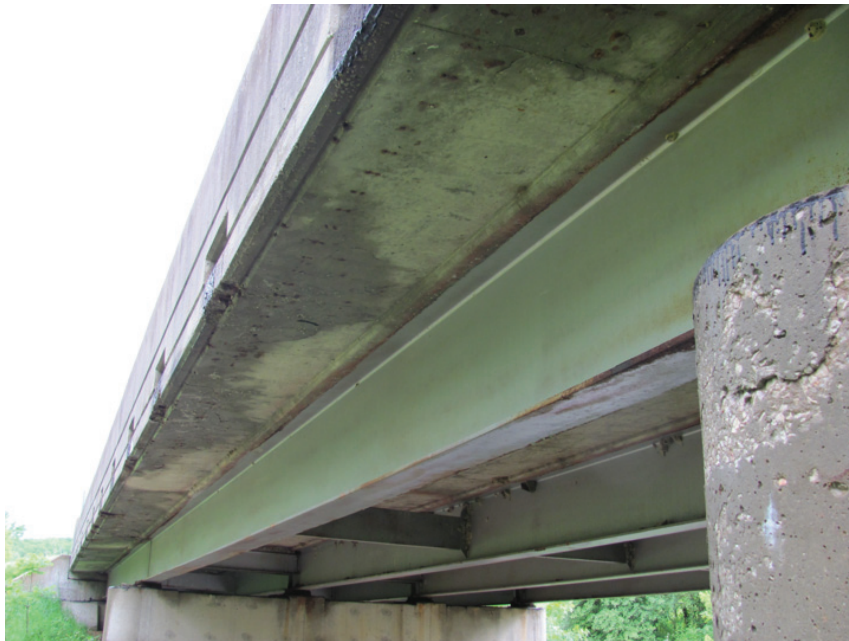
Poor Condition – Facia Girder Mid-Span

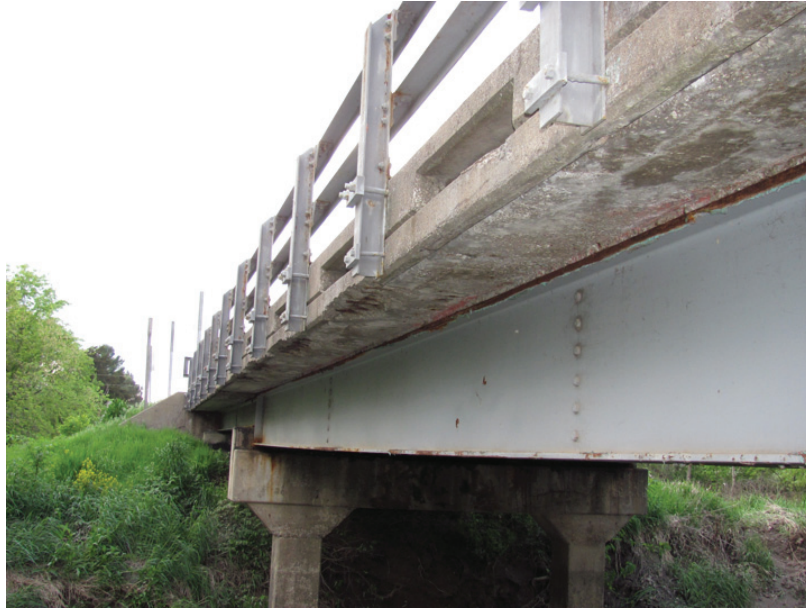
Poor Condition – Facia Girder Mid-Span

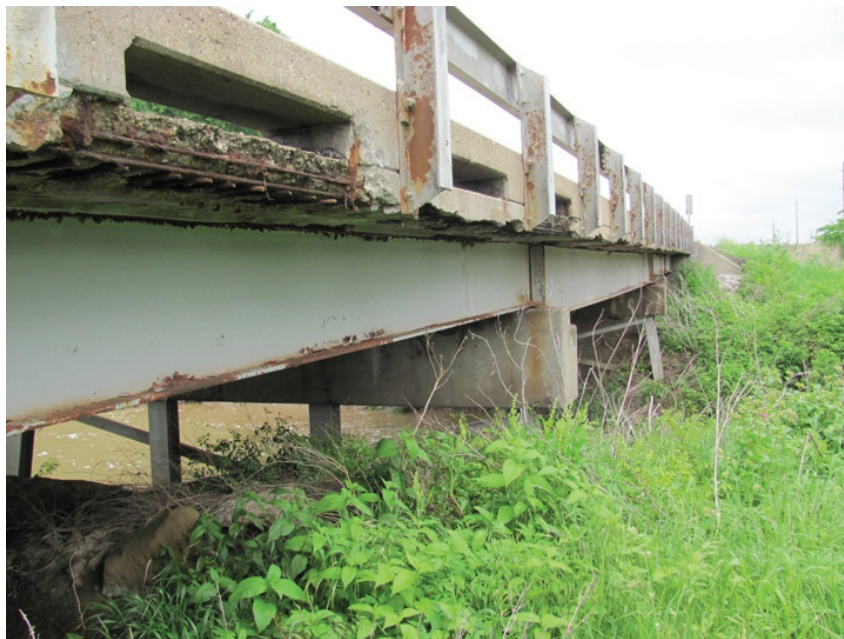
Poor Condition – Facia Girder Mid-Span

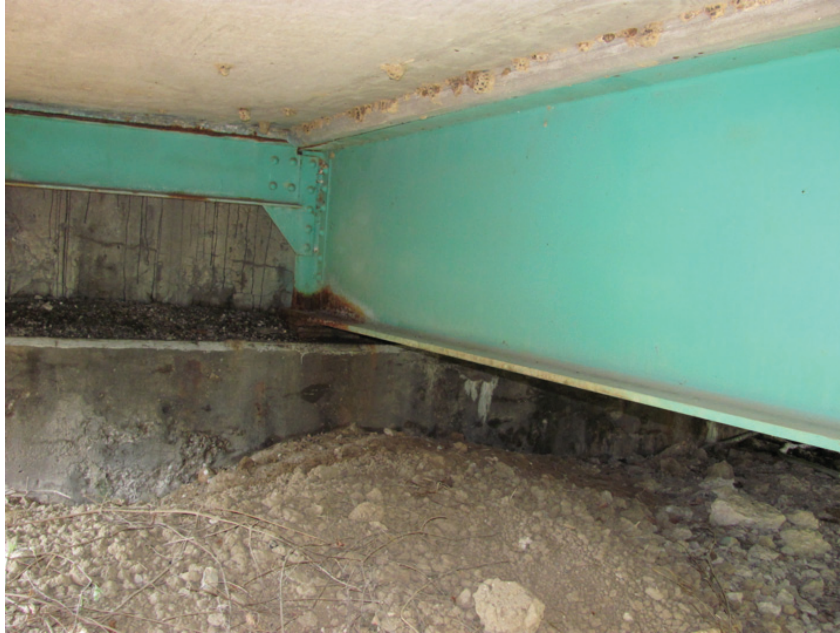
Poor Condition – Interior Beam End-Span

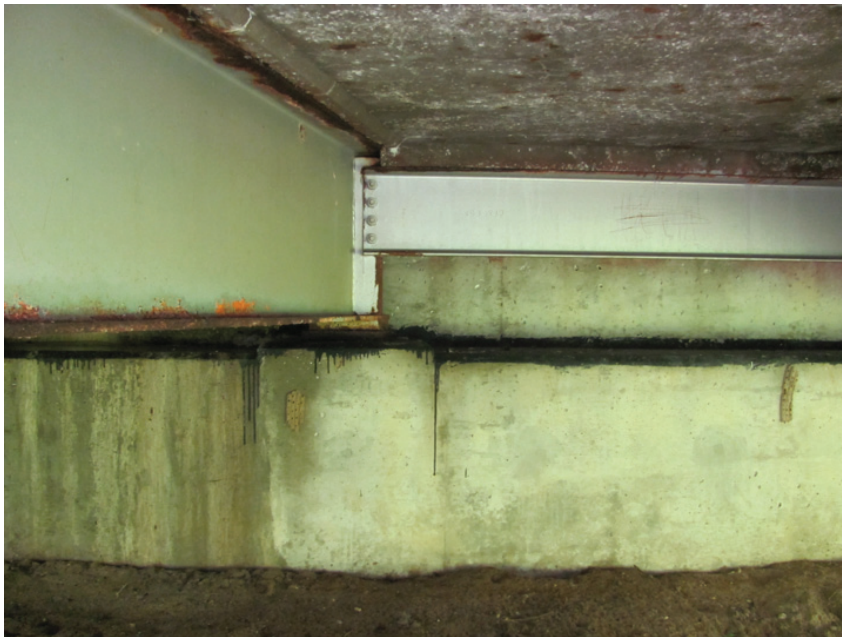
Poor Condition – Interior Beam End-Span

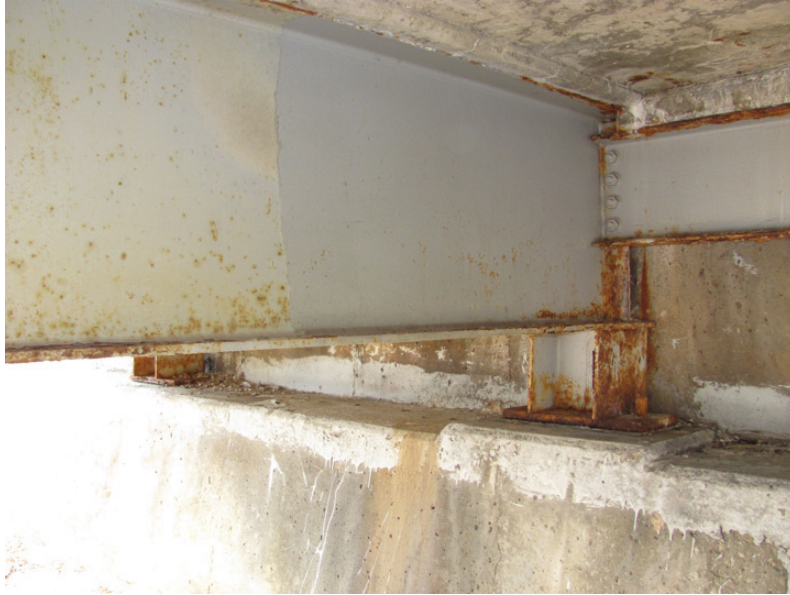
Poor Condition – Interior Beam End-Span

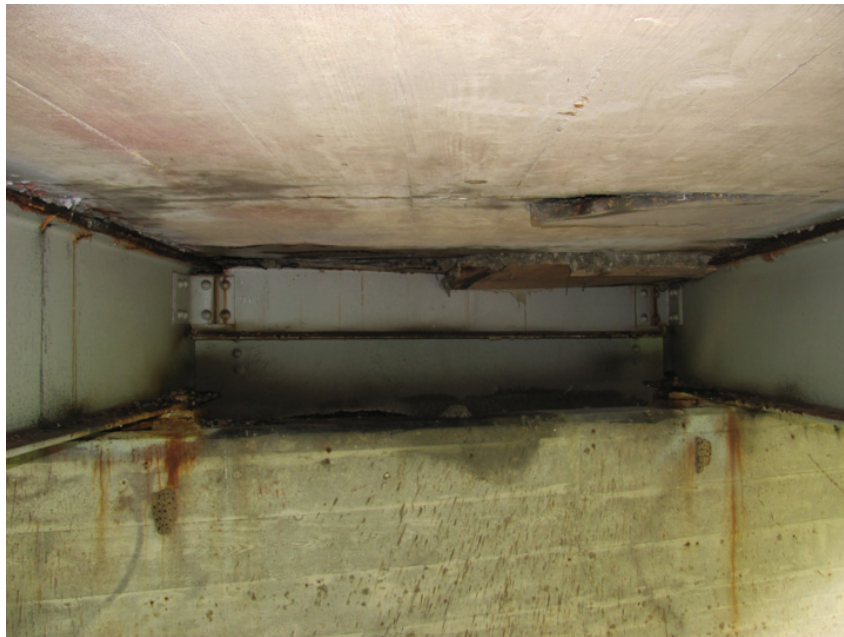
Poor Condition – Interior Beam End-Span

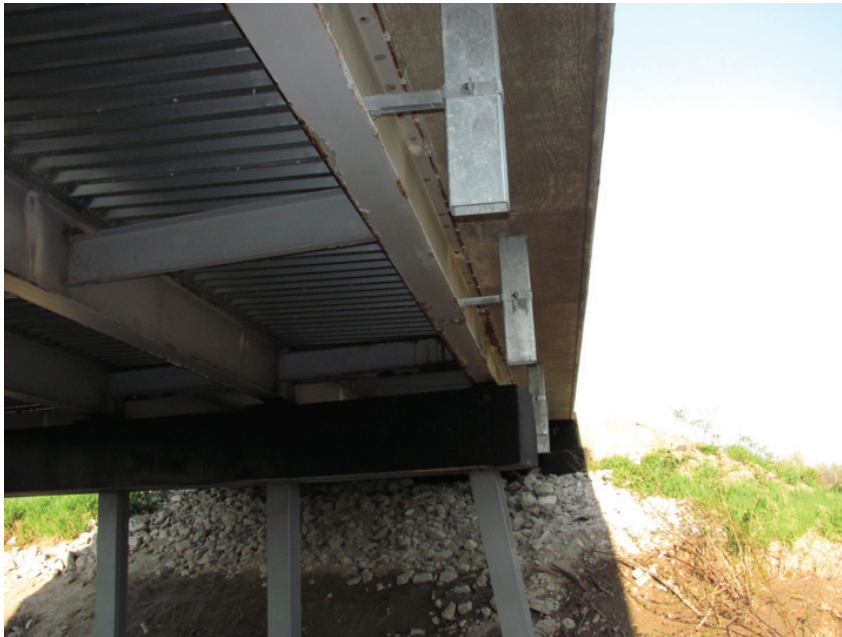
Poor Condition – Interior Beam Mid-Span

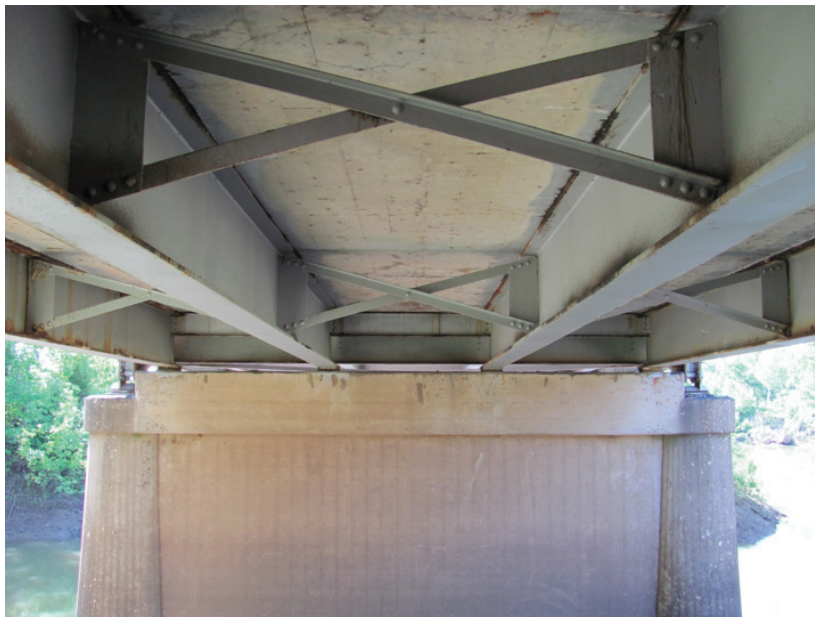
Poor Condition – Interior Beam Mid-Span

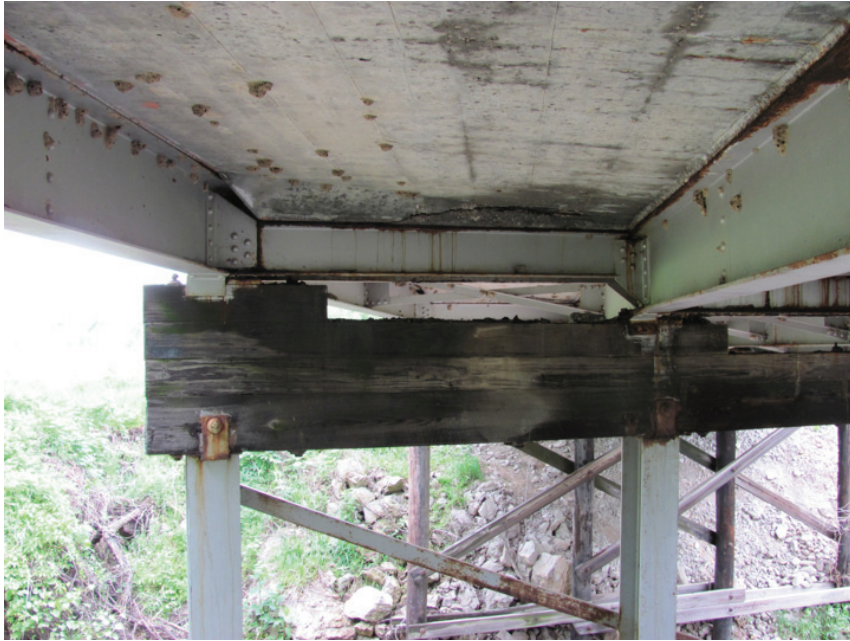
Poor Condition – Interior Beam Mid-Span

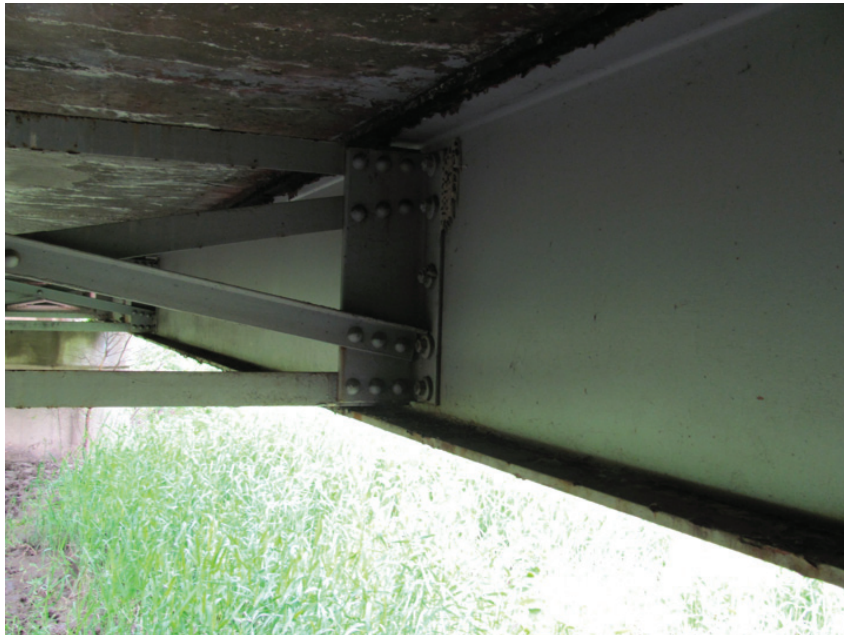
Poor Condition – Interior Beam Mid-Span

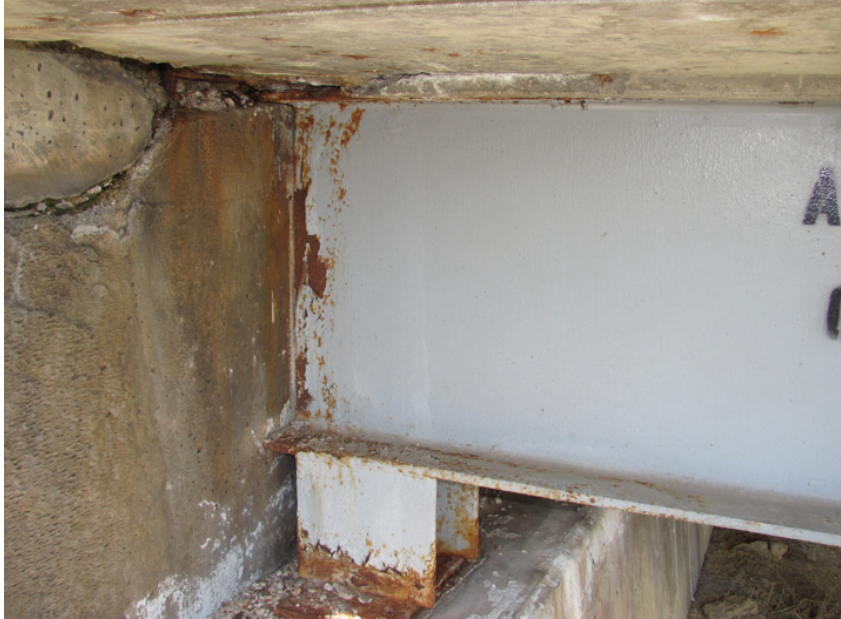
Poor Condition – Interior Beam End-Span

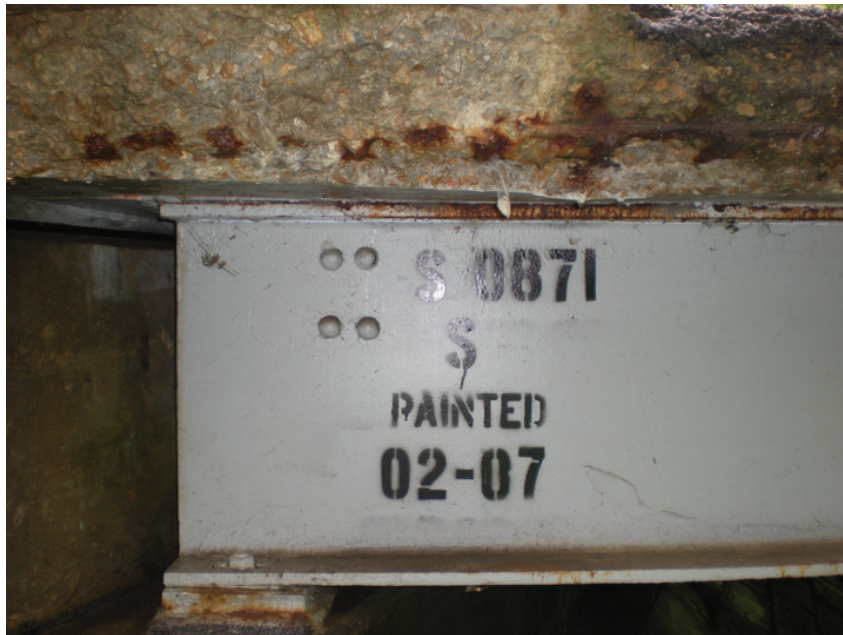
Poor Condition – Exterior Beam End-Span

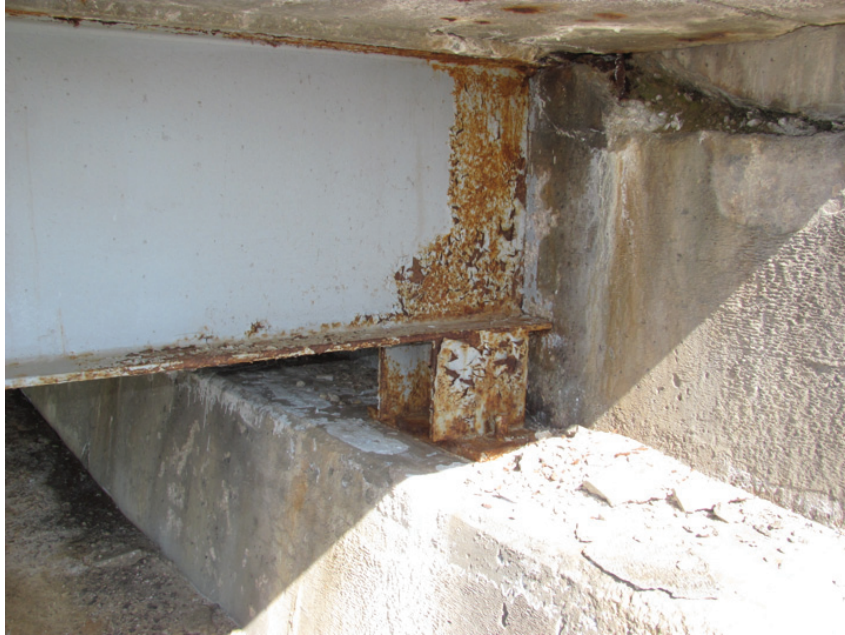
Poor Condition – Exterior Beam End-Span

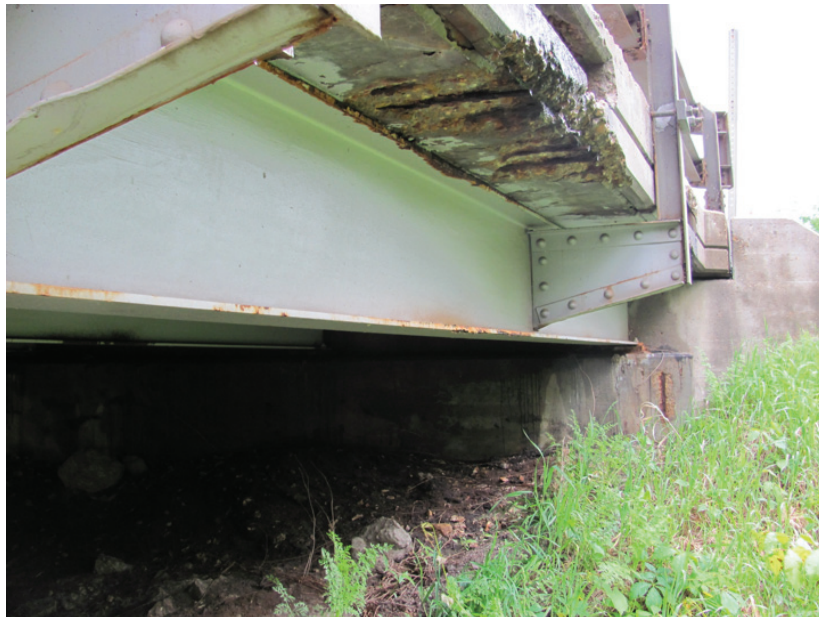
Poor Condition – Exterior Beam End-Span

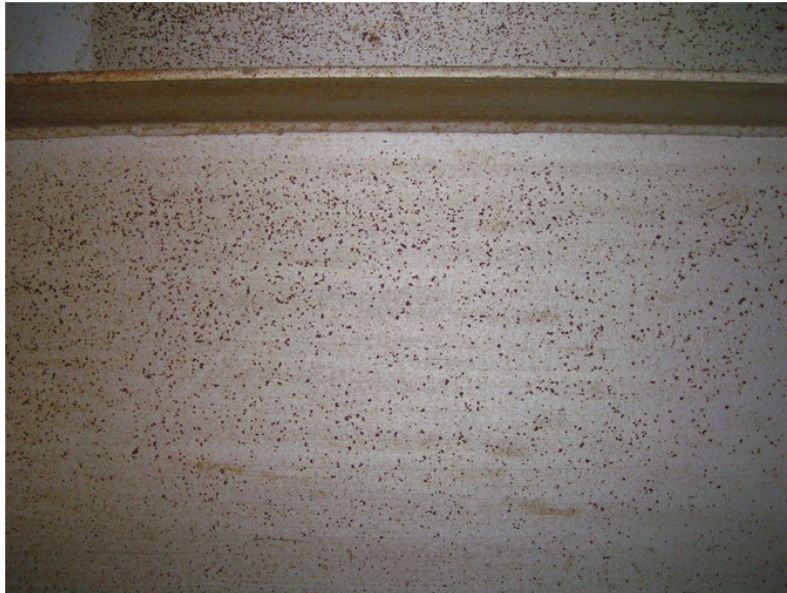
Poor Condition – Close-up

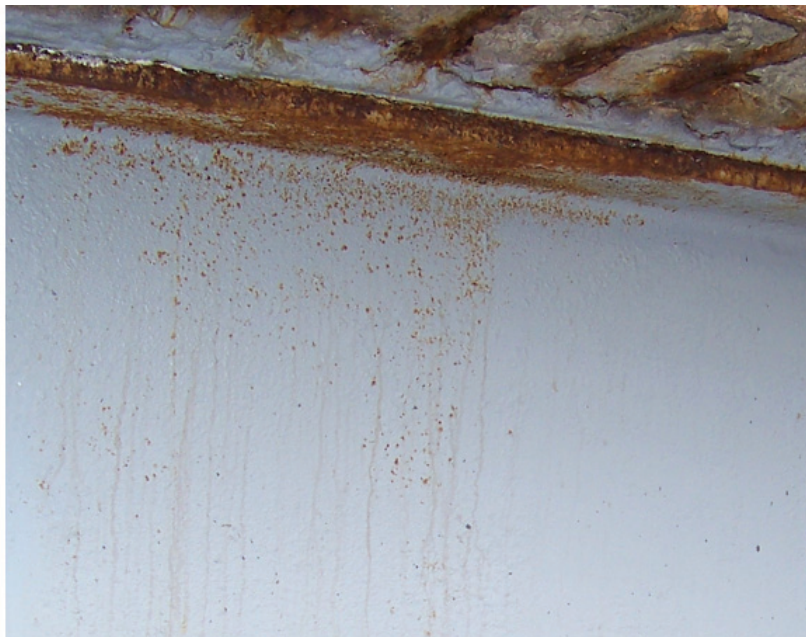
Poor Condition – Close-up

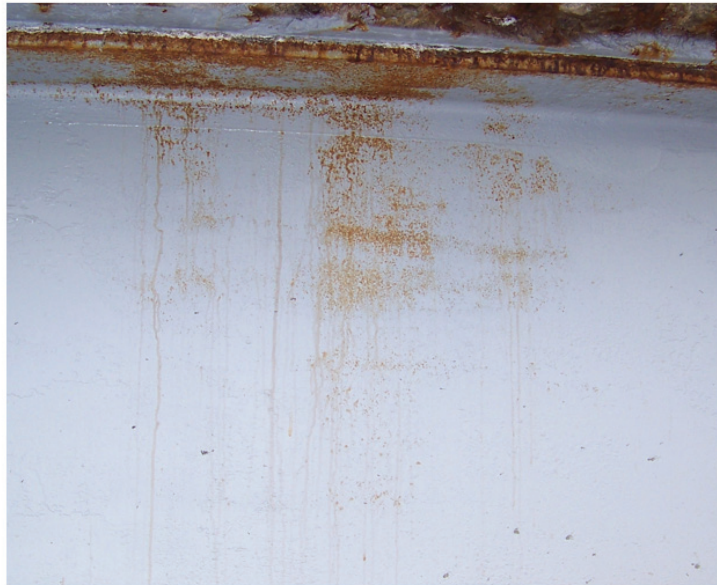
Poor Condition – Close-up

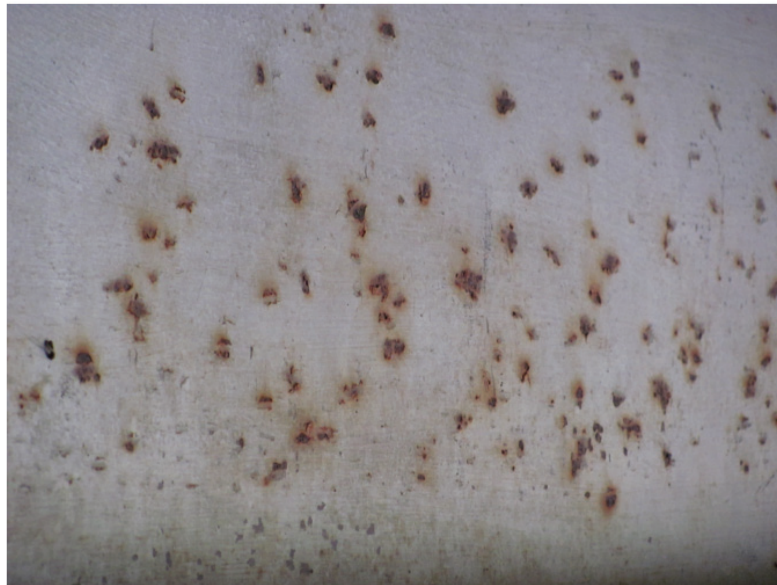
Poor Condition – Close-up

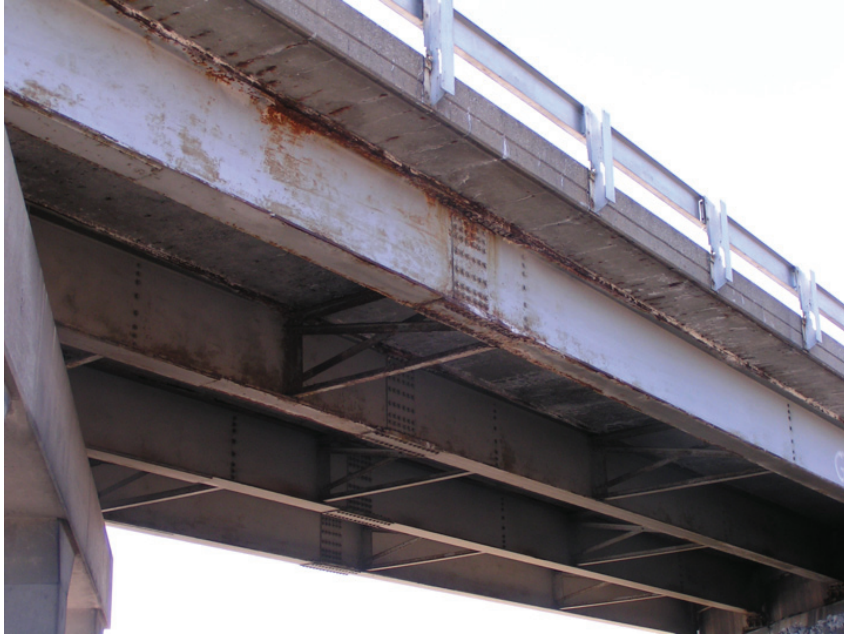
The coating system is in advanced stages of deterioration, with greater than 10% rust corresponding to SSPC-3 or less.

Very Poor Condition – Facia Girder Mid-Span

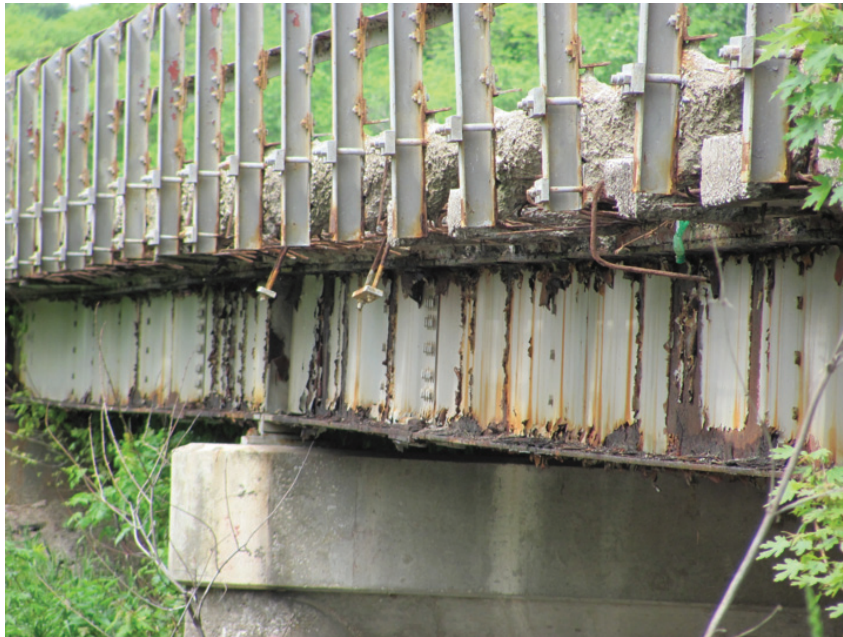
Very Poor Condition – Facia Girder Mid-Span

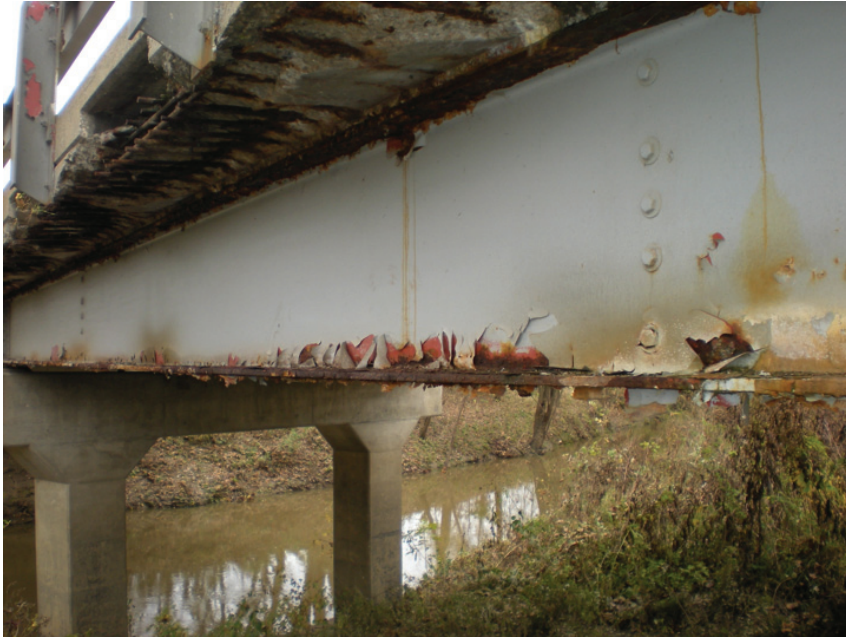
Very Poor Condition – Facia Girder Mid-Span

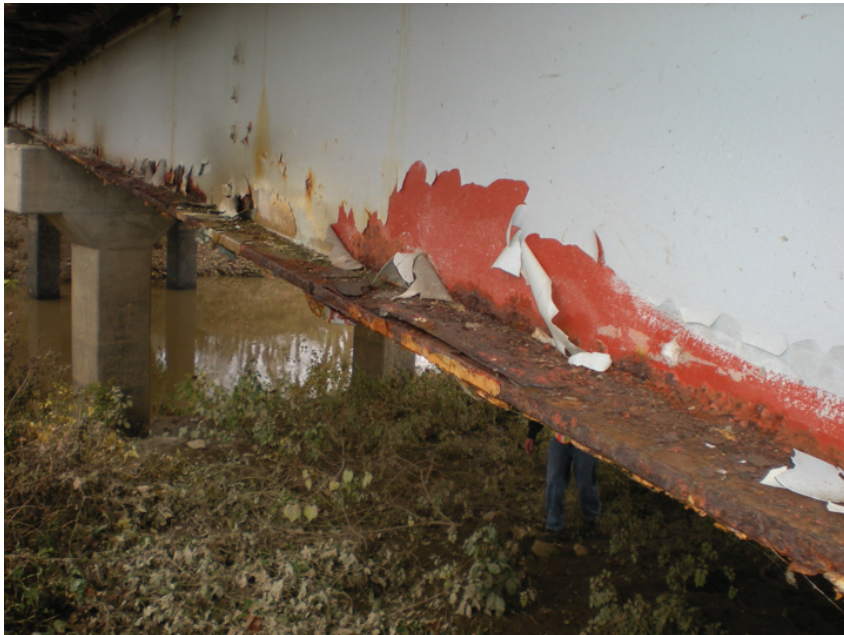
Very Poor Condition – Facia Girder Mid-Span
