Structural Steel Coatings for Corrosion Mitigation

**NUTC
R233
R238**

Prepared for
Missouri Department of Transportation
Organizational Results

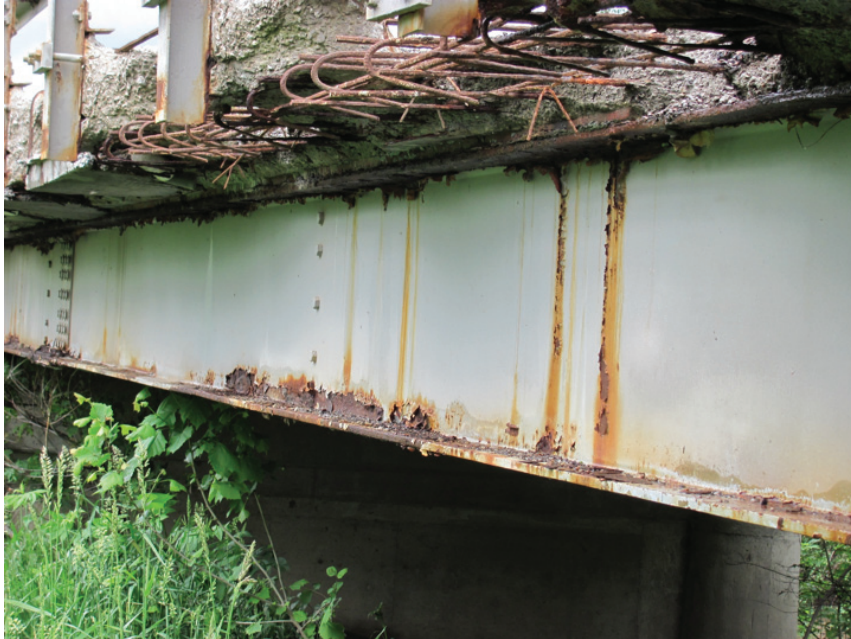
Very Poor Condition – Fascia Girder Mid-Span

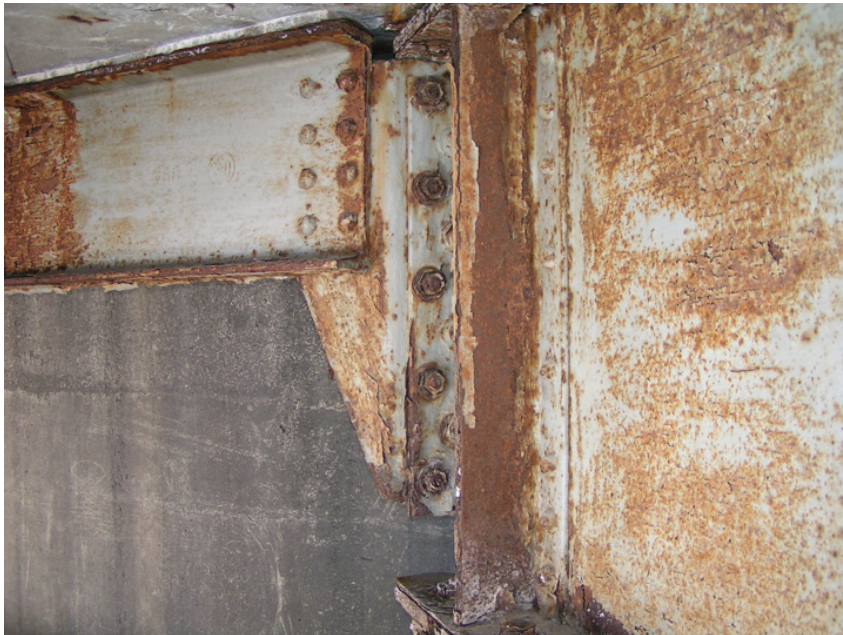
Very Poor Condition – Interior Beam End-Span

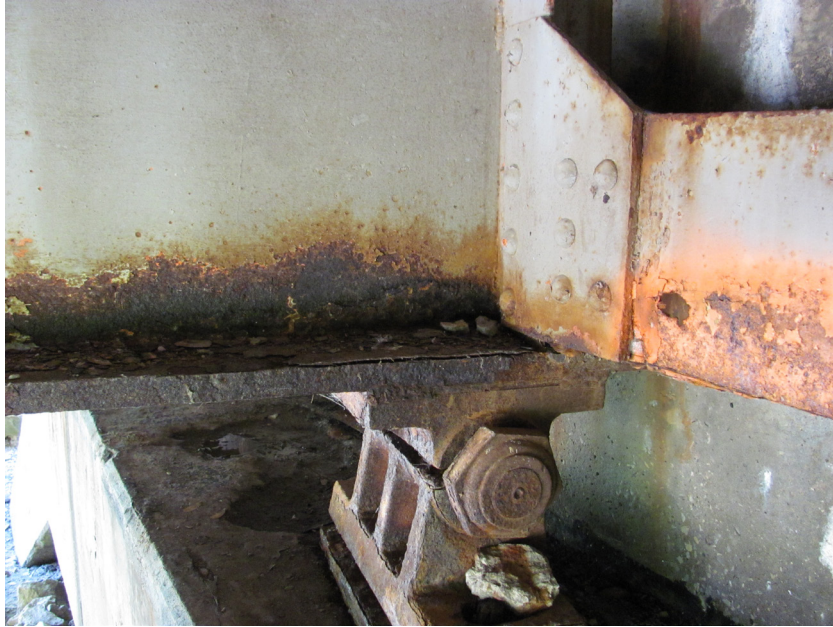
Very Poor Condition – Interior Beam End-Span

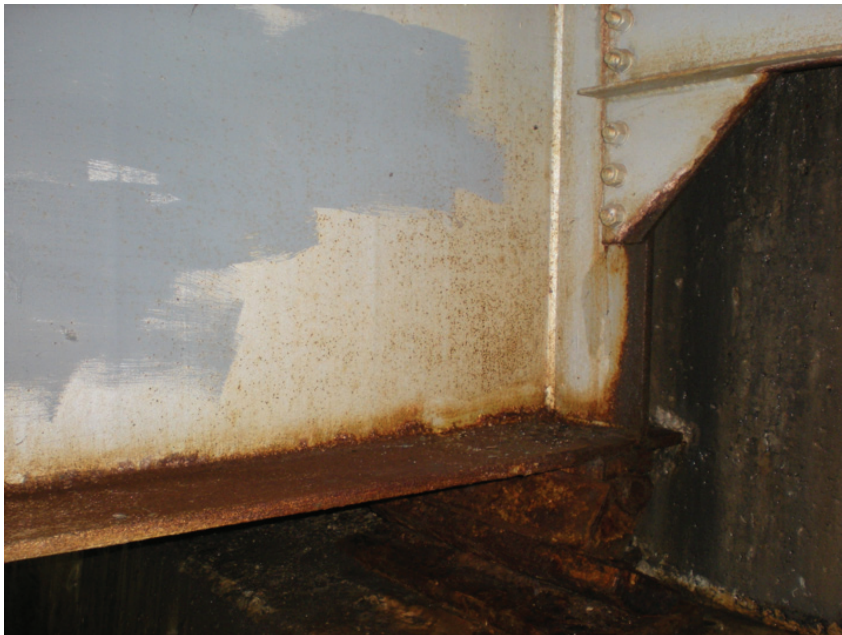
Very Poor Condition – Interior Beam End-Span

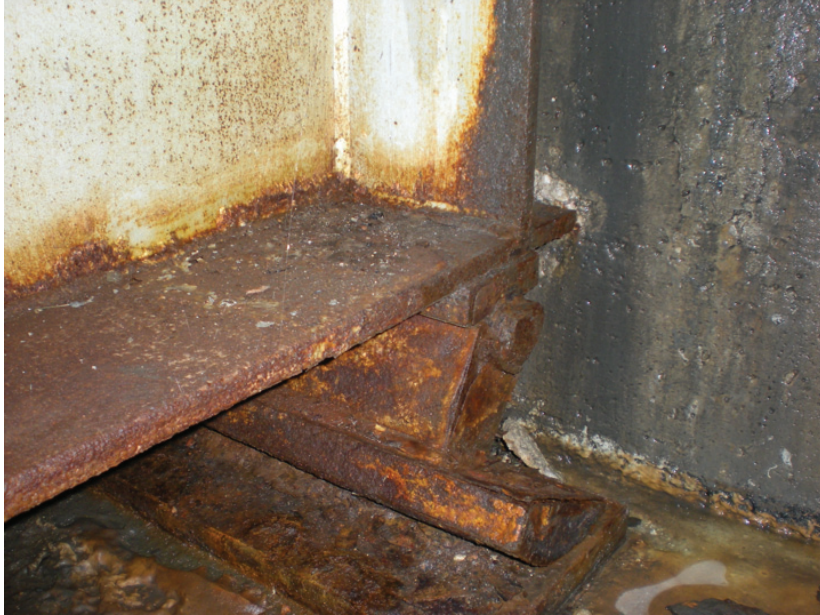
Very Poor Condition – Interior Beam End-Span

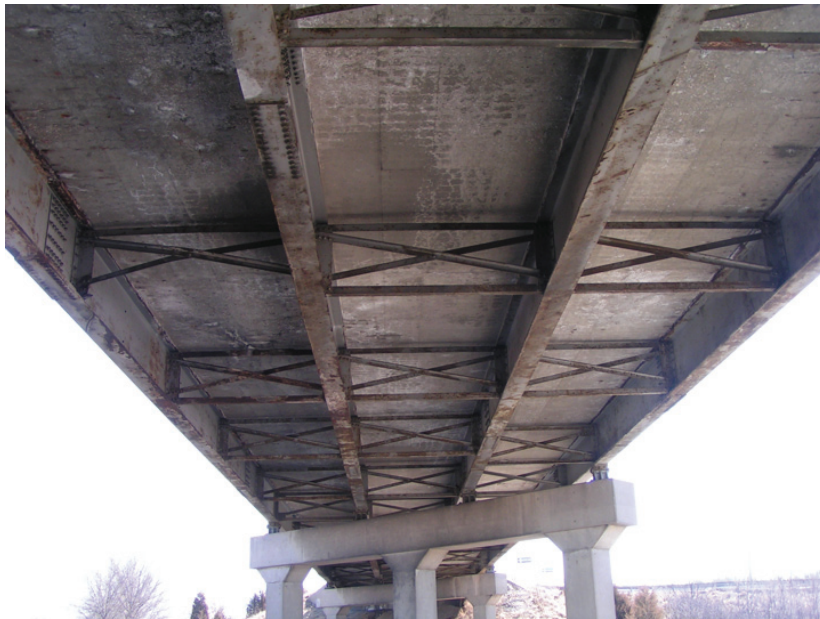
Very Poor Condition – Interior Beam Mid-Span

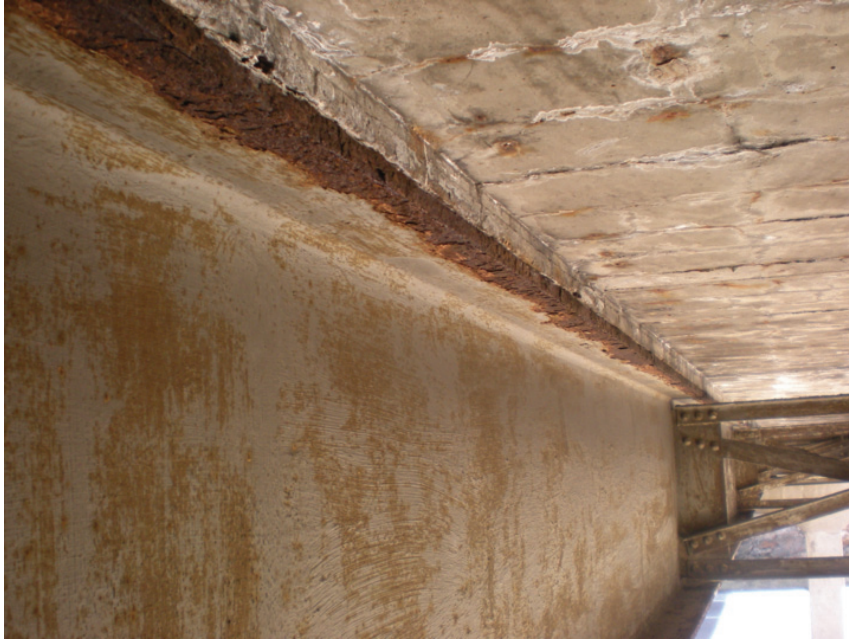
Very Poor Condition – Interior Beam Mid-Span

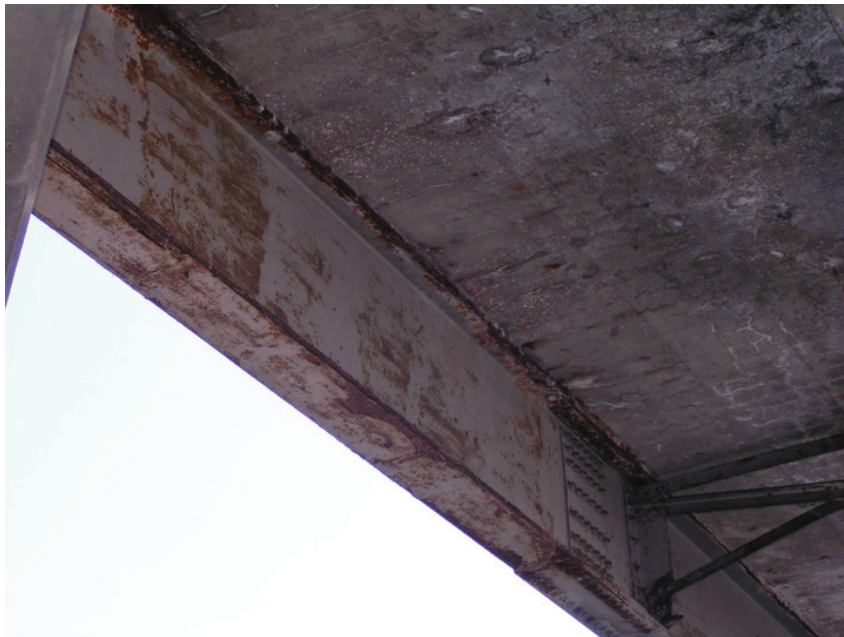
Very Poor Condition – Interior Beam Mid-Span

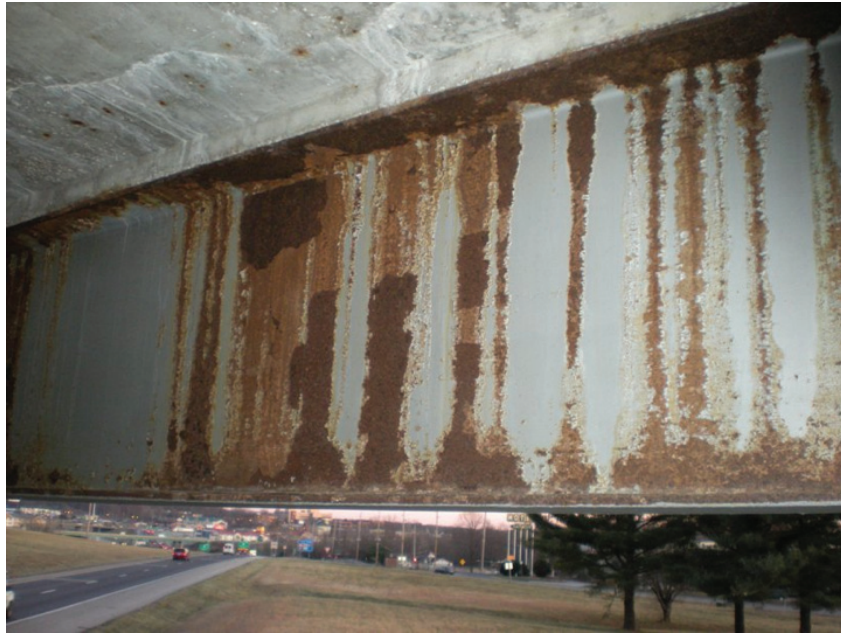
The coating system is in advanced stages of deterioration, with greater than 10% rust corresponding to SSPC-3 or less.

Very Poor Condition – Interior Beam Mid-Span

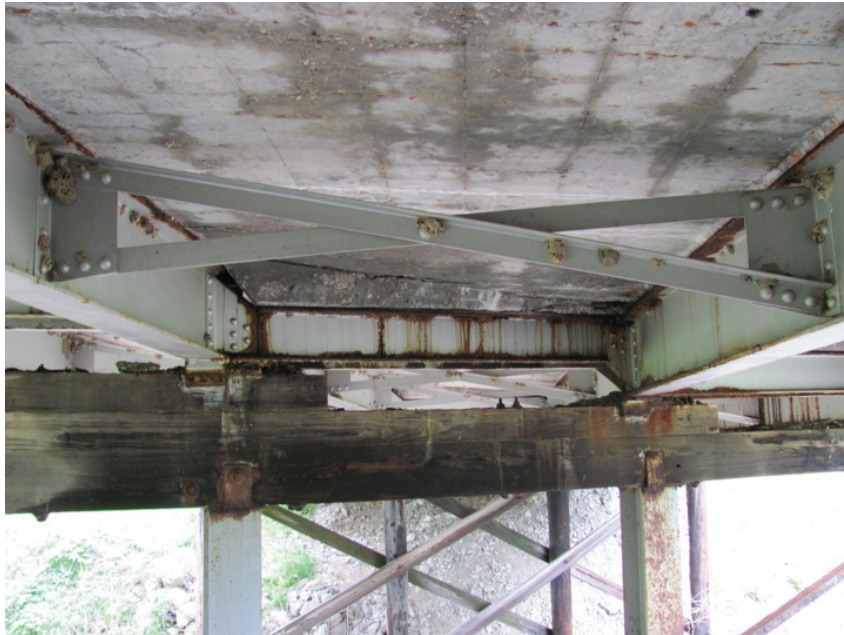
Very Poor Condition – Interior Beam Mid-Span

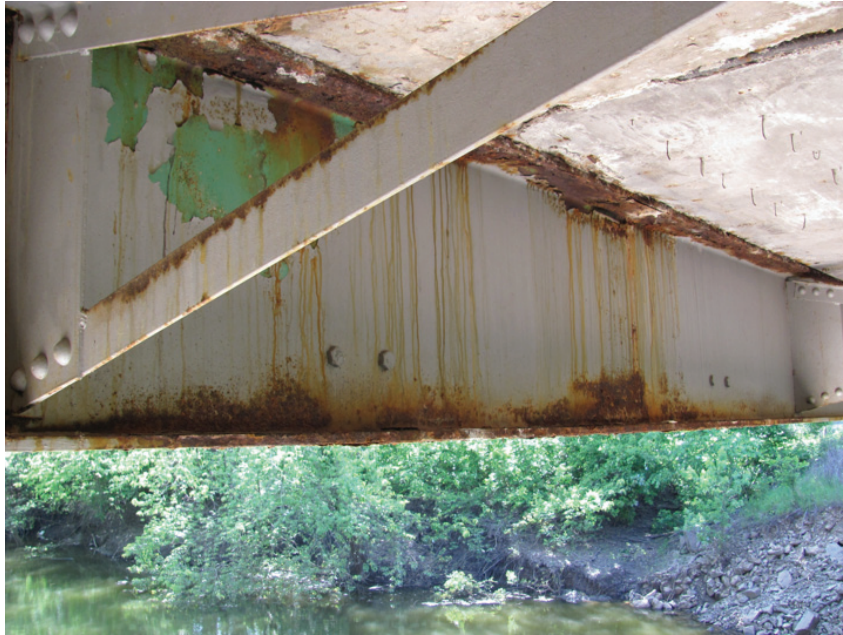
Very Poor Condition – Interior Beam Mid-Span

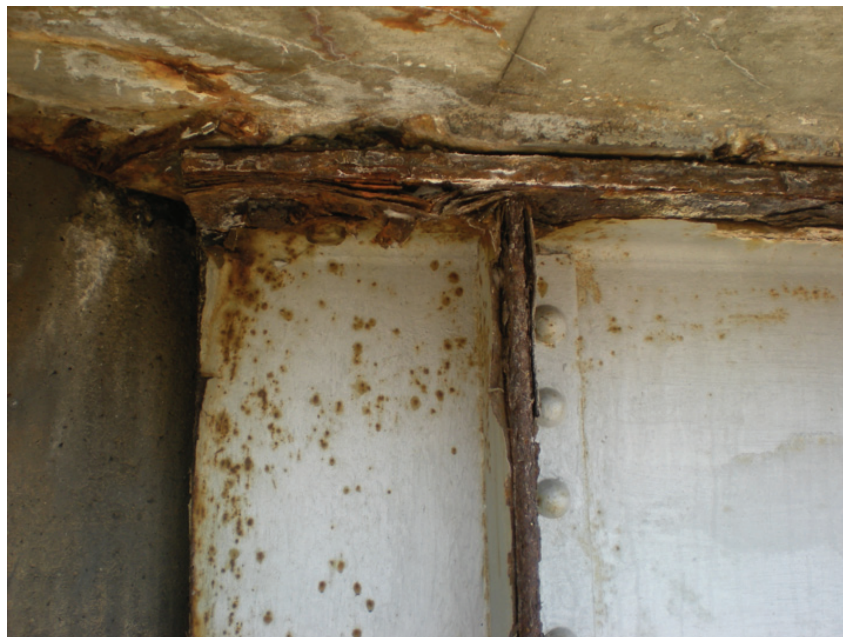
Very Poor Condition – Exterior Beam End-Span

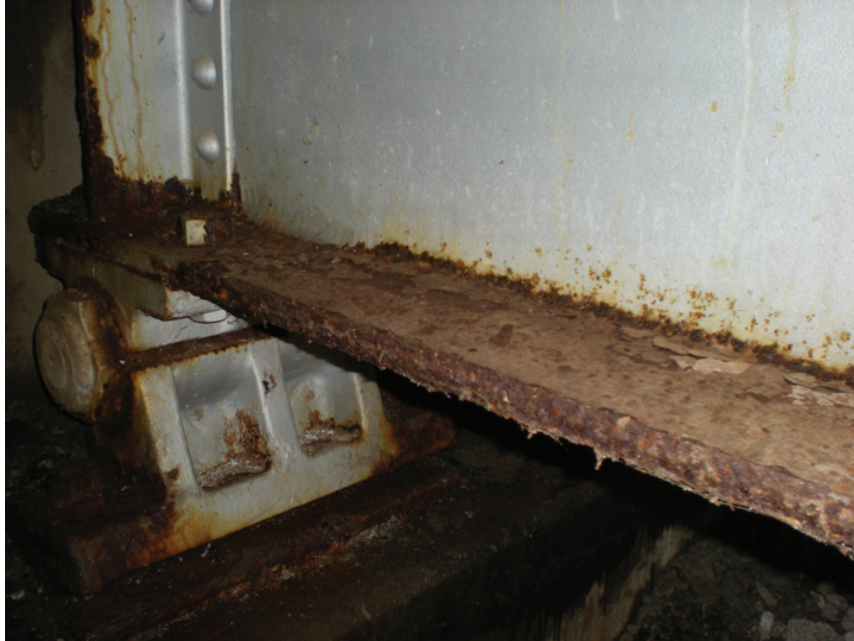
Very Poor Condition – Exterior Beam End-Span

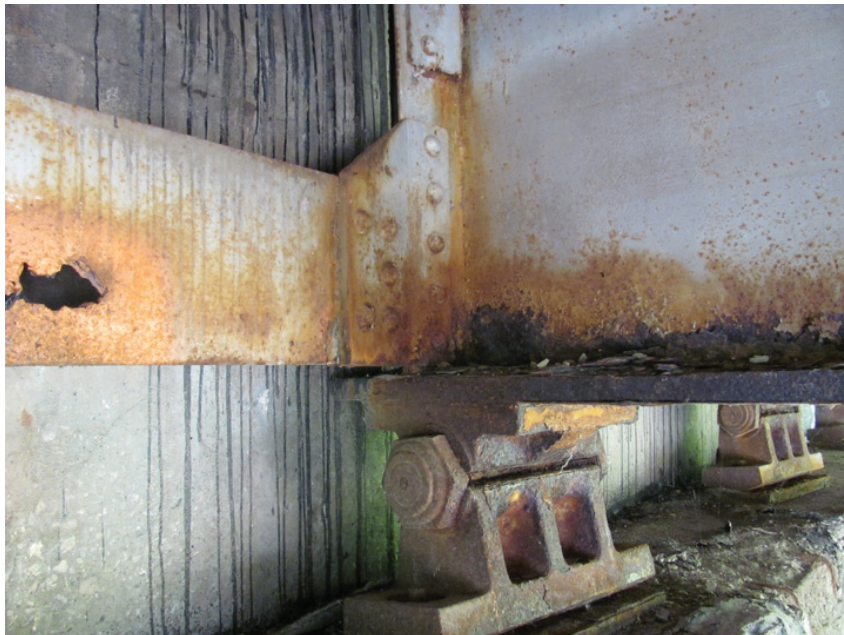
Very Poor Condition – Exterior Beam End-Span

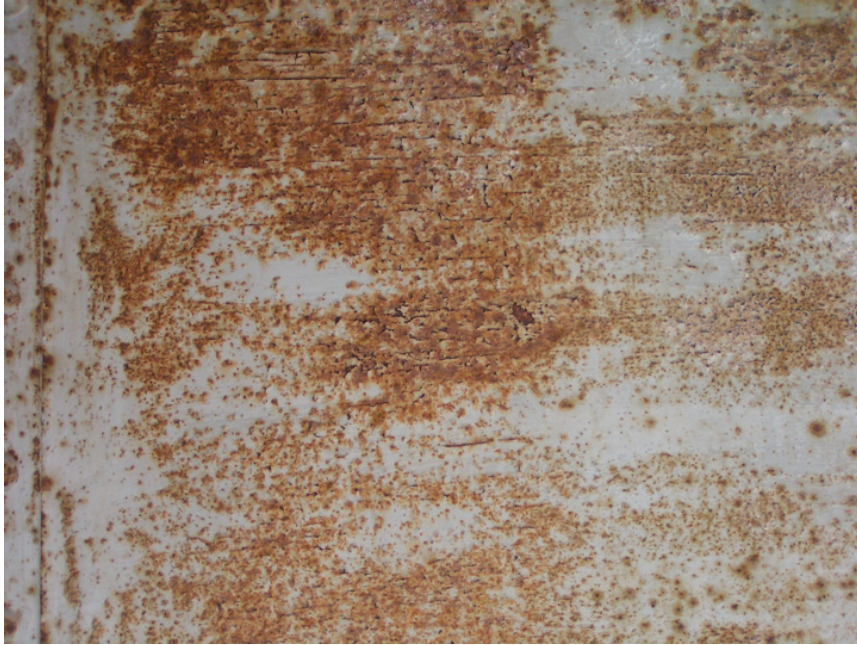
Very Poor Condition – Close-up

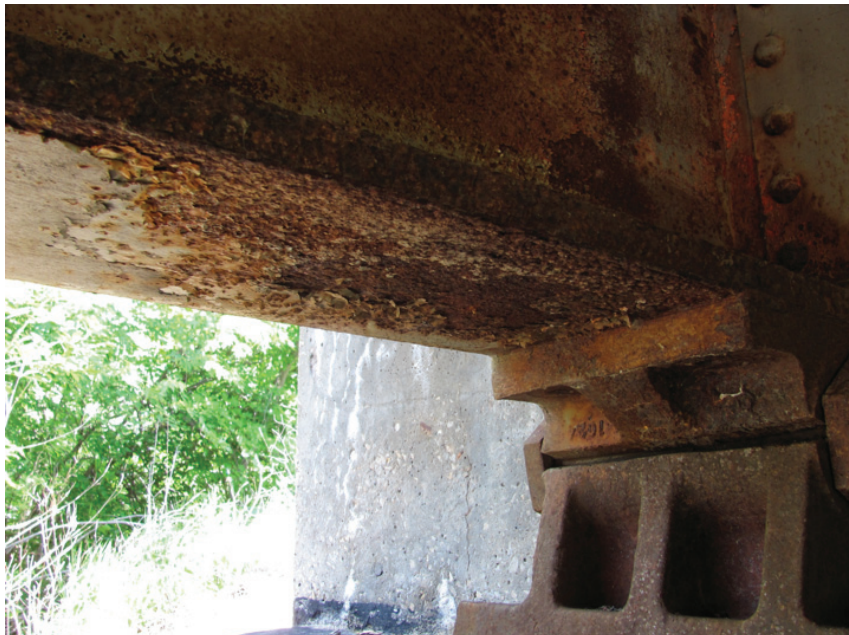
Very Poor Condition – Close-up

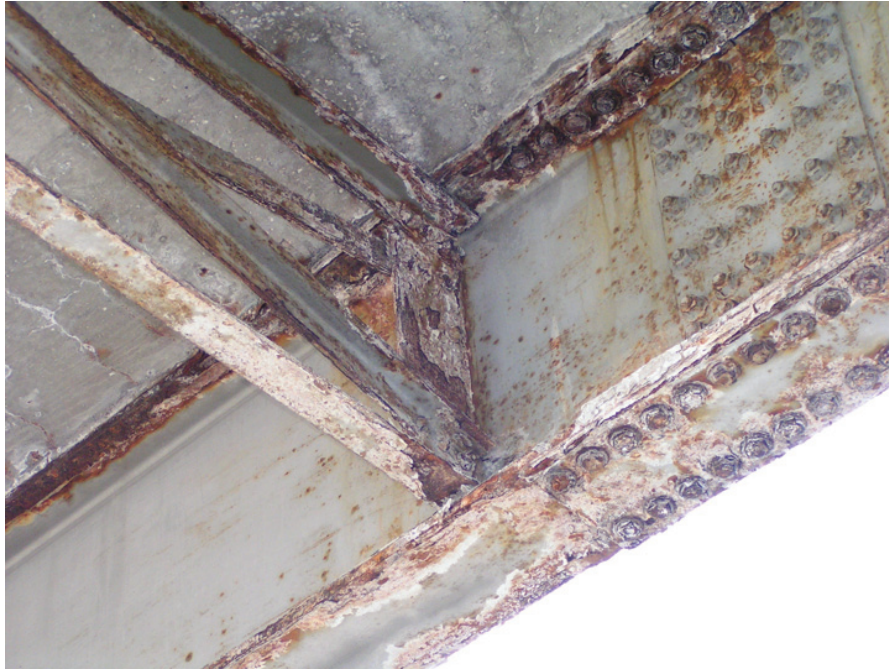
Very Poor Condition – Close-up

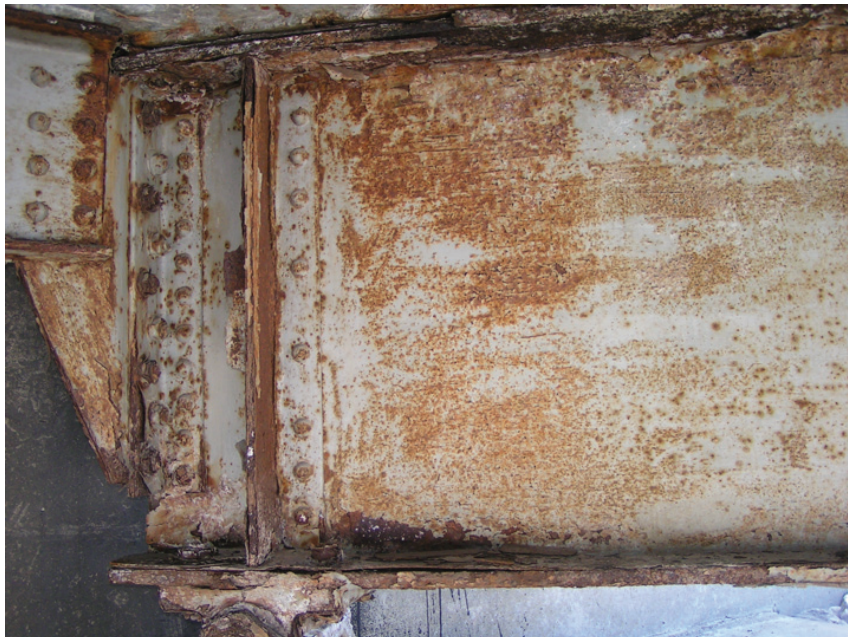
Very Poor Condition – Close-up

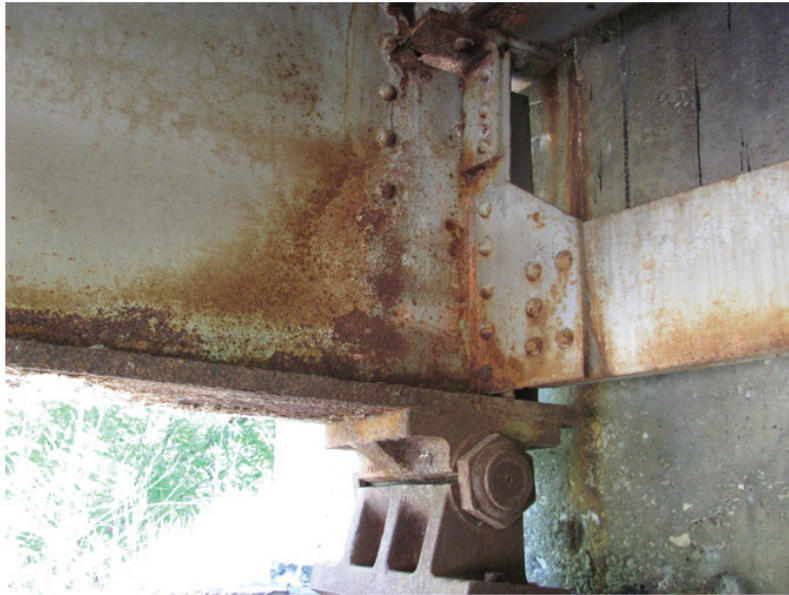
Very Poor Condition – Close-up

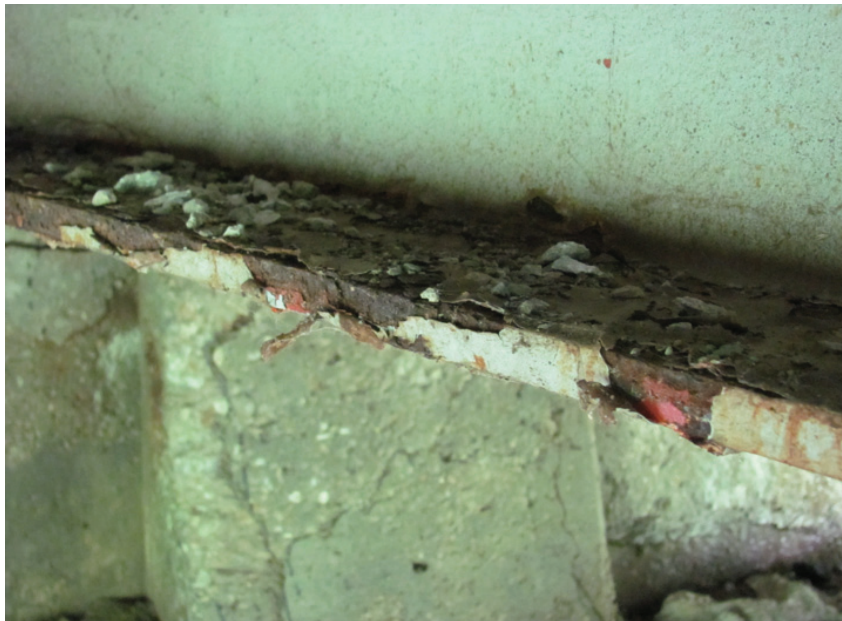
Very Poor Condition – Close-up

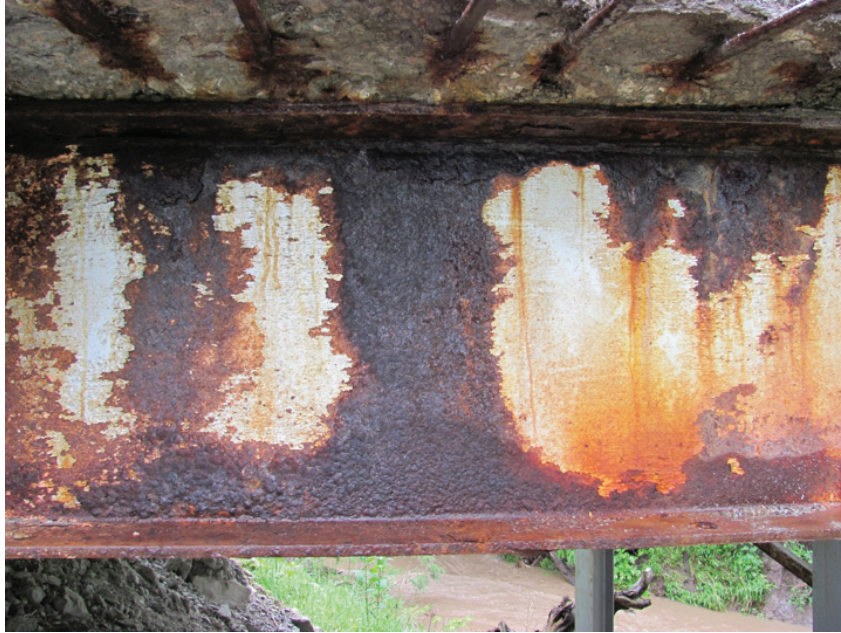
Very Poor Condition – Close-up
