**INVESTIGATING PREMATURE PAVEMENT
FAILURE DUE TO MOISTURE**

FINAL REPORT

SPR 632

July 2009

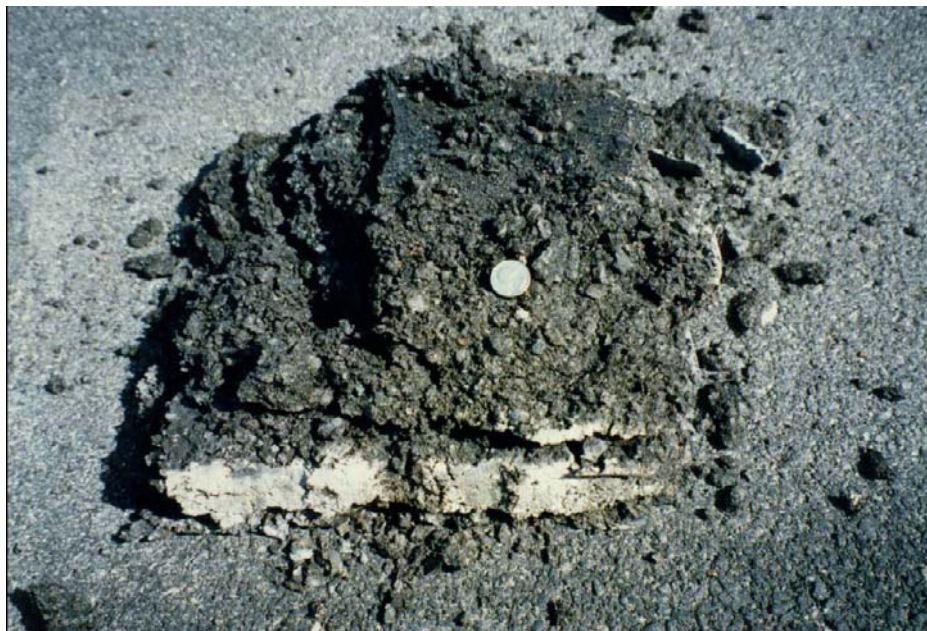
Figure A-3.2: Example of a Stripped HMA Mix (After Kandhal 2001)

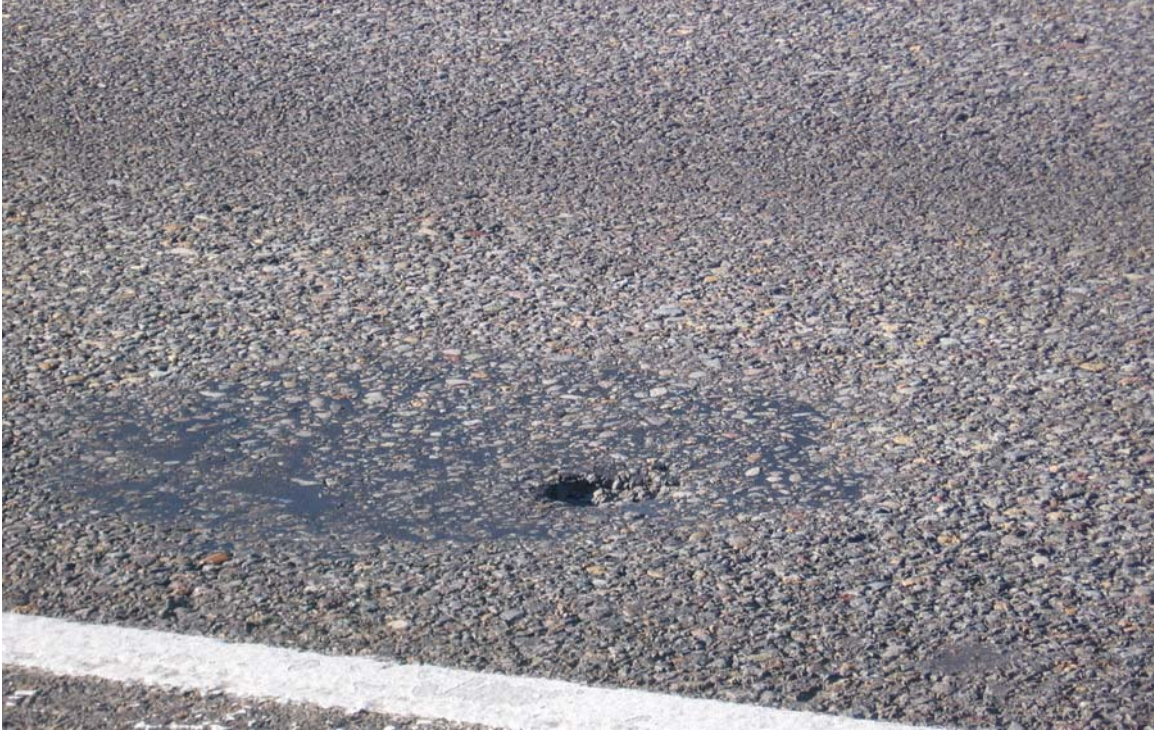
Northbound Direction: The northbound lanes were in much better condition as compared with the southbound lanes. Still, intermittent patching was found along the project. A small pot hole in combination with bleeding was found in one location (Figure D-1.10). An interesting observation along this stretch of the pavement was the amount of vegetation growth and water stagnation along the pavement sides as shown in Figure D-1.11.

Figure D-1.10: A Pot Hole with Some Bleeding

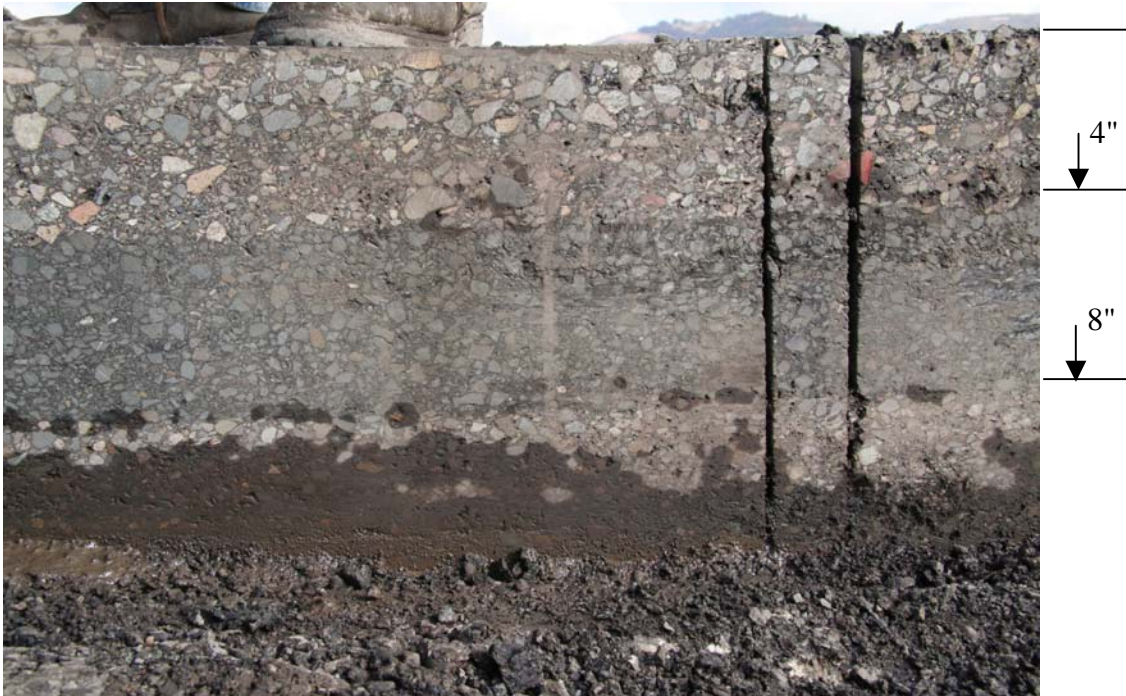
b) Garden Valley-Roberts Creek, MP 118.645, SB

The cores at this nominal station appear from the videolog to be at mile points 118.550 and 118.645. Since the core data reports a nominal location of 118.6, the core data has been plotted at both locations in Attachment B. The GPR data shows 3 layers at depths of 4, 9, and 16 inches. A typical core log is shown in Figure 7. The trench and core data (Figures 6b and 7, respectively) show layers at 4, 8, 11, and 16 inches, and is reasonably consistent with the GPR data. The trench data shows moisture infiltration through the lower AC layers up to the 8 inch depth level. The core data shows moisture damage at various depths, but most consistently in the depth range from 11 to 16 inches.
