REPORT APPENDIX

IDENTIFICATION OF CAUSES AND SOLUTION STRATEGIES FOR DECK CRACKING IN JOINTLESS BRIDGES

Appendix to Report No. CEE-RR – 2012/04

Research Report for MDOT under Contract No. 2009-0746/Z1
SPR No. 108522

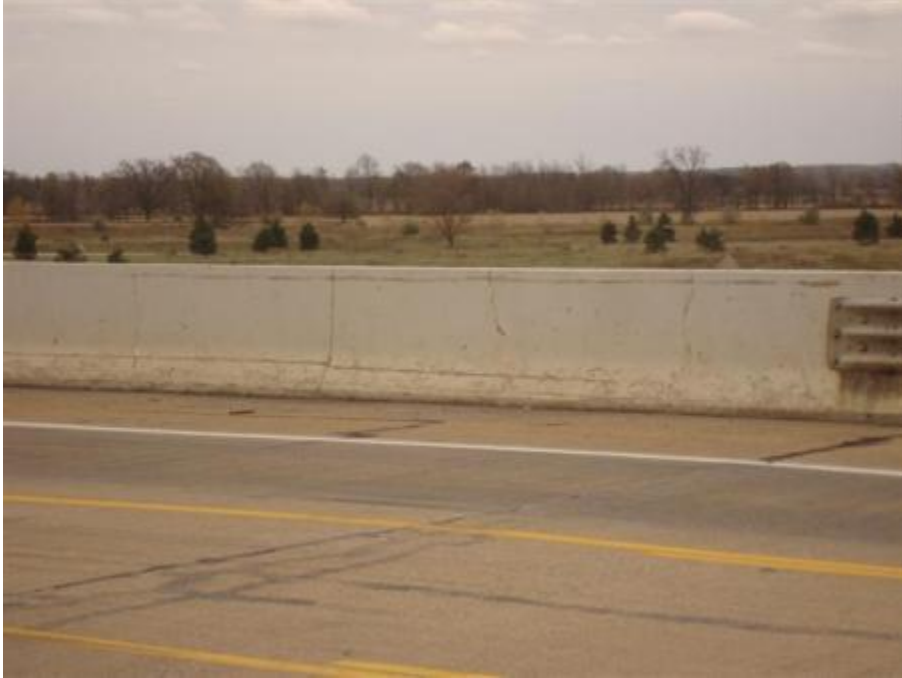
Figure 24. Cracking in barrier wall

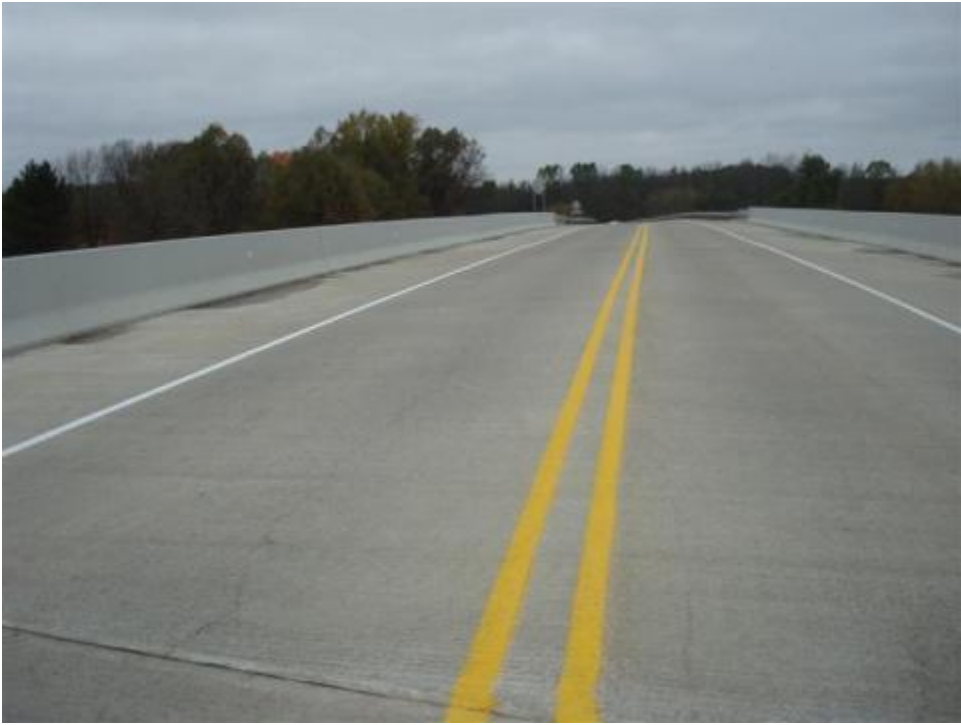
- Spread concrete box beams
- 2-span, continuous deck for live-loading, simply supported beams
- *Some fairly widespread transverse/vertical cracking is evident in the concrete barrier walls. The bottom of the deck/deck fascia does not have any signs of cracking. There is a large extent of transverse cracking in the area of the pier, near the middle of the bridge deck. Longitudinal cracking is evident throughout the bridge, spaced evenly at the same spacing of the beams.*

Figure 40. Bridge surface overall view (note longitudinal cracks)

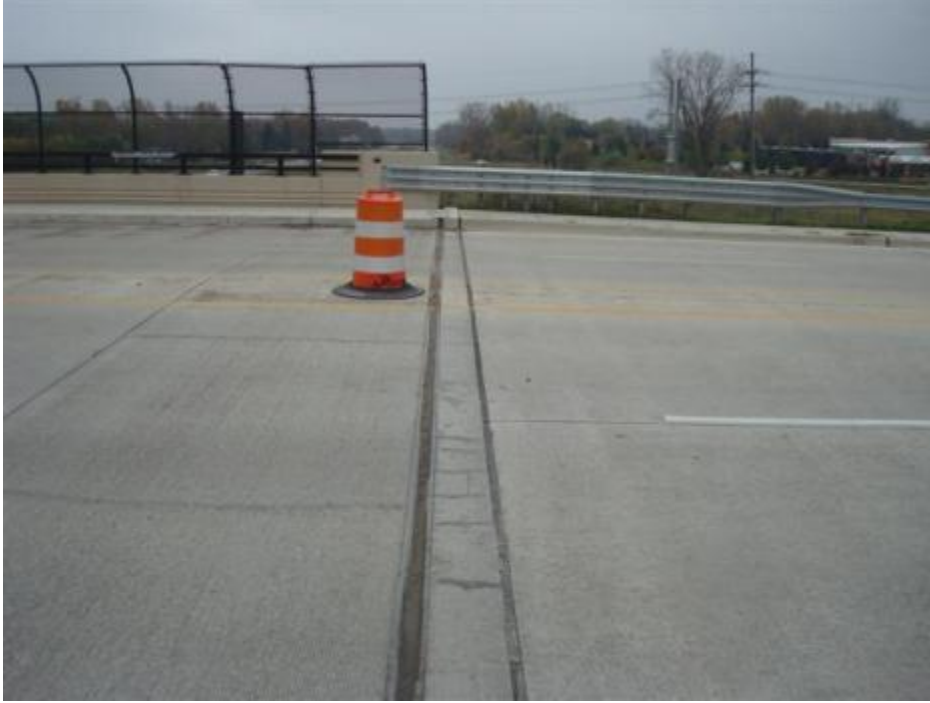
Figure 75. Longitudinal cracking in approach slab

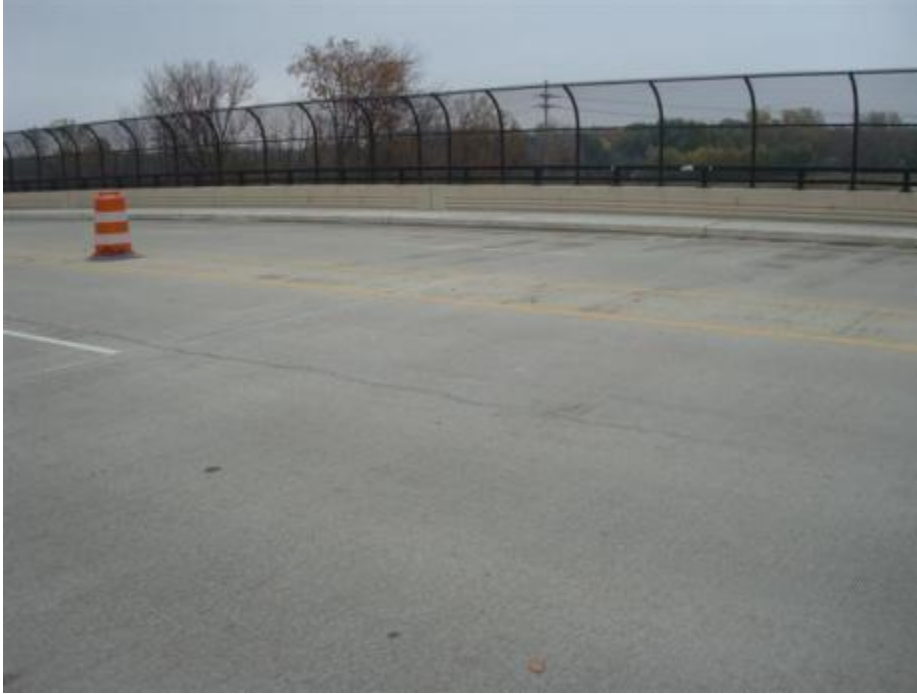
Figure 77. Large longitudinal crack in deck surface

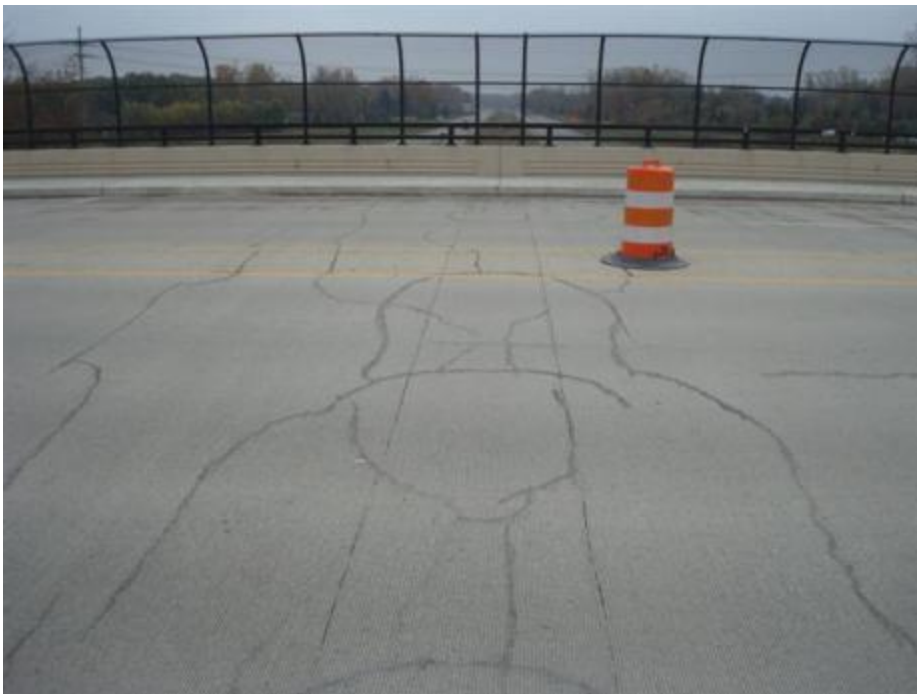
- Spread concrete box beams
- 2-span, non-integral abutment (beams are not cast into abutment), continuous deck for live load, SIP forms used
- *There is a heavy amount of transverse cracking in the area of the pier, and scattered longitudinal cracking throughout the bridge. The longitudinal cracking is spaced at the same spacing of the beams. There is also evenly-spaced transverse cracking in the sidewalk/barrier wall (spaced at 3-4')*

Figure 78. Heavy transverse cracking in pier area

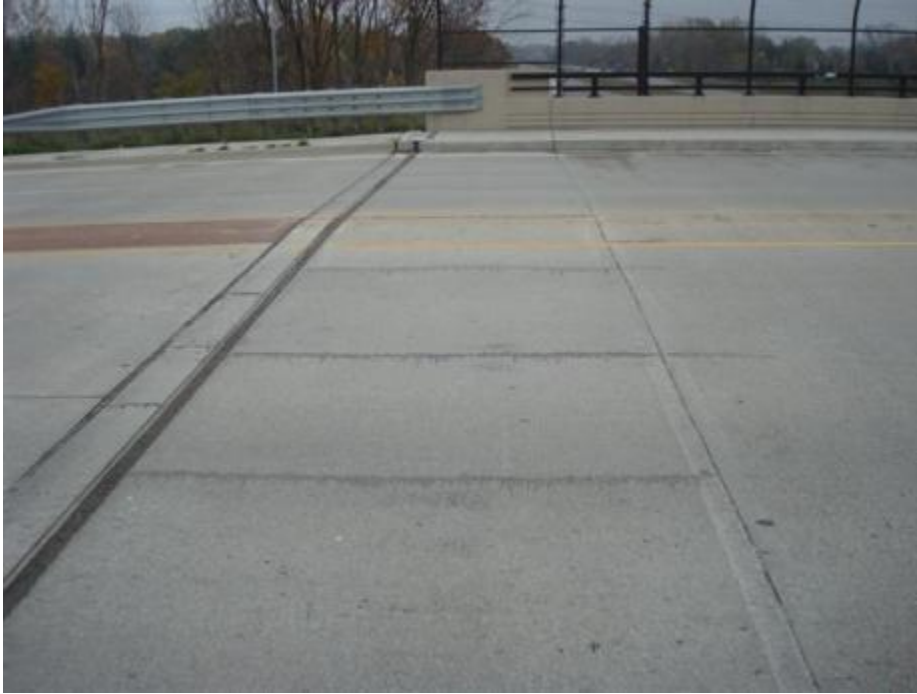
Figure 81. Almost identical cracking in opposite approach slab

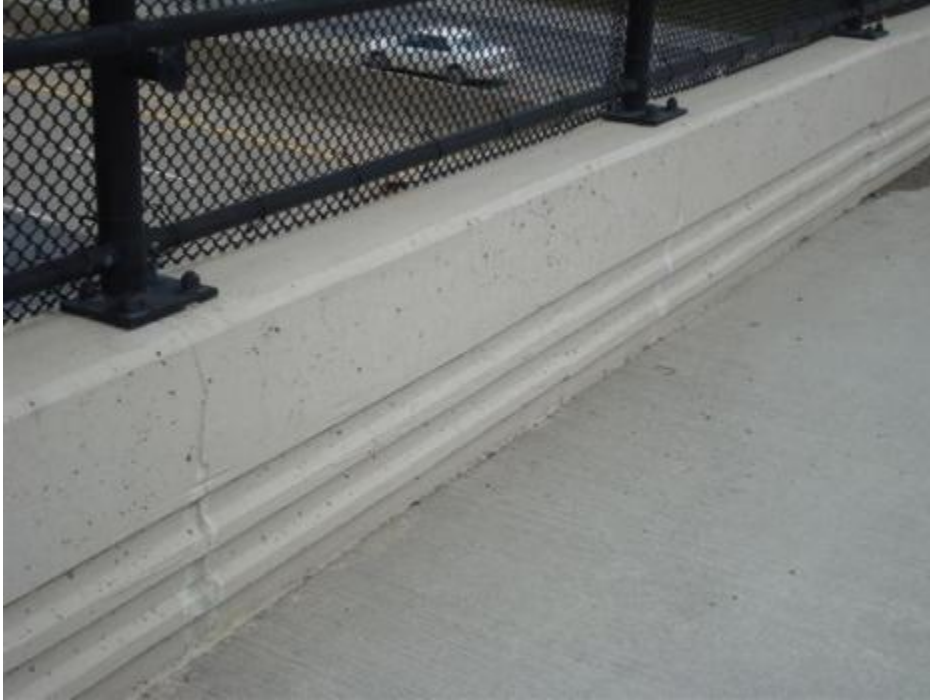
Figure 86. Cracking in barrier wall (typical)

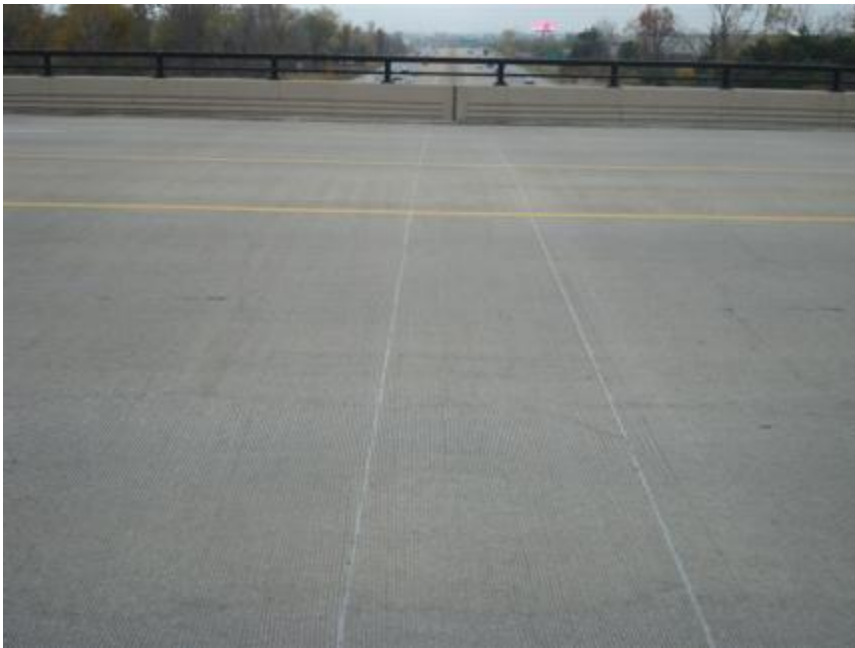
Figure 88. Longitudinal and transverse cracks in pier area

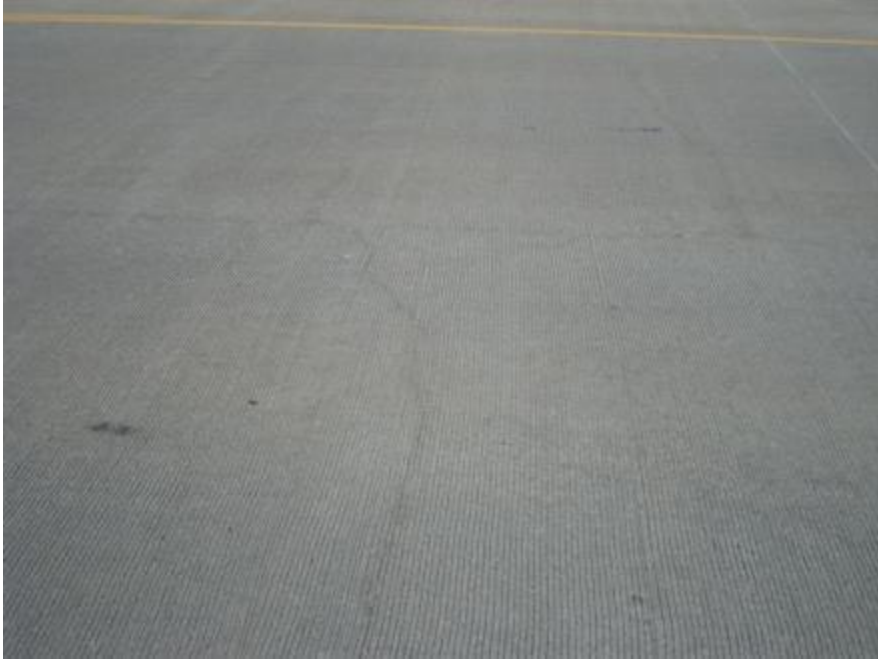
Figure 89. Transverse cracking in pier area

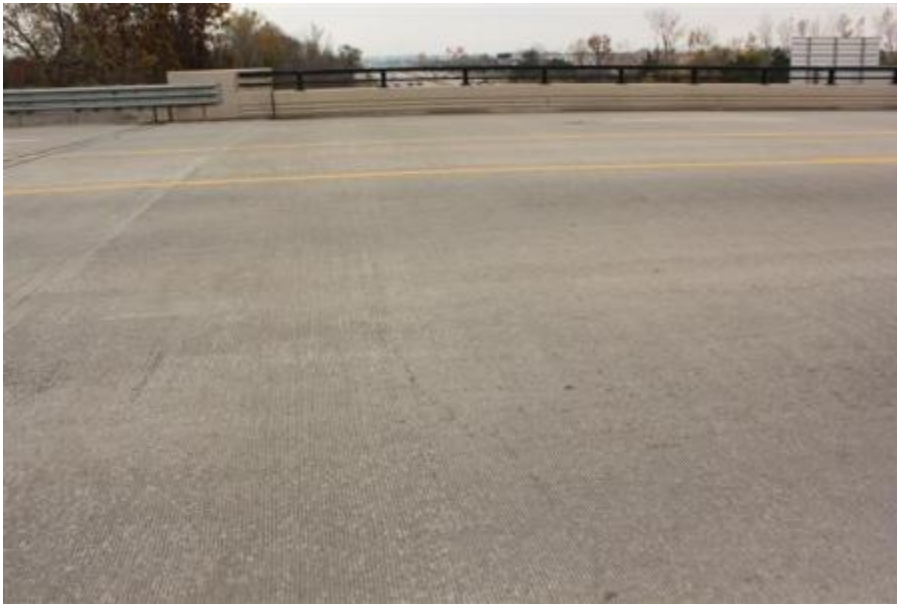
Figure 90. Transverse cracking in second span, near the abutment

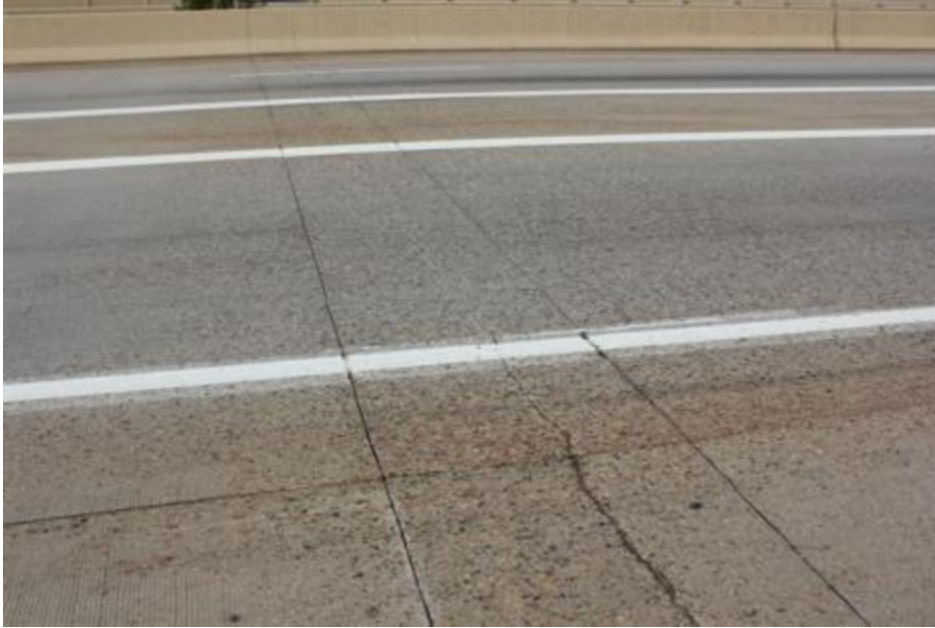
Figure 99. Transverse cracking bridge deck, near the abutment

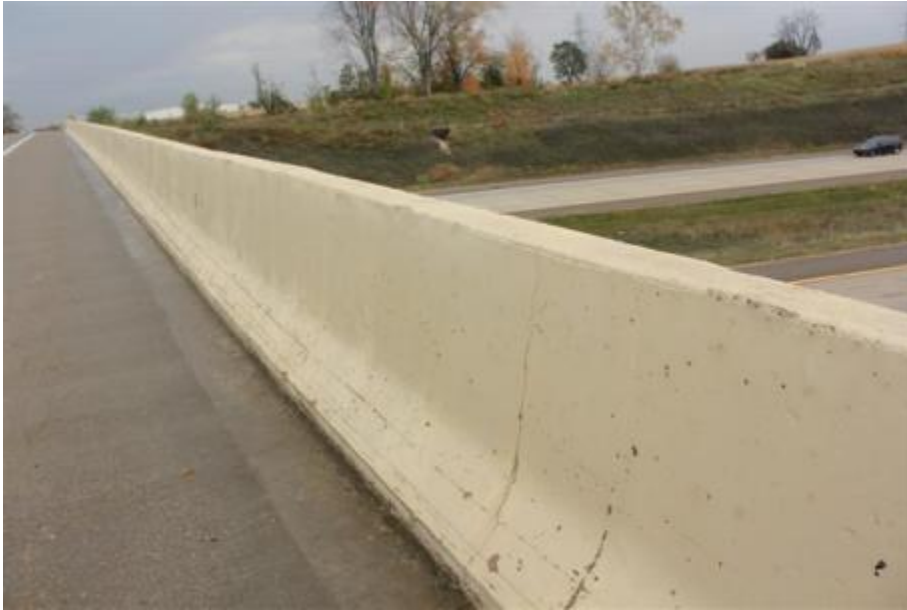
- Concrete I-girders (MI-1800)
- 2-span, continuous deck for live loading, integral abutment
- *Heavy amount of longitudinal cracking, spaced evenly at girder spacing through the entire bridge. Some transverse cracking evident at the approaches and in the middle by the pier. Random map cracking throughout.*

Figure 118. Cracking in barrier wall (typical)

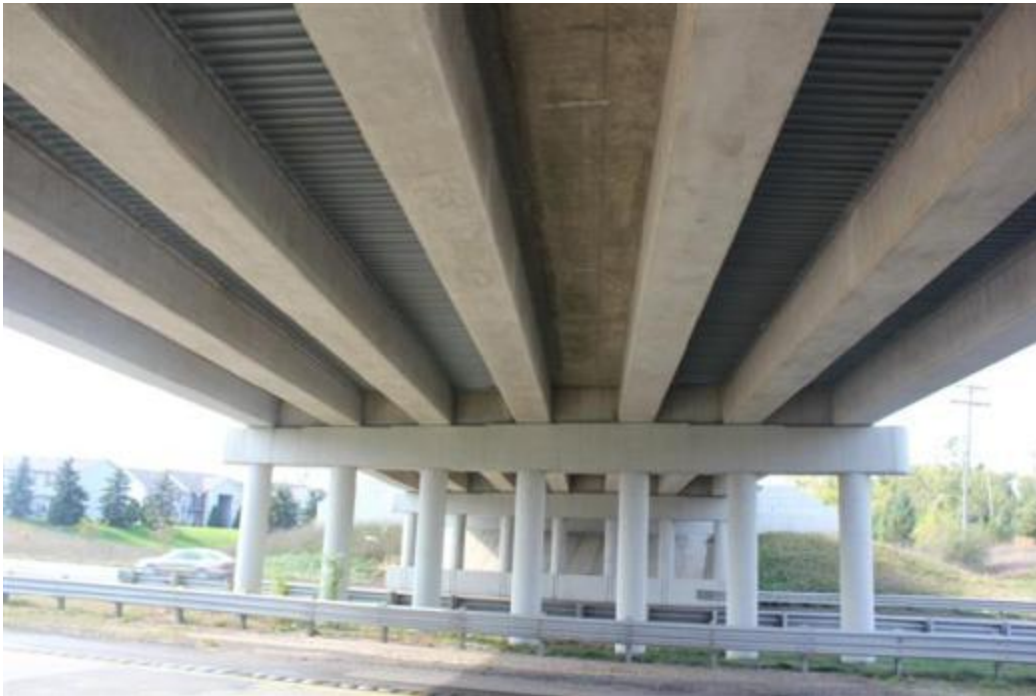
**Part-width construction may have had an effect on the cracking in this bridge*

Figure 132. Bridge underside detail (note part-width construction area without SIP forms)
