Evaluating Roadway Subsurface Drainage Practices – Phase II

Final Report
April 2015

IOWA STATE UNIVERSITY
Institute for Transportation

Sponsored by
Iowa Highway Research Board
(IHRB Project TR-662)
Iowa Department of Transportation
(InTrans Project 13-473)

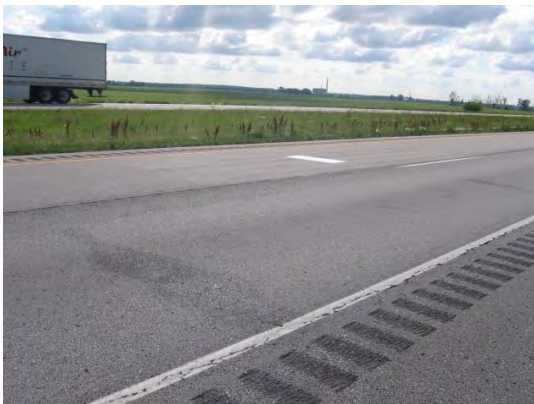
I-29/N/MP3.05/Fremont County

- Pavement type: HMA over JPCP (6.0 in HMA/8.0 in JPCP)
- Construction year: 2007 (overlay)/1972 (existing pavement)
- AADTT: 12,000
- Raveling/patching

Figure 25. Moisture-related damage observed on HMA over JPCP sites where no drainage outlet was found

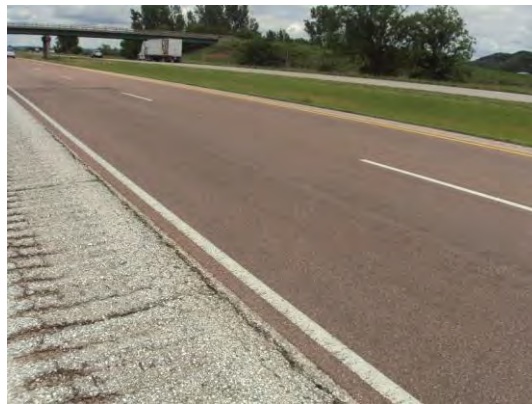
I-29/S/MP 28.45/Mills County

- Pavement type: HMA over JPCP (8.0 in HMA/8.0 in JPCP)
- Construction year: 1999(overlay)/1971 (existing pavement)
- AADTT: 12,000
- Rutting

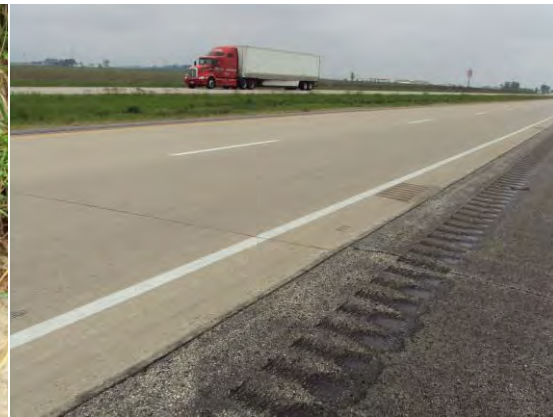
No pavement surface distress

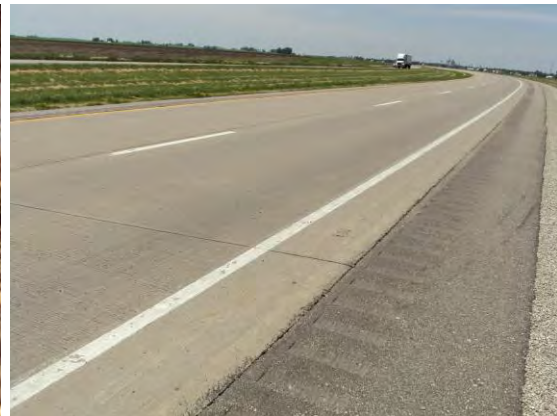
No pavement surface distress

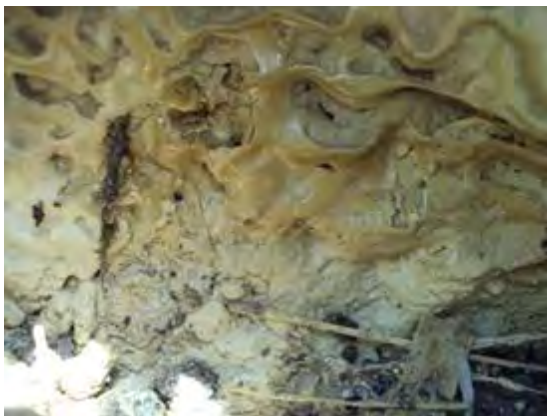
- Number of outlet pipe: 2
- Type of outlet pipe: Corrugated steel
- Size of outlet pipe: 6 inch
- Condition of outlet pipe: 100% blockage (tufa blockage)
- Water present inside outlet pipe: Yes (standing)
- Type of rodent guard: Gate screen
- Tufa/Dead zone (due to tufa) present: Yes
- Embankment slop condition: Less than 30 degree

Tufa blockage

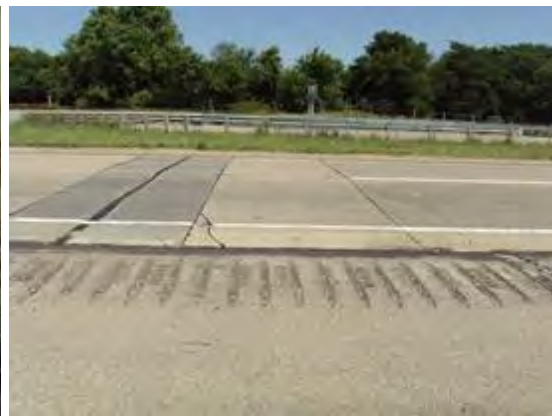
Transverse patching

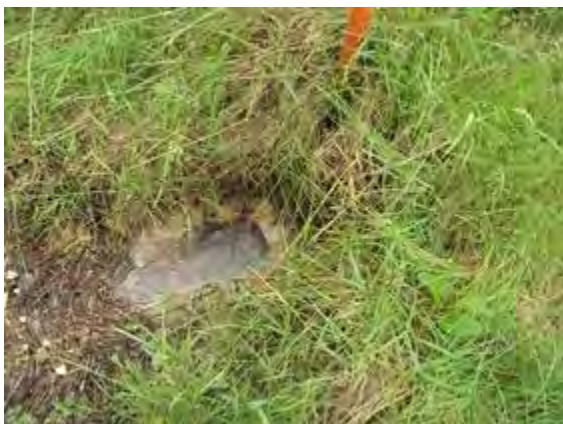
- Number of outlet pipe: 1
- Type of outlet pipe: Corrugated steel
- Size of outlet pipe: 6 inch
- Condition of outlet pipe: 90% blockage (soil blockage)
- Water present inside outlet pipe: Yes (standing)
- Type of rodent guard: Fork
- Tufa/Dead zone (due to tufa) present: Yes
- Embankment slop condition: Less than 30 degree
- Slope condition at outlet: Uphill

Soil backup

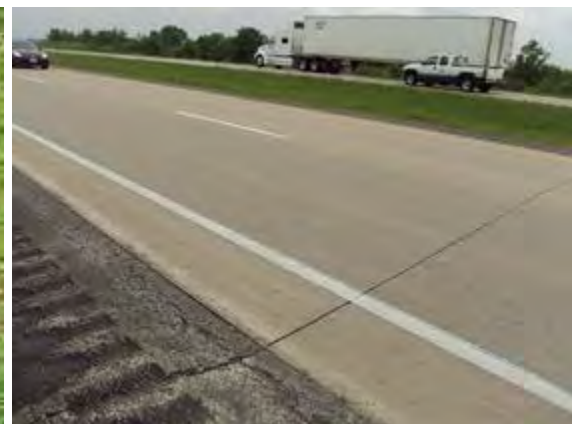
No pavement surface distress

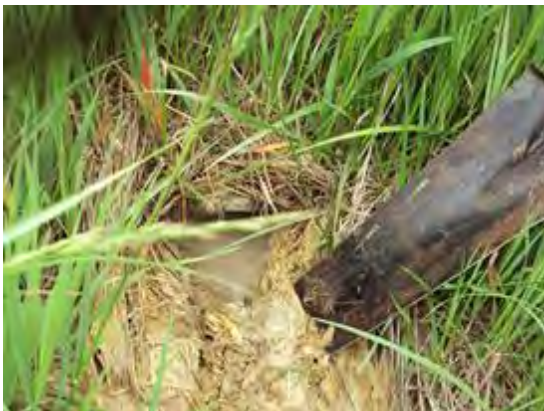
- Number of outlet pipe: 1
- Type of outlet pipe: Corrugated steel
- Size of outlet pipe: 6 inch
- Condition of outlet pipe: 50% blockage (tufa blockage and damaged)
- Water present inside outlet pipe: Yes (standing)
- Type of rodent guard: Fork
- Tufa/Dead zone (due to tufa) present: Yes
- Embankment slop condition: More than 30 degree
- Slope condition at outlet: Uphill

Tufa blockage

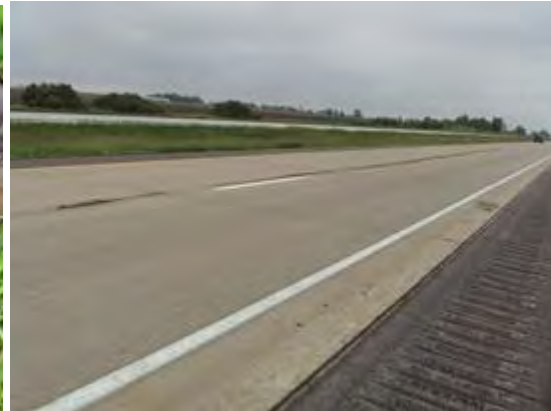
No pavement surface distress

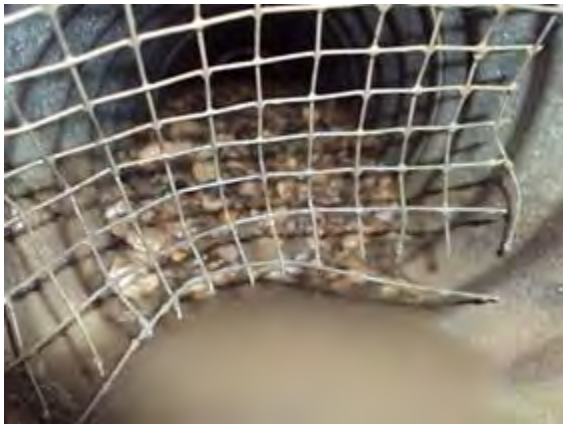
- Number of outlet pipe: 1
- Type of outlet pipe: Corrugated steel
- Size of outlet pipe: 6 inch
- Condition of outlet pipe: 20% blockage (sediment blockage)
- Water present inside outlet pipe: Yes (free flowing)
- Type of rodent guard: Gate
- Tufa/Dead zone (due to tufa) present: No
- Embankment slop condition: More than 30 degree
- Slope condition at outlet: Downhill

Sediment blockage

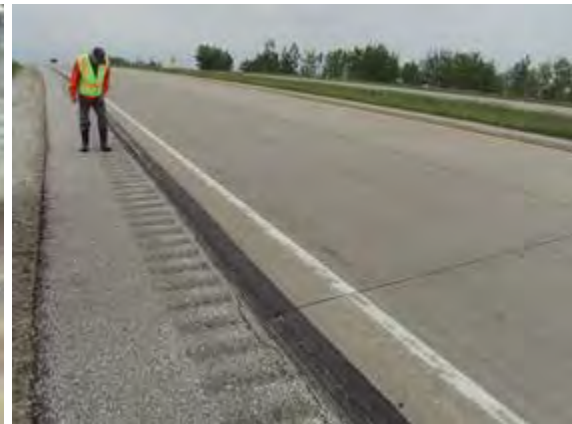
No pavement surface distress

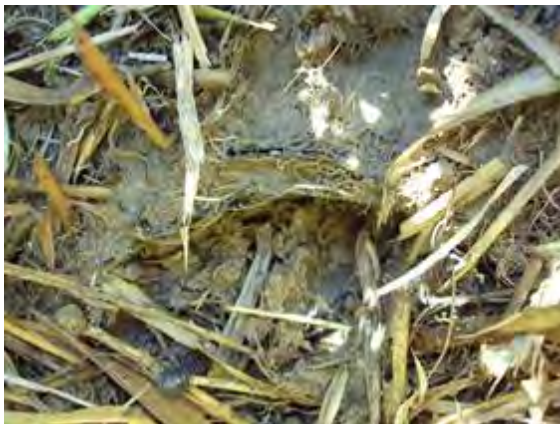
- Number of outlet pipe: 1
- Type of outlet pipe: Corrugated plastic
- Size of outlet pipe: 6 inch
- Condition of outlet pipe: 100% blockage (soil blockage)
- Water present inside outlet pipe: No
- Type of rodent guard: Gate
- Tufa/Dead zone (due to tufa) present: No
- Embankment slop condition: More than 30 degree
- Slope condition at outlet: Downhill

Covered pipe

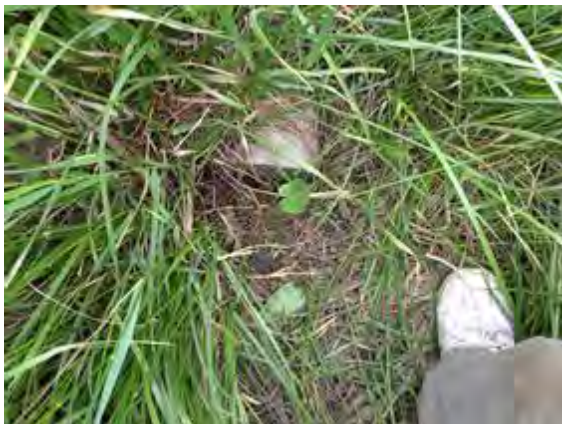
No blockage

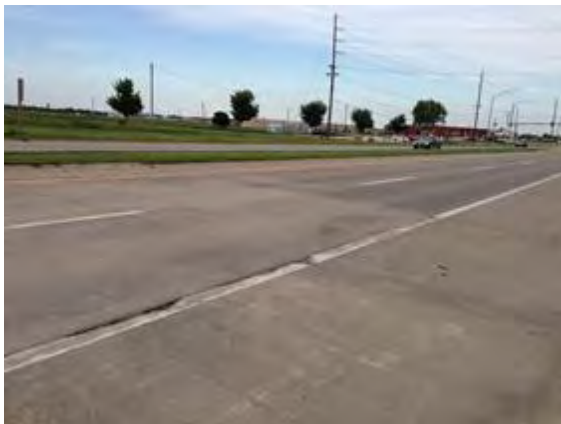
No pavement surface distress

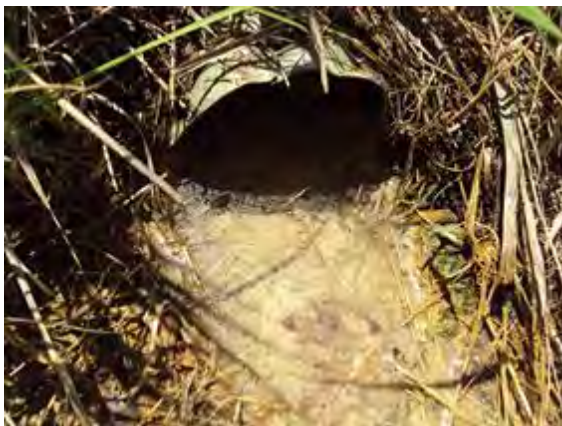
- Number of outlet pipe: 1
- Type of outlet pipe: Corrugated steel
- Size of outlet pipe: 6 inch
- Condition of outlet pipe: 10% blockage (tufa blockage)
- Water present inside outlet pipe: Yes (standing)
- Type of rodent guard: N/A
- Tufa/Dead zone (due to tufa) present: No
- Embankment slop condition: Less than 30 degree
- Slope condition at outlet: Parallel/Less than 1-ft. downhill

Tufa blockage

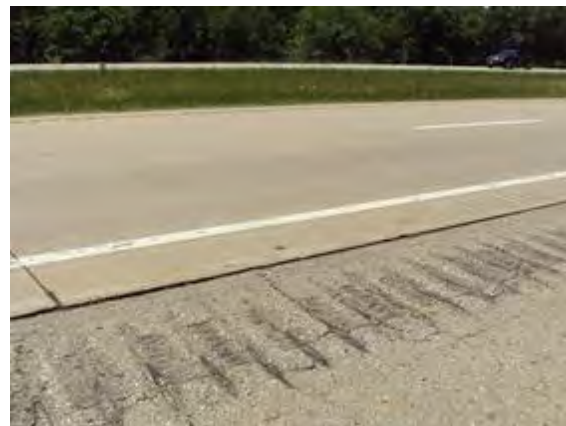
No pavement surface distress

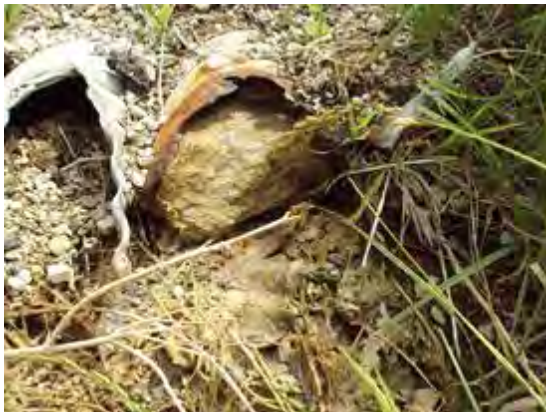
- Number of outlet pipe: 2
- Type of outlet pipe: Corrugated steel
- Size of outlet pipe: 6 inch
- Condition of outlet pipe: 95% blockage (tufa blockage and damaged)
- Water present inside outlet pipe: Yes (free flowing)
- Type of rodent guard: N/A
- Tufa/Dead zone (due to tufa) present: Yes
- Embankment slop condition: More than 30 degree
- Slope condition at outlet: Downhill

Tufa blockage

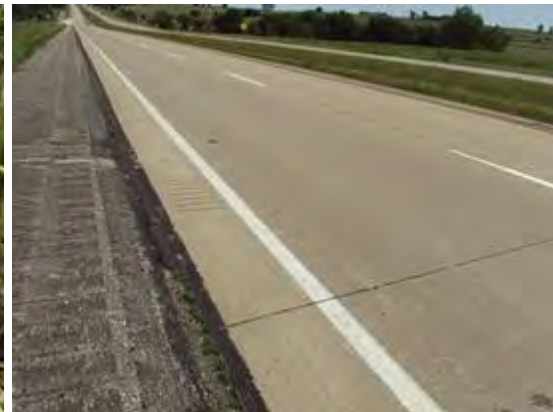
No pavement surface distress

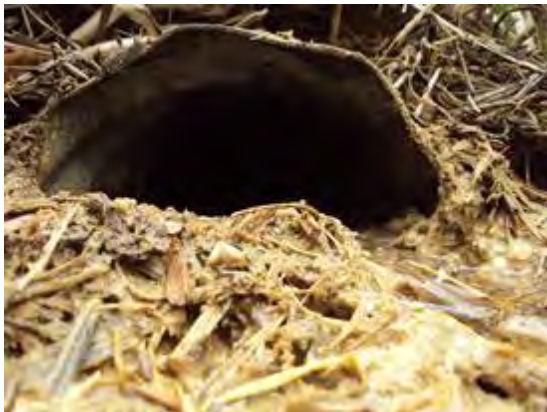
Tufa blockage

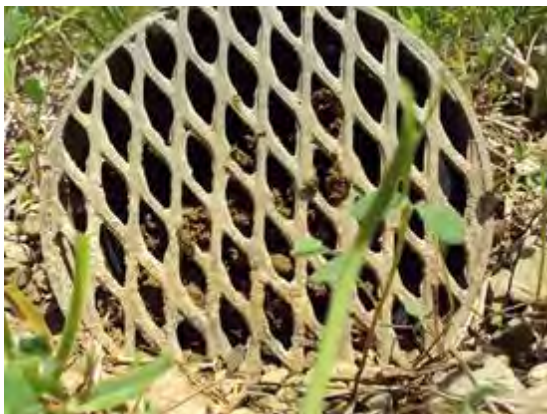
Sediment blockage

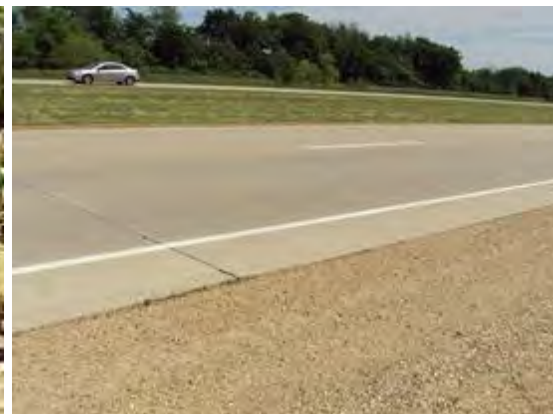
No pavement surface distress

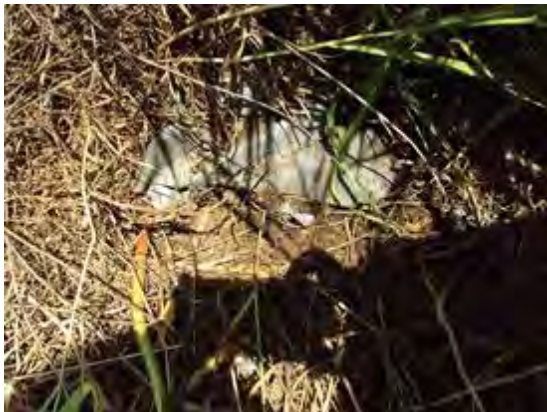
- End of the pipe is clamped shut

End clamped shut

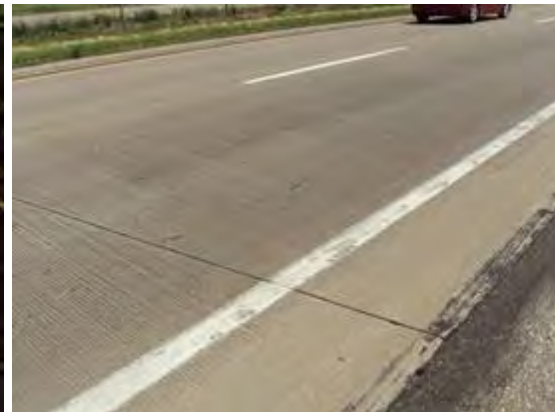
Longitudinal cracking

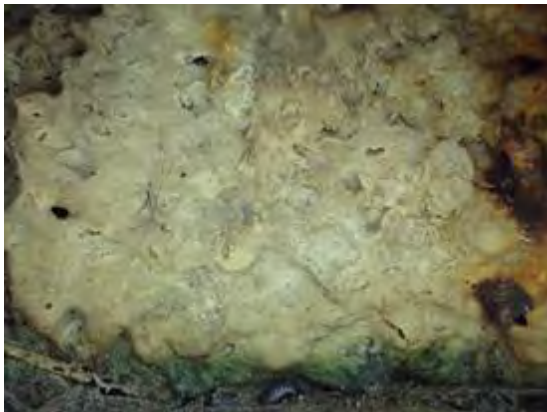
Tufa blockage

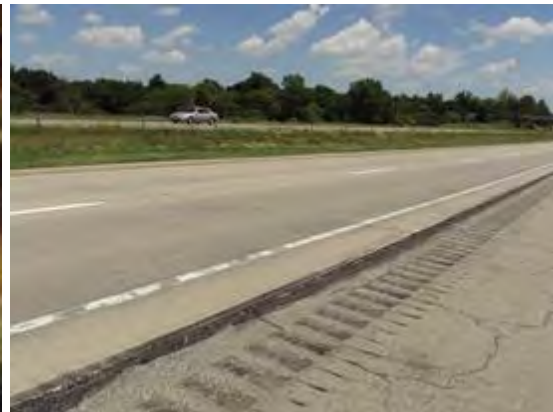
No pavement surface distress

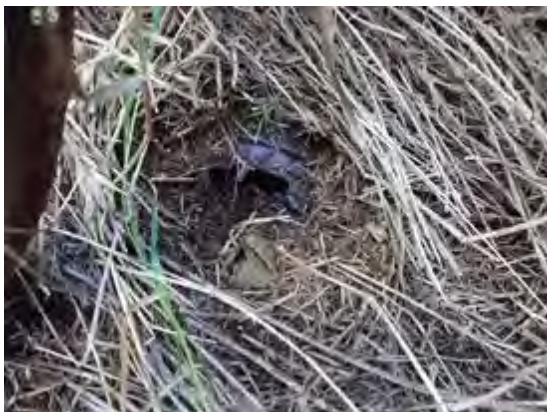
Soil blockage

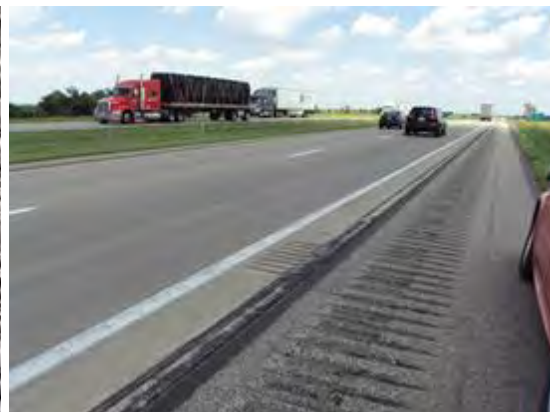
No pavement surface distress

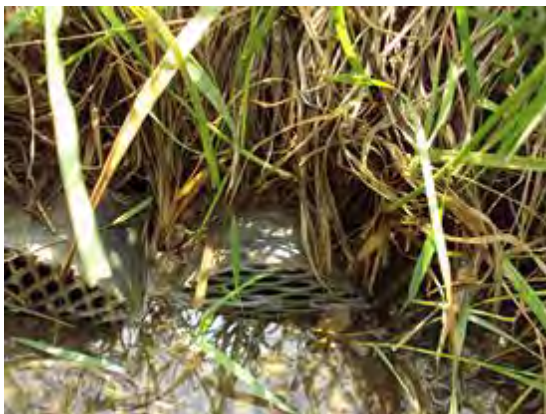
Soil blockage

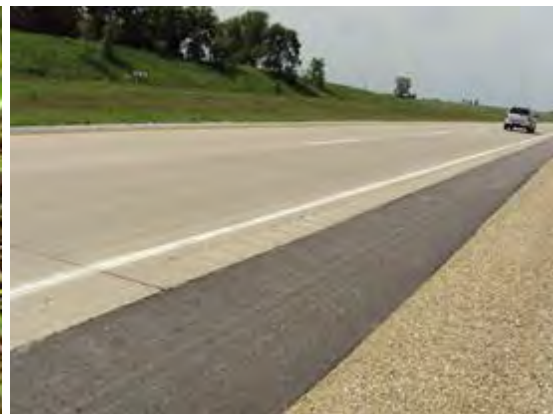
No pavement surface distress

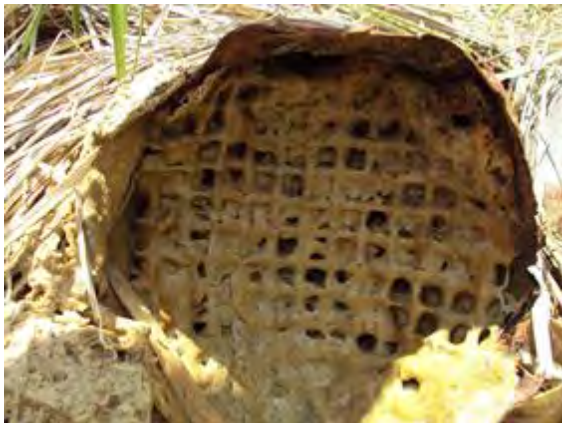
Tufa blockage

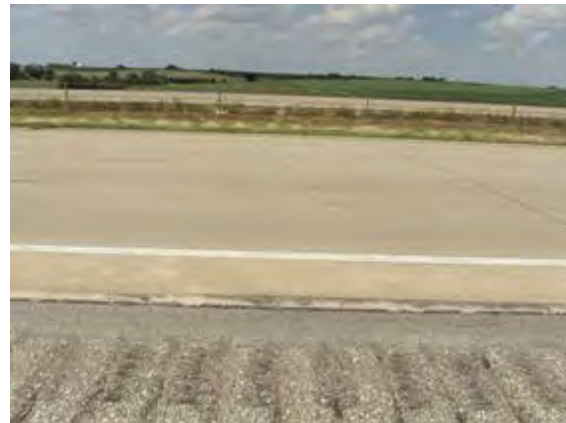
No pavement surface distress

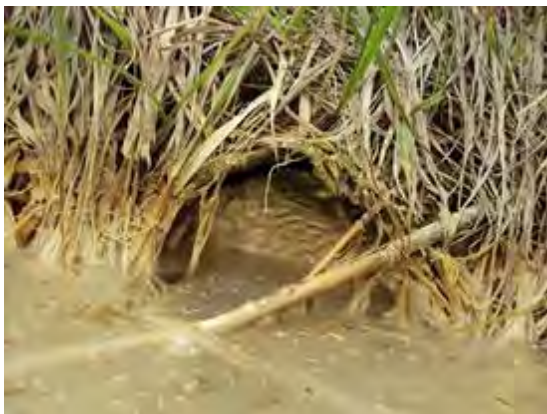
Tufa blockage

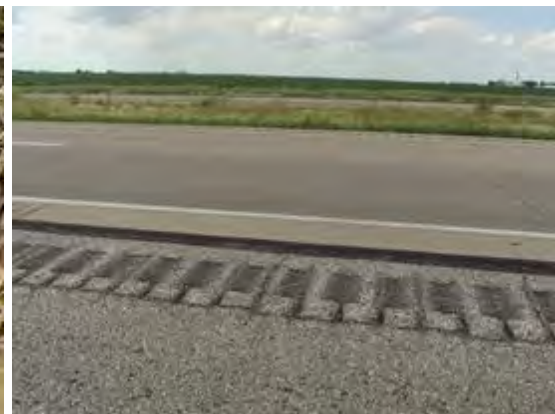
No pavement surface distress

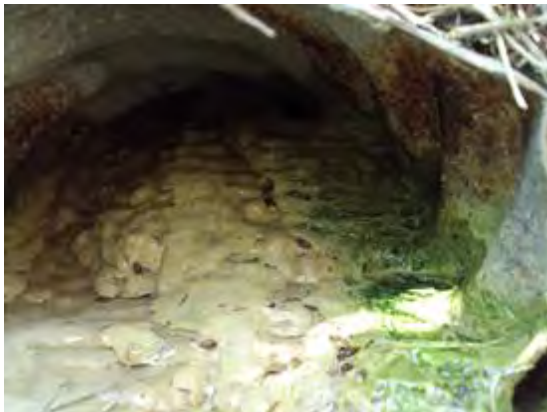
Tufa blockage

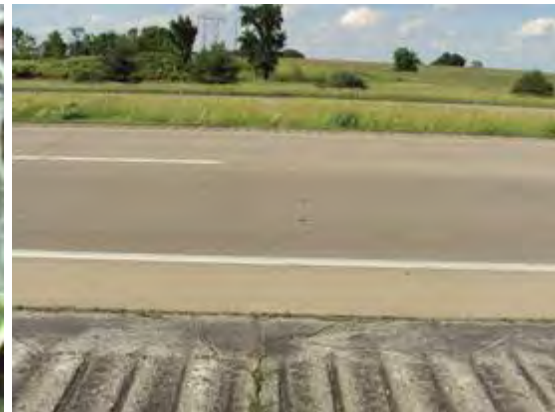
No pavement surface distress

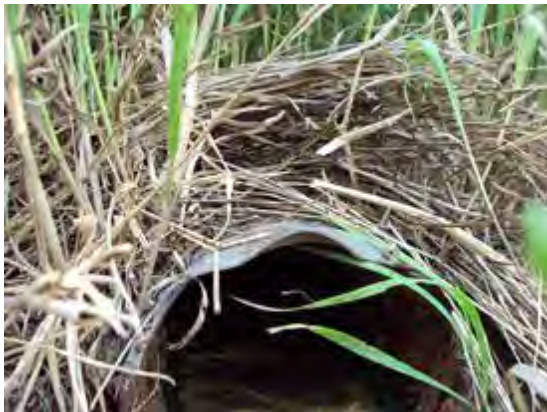
Tufa blockage

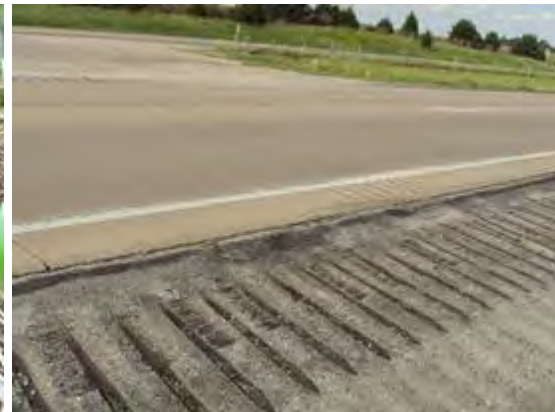
No pavement surface distress

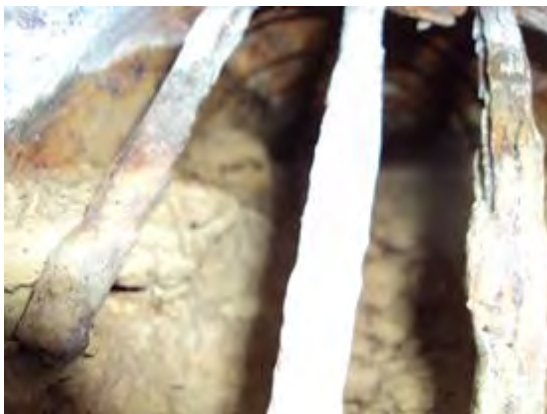
Tufa blockage

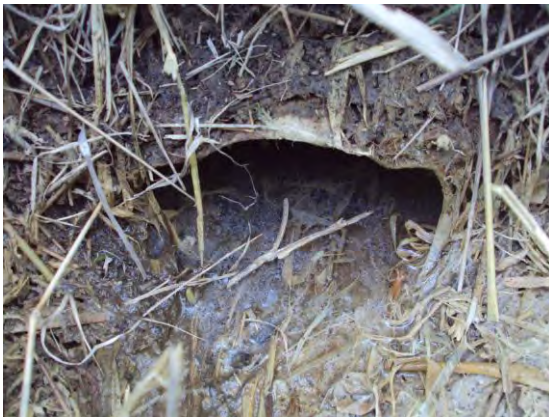
Tufa blockage

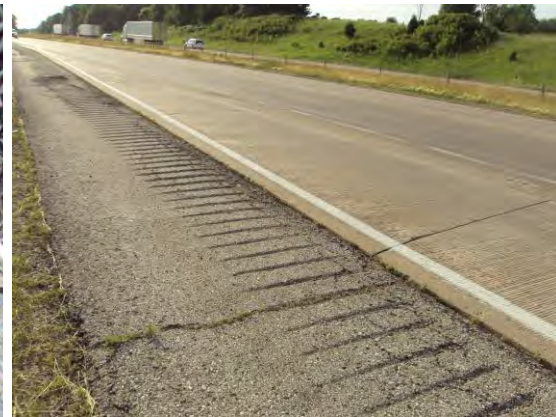
No pavement surface distress

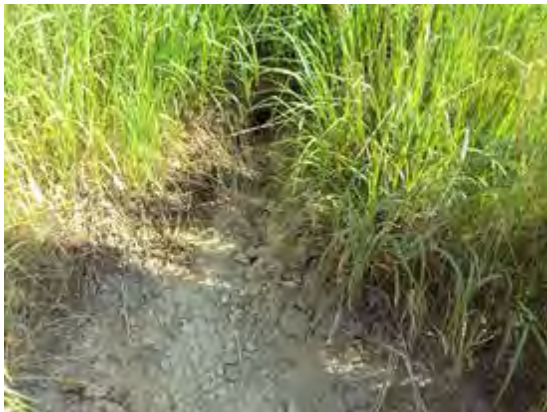
- Number of outlet pipe: 1
- Type of outlet pipe: Corrugated steel
- Size of outlet pipe: 6 inch
- Condition of outlet pipe: 40% blockage (tufa blockage)
- Water present inside outlet pipe: No
- Type of rodent guard: Fork
- Tufa/Dead zone (due to tufa) present: Yes
- Embankment slop condition: Less than 30 degree
- Slope condition at outlet: Parallel/Less than 1-ft. downhill

Tufa blockage and dead zone

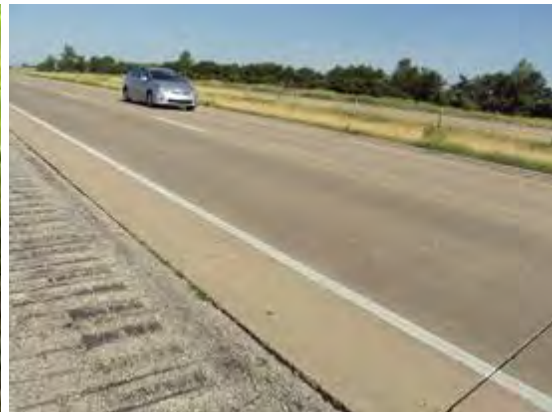
No pavement surface distress

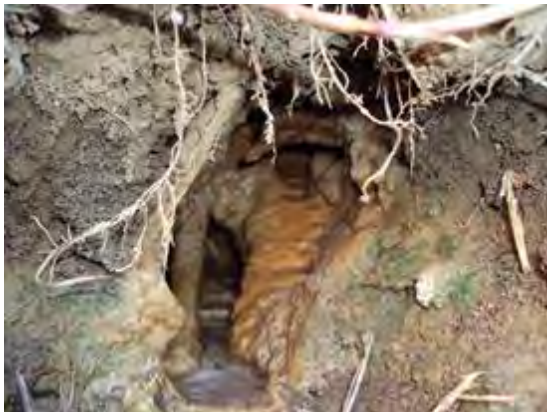
- Number of outlet pipe: 1
- Type of outlet pipe: Corrugated steel
- Size of outlet pipe: 6 inch
- Condition of outlet pipe: 95% blockage (tufa blockage)
- Water present inside outlet pipe: Yes (standing)
- Type of rodent guard: Fork
- Tufa/Dead zone (due to tufa) present: Yes
- Embankment slop condition: Less than 30 degree
- Slope condition at outlet: Downhill

Tufa blockage

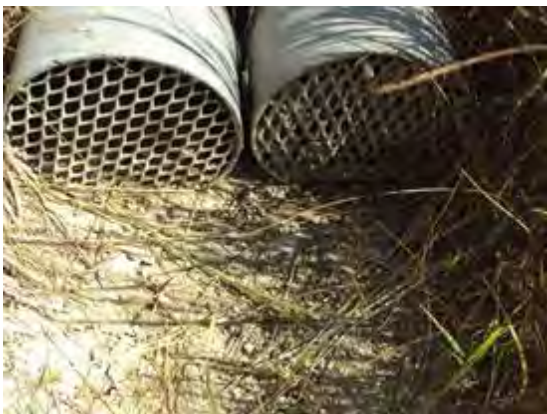
- Number of outlet pipe: 1
- Type of outlet pipe: Corrugated steel
- Size of outlet pipe: 6 inch
- Condition of outlet pipe: 20% blockage (tufa blockage)
- Water present inside outlet pipe: No
- Type of rodent guard: Gate
- Tufa/Dead zone (due to tufa) present: Yes
- Embankment slop condition: Less than 30 degree
- Slope condition at outlet: Parallel/Less than 1-ft. downhill

Tufa blockage

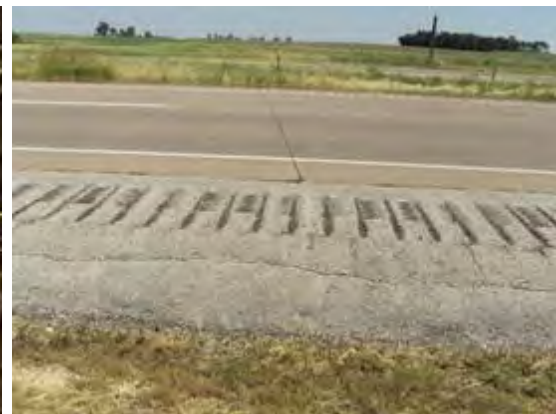
Pavement patching

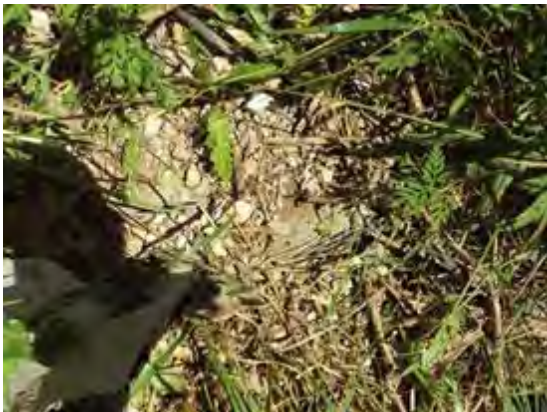
- Number of outlet pipe: 1
- Type of outlet pipe: Corrugated plastic
- Size of outlet pipe: 4 inch
- Condition of outlet pipe: 95% blockage (soil blockage)
- Water present inside outlet pipe: No
- Type of rodent guard: Gate
- Tufa/Dead zone (due to tufa) present: No
- Embankment slop condition: Less than 30 degree
- Slope condition at outlet: Downhill

Soil blockage

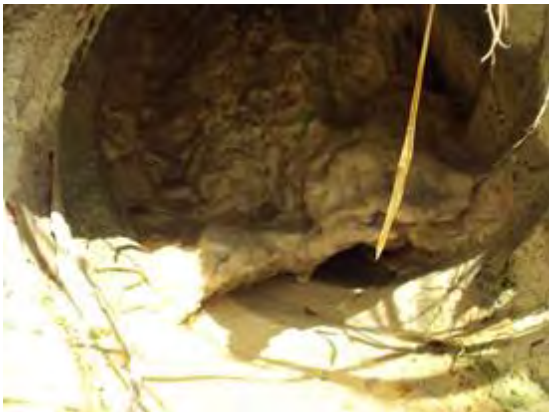
- Number of outlet pipe: 1
- Type of outlet pipe: Corrugated steel
- Size of outlet pipe: 6 inch
- Condition of outlet pipe: 95% blockage (tufa blockage)
- Water present inside outlet pipe: Yes (free flowing)
- Type of rodent guard: Fork
- Tufa/Dead zone (due to tufa) present: Yes
- Embankment slop condition: Less than 30 degree
- Slope condition at outlet: Downhill

Tufa blockage

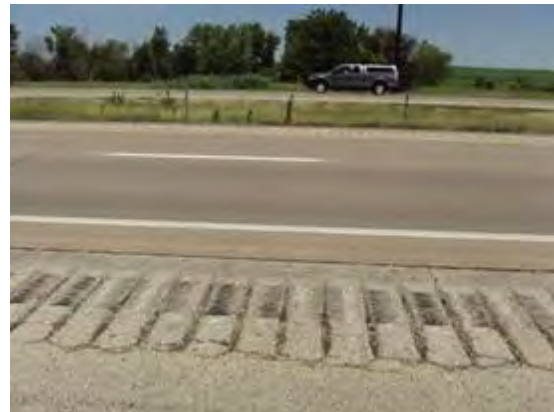
No pavement surface distress

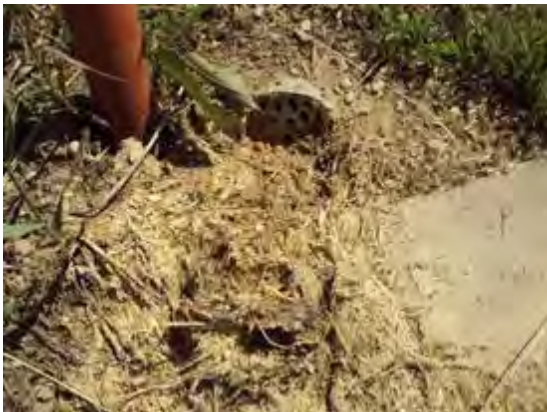
- Number of outlet pipe: 1
- Type of outlet pipe: Corrugated plastic
- Size of outlet pipe: 4 inch
- Condition of outlet pipe: 95% blockage (tufa blockage)
- Water present inside outlet pipe: No
- Type of rodent guard: Gate
- Tufa/Dead zone (due to tufa) present: Yes
- Embankment slop condition: Less than 30 degree
- Slope condition at outlet: Downhill

Tufa blockage

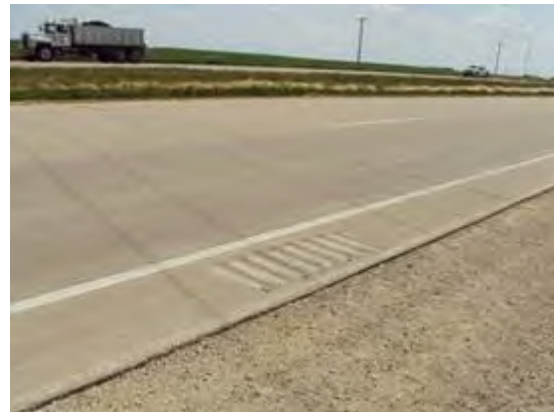
No pavement surface distress

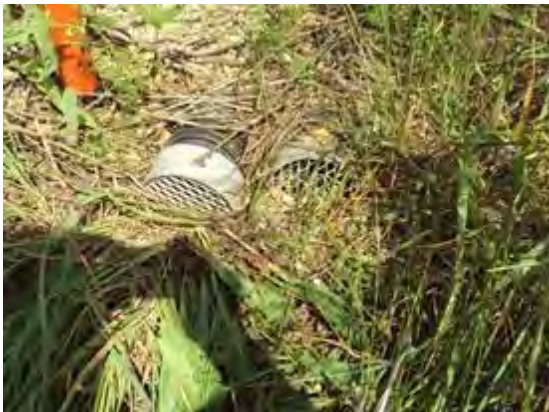
- Number of outlet pipe: 1
- Type of outlet pipe: Corrugated plastic
- Size of outlet pipe: 4 inch
- Condition of outlet pipe: 40% blockage (soil blockage)
- Water present inside outlet pipe: No
- Type of rodent guard: Gate
- Tufa/Dead zone (due to tufa) present: No
- Embankment slop condition: Less than 30 degree
- Slope condition at outlet: Parallel/Less than 1-ft. downhill

Soil blockage

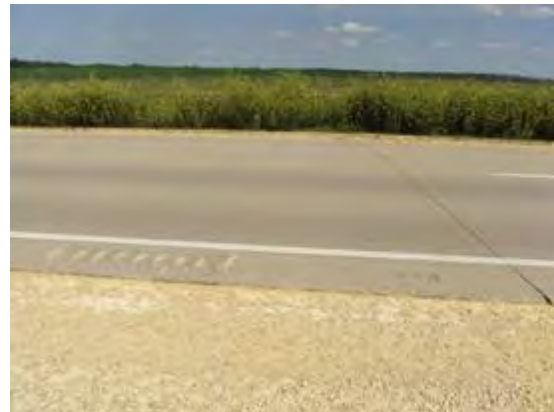
No pavement surface distress

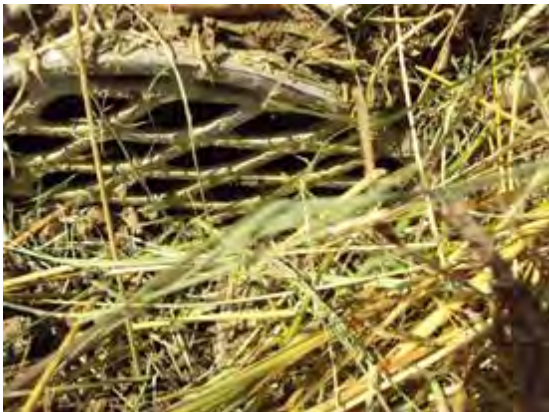
- Number of outlet pipe: 1
- Type of outlet pipe: Corrugated plastic
- Size of outlet pipe: 4 inch
- Condition of outlet pipe: 65% blockage (soil blockage)
- Water present inside outlet pipe: No
- Type of rodent guard: Gate
- Tufa/Dead zone (due to tufa) present: No
- Embankment slop condition: Less than 30 degree
- Slope condition at outlet: Parallel/Less than 1-ft. downhill

Soil blockage

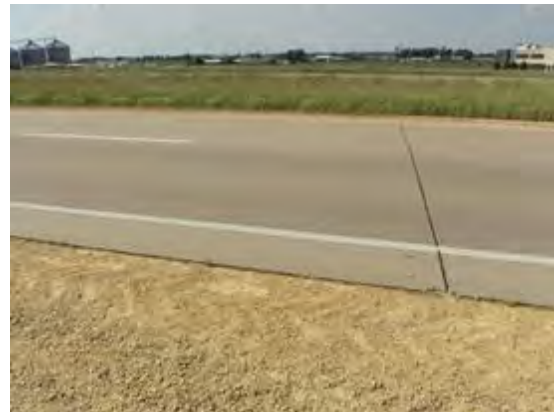
No pavement surface distress

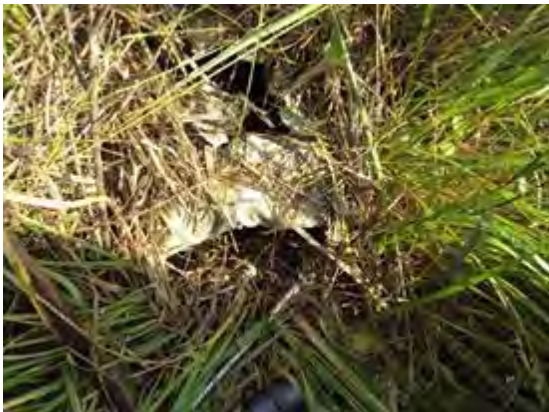
- Number of outlet pipe: 1
- Type of outlet pipe: Corrugated steel
- Size of outlet pipe: 6 inch
- Condition of outlet pipe: 50% blockage (soil blockage and damaged)
- Water present inside outlet pipe: No
- Type of rodent guard: Gate
- Tufa/Dead zone (due to tufa) present: No
- Embankment slop condition: Less than 30 degree
- Slope condition at outlet: Parallel/Less than 1-ft. downhill

Soil blockage

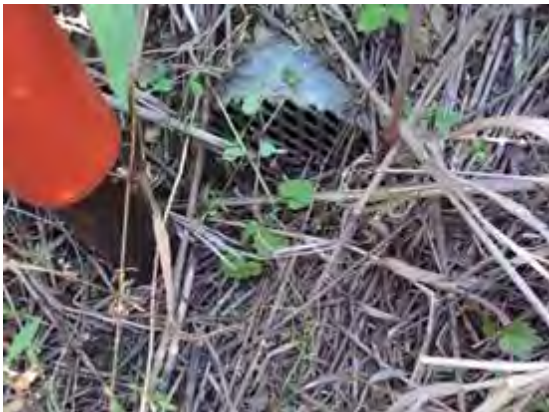
- Number of outlet pipe: 1
- Type of outlet pipe: Corrugated plastic
- Size of outlet pipe: 4 inch
- Condition of outlet pipe: 70% blockage (soil blockage)
- Water present inside outlet pipe: Yes (standing)
- Type of rodent guard: Gate
- Tufa/Dead zone (due to tufa) present: No
- Embankment slop condition: Less than 30 degree
- Slope condition at outlet: Parallel/Less than 1-ft. downhill

Soil blockage

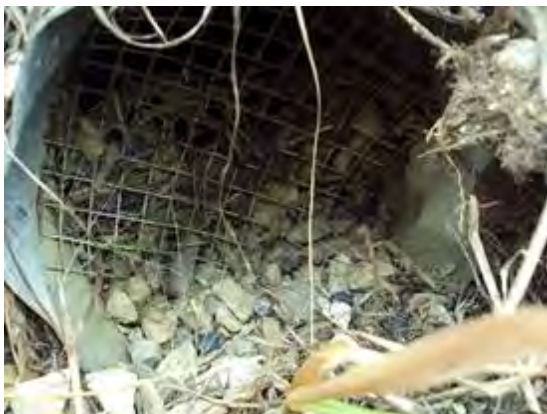
Sediment blockage

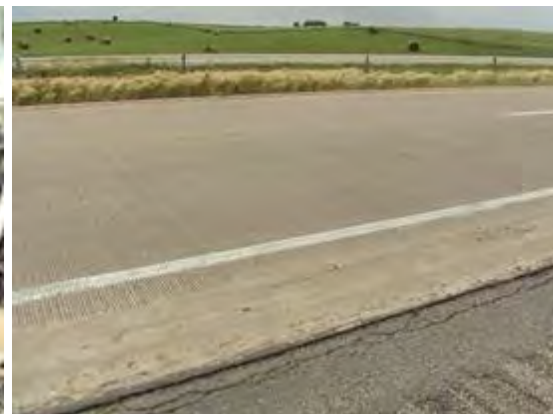
No pavement surface distress

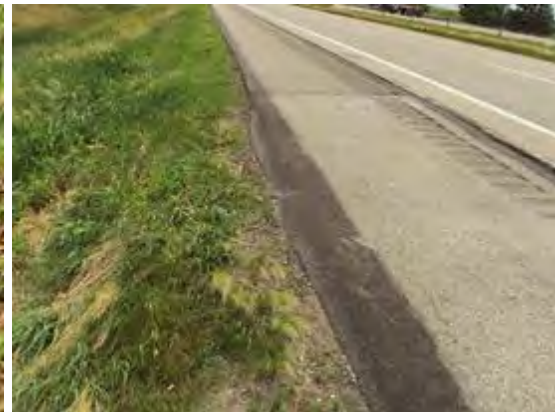
Slight shoulder dip

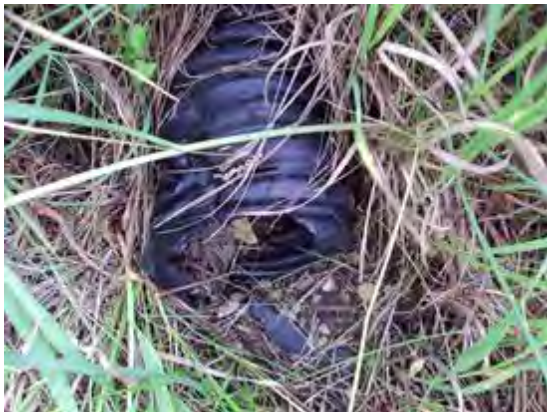
Sediment blockage

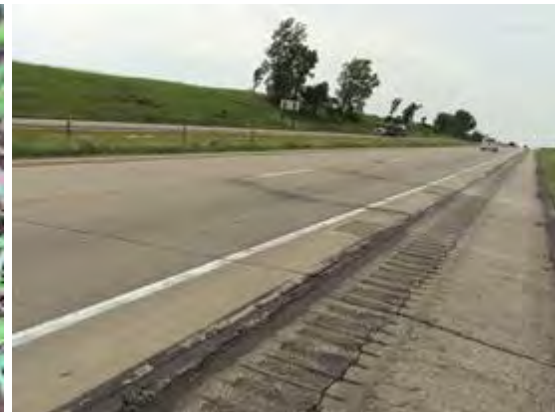
- Transverse cracks two slabs away

Transverse cracking

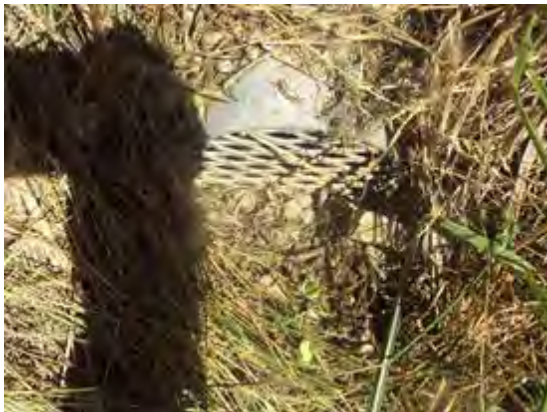
Soil blockage

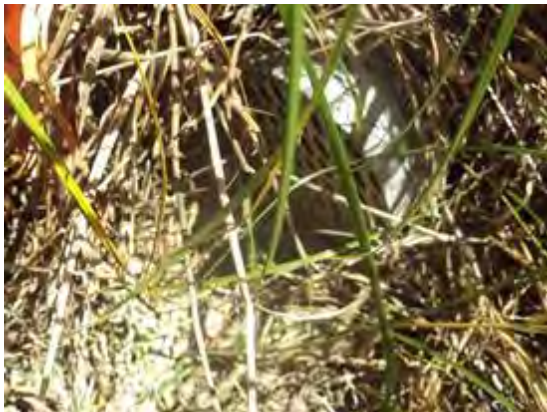
Sediment blockage

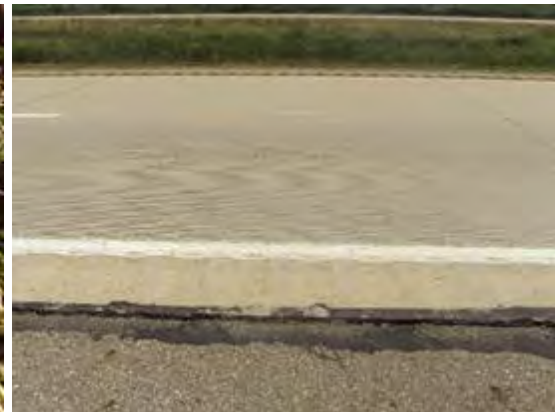
No pavement surface distress

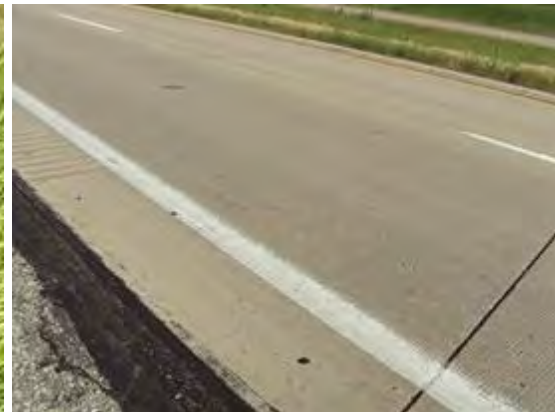
No pavement surface distress

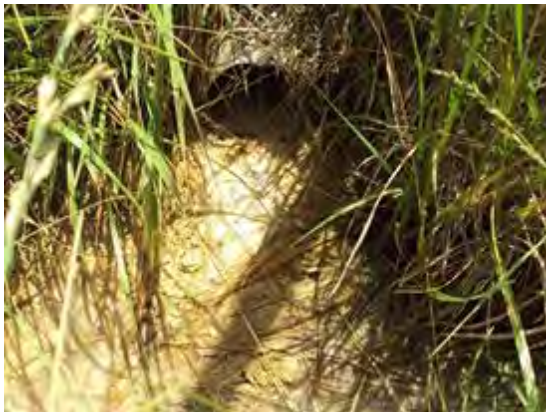
Tufa blockage

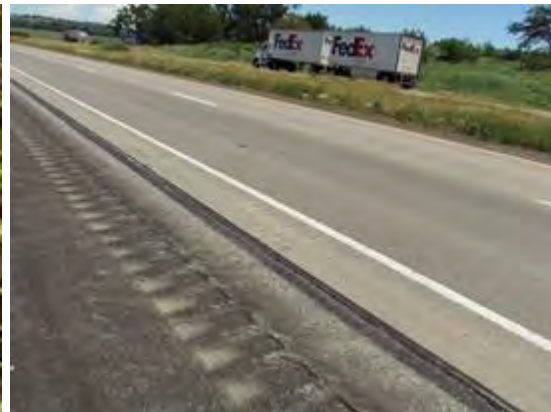
No pavement surface distress

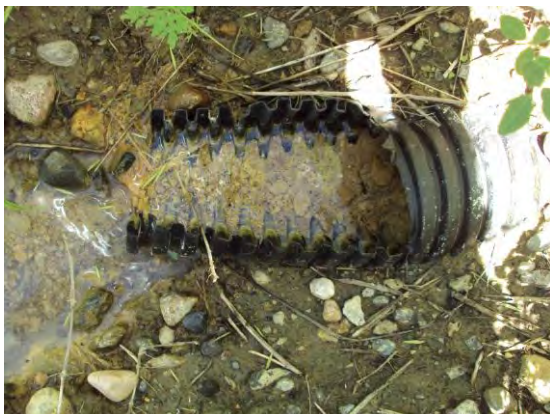
- Tufa in plastic pipe (only one observation in all inspected locations)

Tufa blockage

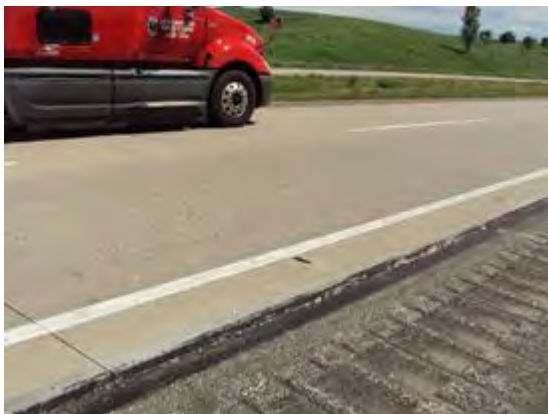
No pavement surface distress

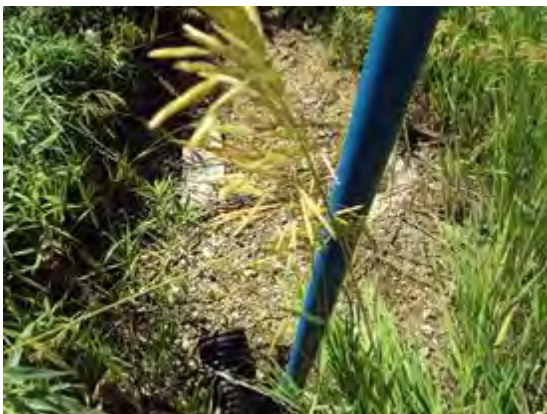
- New installation

No blockage

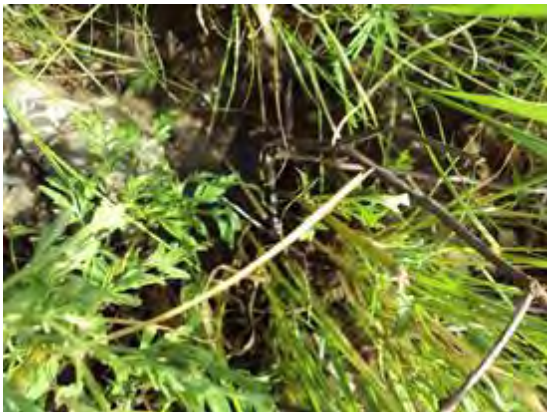
Soil blockage

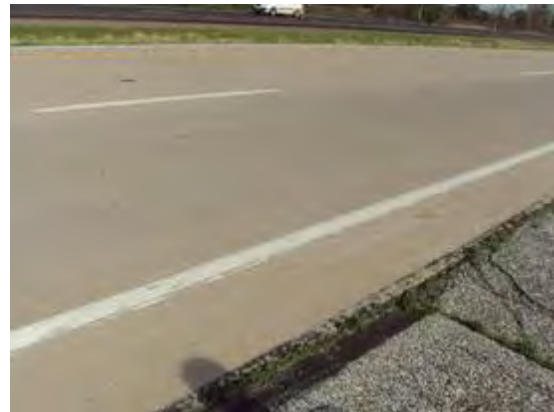
No distress

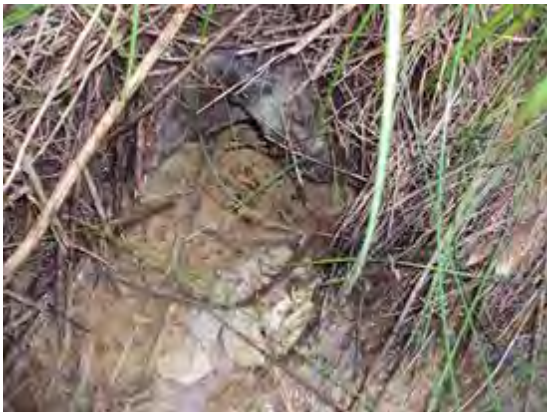
Tufa blockage

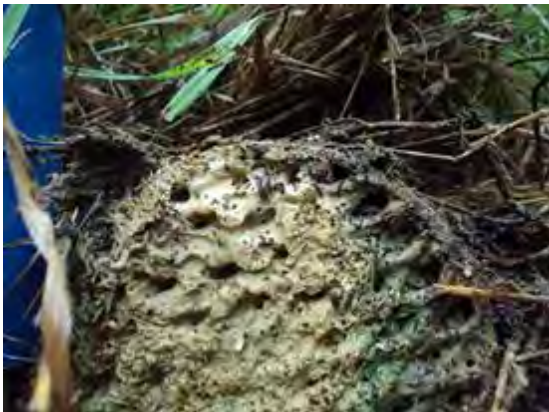
Tufa blockage

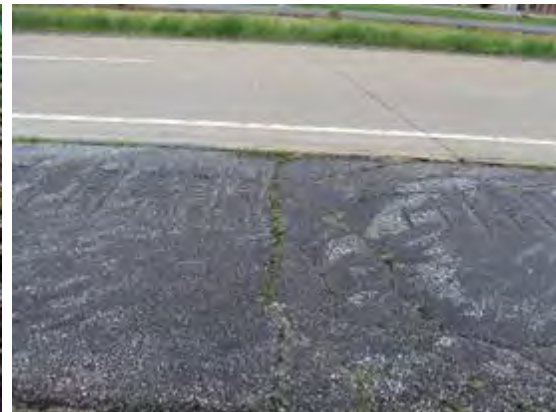
No pavement surface distress

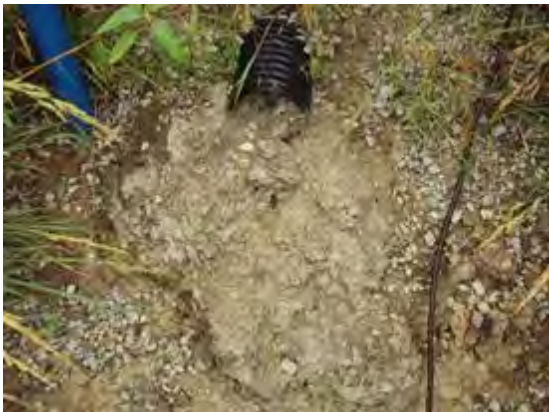
I-80/E/MP8.64

- Number of outlet pipe: 1
- Type of outlet pipe: Corrugated plastic
- Size of outlet pipe: 4 inch
- Condition of outlet pipe: 90% blockage (tufa blockage)
- Water present inside outlet pipe: Yes (standing)
- Type of rodent guard: N/A
- Tufa/Dead zone (due to tufa) present: Yes
- Embankment slop condition: More than 30 degree
- Slope condition at outlet: Downhill

Tufa blockage

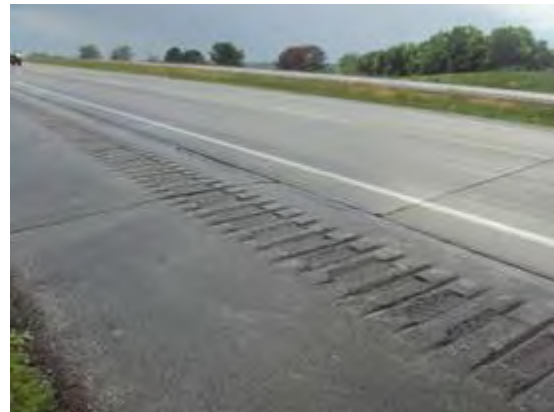
No pavement surface distress

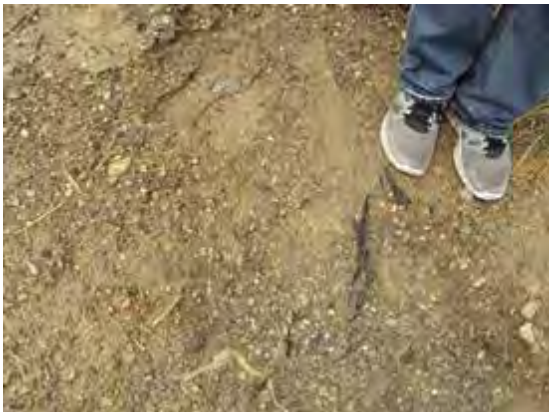
I-80/E/MP27.53

- Potential break higher up in pipe

Water flowing out of ground

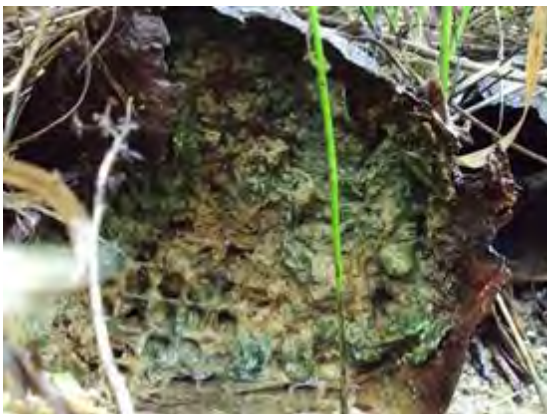
I-80/E/MP35.10

- Number of outlet pipe: 1
- Type of outlet pipe: Corrugated steel
- Size of outlet pipe: 6 inch
- Condition of outlet pipe: 100% blockage (tufa blockage)
- Water present inside outlet pipe: Yes (standing)
- Type of rodent guard: Gate
- Tufa/Dead zone (due to tufa) present: Yes
- Embankment slop condition: Less than 30 degree
- Slope condition at outlet: Parallel/Less than 1-ft. downhill

Tufa blockage

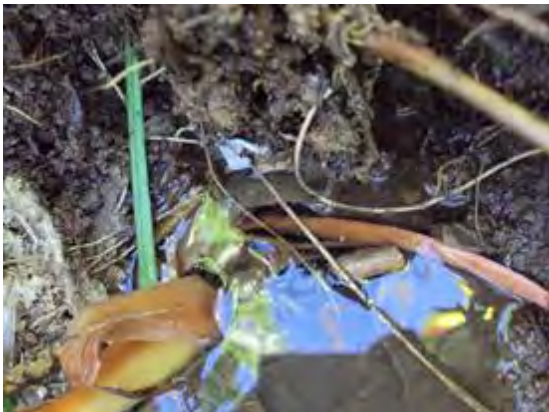
- Number of outlet pipe: 1
- Type of outlet pipe: Corrugated steel
- Size of outlet pipe: 6 inch
- Condition of outlet pipe: 100% blockage (soil blockage)
- Water present inside outlet pipe: Yes (standing)
- Type of rodent guard: Fork
- Tufa/Dead zone (due to tufa) present: Yes
- Embankment slop condition: Less than 30 degree
- Slope condition at outlet: Uphill

Soil blockage

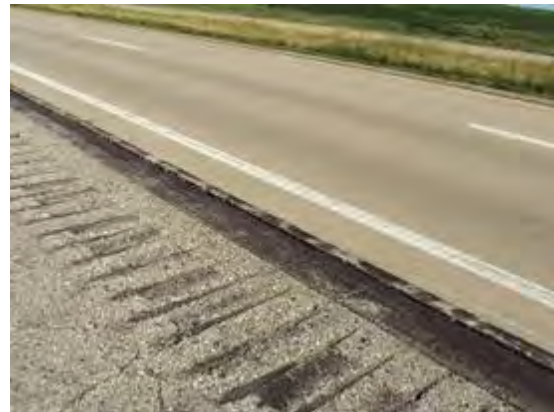
No pavement surface distress

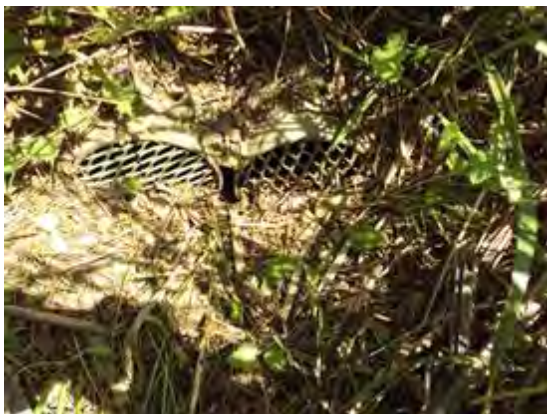
- Number of outlet pipe: 2
- Type of outlet pipe: Corrugated plastic
- Size of outlet pipe: 4 inch
- Condition of outlet pipe: 40% blockage (soil blockage)
- Water present inside outlet pipe: No
- Type of rodent guard: Gate
- Tufa/Dead zone (due to tufa) present: No
- Embankment slop condition: Less than 30 degree
- Slope condition at outlet: Downhill

Soil blockage

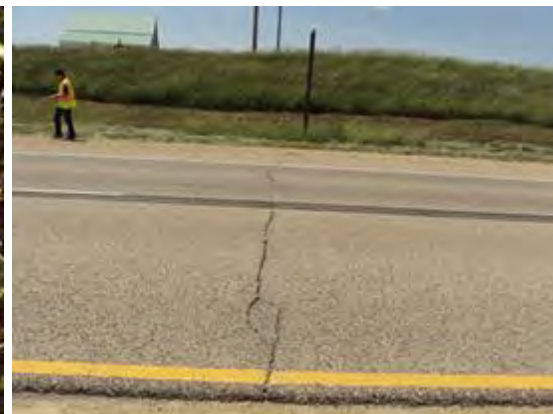
- Transverse cracking

Transverse cracking

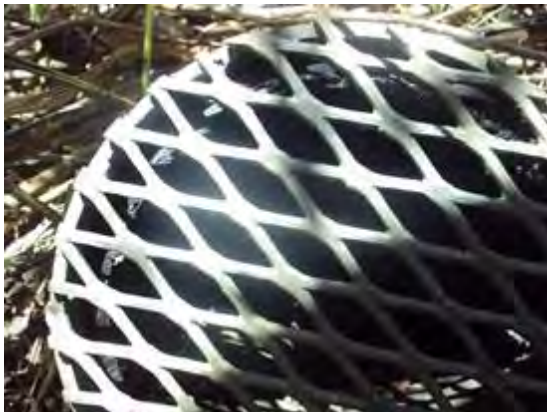
IA 60/E/MP 46.94

- Number of outlet pipe: 2
- Type of outlet pipe: Corrugated plastic
- Size of outlet pipe: 4 inch
- Condition of outlet pipe: 10% blockage (sediment blockage)
- Water present inside outlet pipe: No
- Type of rodent guard: Gate
- Tufa/Dead zone (due to tufa) present: No
- Embankment slop condition: Less than 30 degree
- Slope condition at outlet: Downhill

Sediment blockage

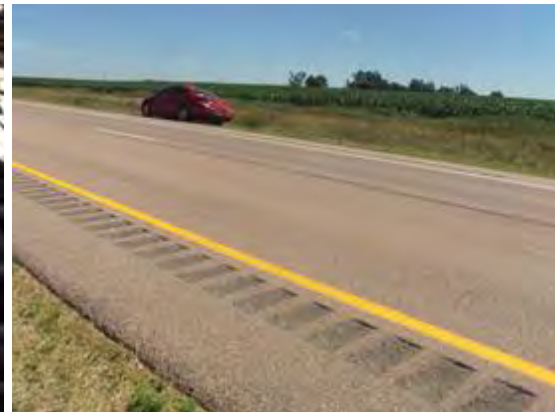
No pavement surface distress

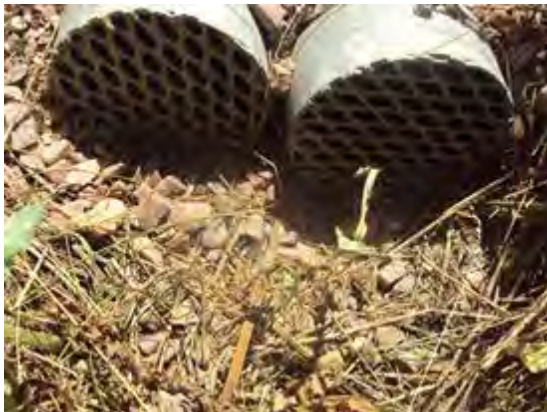
IA 60/W/MP 43.04

- Number of outlet pipe: 2
- Type of outlet pipe: Corrugated plastic
- Size of outlet pipe: 4 inch
- Condition of outlet pipe: 20% blockage (soil blockage)
- Water present inside outlet pipe: No
- Type of rodent guard: Gate
- Tufa/Dead zone (due to tufa) present: No
- Embankment slop condition: Less than 30 degree
- Slope condition at outlet: Downhill

Soil blockage
