Evaluating Roadway Subsurface Drainage Practices – Phase II

Final Report
April 2015

IOWA STATE UNIVERSITY
Institute for Transportation

Sponsored by
Iowa Highway Research Board
(IHRB Project TR-662)
Iowa Department of Transportation
(InTrans Project 13-473)

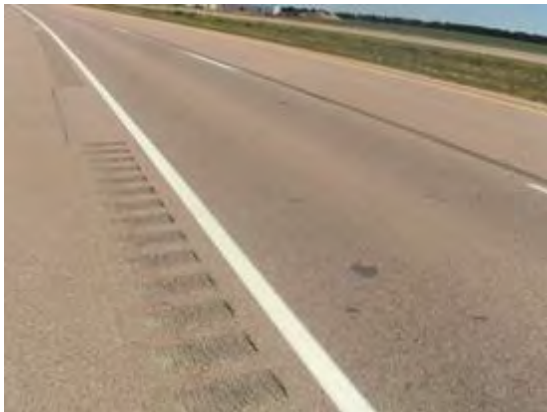
No pavement surface distress

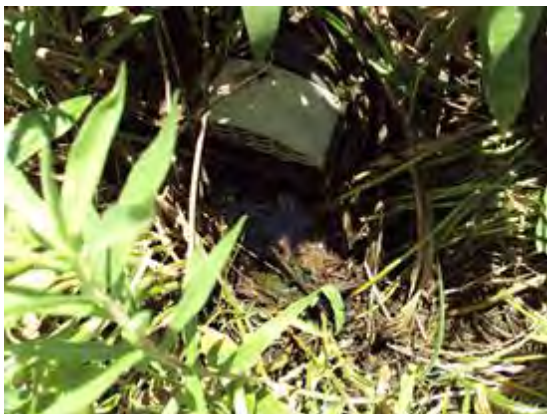
US 30/W/MP 57.28

- Number of outlet pipe: 1
- Type of outlet pipe: Corrugated plastic
- Size of outlet pipe: 4 inch
- Condition of outlet pipe: 20% blockage (soil blockage)
- Water present inside outlet pipe: Yes (free flowing)
- Type of rodent guard: Gate
- Tufa/Dead zone (due to tufa) present: No
- Embankment slop condition: More than 30 degree
- Slope condition at outlet: Downhill

Soil blockage

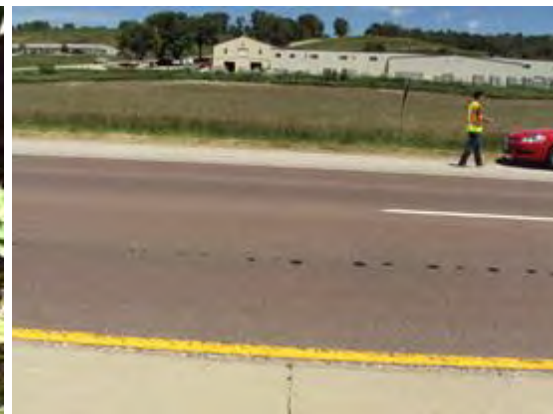
- Transverse cracking

Transverse cracking

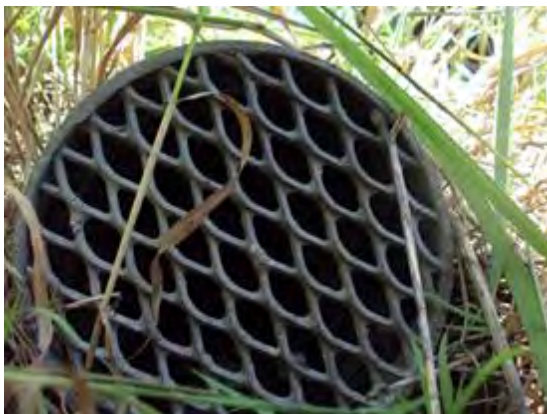
US 30/E/MP 64.70

- Number of outlet pipe: 1
- Type of outlet pipe: Corrugated plastic
- Size of outlet pipe: 4 inch
- Condition of outlet pipe: No blockage
- Water present inside outlet pipe: No
- Type of rodent guard: Gate
- Tufa/Dead zone (due to tufa) present: No
- Embankment slop condition: Less than 30 degree
- Slope condition at outlet: Downhill

No blockage

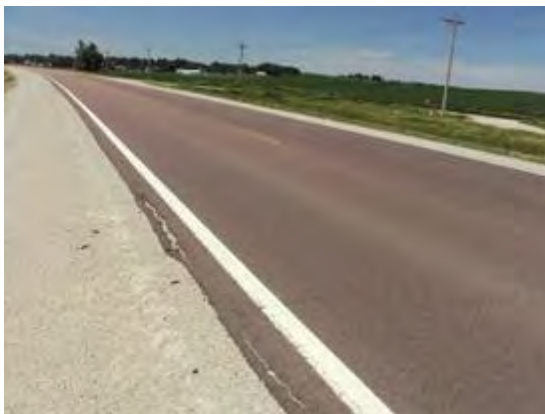
- Transverse cracking

Transverse cracking

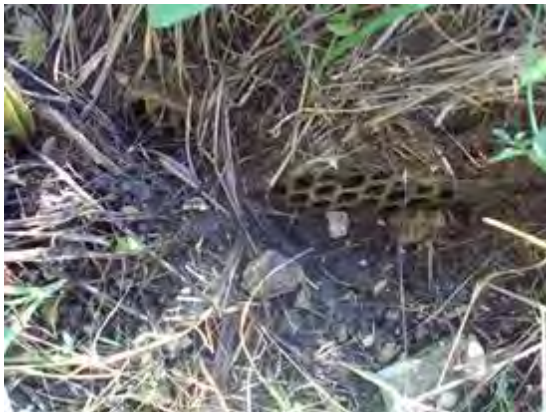
US 18/E/MP 213.97

- Number of outlet pipe: 1
- Type of outlet pipe: Corrugated plastic
- Size of outlet pipe: 4 inch
- Condition of outlet pipe: 90% blockage (soil blockage)
- Water present inside outlet pipe: No
- Type of rodent guard: Gate
- Tufa/Dead zone (due to tufa) present: No
- Embankment slop condition: Less than 30 degree
- Slope condition at outlet: Downhill

Soil blockage

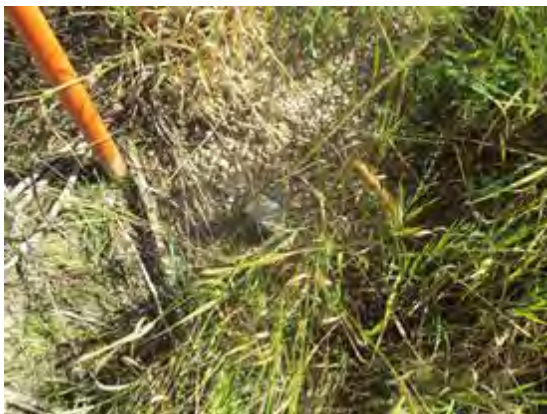
US 218/S/MP 219.75

- Number of outlet pipe: 1
- Type of outlet pipe: Corrugated plastic
- Size of outlet pipe: 4 inch
- Condition of outlet pipe: 95% blockage (soil blockage)
- Water present inside outlet pipe: No
- Type of rodent guard: Gate
- Tufa/Dead zone (due to tufa) present: No
- Embankment slop condition: Less than 30 degree
- Slope condition at outlet: Downhill

Soil blockage

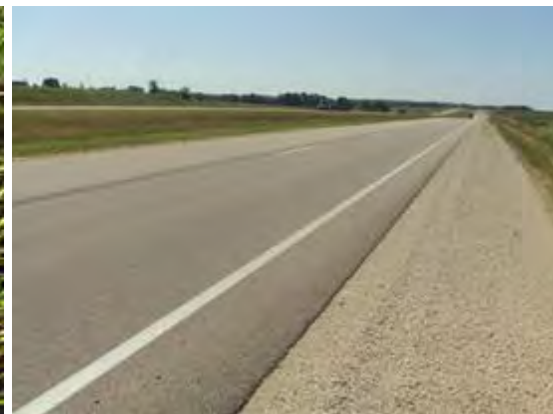
No pavement surface distress

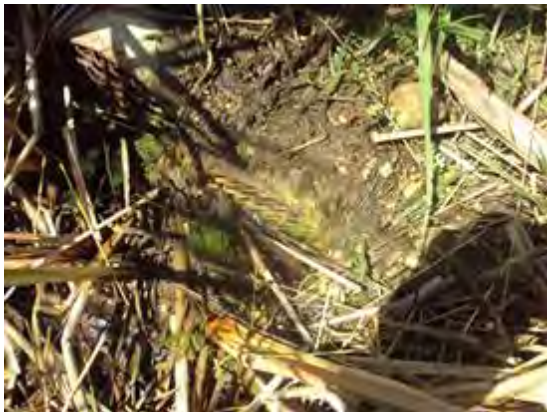
US 218/N/MP 214.22

Soil blockage

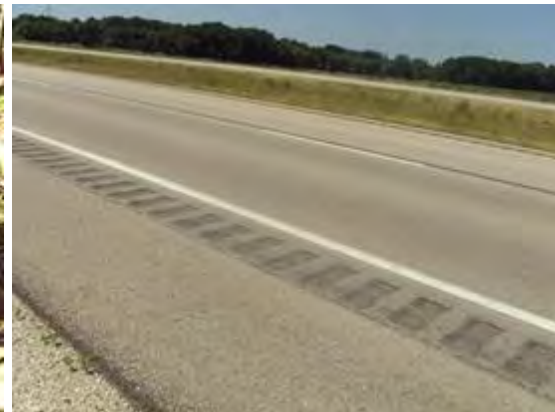
No pavement surface distress

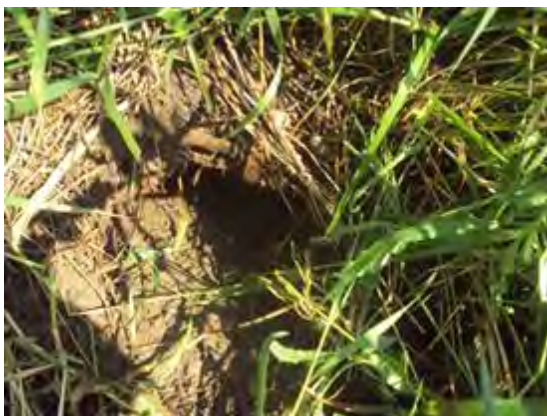
Soil blockage

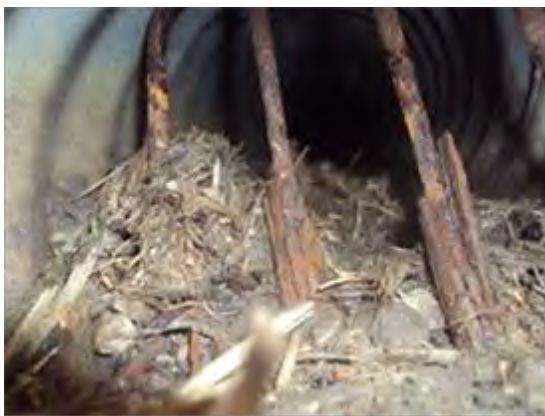
Sediment blockage

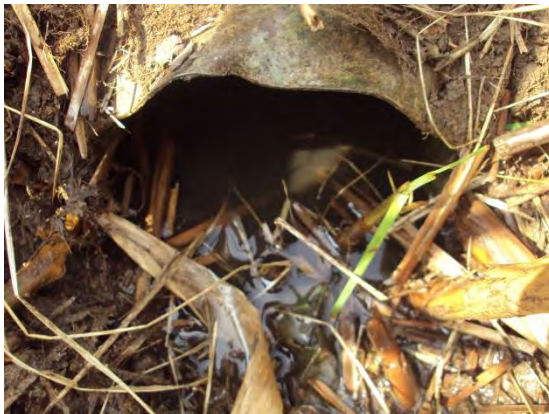
US 63/N/MP0.00

Sediment blockage

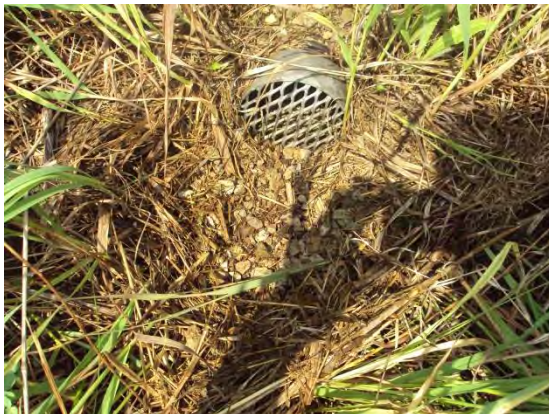
US 63/N/MP3.00

Soil blockage

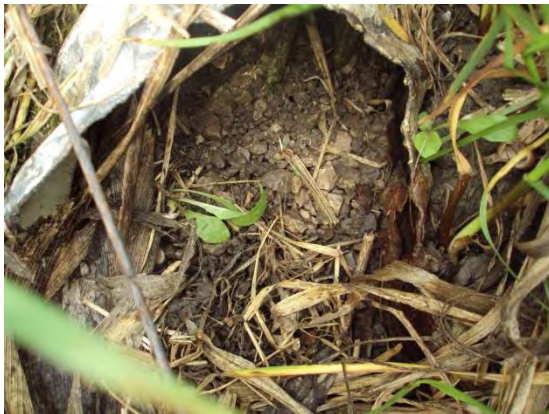
US 63/N/MP7.00

Soil blockage

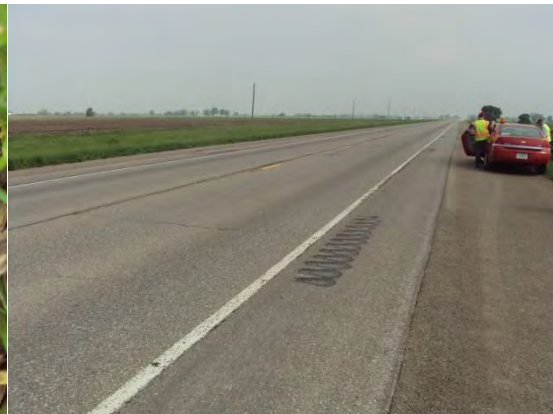
- Suggested by District 5 for investigation
- Cracked and sealed in 1990
- No load transfer in existing JPCP

Transverse cracking

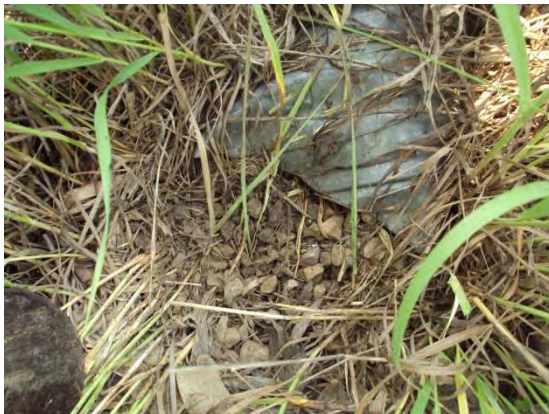
US 63/N/MP10.00

Soil blockage

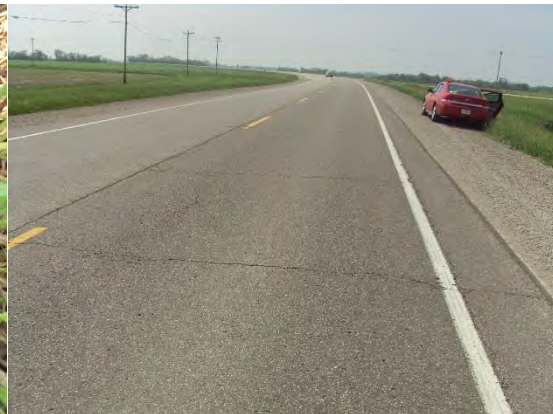
- Suggested by District 5 for investigation
- Cracked and sealed in 1990
- No load transfer in existing JPCP

Reflection cracking

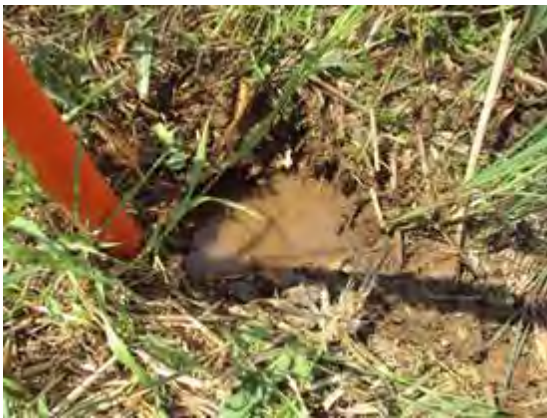
US 63/N/MP20.00

Soil blockage

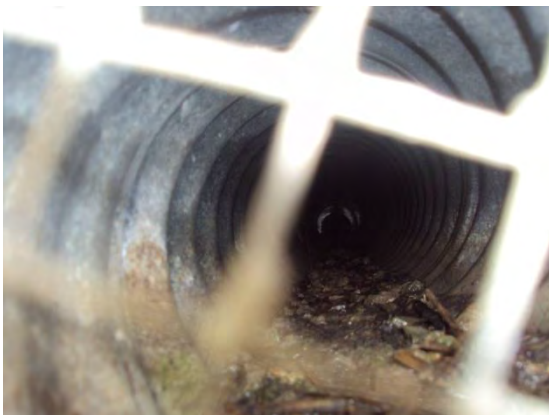
Sediment blockage

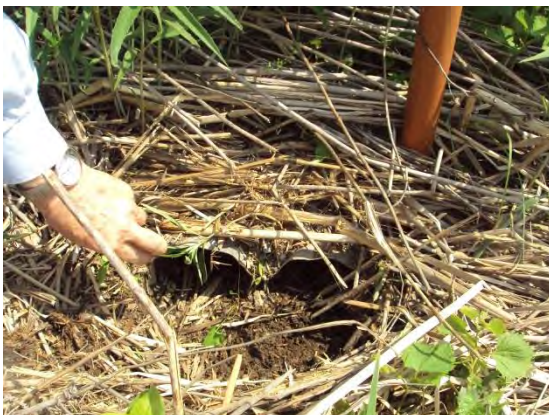
Soil blockage

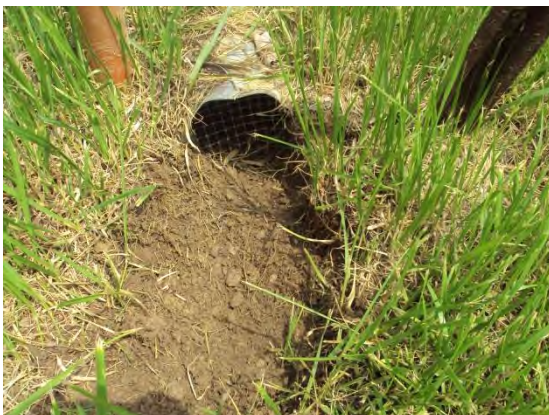
Soil blockage

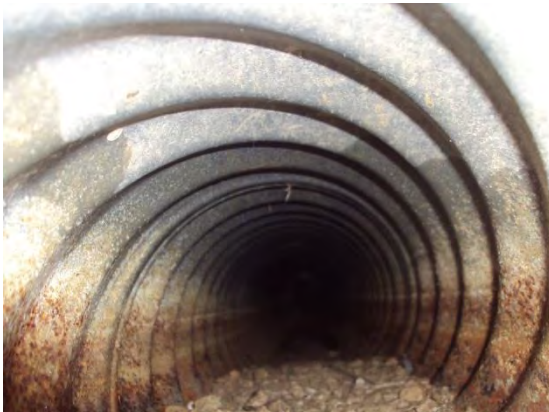
- Number of outlet pipe: 1
- Type of outlet pipe: Corrugated steel
- Size of outlet pipe: 6 inch
- Condition of outlet pipe: 40% blockage (sediment blockage)
- Water present inside outlet pipe: Yes (flowing)
- Type of rodent guard: N/A
- Tufa/Dead zone (due to tufa) present: No
- Embankment slop condition: Less than 30 degree
- Slope condition at outlet: Parallel

Sediment blockage

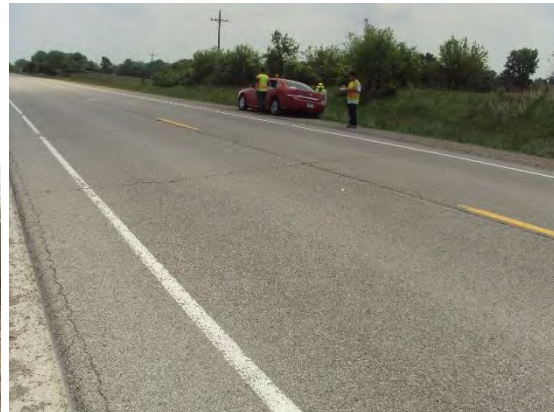
Reflection cracking

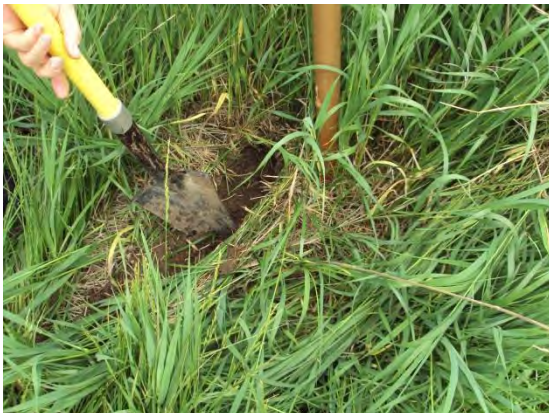
- Number of outlet pipe: 1
- Type of outlet pipe: Corrugated steel
- Size of outlet pipe: 6 inch
- Condition of outlet pipe: 100% blockage (soil blockage and damaged)
- Water present inside outlet pipe: No (wet)
- Type of rodent guard: Fork
- Tufa/Dead zone (due to tufa) present: No
- Embankment slop condition: Less than 30 degree
- Slope condition at outlet: Parallel

Soil blockage

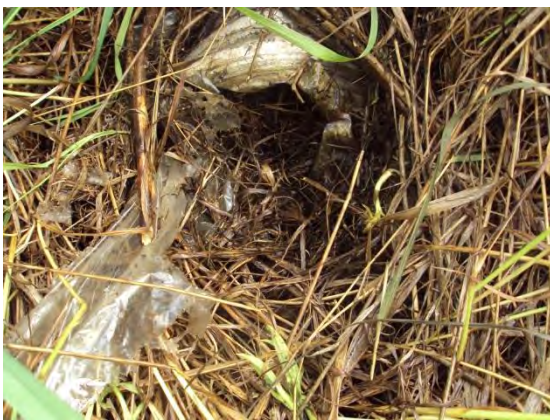
- Number of outlet pipe: 1
- Type of outlet pipe: Corrugated steel
- Size of outlet pipe: 6 inch
- Condition of outlet pipe: 100% blockage (soil blockage)
- Water present inside outlet pipe: Yes (standing)
- Type of rodent guard: Fork
- Tufa/Dead zone (due to tufa) present: No
- Embankment slop condition: Less than 30 degree
- Slope condition at outlet: Parallel

Soil blockage

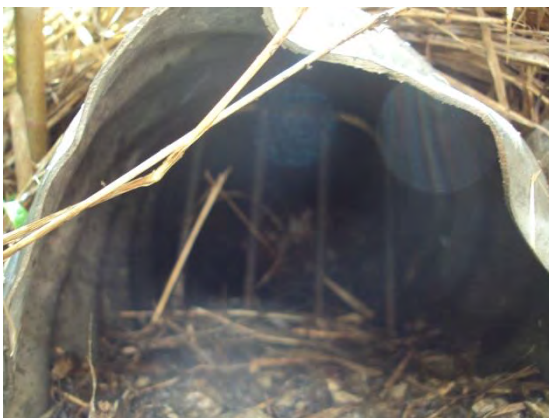
- Number of outlet pipe: 1
- Type of outlet pipe: Corrugated steel
- Size of outlet pipe: 6 inch
- Condition of outlet pipe: 50% blockage (soil blockage)
- Water present inside outlet pipe: Yes (standing)
- Type of rodent guard: Fork
- Tufa/Dead zone (due to tufa) present: No
- Embankment slop condition: Less than 30 degree
- Slope condition at outlet: Parallel

Soil blockage

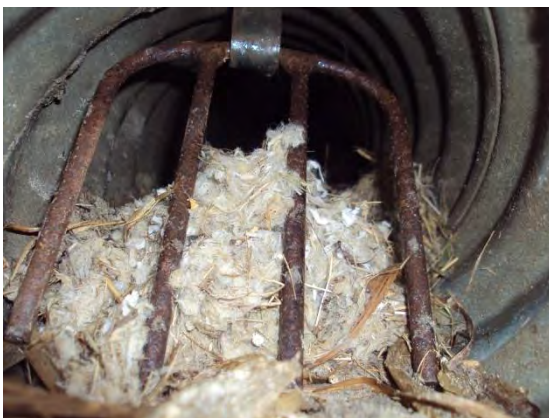
- Number of outlet pipe: 1
- Type of outlet pipe: Corrugated steel
- Size of outlet pipe: 6 inch
- Condition of outlet pipe: 70% blockage (sediment blockage)
- Water present inside outlet pipe: No
- Type of rodent guard: Fork
- Tufa/Dead zone (due to tufa) present: No
- Embankment slop condition: Less than 30 degree
- Slope condition at outlet: Parallel

Sediment blockage

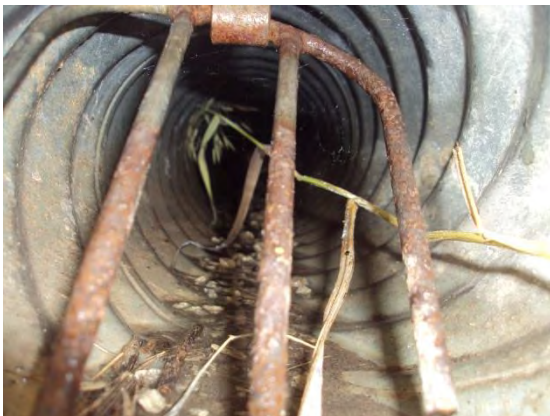
No blockage

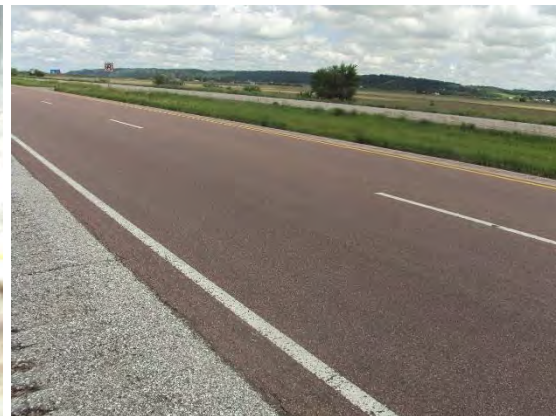
No pavement surface distress

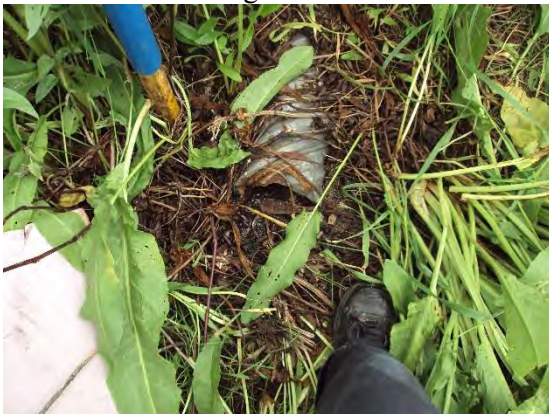
- Number of outlet pipe: 1
- Type of outlet pipe: Corrugated steel
- Size of outlet pipe: 6 inch
- Condition of outlet pipe: 50% blockage (sediment blockage)
- Water present inside outlet pipe: Yes (standing)
- Type of rodent guard: Fork
- Tufa/Dead zone (due to tufa) present: No
- Embankment slop condition: Less than 30 degree
- Slope condition at outlet: Parallel

Soil blockage

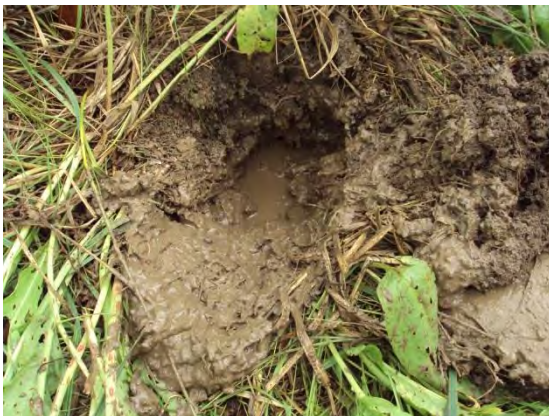
- Number of outlet pipe: 1
- Type of outlet pipe: Corrugated steel
- Size of outlet pipe: 6 inch
- Condition of outlet pipe: 100% blockage (soil blockage)
- Water present inside outlet pipe: Yes (standing)
- Type of rodent guard: N/A
- Tufa/Dead zone (due to tufa) present: No
- Embankment slop condition: Less than 30 degree
- Slope condition at outlet: N/A

Soil blockage

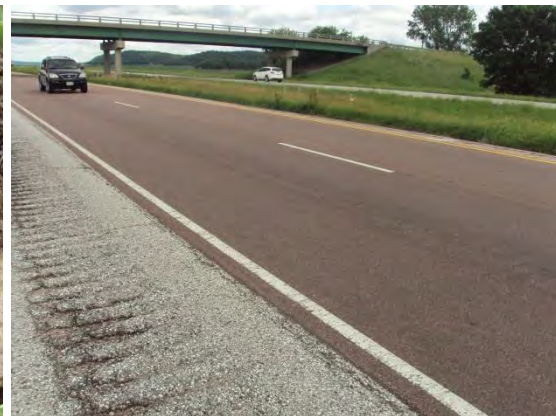
Rutting

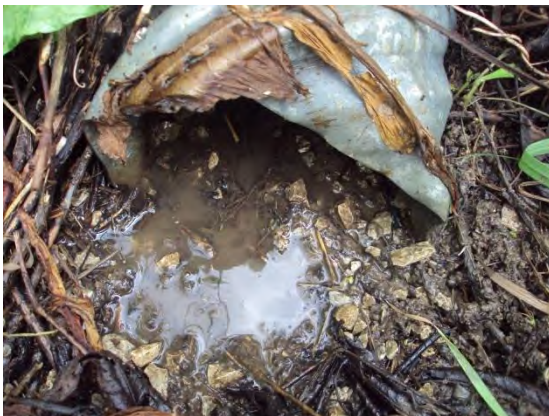
- Number of outlet pipe: 1
- Type of outlet pipe: Corrugated steel
- Size of outlet pipe: 6 inch
- Condition of outlet pipe: 50% blockage (sediment blockage)
- Water present inside outlet pipe: Yes (flowing)
- Type of rodent guard: Fork
- Tufa/Dead zone (due to tufa) present: No
- Embankment slop condition: Less than 30 degree
- Slope condition at outlet: Parallel

Sediment blockage

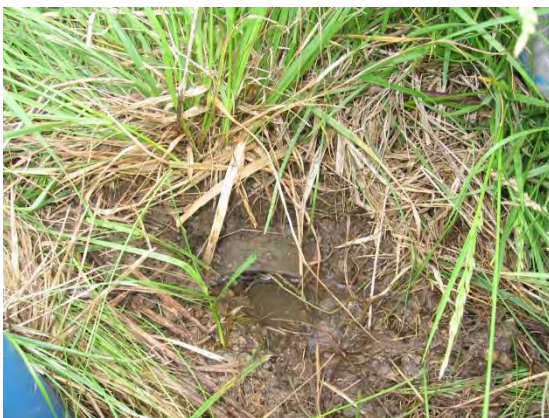
- Number of outlet pipe: 1
- Type of outlet pipe: Corrugated plastic
- Size of outlet pipe: 4 inch
- Condition of outlet pipe: 100% blockage (soil blockage)
- Water present inside outlet pipe: Yes (standing)
- Type of rodent guard: Gate screen
- Tufa/Dead zone (due to tufa) present: No
- Embankment slop condition: Less than 30 degree
- Slope condition at outlet: Uphill

Soil blockage

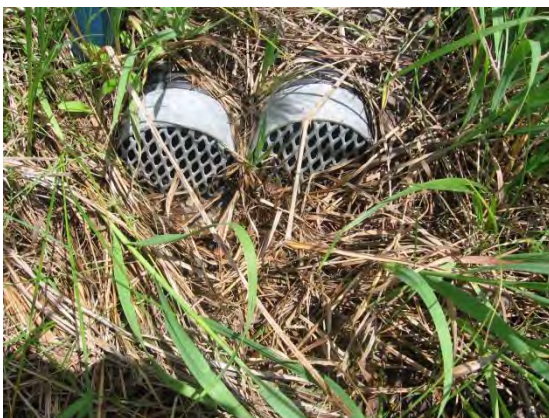
- Number of outlet pipe: 2
- Type of outlet pipe: Corrugated plastic
- Size of outlet pipe: 4 inch
- Condition of outlet pipe: 20% blockage (soil blockage)
- Water present inside outlet pipe: Yes (standing)
- Type of rodent guard: Gate screen
- Tufa/Dead zone (due to tufa) present: No
- Embankment slop condition: Less than 30 degree
- Slope condition at outlet: Parallel

Soil blockage

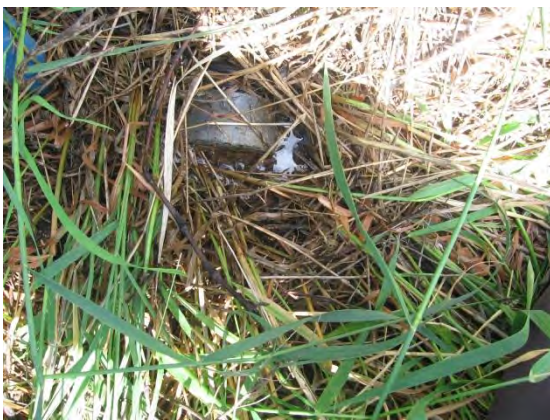
Soil blockage

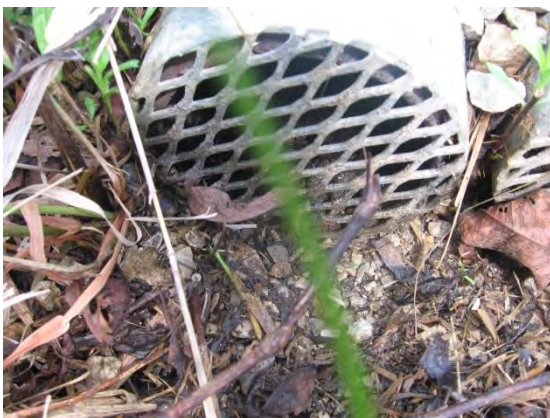
Sediment blockage

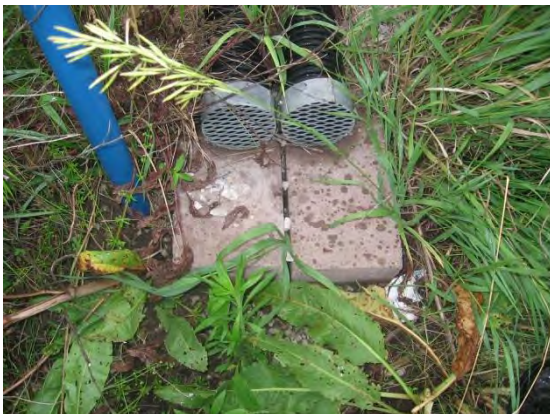
No blockage

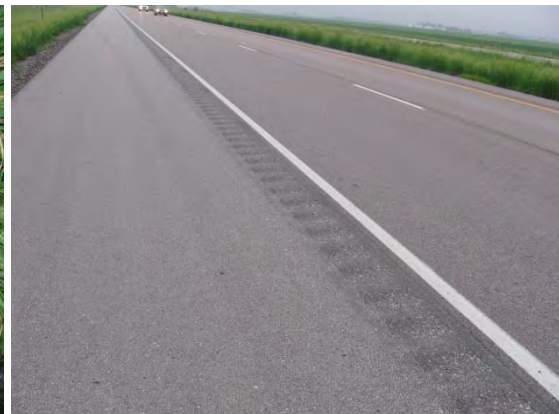
No pavement surface distress

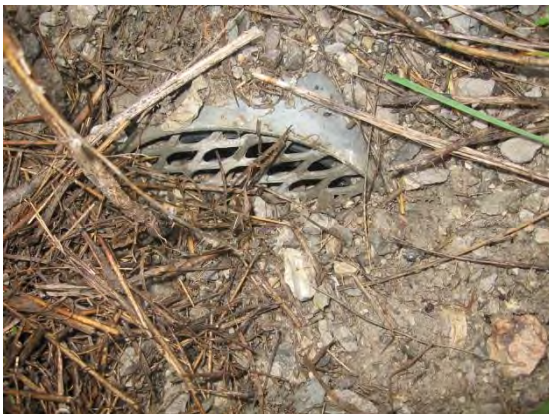
Soil blockage

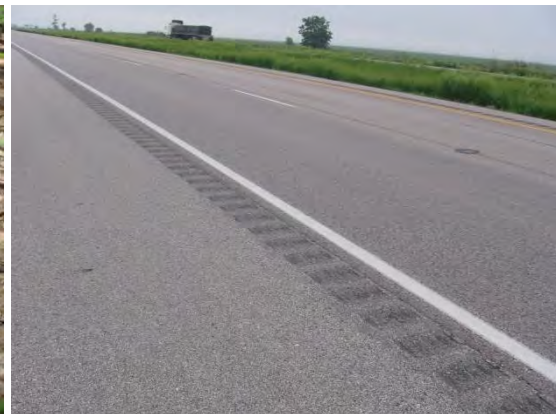
No pavement surface distress

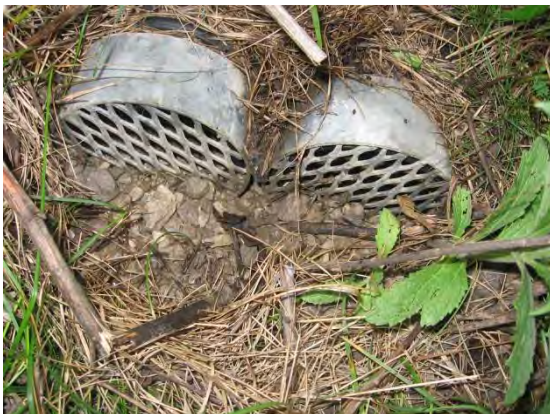
Soil blockage

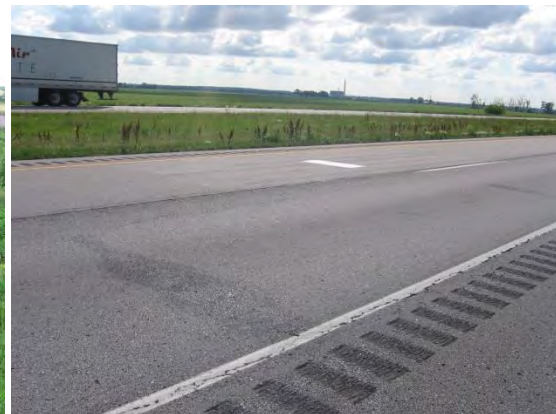
Stripping/patching

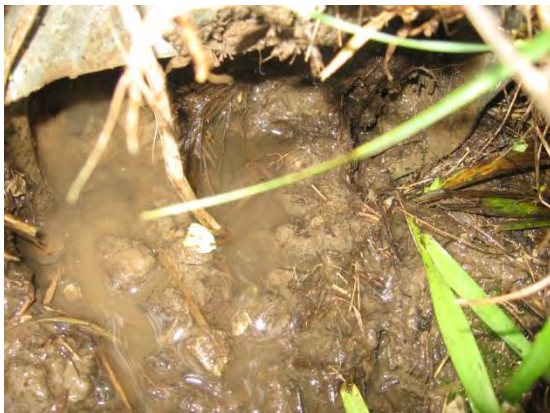
Soil blockage

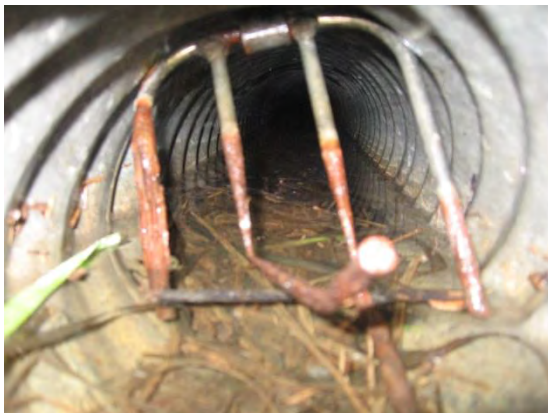
Sediment blockage

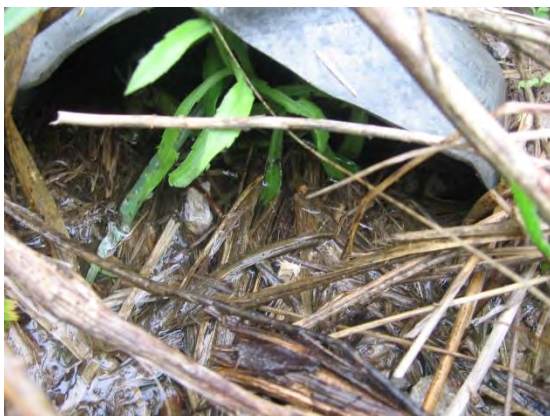
Sediment blockage

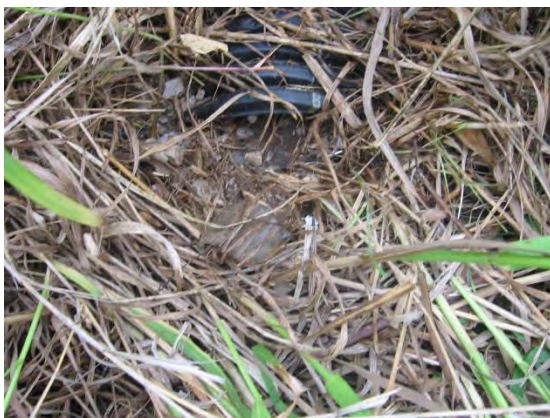
Soil blockage

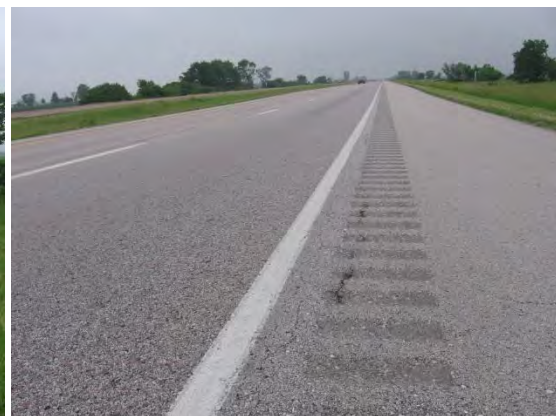
Rutting

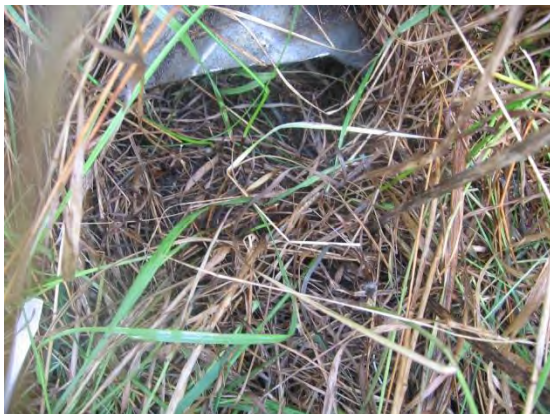
Soil blockage

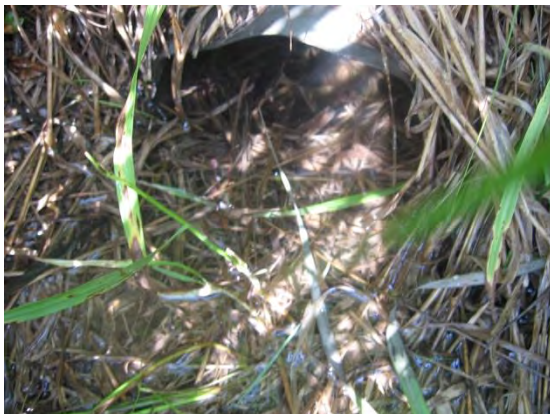
Soil blockage

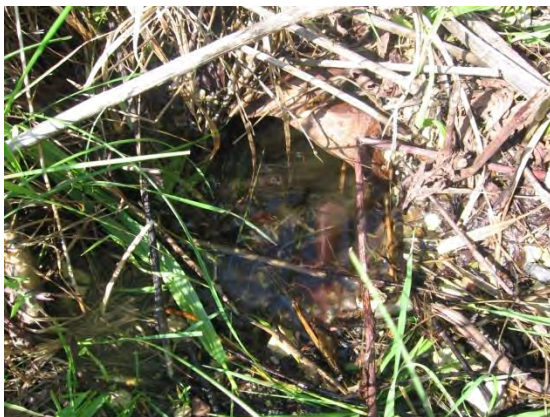
Soil blockage

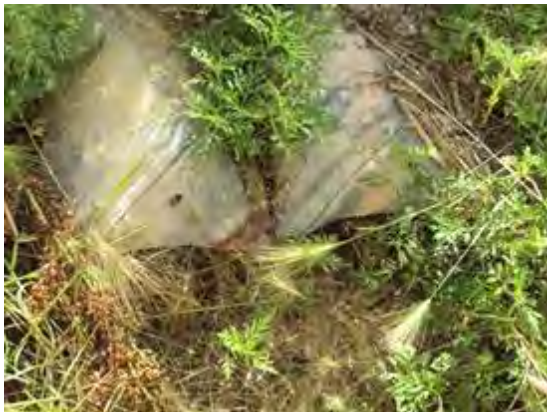
Sediment blockage

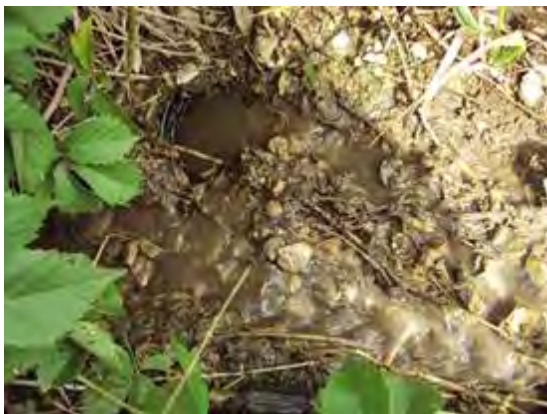
- Number of outlet pipe: 2
- Type of outlet pipe: Corrugated plastic
- Size of outlet pipe: 4 inch
- Condition of outlet pipe: 90% blockage (soil blockage)
- Water present inside outlet pipe: Yes (free flowing)
- Type of rodent guard: Gate
- Tufa/Dead zone (due to tufa) present: No
- Embankment slop condition: More than 30 degree
- Slope condition at outlet: Downhill

Soil blockage

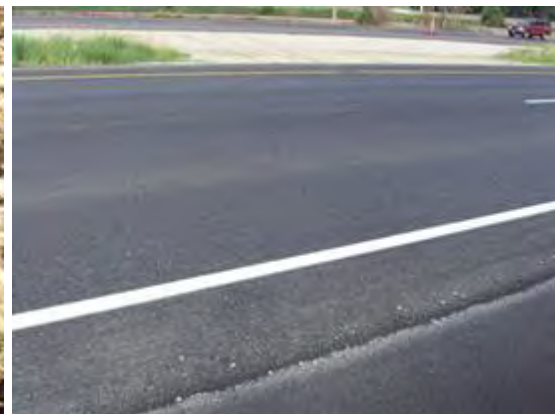
I-29/N/MP 72.15

New HMA overlay

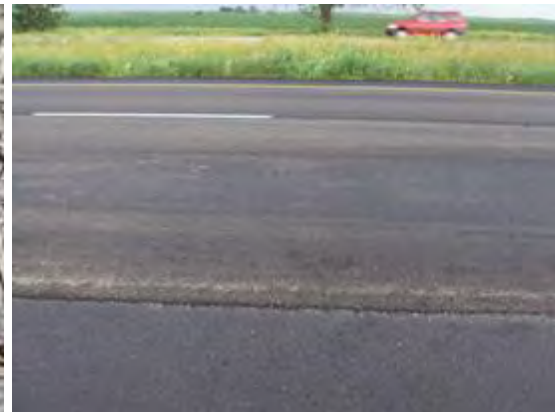
New HMA overlay
