In-Service Evaluation of High Tension Cable Barrier Systems

Kentucky Transportation Center Research Report – KTC-17-17/SPR16-526-1F

April 2017

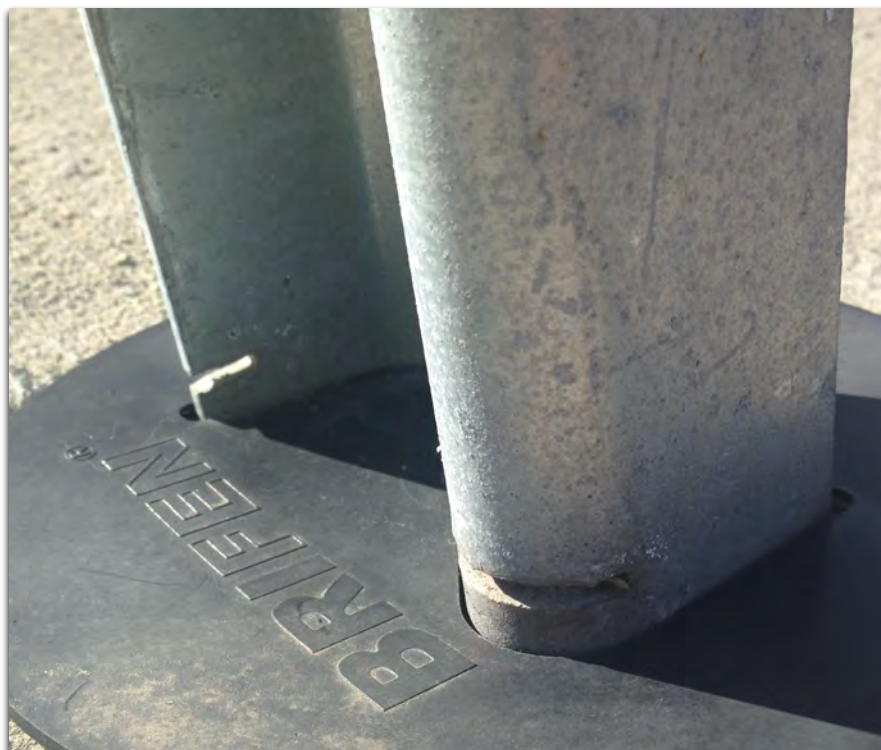
Figure J: Brifen End Post with sufficient weakening cut

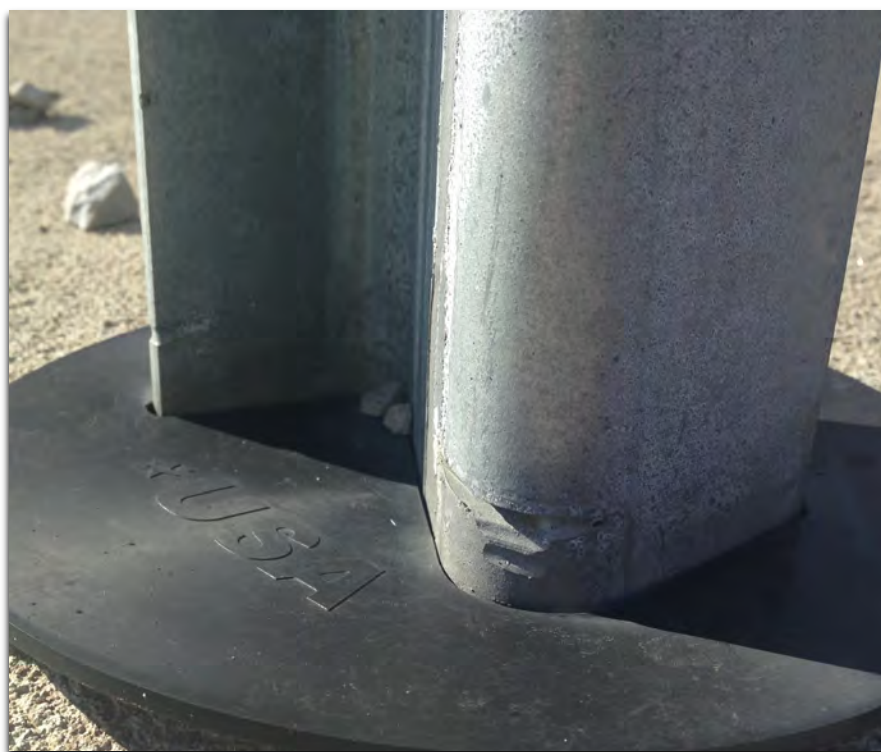
Figure K: Brifen End Post with insufficient weakening cut (not cut all the way through)

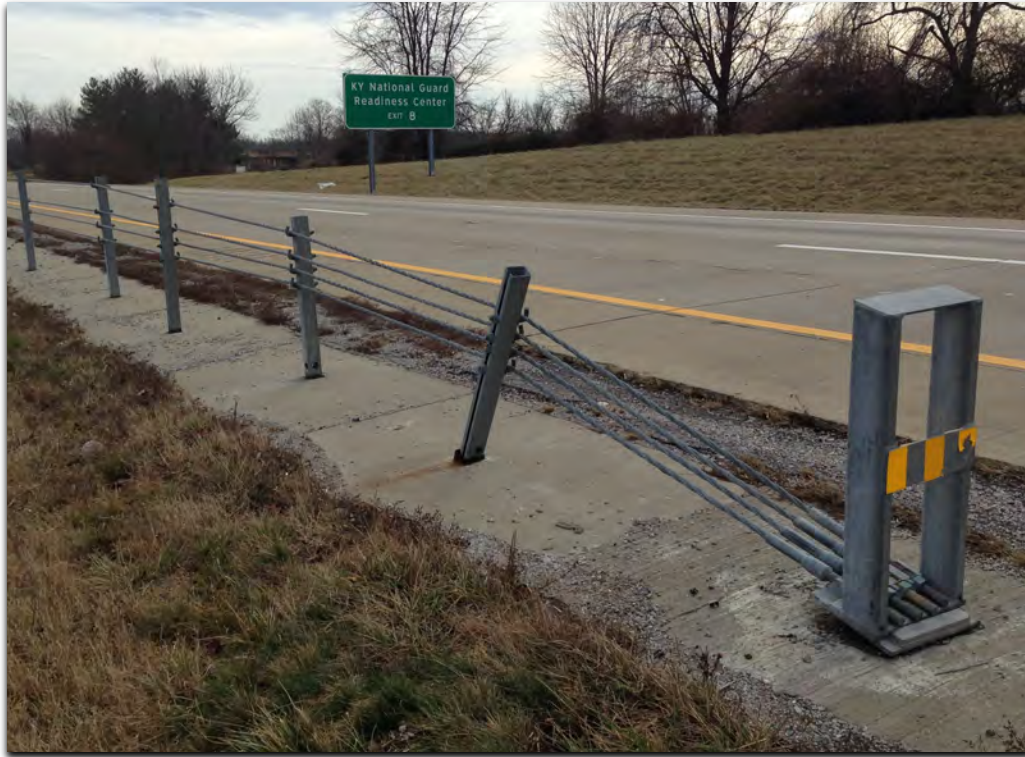
Figure L: Gibraltar End Post vertical angle out of tolerance (less than 84.1 degrees)

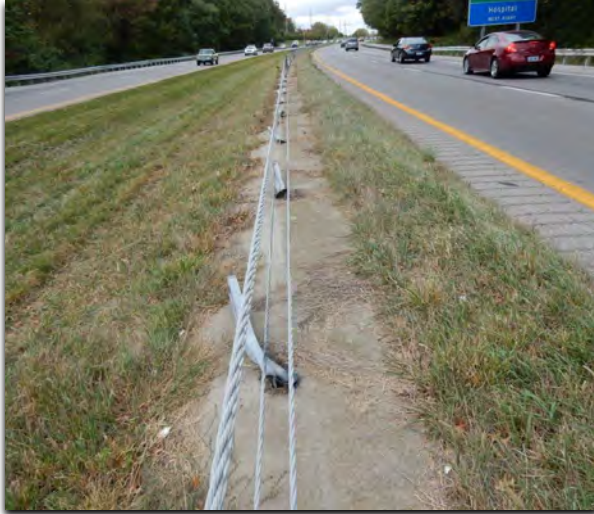
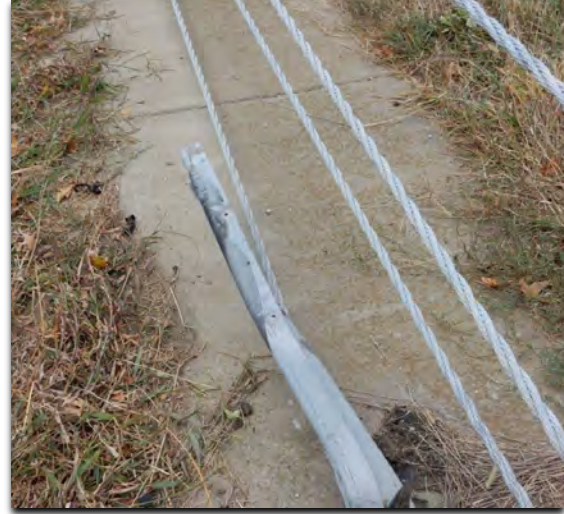
Description: A Ford Escape contacted the cable barrier adjacent to its lane of travel at a shallow angle. There was tire transfer on the posts and cable with a maximum deflection of about one foot. A total of 13 posts were damaged with the final rest position of the vehicle in the original lane of travel. Limited tension was maintained in the damaged area. No injury was reported.

Damaged Brifen post

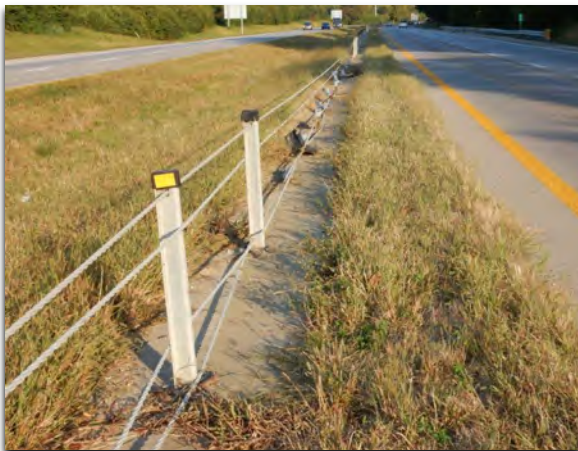
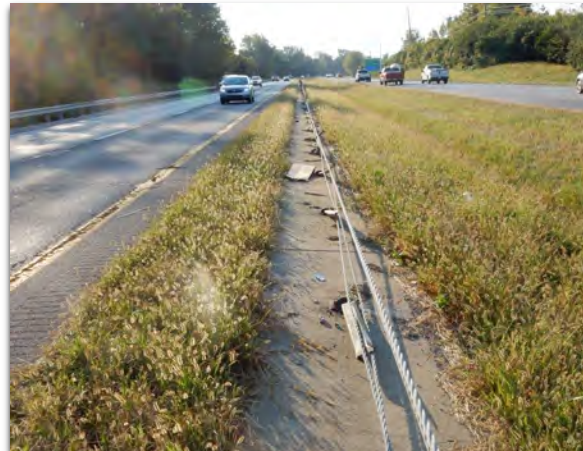
Date	County	Route	Mile Point	Vendor
October 4, 2016	Fayette	KY 4	3.1	Brifen

Description: A Toyota Tundra struck the cable barrier adjacent to its lane of travel at a shallow angle and then, after rebounding into its original lane of travel, struck the barrier a second time. The first impact damaged 14 posts. After a gap of 22 posts, there was damage to 22 posts. Prior to the first damaged post, there were 14 posts where either the bottom or two bottom cables were out of position. For the 22 posts between the two contacts all of the four cables were in their original position on eight posts. There was no injury related to the collisions.

Damaged Brifen CMB section

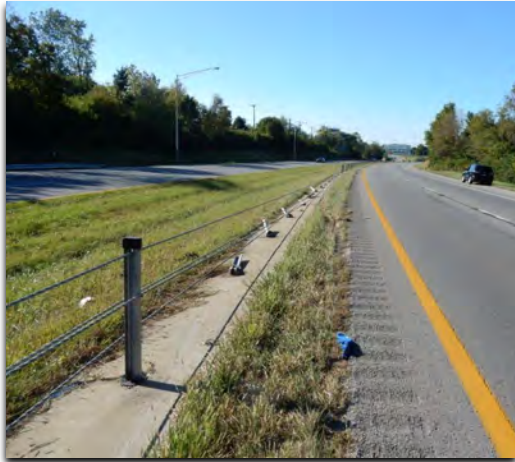
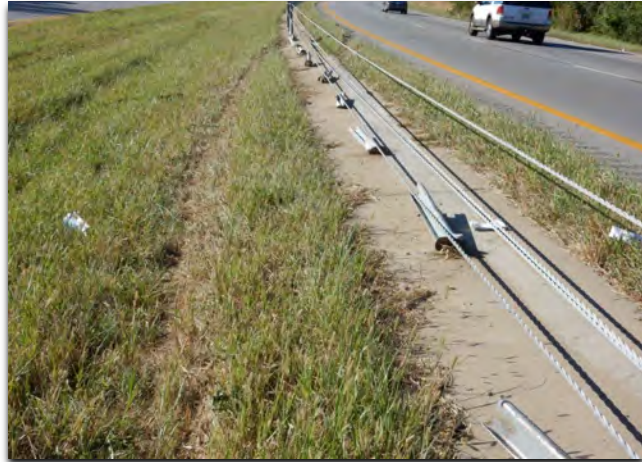
Date	County	Route	Mile Point	Vendor
October 7, 2016	Fayette	KY 4	11.9	Brifen

Description: A Ford Excursion had a tire failure with the cable barrier adjacent to the travel lanes contacted at a shallow angle. There was damage to 16 posts with a maximum deflection of about five feet. Tension was lost in the area of contact. There was no reported injury.

Damaged Brifen posts

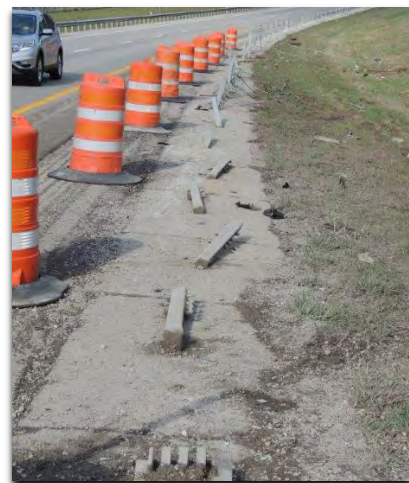
Damaged Gibraltar CMB section

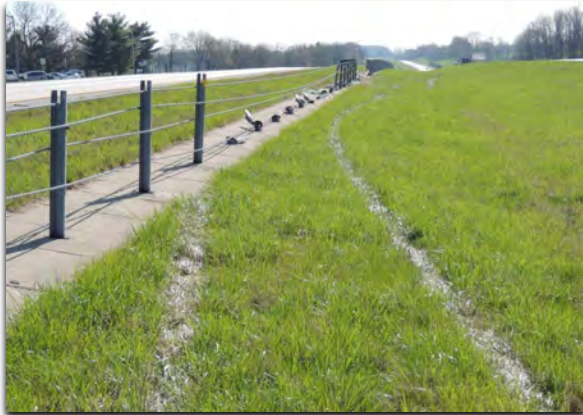
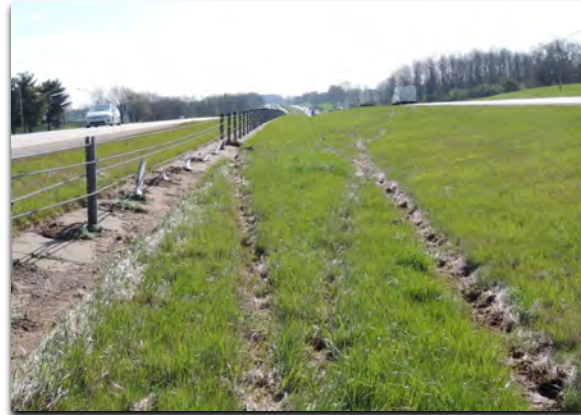
Date	County	Route	Mile Point	Vendor
March 27, 2016	Woodford	I-64	59.7	Brifen

Description: A Chevrolet Silverado crossed the grass median and struck the cable barrier. The vehicle contacted nine posts and then rotated around seven posts with damage to five additional posts where the pickup came to final rest. Tension was reduced in the first contact with tension maintained at the second location. There was no injury reported.

Damaged Brifen posts

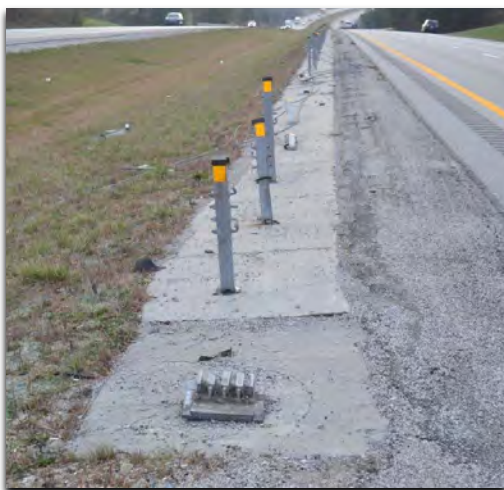
Date	County	Route	Mile Point	Vendor
December 23, 2015	Laurel	I-75	43.9	Gibraltar

Description: A Chevrolet truck struck the cable near the end of a section of cable barrier. Five posts were damaged with contact at the fourth post from the end. The anchor became unattached with loss of tension for a substantial distance (and at splices a long distance from the impact area). There was no reported injury.

Damaged Gibraltar CMB Section

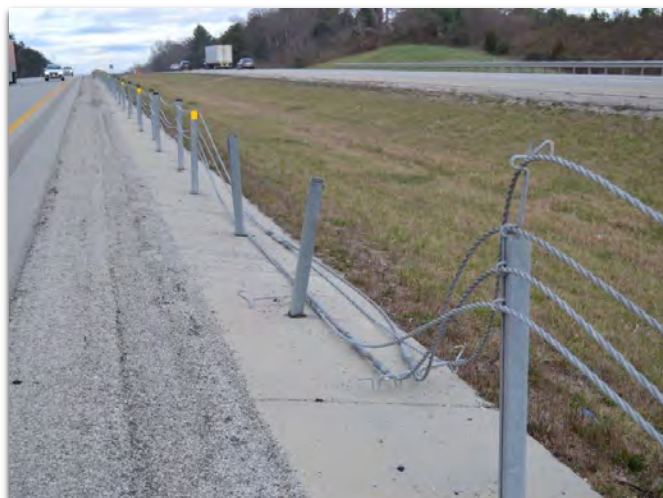
Damaged Gibraltar CMB Section

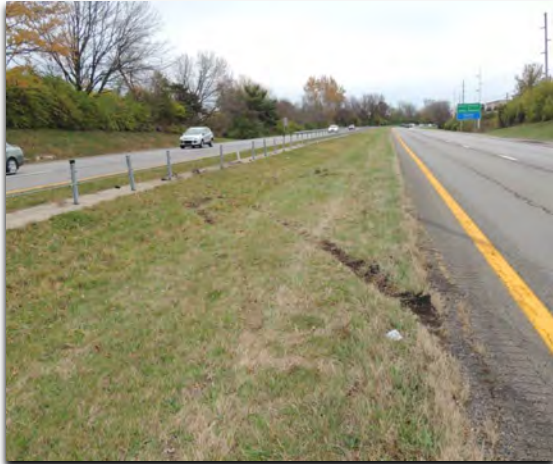
Description: A Suzuki SX4 passenger car rotated across the median (at a substantial angle) and impacted the cable barrier. Two posts were damaged with the car stopping in the median. There was no reported injury.

Damaged Brifen posts

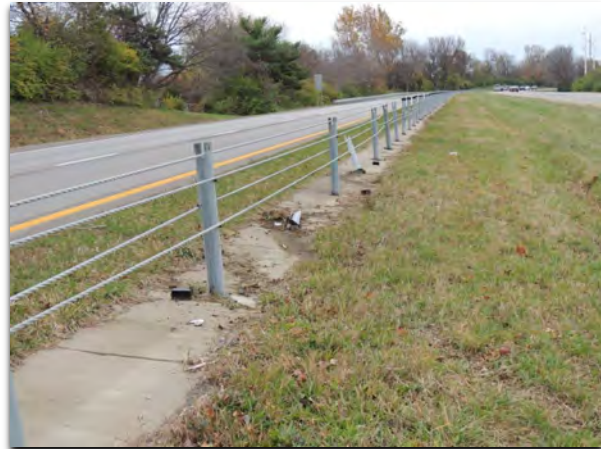
Damaged Brifen posts

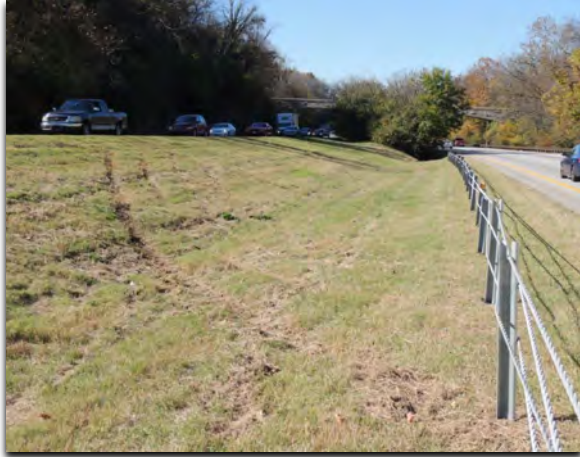
Damaged Brifen posts

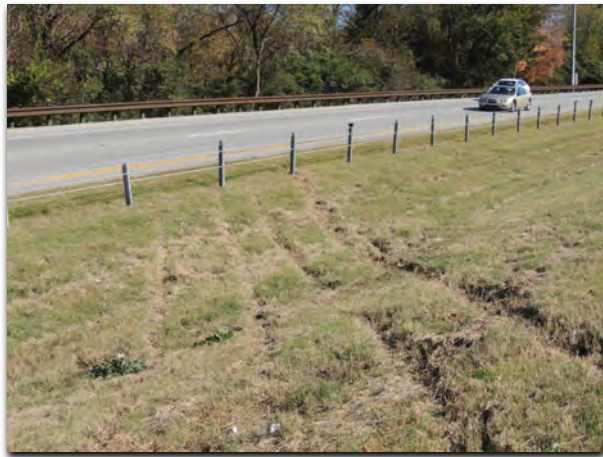
Damaged Brifen posts

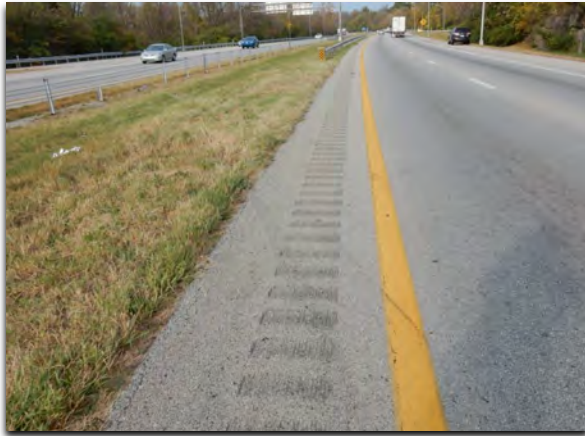
remained in its original positions (with less tension). The height of the median is slightly higher on the side where the vehicle exited the lanes compared to the cable adjacent to the opposing lanes. There was no reported injury.

Damaged Brifen posts

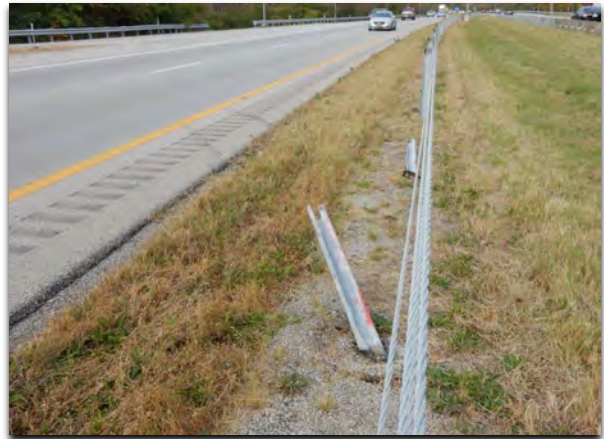
Damaged Brifen posts

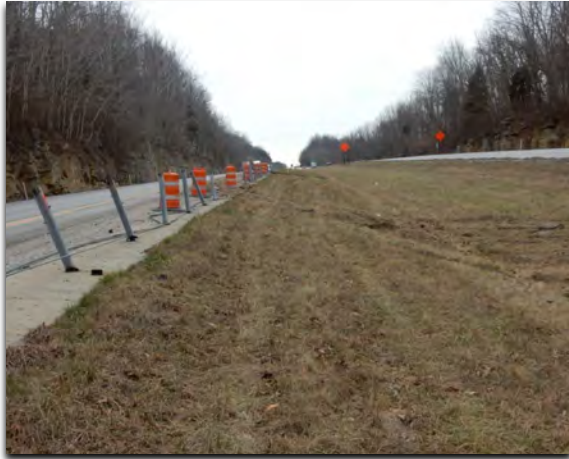
contact was about 16 posts from the end. Four posts were pushed down with the vehicles entering the opposing lane contacting a Toyota Prius. There were seven posts damaged in the area of the second impact. There was a vehicle fire with cable strands burned to the point of separation. Tension was lost for several tenths of a mile. There were no reported injuries.

Damaged Brifen CMB section

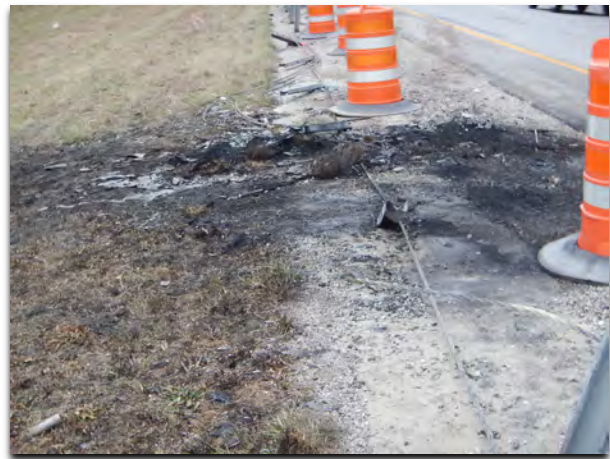
Damaged Brifen CMB section
