Continued Field Evaluation of Precutting for Maintaining Asphalt Concrete Pavements with Thermal Cracking

August 2017

INE/AUTC 17.17

FHWA-AK-RD-4000(155)

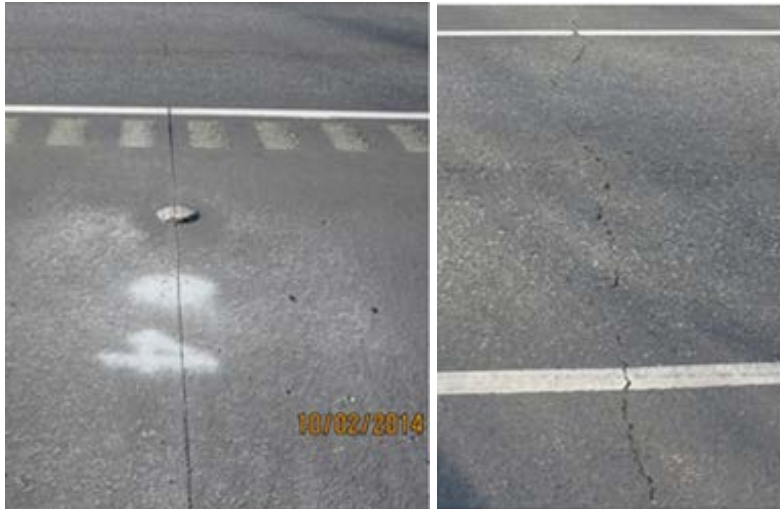
Figure 1.1 Cracks on the road

(a) Precut

(b) Natural crack

Regarding thermal crack formation, the subject of this report, the ADOT&PF currently recognizes two distinct and common types of thermal cracks simply produced by air temperature variations. The major transverse thermal crack type is shown in Figure 1.1b. The identifying features of this crack type are that the crack **extends completely across the paved road surface** and is **at least generally perpendicular to the centerline**. These thermal cracks extend through the pavement layer and well into the granular material below. Although they are often nearly

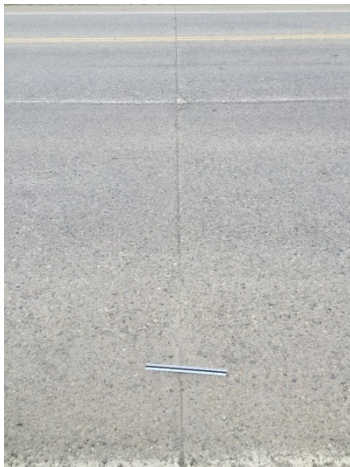
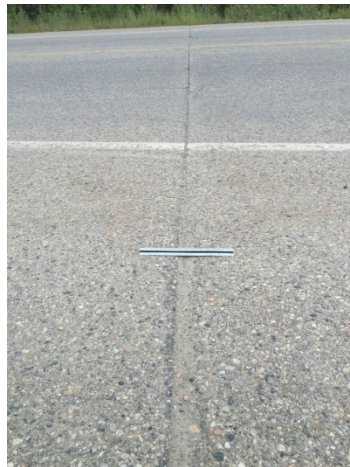
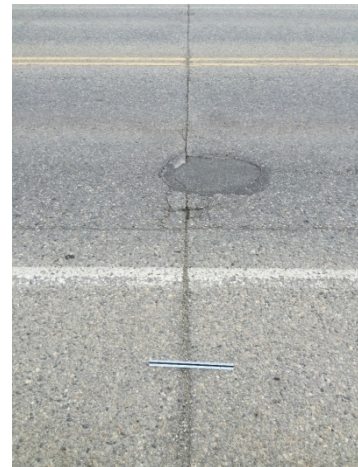
Figure 4.1 Field observations of 32-year old Phillips Field Road, Fairbanks, Alaska

After 32 years of service, even the active precuts showed acceptable appearance (Figure 4.1e). Better appearance of the inactive precut was also observed (Figure 4.1d). In contrast, the natural crack (Figure 4.1c) offered a broken and crooked appearance, which is unpredictable and more difficult to maintain. The driving public and state agencies would tend to prefer the “nicely designed” precuts rather than broken natural cracks. The long-term, regular appearance of pavement surfaces is considered important. For Portland cement concrete road pavements, sidewalks, etc., use of expansion joints and regularly spaced scoring has long been the standard way of controlling appearance and damage severity due to inevitable thermal cracking. Therefore, the precut technique for asphalt concrete can be considered “successful” for its effectiveness in controlling the locations of many more natural cracks that could have developed.

Several small potholes were observed where longitudinal cracks and precuts intersected (Figure 4.1f). The observation about potholes was consistent with Minnesota's experience of precutting asphalt pavement (Janisch and Turgeon 1996). Their report indicated that "a cupped depression developed approximately 5–7 years after implementation of precuts." However, the small potholes that accumulated over 30+ years on Phillips Field Road required minimal patching and did not significantly influence ride quality.

In summary, the Phillips Field Road precut site was 32 years old, but its general driving condition was found to be good. Potholes needed to be maintained, but all the cracks, including transverse cracks, active precuts, longitudinal cracks, and block cracks seemed not to deteriorate the pavement condition significantly.

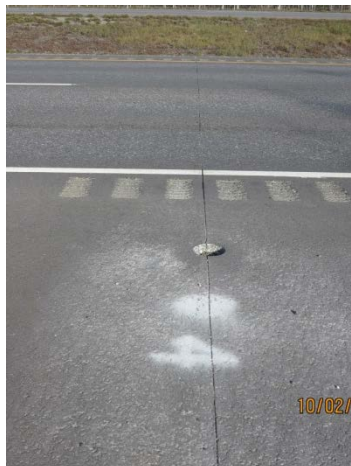
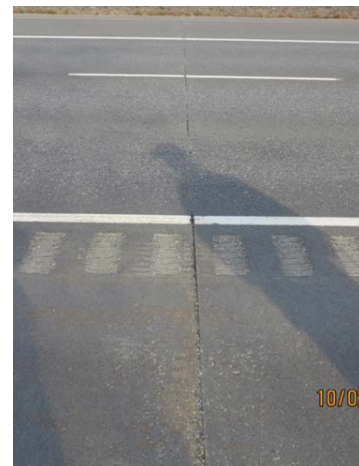
Figure 4.3 Select field survey photos in 2013 and 2014 (Liu et al. 2015)

The details of the field surveys (Figure 4.2) conducted in 2013 and 2014 can be found in a previous project report (Liu et al. 2015). Figure 4.3 presents select survey photos of observed natural cracks, and both non-active precut and active precut cracks.

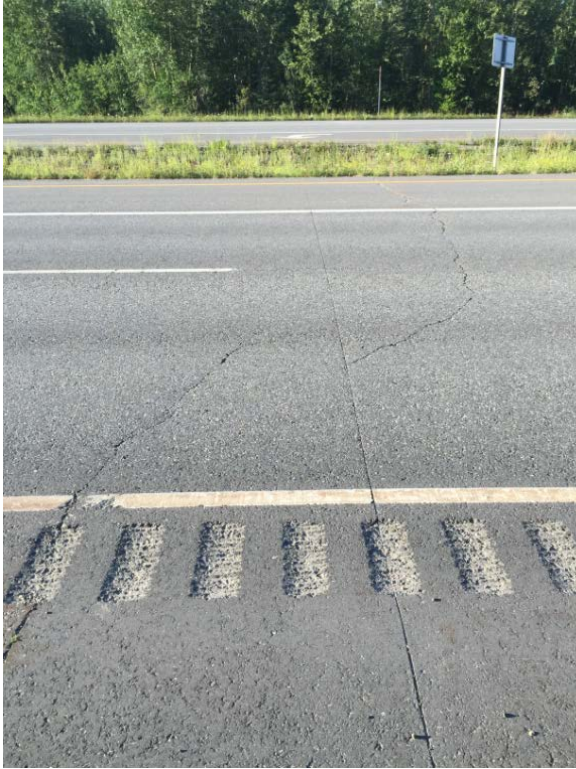
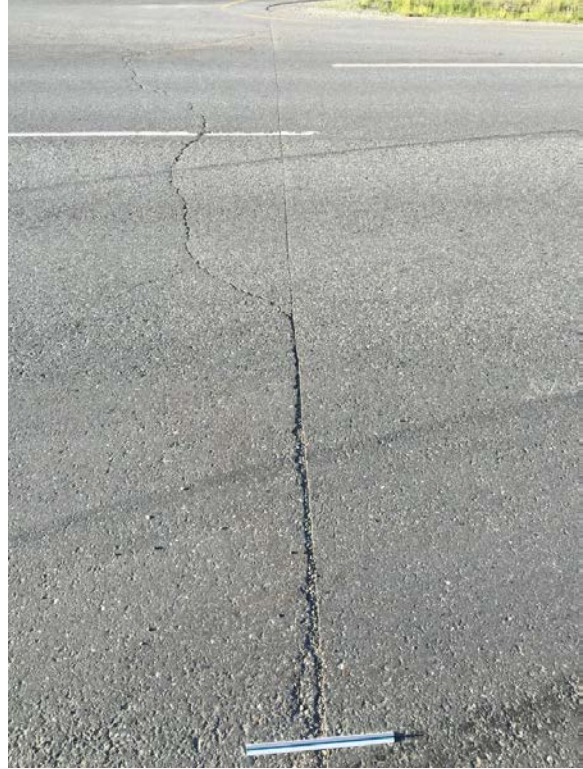
The three sections, No. 8 to No. 10 in Table 3.1, were specially designed for the Moose Creek project. The objective was to evaluate the effectiveness of precutting on the locations of pre-existing cracks. Figures 4.11 to 4.13 present the observations that are worth some discussion. Figure 4.11 shows two cases of transverse cracks near precuts. The crack shown in Figure 4.11a was not controlled by the precut at all, but the one shown in Figure 4.11b was partially re-located (partially captured) by the precut. According to the survey maps presented in Appendix B8 to B10, a big portion of the transverse cracks occurred on or adjacent to precuts in these sections. The idea of precutting at the old thermal crack location seems reasonable, but it is still difficult to determine how effective it can be.

Figure 4.11 Natural transverse cracks near precuts—where precuts are at locations of old thermal cracks on the Moose Creek project: (a) high severity (section No. 8); (b) low severity (section No. 8)

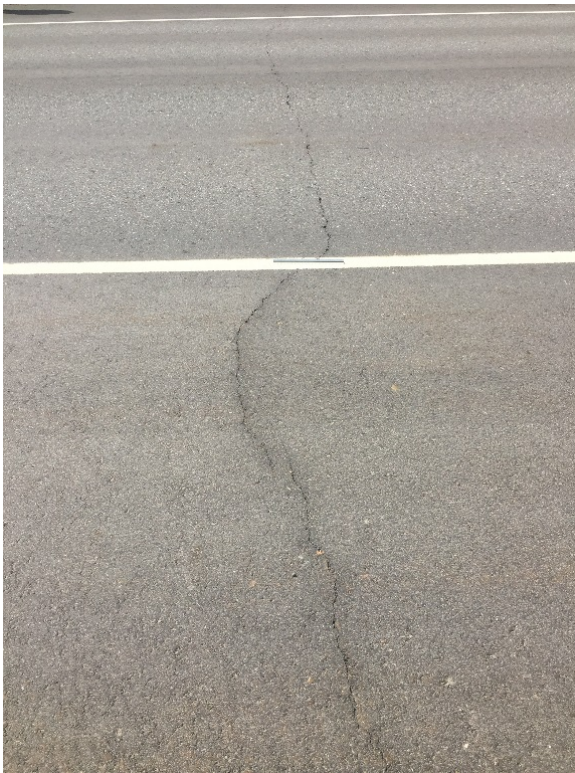
Figure 4.23 Transverse cracks observed: (a) low-severity crack (on precast section) (section No. 6); (b) high-severity crack (on control section) (section No. 2)

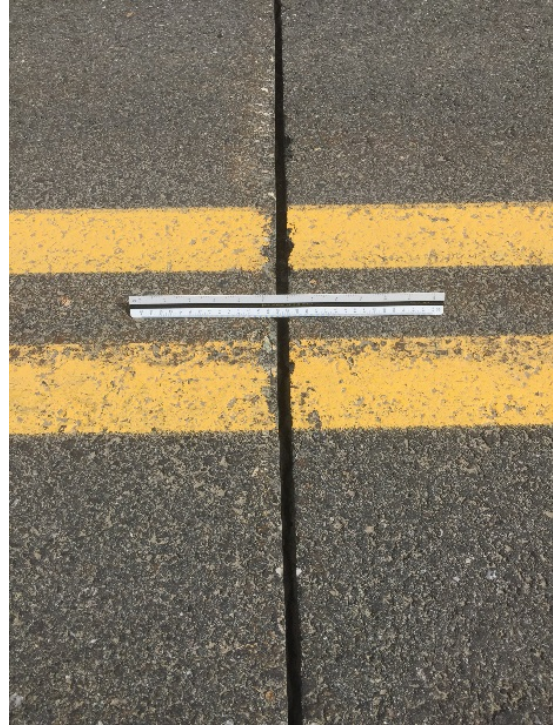
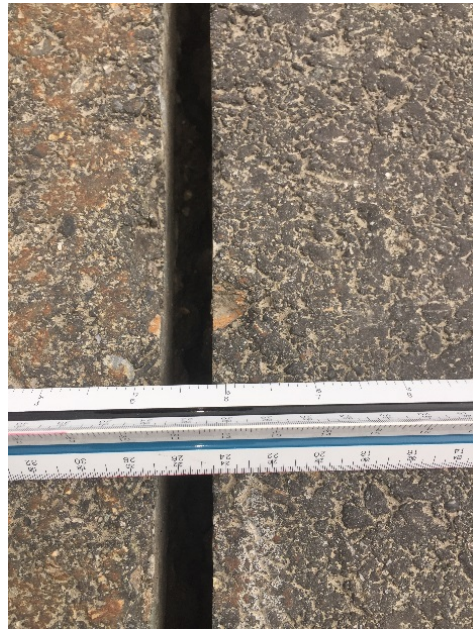
Healy sections were visited in summer 2016. Detailed survey maps and photos showing all the distress can be found in Appendix C. Figures 4.22–4.24 show some general observations documented as survey results for Healy sections, including overview of the field site, transverse cracks, and precut status. Note that some highly active precuts (Figure 4.24c) were observed on the Healy experimental sections.

Figure 4.24 Precuts observed: (a) non-active precut (section No. 9); (b) active precut (section No. 8); (c) highly active precut (section No. 3)
