Preventive Maintenance Study – Interim Report

WA-RD 871.1

**Washington State
Department of Transportation**

Preventive Maintenance Study

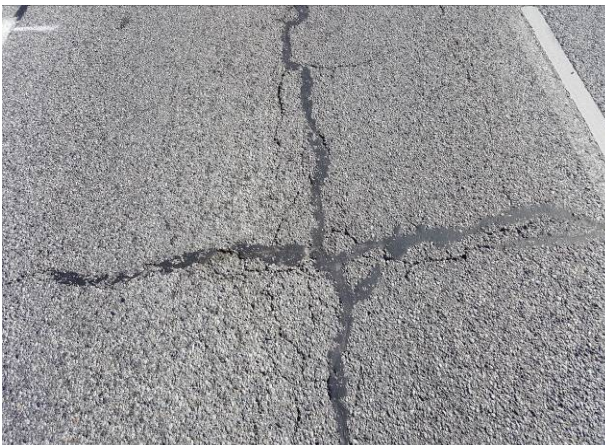
Figure 7. NC2, SR2, Strategic, age 26 months. No spalling or potholes.

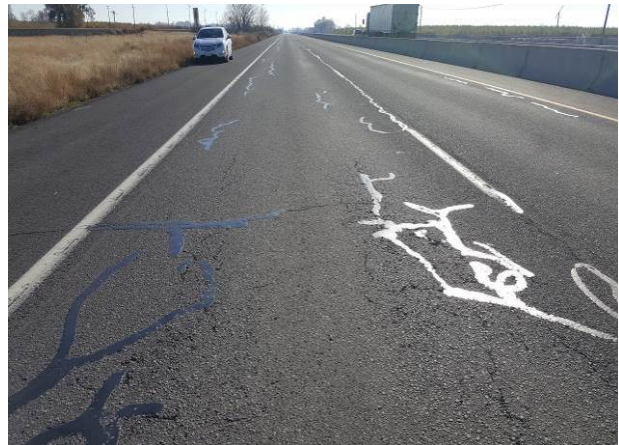
Figure 8. SC1, SR97, Strategic, age 14 months. No spalling or potholes.

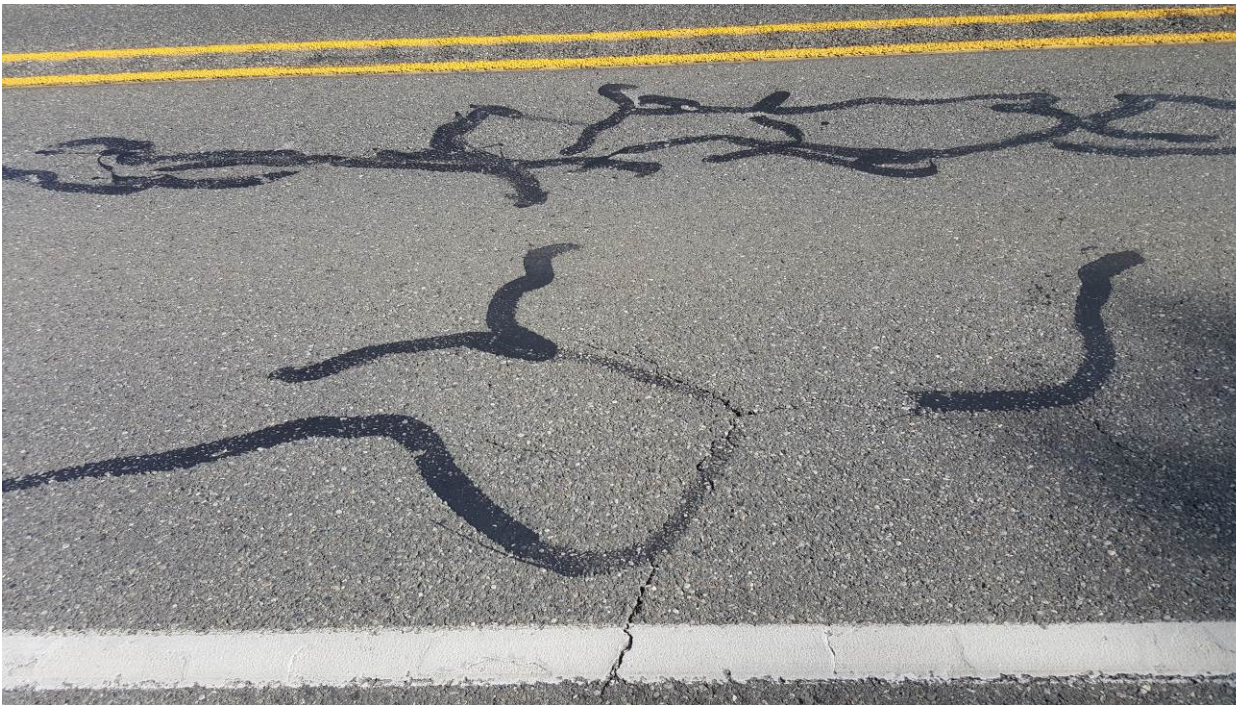
Figure 18. OR1, SR101, three years after installation. There is not much change from year one.

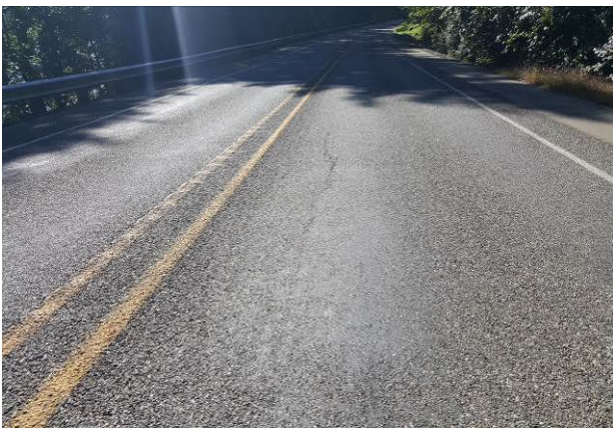
occurring at 14 months after installation on one site and at 21 months on the other; however, these cracks do not currently have an adverse impact on the overall performance of the roadway. Delamination and spalling is occurring on one of the remaining sites and the other is suffering from a partial loss of aggregate. Slight flushing was noted on one site. In general, the performance of the full lane chip seals has been lower than expected. Figures 20-23 show the condition of the chip seals at the four test sites.

Figure 20. OR1b, SR101, Reactive, age 50 months. Longitudinal cracking noted at 21 months. Slight flushing in the wheel paths.

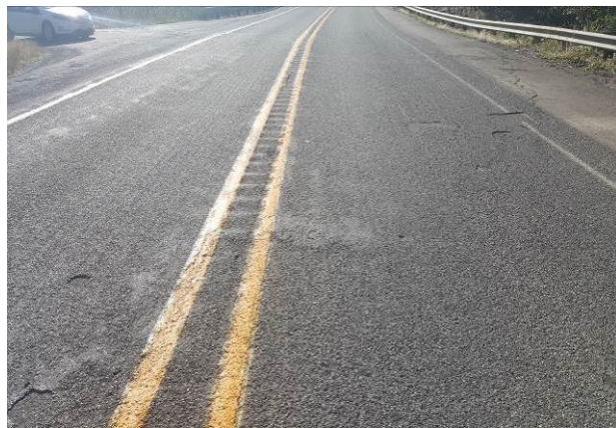
Figure 21. OR3b, SR101, Reactive, age 50 months. Delamination and spalling noted.

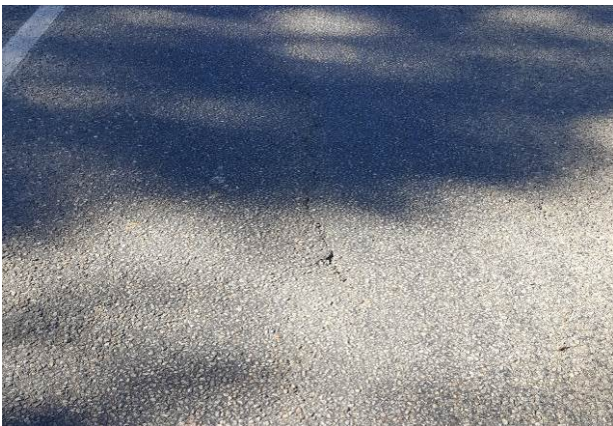
Figure 22. OR16, SR16, Strategic, age 38 months. Longitudinal crack and pumping of fines noted at 14 months.

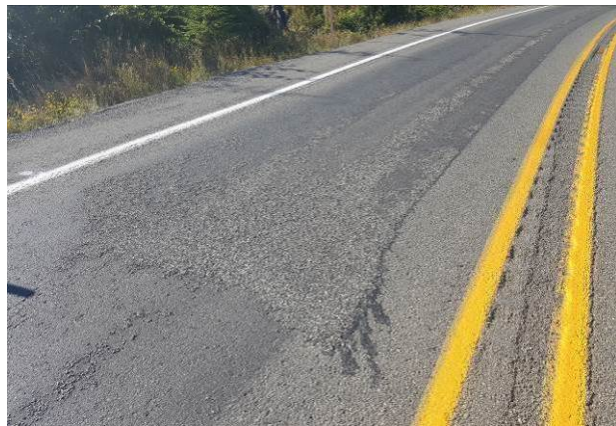
Figure 23. OR22, SR101, Strategic, age 14 months. Loss of aggregate at bottom of superelevation.

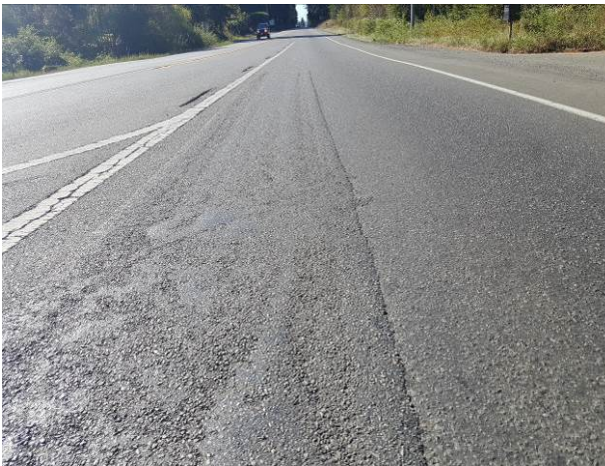
The two wheel path chip seal patching test sites ranged in age from 13 to 38 months at the 2016 inspection. Both are located in the Olympic Region where the wheel path chip sealing is done primarily to address alligator or longitudinal cracking. A longitudinal reflection crack was noted at 10 months on one of the two sites. Some loss of chips was noted along the edges of the seals of the other site. Figures 29 and 30 show the condition of the two test sites at the 2016 site visit.

Figure 29. OR12, SR20, Strategic, age 38 months. Longitudinal reflection crack and flushing noted at 10 months.

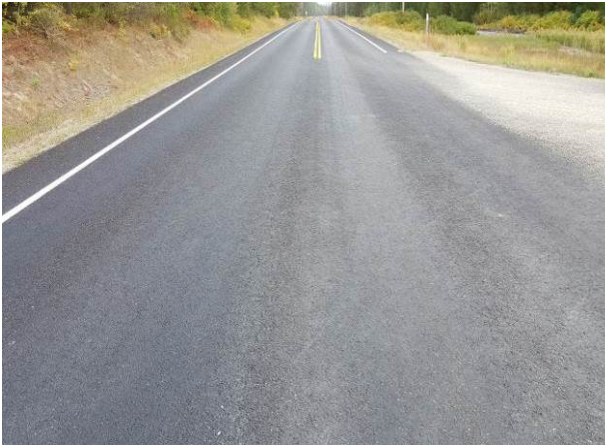
Figure 36. ER7, SR20, Strategic, age 37 months. Full lane seal applied in 2015.

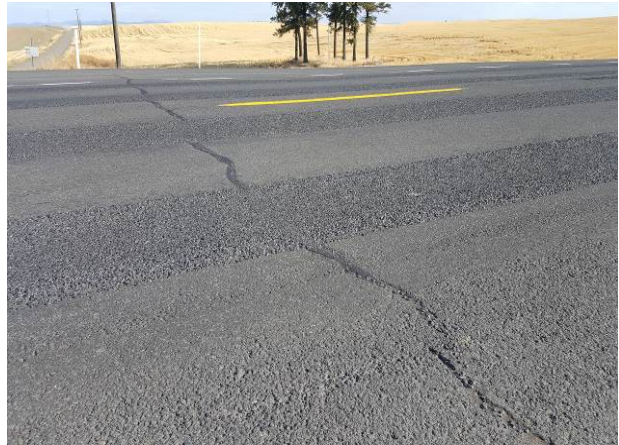
Figure 37. ER10, SR2, Strategic, age 24 months. Cracking noted at 12 months.

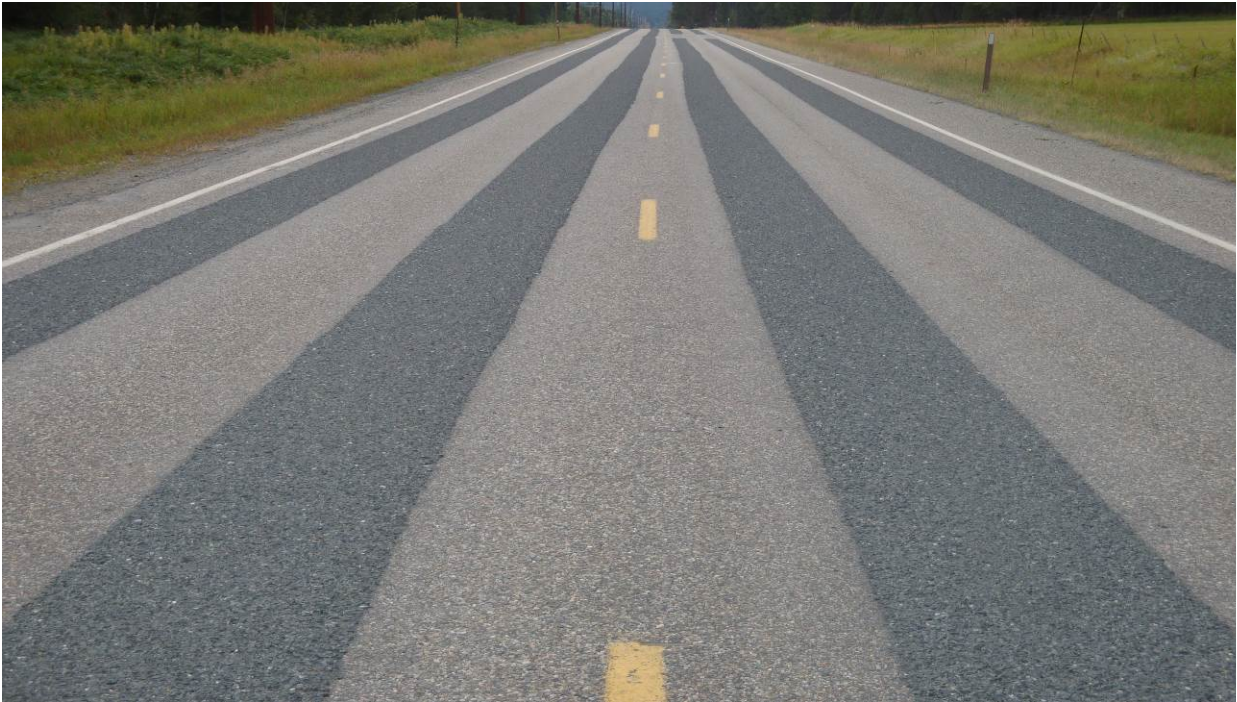
Figure 42. ER7, SR20, a few months after installation. Excellent looking wheel path chip seal rut filling.

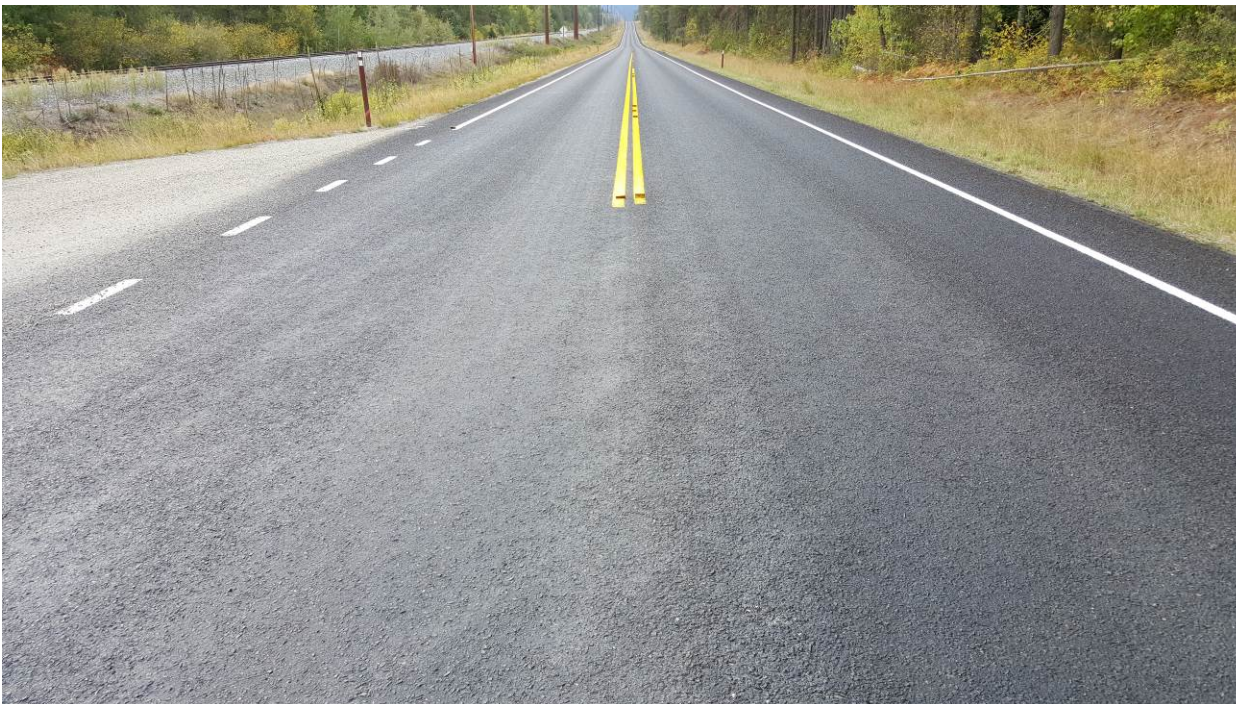
Figure 45. ER7, SR20, three years after installation. Full lane chip seal installed under Contract 8728, US 2 ET AL 2015 Eastern Region Chip Seal.

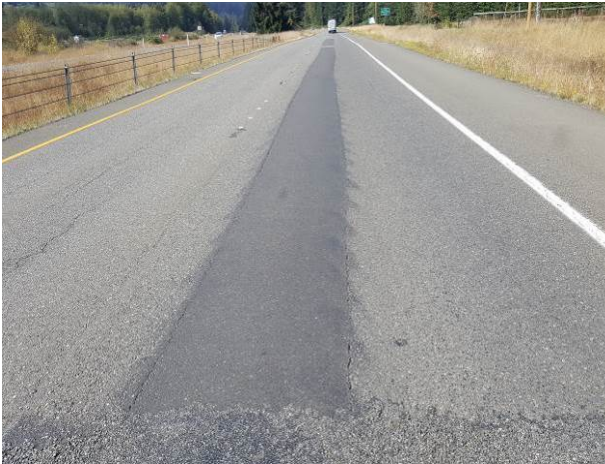
Figure 53. OR2, SR8, Emerging, age 50 months. Excellent performance.

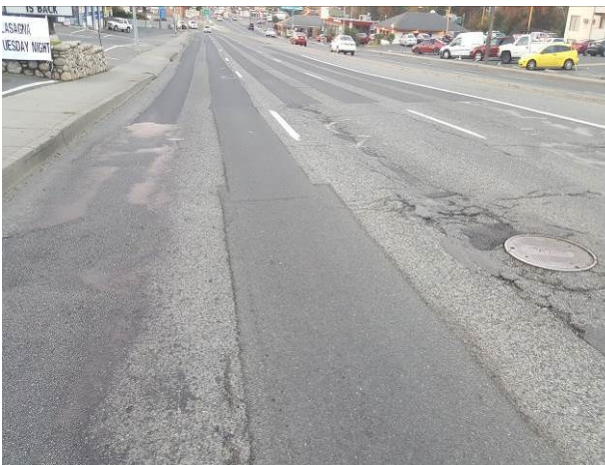
Figure 55. ER2/4, US2, Emerging, age 50 months. Additional dig outs installed in 2013 and 2015.

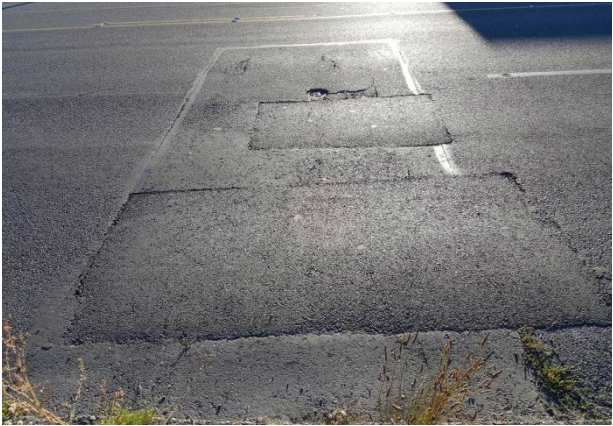
Figure 57. OR5, SR7, Strategic, age 39 months. No problems with patches, pavement continues to deteriorate adjacent to the patches.

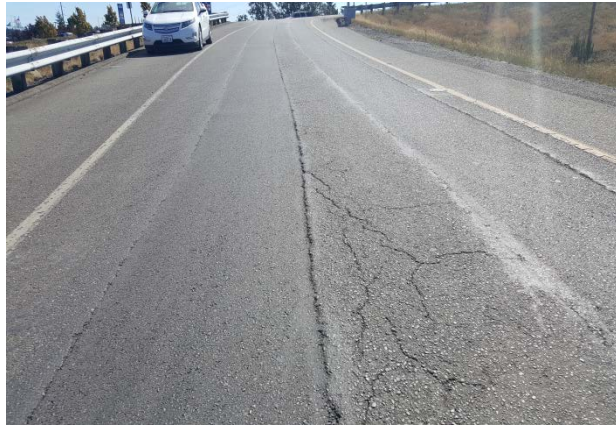
Figure 58. OR8a, SR101, Reactive, age 39 months. Excellent performance.

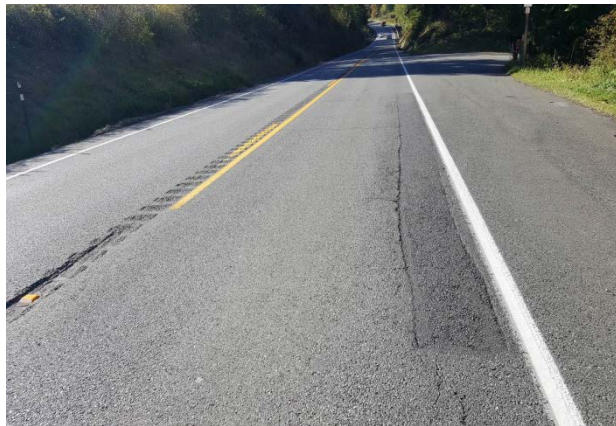
Figure 60. OR11, SR20, Strategic, age 38 months. Raveling of patch edges noted at 25 months.

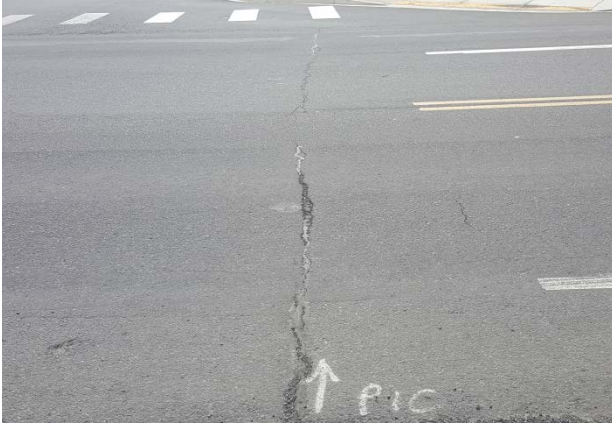
Figure 62. ER9, SR395, Strategic, age 25 months. Additional dig outs installed in 2015.

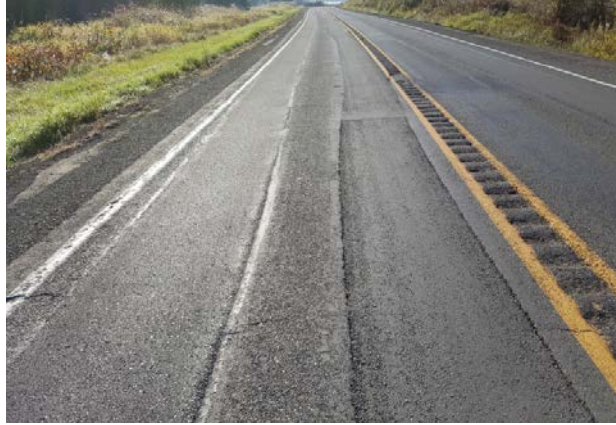
Figure 63. ER11, SR270, Emerging, age 25 months. Transverse crack at 12 months after installation.

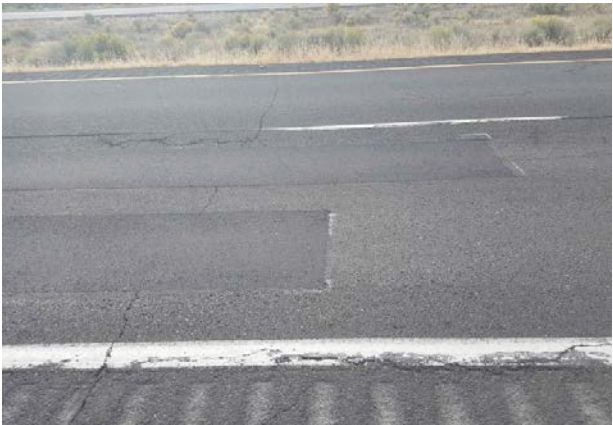
Figure 64. SW5, SR6, Strategic, are 14 months. More dig outs added in 2015.

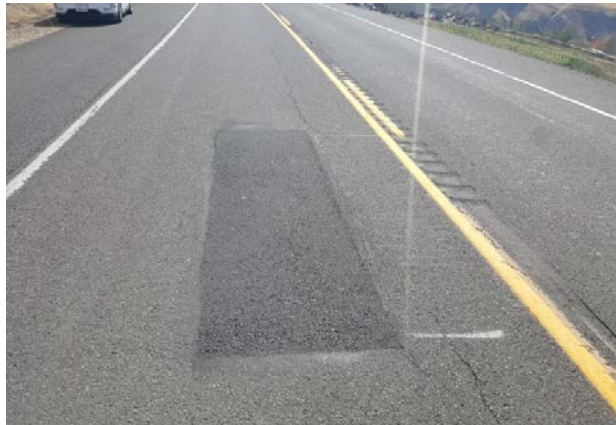
Figure 65. ER17, SR395, Strategic, age 14 months. Excellent performance.

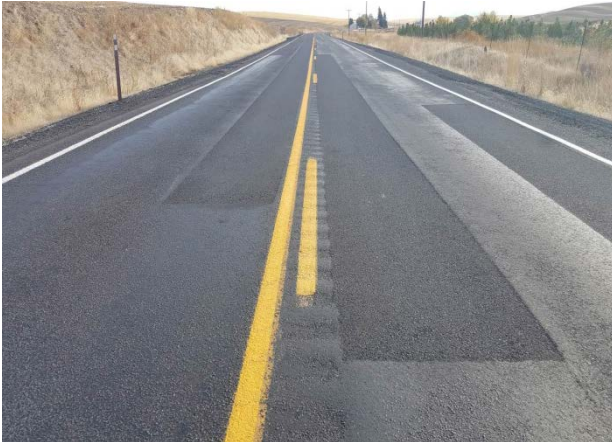
Figure 66. ER24, SR127, Strategic, age 13 months. Excellent performance.

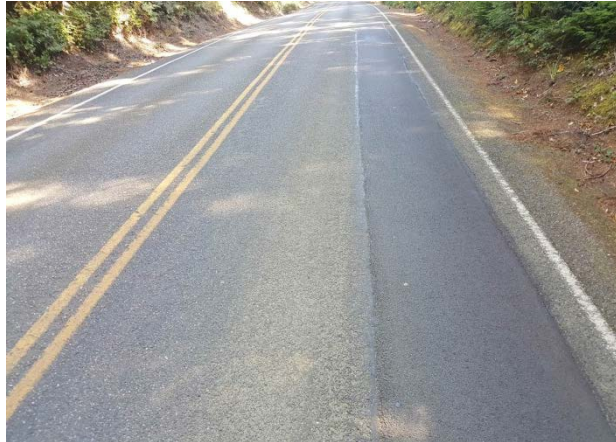
Figure 67. ER29, SR27, Strategic, age 14 months. Excellent performance.

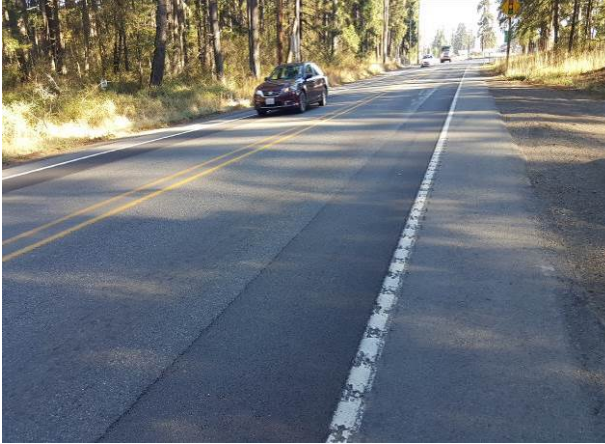
Figure 68. OR24, SR119, Strategic, age 14 months. Excellent performance.

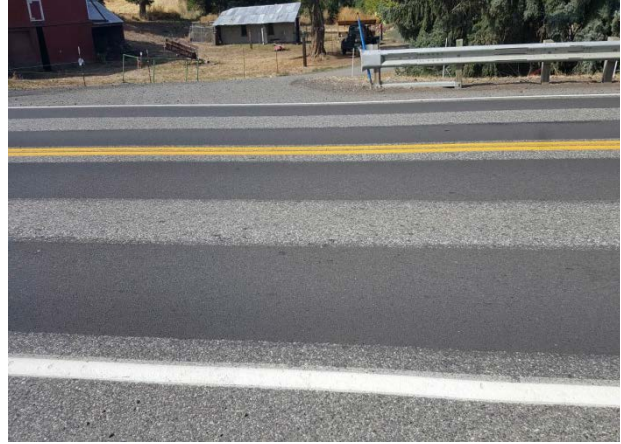
Figure 69. OR28, SR507, Strategic, age 14 months. Excellent performance.

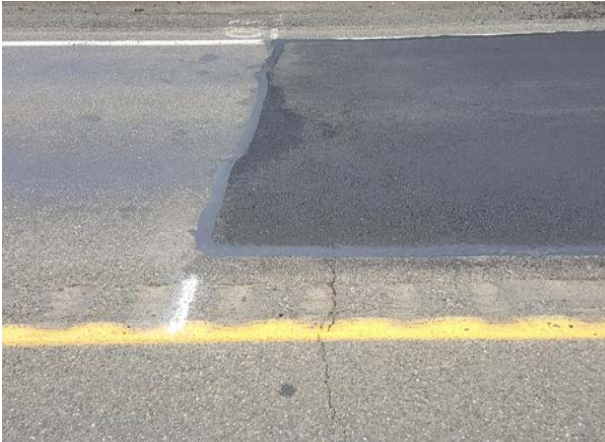
Figure 70. SC5, SR12, Strategic, age 15 months. Excellent performance.

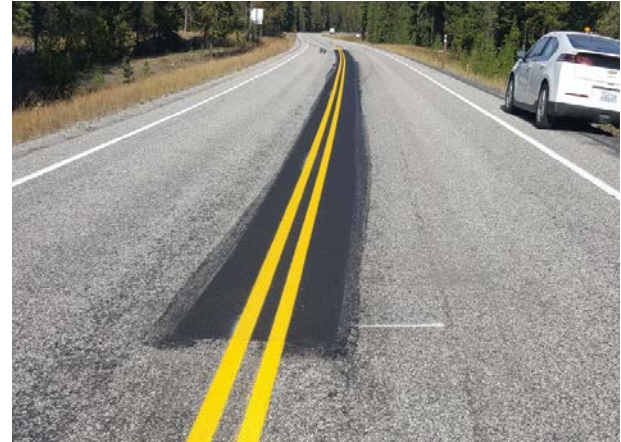
Figure 71. SW6, SR6, Strategic, age 3 months. Excellent performance.

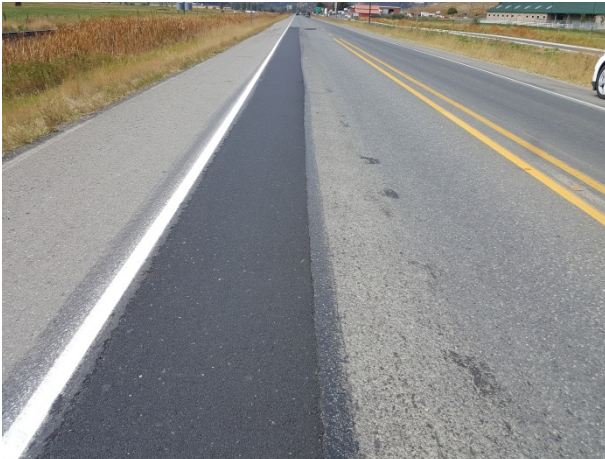
Figure 72. ER42, SR20, Strategic, age 2 months. Excellent performance.

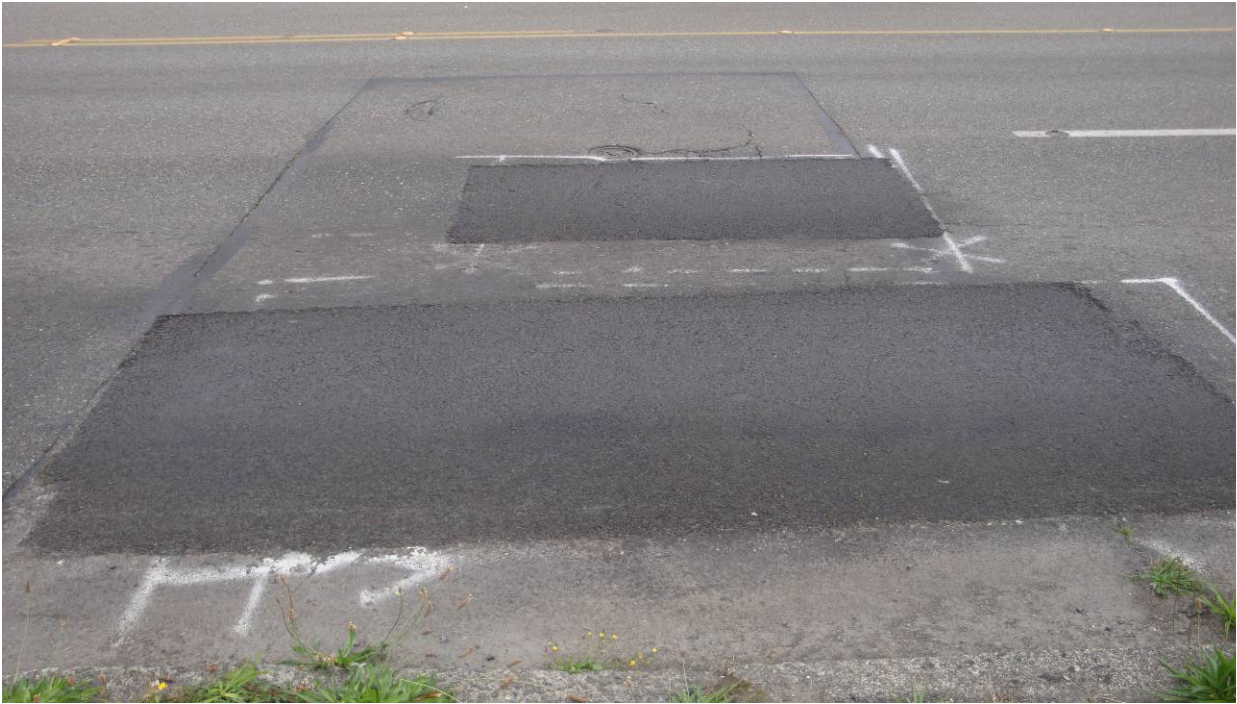
Figure 80. OR5, SR7, immediately after installation. Dig out patches look good. They appear to be related to utility cuts in original pavement.

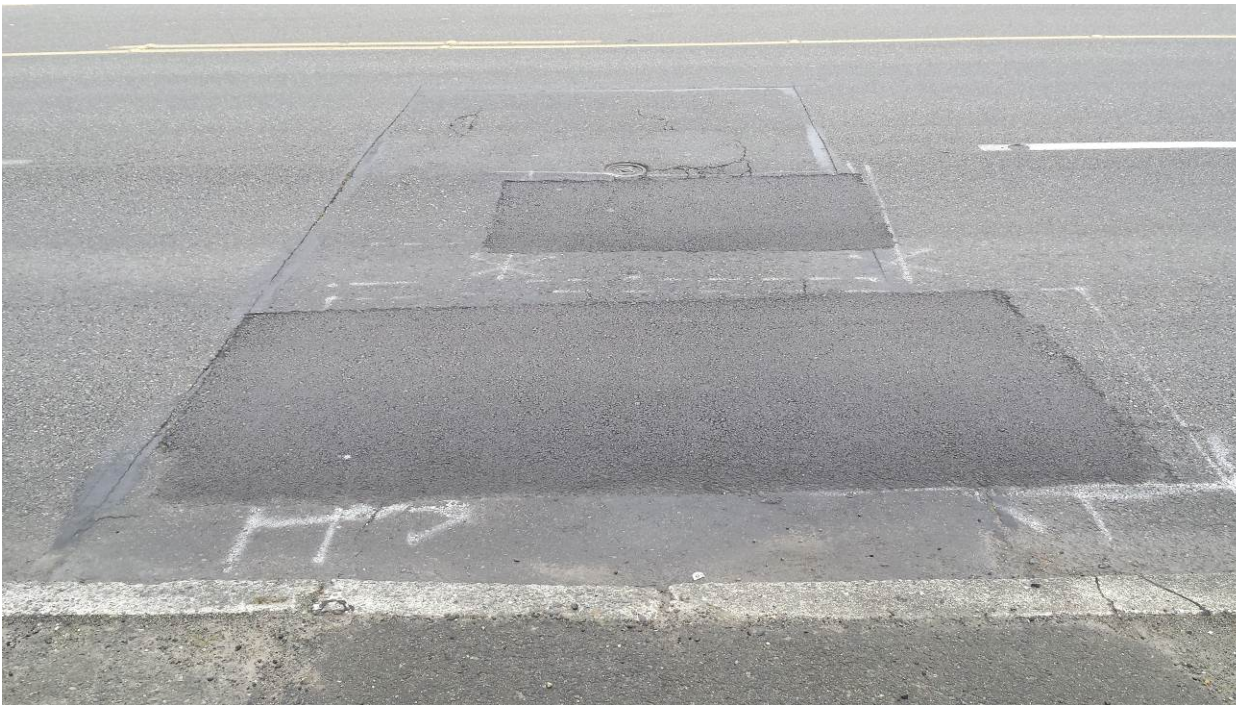
Figure 81. OR5, SR7, one year after installation. No change in the dig out patches.

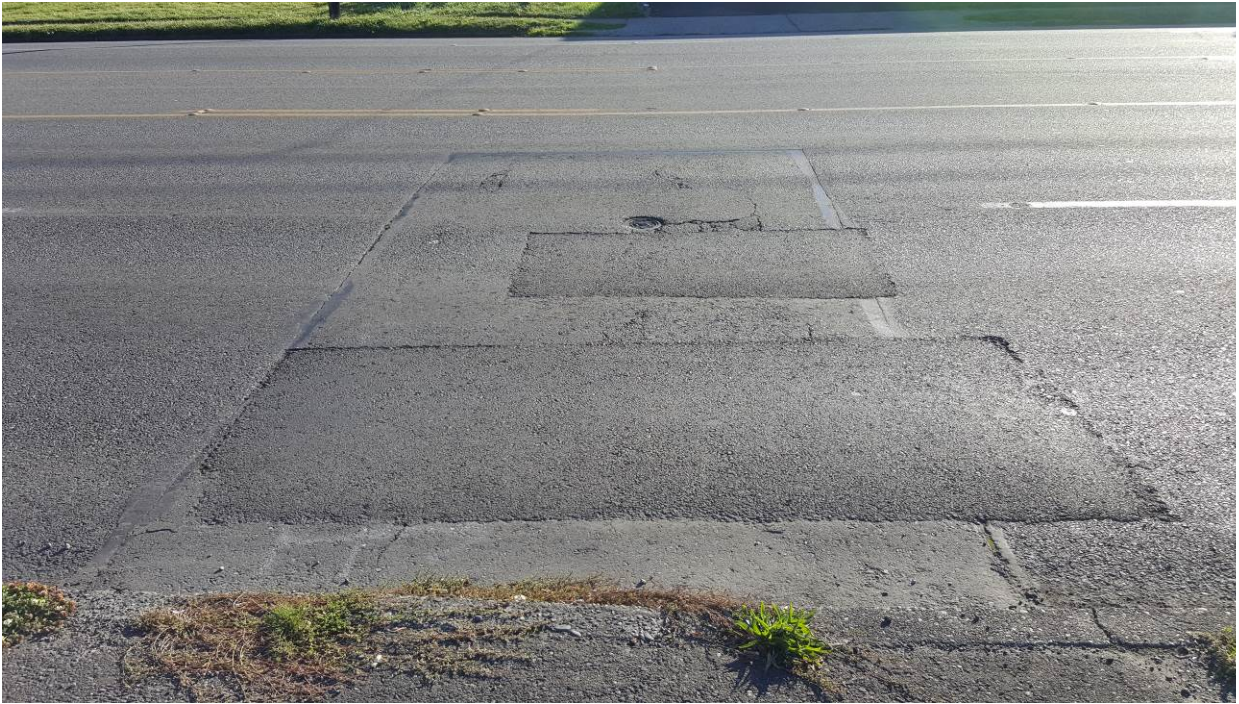
Figure 82. OR5, SR7, two years after installation. No change in the dig out patches.

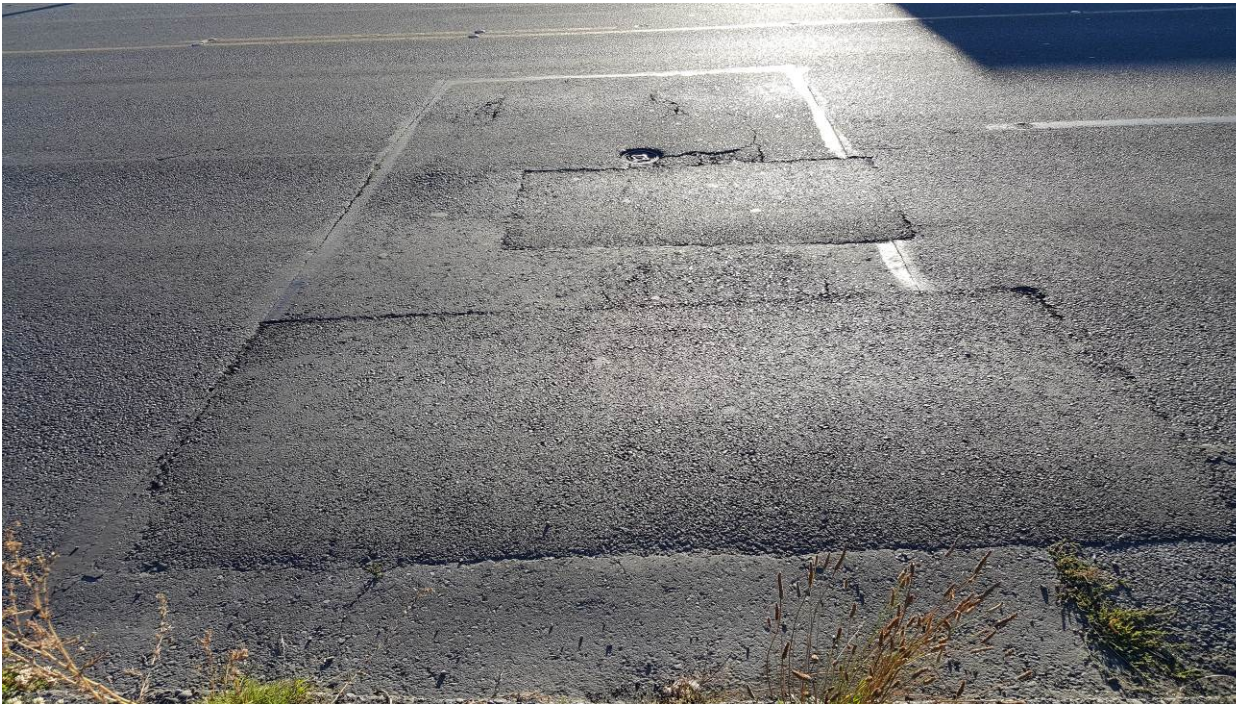
Figure 83. OR5, SR7, three years after installation. No change in the dig out patches.

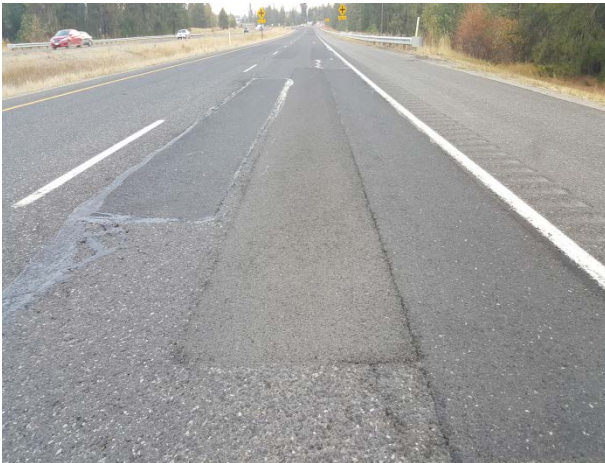
Figure 84. ER1, SR2, Reactive, age 50 months. Additional dig outs and crack sealing done in 2015.

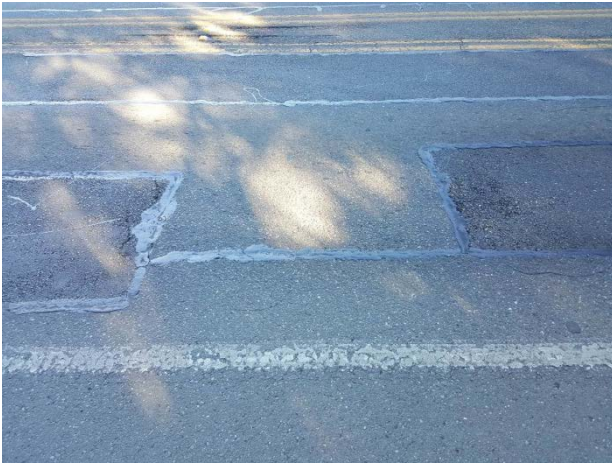
Figure 86. OR27, SR307, Strategic, age 14 months.

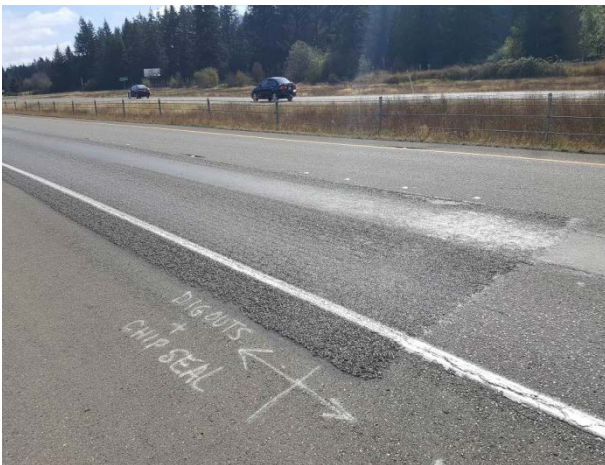
Figure 93. OR2a, SR8, Strategic, age 50 months. Flushing over the dig out patches.

The type of flushing observed on this site was typical of five of the six sites. The flushing was caused by an excess of asphalt binder that results from a combination of the binder from the patch and the new binder used for the chip seal process. The common practice used to prevent this type of flushing is to wait for a period of time before applying the chip seal. One year is advisable, but shorter periods of time may also work.

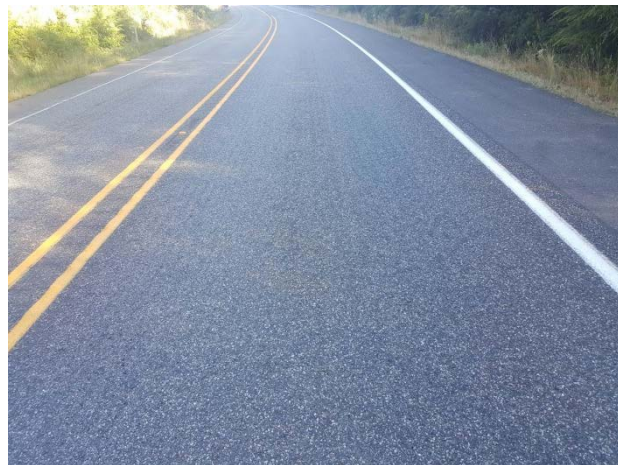
Figure 94. OR3, SR101, Reactive, age 50 months. Excellent performance.

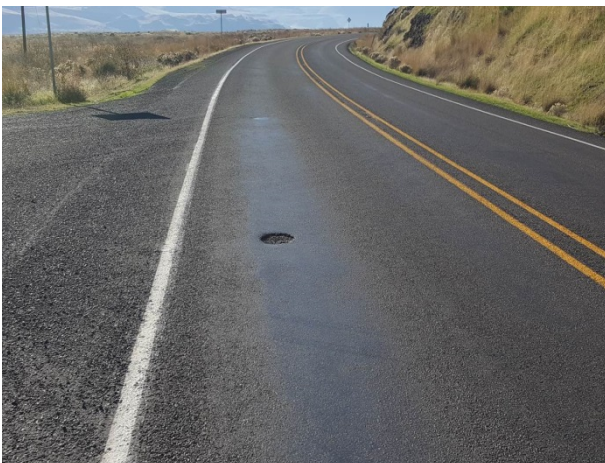
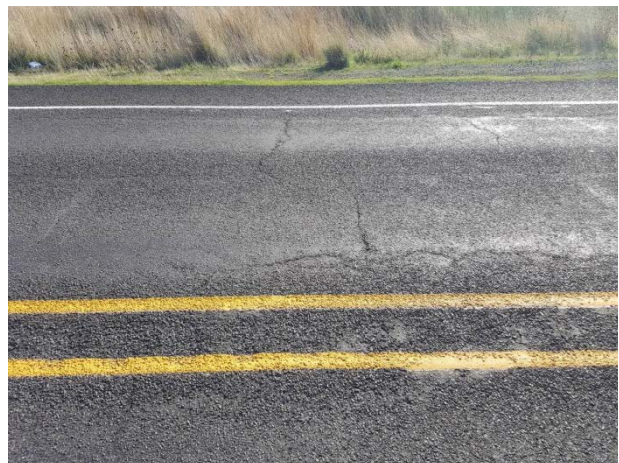
Figure 95. SW1, SR14, Reactive, age 51 months. Transverse reflection cracking and flushing noted at 9 months after installation.

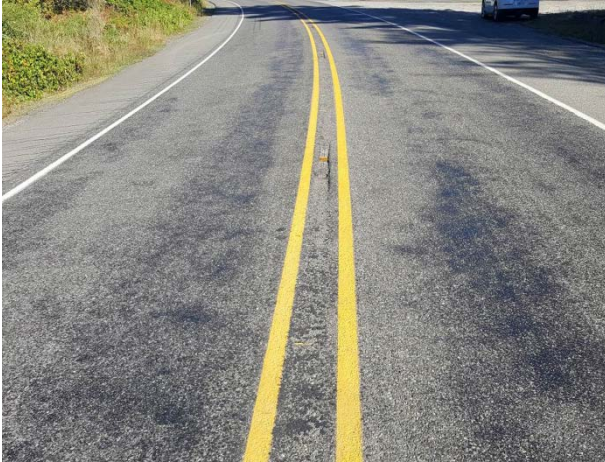
Figure 96. SW1a, SR14, Reactive, age 51 months. Transverse and longitudinal reflection cracking and flushing noted at 12 months after installation.

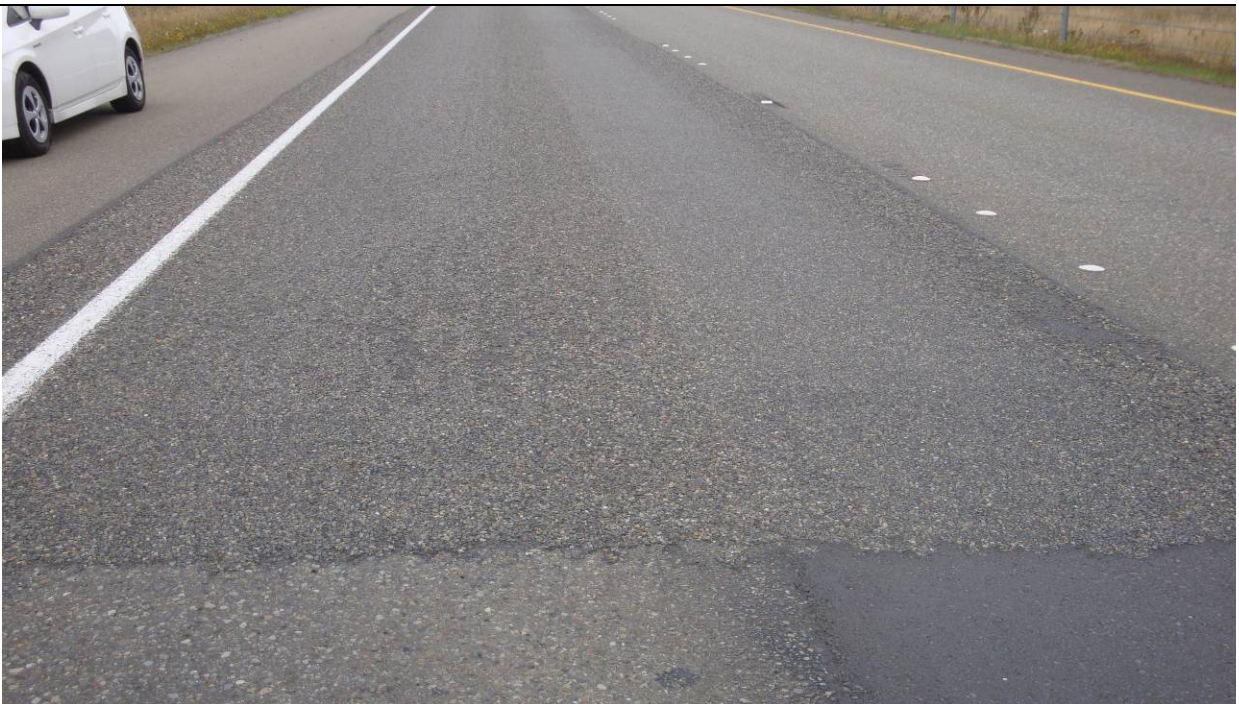
Figure 100. OR2a, SR8, one year after installation. Slight flushing in the wheel paths over the dig out patches.

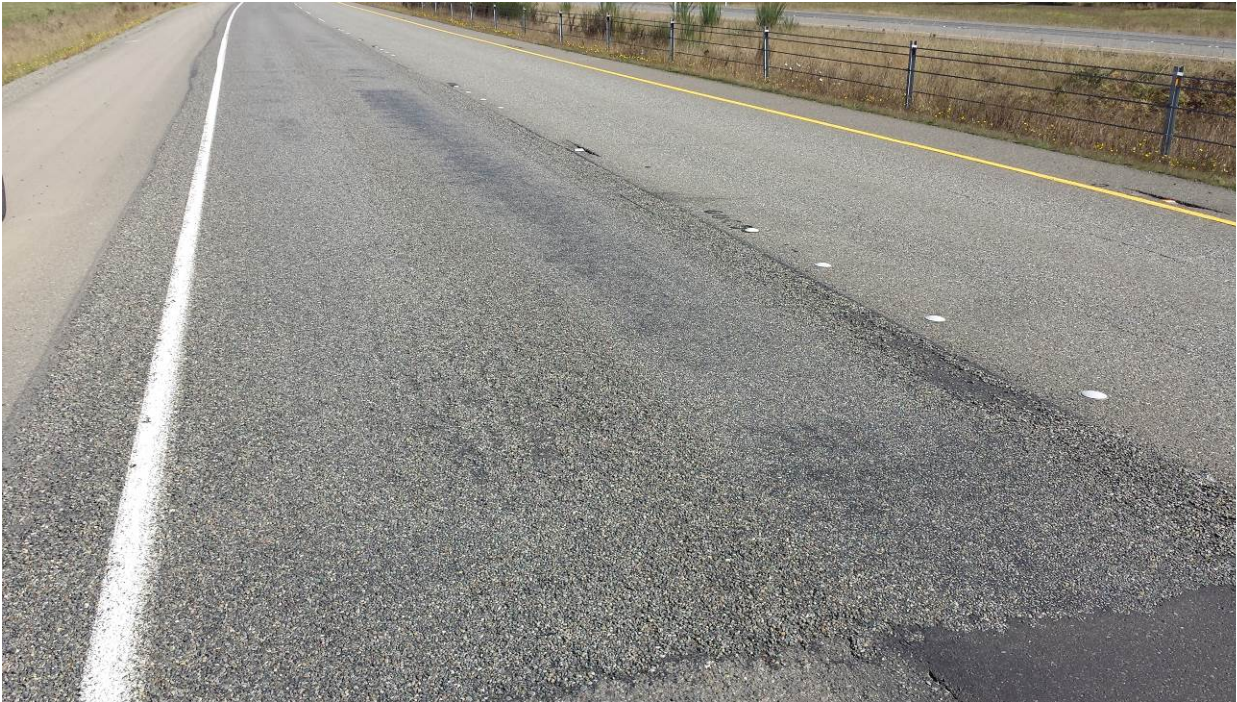
Figure 101. OR2a, SR8, two years after installation. Increased flushing in the wheel paths over the dig out patches.

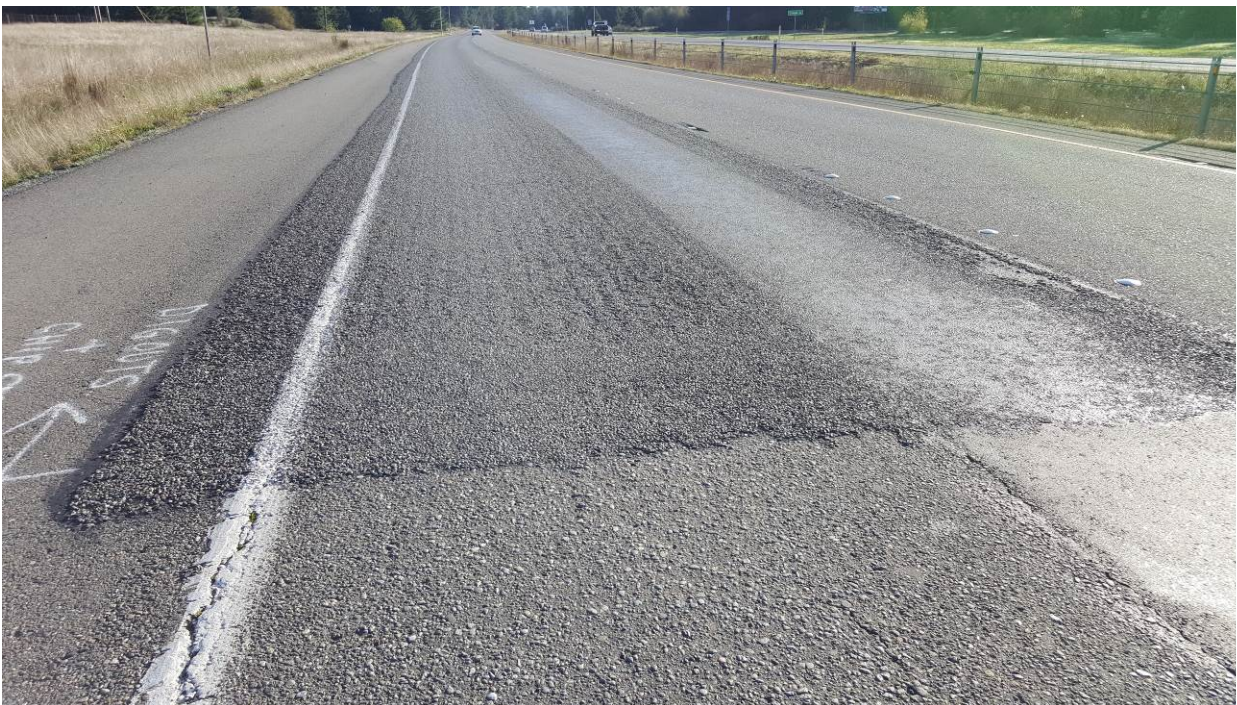
Figure 102. OR2a, SR8, three years after installation. Increased flushing in the left wheel path throughout the length of the chip seal.

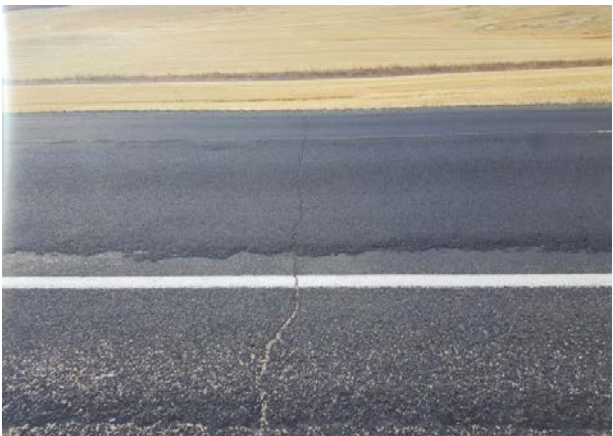
Figure 106. ER20, SR272, Strategic, age 12 months. Transverse crack reflecting through the patch.

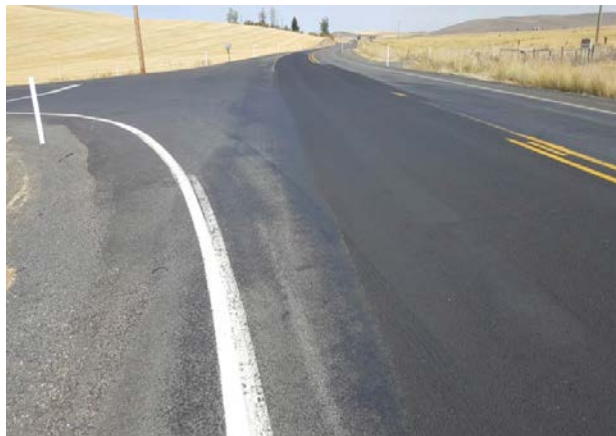
Figure 107. ER26, SR127, Strategic, age 13 months. Good Performance.

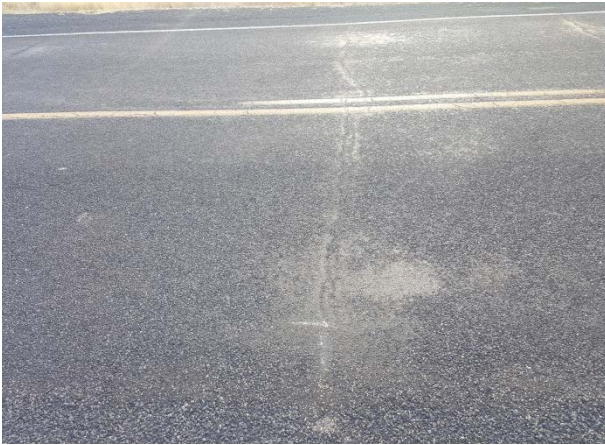
Figure 108. ER31, SR21, Strategic, age 13 months. Good Performance.

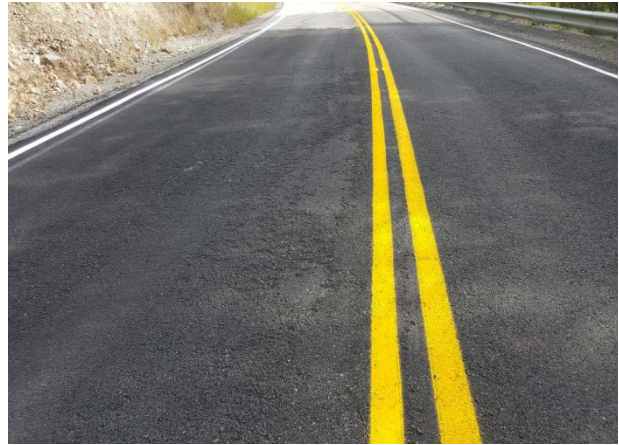
Figure 109. ER32, SR20, Strategic, age 12 months. Fair performance.

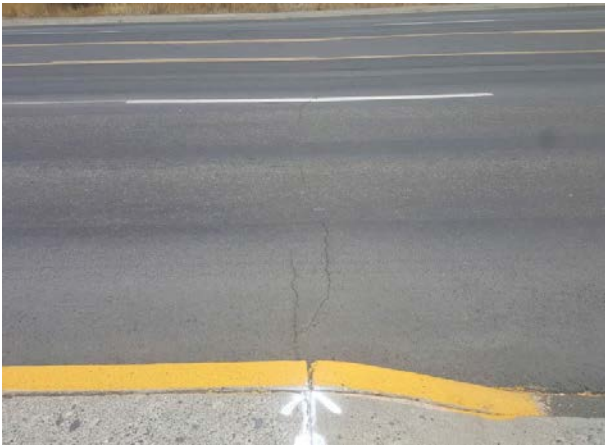
Figure 110. ER33, SR270, Strategic, age 12 months. Good performance.

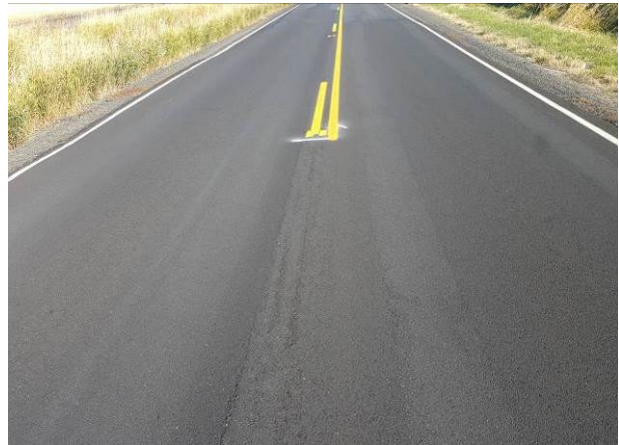
Figure 111. ER34, SR271, Strategic, age 12 months. Good performance.

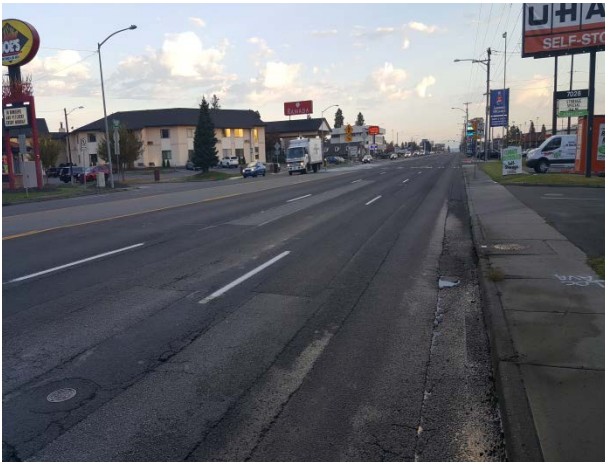
Figure 119. ER2a, SR2, Reactive, at 2016 inspection. Dig outs, crack sealing and patching were necessary to preserve the roadway.

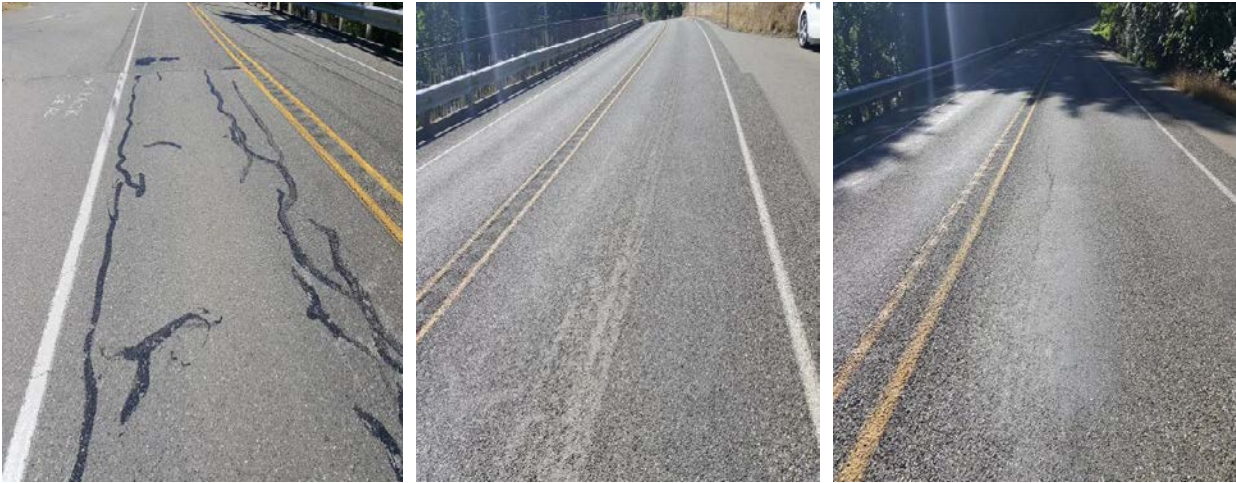
OR1, OR1a and OR1b were all located side by side on SR 101 along Hood Canal between Eldon and Lilliwaup. It is a two lane roadway (one lane in each direction) classified as a rural-principal arterial. OR1 was treated with crack sealing, OR1a was also crack sealed, but in addition received a chip seal, and OR1b received just a chip seal with no crack sealing (see Figure 129). The site with only crack sealing performed very well with no deterioration of the crack sealant except where traffic had worn down the over-banding. Additional cracking and growth of the existing cracks was noted in the section, but no additional work was required on the site during the four plus years of observation. The site with the crack seal followed by a chip seal was in very good condition with no flushing and no cracks reflecting through from the underlying pavement. No additional work was required on the section for four plus years. The section with only the chip seal did not perform as well as the other two sections with rutting and flushing in the wheel paths and a longitudinal crack reflected through the chip seal. No additional work occurred on the section for four plus years; however, it could be argued that the flushing, rutting and reflection crack may have warranted some additional attention. It could also be argued that crack sealing was the best treatment solution for this particular location knowing that the cost of crack sealing would be much less than the other two treatment choices. The choice depends on how long the pavement needs to be delayed until the next rehabilitation cycle.

Figure 129. OR1, OR1a and OR1b on SR 101. OR1 has crack sealing, OR1a has crack sealing and chip sealing, and OR1b has a chip seal with no crack sealing.

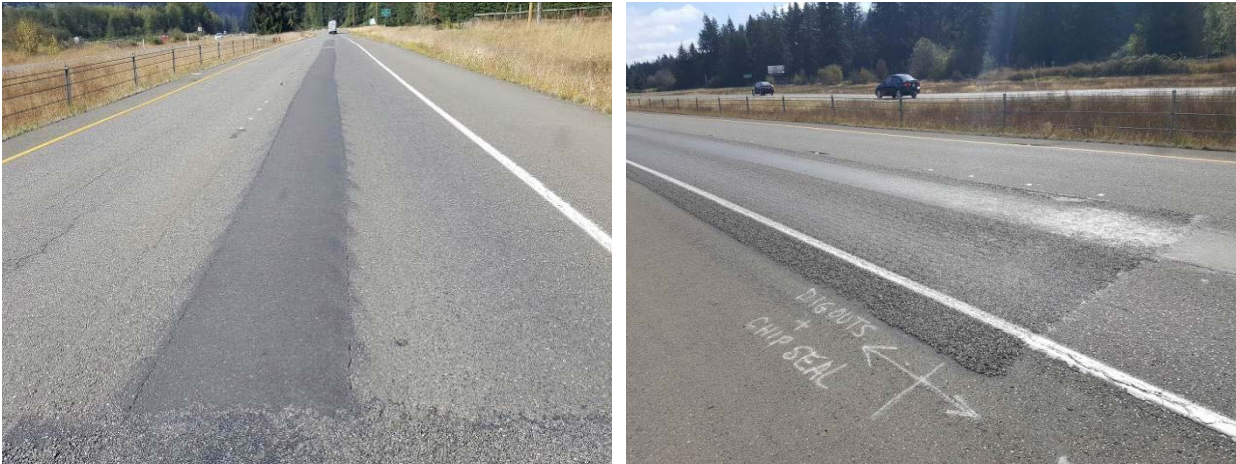
The next location with multiple treatments was OR2 and OR2a, located on the westbound lanes of SR 8 approaching McCleary. It is a four lane divided roadway (two lanes in each direction) classified as a rural-principal arterial. OR2 received dig outs and OR2a received dig outs and a chip seal (Figure 130). The section with dig outs performed very well with no deterioration of the dig out patches and minor transverse reflection cracks. The dig out patching was only installed in the inside wheel path. The outside wheel path had severe longitudinal cracking that was beginning to show some spalling they intersected transverse cracks. The section that received the chip seal over the dig outs had flushing present in the wheel paths throughout the section with severe flushing over the dig out patches. Longitudinal cracking was also reflecting through the chip seal in the outside wheel path, the same longitudinal cracks not addressed in the section with only the dig outs. Dig outs without the chip seal performed much better than the section with the chip seal due to the flushing of the chip seal; however, both sites lasted four plus years without additional treatment. The application of the chip seal was apparently due to a misunderstanding between the Olympic Region Materials Engineering and Maintenance. The Materials Engineering indicated that the dig outs and chip sealing were alternatives for the treatment and were not meant to be applied in combination. It was difficult to make the right

choice on this site. Crack sealing the outside wheel path and omitting the chip seal followed by the chip seal the next summer may have been the optimum fix

Figure 130. OR2 and OR2a on SR8. OR2 received dig outs and OR2a received dig outs and a chip seal.
