Preventive Maintenance Study – Interim Report

WA-RD 871.1

**Washington State
Department of Transportation**

Preventive Maintenance Study

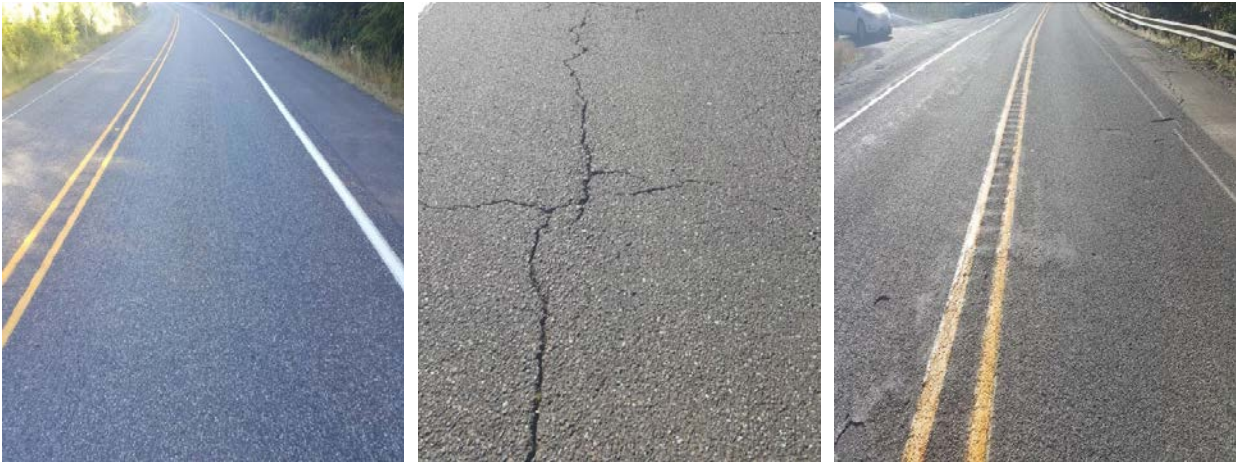
The final location is OR3, OR3a and OR3b located on SR 101 south of the Queets River Bridge. It is a two lane roadway (one lane in each direction) classified as a rural-principal arterial. OR3 received dig outs and a chip seal, OR3b a chip seal with no dig outs, and OR3a was a control section with no treatment (Figure 131). It is evident that the dig outs and chip seal section is performing much better than the section with only the chip seal; however, this may be due in part to the poor condition of the original pavement in the chip seal only section. The control section is also performing fairly well, although the cracks have grown in length and become wider with vegetation growing in the cracks. The best treatment solution for this location appears to be no treatment since the section survived for four plus years without potholes or excessive spalling of the cracks; but now is the time to perform preventive maintenance before the cracks turn into potholes. The mild climate and low traffic volumes (ADDT of 870) were contributing factors to the slow deterioration of this section of pavement.

Figure 131. OR3, OR3a and OR3b on SR101. OR3 received dig outs and a chip seal, OR3a is a control section with no treatment and OR3b received a chip seal with no dig outs.

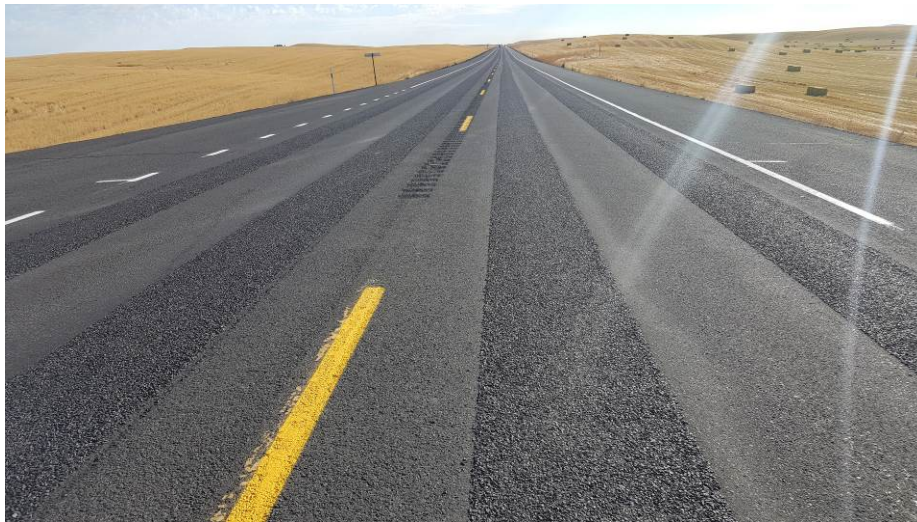
Wheel path chip sealing is a good option when alligator cracking is confined to the wheel paths or when there is rutting in the wheel paths (Figure 133). The Eastern Region used wheel path chip sealing to fill ruts one summer followed by a full lane chip seal the next summer on one test site.

Figure 133. ER10, wheel path chip seal rut filling on US 2. (September 2016)

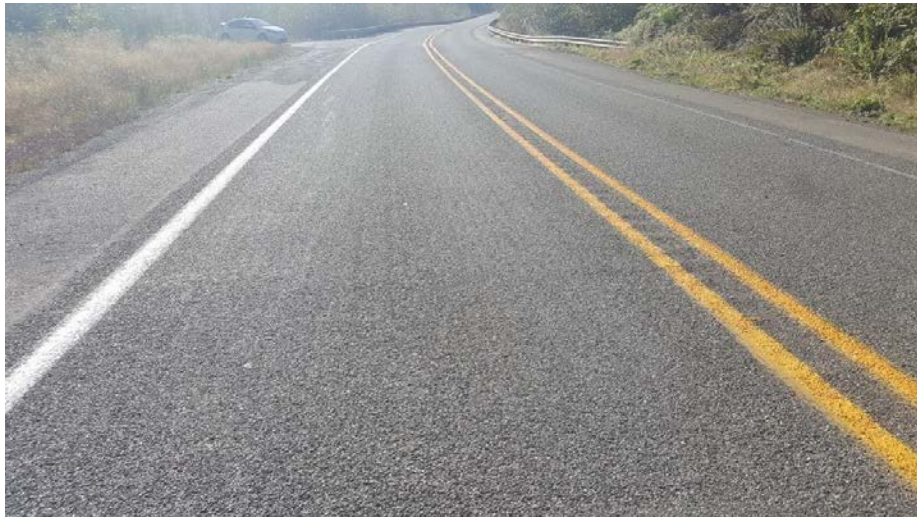
Full lane chip sealing is one of the most effective treatments because it can cover a multitude of pavement distress (Figure 134). This would include alligator cracking, longitudinal cracking and transverse cracking (provided the cracks are less than $\frac{1}{4}$ inch in width), and patching. The experience in this study with three of the four test sites exhibited flushing would seem to indicate that this is a choice to be avoided, especially if the wheel paths are rutted; however, the very good experience when full lane chip seals placed under Region wide chip seal contracts would indicate just the opposite. As indicated previously, it may be that the materials used or the application techniques that may need to be given scrutiny in order to achieve the desired results. Chip sealing is often described as an art due to the many factors that can contribute to either success or failure. A few of these factors include the condition of the application equipment, both chip

Figure 134. OR3b full lane chip seal on SR 101. (September 2016)

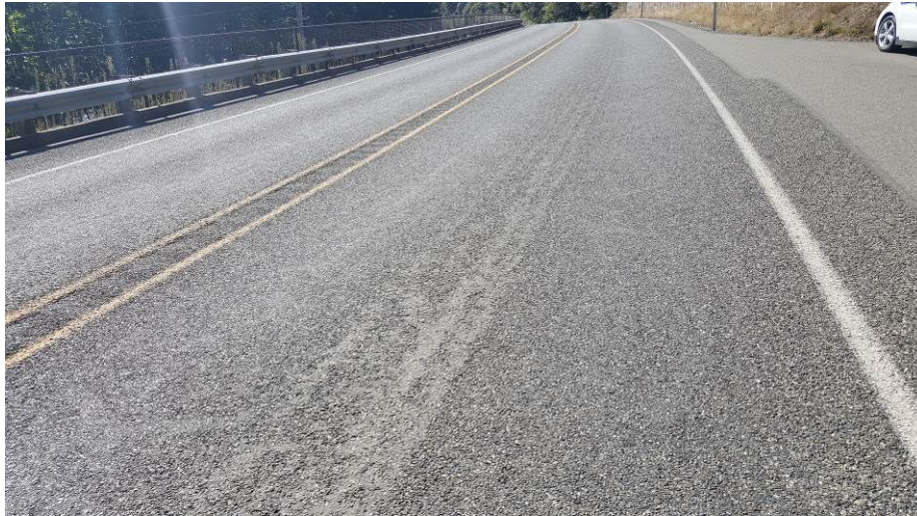
The crack sealing plus chip sealing is the next lowest cost option (Figure 135). It is best used where some of the cracks exceed 1/4 inch in width and some are very fine. Sealing these larger cracks prior to the application of the chip seal will likely prevent the cracks from reflecting through the chip seal. Its use was limited to two test sites, probably due to the higher costs involved. On the Olympic Region test site (OR1a), either crack sealing or chip sealing alone would probably have provided a solution that would have lasted four plus years. The adjacent sections, OR1 and OR1b, which received only crack sealing or chip sealing, respectively, have performed very well. On the North Central site NC1, a special crack sealant was used to seal very wide thermal cracks in the chip seal prior to the application of another chip seal. In this case, the crack

sealing was a necessity due to the wide transverse cracks in the existing pavement. To minimize issues with chip seal flushing, it is best to wait at least one season after the crack sealant is placed before placing the chip seal.

Figure 135. OR1a crack sealing plus chip sealing on SR 101.
(September 2016)

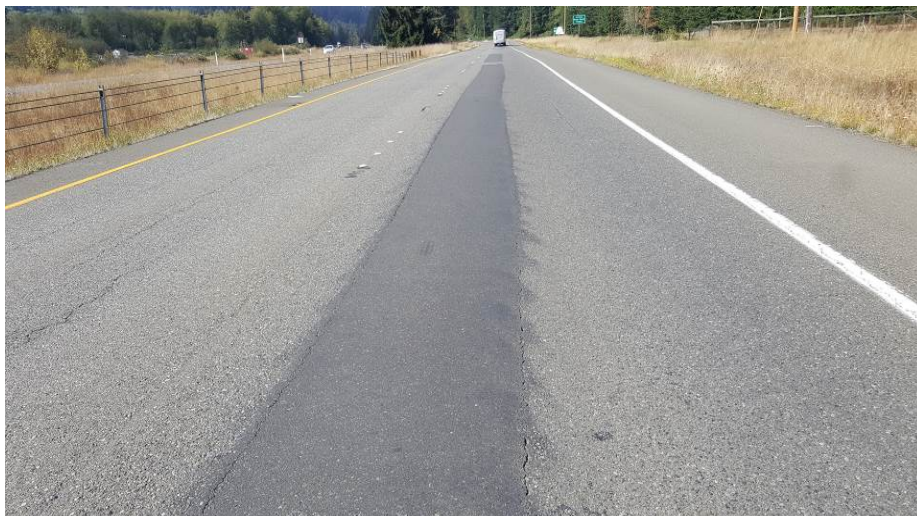
Dig outs are one of the more expensive treatments due to the high cost of equipment, labor and materials required to prepare the holes, fill the holes, and compact the HMA (Figure 137). It is used when cracking in the wheel paths are wide and interconnected and are beginning to develop potholes. It is very effective because it removes the entire area of the distressed pavement and replaces it with new HMA. The performance of the dig out patches has been excellent on all of the test sites.

Figure 137. OR2 dig outs on SR 8. (September 2016)

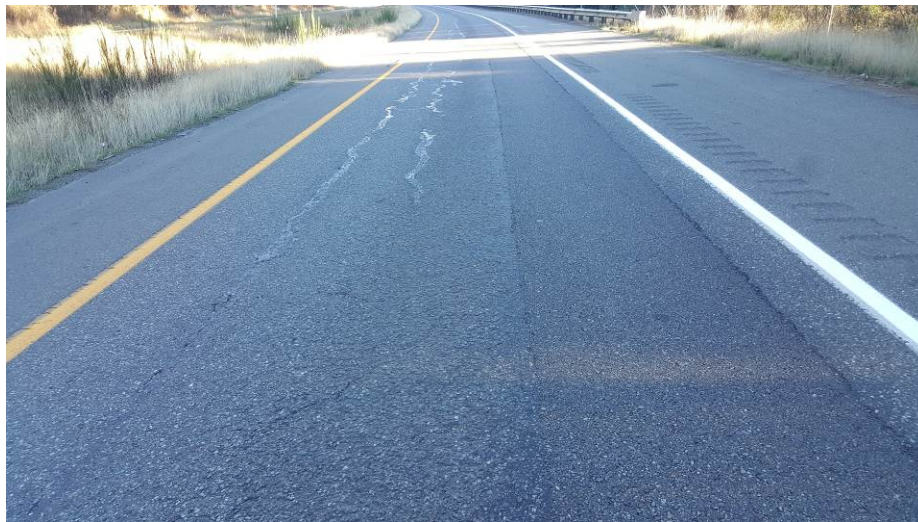
Using a combination of dig outs and crack sealing is a very expensive fix, but may be necessary to fix a pavement with alligator cracking in the wheel paths and longitudinal and transverse cracking throughout (Figure 138). The dig outs plus crack sealing test sites were ones in which the pavement was in such poor condition that the dig outs could not encompass all of the distressed pavement, and as a result, crack sealing was necessary to fill the large cracks between the dig outs.

Figure 138. OR4 dig outs plus crack sealing on SR 3. (September 2016)

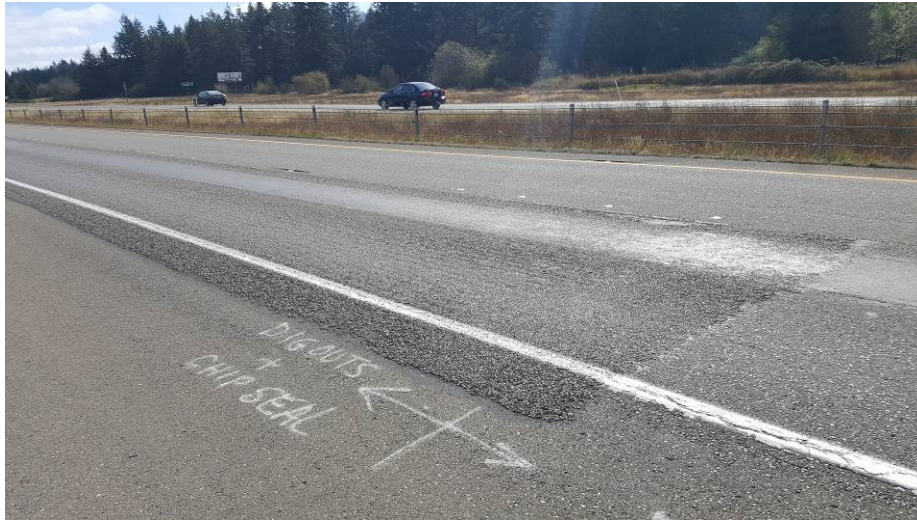
Dig outs plus chip sealing is the most expensive option (Figure 139). The flushing conditions on several of the sites could have been avoided by eliminating the chip seal. Placing a chip seal over newly placed dig out patches is not a good practice due to the strong possibility that the chip seal will flush or could result in chip loss. A solution is to place the chip seal in the next construction season after the patch has aged.

Figure 139. OR2a dig outs plus chip seal SR 8. (September 2016)
