Preventive Maintenance Study - Final Report

WA-RD 871.2

Preventive Maintenance Study

Washington State – Statewide Locations

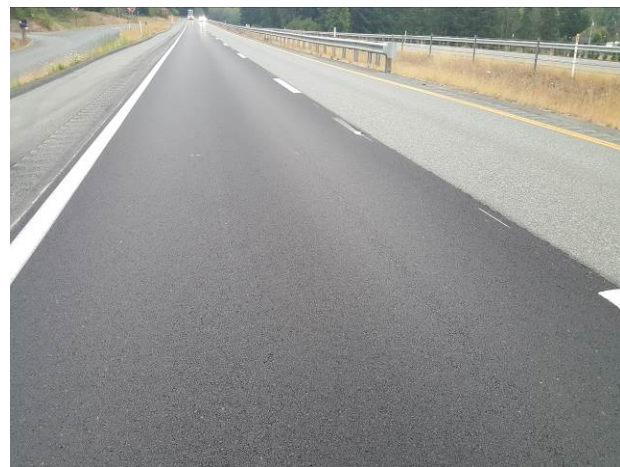
Figure 3. OR6, SR8, Good, age 50 months. HMA grind/inlay in 2017, C9001.

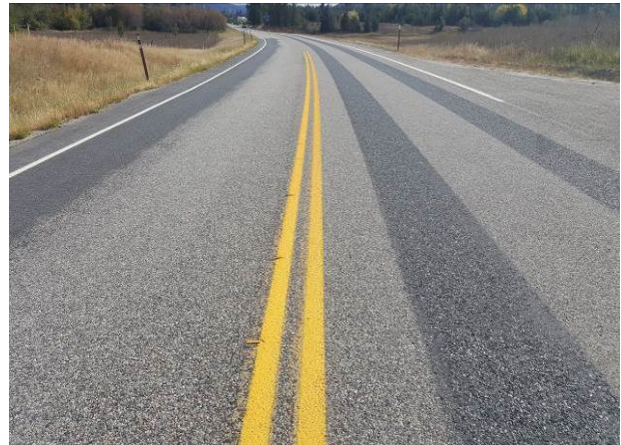
Figure 41. ER18, SR31, Good, age 26 months. BST in 2017, C9031. Photo is from 2016.

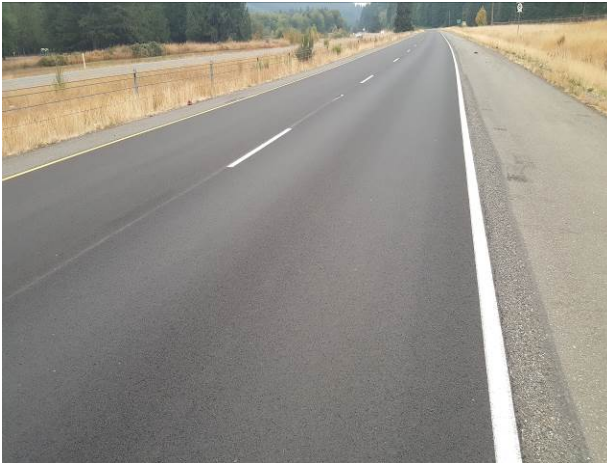
Figure 56. OR2, SR8, Fair, age 62 months. HMA grind/inlay in 2017, C9001.

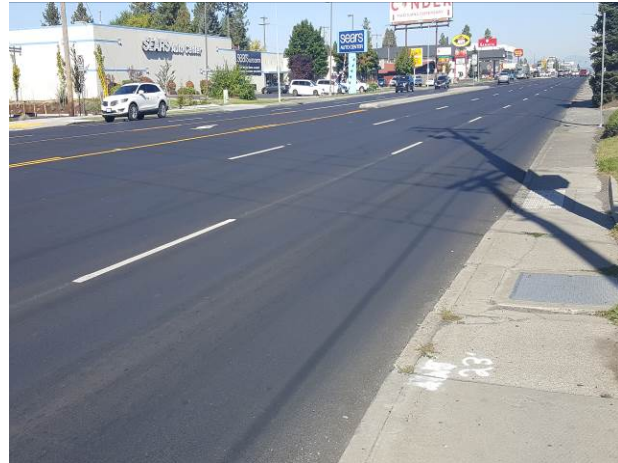
Figure 57. ER2, US2, Fair, age 62 months. HMA grind/inlay in 2017, C9063.

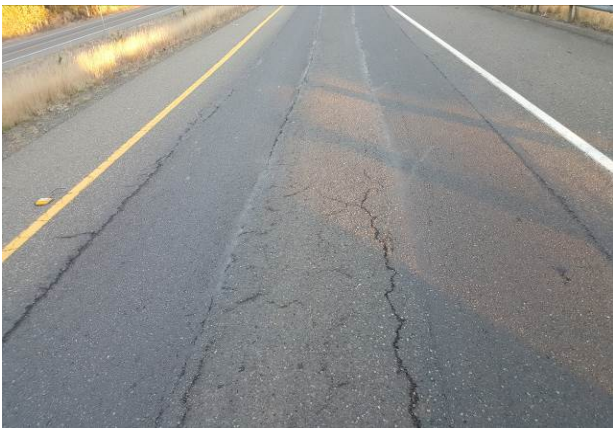
Figure 62. OR8a, SR101, Poor, age 51 months.

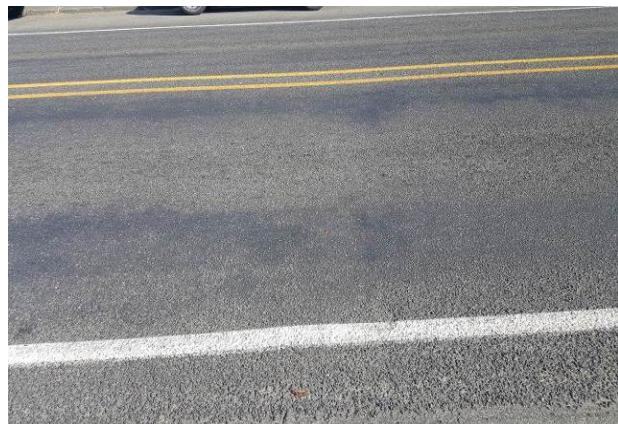
Figure 65. OR15, SR12, Fair, age 49 months. BST in 2016, C8870.

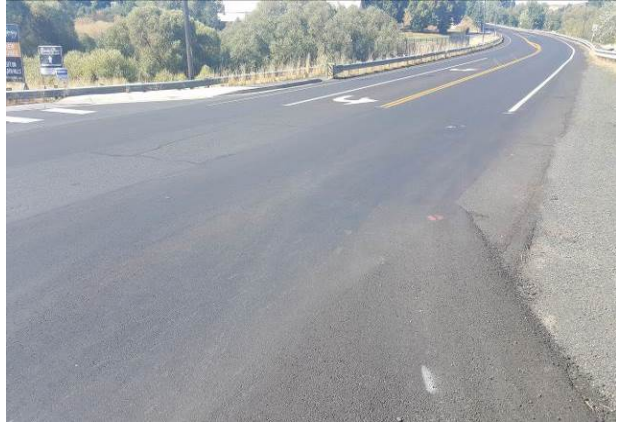
Figure 67. ER11, SR270, Fair, age 37 months. HMA grind/inlay in 2017, C9062.

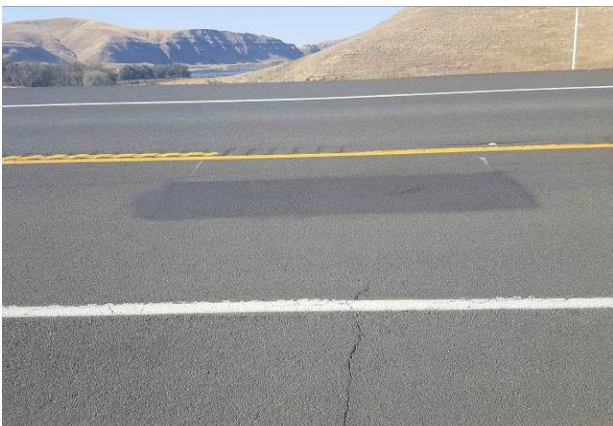
Figure 70. ER24, SR127, Good, age 25 months. Excellent performance.

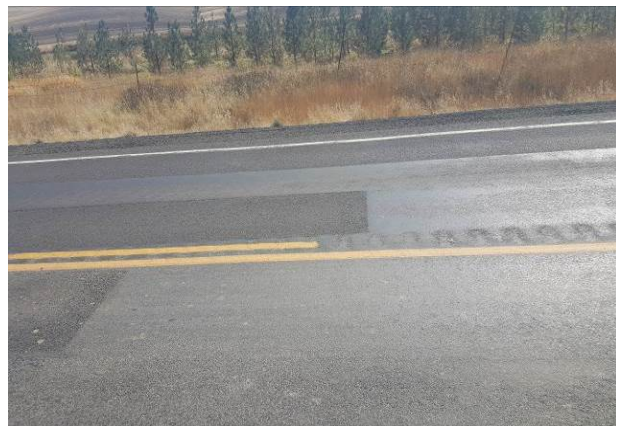
Figure 71. ER29, SR27, Good, age 26 months. Excellent performance.

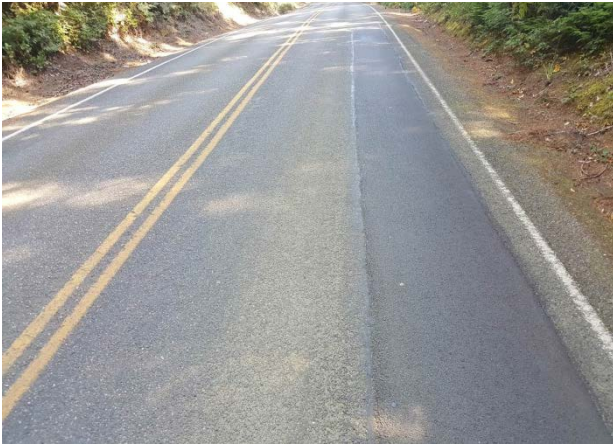
Figure 72. OR24, SR119, Good, age 14 months. BST in 2017, C9077.

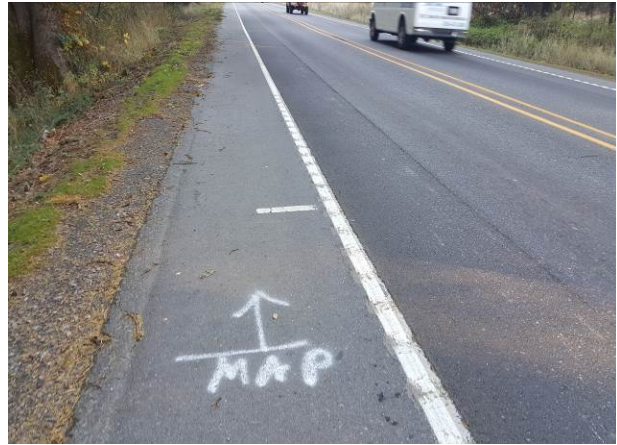
Figure 73. OR28, SR507, Good, age 28 months. Excellent performance.

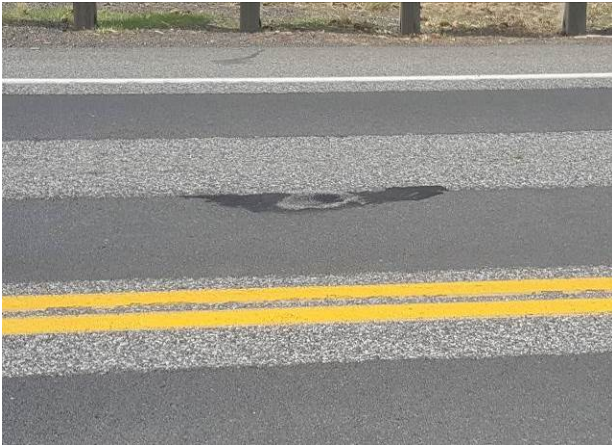
Figure 74. SC5, SR12, Good, age 28 months. Excellent performance.

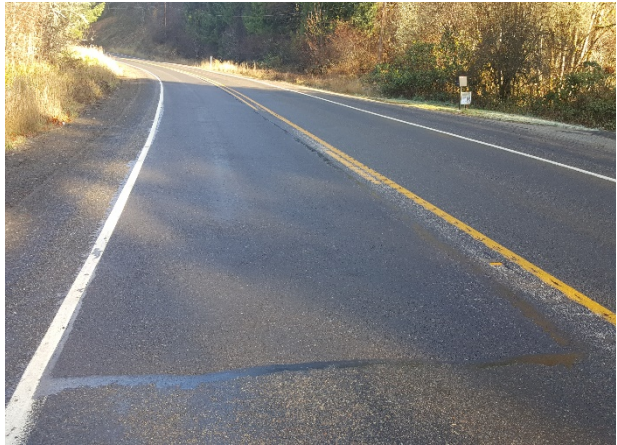
Figure 75. SW6, SR6, Good, age 27 months. Excellent performance.

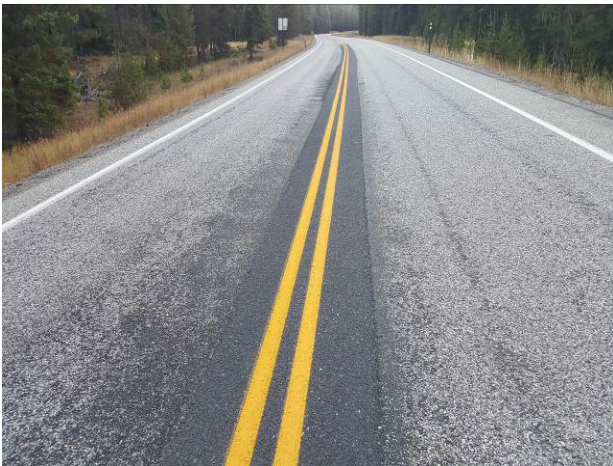
Figure 76. ER42, SR20, Good, age 14 months. Excellent performance.

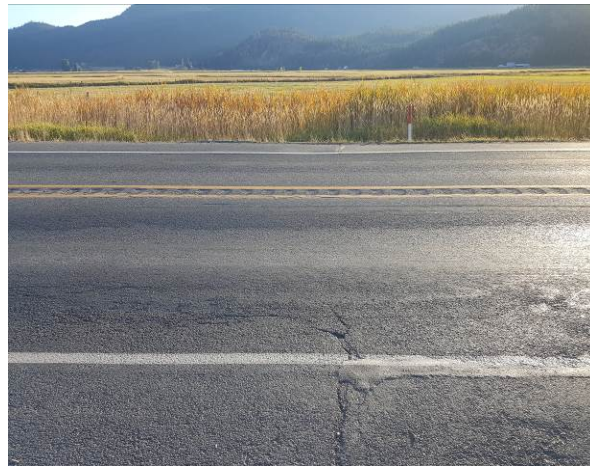
Figure 77. ER43, SR395, Good, age 14 months. Excellent performance.

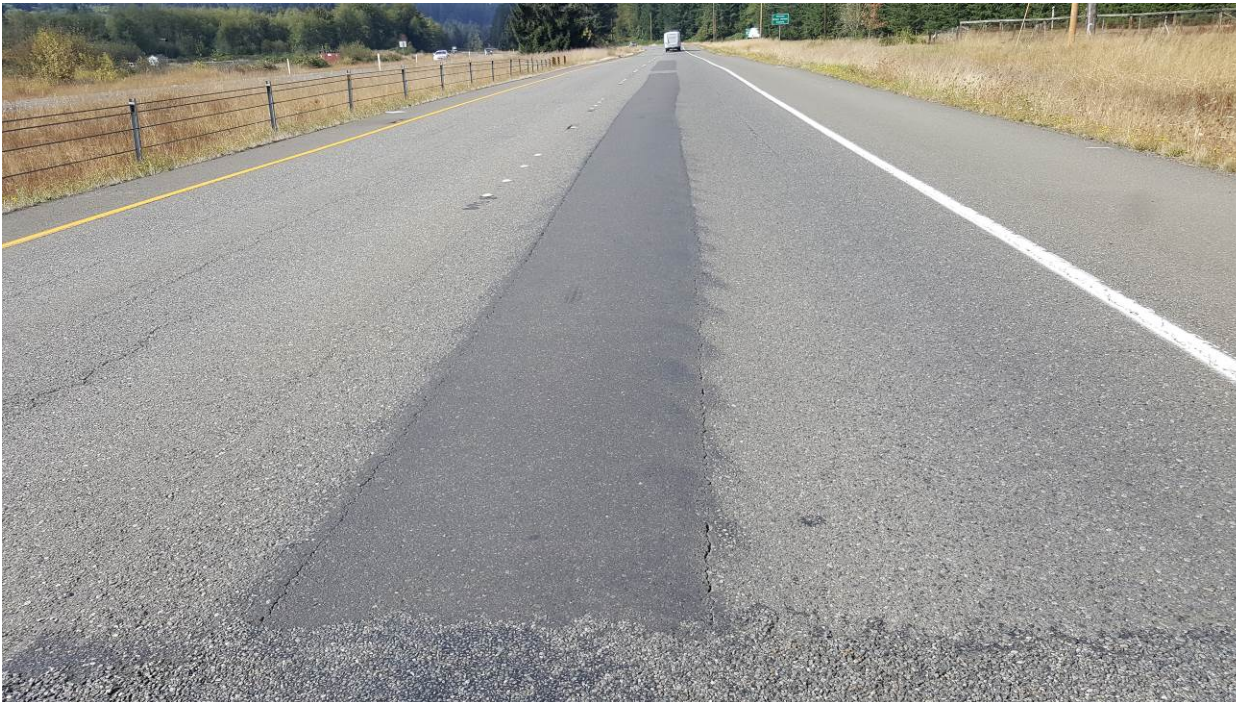
Figure 82. OR2, SR8 four years after installation. No change in past year.

The dig out patch shown in the photos has not changed in appearance for 62-months except for some slight rutting. The section received an HMA grind/inlay in 2017.

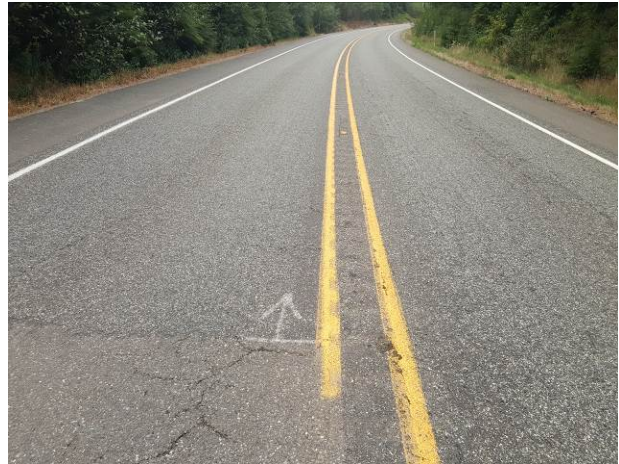
Figure 101. OR3, SR101, Poor, age 62 months. Excellent performance.

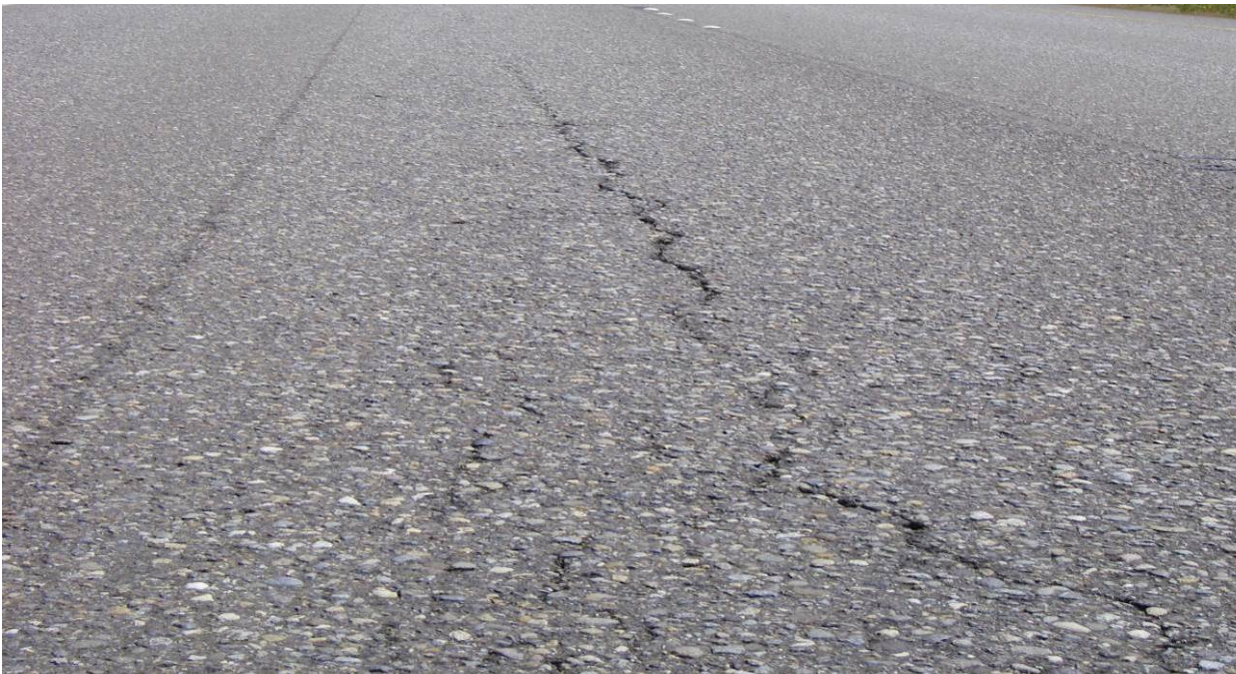
Figure 106. OR2a, SR8, prior to treatment.

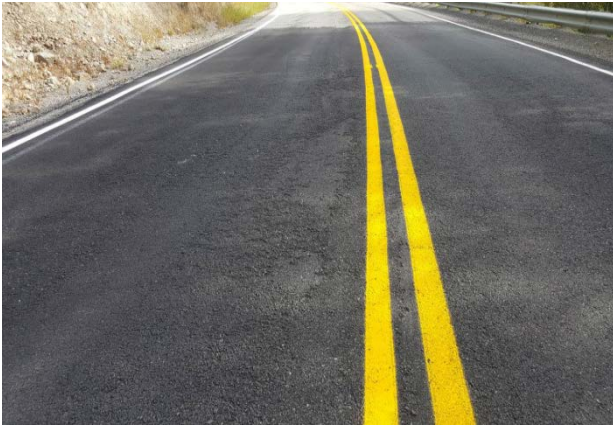
Figure 116. ER32, SR20, Good, age 12 months. Additional patches in 2017.

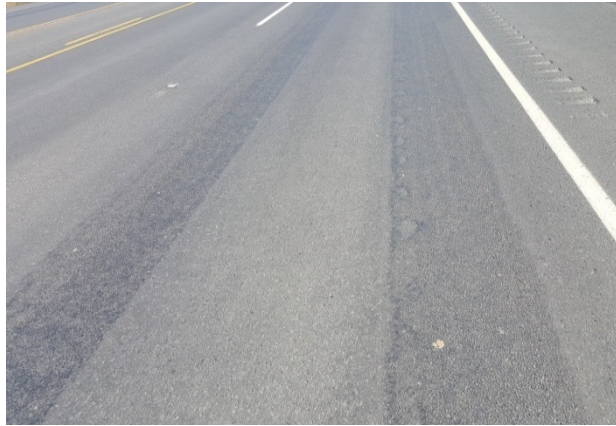
Figure 117. ER33, SR270, Good, age 24 months.

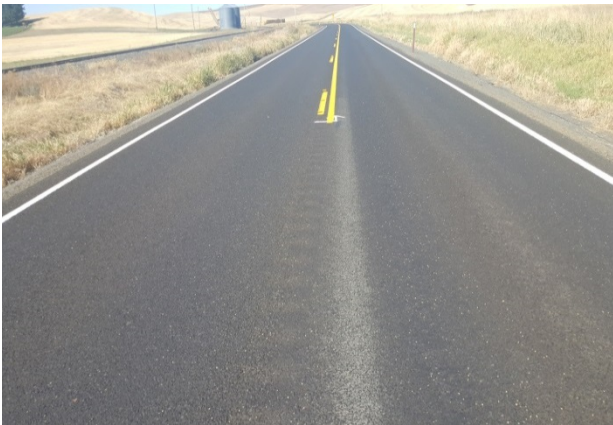
Figure 118. ER34, SR271, Good, age 24 months. Good performance. BST in 2017, C9031.

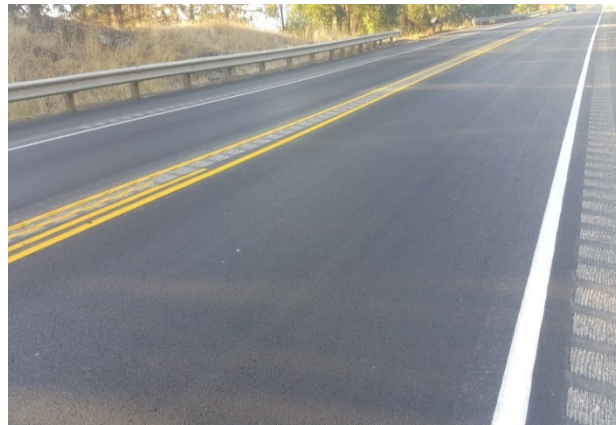
Figure 119. ER37, SR395, Fair, age 25 months. Excellent performance. HMA grind/inlay in 2017, C9105.

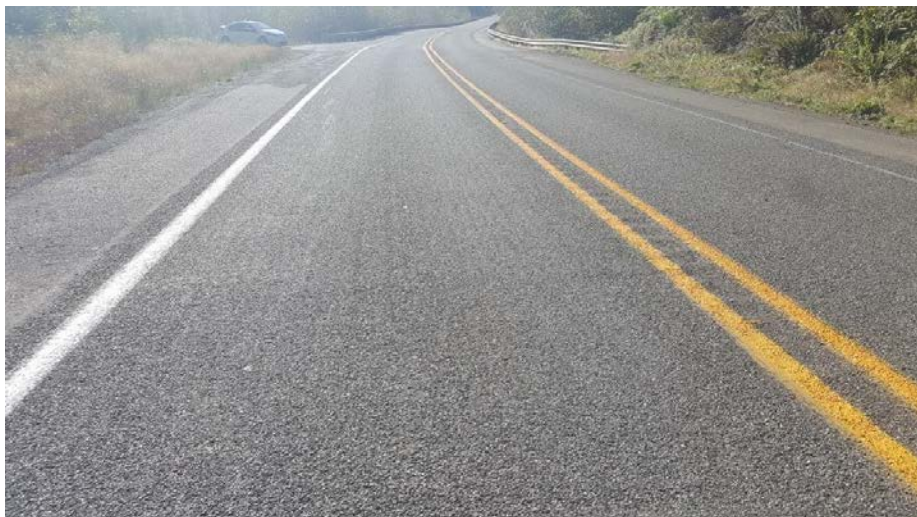
Full lane chip sealing is one of the most effective treatments because it can cover a multitude of pavement distress (Figure 141). This would include alligator cracking, longitudinal cracking and transverse cracking (provided the cracks are less than $\frac{1}{4}$ inch in width), and patching. The experience in this study with three of the four test sites exhibited flushing would seem to indicate that this is a choice to be avoided, especially if the wheel paths are rutted; however, the very good experience when full lane chip seals placed under Region wide chip seal contracts would indicate just the opposite. As indicated previously, it may be that the materials used or the application techniques that may need to be given scrutiny in order to achieve the best results. Chip sealing is often described as an art due to the many factors that can contribute to either success or

Figure 141. OR3b full lane chip seal on SR 101. (September 2016)
