EVALUATION AND PERFORMANCE OF HDPE PIPES UNDER CDOT HIGHWAYS, T-REX, AND OTHER LOCATIONS

Report No. CDOT-2018-09
March 2018

APPENDIX I – FOUNTAIN COLORADO,
DUROMAXX LASER PROFILE INSPECTION,
I-25, MP 122, MP 122.5, AND MP 123 (2013)
LEO JOHN FLECKENSTEIN

Fountain Colorado
3 Year Performance Comparison
DuroMaxx Laser Profile Inspection1
I-25, MP 122, MP 122.5, and MP 123

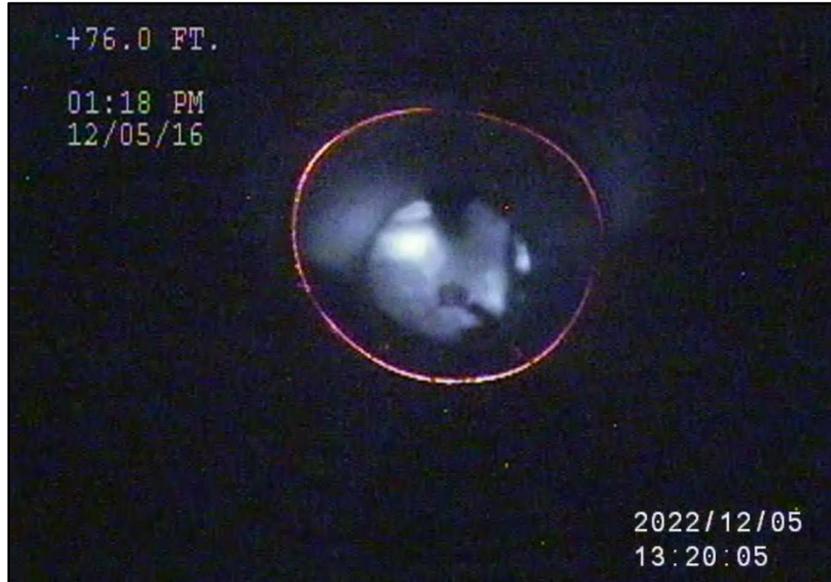
Figure 43. Typical laser ring projected onto the internal surface of failed pipe

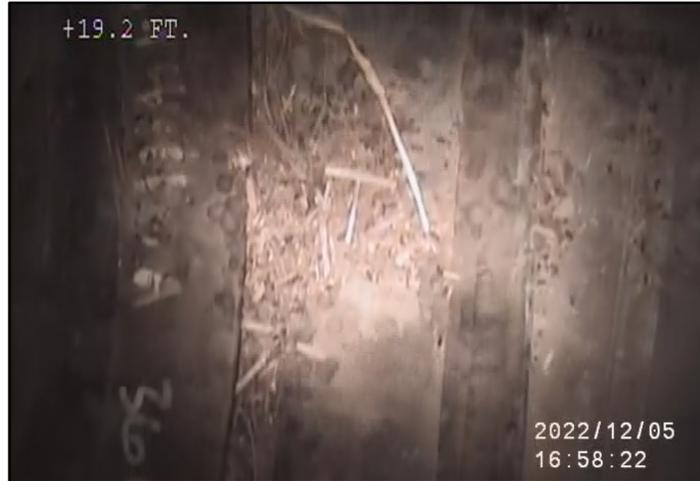
Figure 55. Close-up of a separated joint using CCTV recording

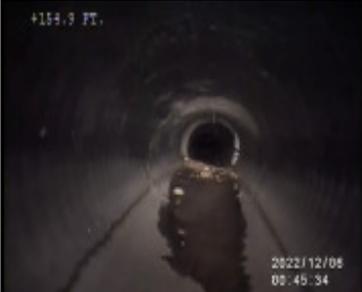
Distance	Fault Observation	Picture
154.9	View down barrel

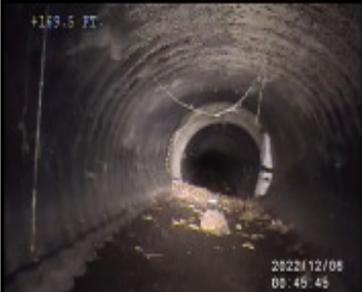
169.5	Debris coming into drop inlet

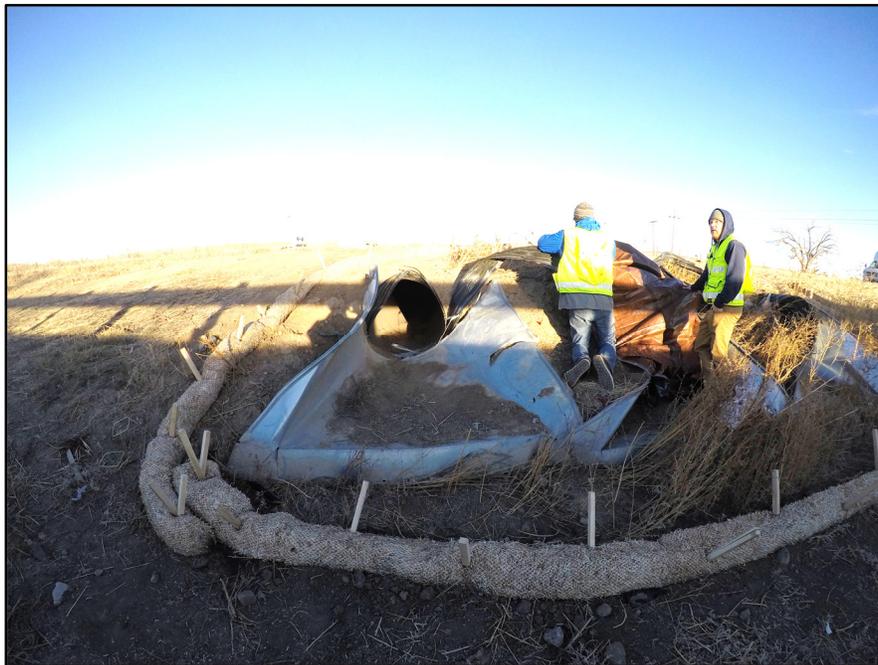
Figure 4412. Manual inspection of I-25 HDPE cross-culverts near Colorado Springs

Location	Date	Pipe Type	Pipe Size	Distance (ft)	Start ID	End ID	Deflection (2.5%)	Deflection (5%)	Observations
MP 123, Northern Pipe	9/30/2013	DuroMaxx	36-inch	88	Outlet	Inlet	100% of readings below 2.5%		Max deflection less than 2.5%, slight dent in left springline, wooden stake driven through crown near inlet end.
MP 123, Center Pipe	9/30/2013	DuroMaxx	36-inch	88	Outlet	Inlet	92% of readings below 2.5%	100% of readings below 5%	Max deflection approximately 4% at 23 ft, small dent at left springline at 73 ft, wooden stakes driven through crown of pipe near inlet end.
MP 124, Southern Pipe	9/30/2013	DuroMaxx	36-inch	88	Outlet	Inlet	100% of readings below 2.5%		Max deflection approximately 2.5% at 24 ft, wooden stake driven through crown of pipe near inlet.
MP 122.5	9/30/2013	DuroMaxx	48-inch	102	Outlet	Inlet	86.8% of readings below 2.5%	100% of readings below 5%	Max deflection approximately 2.8% at 88 ft

77.2% of readings below 2.5%	<1.9% of readings above 5%	Max deflection approximately 5.30% near inlet end (approx. 90 to 88 ft). Pipe moderately racked in right crown. Remainder of pipe 4% or less. Small puncture due to stake near outlet, pipe slightly racked at 8 ft. Slight hump at right haunch at 46 ft. Slight dent in invert at 56 ft.
MP 122	9/30/2013	DuroMaxx	48-inch	103	Outlet	Inlet

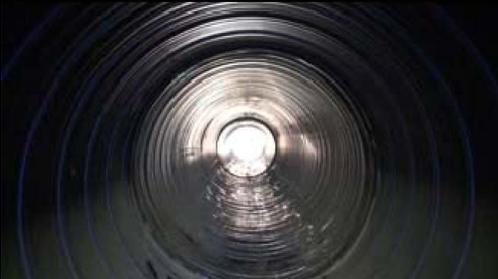
20.0	General Observation Remarks: Joint No. 1	03:13 00:00:26

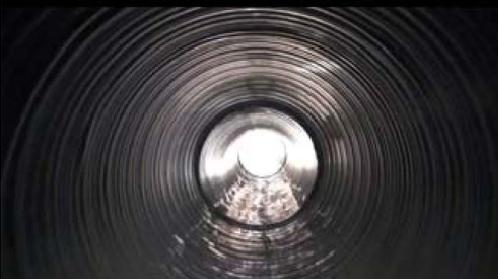
30.0	General Observation Remarks: Slight dent left springline	07:04 00:00:40

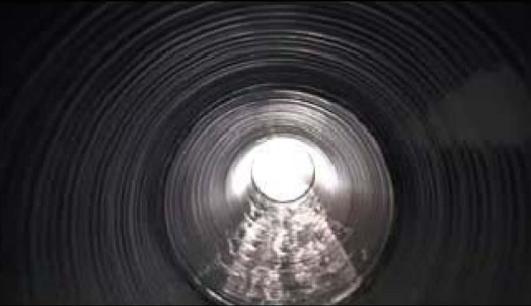
Distance	Fault Observation	Time	Picture
40.0	<p>General Observation Remarks: View of joint at 40 ft.</p>	<p>8:10 00:00:45</p>

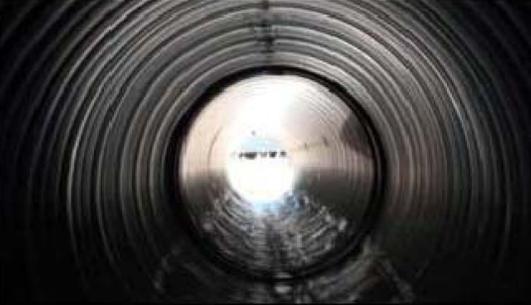
60.0	<p>General Observation Remarks: View of joint at 66 ft.</p>	<p>10:33 00:01:13</p>

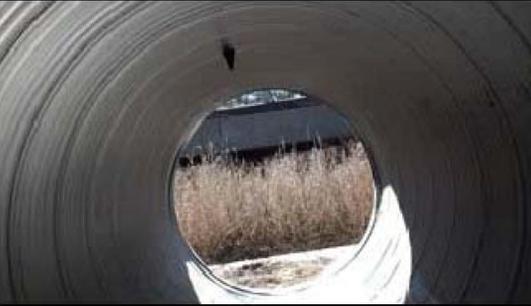
80.0	<p>General Observation Remarks: Stake driven through crown of pipe at 84 ft.</p>	<p>12:37 00:01:45</p>

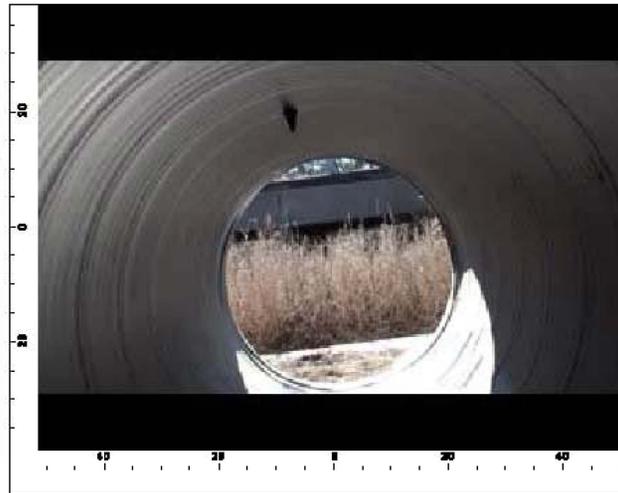
Stake for erosion control driven through crown of pipe.

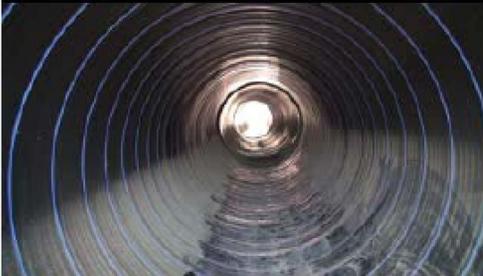
Distance	Fault Observation	Time	Picture
2.0	<p style="text-align: center;"> Start Inspection Remarks: Start inspection, center pipe </p>	<p style="text-align: center;"> 01:09 00:00:00 </p>

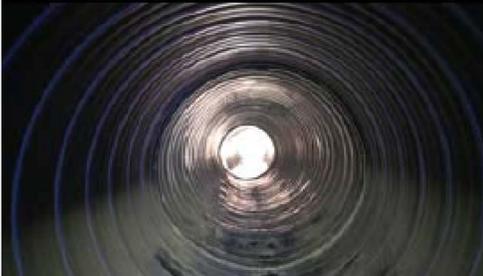
20.0	<p style="text-align: center;"> General Observation Remarks: View of joint at 21 ft. </p>	<p style="text-align: center;"> 04:45 00:01:14 </p>

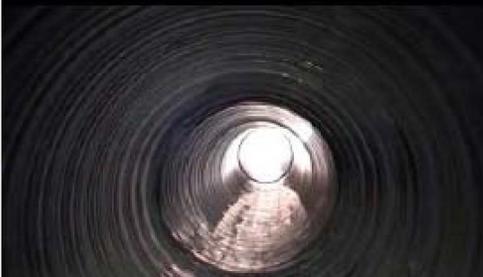
40.0	<p style="text-align: center;"> General Observation Remarks: View of joint at 43 ft. </p>	<p style="text-align: center;"> 05:44 00:01:39 </p>

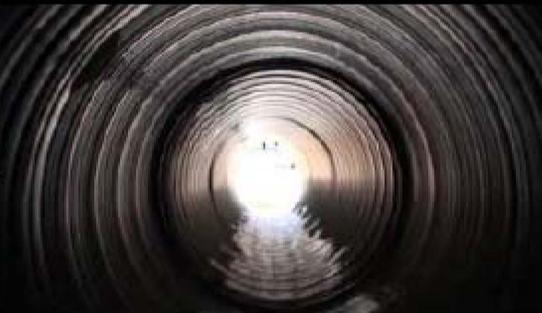
Distance	Fault Observation	Time	Picture
63.0	<p data-bbox="569 370 972 431"> General Observation Remarks: View of joint at 65 ft. </p>	<p data-bbox="984 370 1089 431"> 07:52 00:02:14 </p>

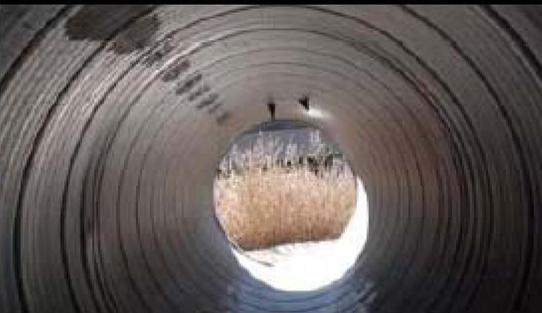
78.0	<p data-bbox="569 1188 972 1282"> General Observation Remarks: Small dent at left springline </p>	<p data-bbox="984 1208 1089 1269"> 10:33 00:02:53 </p>

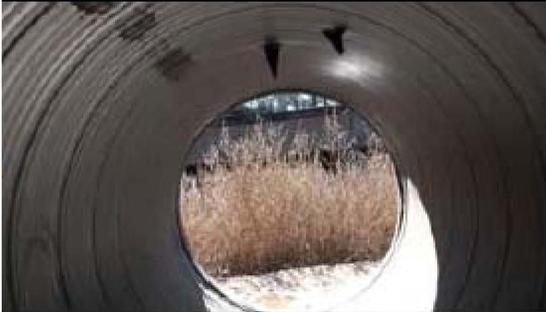
Distance	Fault Observation	Time	Picture
82.0	General Observation Remarks: Wood stakes driven through crown of pipe	11:40 00:03:10

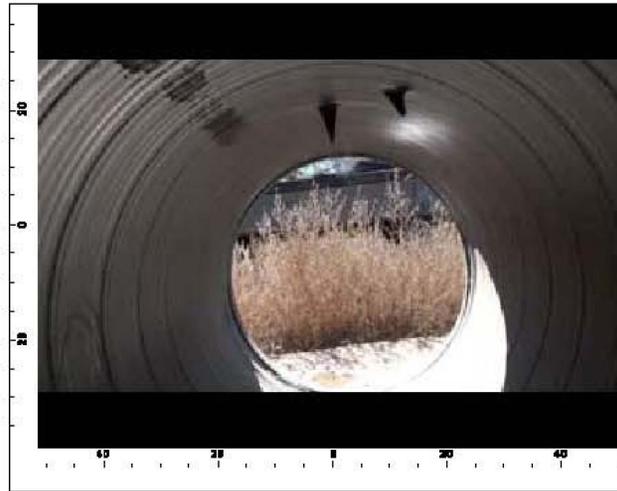
Stakes from erosion control devices.

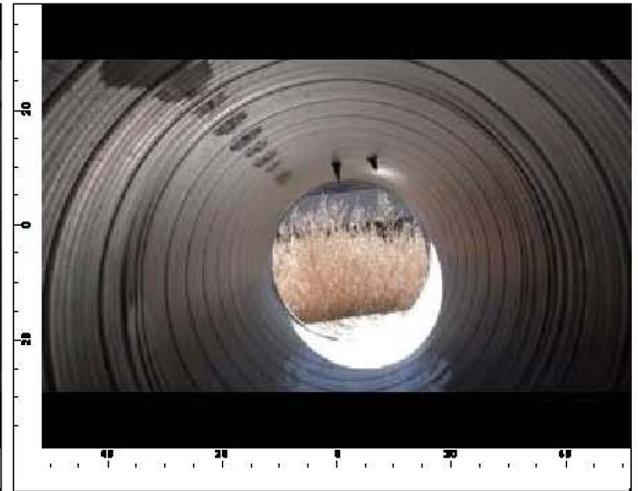
Slight dent at left springline at 78 ft.

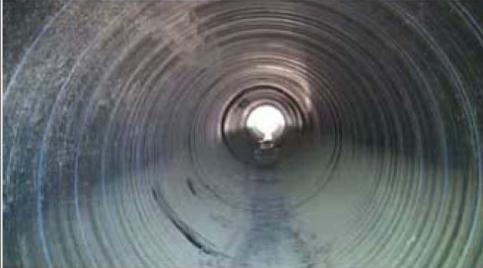
Distance	Fault Observation	Time	Picture
2.0	Start Inspection Remarks: View from outlet	01:47 00:00:00

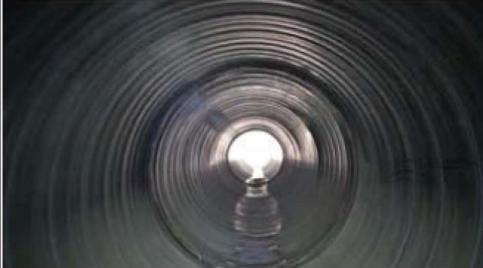
22.0	General Observation Remarks: Joint at 22 ft.	2:30:17 00:00:36

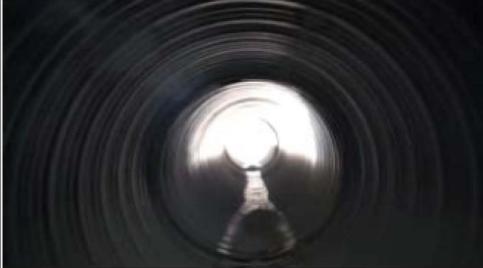
44.0	General Observation Remarks: Joint at 44 ft	2:31:30 00:01:05

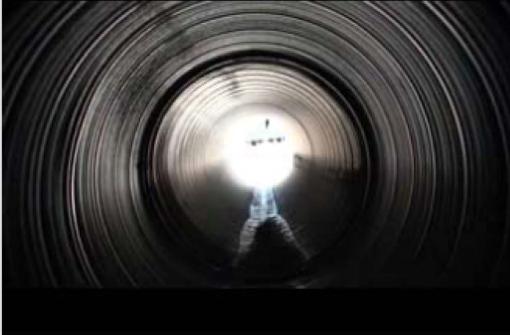
Distance	Fault Observation	Time	Picture
66.0	General Observation Remarks: Joint at 66 ft.	2:32:18 00:01:26

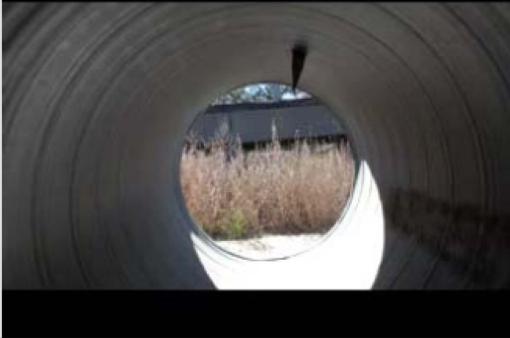
84.0	General Observation Remarks: Stake through crown of pipe	2:33:18 00:01:54

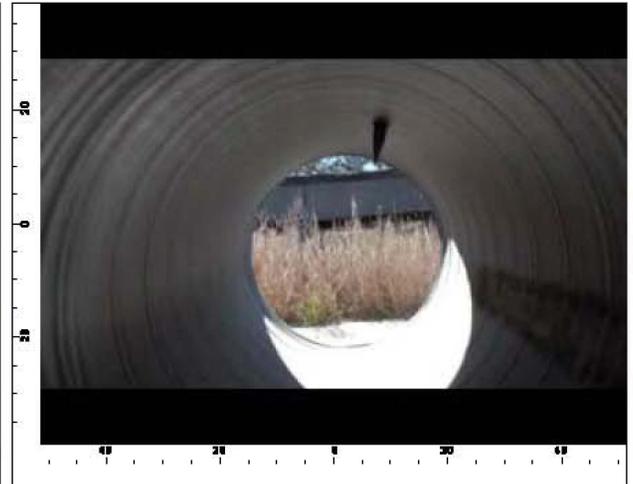
View of erosion control stake through crown of structure.

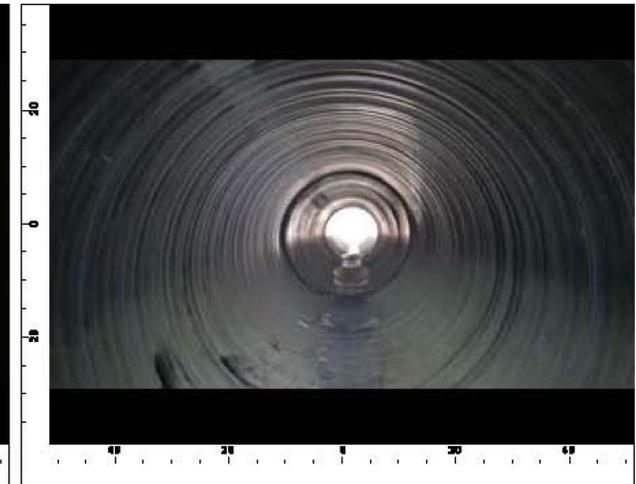
View of pipe towards outlet end of the structure. Pipe appears to be round and uniform.

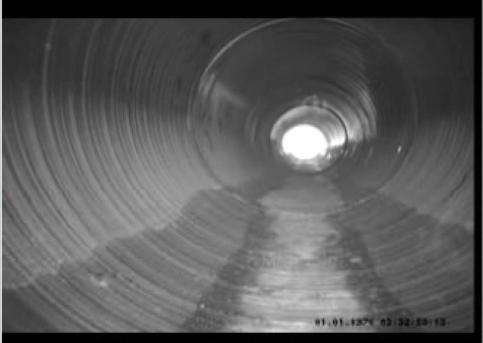
22.0	General Observation Remarks: View of first joint at approx 22 ft.	06:09 00:00:48

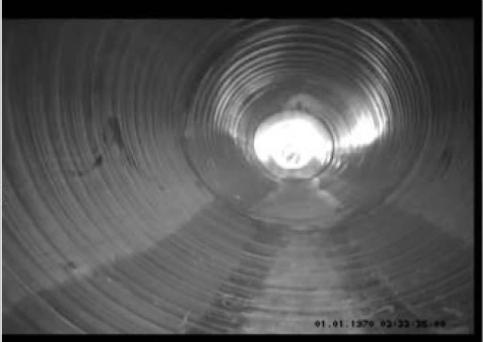
44.0	General Observation Remarks: View of second joint at approx. 44 ft.	07:51 00:01:24

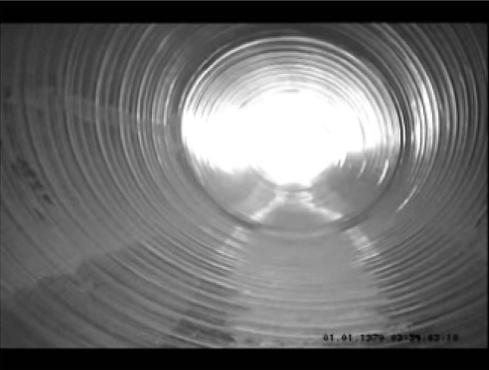
Distance	Fault Observation	Time	Picture
66.0	<p>General Observation Remarks: View of third joint at approx. 66 ft.</p>	<p>10:39 00:01:53</p>

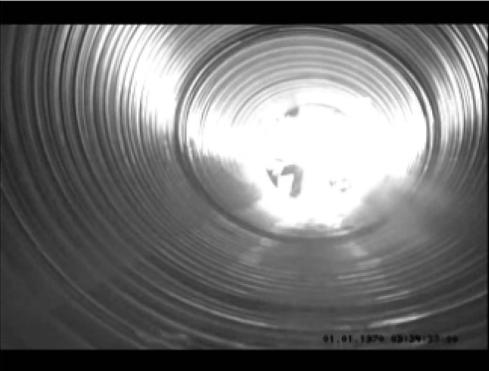
<p>01_01_1879_00:01:53-10</p>
88.0	<p>General Observation Remarks: View of fourth joint at approx. 88 ft.</p>	<p>11:51 00:02:27</p>

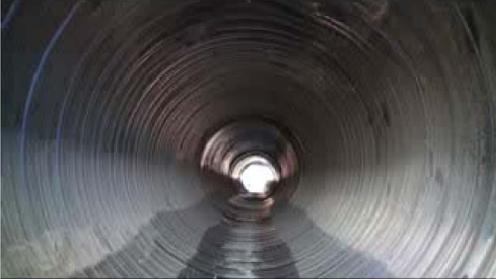
8.0	General Observation Remarks: Pipe slightly racked, small puncture at crown from stake at 10 ft.	02:30 00:00:43

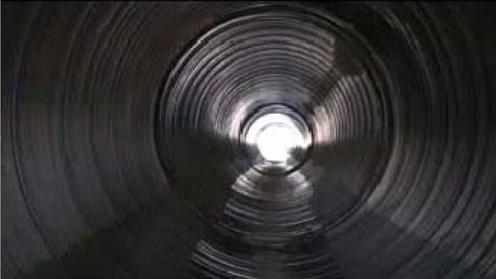
26.0	General Observation Remarks: View of joint at 26 ft.	12:08 00:01:27

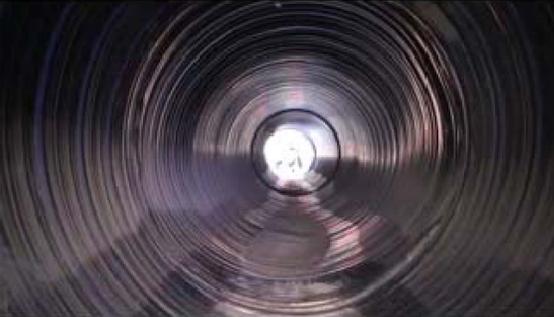
Distance	Fault Observation	Time	Picture
46.0	<p>General Observation Remarks: View of joint at 46 ft. Slight hump at right haunch.</p>	<p>14:40 00:02:17</p>

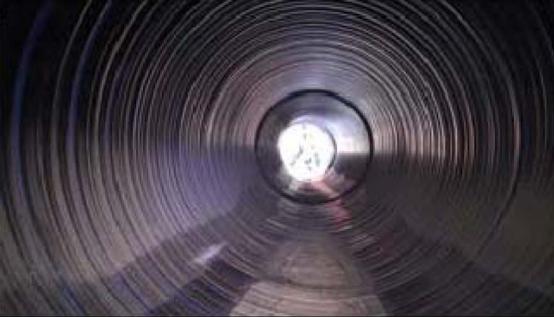
56.0	<p>General Observation Remarks: Slight dent in invert at 56 ft.</p>	<p>16:11 00:02:33</p>

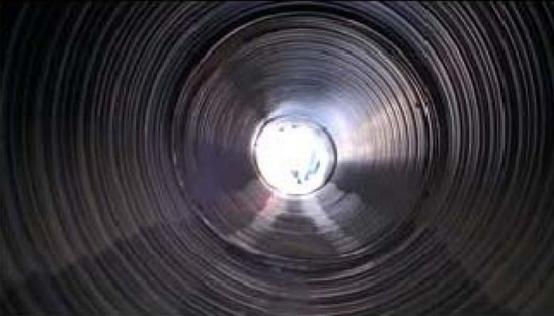
70.0	<p>General Observation Remarks: View of joint at 70 ft.</p>	<p>17:18 00:03:03</p>

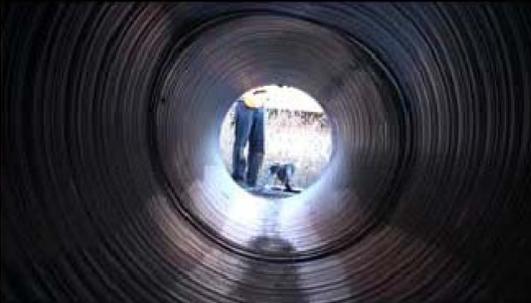
Distance	Fault Observation	Time	Picture
90.0	<p style="text-align: center;">General Observation Remarks: Pipe slight racked in right crown.</p>	<p style="text-align: center;">18:41 00:03:48</p>

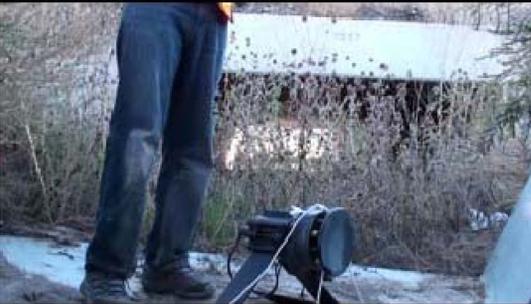
103.0	<p style="text-align: center;">End Inspection Remarks: End inspection, view of laser skid at inlet.</p>	<p style="text-align: center;">21:21 00:04:14</p>

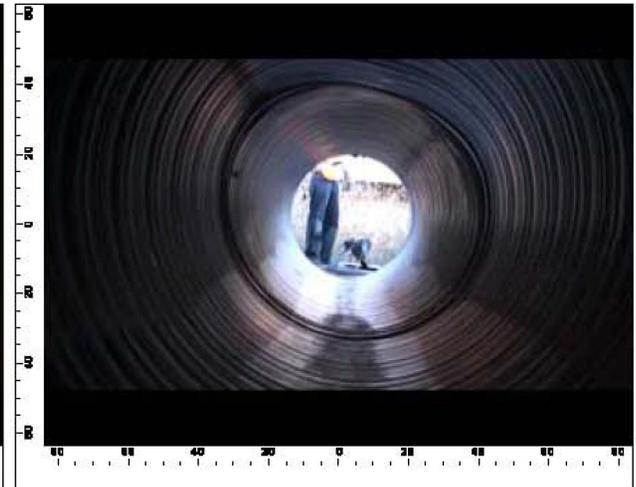
View of compressed area at 90 ft.

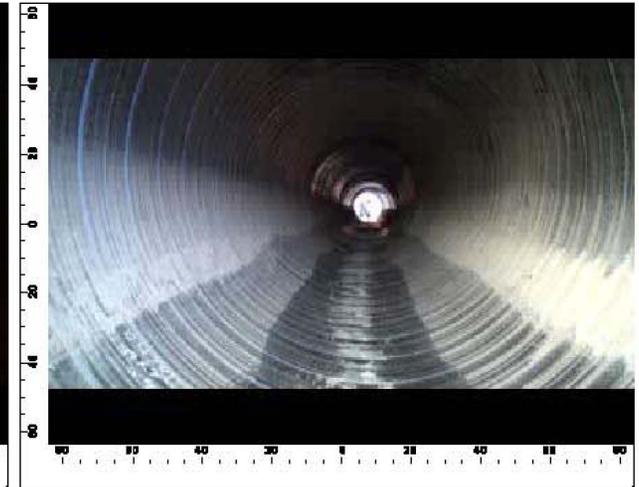
View from outlet end, pipe slight racked near outlet end not caught by laser.

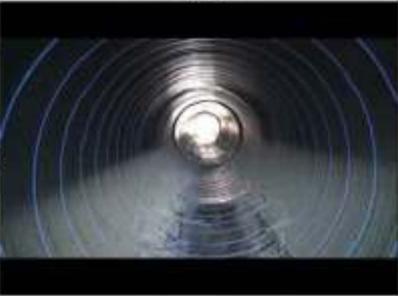
20.0	General Observation Remarks: Joint No. 1	03:13 00:00:26

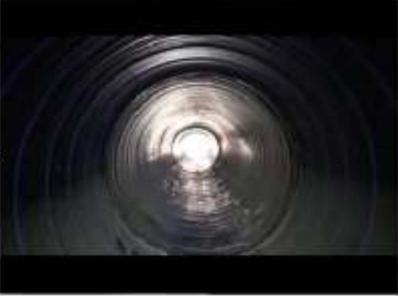
30.0	General Observation Remarks: Slight dent left springline	07:04 00:00:40

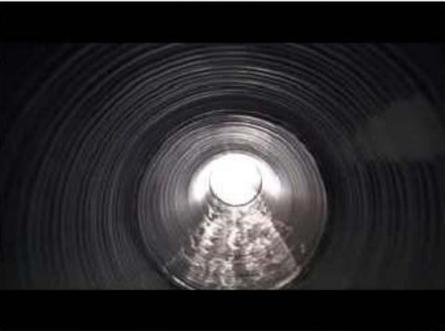
60.0	General Observation Remarks: View of joint at 66 ft.	10:33 00:01:13

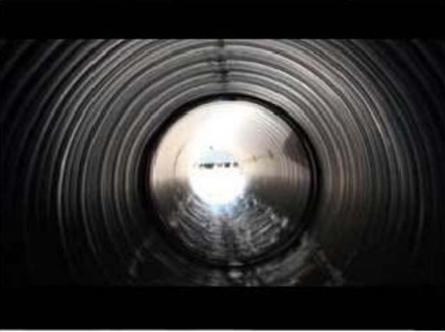
80.0	General Observation Remarks: Stake driven through crown of pipe at 84 ft.	12:37 00:01:45

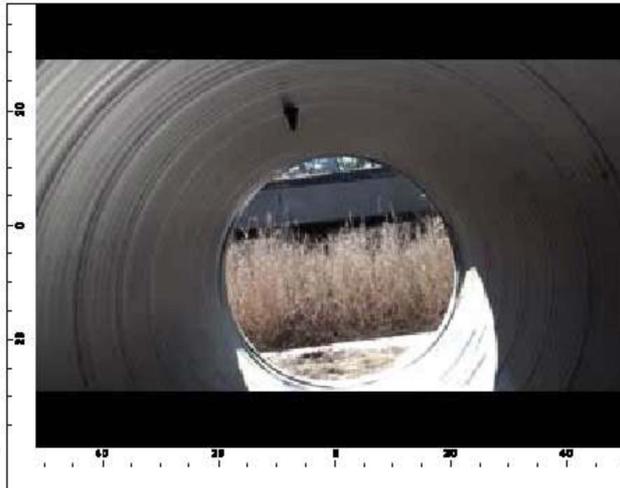
Stake for erosion control driven through crown of pipe.

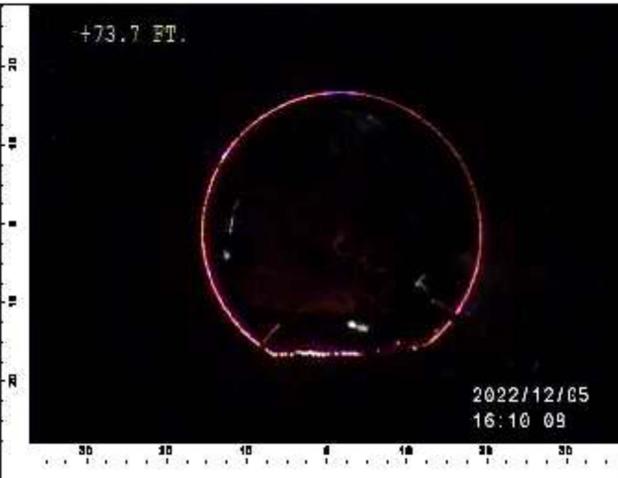
Debris in invert causing spike in vertical data.

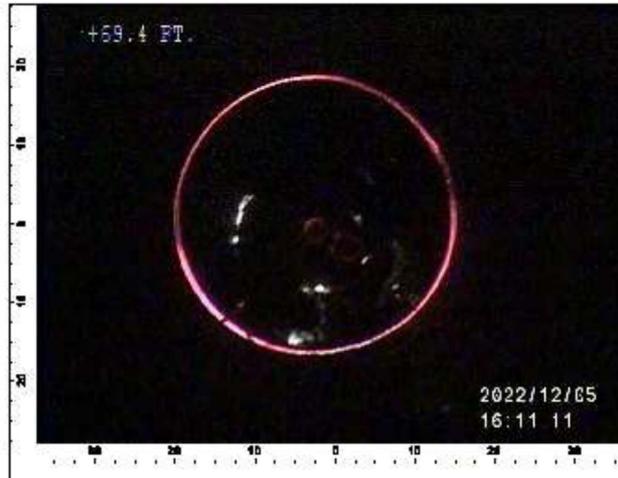
Noise causing spike in data

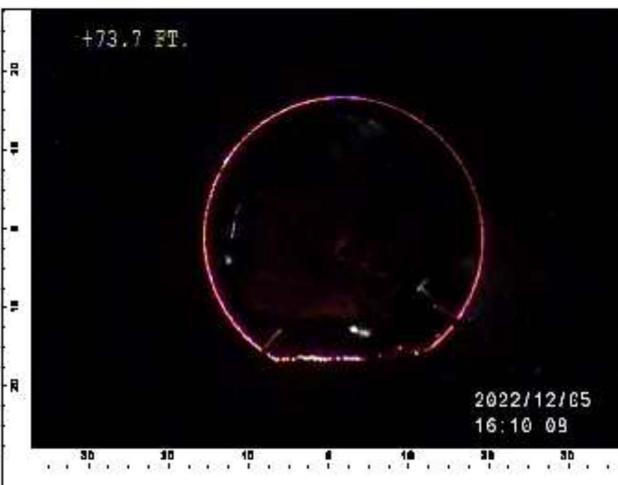
Debris in invert causing spike in vertical data.

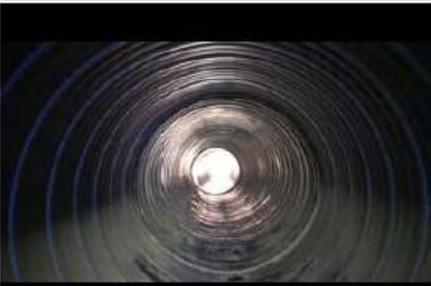
20.0	General Observation Remarks: View of joint at 21 ft.	04:45 00:01:14

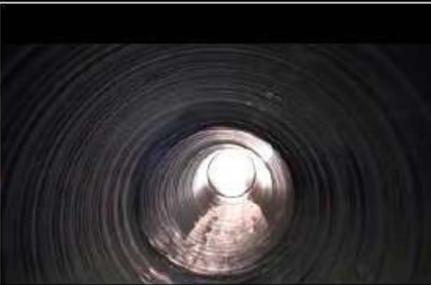
40.0	General Observation Remarks: View of joint at 43 ft.	05:44 00:01:39

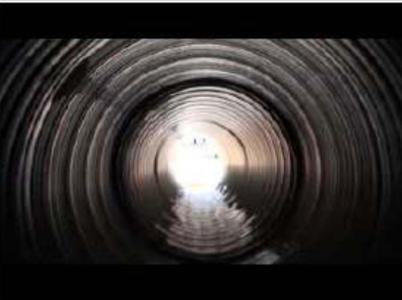
Distance	Fault Observation	Time	Picture
63.0	General Observation Remarks: View of joint at 65 ft.	07:52 00:02:14

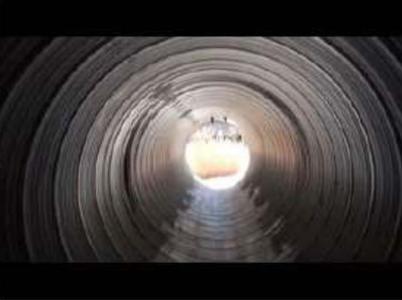
73.0	General Observation Remarks: Small dent at left springline	09:22 00:02:30

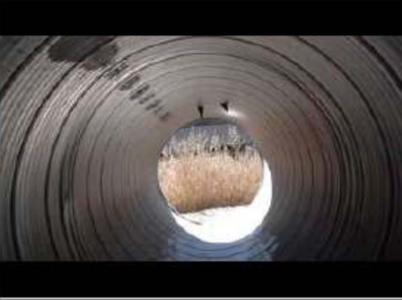
78.0	General Observation Remarks: Small dent at left springline	10:33 00:02:53

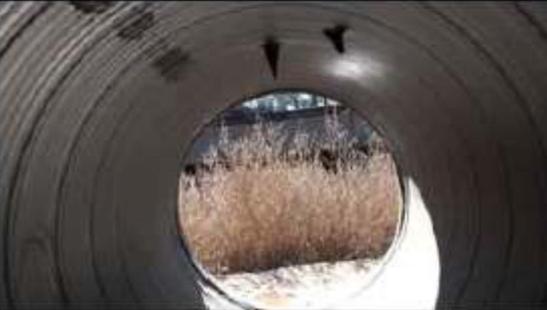
Distance	Fault Observation	Time	Picture
82.0	General Observation Remarks: Wood stakes driven through crown of pipe	11:40 00:03:10

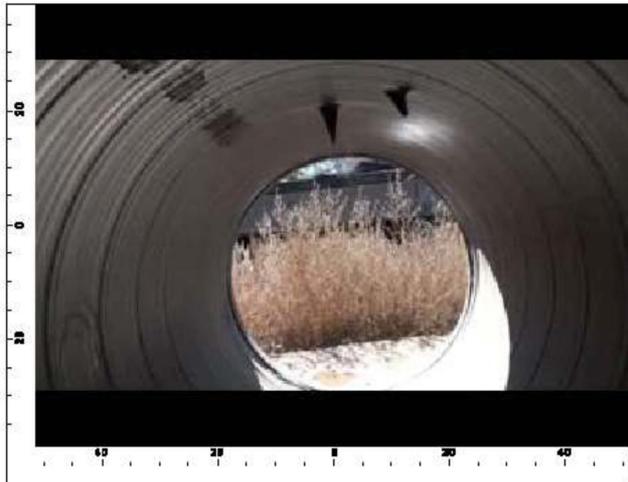
Stakes from erosion control devices.

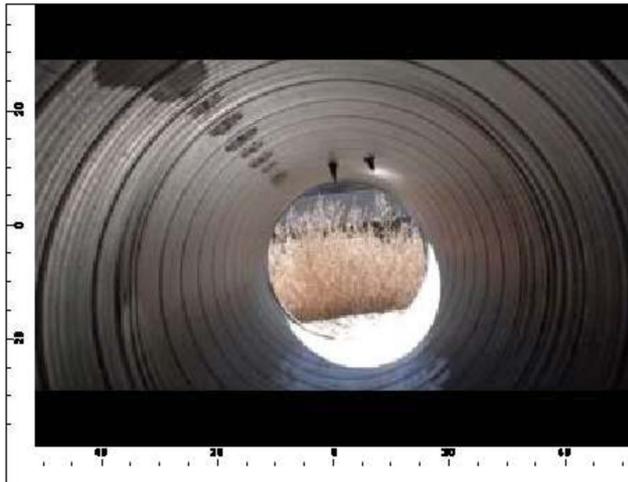
Slight dent at left springline at 78 ft.

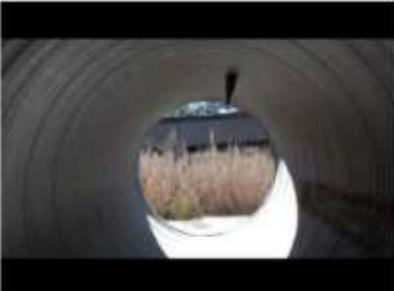
84.0	General Observation Remarks: Stake through crown of pipe	2:33:18 00:01:54

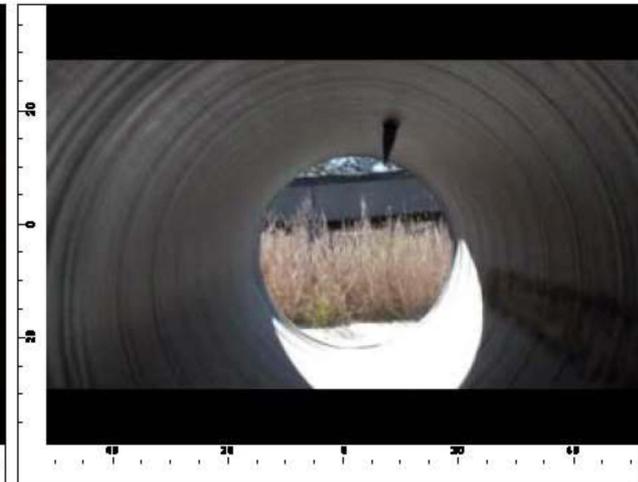
View of erosion control stake through crown of structure.

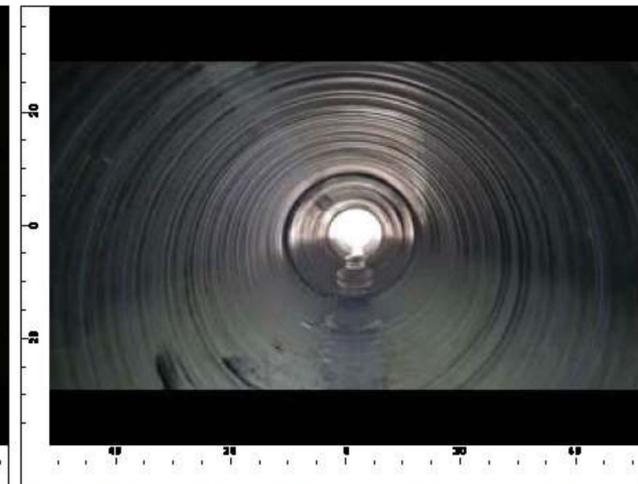
View of pipe towards outlet end of the structure. Pipe appears to be round and uniform.

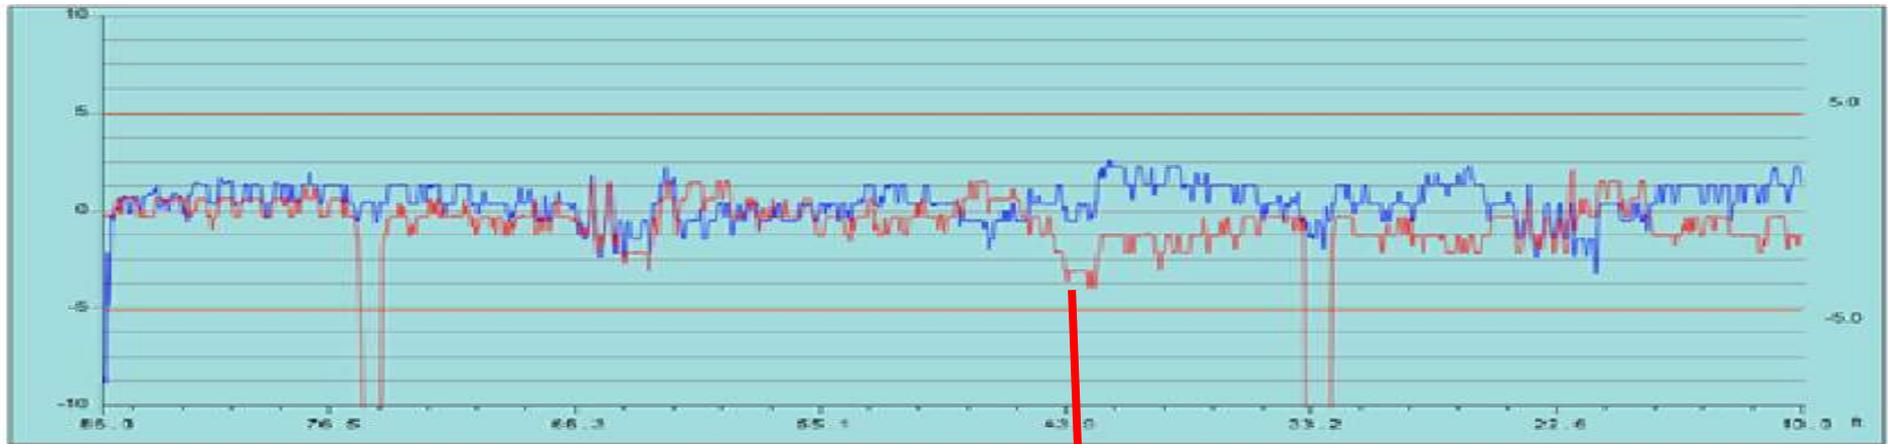
Performance Summary MP 123 (Southern Pipe)

Minor punctures from construction stakes were still visible at the inlet end. Deflections are still below 5%. Some slight possible movement might have occurred around 44 ft.

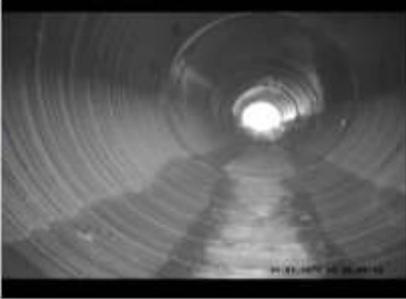
44.0	General Observation Remarks: View of second joint at approx. 44 ft.	07:51 00:01:24

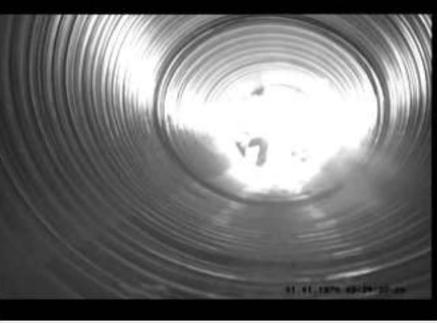
88.0	General Observation Remarks: View of fourth joint at approx. 88 ft.	11:51 00:02:27

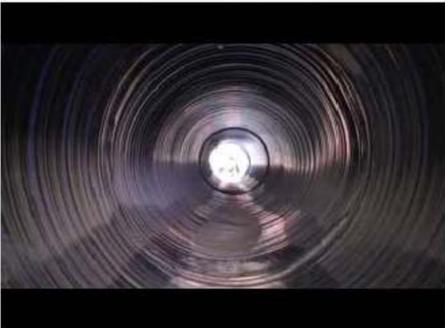
56.0	General Observation Remarks: Slight dent in invert at 56 ft.	16:11 00:02:33

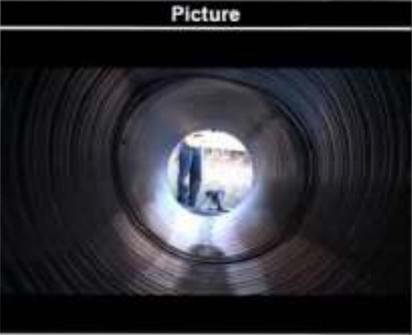
Distance	Fault Observation	Time	Picture
90.0	General Observation Remarks: Pipe slight racked in right crown.	18:41 00:03:48

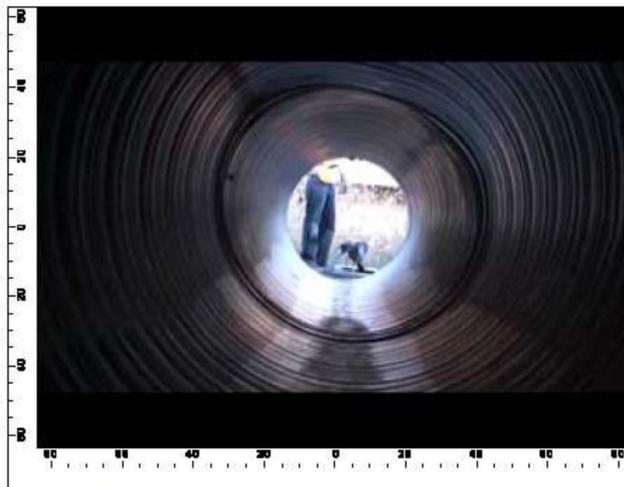
View of compressed area at 90 ft.

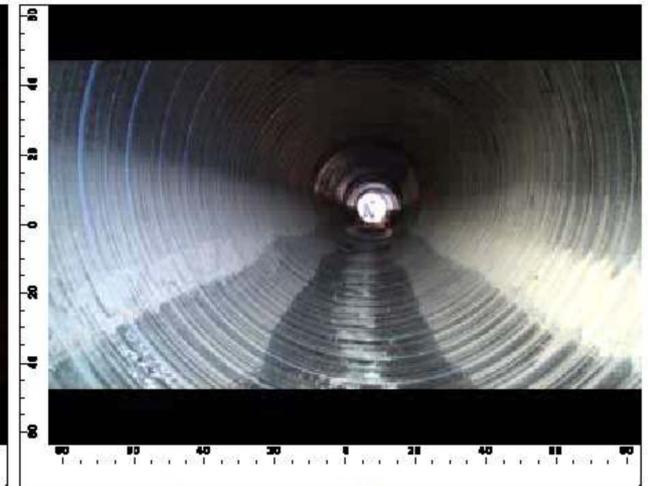
View from outlet end, pipe slight racked near outlet end not caught by laser.

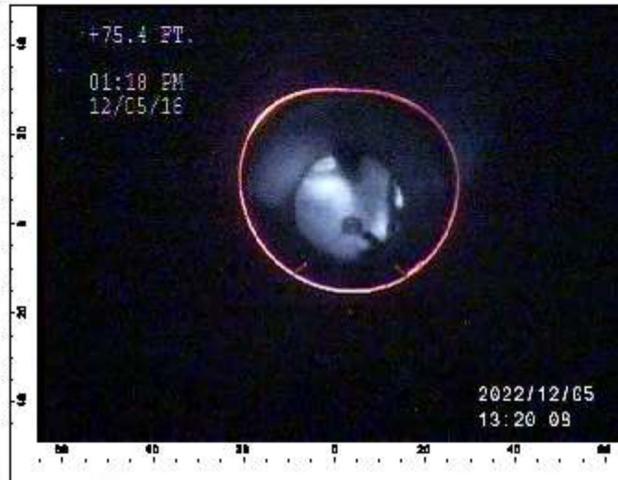
Pipe deflected approximately 5.8%.

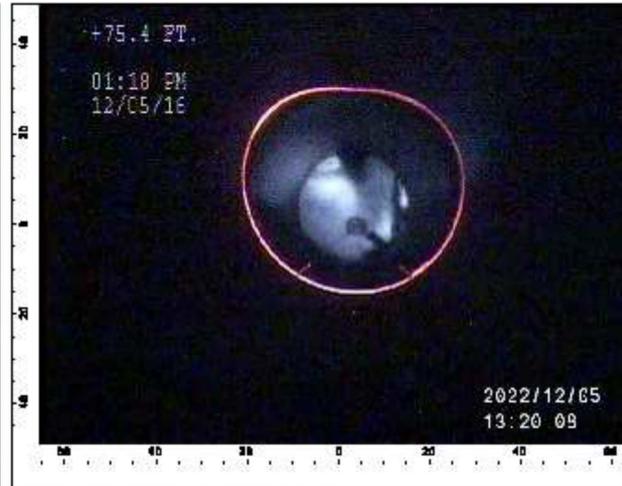
Noise in data due to outside light.

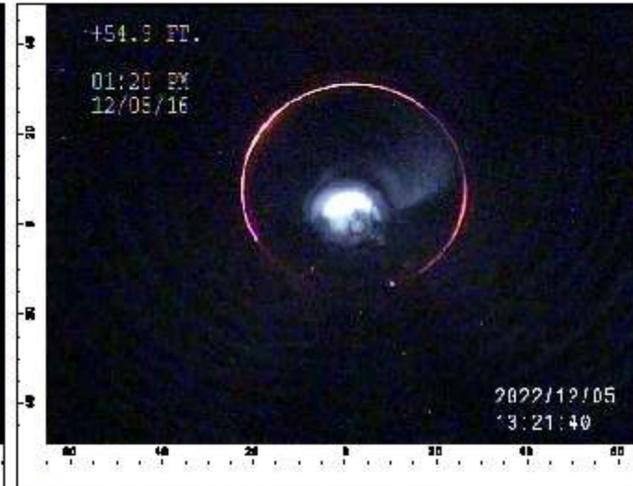
Pipe deflected approximately 5.8%.

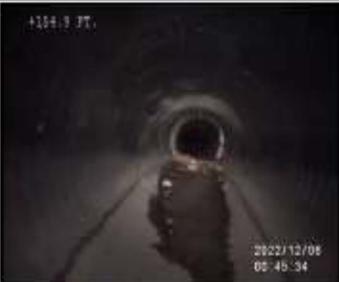
Distance	Fault Observation	Picture
154.9	View down barrel

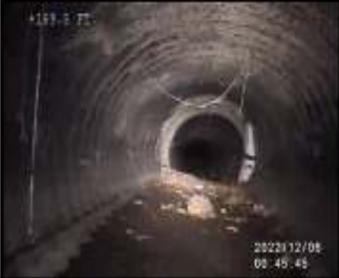
169.5	Debris coming into drop inlet

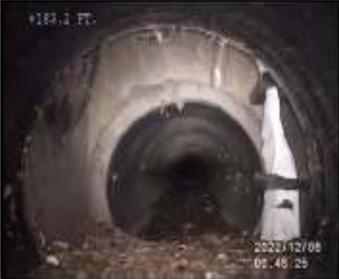
183.2	Drop Inlet

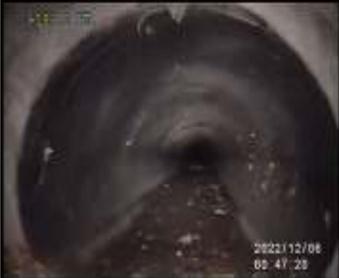
183.2	End Inspection
