Phase IV Development of a Short-Radius Guardrail for Intersecting Roadways

MwRSF Research Report No. TRP-03-199-08

February 29, 2008

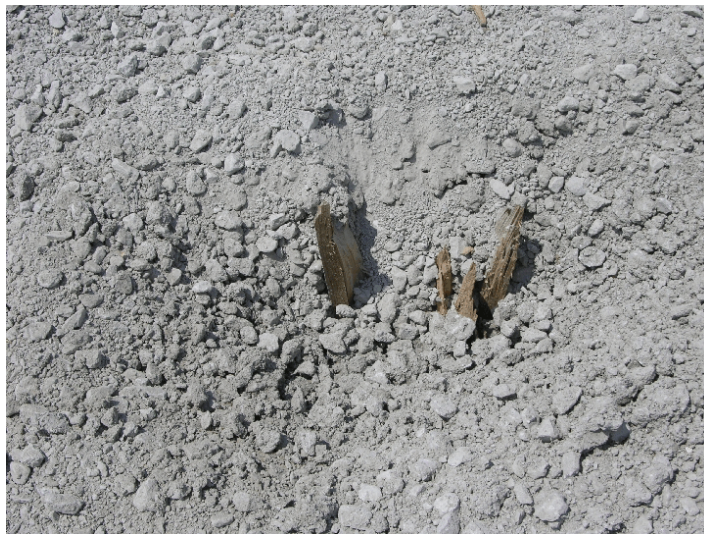
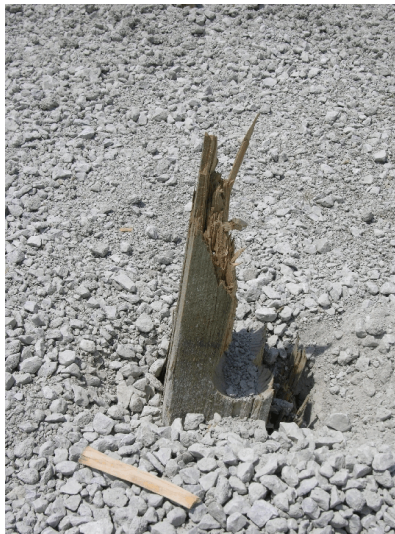
Figure 51. Post Nos. 6S through 8S Damage, Test SR-7

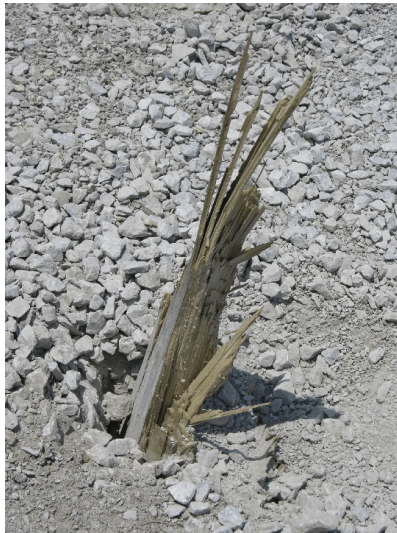
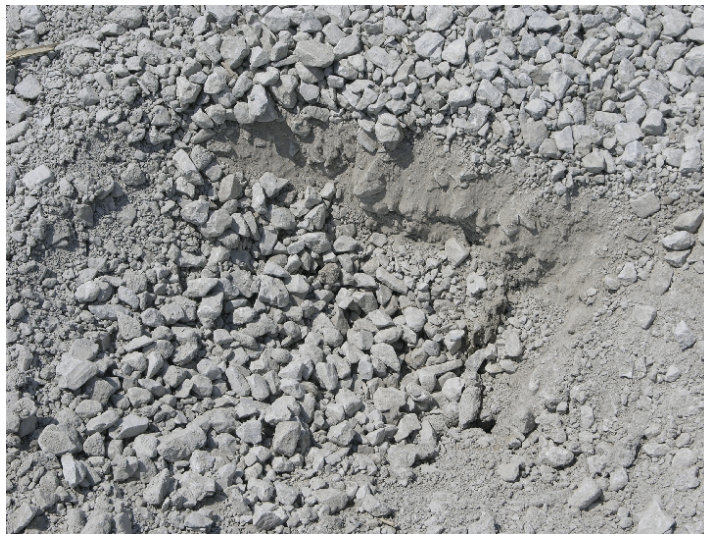
Figure 52. Post Nos. 3S through 5S Damage, Test SR-7

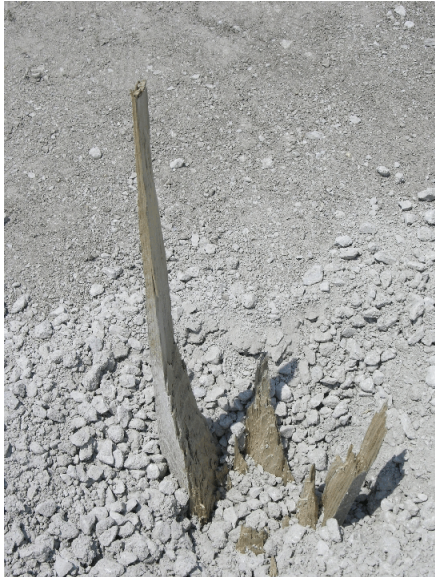
Figure 55. Post Nos. 6P through 9P Damage, Test SR-7

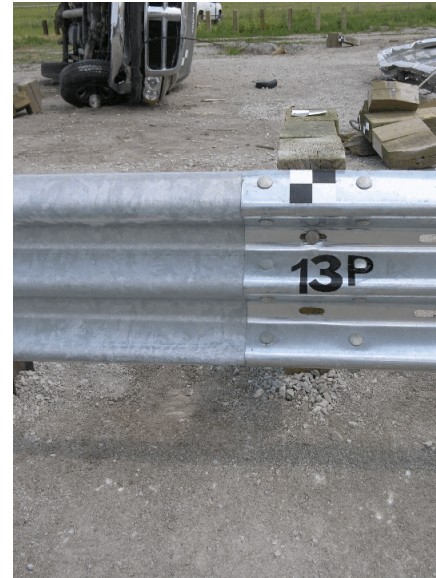
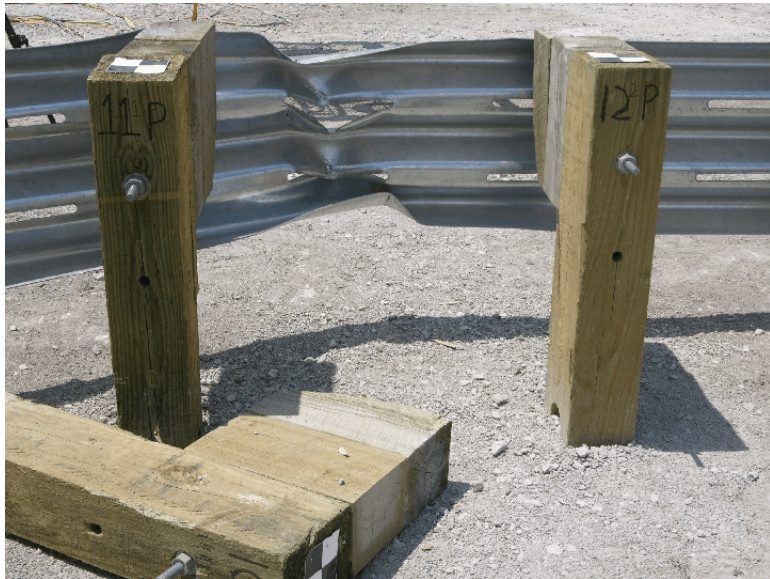
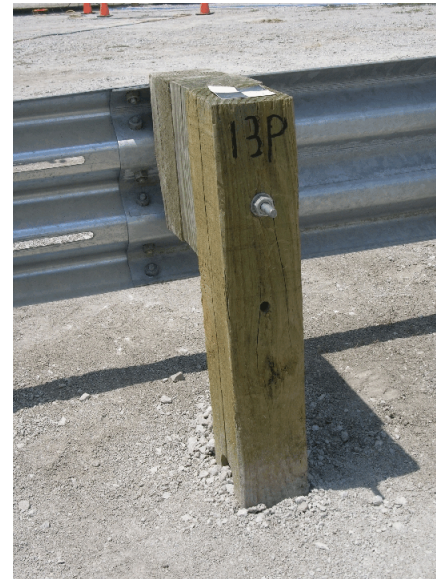
Figure 56. Post Nos. 11P through 13P Damage, Test SR-7

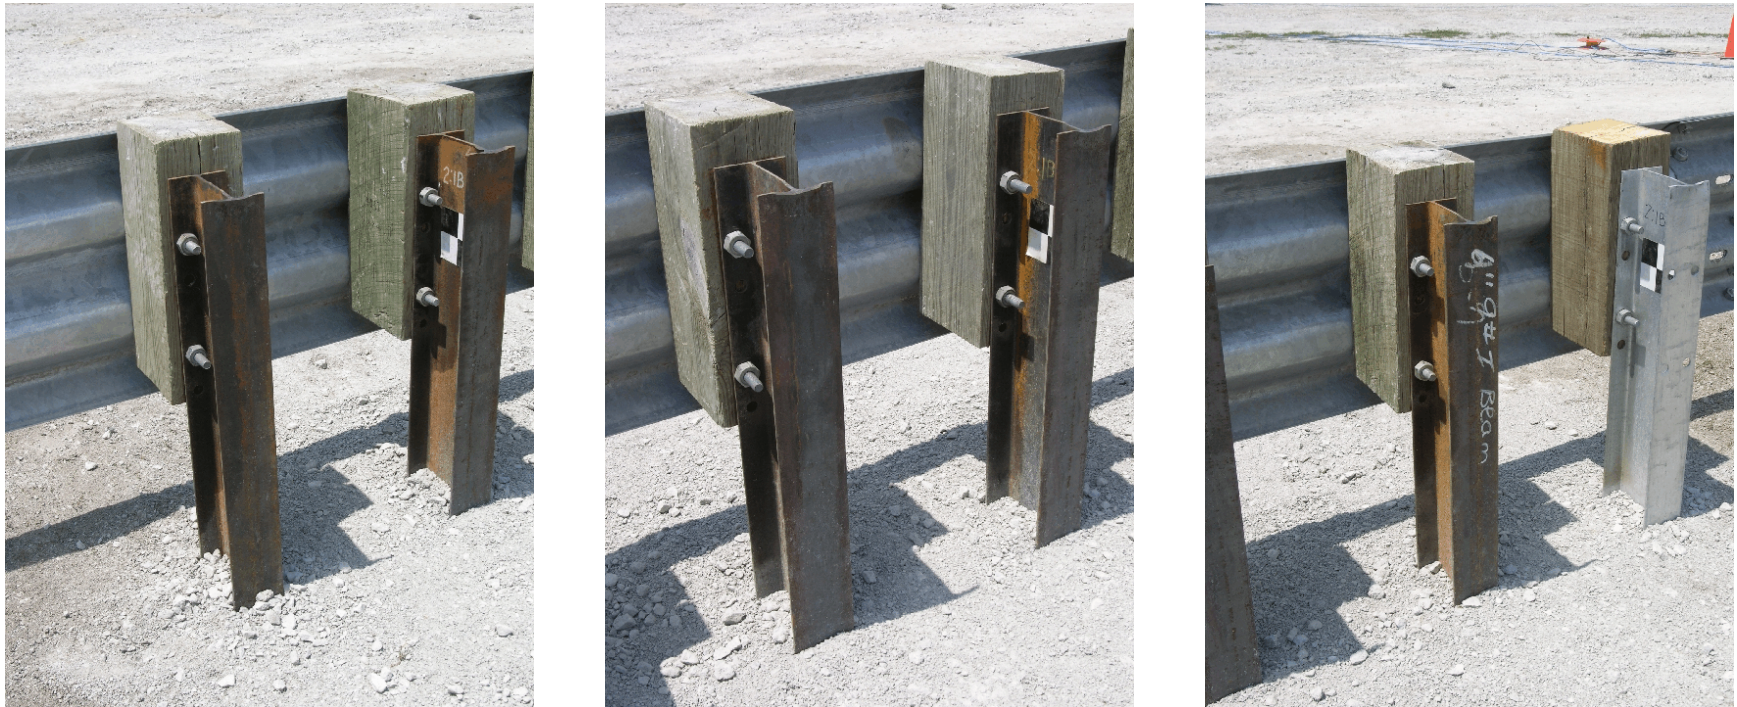
Figure 57. Post Nos. 14P through 19P Damage, Test SR-7

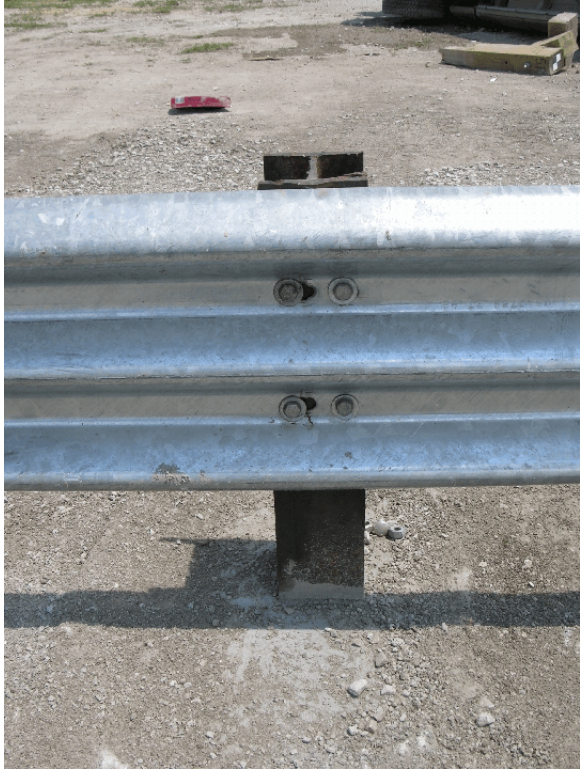
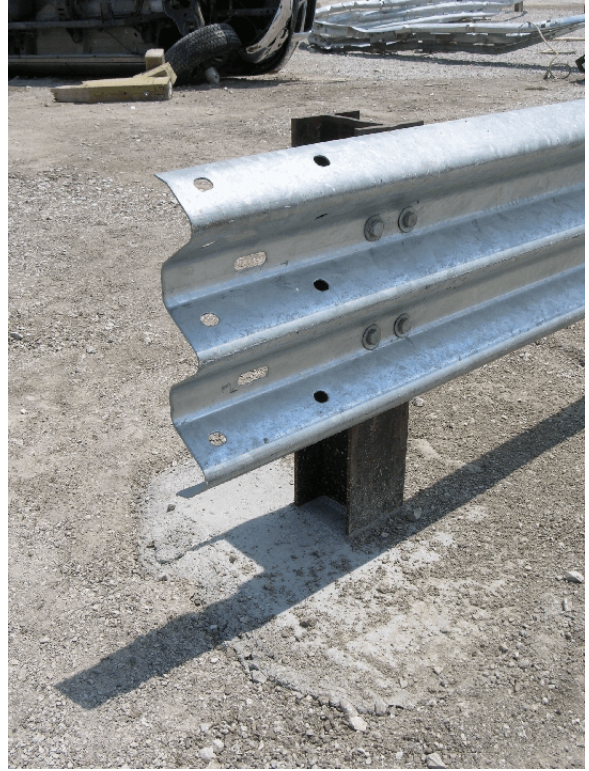
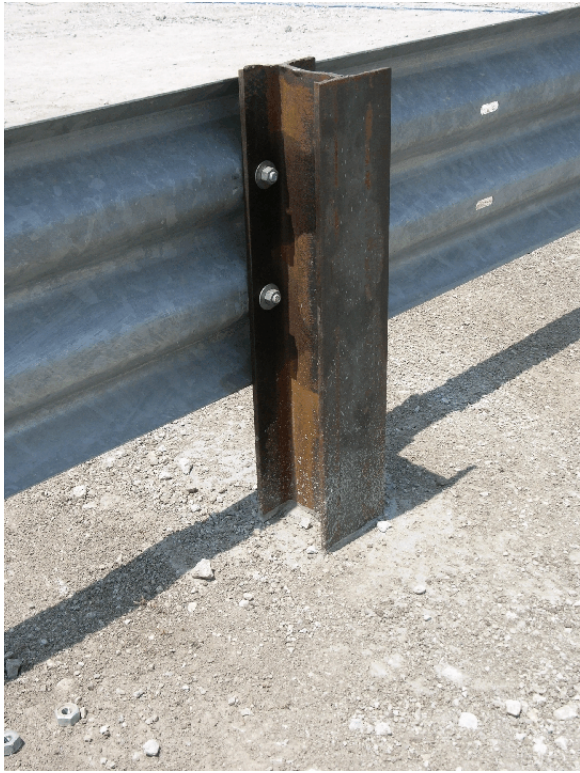
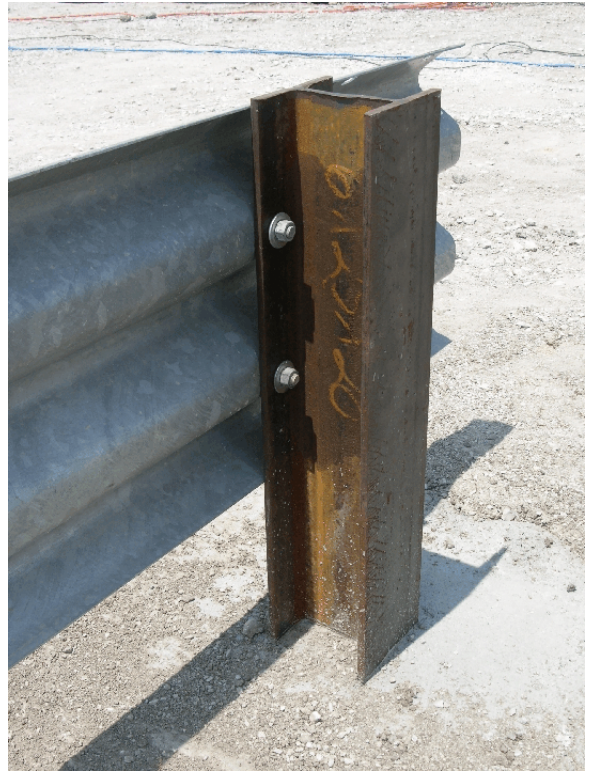
Figure 58. Post Nos. 20 and 21P Damage, Test SR-7

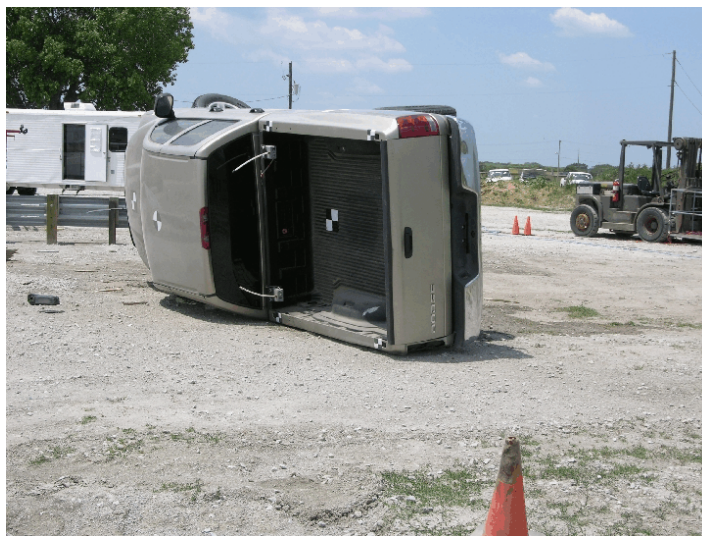
Exterior vehicle damage was moderate, as shown in Figures 59 through 62. Occupant compartment deformations to the right side and center of the floorboard were judged insufficient to cause serious injury to the vehicle occupants. A maximum longitudinal deflection of 13 mm (0.5 in.) was located in the right-front corner of the right-side floor pan. A maximum lateral deflection of 13 mm (0.5 in.) was located at the center of the right side of the right-side floor pan. Maximum vertical deflections of 6 mm (0.25 in.) were located throughout the right-side floor pan. Complete occupant compartment deformations and the corresponding locations are provided in Appendix C.

Figure 59. Vehicle Damage, Test SR-7

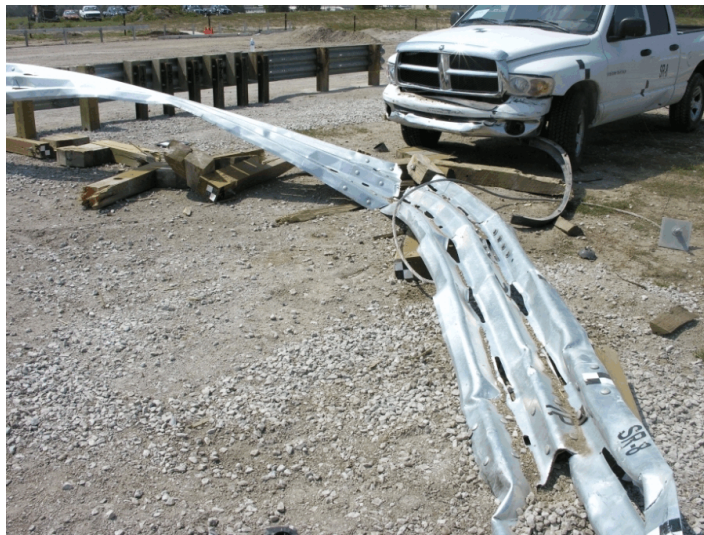
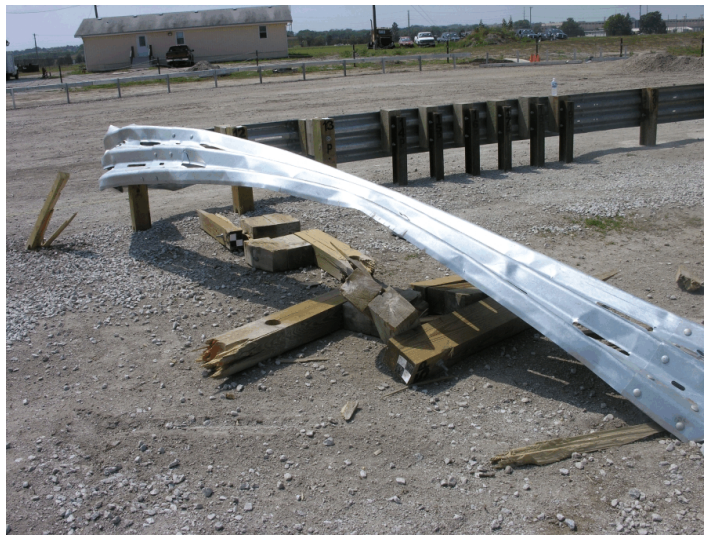
Figure 86. System Damage, Test SR-8

Barrier damage was extensive, as shown in Figures 85 through 93. Damage consisted mostly of flattened, deformed and torn guardrail, fractured posts, blockouts, and bolts, and deformed cable anchor hardware. System damage occurred between post nos. 8S and post no. 11P. The maximum permanent set of the guardrail was 6,518 mm (21 ft - 4.5 in.) from the primary side and 8,448 mm (27 ft - 9 in.) from the secondary side, measured to the center of the nose.

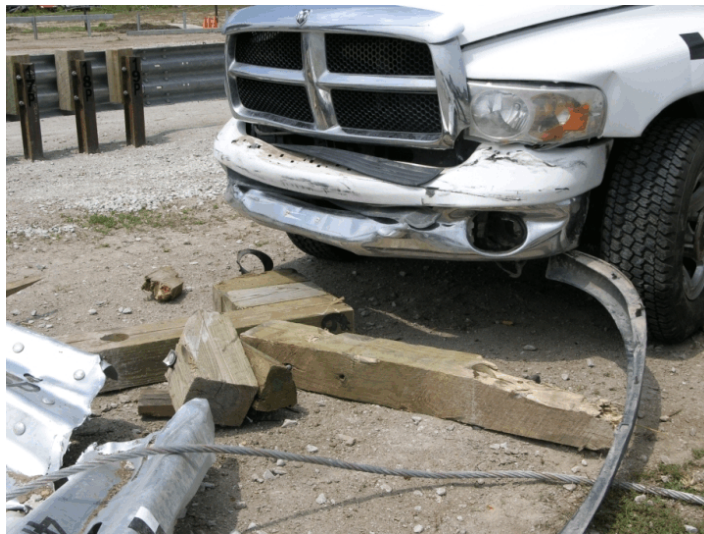
Figure 95. Vehicle Damage, Test SR-8

Exterior vehicle damage was minimal, as shown in Figures 94 through 96. Occupant compartment deformations to the right side and front of the floorboard were deemed insufficient to cause injury to the vehicle occupants. Maximum longitudinal displacements of 6 mm (0.25 in.) occurred throughout the right side of the floorboard. Maximum lateral displacements of 19 mm (0.75 in.) occurred at the left-front corner of the right-side floorboard. Maximum vertical displacements of 6 mm (0.25 in.) were located throughout the right-side floorpan. Complete occupant compartment deformations and the corresponding locations are provided in Appendix G.
