MPC 19-389 | S. Rimal, B. Kidd, M. Tazarv, J. Seo, and N. Wehbe

Methodology for Load Rating Double-Tee Bridges

Department of Civil and Environmental Engineering
South Dakota State University
Brookings, South Dakota

July 2019

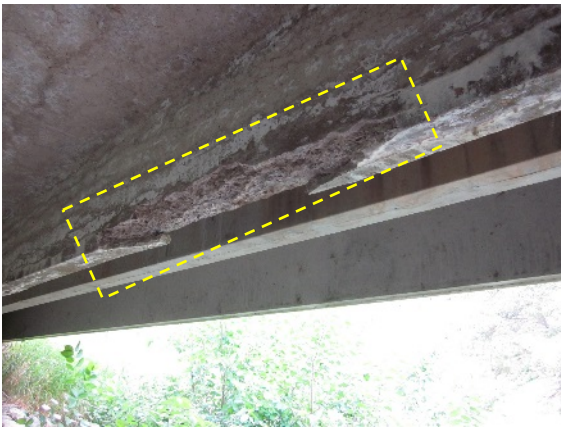
(a) Stem Cover Deterioration

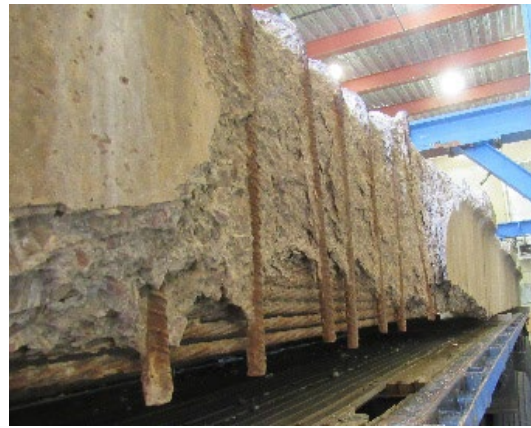
(b) Stem Reinforcement Exposure

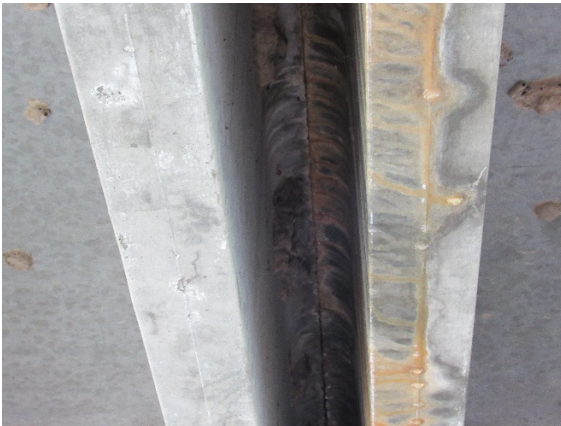
(c) Girder-to-Girder Damage

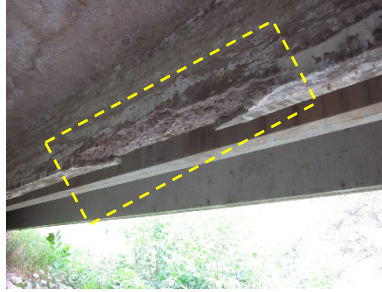
(b) Stem Cover Deterioration (CS-3)

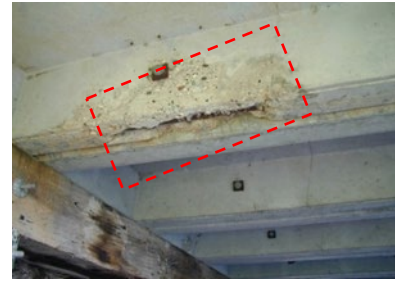
(c) Stem Cover Deterioration (CS-4)

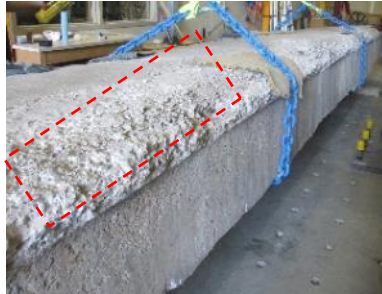
(e) Flange Cover Deterioration (CS-3)

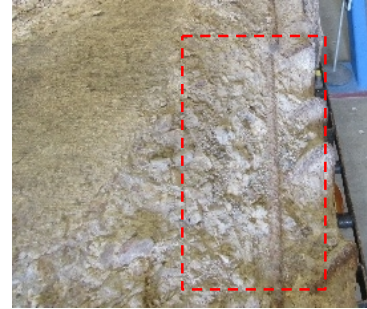
(f) Flange Cover Deterioration (CS-4)

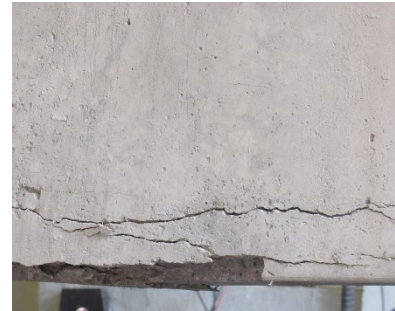
(i) Stem Cracking (CS-4)

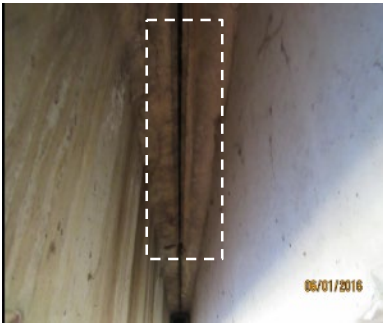
(m) Flange Girder to Girder Longitudinal Joint Deterioration (CS-2)

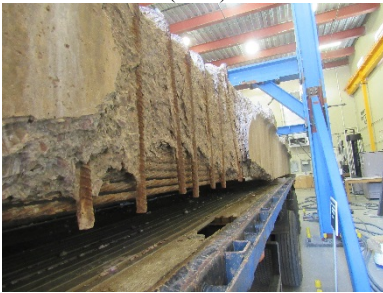
(p) Stem Exposure of Strand (CS-2)

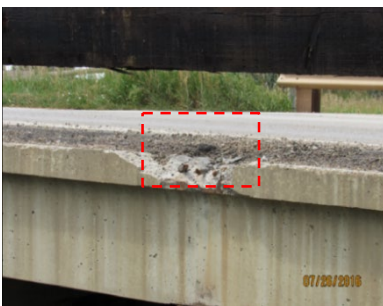
(v) Flange Exposure of Rebar (CS-1) & Flange Cover Deterioration (CS-4)

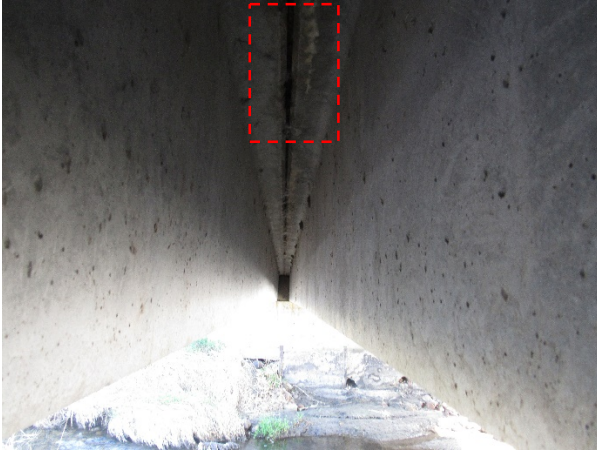
(a) Efflorescence in Joint

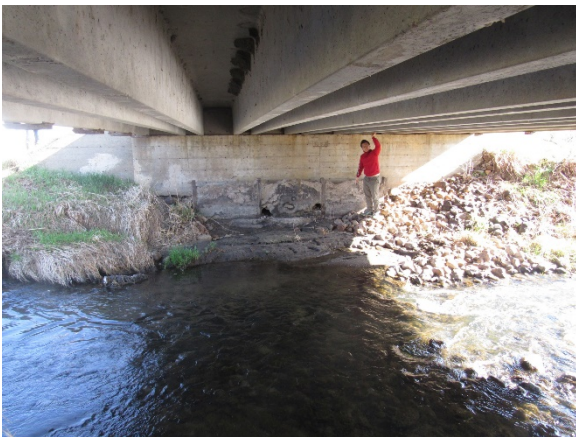
(e) Underneath of Bridge

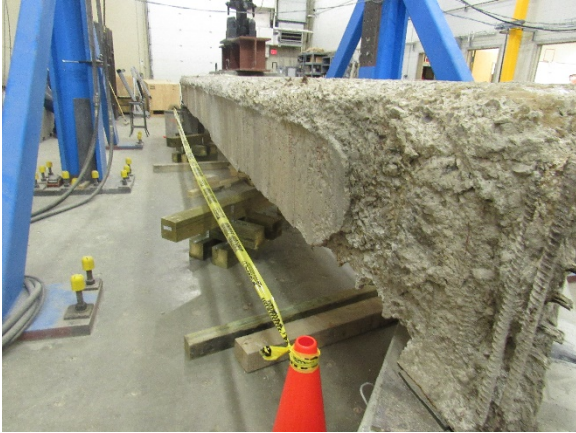
Girder Depth, in. (mm)	Girder Length, ft (m)	As received Girder Damage Type and Condition State
23 (584)	30 (9.14)	Spalling of stem concrete cover (with a condition state of severe, Fig. 6.4a), exposure of stem transverse reinforcement (with a condition state of severe, Fig. 6.4a & c), and leakage of girder-to-girder joints (with a condition state of poor).
23 (584)	50 (15.24)	Deterioration of concrete cover (with condition state of severe, Fig. 6.4b), exposure of transverse rebar (with a condition state of severe, 8.4f), exposure of longitudinal prestressing (with a condition state of severe, Fig. 6.4f), and leakage of girder-to-girder joints (with a condition state of poor).

(a) Stem Cover Deterioration for 30-ft (9.14-m) Girder

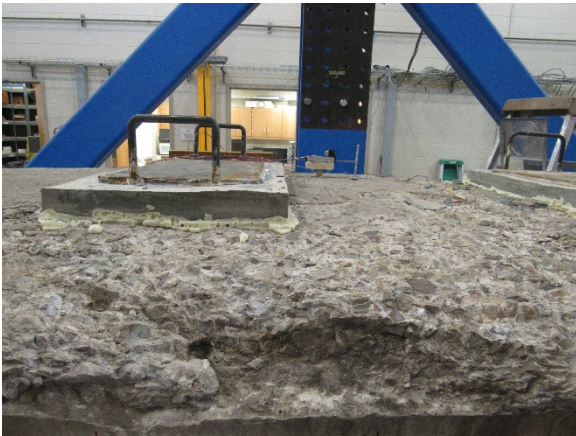
(c) Flange Cover Deterioration of 30-ft (9.14-m) Girder

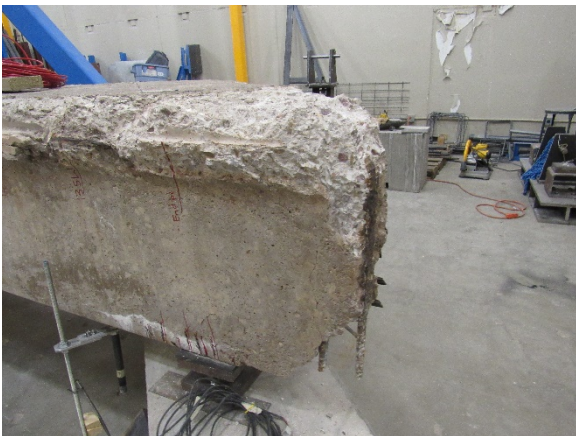
(e) Reinforcement Exposure of 30-ft (9.14-m) Girder

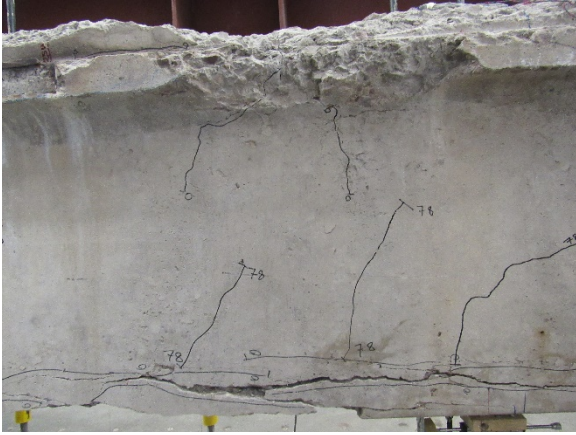
(a) First Flexural Crack at Midspan

The 45-year old girder had several damages prior to testing (Fig. 6.4). As was mentioned in Sec. 6.1, this girder was cracked at the midspan during unloading from the delivery truck. The first flexural crack was observed at the midspan at a 24.9-kip (110.7-kN) load as shown in Fig. 6.26 (marked as Run No. 78). New flexural cracks developed at the midspan at higher loads (Fig. 6.26b) and the concrete spalled at the north support (Fig. 6.26c). Finally, the girder failed at the midspan in a brittle manner (Fig. 6.26d). It was concluded from the analytical study (Sec. 6.7) that the girder failure was due to failure of the flange concrete.

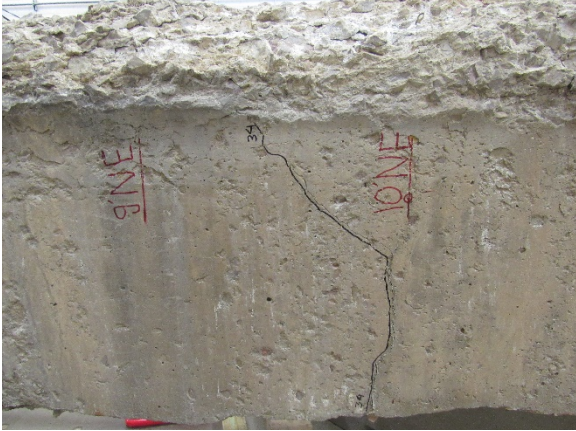
(a) First Shear Crack at North End

The 45-year old girder had several damages prior to testing (Fig. 6.4). The north end of the girder had more prior-to-testing apparent damage than the south end. That is probably why the first crack occurred near the north end (Fig. 6.32a, marked as Run No. 34), 10 ft (3.05 m) away from the midspan at an actuator load of 15.3 kips (68.06 kN). The first flexural crack was observed at a distance of 5 ft (1.5 m) from the midspan at a 22.41-kip (99.68-kN) load as shown in Fig. 6.32b (marked as Run No. 47). The width of cracks extended, and new cracks formed, at higher loads (Fig. 6.32c & d). Finally, the girder failed in flexure at the midspan (a major flexural crack as marked in Fig. 6.32e), which was a ductile failure.

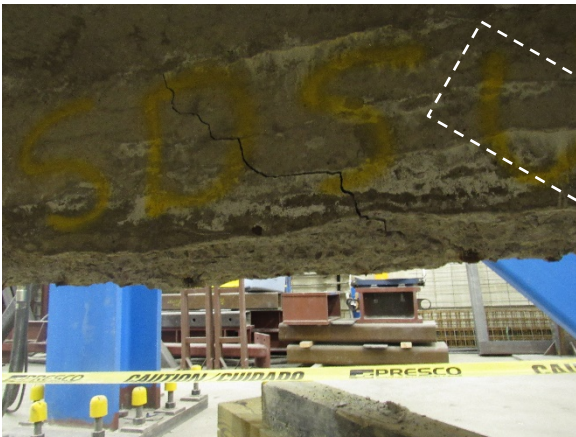
(e) A Major Flexural Crack at Midspan– Stem inside View

The 30-ft (9.14-m) long girder failed in a ductile manner at the midspan with a load of 37.37 kips (166.23 kN). Table 6.8 also presents the calculated capacities of this girder including all damages. The calculated shear and moment capacities for this girder at the failure section were 64.7 kips (287.8 kN) and 223.58 kip.ft (303.5 kN.m), respectively. The equivalent calculated load carrying capacities (a point load at the midspan, $P_{calculated}$) were respectively 129.4 kips (575.6 kN) and 35.89 kips (159.65 kN), which is 3.9% higher than measured load. Therefore, the 30-ft (9.14-m) long girder failed by the flexural failure of the section, which is a ductile failure.

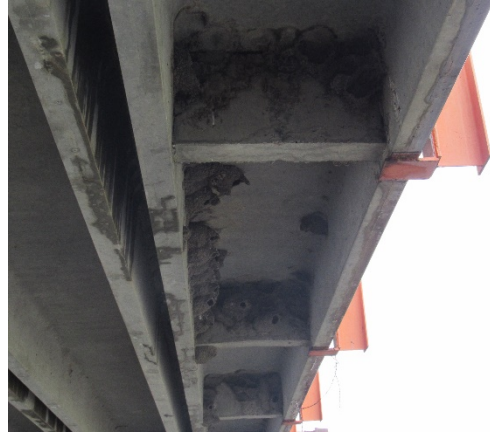
(b) Diaphragm at the exterior girder

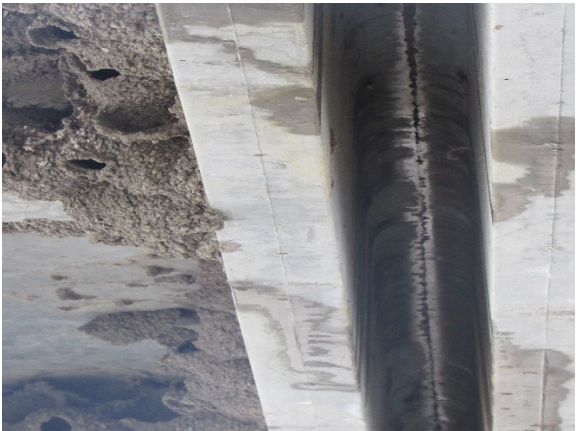
Bridge ID	County	Span Length and Depth	Damage Type and Condition State	Age, Yr.
31024230	Hanson, SD	40.8 ft (12.4 m) Seven 23-in (584-mm) Deep Girders	<i>Non-skewed,</i> Minor water leakage between deck units (with a condition state of Poor).	36
34075220	Hutchinson, SD	43 ft (13.1 m) Seven 23-in (584-mm) Deep Girders	<i>Non-skewed,</i> Light staining from leakage between longitudinal joints, spalling, and delamination. Only one longitudinal joint had water leakage after rain (with a condition state of Poor).	37
34140033	Hutchinson, SD	100 ft (30.5 m) 3 span Eight 23-in (584-mm) Deep Girders	<i>Non-skewed,</i> Severe water leakage between all longitudinal joints after rain with minor corrosion of steel plates (with a condition state of Poor).	39
42104110	Lincoln, SD	46 ft (14.02 m) Seven 30-in. (762-mm) Deep Girders	<i>Non-skewed, girders have transverse diaphragms,</i> Spalling of stem concrete cover (condition state not available), exposure of stem transverse reinforcement (with a condition state of Severe), and leakage of girder-to-girder joints (with a condition state of Poor).	35

(e) Efflorescence in joint

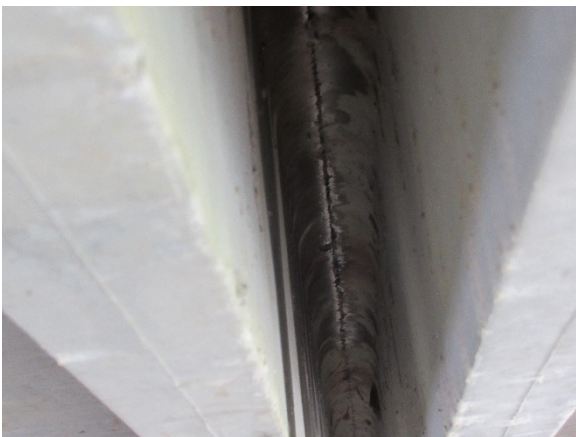
(c) Efflorescence in joint

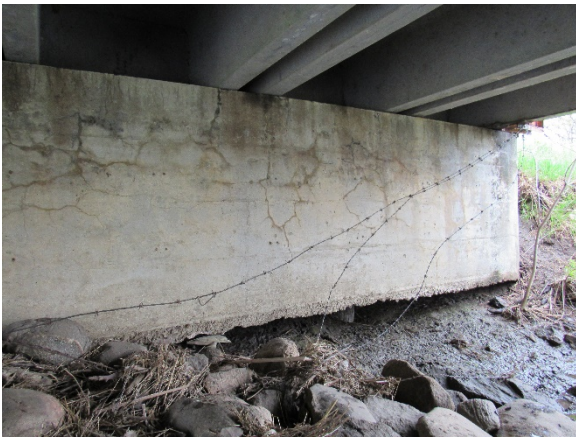
(e) Scouring from bottom of abutment

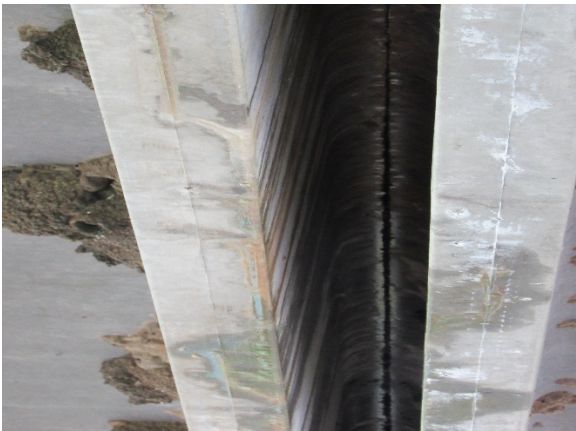
(e) Efflorescence

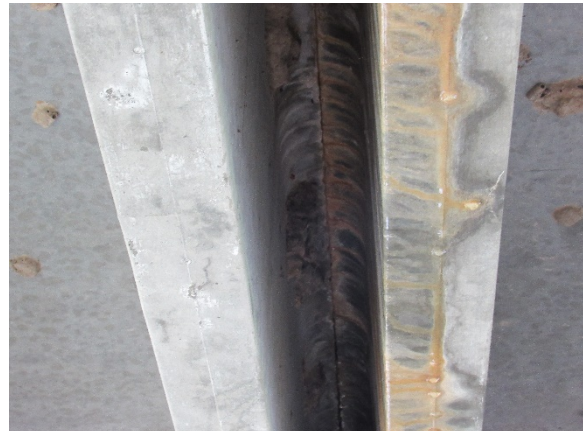
(f) Sign of corrosion

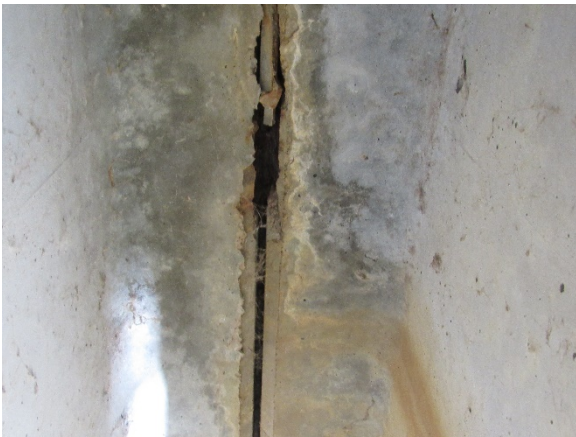
(c) Joint deterioration

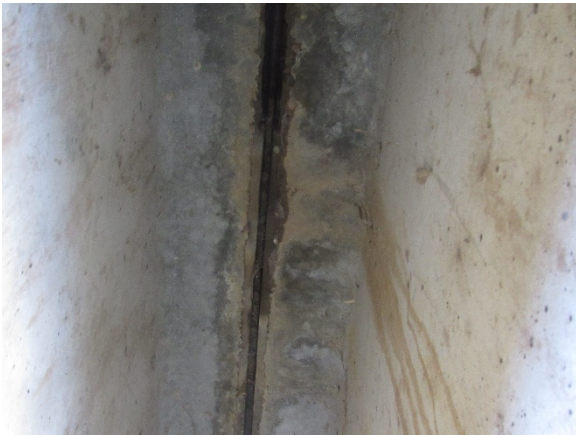
(e) Leakage from joint

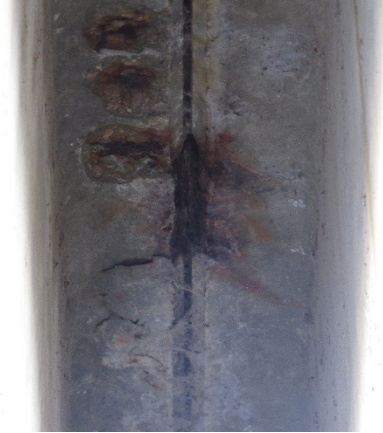
42130065	Lincoln, SD	45.8 ft (13.9 m) Six 30-in. (762-mm) Deep Girders	<i>Non-skewed,</i> Spalling of both stem and flange concrete cover (with a condition state of Fair and Good, respectively), and leakage of girder-to-girder joints (with a condition state of Poor).	40
42165153	Lincoln, SD	42 ft (12.8 m) Seven 30-in. (762-mm) Deep Girders	<i>Non-skewed,</i> Spalling of stem concrete cover (with a condition state of Fair), and leakage of girder-to-girder joints (with a condition state of Poor).	34
51008010	Moody, SD	50 ft (15.24 m) Six 23-in (584-mm) Deep Girders	<i>Non-skewed,</i> Spalling with exposed rebar, efflorescence and water staining between the deck units due to leaking of the joints.	40
51090012	Moody, SD	50 ft (15.24 m) Eight 23-in. (584-mm) Deep Girders	<i>Non-skewed,</i> Water leakage between all deck units, stains from minor corrosion of steel plates in longitudinal joints (with a condition state of Poor), concrete spalling (with a condition state of Fair).	38

(b) Corrosion in joint

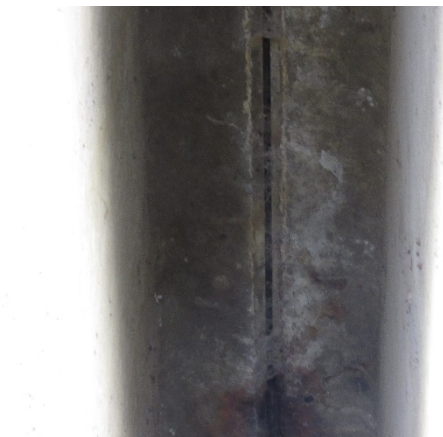
(c) Efflorescence in joint

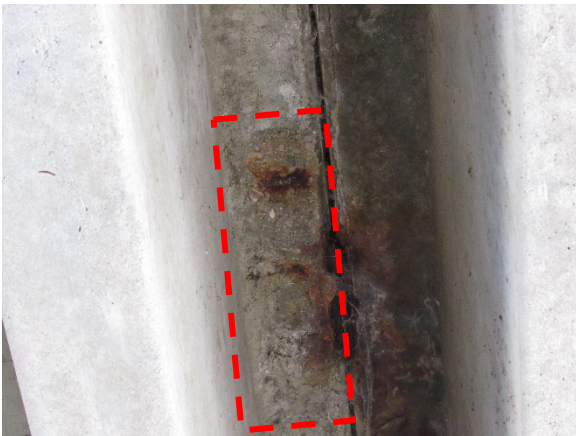
(e) Deterioration in Joint

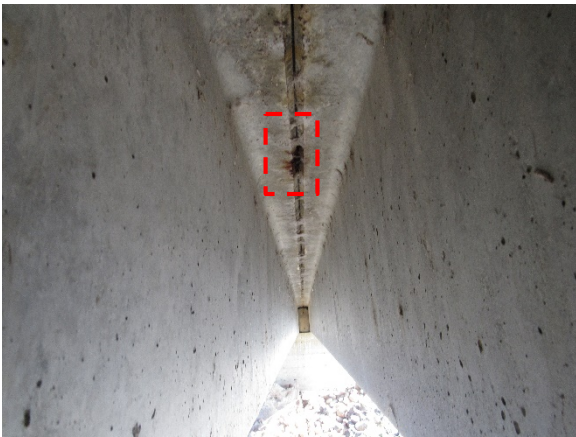
(c) Corrosion in the joint

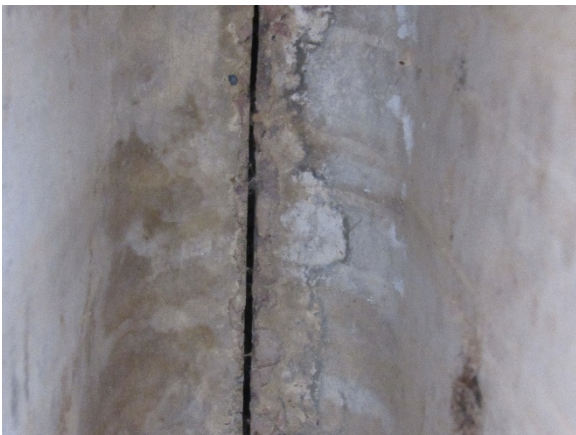
(e) Efflorescence at joint

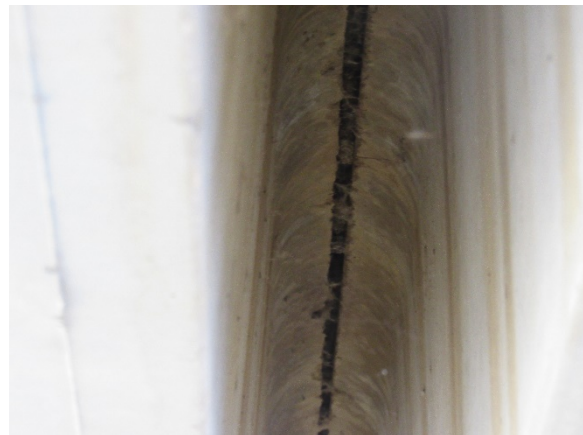
(f) Wide gap in joint

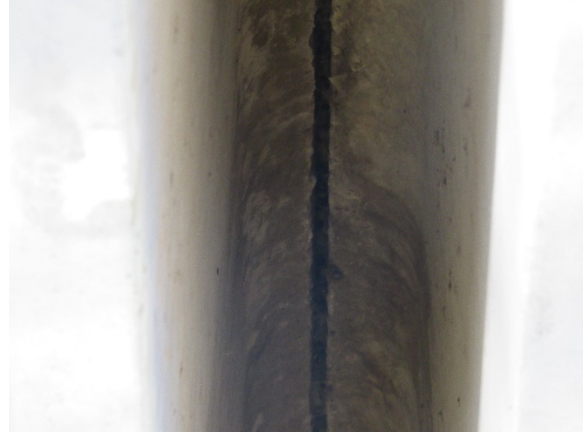
(b) Gap of joint

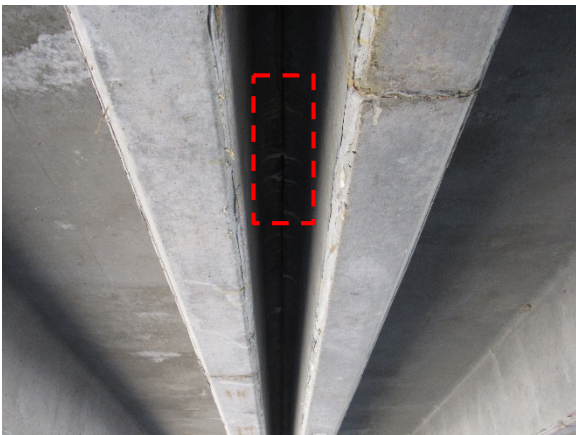
(e) Efflorescence at joint

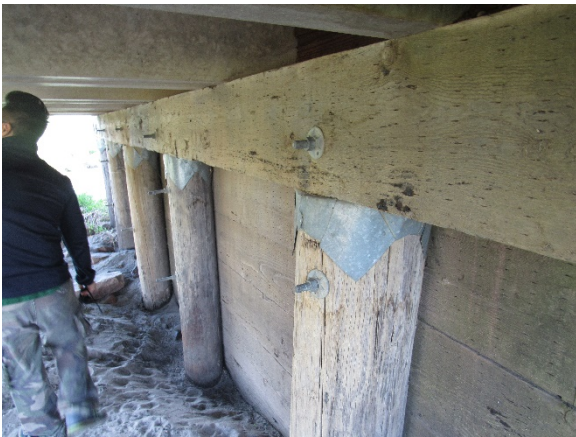
(c) Wooden abutment
