MASH TEST NO. 3-10 OF A NON-PROPRIETARY, HIGH-TENSION, CABLE MEDIAN BARRIER FOR USE IN 6H:1V V-DITCH (TEST NO. MWP-9)

MIDWEST ROADSIDE SAFETY FACILITY

MwRSF Research Report No. TRP-03-360-18

March 30, 2018

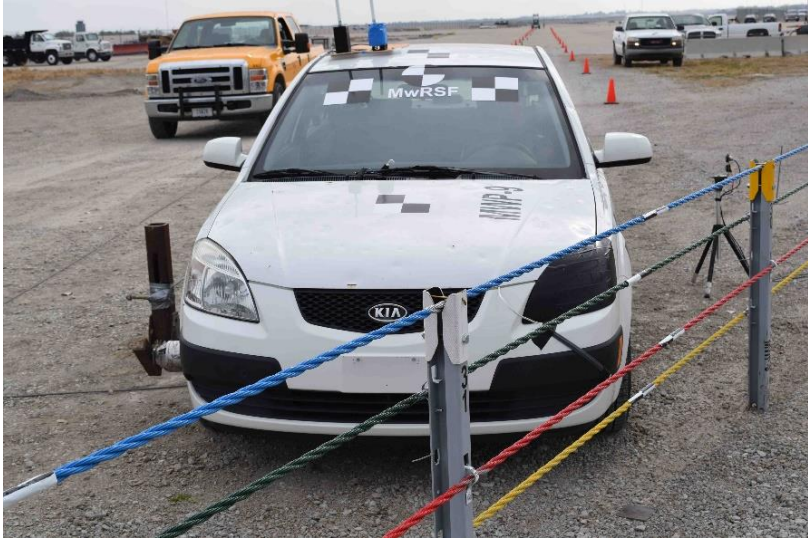
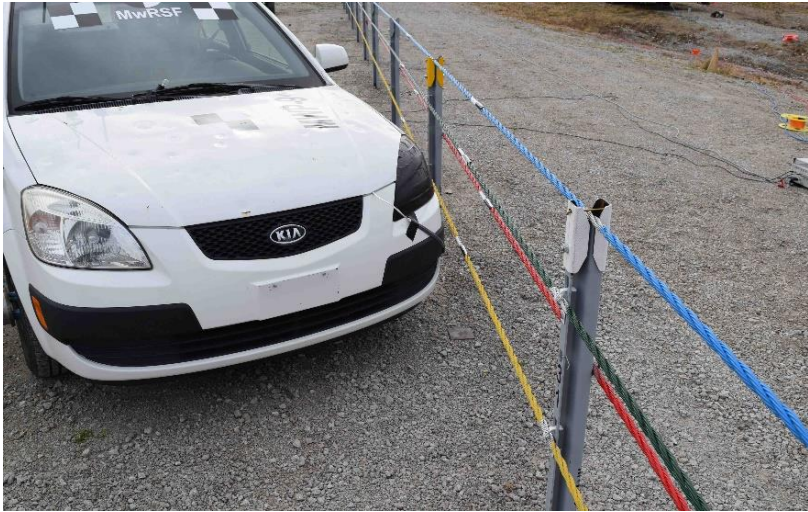
Figure 46. Impact Location, Test No. MWP-9

Initial vehicle impact was to occur at a midspan location, or 4 ft (1.22 m) upstream from post no. 31, as shown in Figure 46, which was selected using Table 2-2D of MASH 2016. The actual point of impact was 3 ft – 10 in. (1.17 m) upstream of post no. 31. A sequential description of the impact events is contained in Table 4. The vehicle came to rest approximately 150 ft – 2 in. (45.77 m) downstream from the point of impact, or between post nos. 48 and 49 and in contact with the cables. Cable no. 4 was located on the non-impact side of the vehicle, cable no. 2 was located on the impact side, and cable nos. 1 and 3 were underneath the vehicle. The vehicle trajectory and final position are shown in Figures 47 and 48.

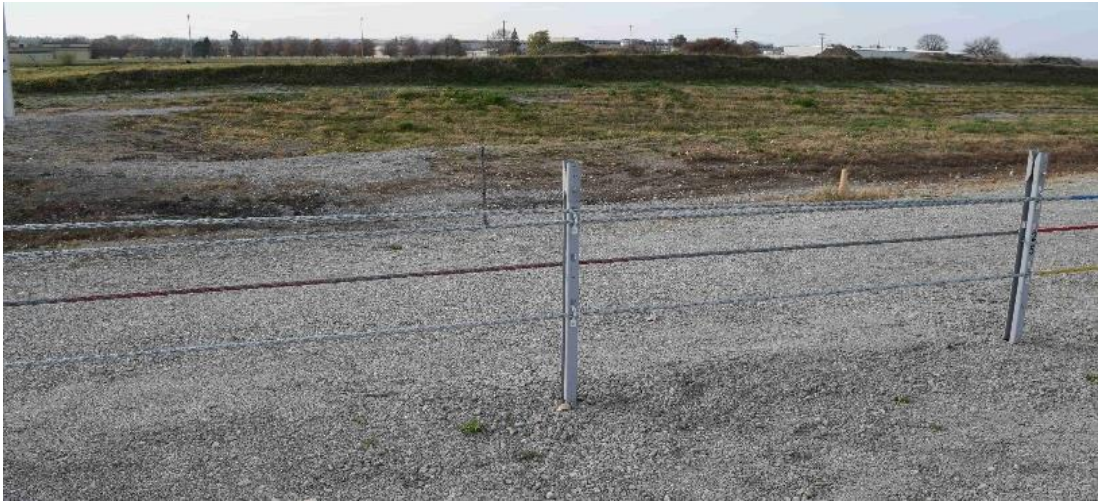
Post Nos. 24 and 25

Figure 50. Post Nos. 21 through 27 Damage, Test No. MWP-9

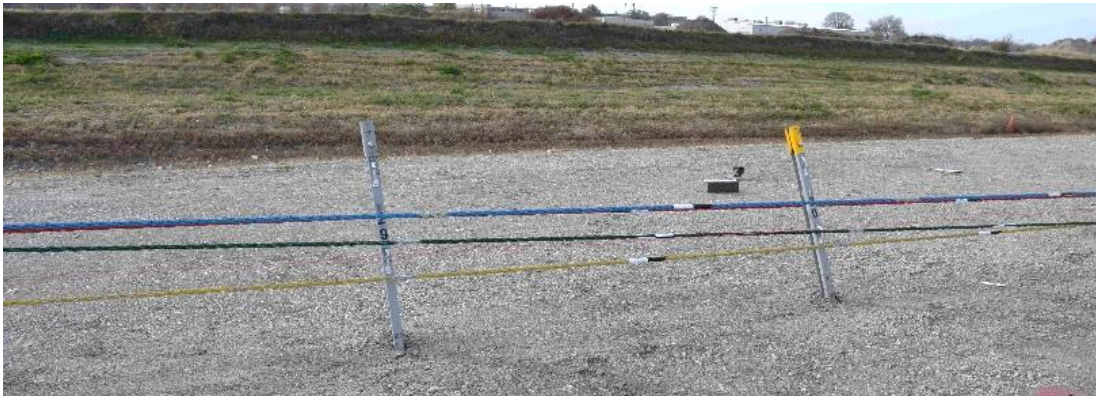
Post Nos. 29 and 30

Figure 51. Post Nos. 28 through 33 Damage, Test No. MWP-9

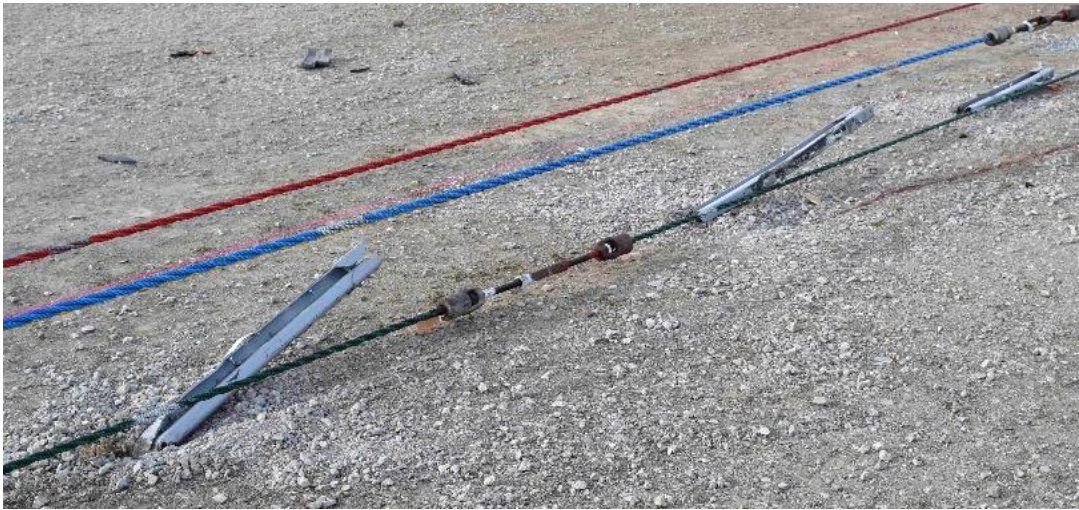
Post Nos. 36 through 38

Figure 52. Post Nos. 34 through 43 Damage, Test No. MWP-9

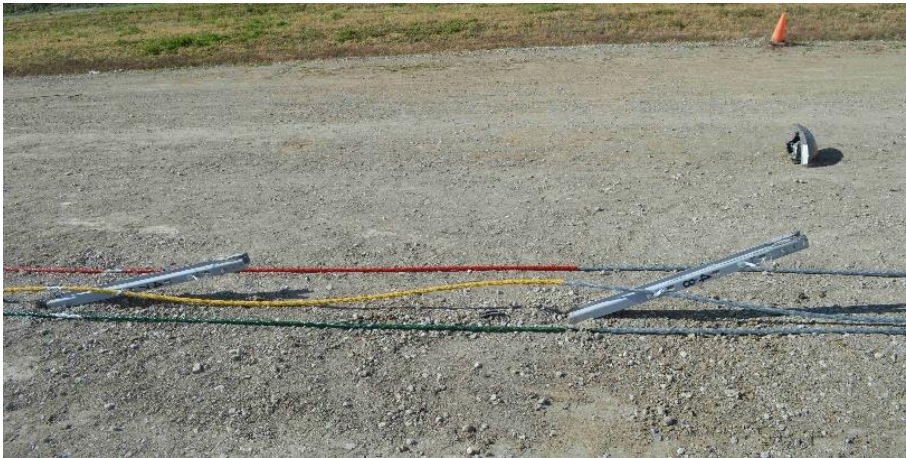
Post Nos. 47 and 48

Figure 53. Post Nos. 44 through 51 Damage, Test No. MWP-9

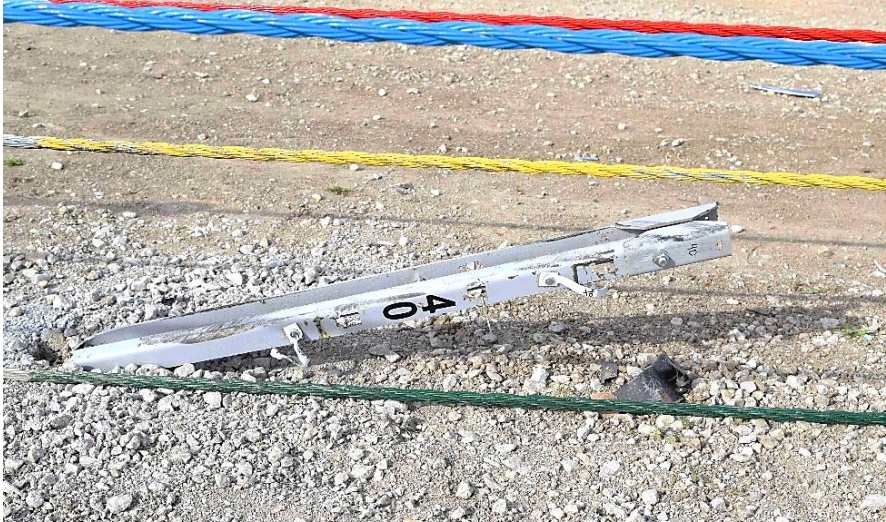
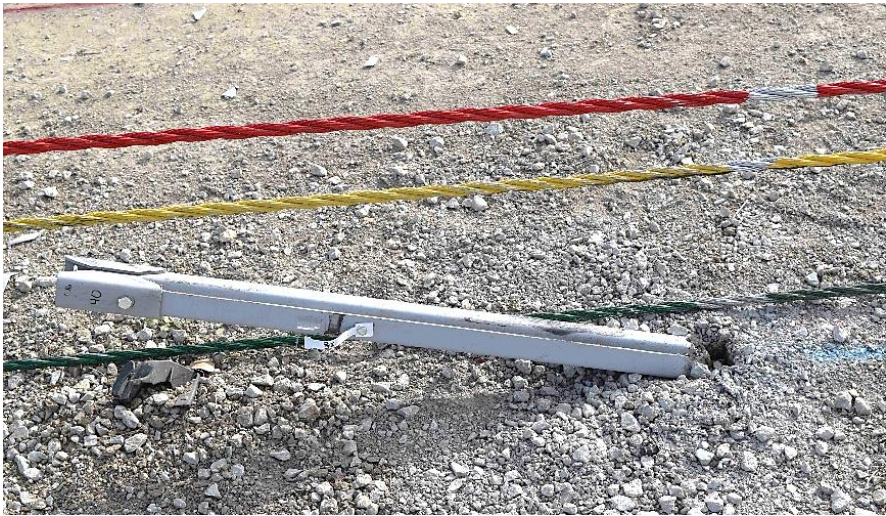
Figure 72. Post No. 40 Damage, Test No. MWP-9

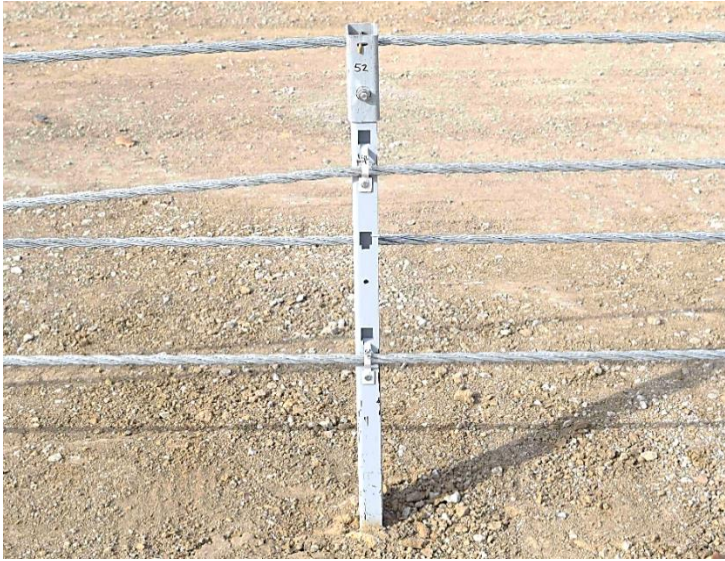
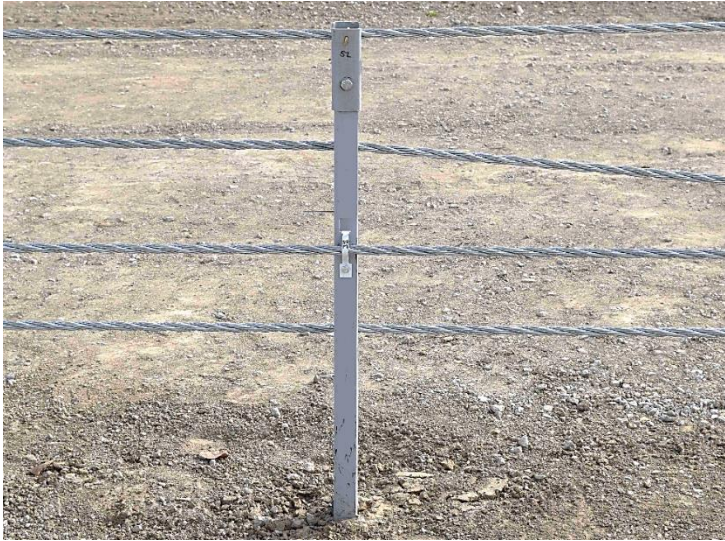
Post No. 52

Figure 84. Post Nos. 52 and 53 Damage, Test No. MWP-9

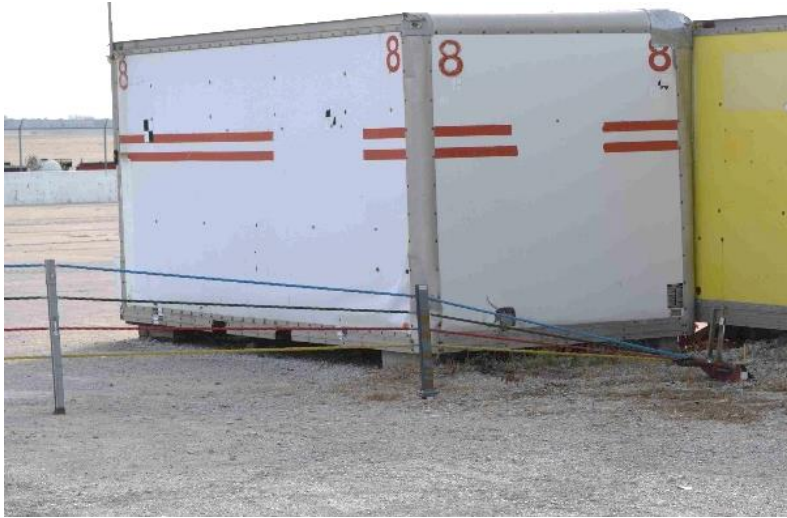
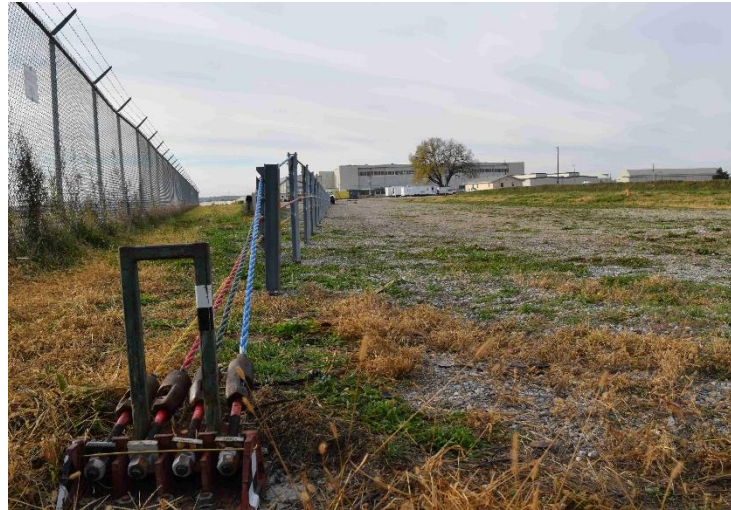
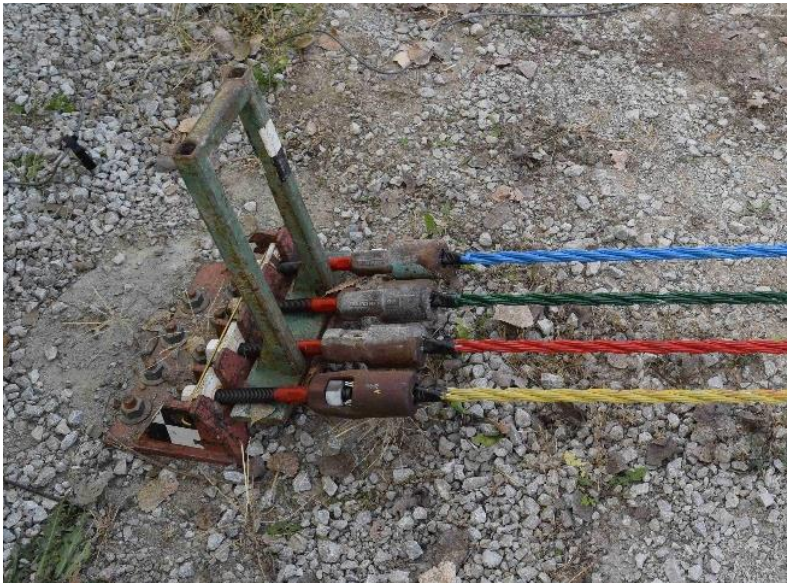
Upstream Anchorage

Figure 85. Anchorage Damage, Test No. MWP-9
