# **INCREASED SPAN LENGTH FOR THE MGS LONG-SPAN GUARDRAIL SYSTEM PART II: FULL-SCALE CRASH TESTING**

MwRSF Research Report No. TRP-03-339-17

April 7, 2017

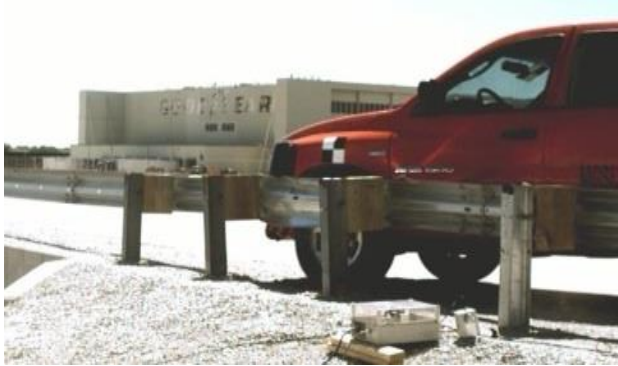
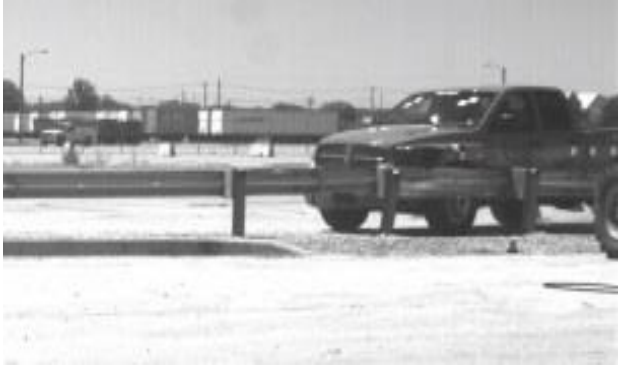
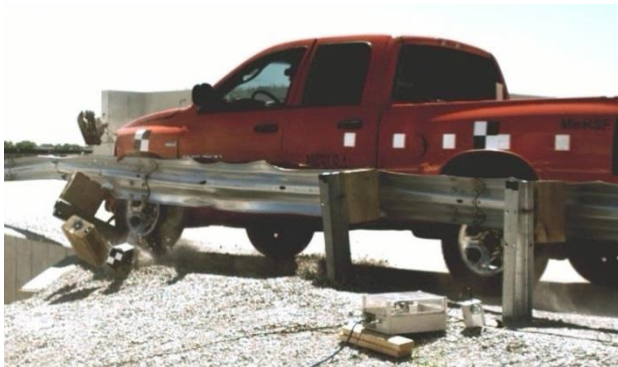
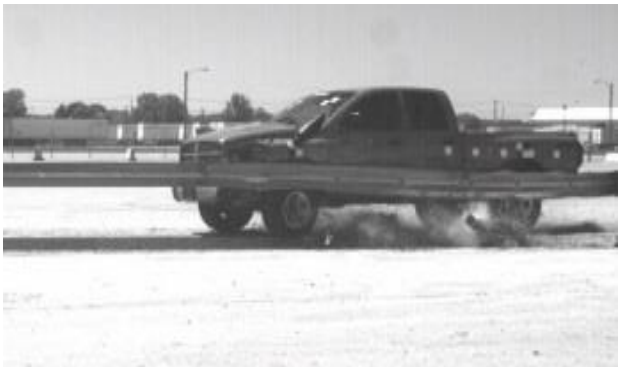
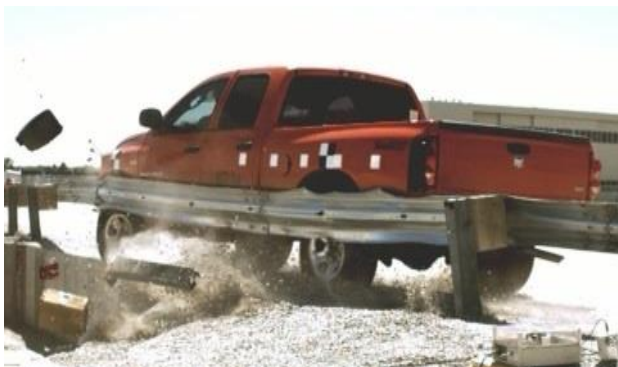
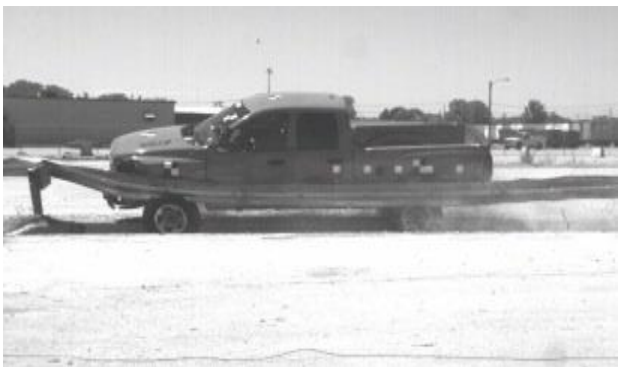
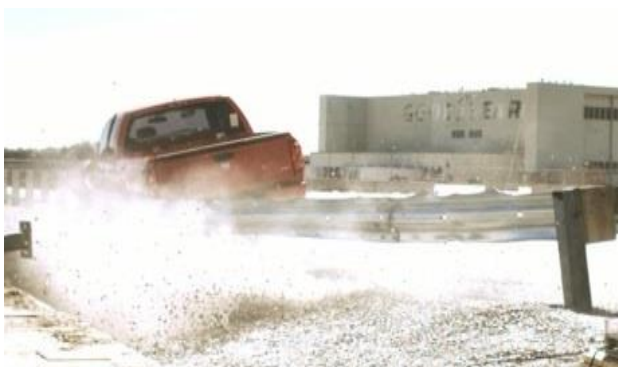
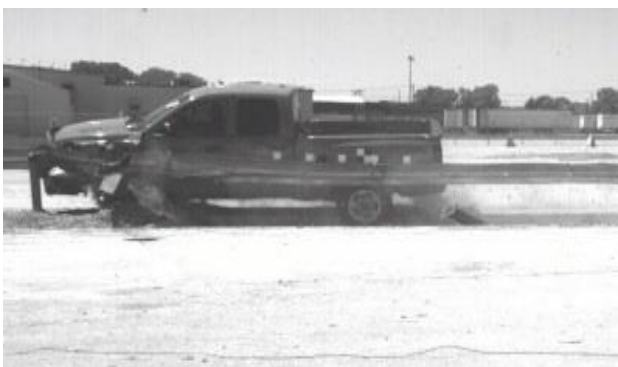
Figure 45. Documentary Photographs, Test No. MGSL-1

In accordance with MASH test designation no. 3-11, the 4,955-lb (2,248-kg) pickup truck impacted the MGS long-span system at a speed of 62.7 mph (100.9 km/h) and an angle of 25.3 degrees. A summary of the test results and sequential photographs are shown in Figure 42. Additional sequential photographs are shown in Figures 43 and 44. Documentary photographs of the crash test are shown in Figure 45.

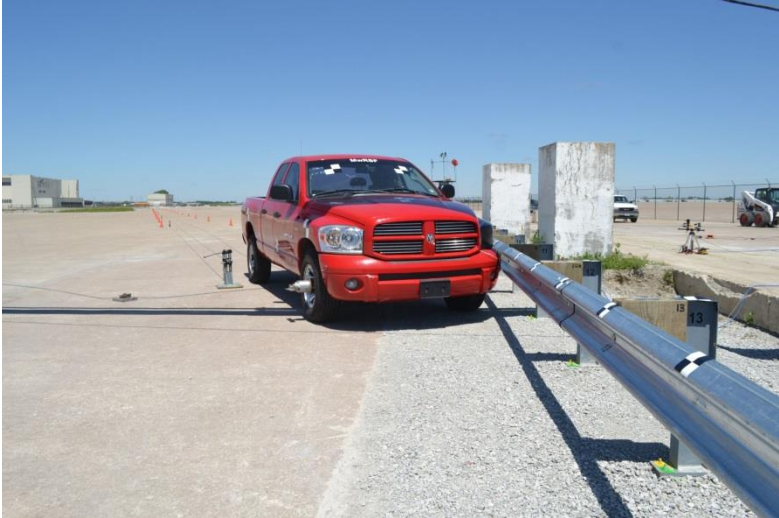
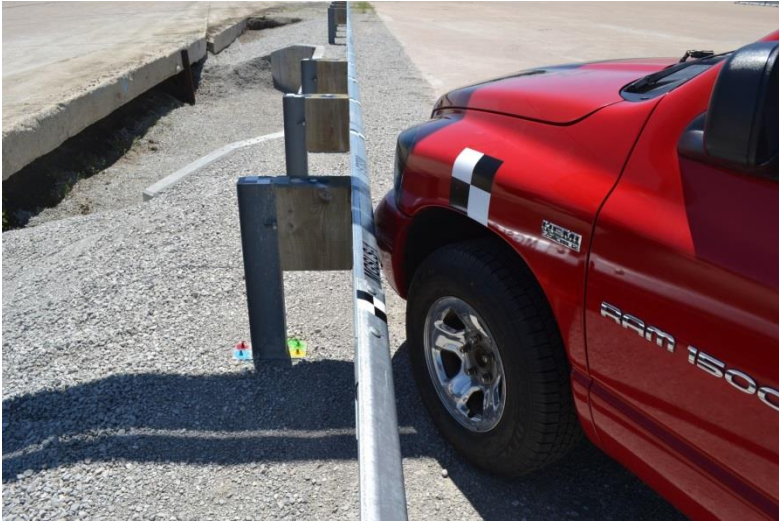
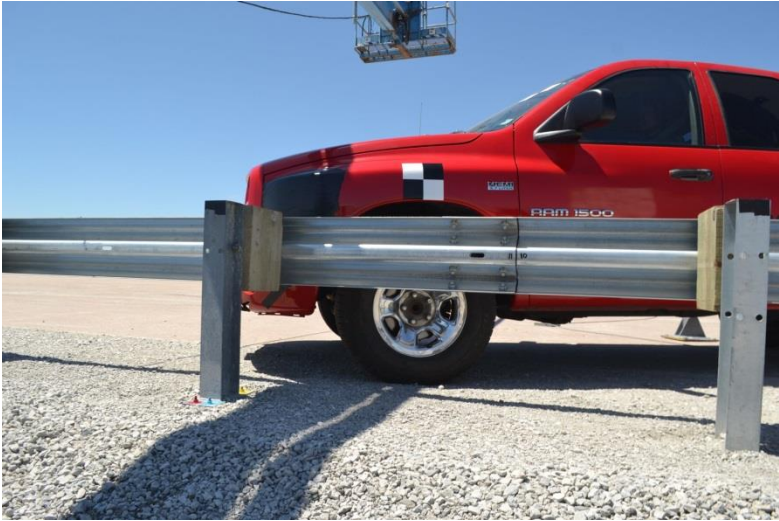
Figure 46. Impact Location, Test No. MGSL-1

Initial vehicle impact was to occur at the centerline of post no. 11, as shown in Figure 46, which was selected using LS-DYNA analysis to evaluate the potential for vehicle instability by maximizing the interaction of the front wheel of the pickup truck with the wing wall of the culvert [3-4]. The actual point of impact was 1¾ in. (44 mm) downstream from post no. 11. A sequential description of the impact events is contained in Table 4. The vehicle came to rest 30 ft – 10 in. (9.4 m) behind the system and 177 ft – 6 in. (54.1 m) downstream from the point of impact. The vehicle trajectory and final position are shown in Figures 42 and 47.

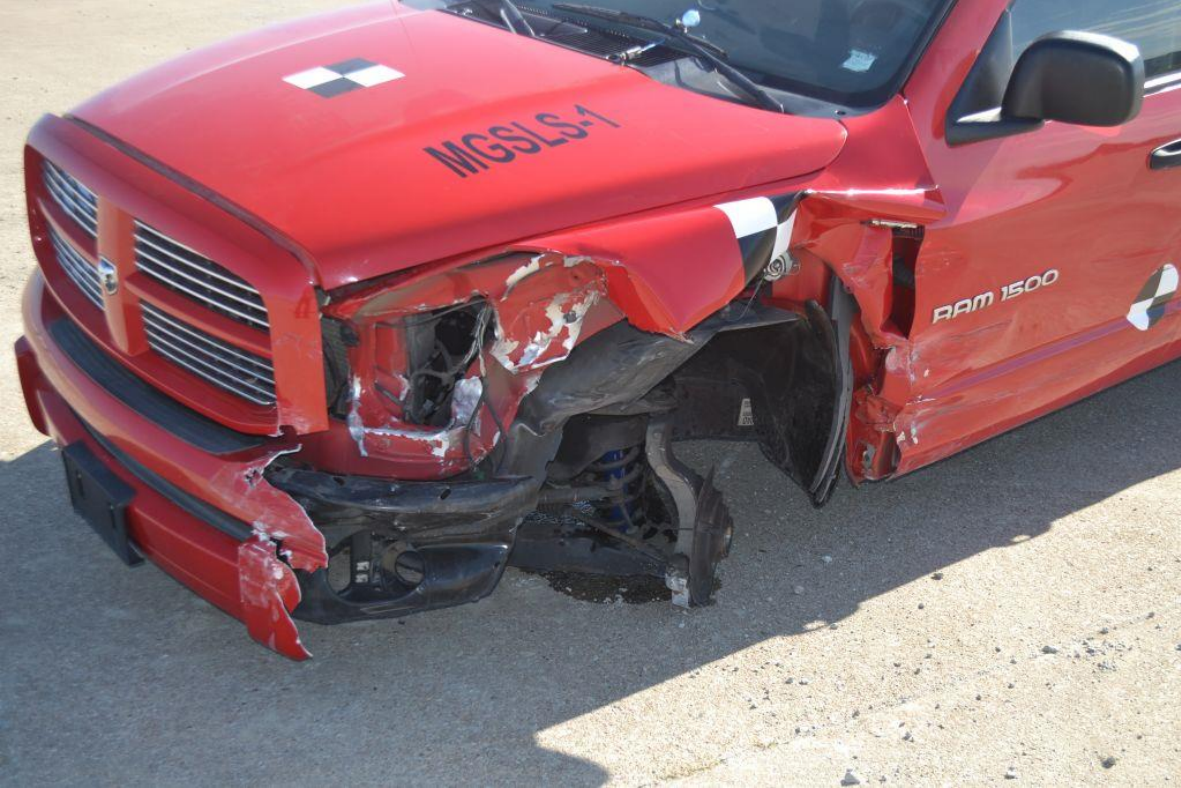
Figure 57. Vehicle Damage, Left Fender, Test No. MGSL-1

The damage to the vehicle was moderate, as shown in Figures 56 through 58. The maximum occupant compartment deformations are listed in Table 5 along with the deformation limits established in MASH for various areas of the occupant compartment. Note that none of the MASH-established deformation limits were violated. Complete occupant compartment and vehicle deformations and the corresponding locations are provided in Appendix D.

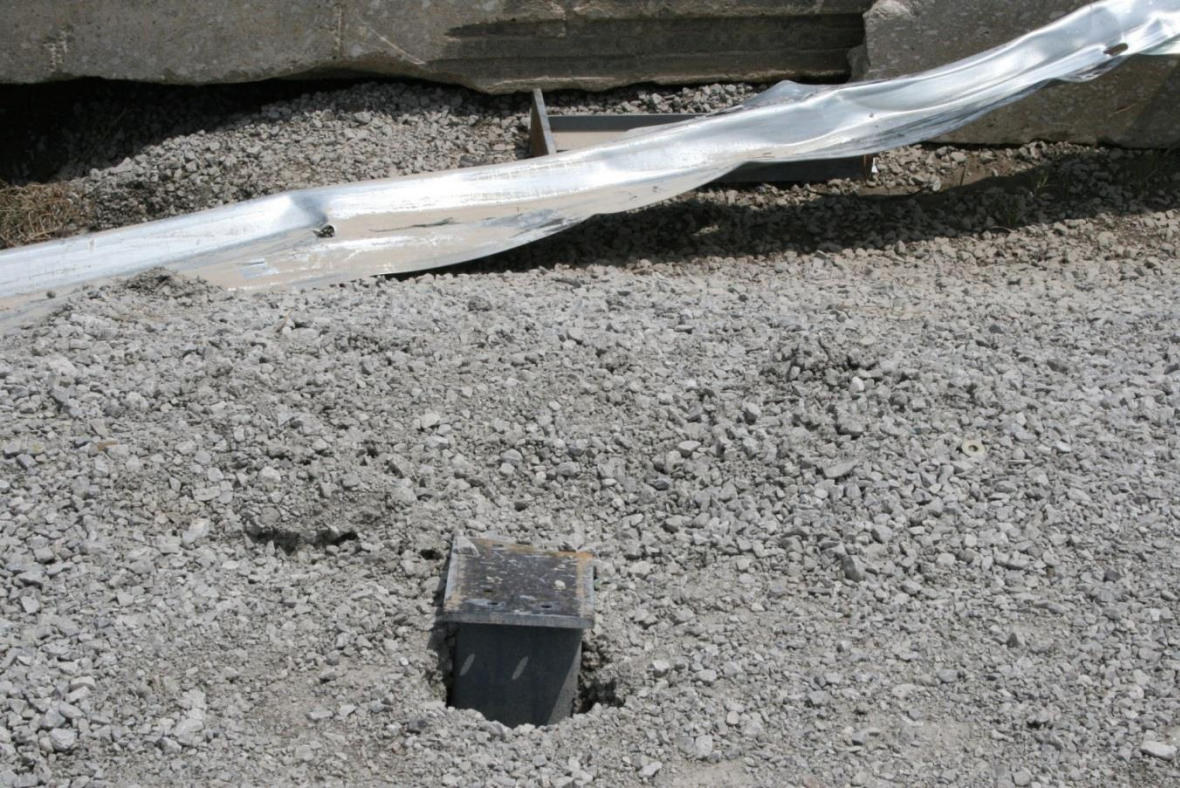
Figure 74. Damage at Post No. 15, Test No. MGSL-2

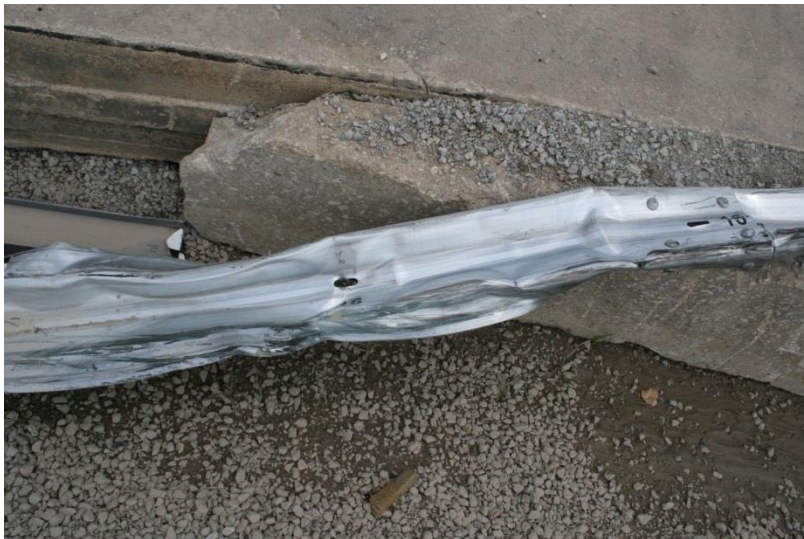
Figure 75. Damage at Post No. 16 and Splice 16-17, Test No. MGSLS-2

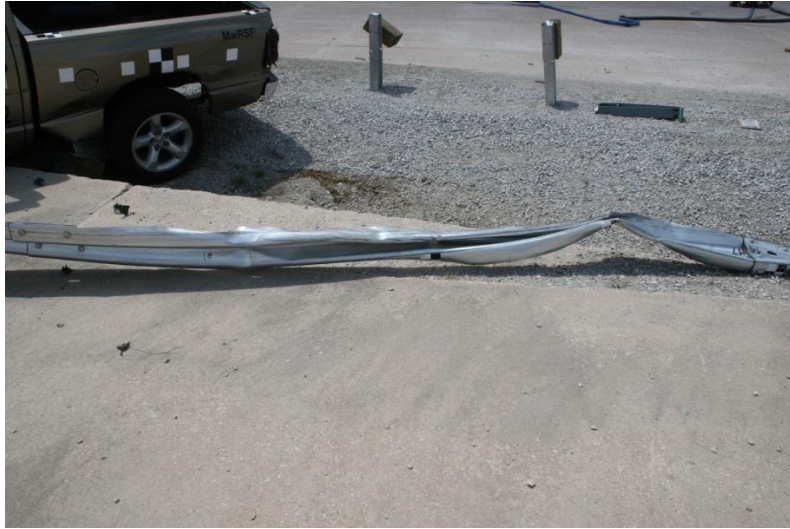
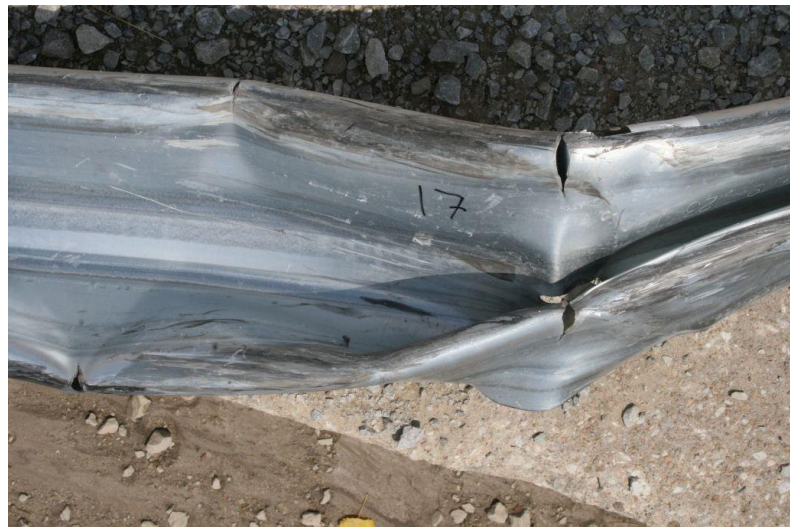
Figure 77. Damage to Rail Between Post Nos. 17 through 19, Test No. MGSLs-2

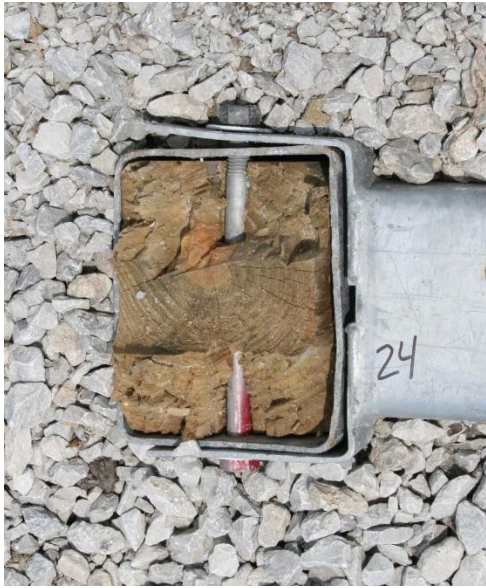
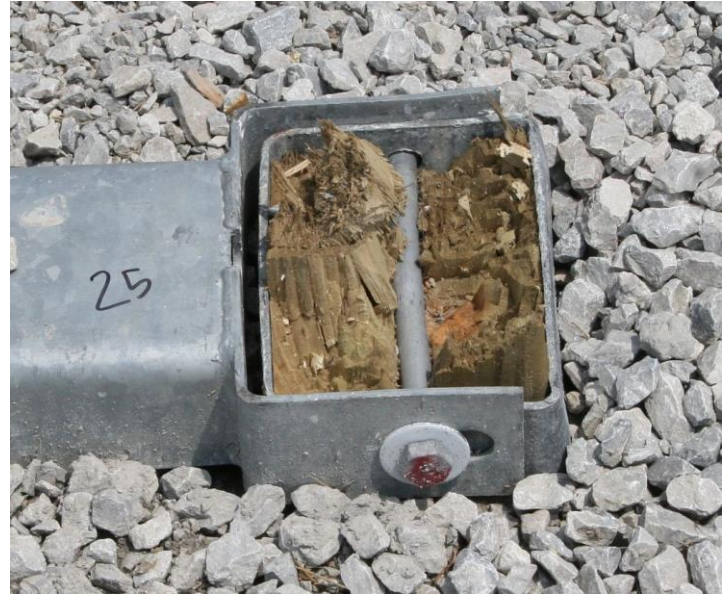
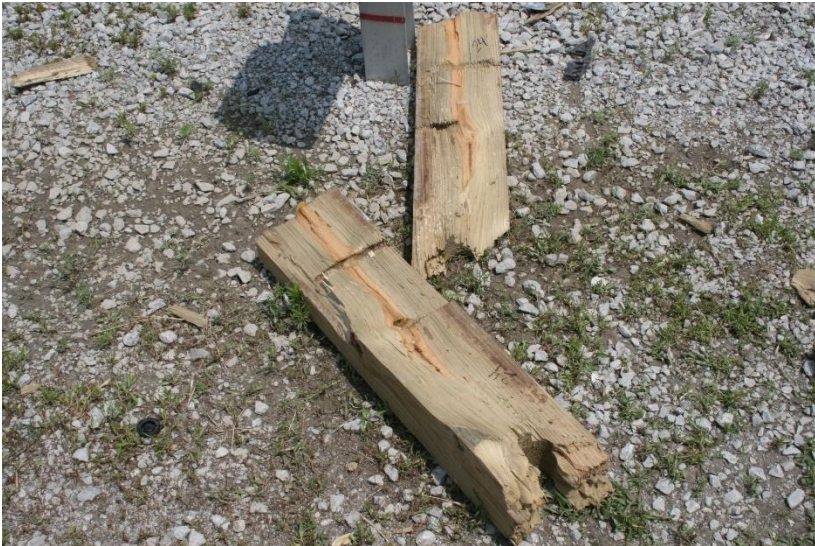
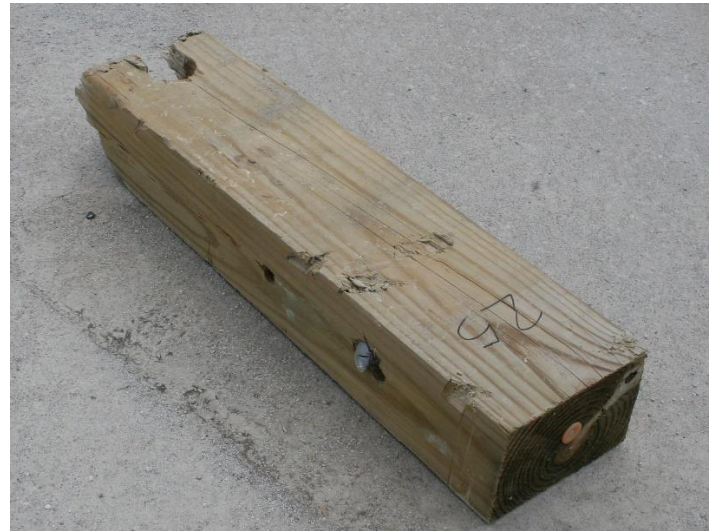
Figure 80. Downstream Anchorage Damage, Test No. MGSLS-2
