Asset Management for Retaining Walls

Final report

Michigan Department of Transportation
ORBP Number OR15-114

March 2020

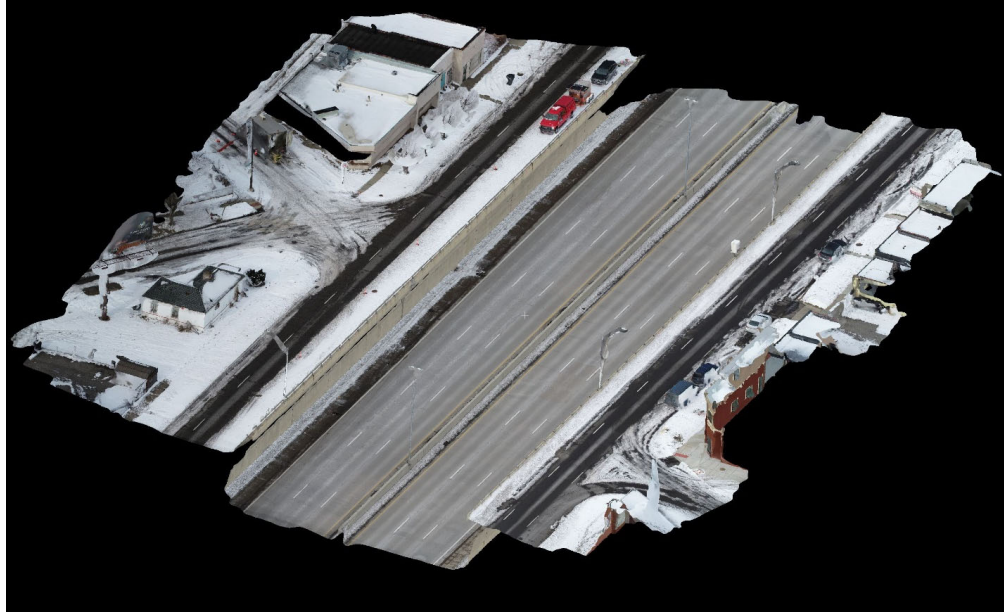
Figure B.5. (a) 3D point cloud generated by Pix4D from aerial UAV imagery collected on January 22, 2020; (b) cross section of Panel 4.

the cross sections that were analyzed. Panels 1 through 9 span the entire area that was surveyed with the UAV. It should be noted that “Panel 4” corresponds to the instrumented panel. As shown, the panels are indeed tilted with tilts ranging from 1 degree (Panel 9) to 2.5 degrees (Panels 2 and 4). These tilts are larger than that measured by the long-term monitoring system (1.6 degrees as measured at Panel 4 by the monitoring system). These differences are likely due to calibration errors in the UAV photogrammetry method; specifically, there is an absence of a true sense of the horizontal plane associated with the cross-sectional analysis shown in Figure B.5. None the less, the relative tilt measurements shows more distress at Panels 1 through 5 with less at Panel 6 through 9. The measurements also confirm that the measurement of the wall leaning toward the highway is valid.

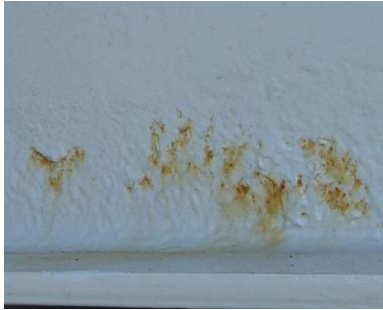
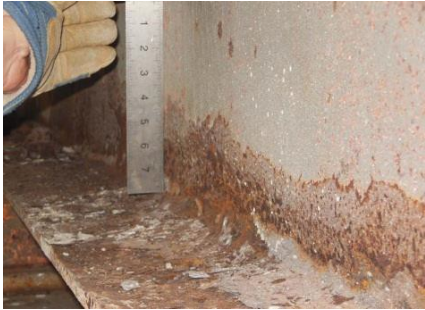
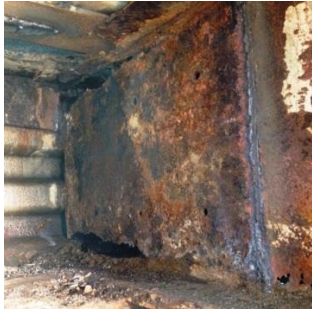
Corrosion	Corrosion	Corrosion

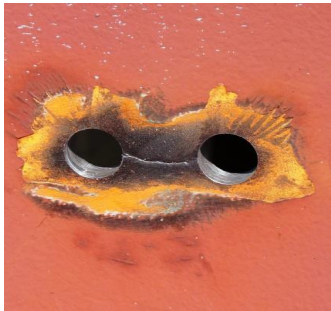
Cracking/Fatigue

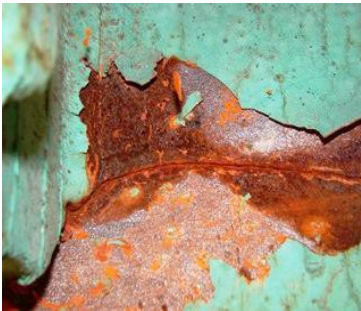
Cracking/Fatigue

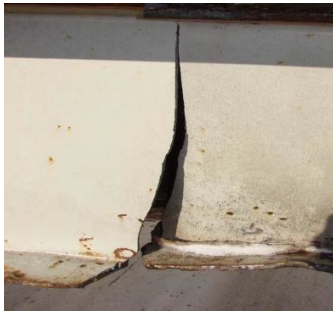
Cracking/Fatigue

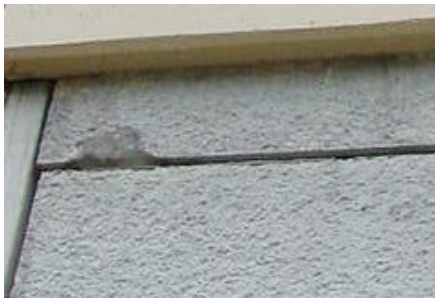
Minor Spall

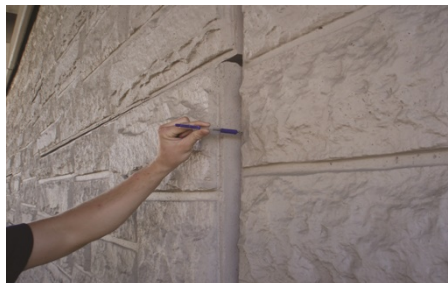
Moderate Misalignment

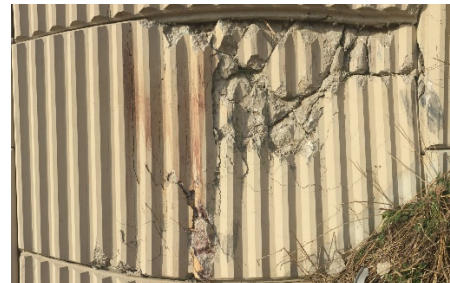
Deteriorated Panel
