Technical Report Documentation Page

| 4. Title and Subtitle<br>Materials Selection for Concrete Overlays: Information Survey<br>Review and Evaluation of Existing Concrete Overlays in Texas | | | | 5. Report Date<br>October 2010; Revision April 2011 | |
| 7. Author(s)<br>Dong hyun Kim, Manuel Trevino, David P. Whitney, David W.<br>Fowler, Raissa Ferron | | | | 8. Performing Organization Report No.<br>0-6590-1 | |

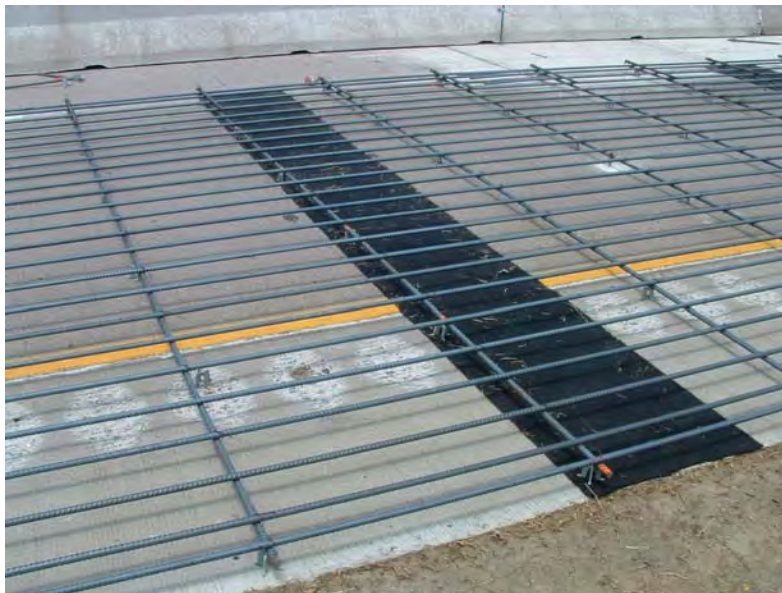
*Figure 8.4: Prepared surface prior to the yellow stripe removal*

The surface was roughened up and cleaned before the BCO placement. However, the survey team noticed that the yellow pavement stripe was still intact, which raised a concern for the possibility of the stripe acting as a debonder. Therefore, the contractor was asked to remove the yellow stripe and thoroughly clean the surface again before the construction began. Figure 8.4 shows the pavement before the yellow strip was removed, and Figure 8.5 shows it after removal.

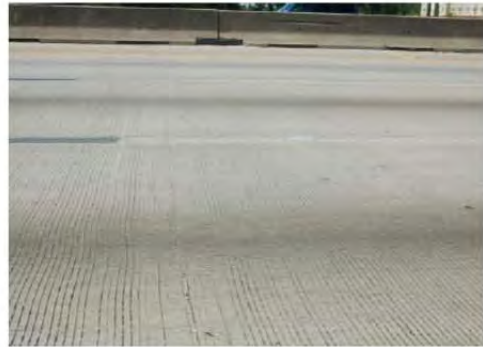
Typical transverse crack

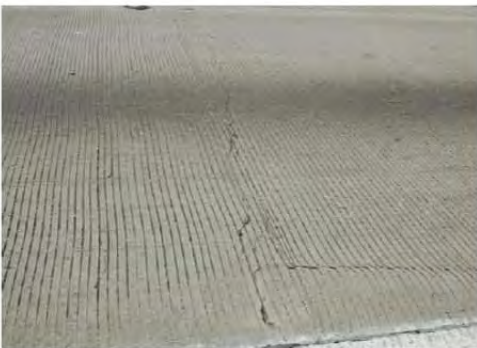
Minor spall

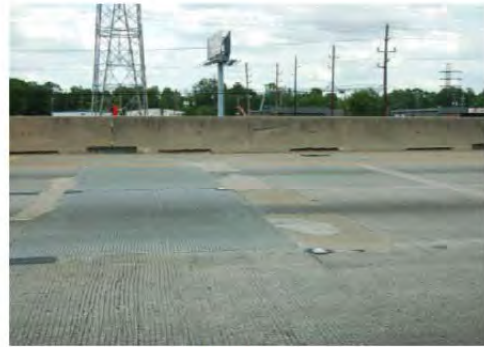
Patches

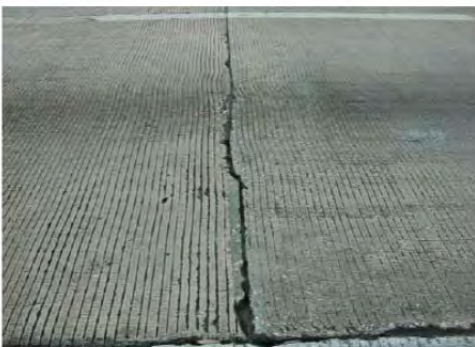
Open joints

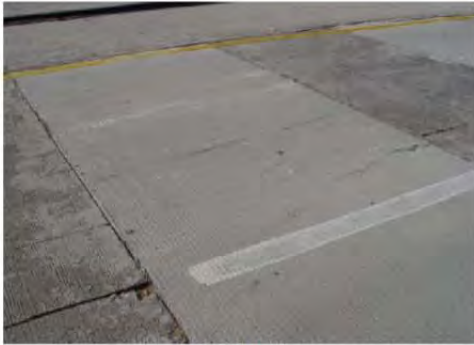
PCC Patch

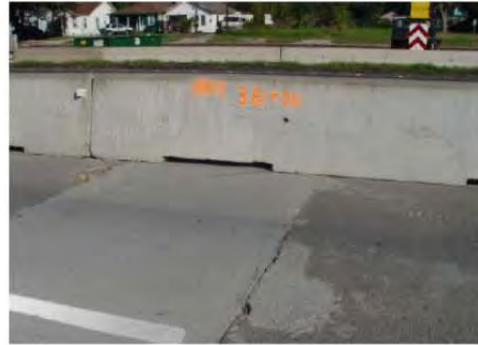
Good condition

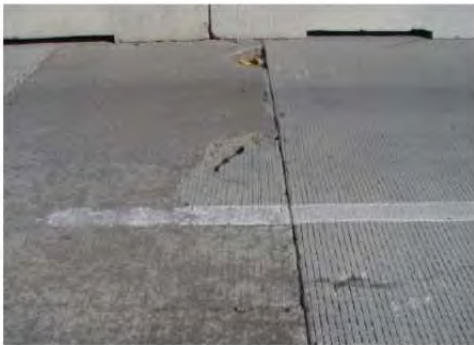
Overlay removed

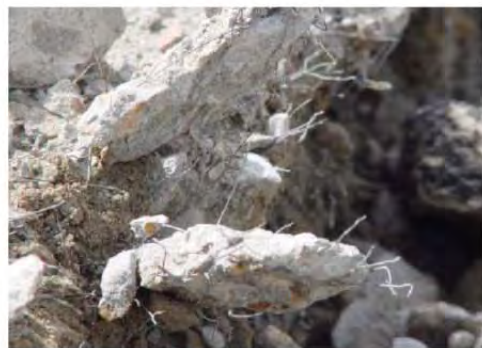
Steel fibers

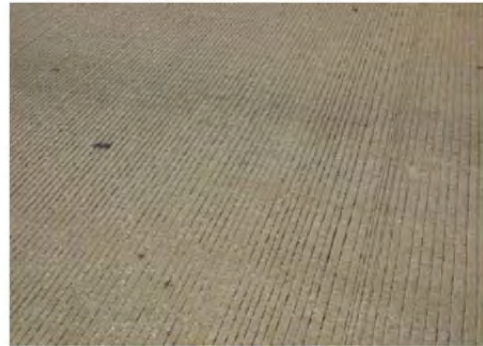
Excellent condition  
1989-1990 Experimental sections (EB)

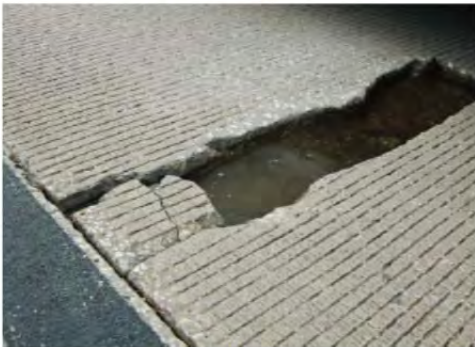
Punchout  
1989-1990 Experimental sections (EB)

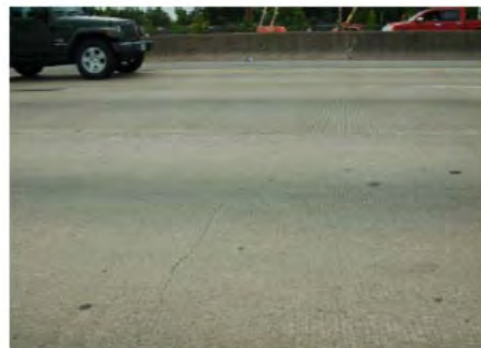
Transverse cracks

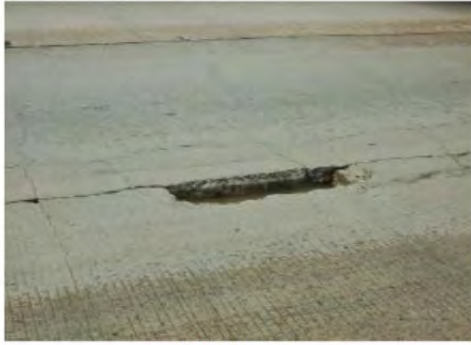
Punchout

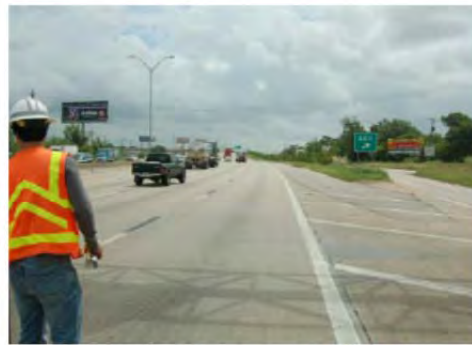
PCC patch with spall

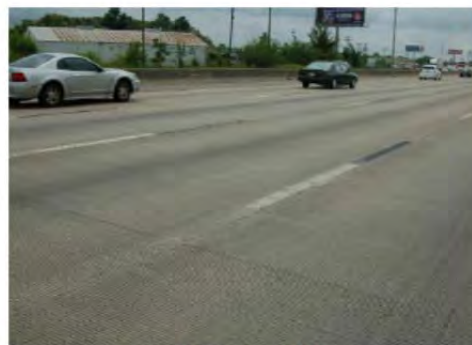
Longitudinal crack  
1983 Experimental sections

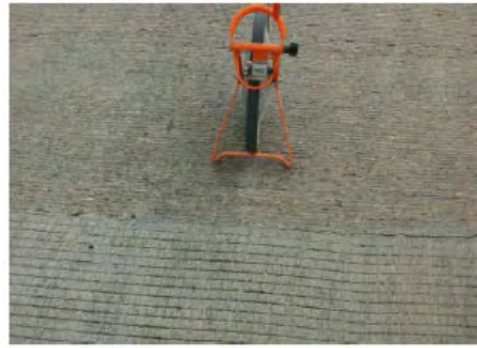
Delaminated area, next to exit ramp  
1983 Experimental sections

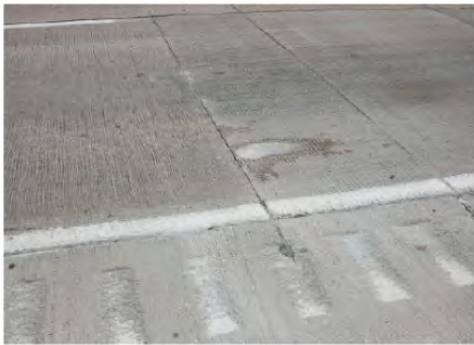
JCP slab in good condition

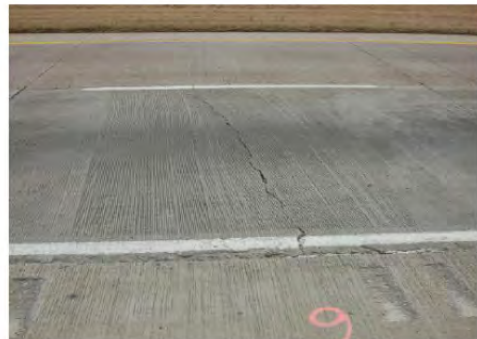
Shoulder joint damage

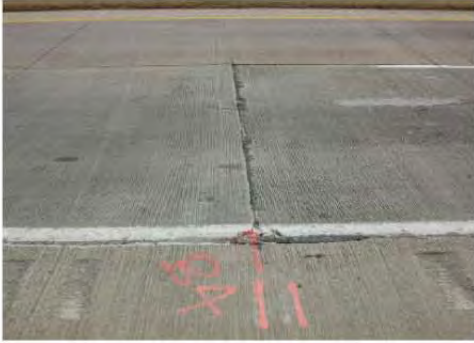
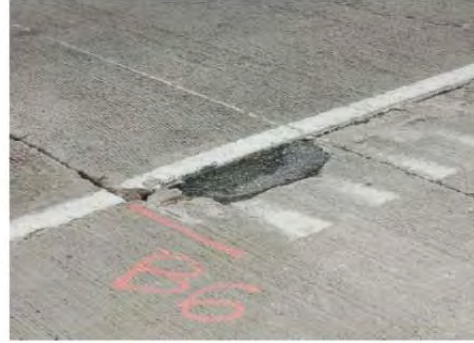
Open joint

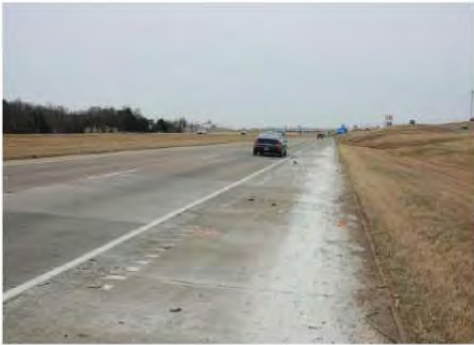
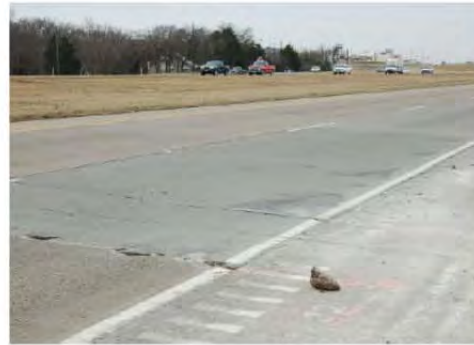
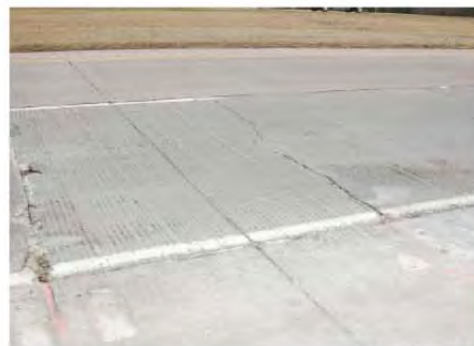
Areas to be repaired prior to BCO placement marked with spray paint

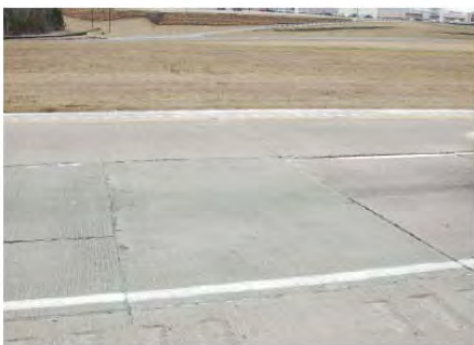
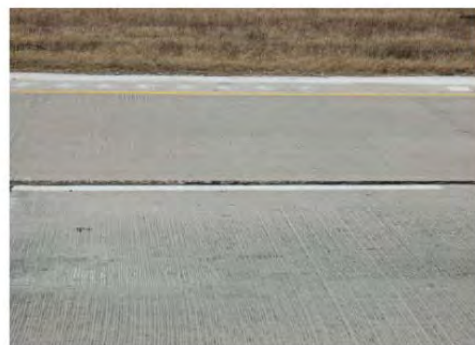
Damaged PCC patch

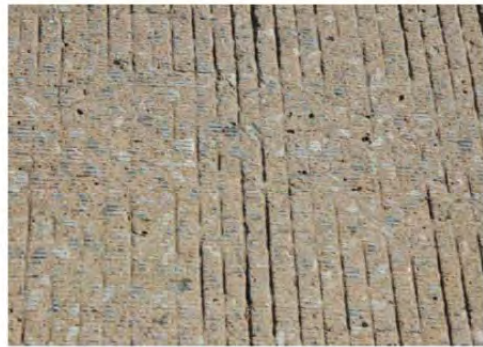
Diamond-ground texture

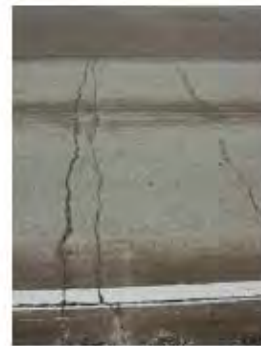
Picture 4  
Area of potential punchout (RM 51 + 214 ft)

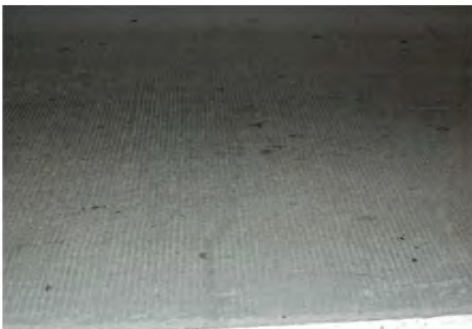
Good condition

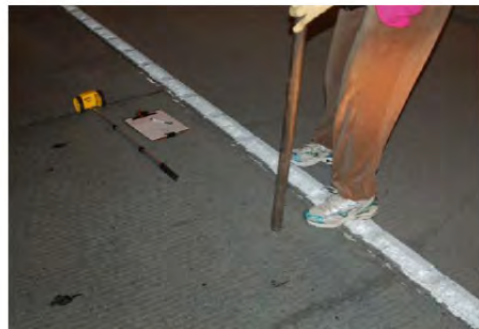
Sounding of delaminated area with no  
superficial distresses
