# Best Practices for Pavement Restoration of Open Cut Utility Installations/Repairs on Local Roadways in Ohio

Prepared by Mary Robbins, Roger Green, Teruhisa Masada, and Dane Redinger (Resource International, Inc.)

June 2019

Final Report

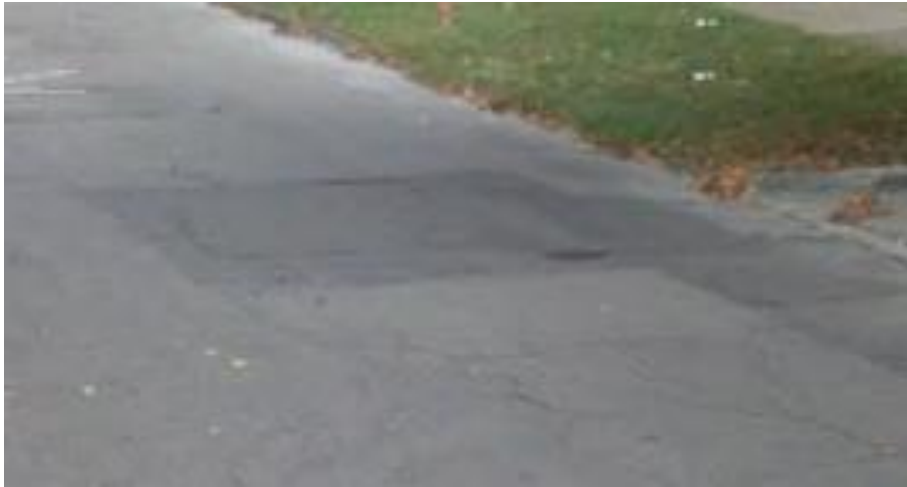
**Figure 38 Repair at 85 W. 3<sup>rd</sup> Ave. (maps.google.com)**

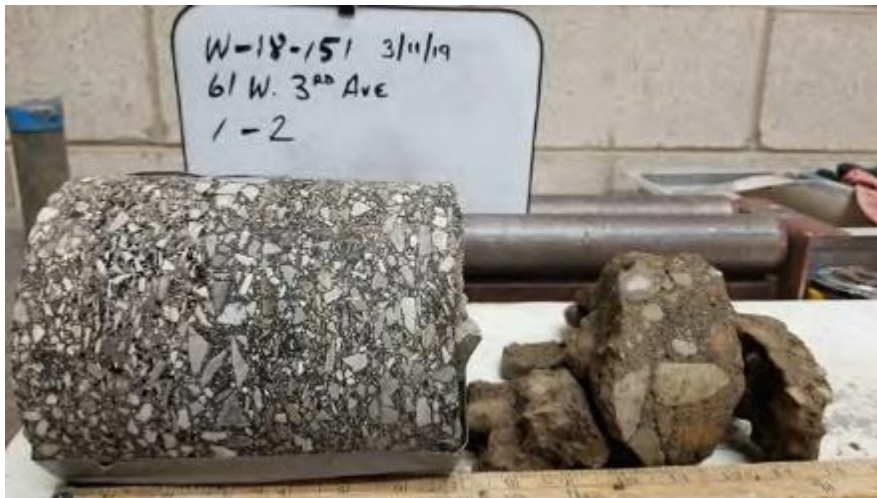
- Voids observed in first lift of intermediate asphalt
- Concrete is highly fractured and in pieces

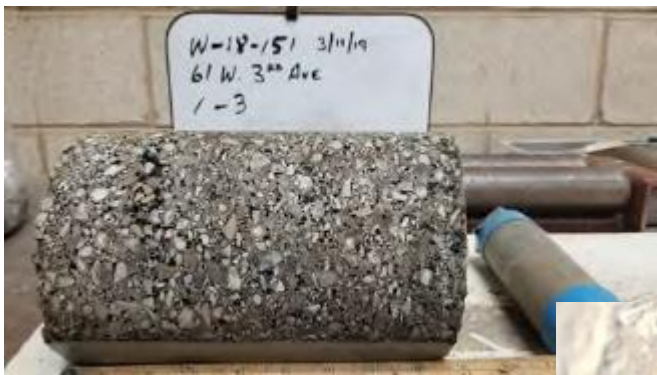
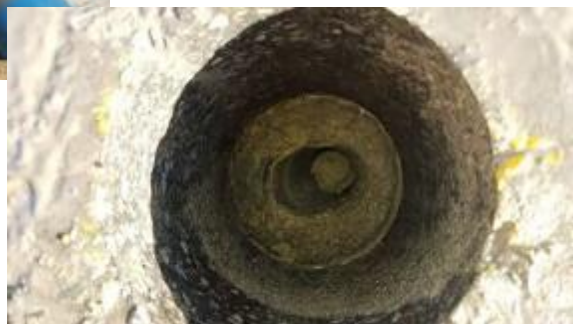
Core Composition							Comments/Remarks		
Core Number	Lift Thickness (in.)	Asphalt				Concrete	Aggregate/Granular Base	CDF	Other
		Surface	Intermediate	Base					
1-3	9.00	X							- Voids throughout asphalt layer - Lift thickness of CDF was not determined in the field
	Unknown						X

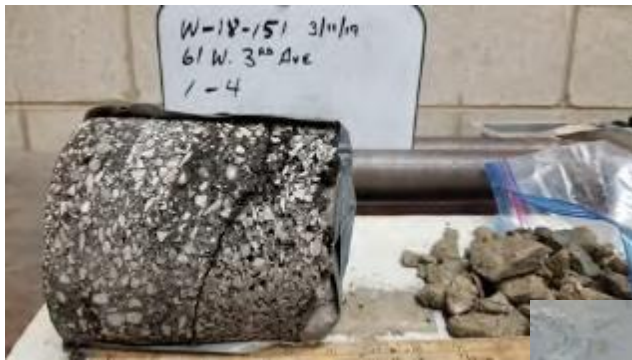
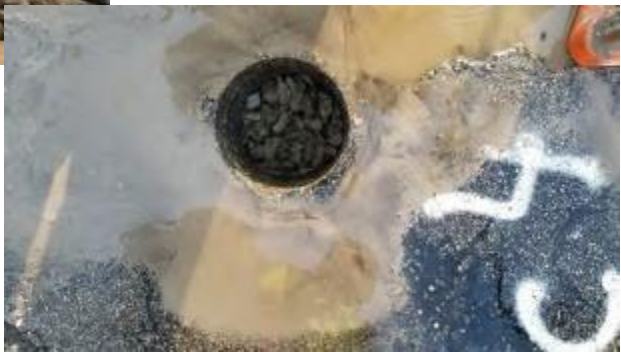
- Trace voids observed in asphalt base

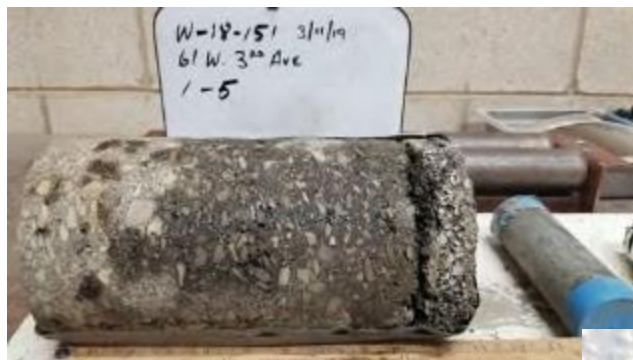
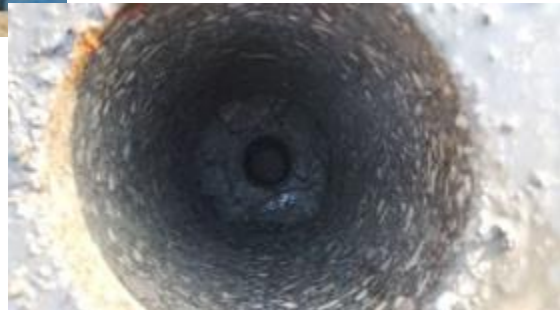
- Trace voids observed in asphalt base
- Lift thickness of CDF was not determined in the field

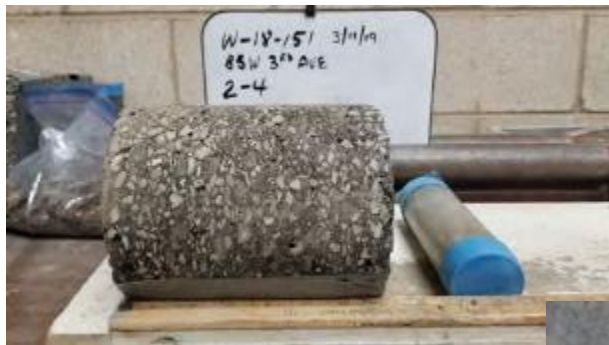
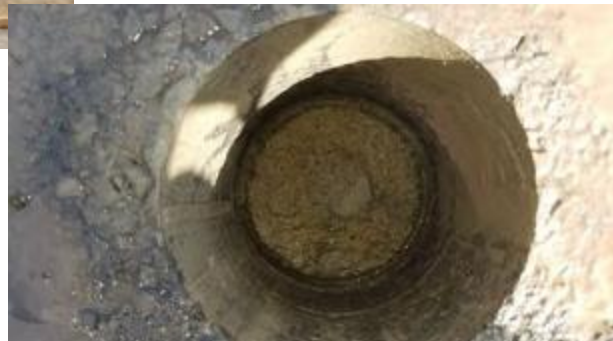
- Trace voids observed in asphalt base

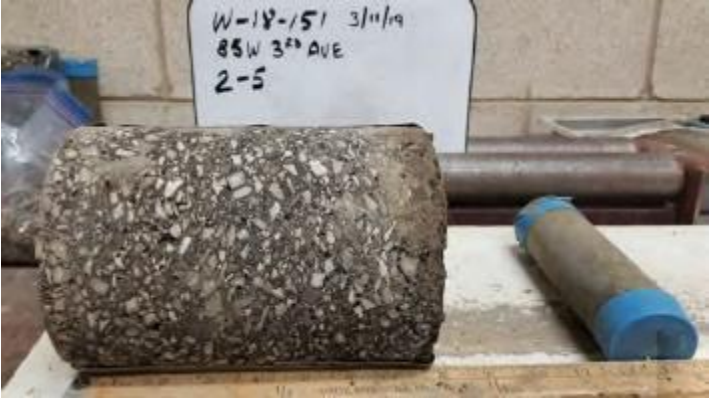
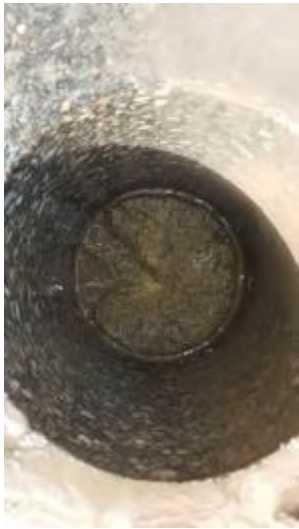
- Trace voids observed in asphalt															
Total Pavement Thickness =		8.00	in.	Total Asphalt Thickness =		8.00	in.	Total Concrete Thickness =		0.00	in.	Total Base Thickness =		0.00	in.

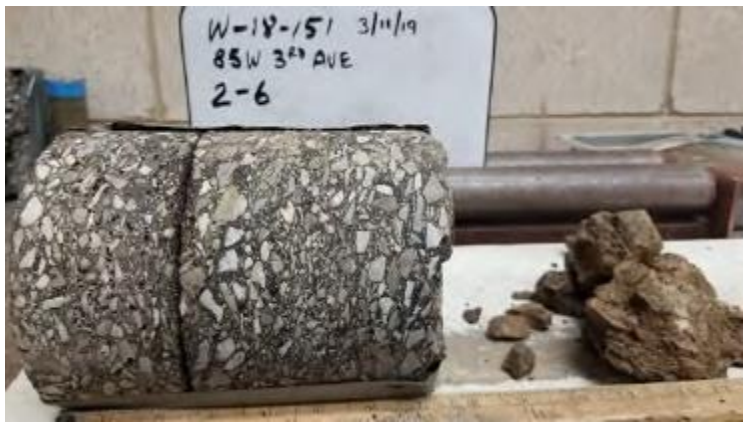
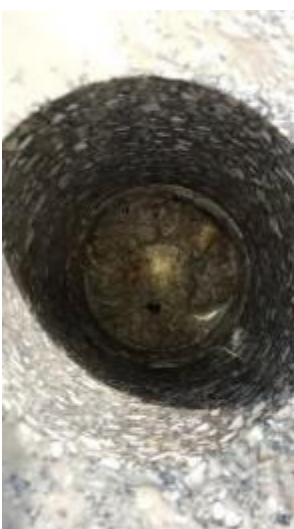
Core Composition										Comments/Remarks	
Core Number	Lift Thickness (in.)	Asphalt				Concrete	Aggregate/Granular Base	Other			
		Surface	Intermediate	Base	CDF						
2-6	1.00	X									- Trace voids observed in intermediate asphalt - Lift thickness of aggregate base was not determined in the field
	1.50		X								
	4.75			X							
	Unknown				X

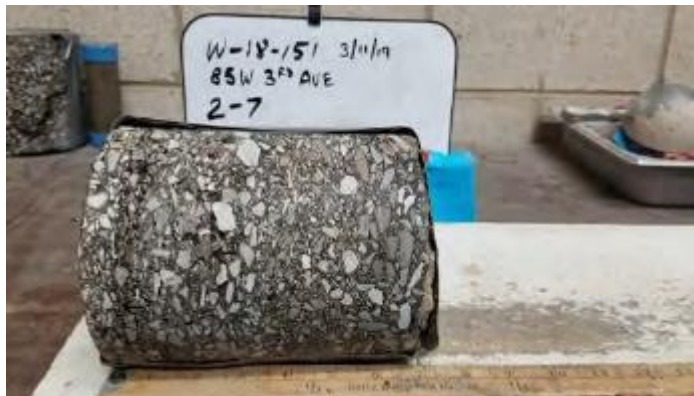
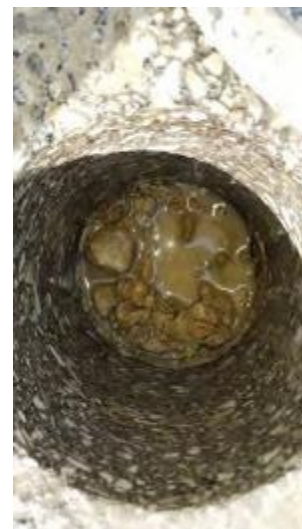
- Trace voids observed in intermediate asphalt
- Lift thickness of aggregate base was not determined in the field

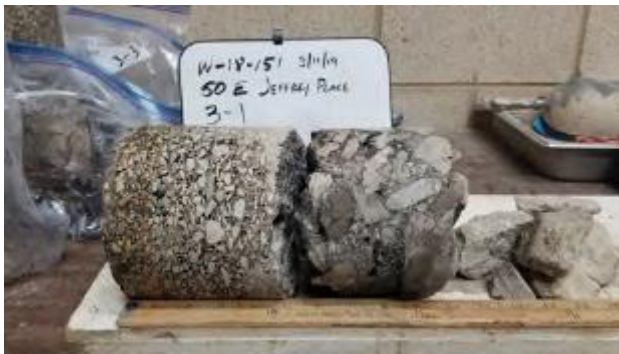
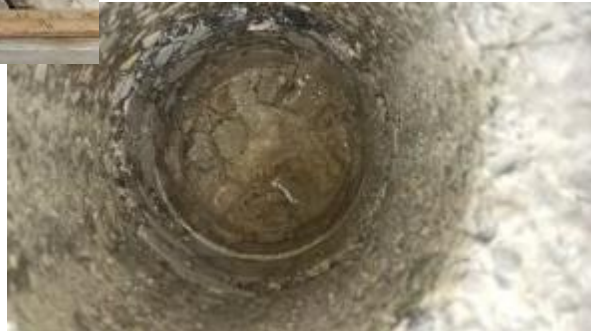
- Trace voids in surface and intermediate asphalt layers
- Separation of asphalt intermediate and base layers
- Lift thickness of aggregate base was not determined in the field

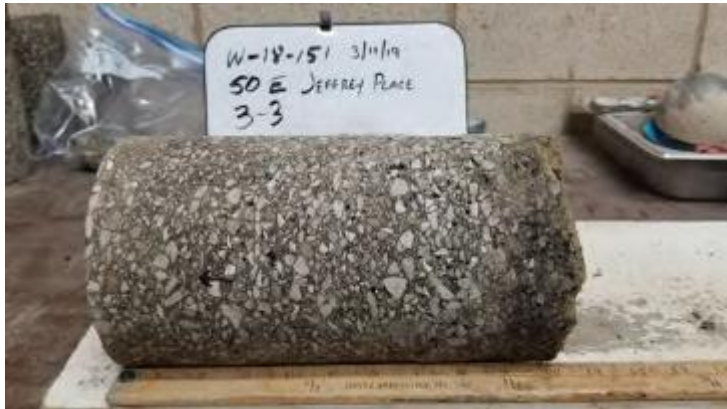
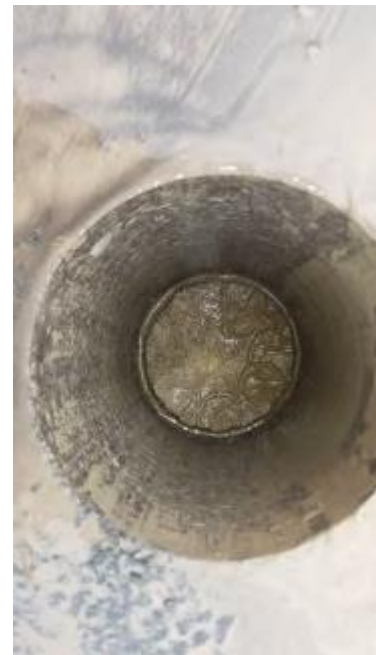
- Trace voids observed in intermediate and base asphalt
- Lift thickness of aggregate base was not determined in the field

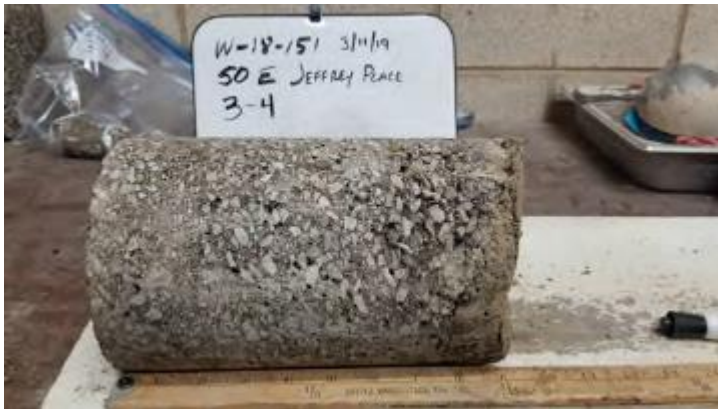
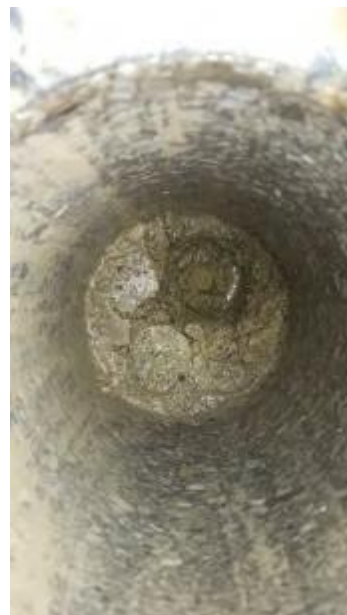
- Trace voids observed in intermediate and base asphalt
- Lift thickness of CDF was not determined in the field

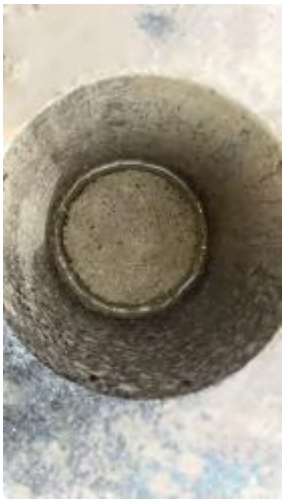
Core Composition							Comments/Remarks						
Core Number	Lift Thickness (in.)	Asphalt			Concrete	Aggregate/Granular Base	CDF	Other					
		Surface	Intermediate	Base									
3-8	1.50	X										- Trace voids observed in intermediate and base asphalt  - Lift thickness of CDF was not determined in the field	
	2.00		X										
	4.50			X									
	unknown						X

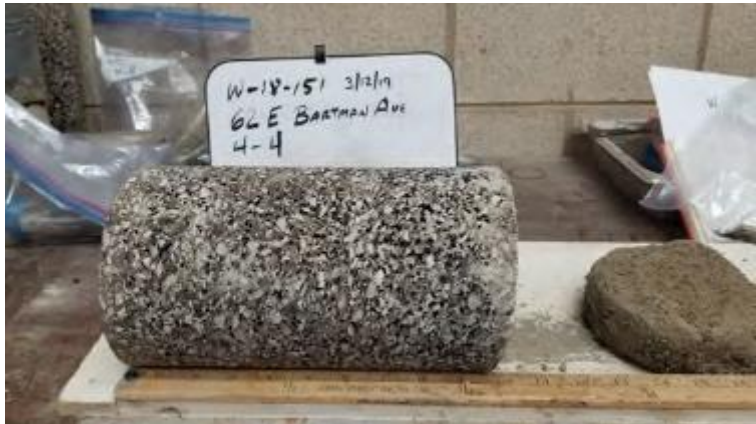
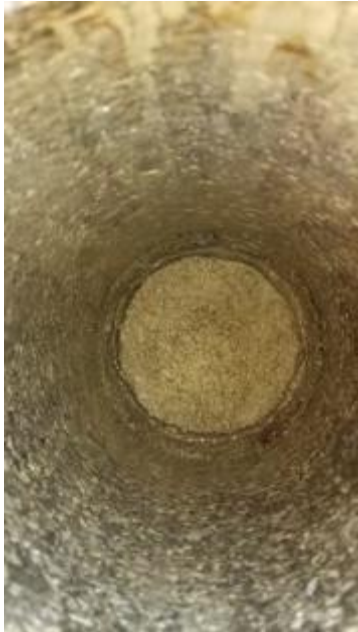
Core Composition										Comments/Remarks					
Core Number	Lift Thickness (in.)	Asphalt				Concrete	Aggregate/Granular Base			CDF	Other				
		Surface	Intermediate	Base											
4-4	9.75	X										- Voids throughout asphalt layer - Lift thickness of CDF was not determined in the field			
	unknown							X							
Total Pavement Thickness =		9.75	in.	Total Asphalt Thickness =		9.75	in.	Total Concrete Thickness =		0.00	in.	Total Base Thickness =		0.00	in.

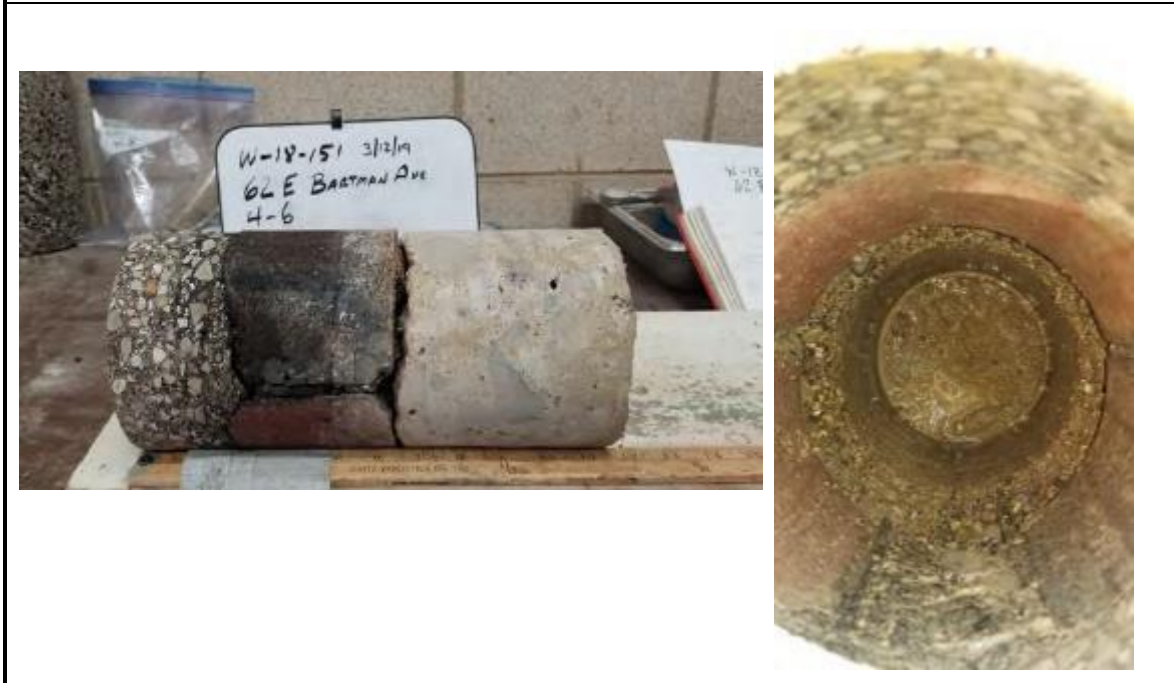
Core Composition										Comments/Remarks			
Core Number	Lift Thickness (in.)	Asphalt				Concrete	Aggregate/Granular Base				CDF	Other	
		Surface	Brick	Base									
4-6	2.50	X											<ul style="list-style-type: none"> <li>- Core samples contained brick beneath asphalt surface</li> <li>- Concrete is intact with little to no voids.</li> <li>- Lift thickness of aggregate base was not determined in the field</li> </ul>
	4.00		X										
	5.00				X								
	unknown					X

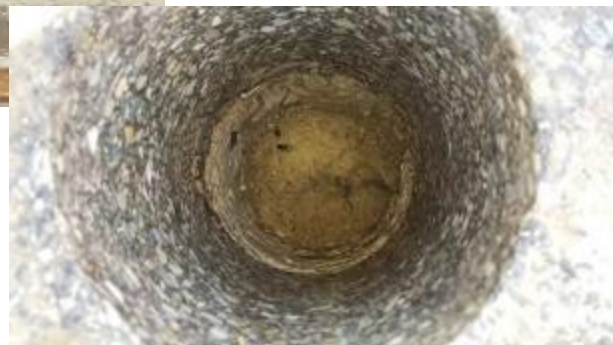
- Trace voids observed at top layer of intermediate asphalt
- Concrete layer was measured in the core hole

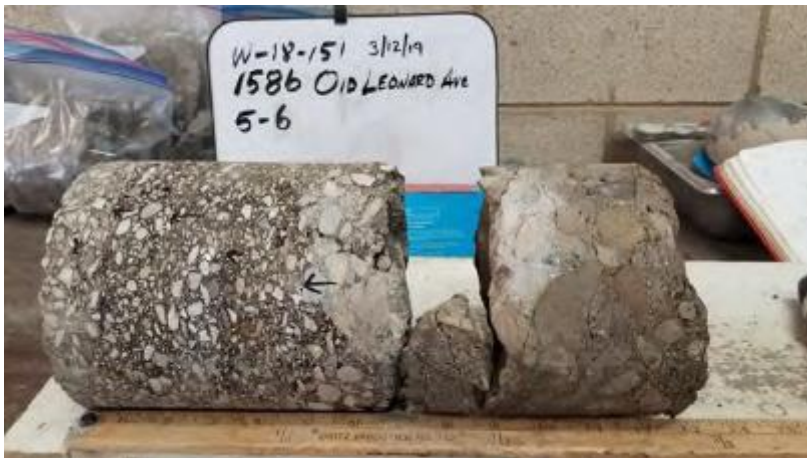
- Asphalt layers contain little voids
- Concrete layer is fractured and in pieces

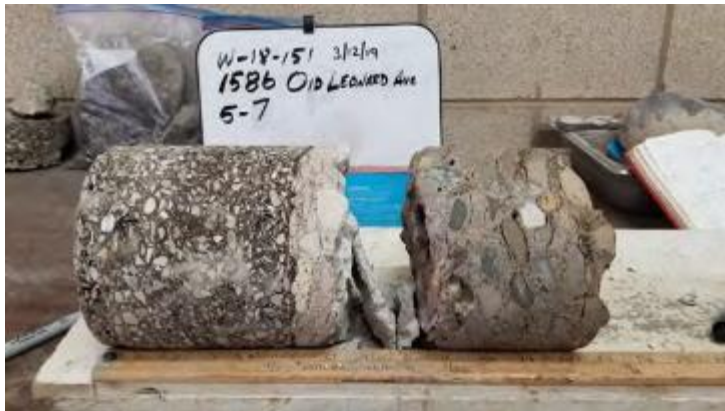
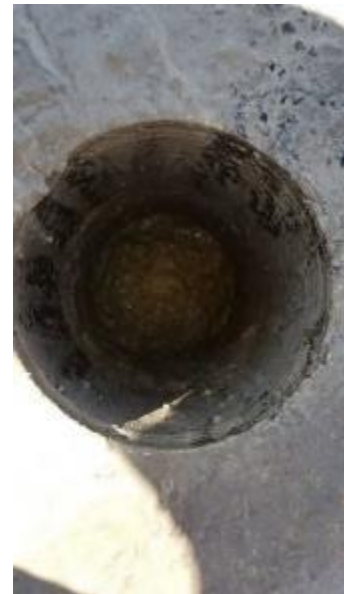
- Asphalt layers contain little voids
- Concrete layer is fractured and in pieces

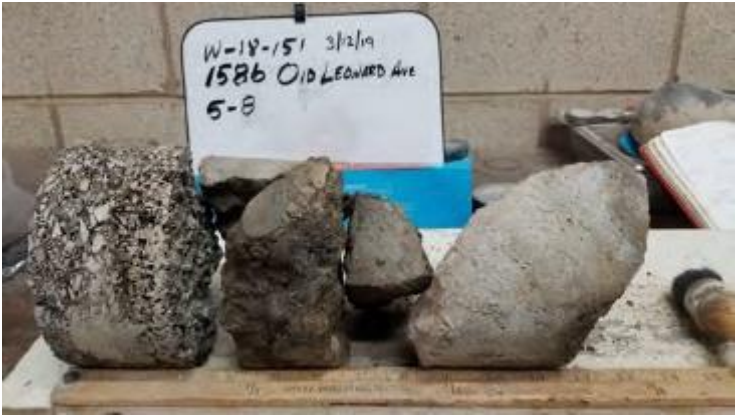
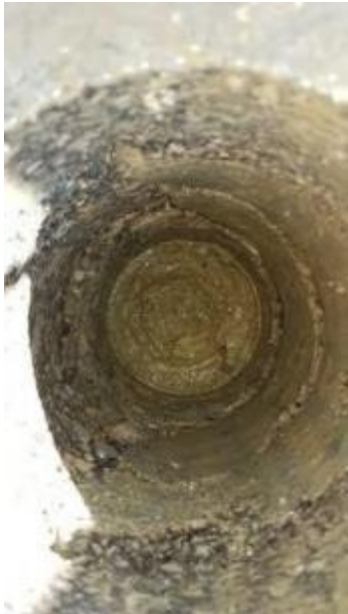
6350 Presidential Gateway Columbus, Ohio 43231 Telephone: (614) 823-4949 Fax Number: (614) 823-4990										Pavement Core Data Summary					
										PROJECT	Practices for Pavement Rest. of Open Cut Utility				
LOCATION JOB	1586 Old Leonard Ave														
No.	W-18-151														
BORING/CORE No.	5-8														
DATE	3/12/2019														
CORE OBTAINED	CORE														
OBTAINED BY	Tom Harper, CET														
Core Composition										Comments/Remarks					
Core Number	Lift Thickness (in.)	Asphalt				Concrete	Other								
		Surface	Intermediate	Base	Aggregate/Granular Base		CDF								
5-8	1.75	X											- Asphalt layers contain many voids  - Concrete base is highly fractured and in pieces

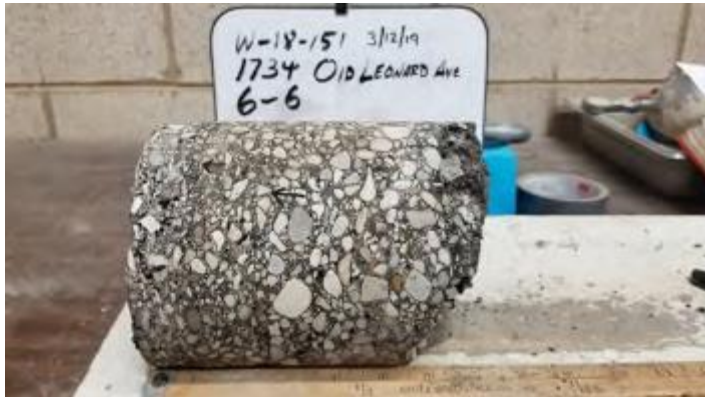
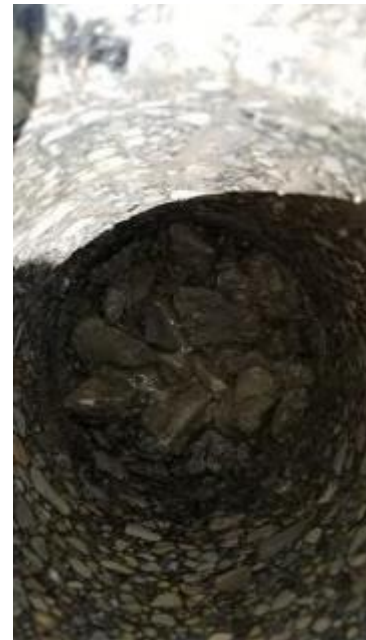
Core Composition										Comments/Remarks	
Core Number	Lift Thickness (in.)	Asphalt				Concrete	Aggregate/Granular Base	CDF	Other		- Asphalt layers contain trace voids - Lift thickness of aggregate base was not determined in the field
		Surface	Intermediate	Base							
6-6	1.25	X									
	1.50		X								
	4.25			X							
	unknown				X

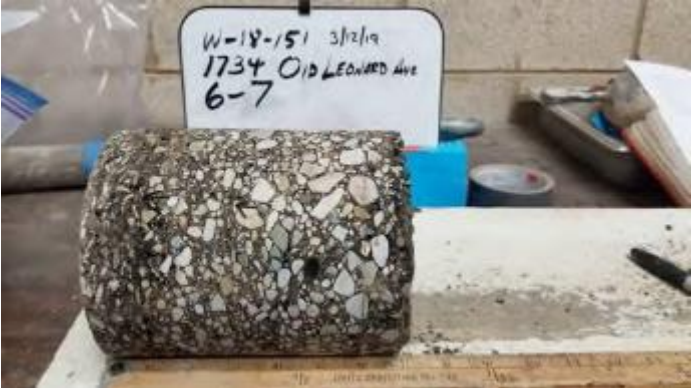
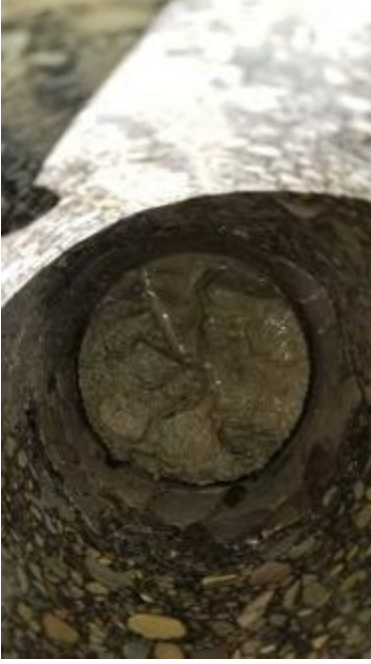
6350 Presidential Gateway Columbus, Ohio 43231 Telephone: (614) 823-4949 Fax Number: (614) 823-4990										Pavement Core Data Summary					
										PROJECT	Practices for Pavement Rest. of Open Cut Utility				
LOCATION JOB	1734 Old Leonard Ave														
No.	W-18-151														
BORING/CORE No.	DATE	6-7													
CORE OBTAINED	CORE	3/12/2019													
OBTAINED BY	Tom Harper, CET														
Core Composition										Comments/Remarks					
Core Number	Lift Thickness (in.)	Asphalt				Concrete	Aggregate/Granular Base				Other				
		Surface	Intermediate	Base											
6-7	1.25	X												- Asphalt surface layer contains some voids  - Lift thickness of aggregate base was not determined in the field

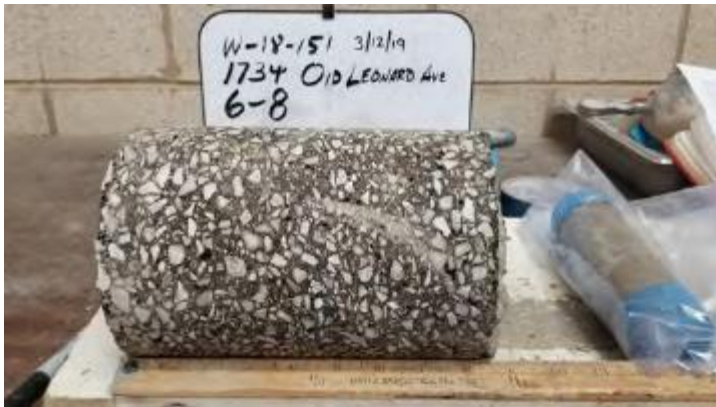
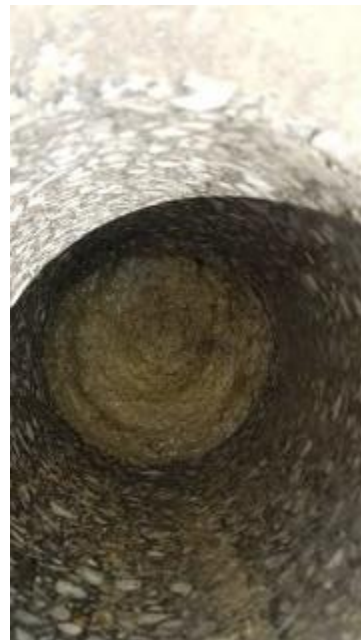
- Little to no voids in both asphalt layers
- Lift thickness of CDF was not determined in the field

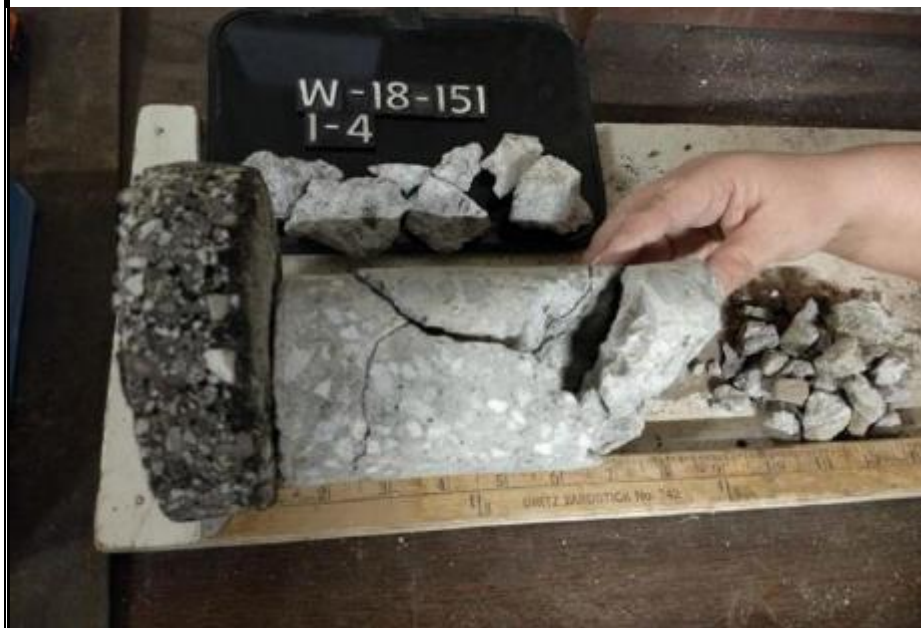
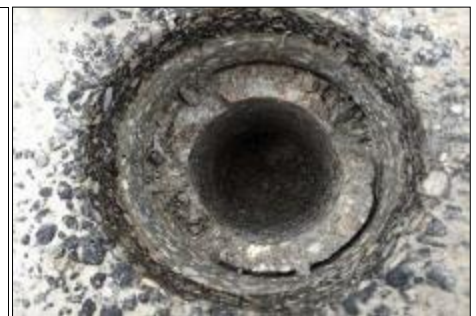
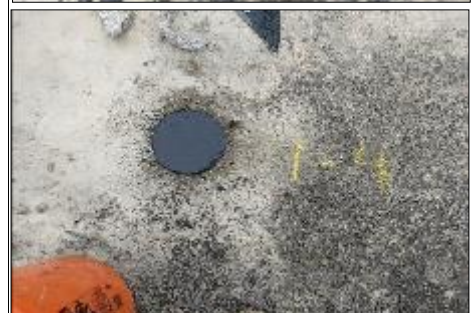
Core Composition							Comments/Remarks						
Core Number	Lift Thickness (in.)	Asphalt			Concrete	Aggregate/Granular Base	Other				- Voids observed throughout asphalt	- Concrete fractured and broken	
		404	402	301									
1-4	1.25	✓											
	7.75				✓

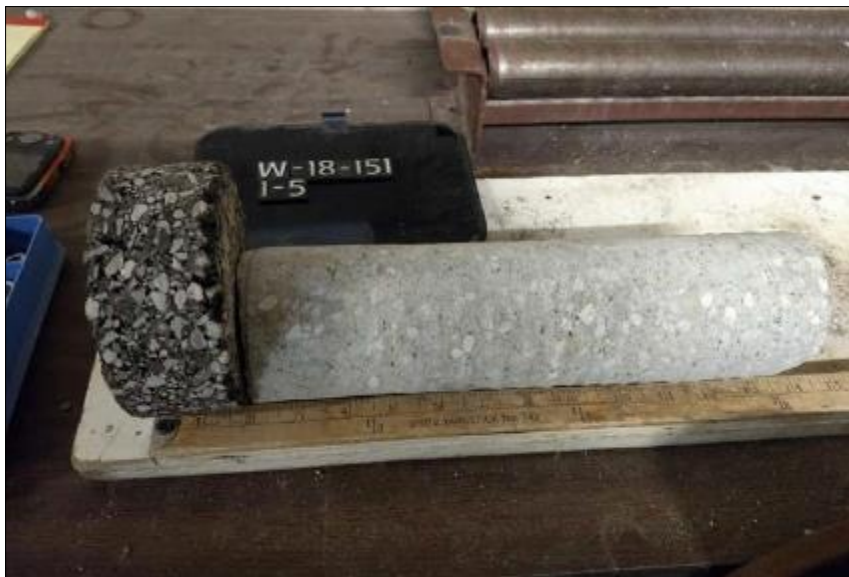
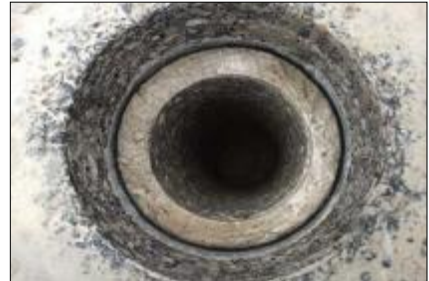
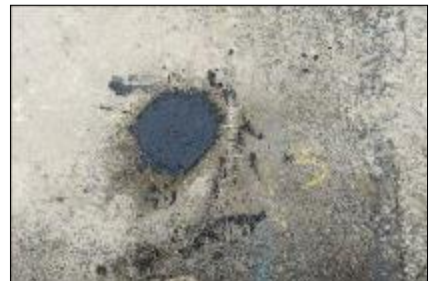
- Small voids throughout asphalt  
 - Lift thickness of granular base could not be determined.

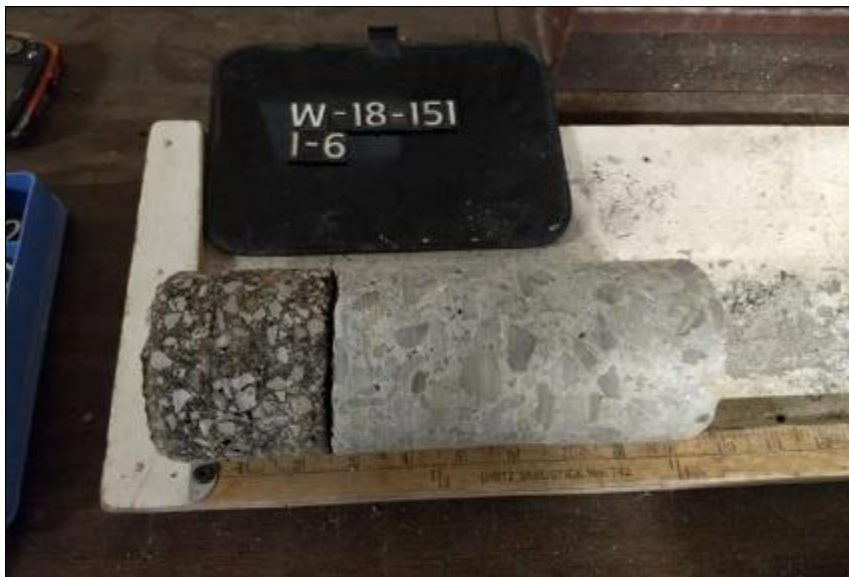
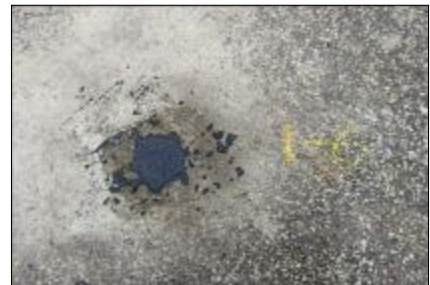
- Trace voids scattered throughout asphalt  
 - Lift thickness of granular base could not be determined.

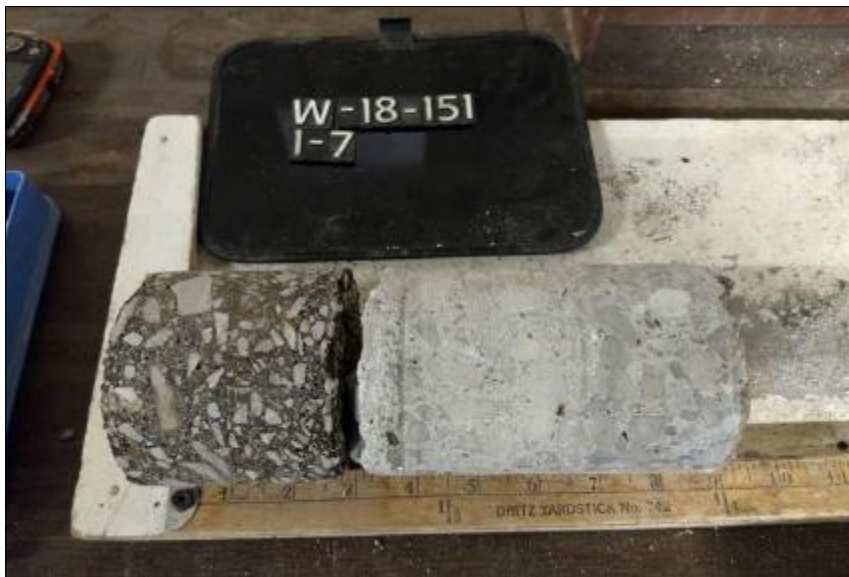
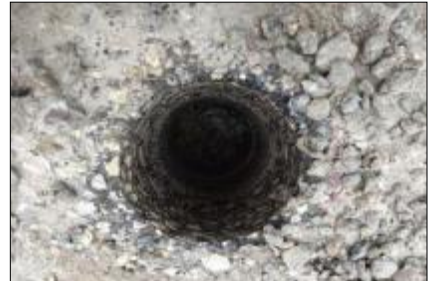
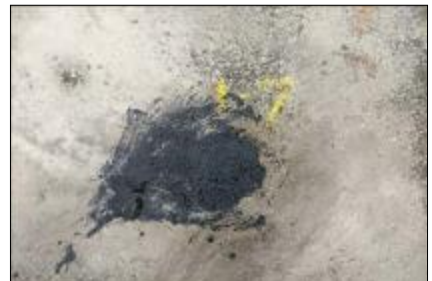
- Trace voids in surface asphalt  
 - Small voids throughout bottom asphalt layer

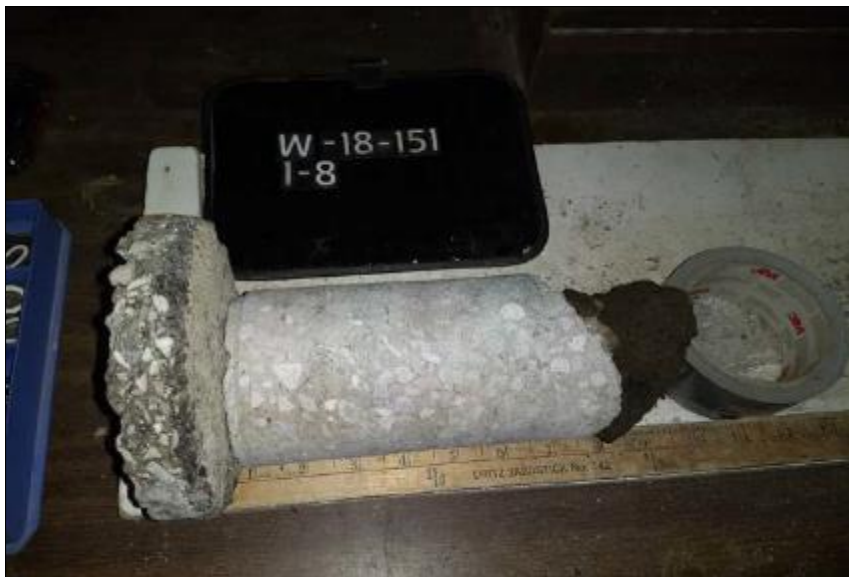
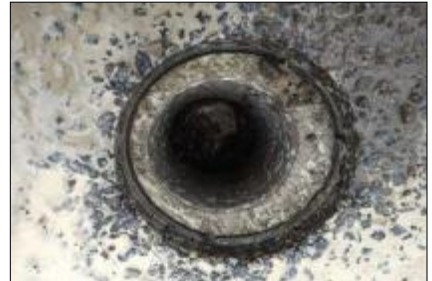
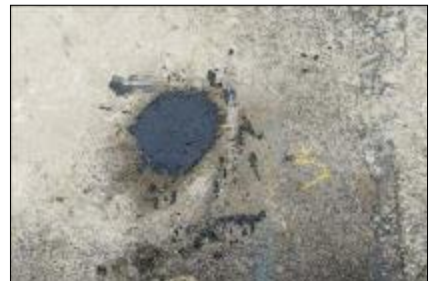
- Voids throughout asphalt layer

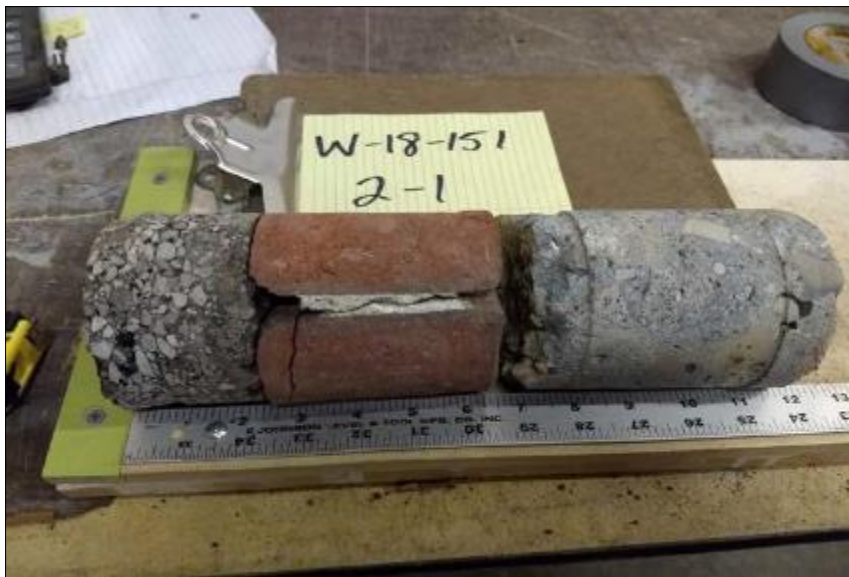
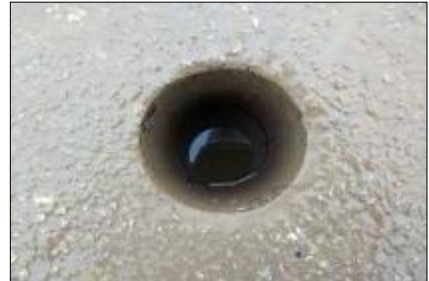
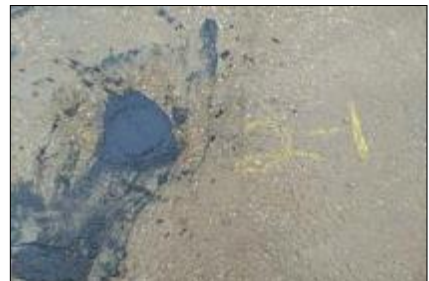
- Voids throughout asphalt surface layer

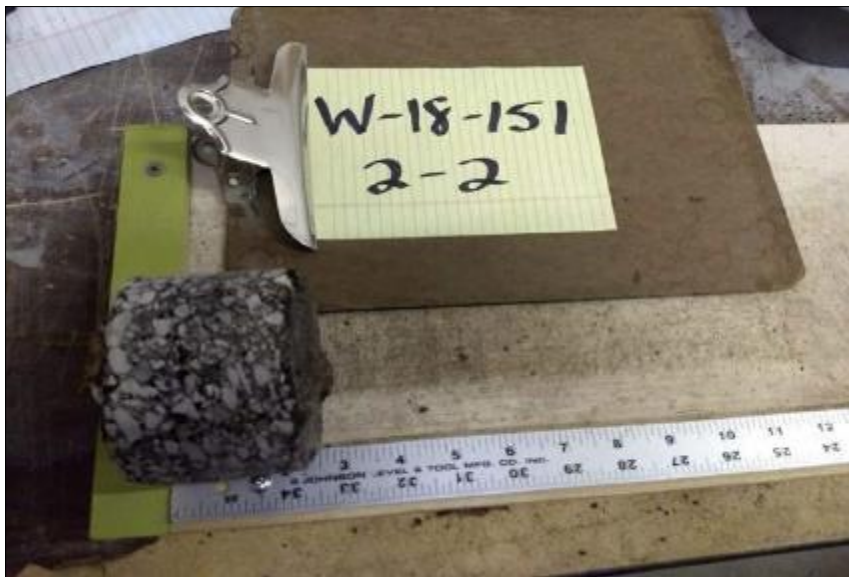
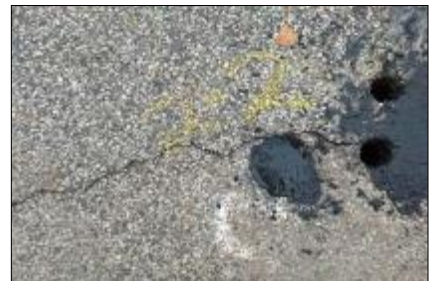
- Voids throughout asphalt layers

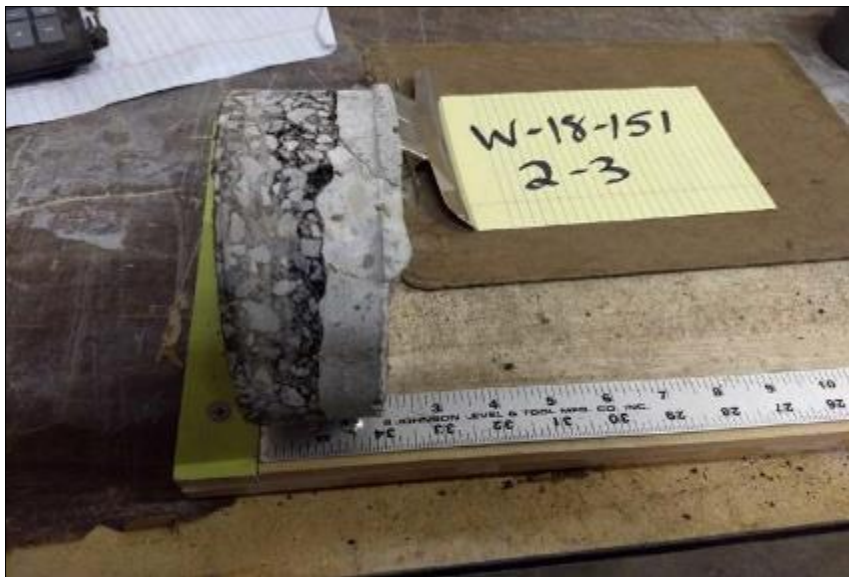
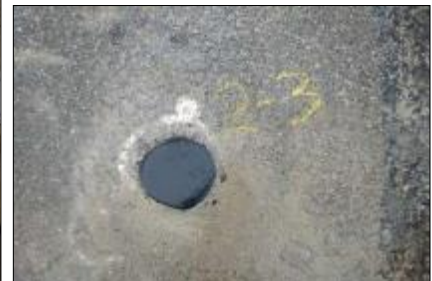
- Trace voids and cracking at asphalt and concrete interface

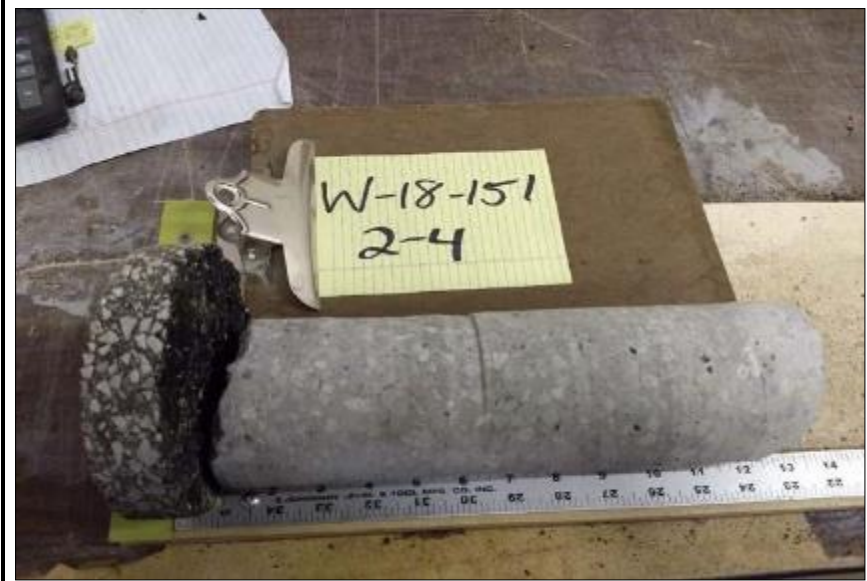
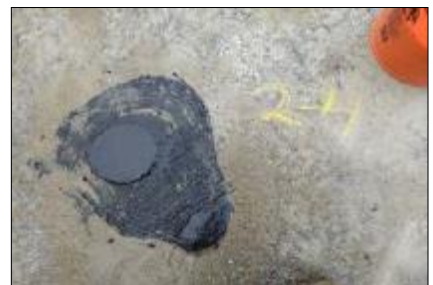
- Trace voids along bottom of asphalt surface layer  
 - Lift thickness of granular base could not be determined.

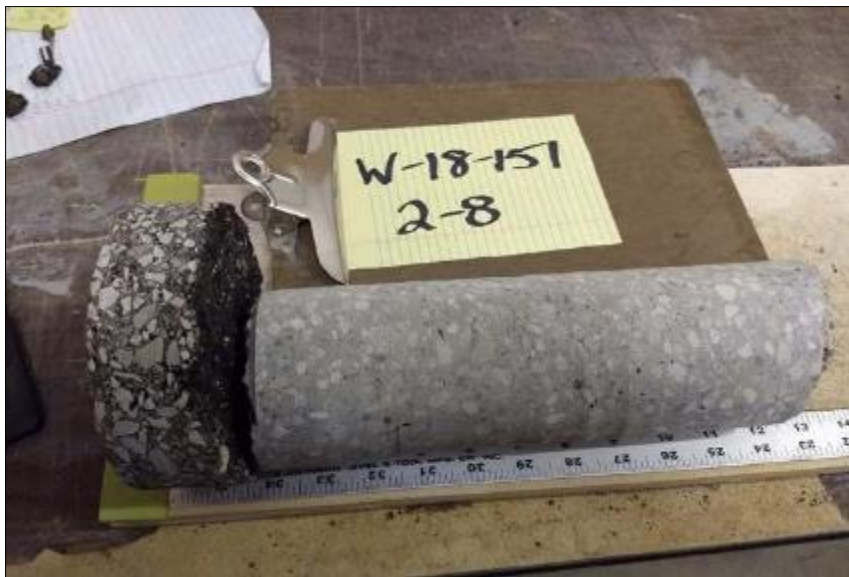
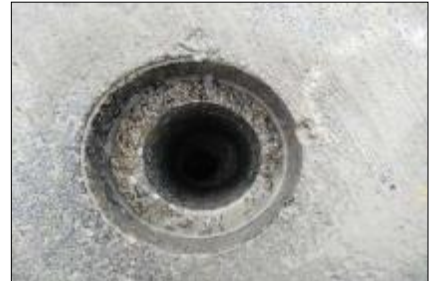
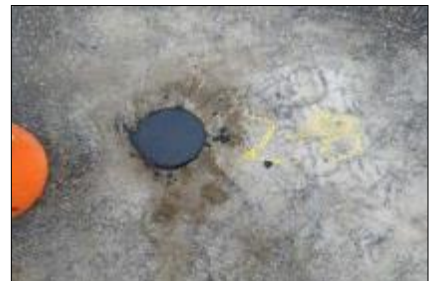
- Trace small voids throughout asphalt

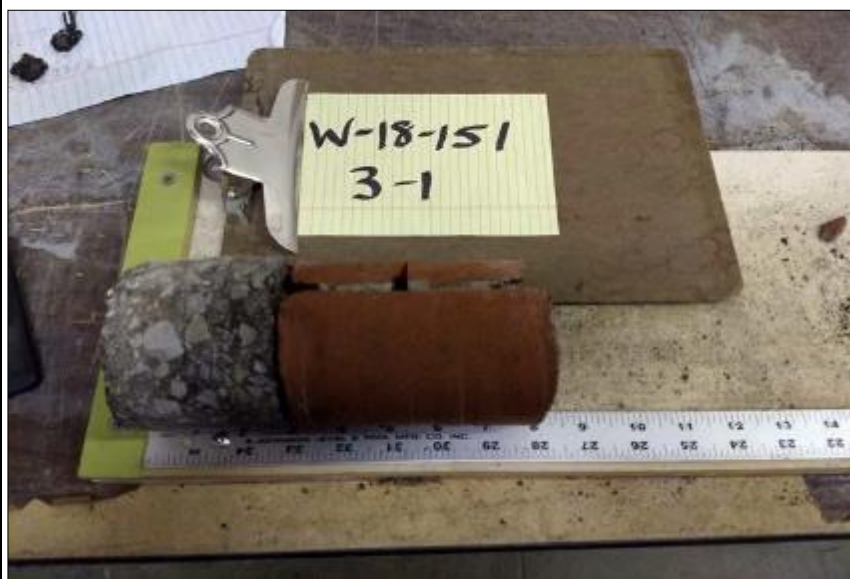
- Small, trace voids scattered throughout asphalt base layer

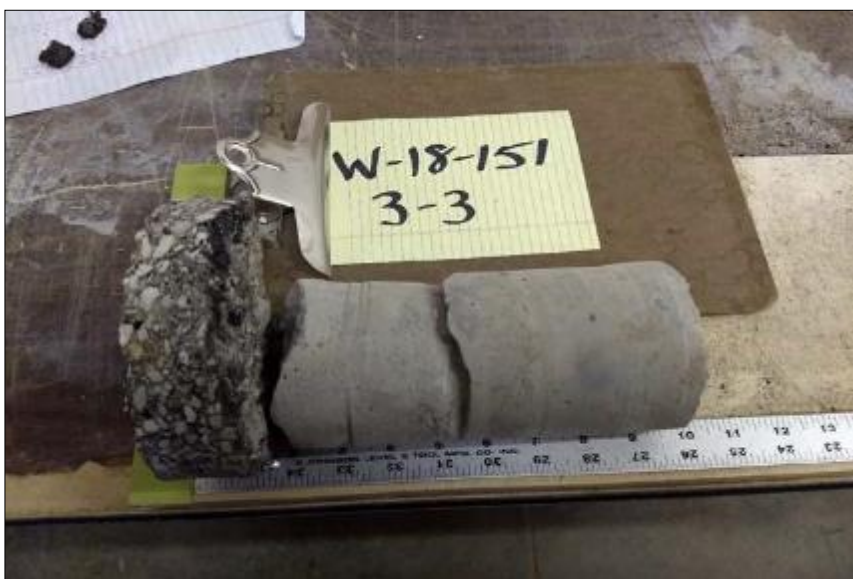
- Voids throughout asphalt  
 - Lift thickness of granular base could not be determined.

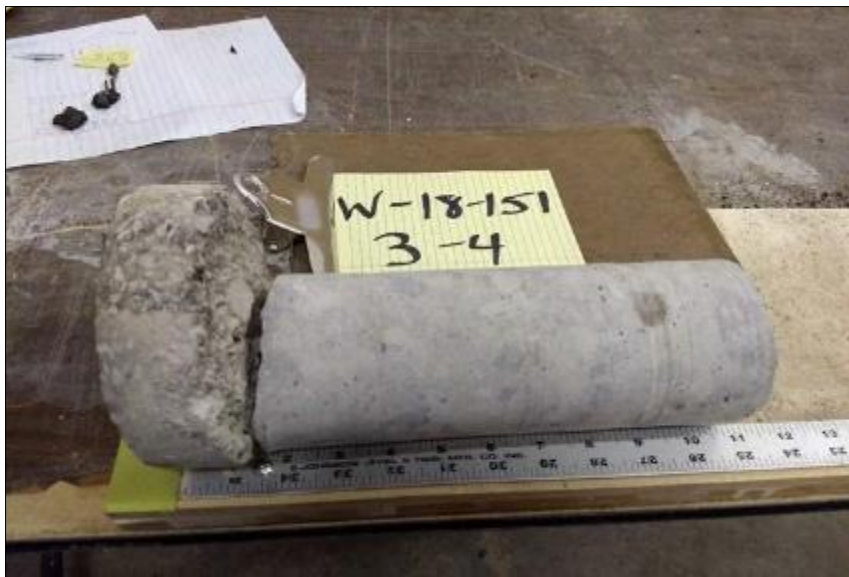
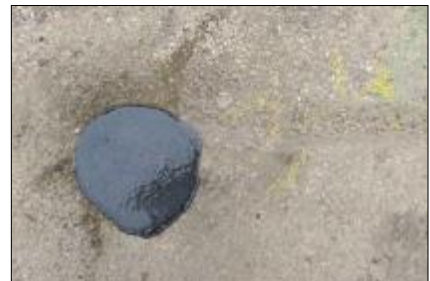
- Voids throughout asphalt layer  
 - Lift thickness of granular base could not be determined.

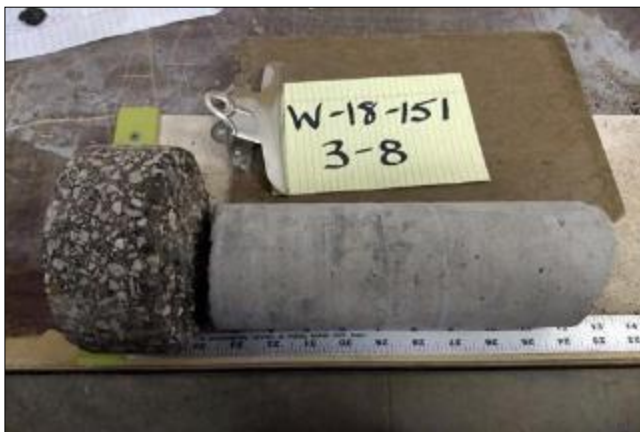
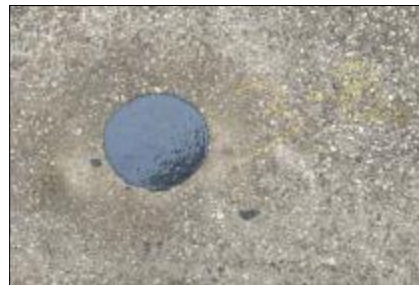
- Voids throughout asphalt layer  
 - Lift thickness of granular base could not be determined.

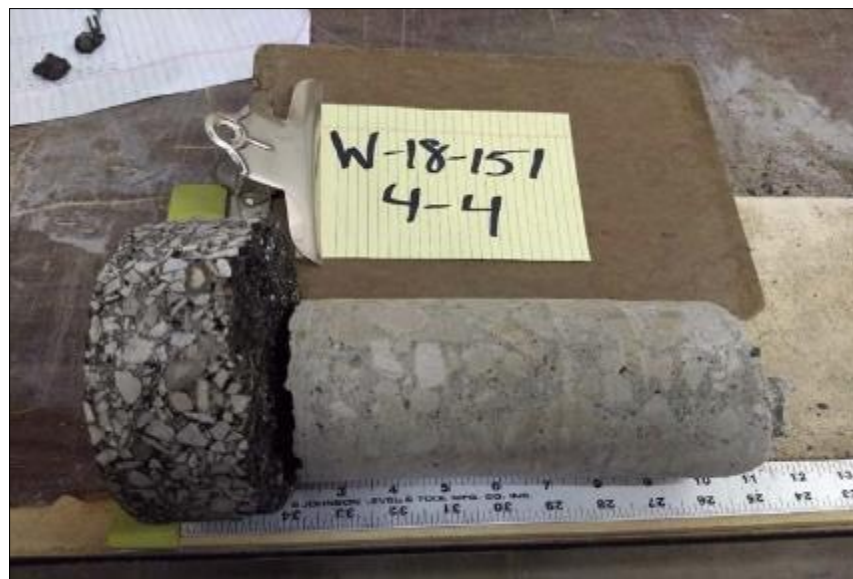
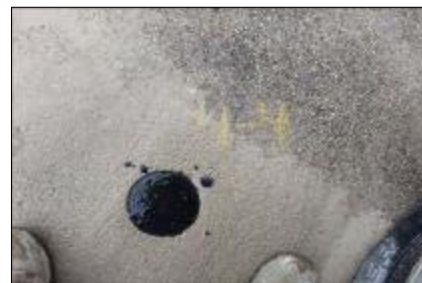
- Lift thickness of pulverized asphalt and concrete could not be determined.  
 - Voids throughout asphalt layer

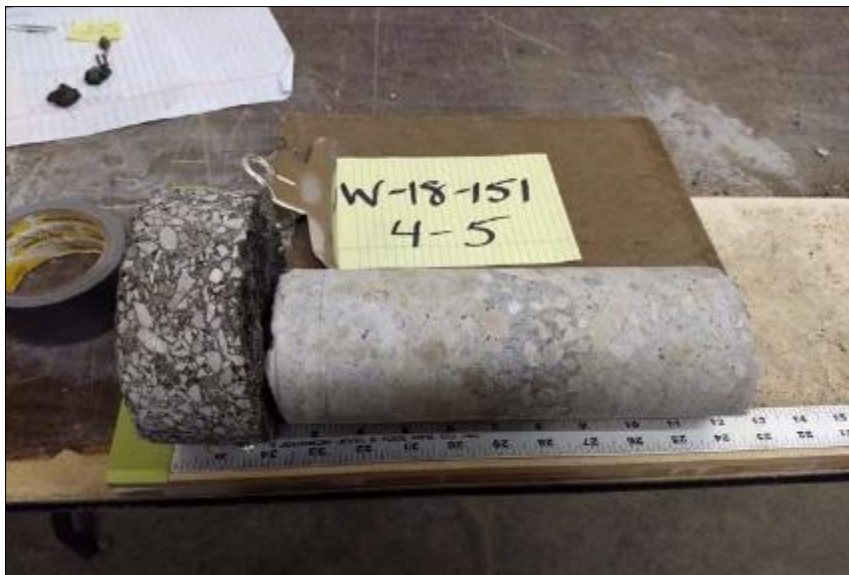
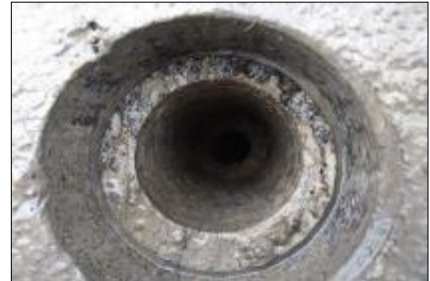
- Lift thickness of granular base could not be determined.  
 - Trace small voids scattered throughout asphalt

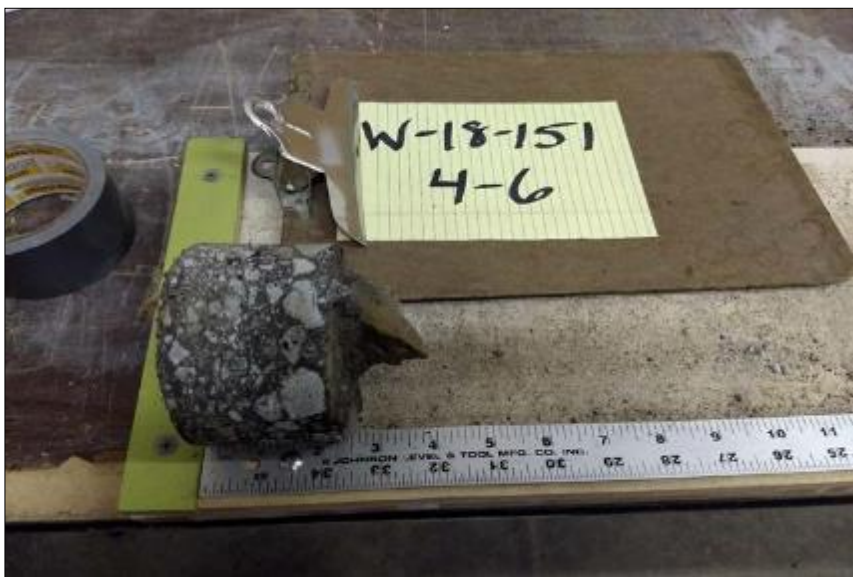
- Small voids scattered throughout asphalt
