# Best Practices for Pavement Restoration of Open Cut Utility Installations/Repairs on Local Roadways in Ohio

Prepared by Mary Robbins, Roger Green, Teruhisa Masada, and Dane Redinger (Resource International, Inc.)

June 2019

Final Report

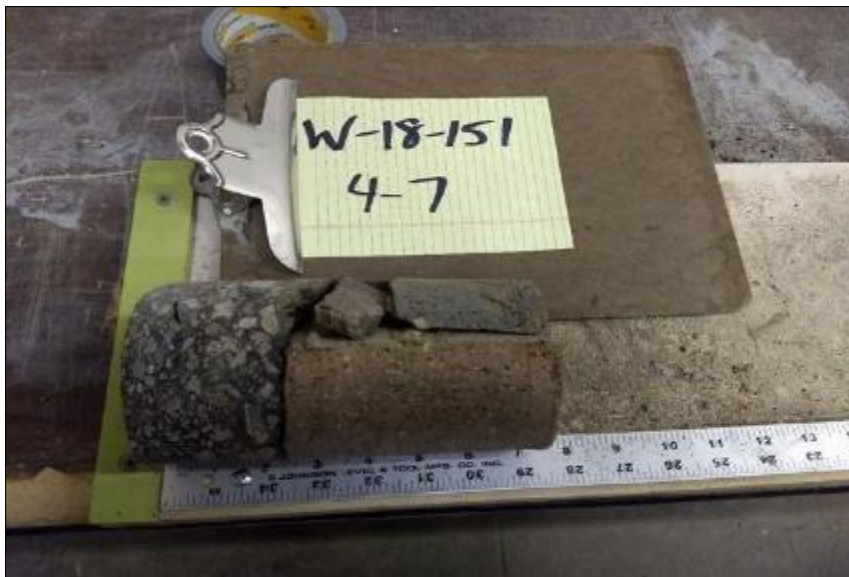
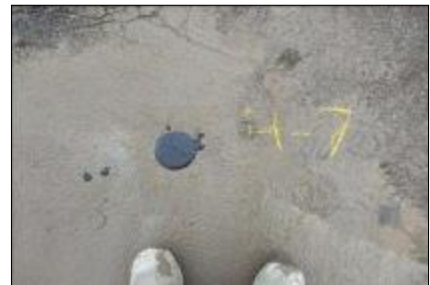
- Lift thickness of granular base could not be determined.  
 - Trace voids throughout asphalt

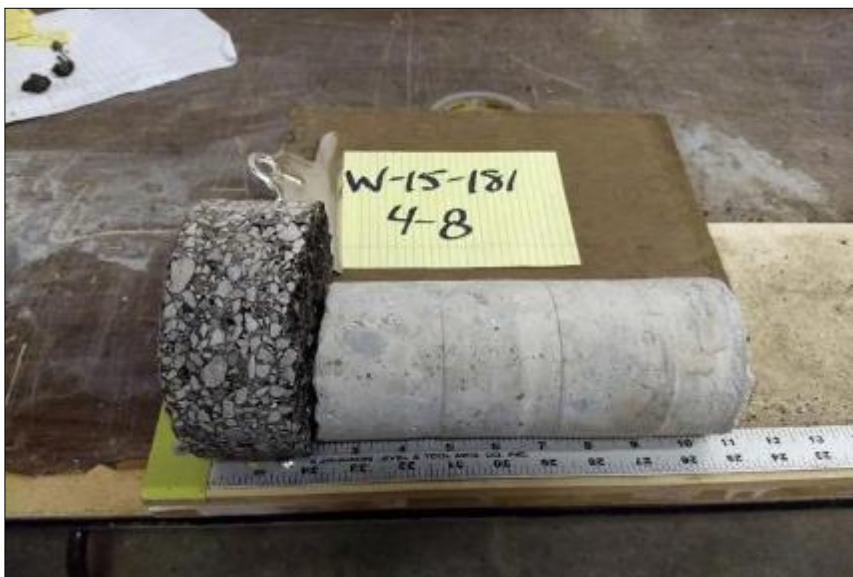
- Lift thickness of granular base could not be determined.  
 - Voids present in asphalt surface

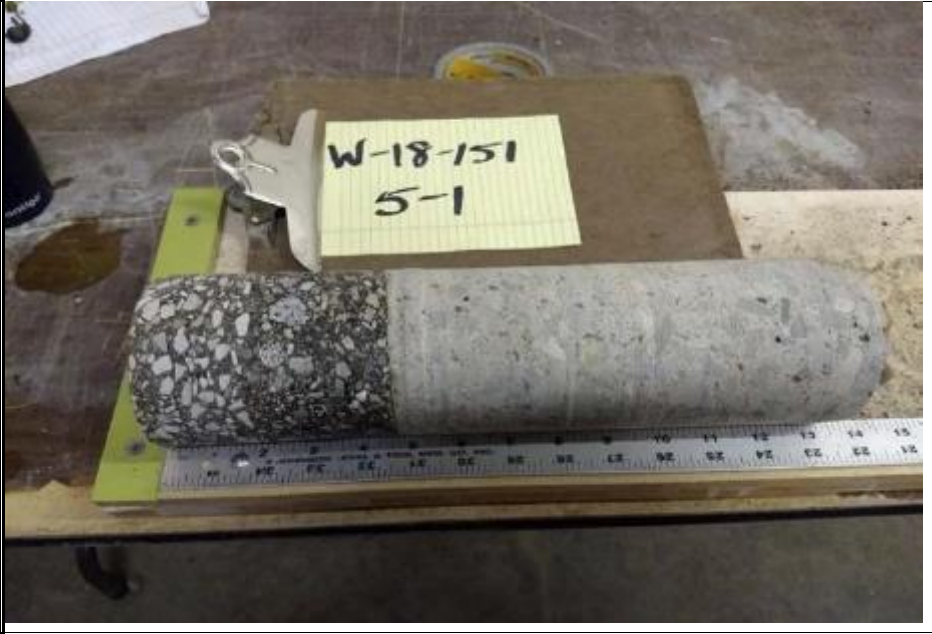
Core Composition										Comments/Remarks	
Core Number	Lift Thickness (in.)	Asphalt			Concrete	Aggregate/Granular Base	Other				
		404	402	301							
5-1	2.00	✓								- Voids present in asphalt base layer	
	2.50			✓							
	9.00				✓

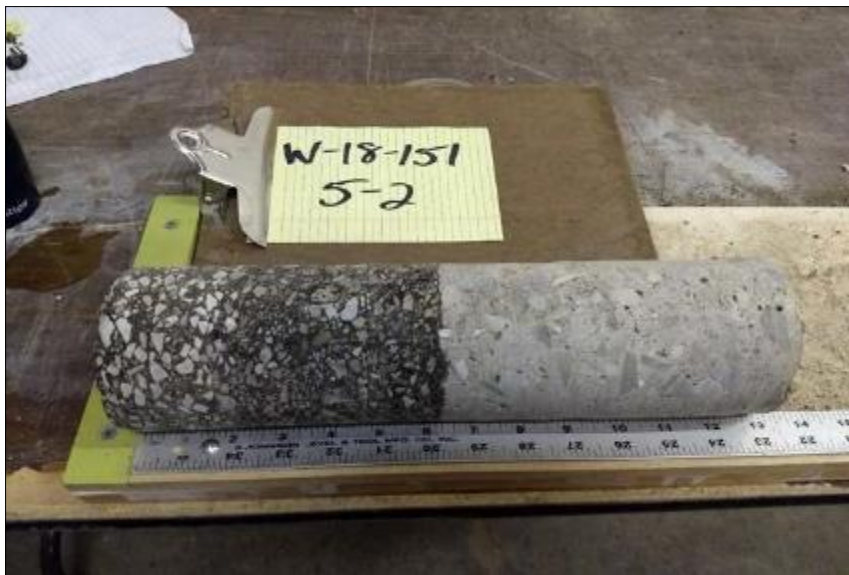
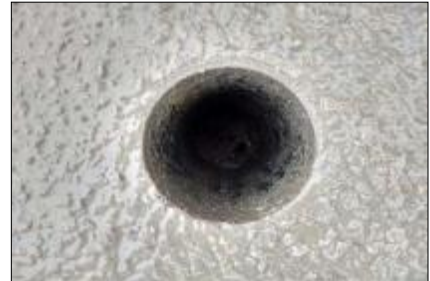
- Trace voids in asphalt surface layer  
 - Voids present in asphalt base layer

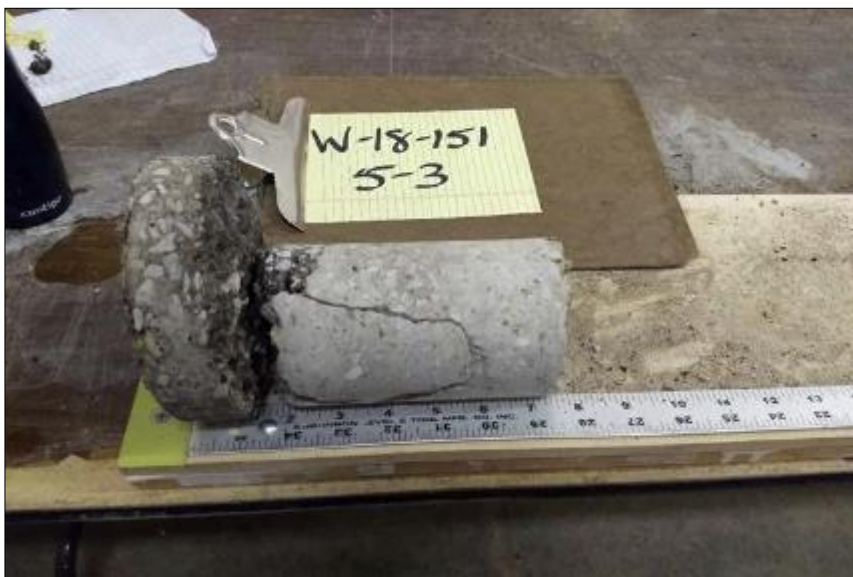
- Lift thickness of granular base could not be determined.  
 - Trace small voids throughout asphalt surface layer

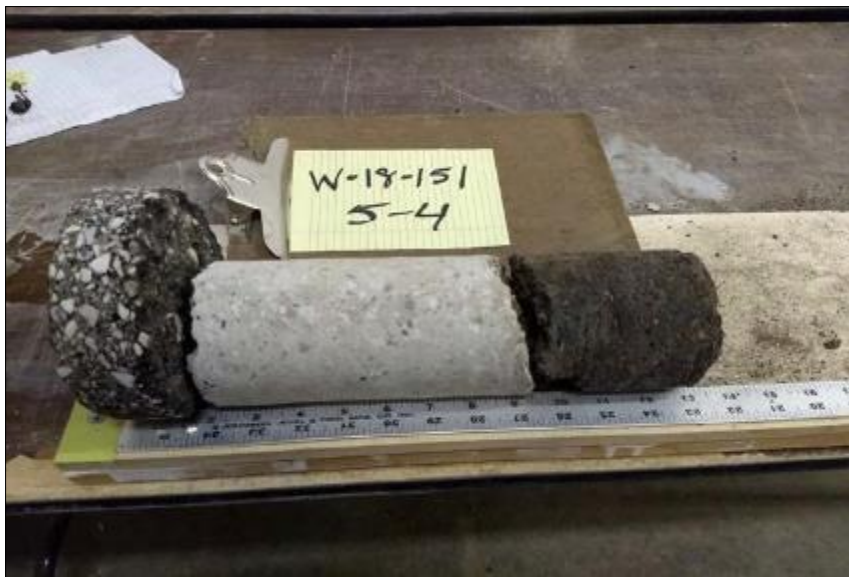
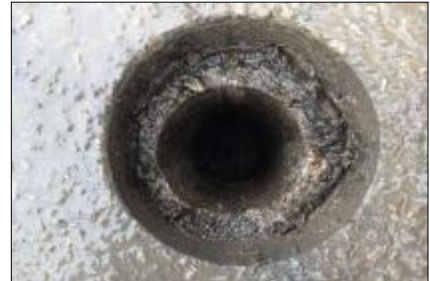
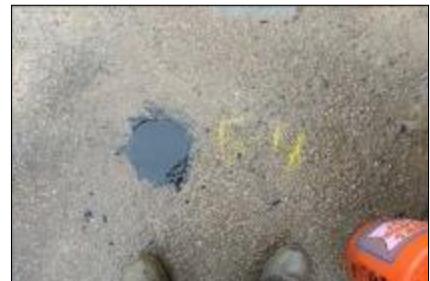
- Small and medium voids throughout asphalt surface layer

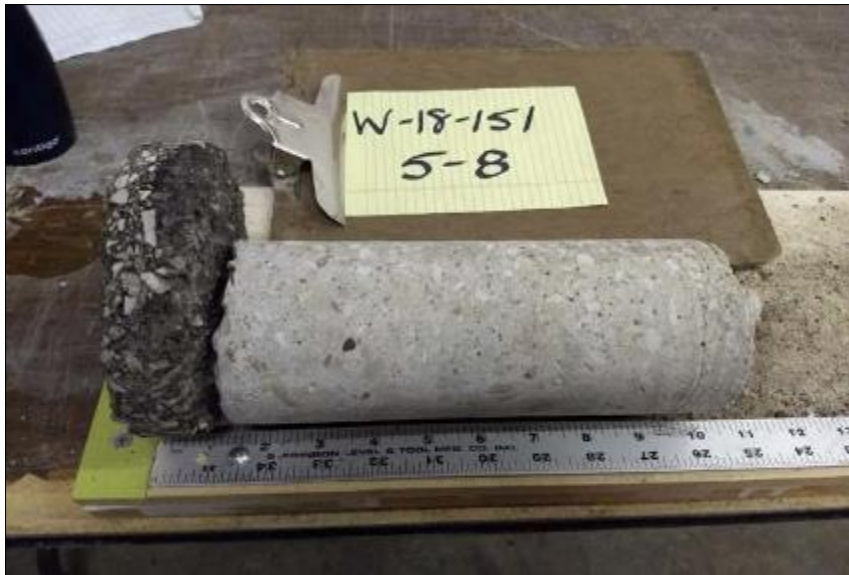
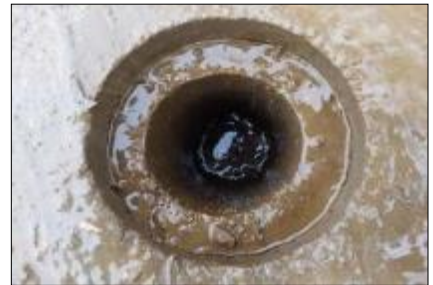
- Voids throughout asphalt surface layer

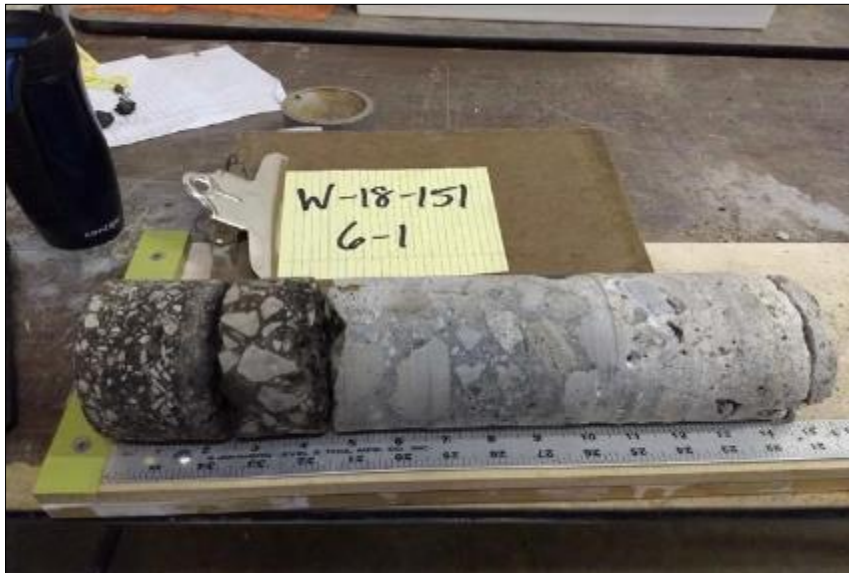
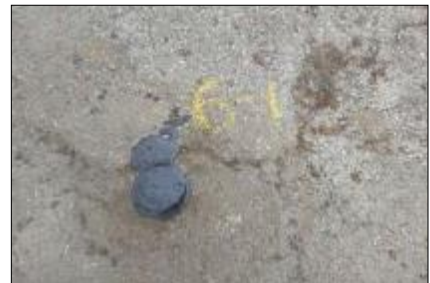
- Lift thickness of pulverized asphalt could not be determined.
- Asphalt layers separated
- Voids present is asphalt surface layer

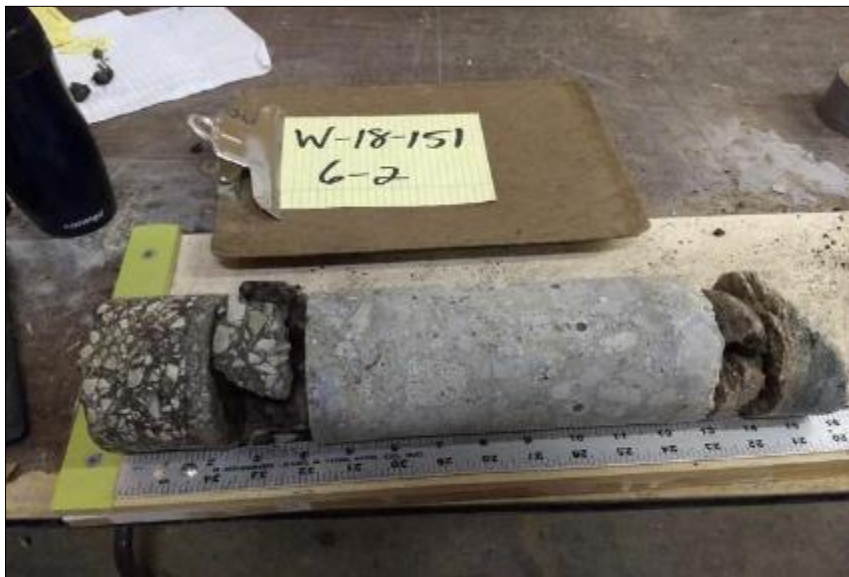
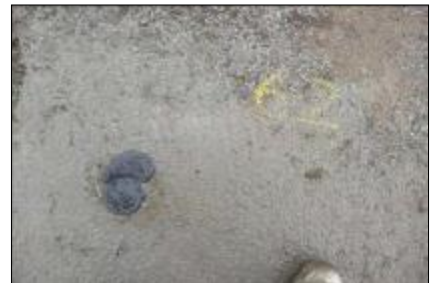
- Asphalt layers separated
- Trace voids present in both asphalt layers
- Asphalt base layer in pieces

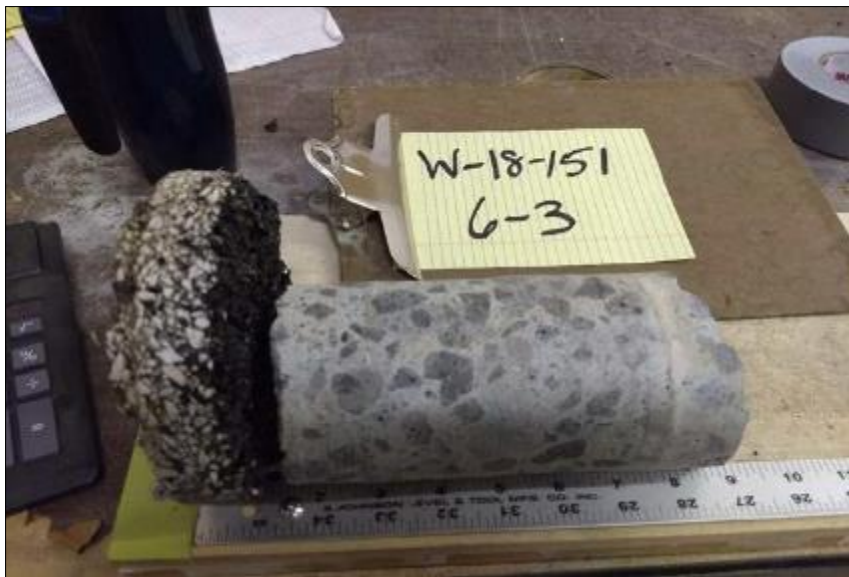
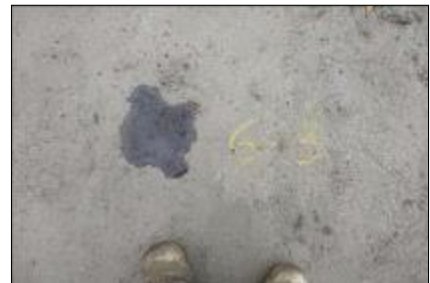
- Voids throughout asphalt surface layer  
 - Heavy tack coat on bottom of asphalt surface layer

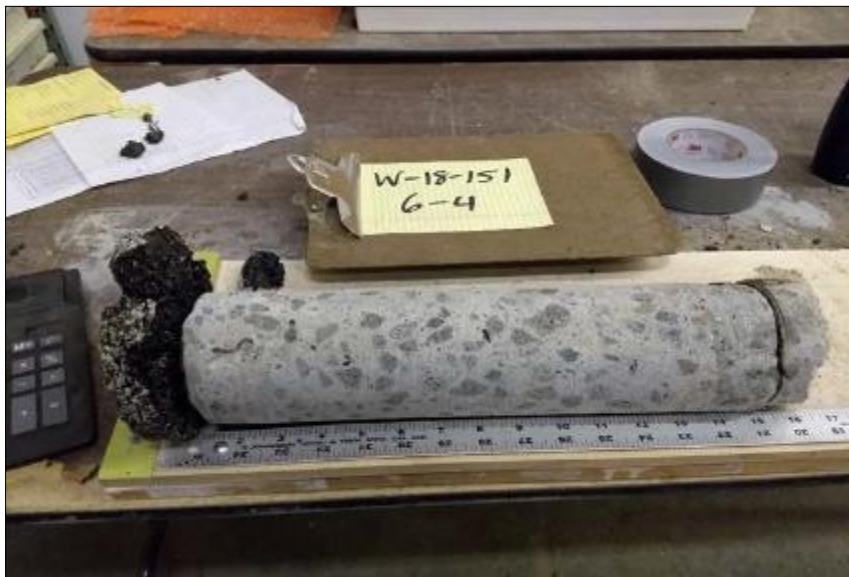
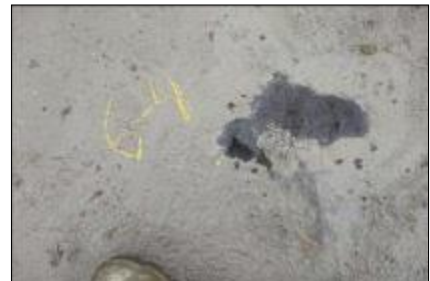
- Lift thickness of granular base could not be determined.
- Asphalt surface layer in pieces
- Voids present throughout asphalt surface layer
- Heavy tack coat on bottom of asphalt surface layer

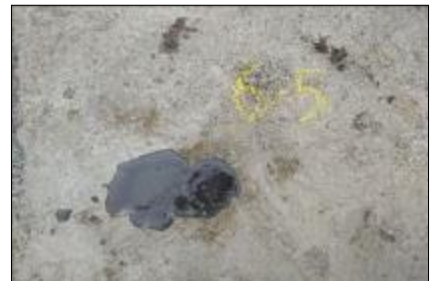
- Lift thickness of granular base could not be determined.  
 - Asphalt layer bonded to concrete base

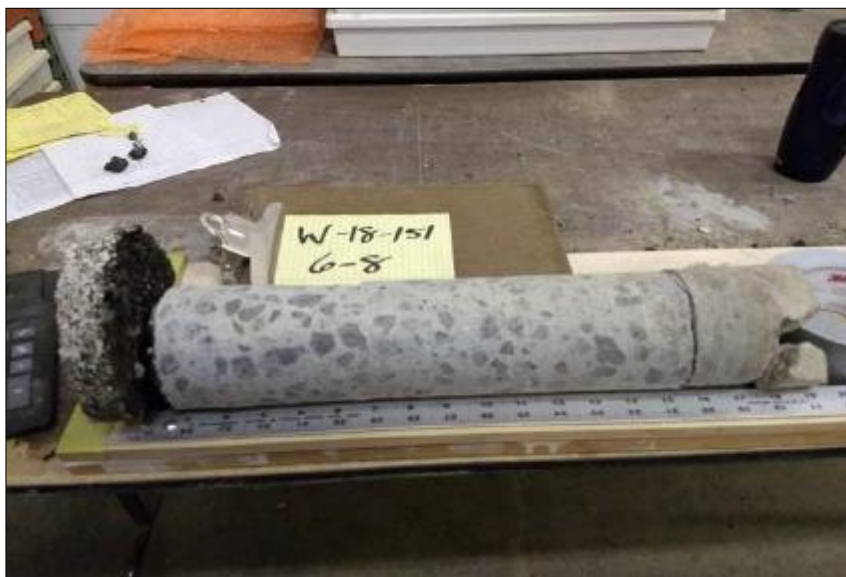
Core Composition										Comments/Remarks	
Core Number	Lift Thickness (in.)	Asphalt			Concrete	Aggregate/Granular Base	Other				
		404	402	301							
6-8	1.00	✓								- Lift thickness of granular base could not be determined. - Voids throughout asphalt surface layer - Heavy tack coat on bottom of asphalt surface layer	
	18.00				✓						
	Unknown					✓

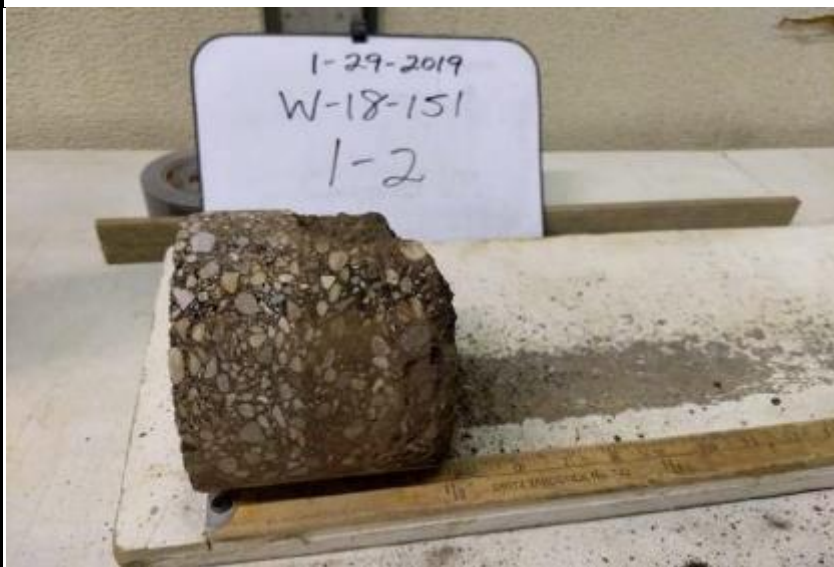
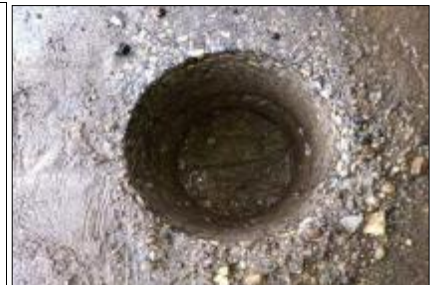
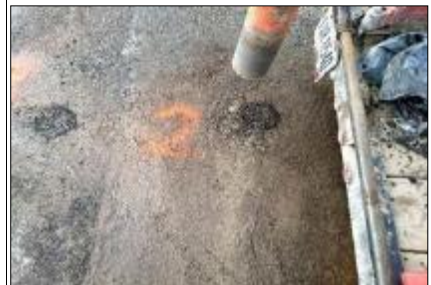
- Trace voids observed throughout asphalt

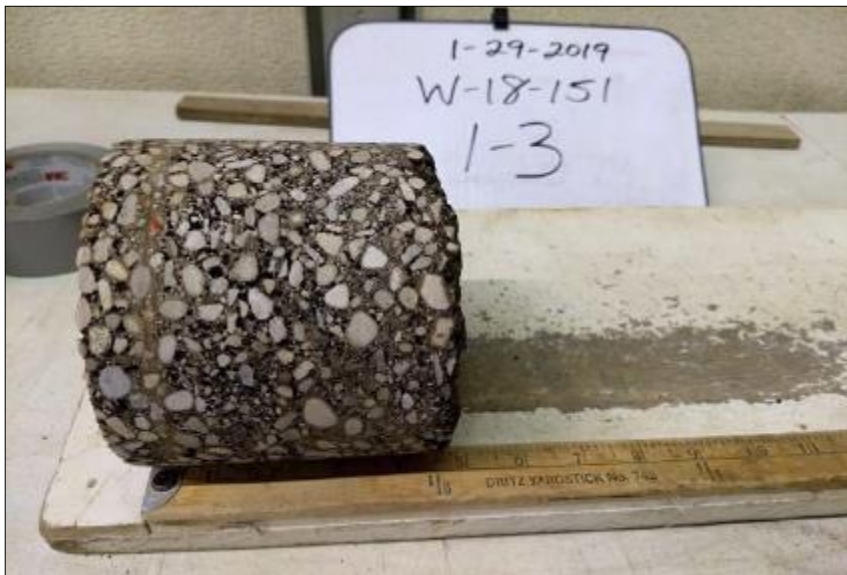
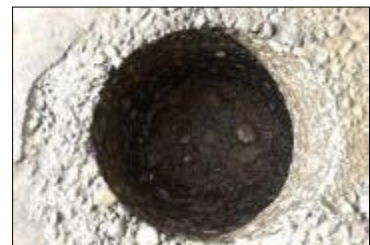
- Lift thickness of aggregate base was not determined in the field  
 - Trace voids observed throughout asphalt

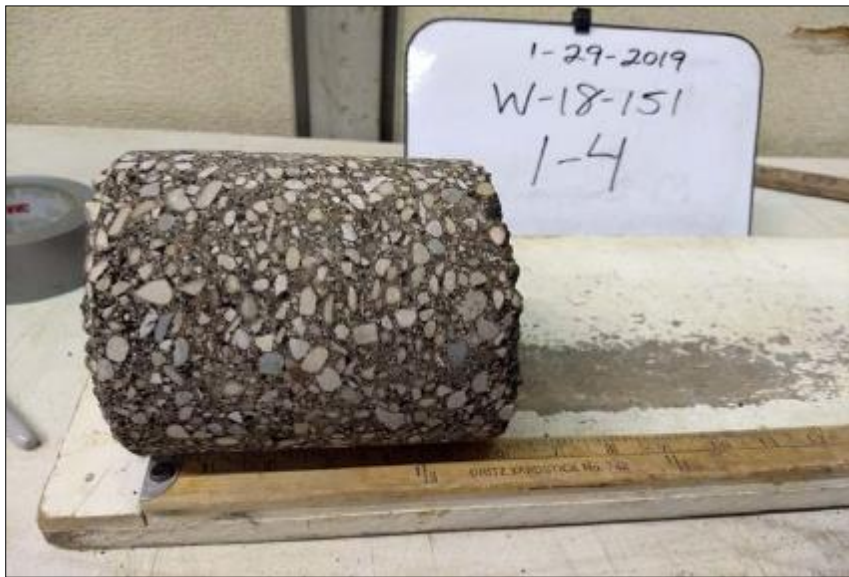
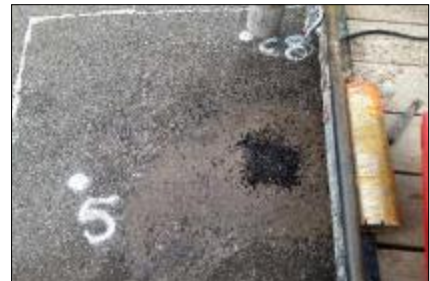
- Lift thickness of aggregate base was not determined in the field  
 - Trace voids observed throughout asphalt

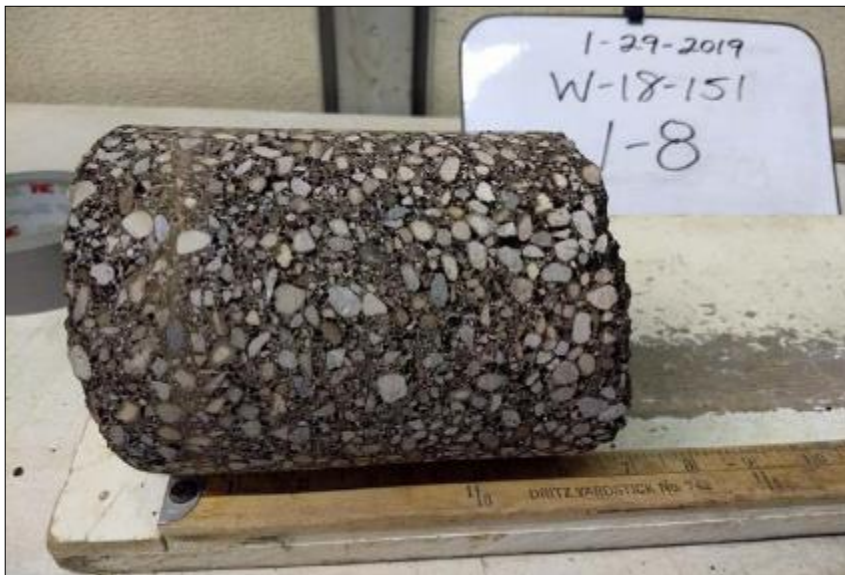
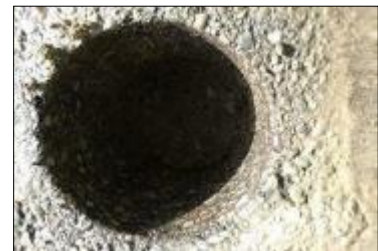
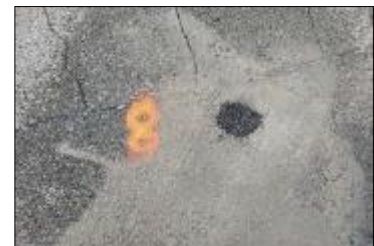
- Lift thickness of aggregate base was not determined in the field  
 - Trace voids observed throughout asphalt

Total Pavement Thickness = 6.25 in. Total Asphalt Thickness = 6.25 in. Total Concrete Thickness = 0.00 in. Total Base Thickness = 0.00 in.

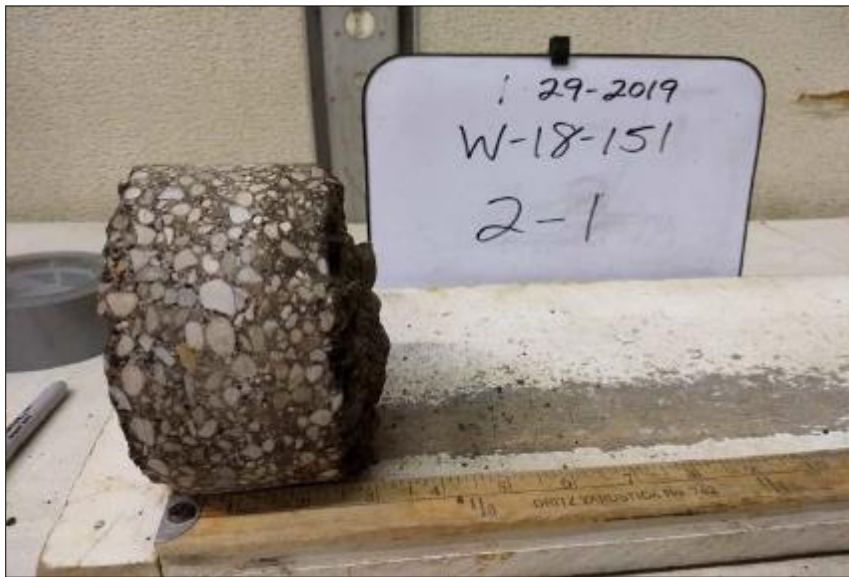
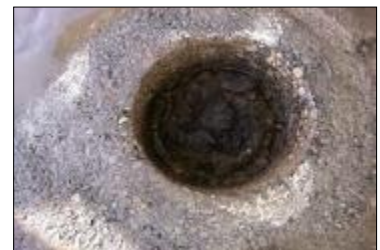
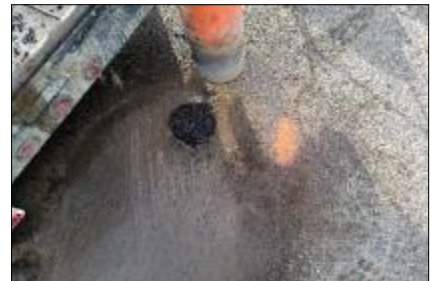
- Trace voids observed throughout asphalt

Total Pavement Thickness = 2.75 in. Total Asphalt Thickness = 2.75 in. Total Concrete Thickness = 0.00 in. Total Base Thickness = 4.00 in.

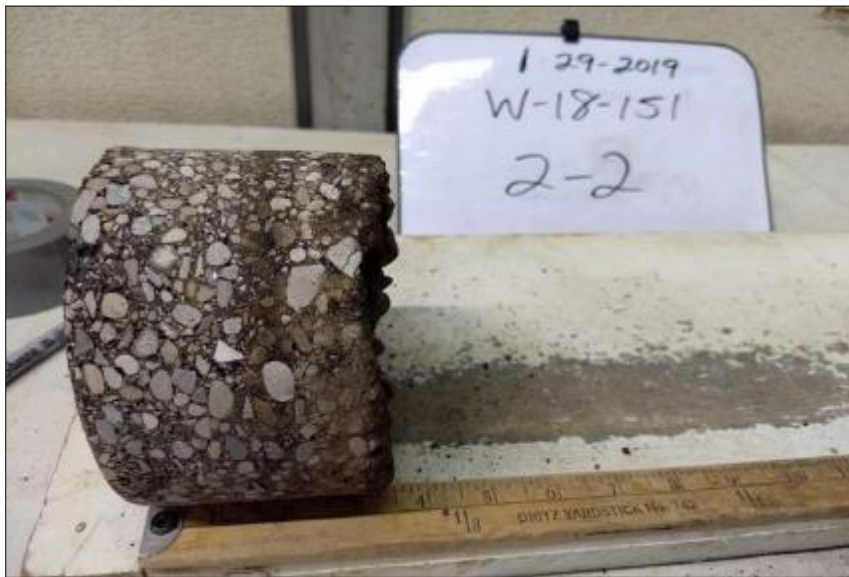
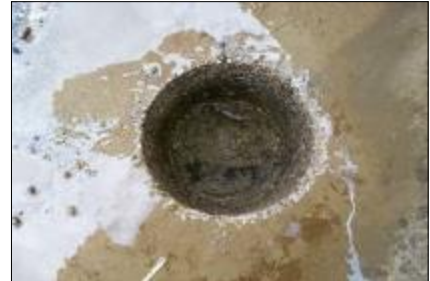
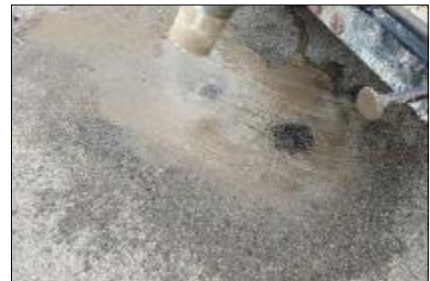
- Lift thickness of aggregate base was not determined in the field  
 - Trace voids observed throughout asphalt

Total Pavement Thickness = 3.25 in. Total Asphalt Thickness = 3.25 in. Total Concrete Thickness = 0.00 in. Total Base Thickness = 0.00 in.

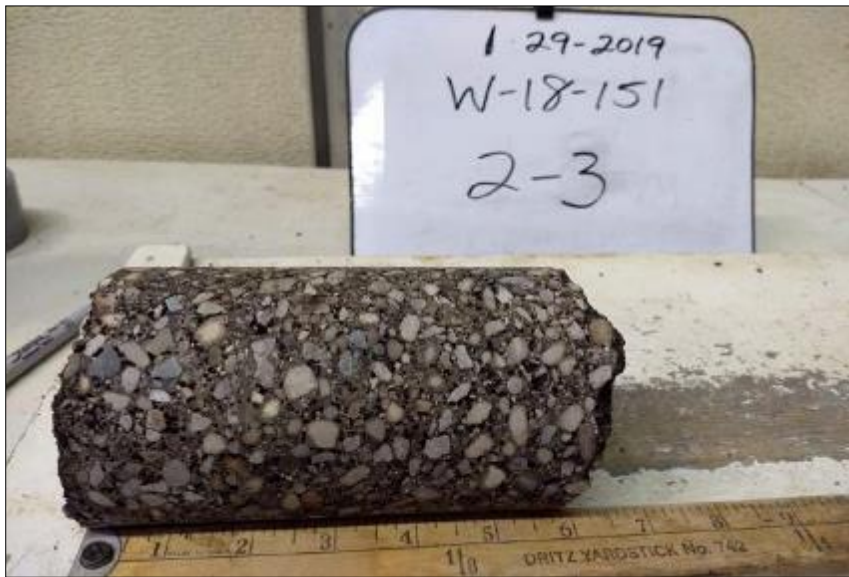
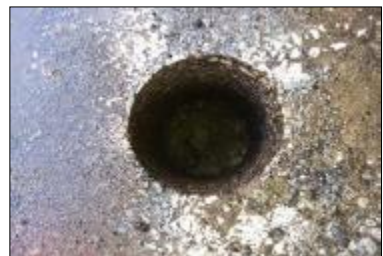
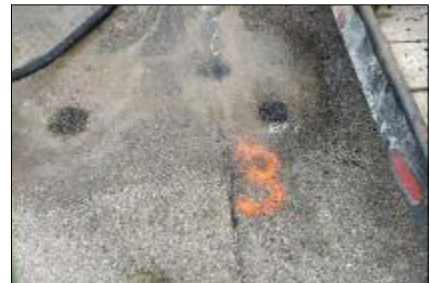
- Lift thickness of aggregate base was not determined in the field  
 - Trace voids observed throughout asphalt

Total Pavement Thickness = 6.00 in. Total Asphalt Thickness = 6.00 in. Total Concrete Thickness = 0.00 in. Total Base Thickness = 0.00 in.

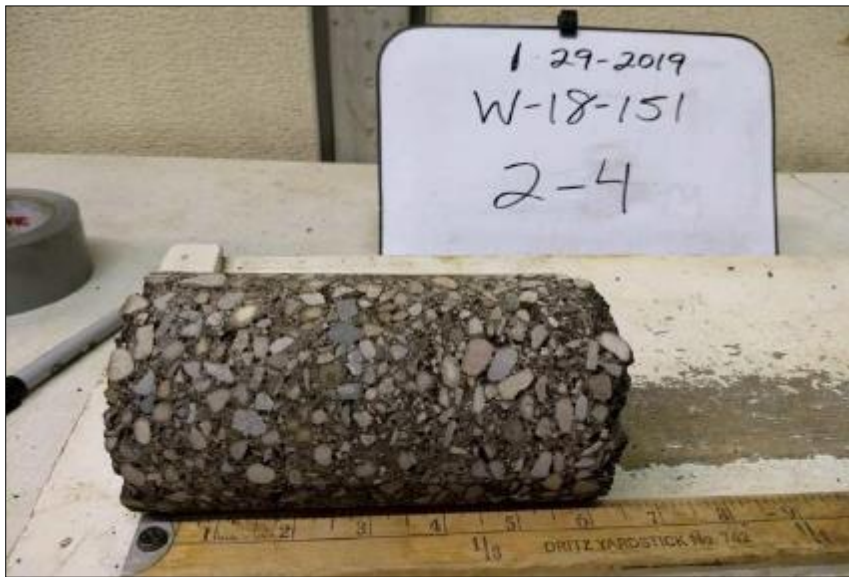
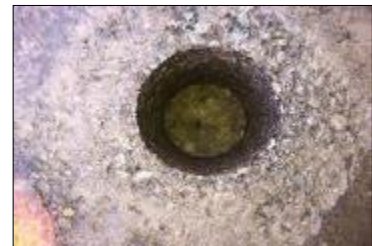
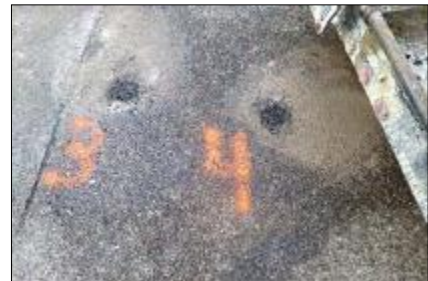
- Lift thickness of aggregate base was not determined in the field  
 - Trace voids observed throughout asphalt

Total Pavement Thickness = 6.25 in. Total Asphalt Thickness = 6.25 in. Total Concrete Thickness = 0.00 in. Total Base Thickness = 0.00 in.

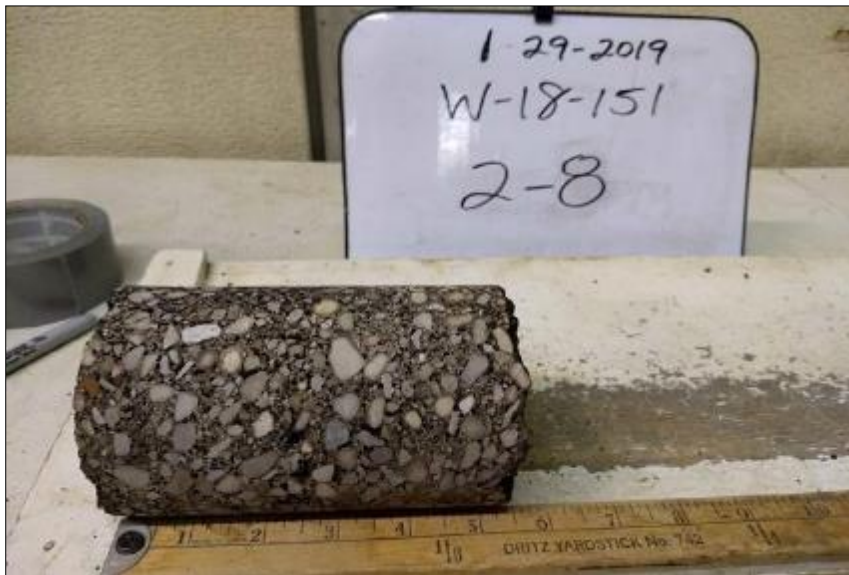
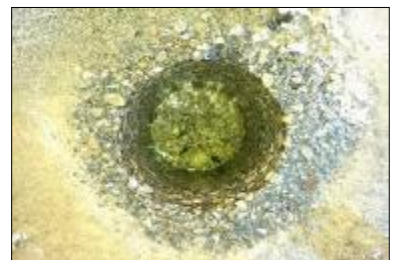
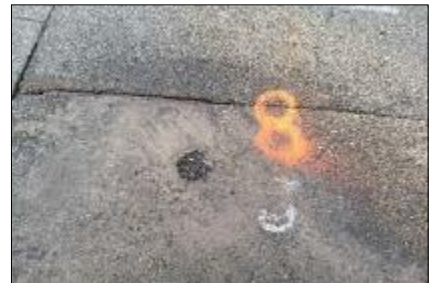
- Lift thickness of aggregate base was not determined in the field  
 - Trace voids observed throughout asphalt

Total Pavement Thickness = 5.50 in. Total Asphalt Thickness = 5.50 in. Total Concrete Thickness = 0.00 in. Total Base Thickness = 0.00 in.

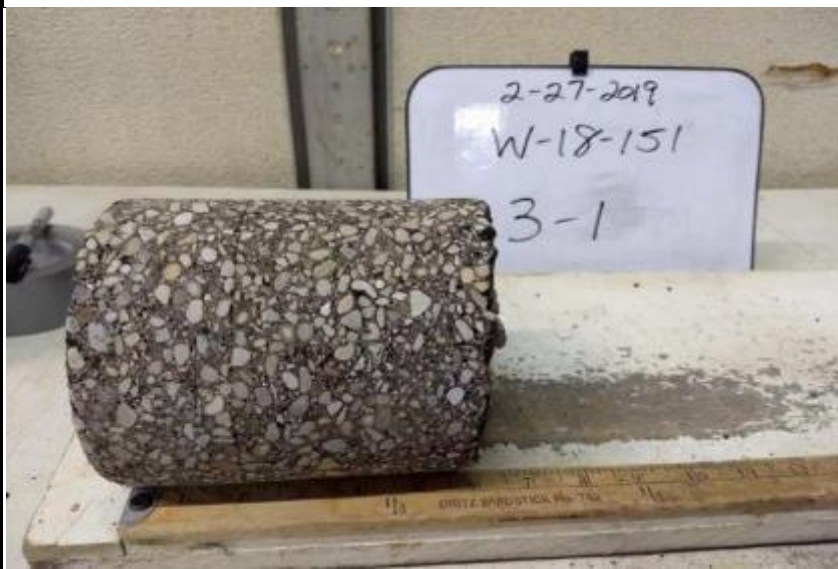
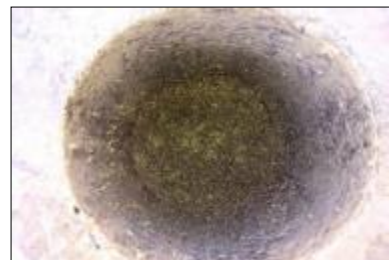
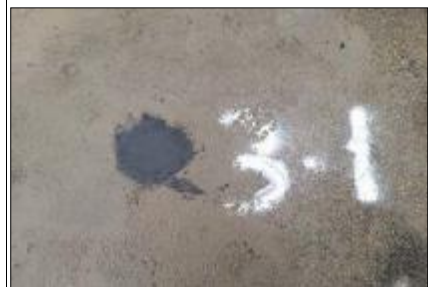
- Lift thickness of aggregate base was not determined in the field  
 - Trace voids observed throughout asphalt

Total Pavement Thickness = 6.00 in. Total Asphalt Thickness = 6.00 in. Total Concrete Thickness = 0.00 in. Total Base Thickness = 0.00 in.

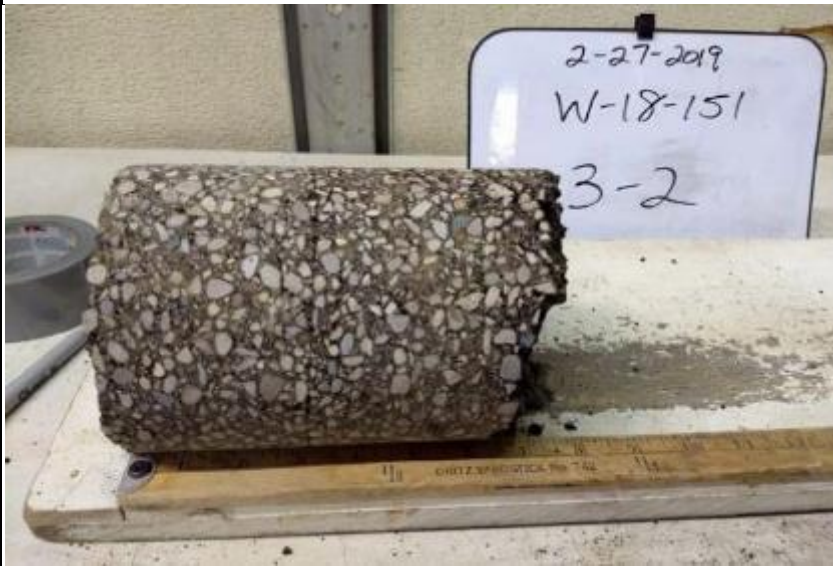
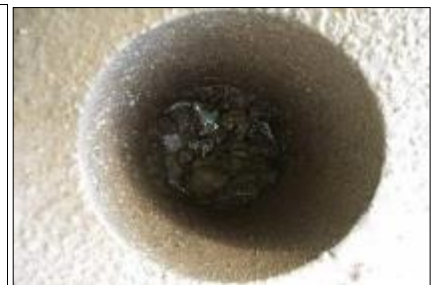
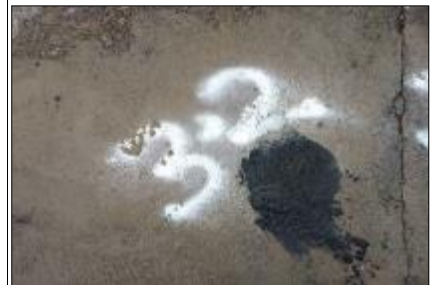
- Lift thickness of aggregate base was not determined in the field  
 - Trace voids observed throughout asphalt

Total Pavement Thickness = 6.50 in. Total Asphalt Thickness = 6.50 in. Total Concrete Thickness = 0.00 in. Total Base Thickness = 0.00 in.

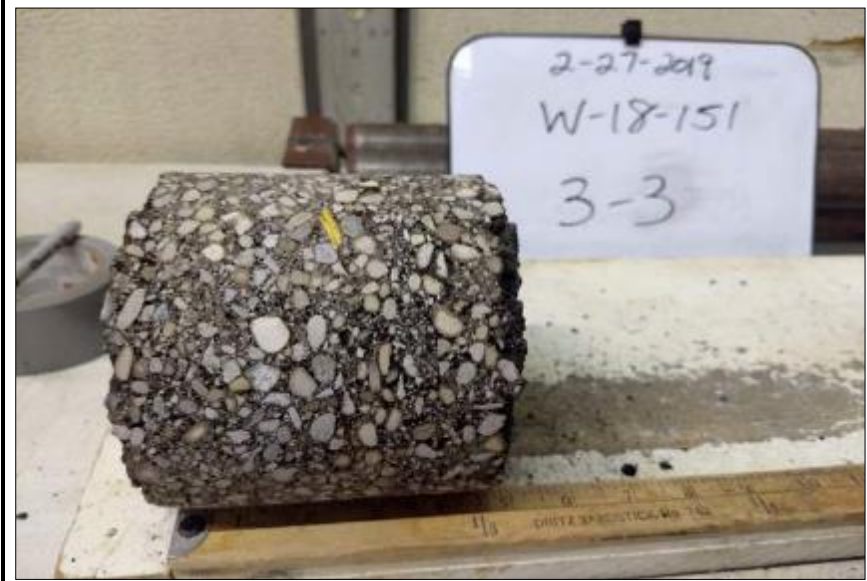
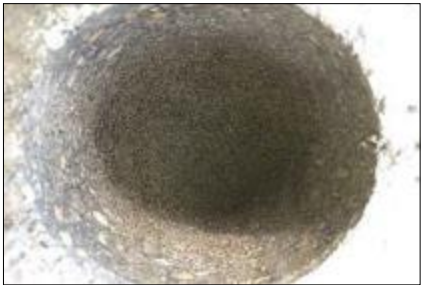
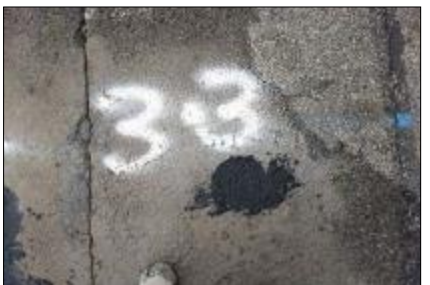
- Lift thickness of aggregate base was not determined in the field

Total Pavement Thickness = 4.75 in. Total Asphalt Thickness = 4.75 in. Total Concrete Thickness = 0.00 in. Total Base Thickness = 0.00 in.

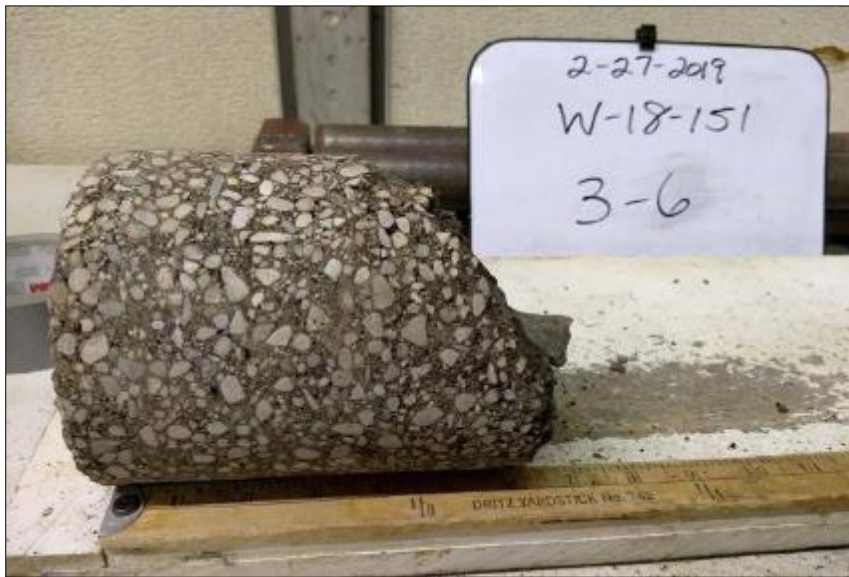
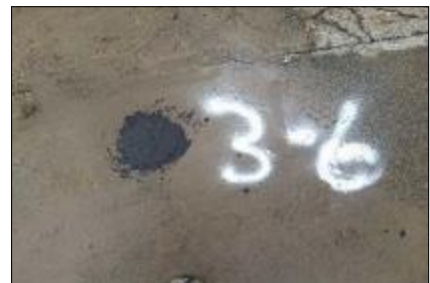
- Lift thickness of aggregate base was not determined in the field  
 - Trace voids observed throughout asphalt

Total Pavement Thickness = 6.25 in. Total Asphalt Thickness = 6.25 in. Total Concrete Thickness = 0.00 in. Total Base Thickness = 0.00 in.

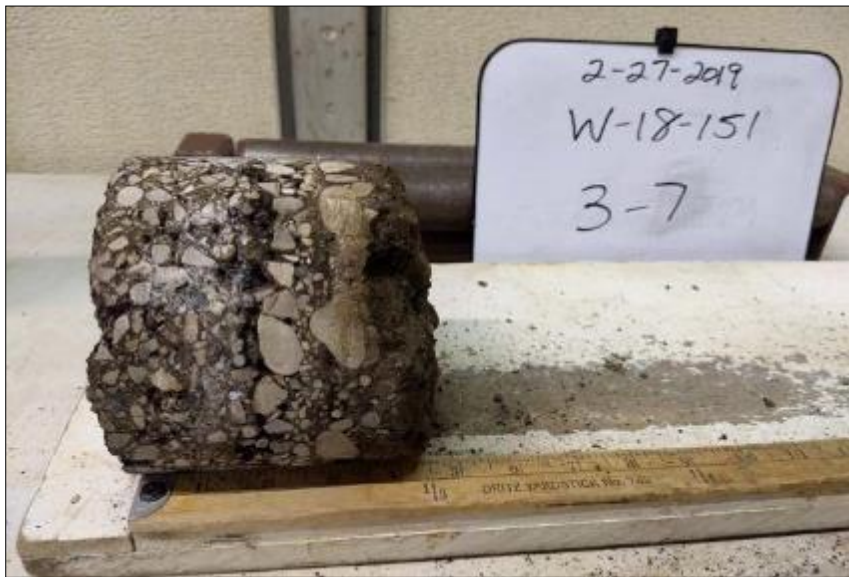
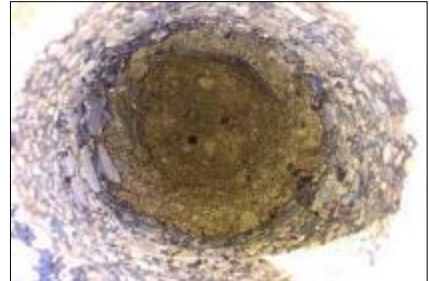
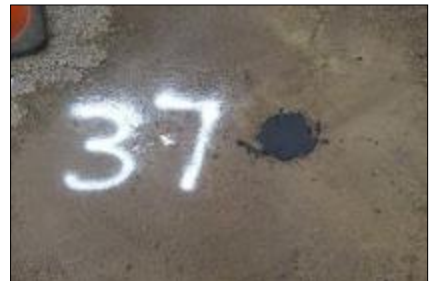
- Large voids seen separating the asphalt courses  
 - Voids observed throughout asphalt

Total Pavement Thickness = 4.50 in. Total Asphalt Thickness = 4.50 in. Total Concrete Thickness = 0.00 in. Total Base Thickness = 8.50 in.

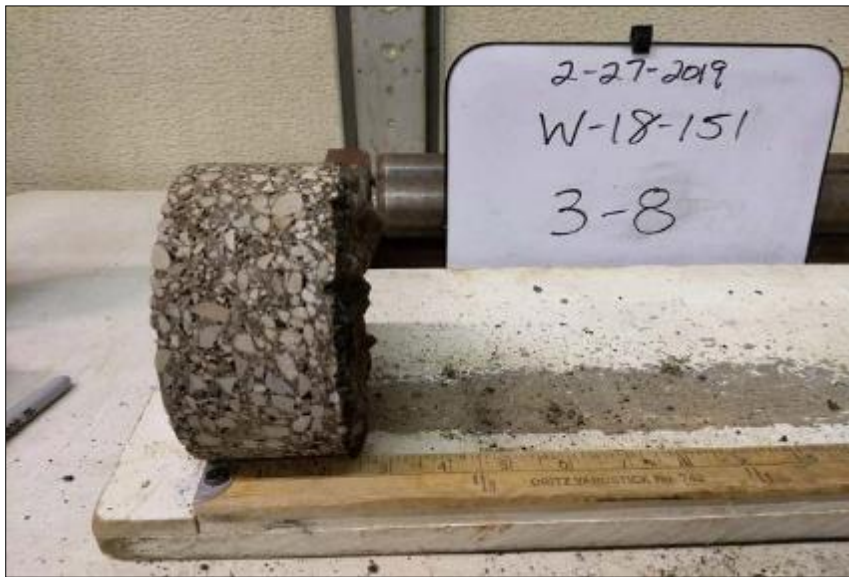
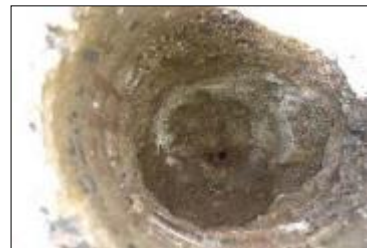
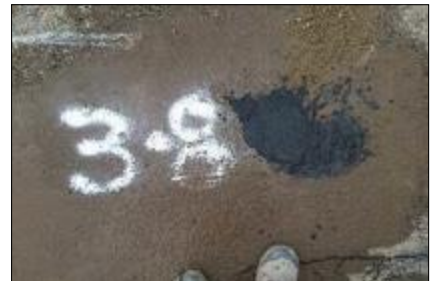
- Small voids observed throughout asphalt

Total Pavement Thickness = 2.50 in. Total Asphalt Thickness = 2.50 in. Total Concrete Thickness = 0.00 in. Total Base Thickness = 9.50 in.

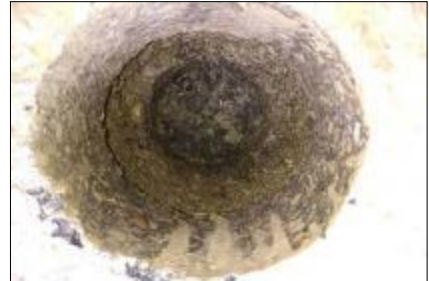
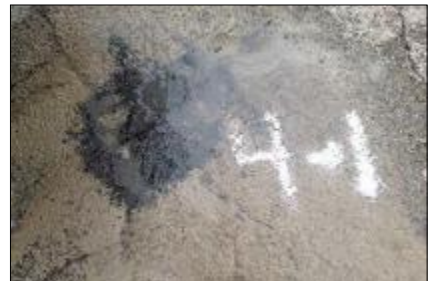
- Trace voids observed throughout asphalt

Total Pavement Thickness = 4.00 in. Total Asphalt Thickness = 4.00 in. Total Concrete Thickness = 0.00 in. Total Base Thickness = 5.00 in.

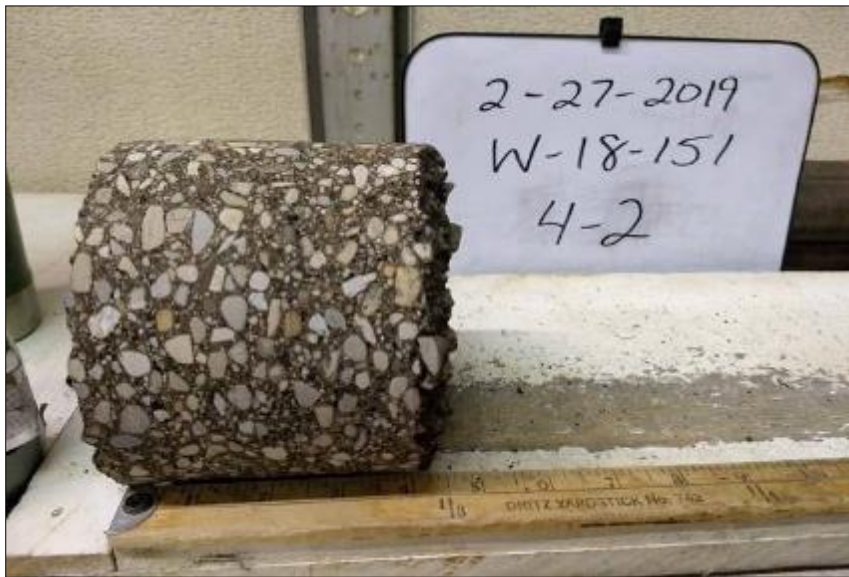
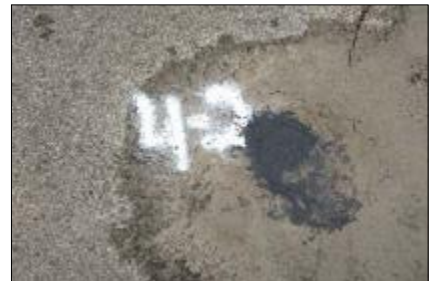
- Trace voids observed throughout asphalt

Total Pavement Thickness = 4.50 in. Total Asphalt Thickness = 4.50 in. Total Concrete Thickness = 0.00 in. Total Base Thickness = 6.50 in.

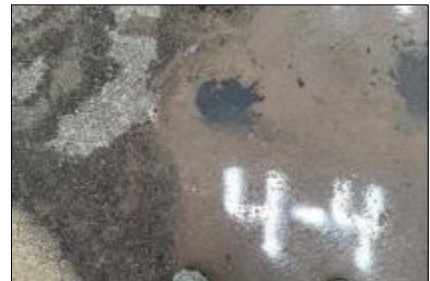
- Lift thickness of aggregate base was not determined in the field  
 - Trace voids observed throughout asphalt

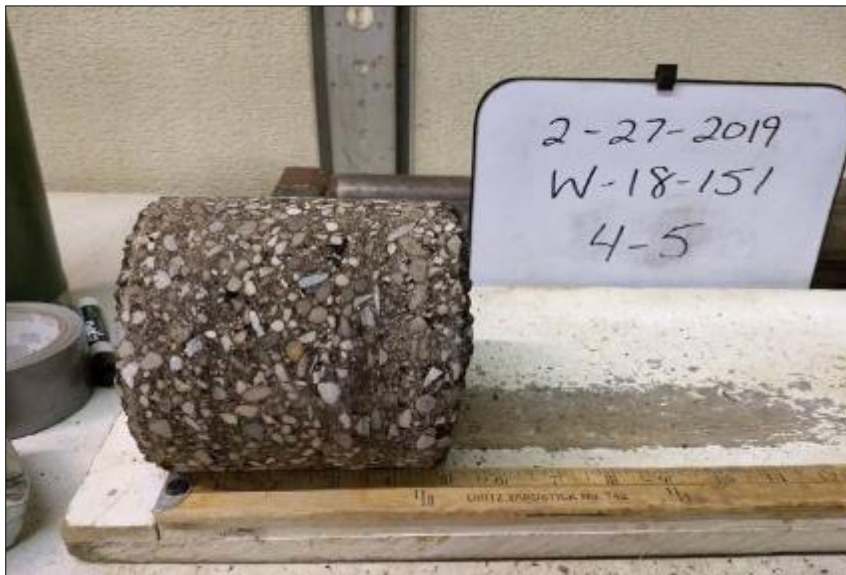
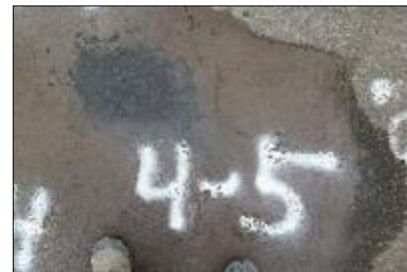
- Lift thickness of aggregate base was not determined in the field  
 - Trace voids observed throughout asphalt

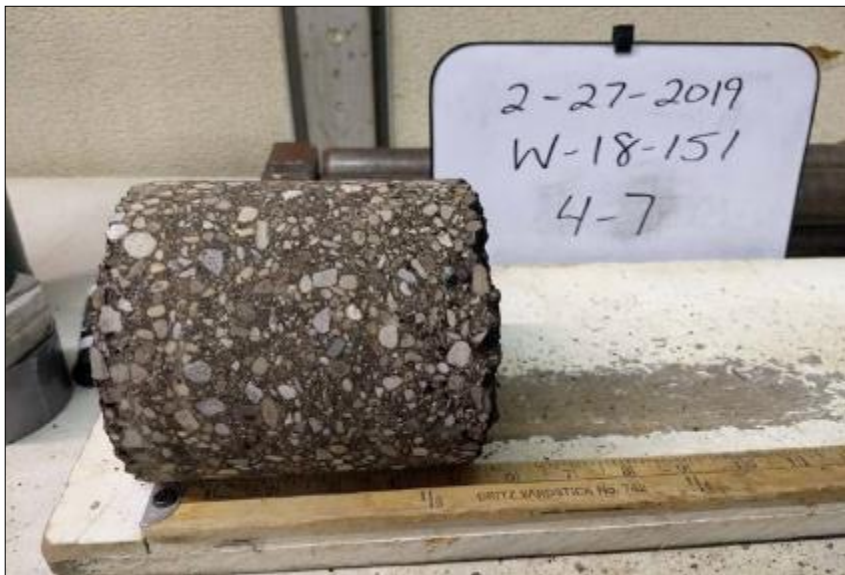
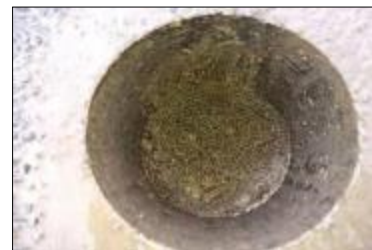
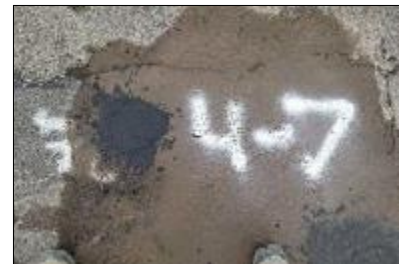
- Lift thickness of aggregate base was not determined in the field  
 - Trace voids observed throughout asphalt

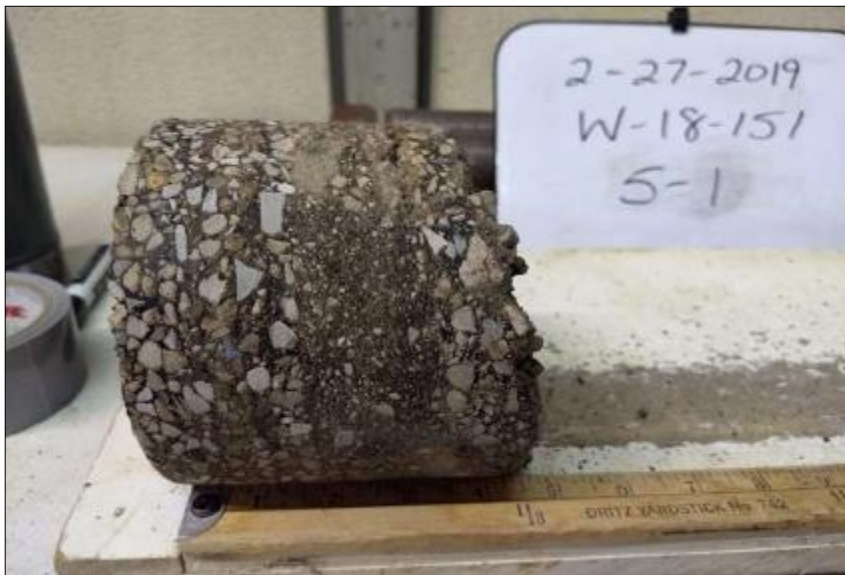
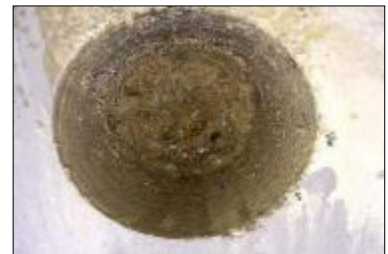
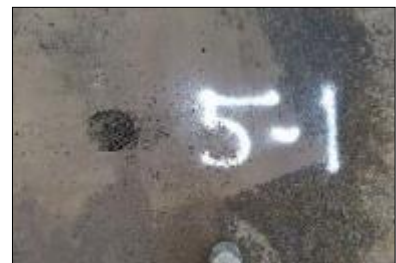
- Trace voids observed throughout asphalt

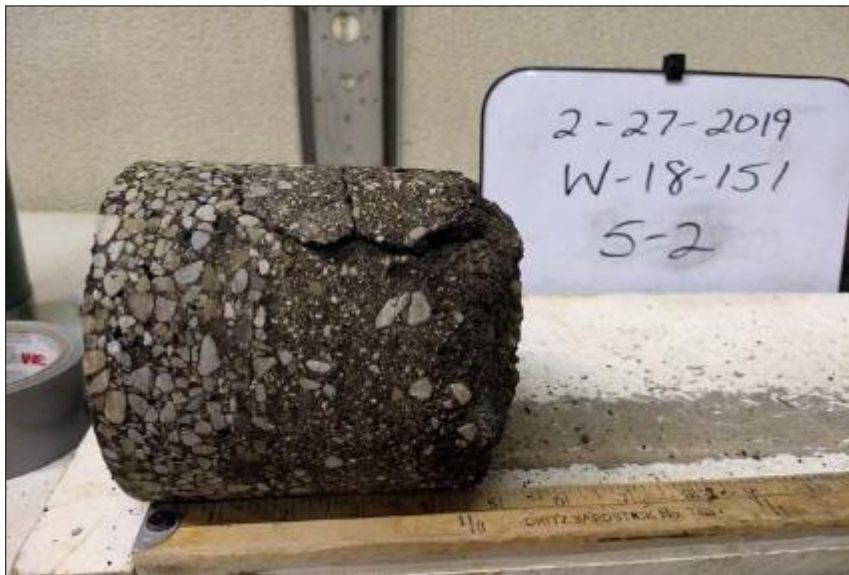
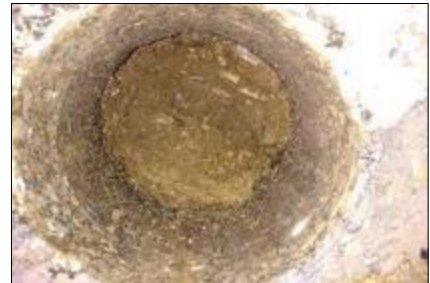
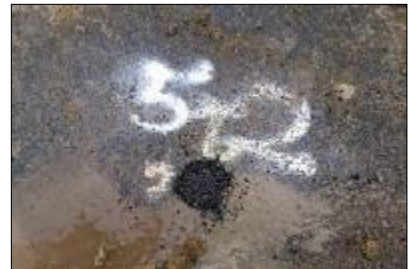
- Encountered cohesive subgrade immediately under asphalt on north side of core
- Lift thickness of aggregate base was not determined in the field
- 2 large chips observed on lateral surface of intermediate course
- Trace voids observed throughout asphalt
