# Best Practices for Pavement Restoration of Open Cut Utility Installations/Repairs on Local Roadways in Ohio

Prepared by Mary Robbins, Roger Green, Teruhisa Masada, and Dane Redinger (Resource International, Inc.)

June 2019

Final Report

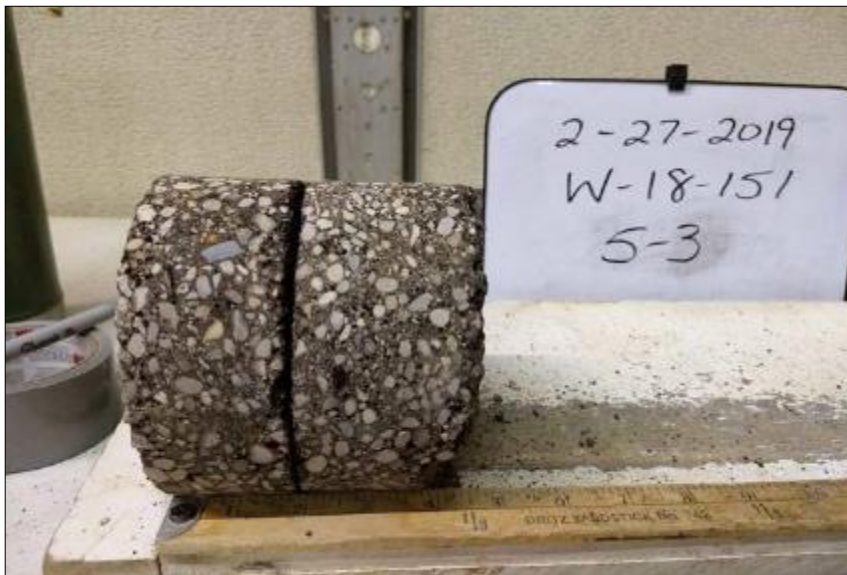
- Lift thickness of aggregate base was not determined in the field
- Asphalt courses separated
- Small voids observed throughout asphalt

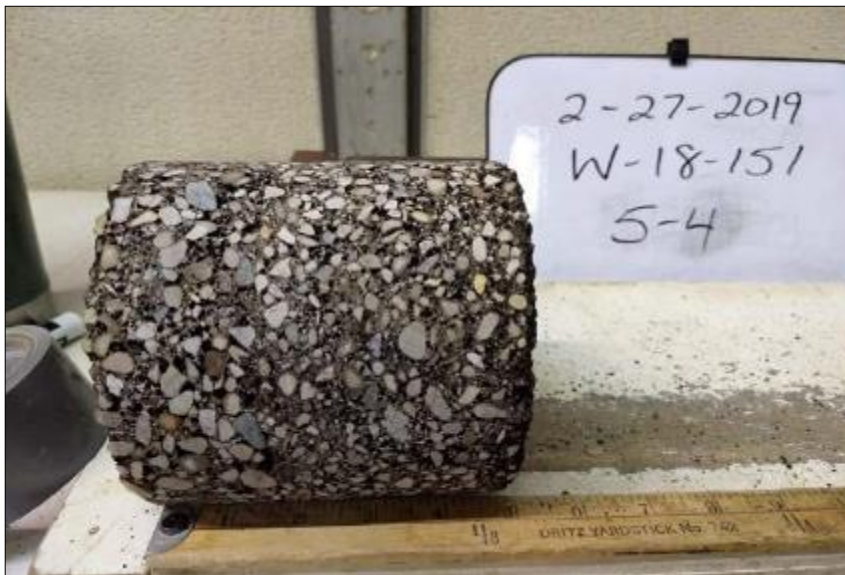
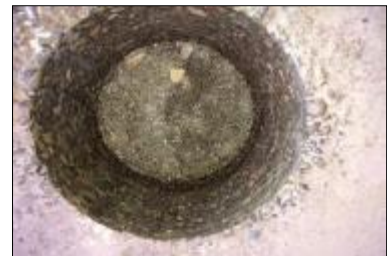
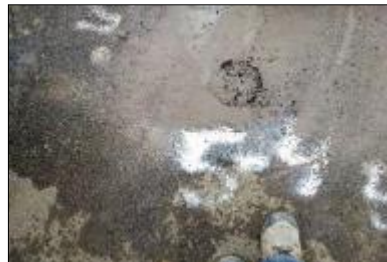
- Lift thickness of aggregate base was not determined in the field  
 - Small voids observed throughout asphalt

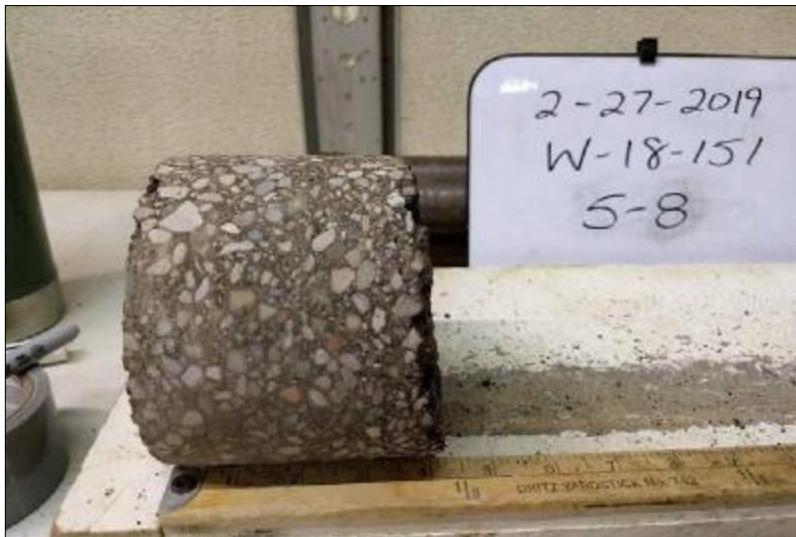
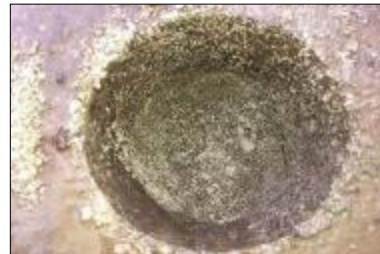
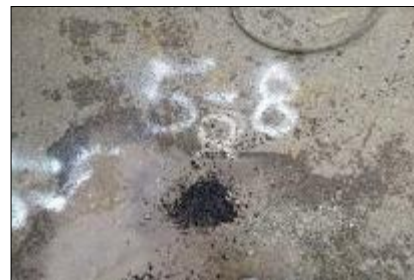
- Lift thickness of aggregate base was not determined in the field  
 - Trace voids observed throughout asphalt

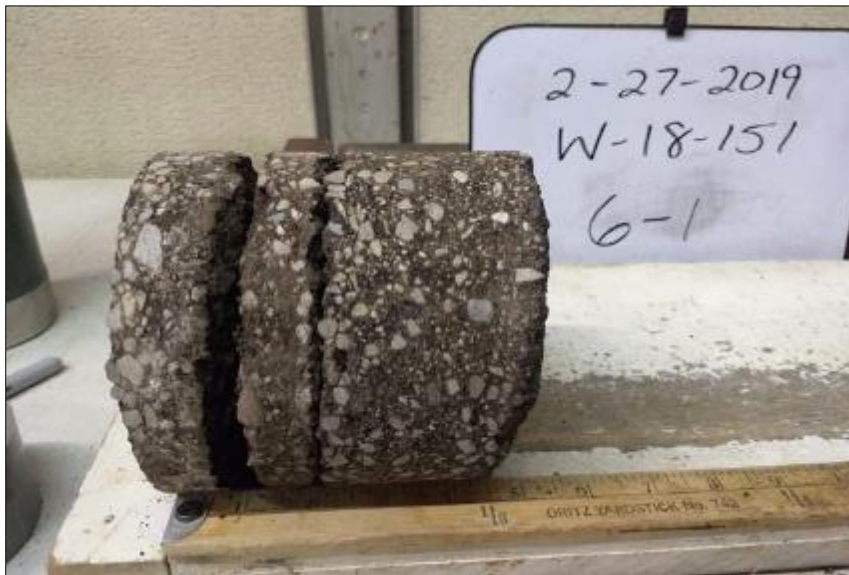
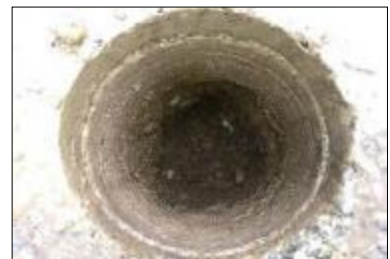
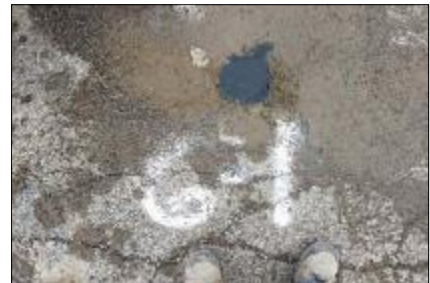
- Asphalt courses separated

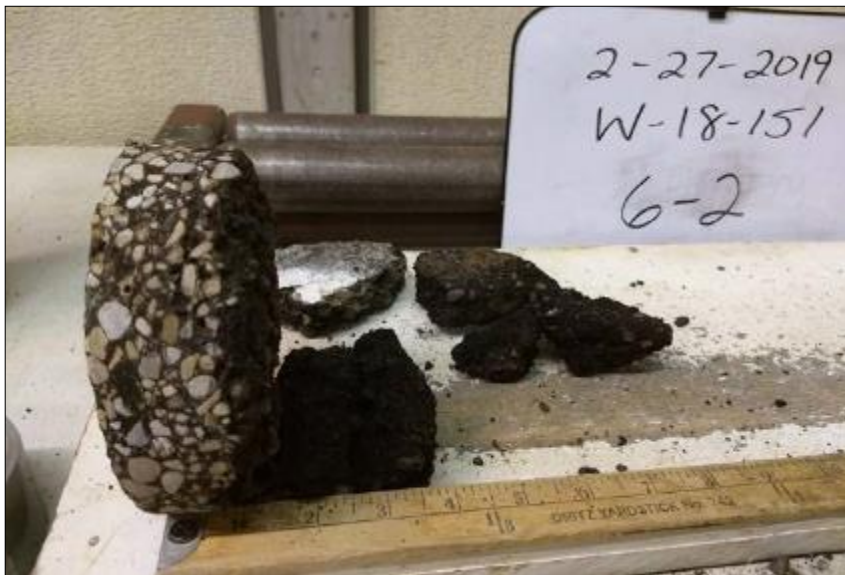
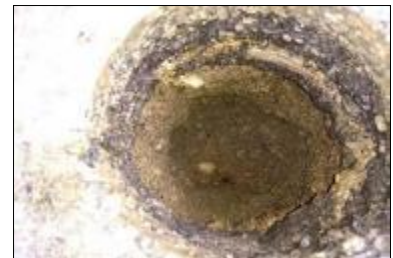
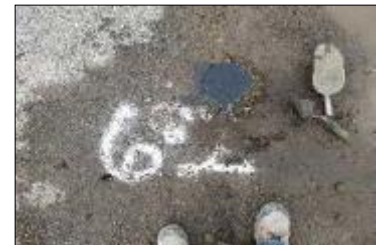
- Surface course has a single fracture that penetrates the entire depth of the course
- Intermediate course is in several pieces
- Asphalt courses separated
- Trace voids observed throughout surface course of asphalt

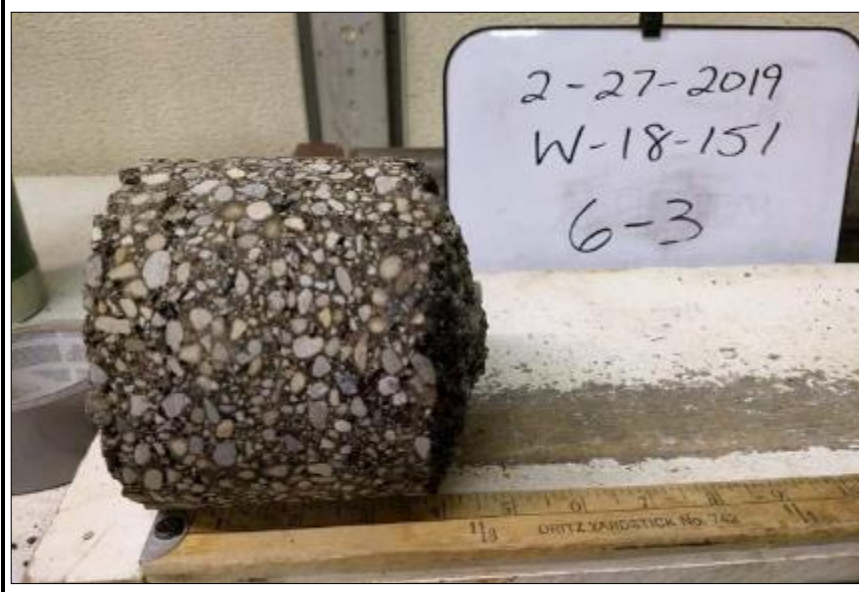
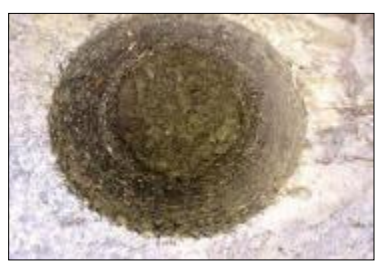
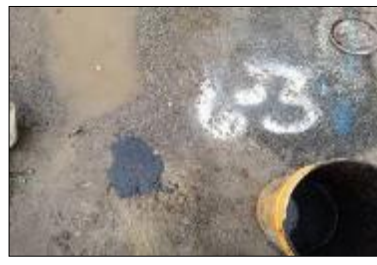
- Lift thickness of aggregate base was not determined in the field  
 - Trace voids observed throughout asphalt

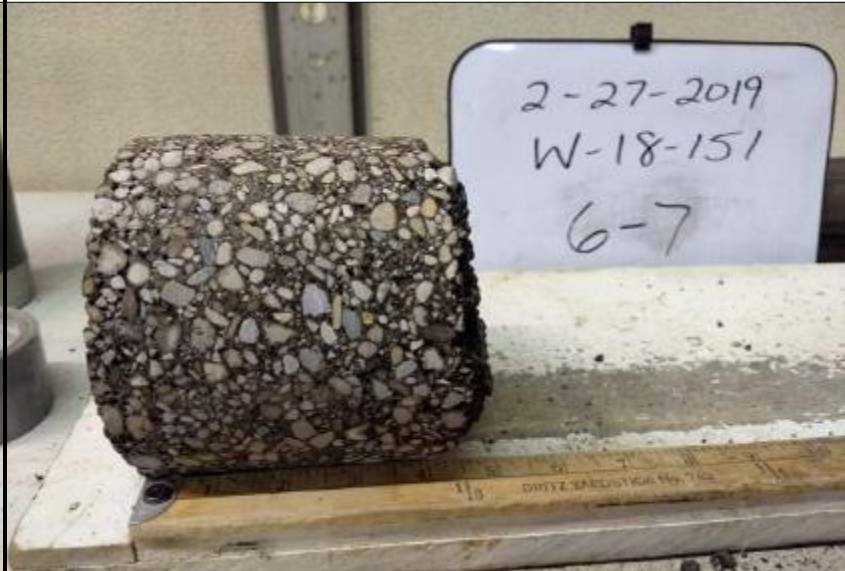
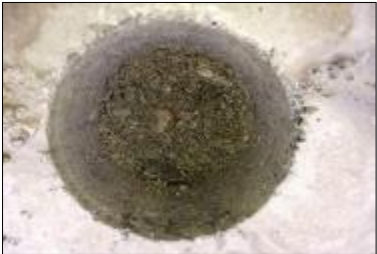
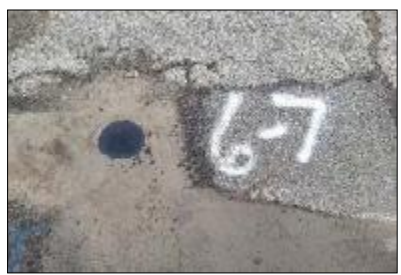
Core Composition							Comments/Remarks			
Core Number	Lift Thickness (in.)	Asphalt			Concrete	Aggregate/Granular Base	Other			
		Surface	Intermediate	Base						
6-7	4.50	✓								- Lift thickness of aggregate base was not determined in the field - Trace voids observed throughout asphalt
	unknown					✓
