Synthesis of Repair Practices of Damaged Precast/Prestressed Concrete Girders

SPR-P1 (19) M090

March 2020

Nebraska Department of Transportation (NDOT)

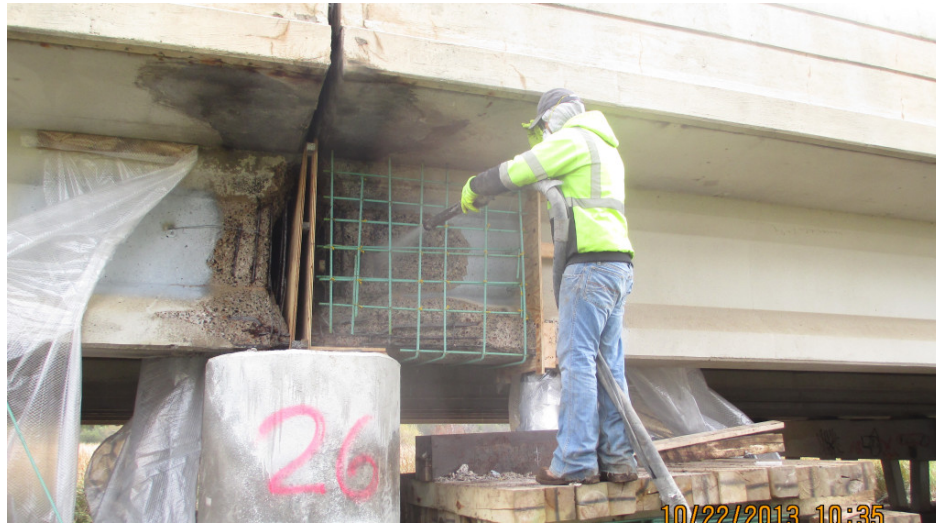
Figure 51: Shotcreting repair at girder end, MN/RC 2018-07 Report

Patching (discussed earlier in section 3.2.2) is used to restore the original girder cross-section, and it can be expanded to cast an end block. A common patching method for girder ends to eliminate the need for forming is shotcreting as shown in Figure 51 and Figure 52. According to Tabatabai

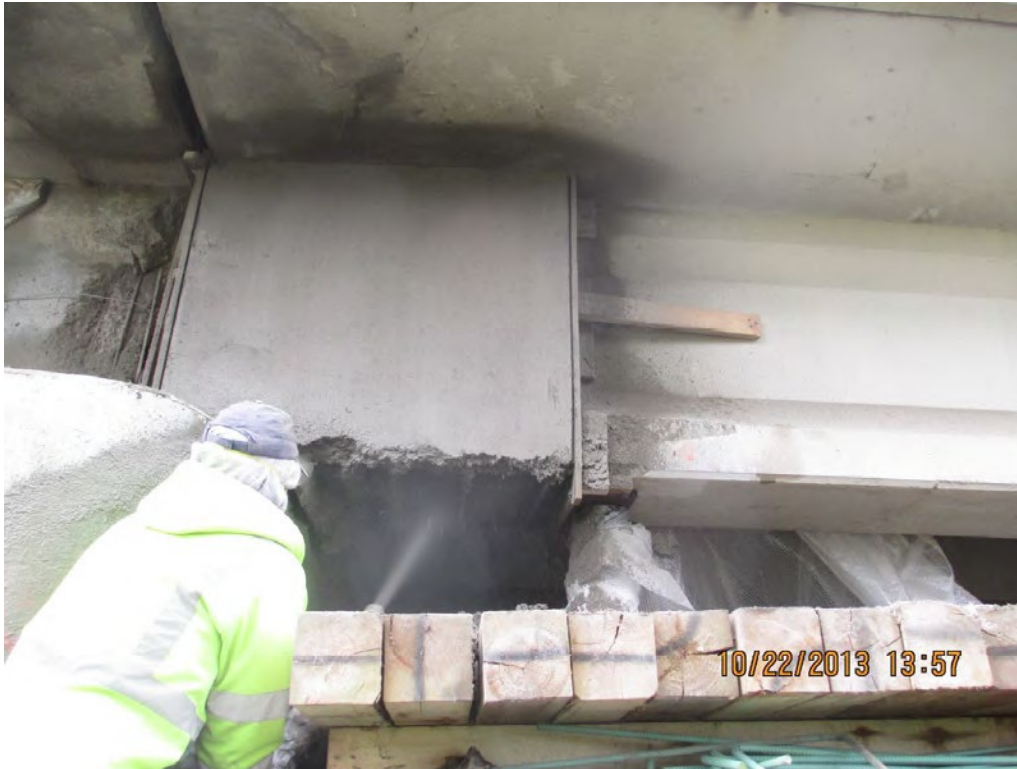
Figure 52: Shotcreting the bottom surface of the repair at girder end, MN/RC 2018-07 Report

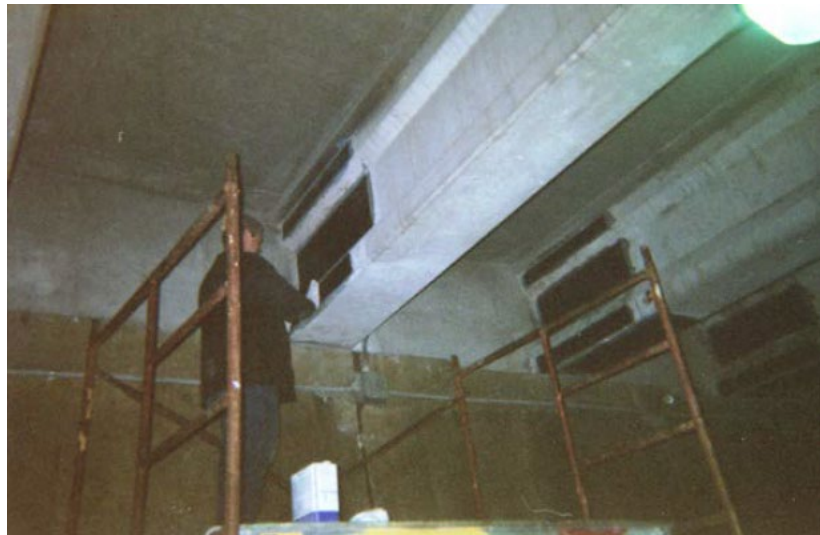
Figure 53: CFRP fabrics installation on I-65 expressway bridge girders, courtesy of Choo et al., 2013

As discussed earlier in section 3.2.5, FRP wrapping is an effective method in both repairing corrosion damage and protection against future corrosion damage by excluding chloride-bearing water from the concrete (Tabatabai et al. 2004). AASHTO type II prestressed girders were repaired from severe cracking discussed by Choo et al., 2013, and shown in Figure 49 by using CFRP wrapped repair. A research project was done by the University of Kentucky and in cooperation with Kentucky Transportation Center and Federal Highway Administration to document and monitor the repairs. The repairs were done on two phases, first concrete cracks were sealed by means of high strength epoxy resin, and then the girders were strengthened with CFRP fabrics as shown in Figure 53. Crack monitoring gauges were installed to ensure the effectiveness of the repair. In addition, linear variable displacement transducers LVDTs were instrumented on two of the bridge girders to monitor vertical and horizontal translations. The CFRP repairs were effective in curtailing relative movement in horizontal directions as evidenced by the lack of movement as

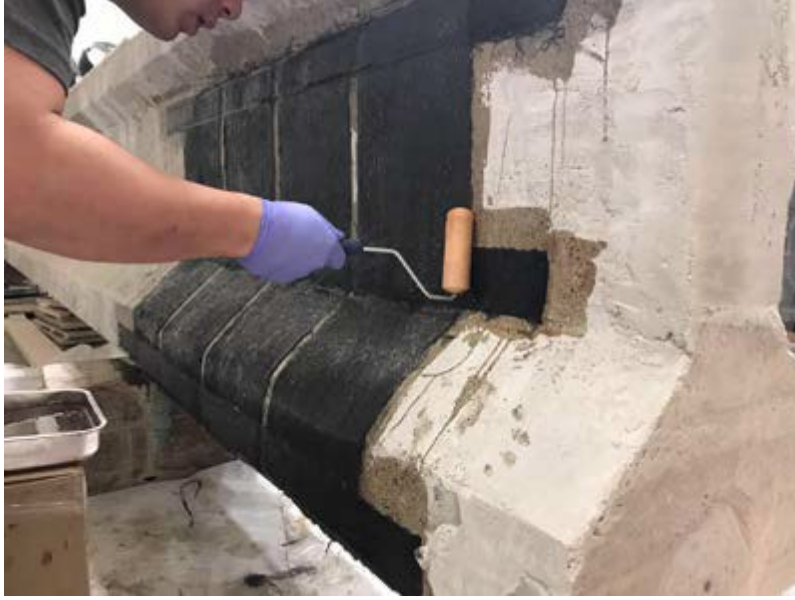
Figure 54: Applying shear CFRP to full-scale prestressed girder end, courtesy of Andrawes et al., 2018

A research project was recently conducted by the University of Illinois and sponsored by the Illinois Department of Transportation (IDOT) to study the use FRP materials to repair and retrofit damaged ends of prestressed concrete beams as shown in Figure 54, Andrawes et al., 2018. Three-point bending tests were performed on small and full-scale prestressed concrete girders. Full-scale girders were retrieved from actual field bridges. The purpose of the full-scale tests was to evaluate the repair technique in repairing and retrofitting damaged girders and also the improvement of shear behavior. Five AASHTO Type II prestressed girders that were extracted after more than 40 years in service. Severe girder end region damage was simulated by removing the concrete cover to the centerline of the stirrups from the web all the way through the bottom flange. Afterward, a quick set mortar was applied to the damaged region to restore the shape of the girder, followed by CFRP laminate application. It was concluded that a mortar repair alone is not sufficient enough to recover the shear strength and ductility of the girder with the damaged end. A weak bond surface between mortar and base concrete and cracks developed above bearing plates diminished the repair effect from the mortar. And that externally bonded CFRP shear reinforcement repair was effective in recovering and even exceeding the shear capacity and ductility of the undamaged girders.

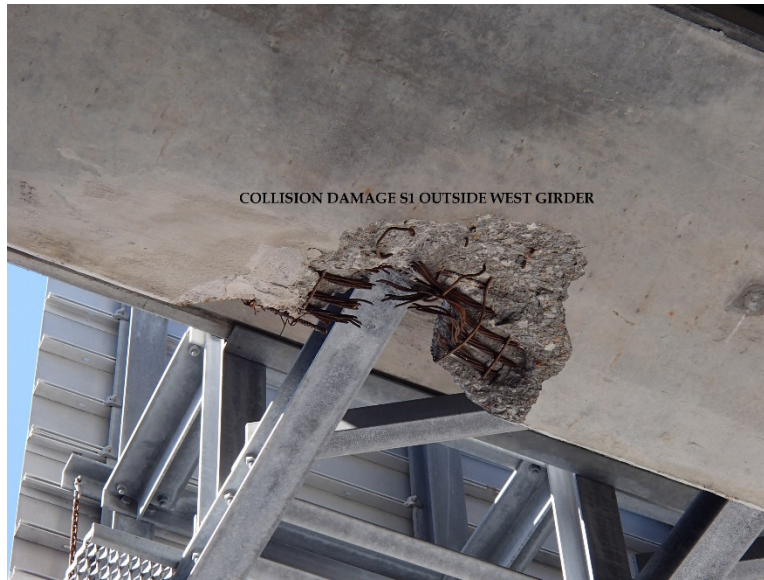
Damage occurred to the bottom flange of an exterior girder as shown in Figure 64 and Figure 65. The spalled area was about 16.91 in. deep over 29 in. length of the bottom flange as shown in Figure 66. At least four strands severed as shown in Figure 66. According to the proposed NDOT damage classification, this damage was classified as Severe II class.

Figure 65: Level of damage, 168th St. over West Dodge Road Bridge, courtesy of NDOT

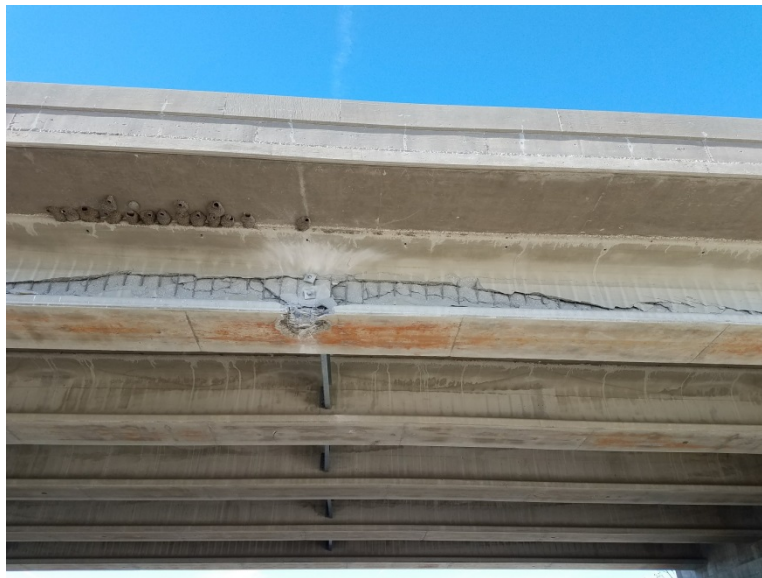
With reference to the accident report, on December 2017 a Union Pacific truck with a boom on the back end hit the bridge at an exterior girder in span 2 as shown in Figure 70. Damage occurred at the bottom flange and the web and severed at least 8 strands as shown in Figure 71. No other damage appeared to the bridge girders or components. The girder replacement was done as shown in Figure 72. According to the proposed NDOT damage classification, this damage was classified as Severe III class.

Figure 70: Level of damage, Schuyler Bridge, courtesy of NDOT

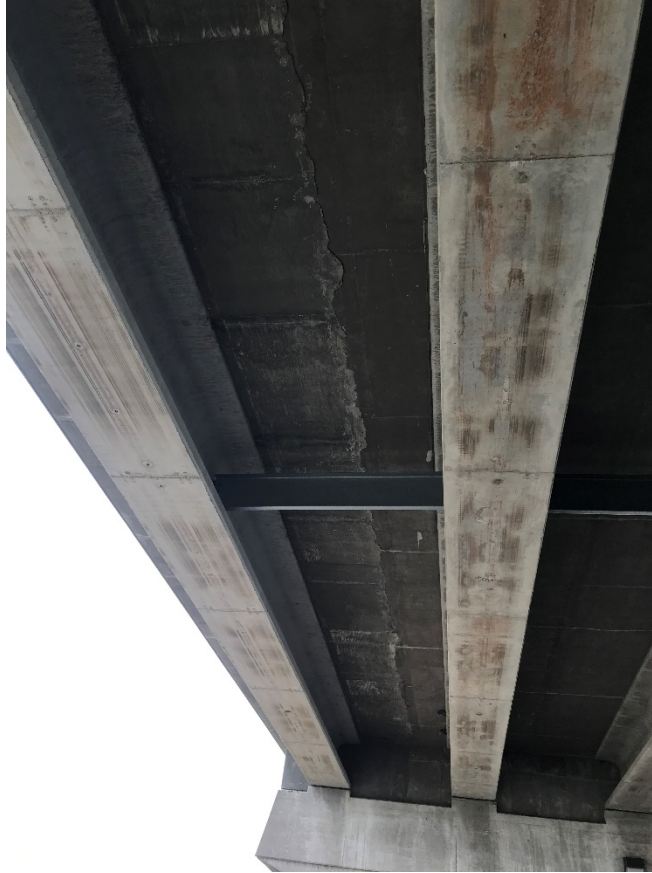
Replacement works took place on January 2018. The latest inspection done on June 2019 reported the superstructure NBI condition rate to be 8 with no notable deficiencies on the replaced girder. A visual inspection visit was done on August 2019 with no notable deficiencies on the replaced girder as shown in Figure 73.

Figure 73: Replaced girder with no notable deficiencies, Schuyler Bridge, courtesy of NDOT

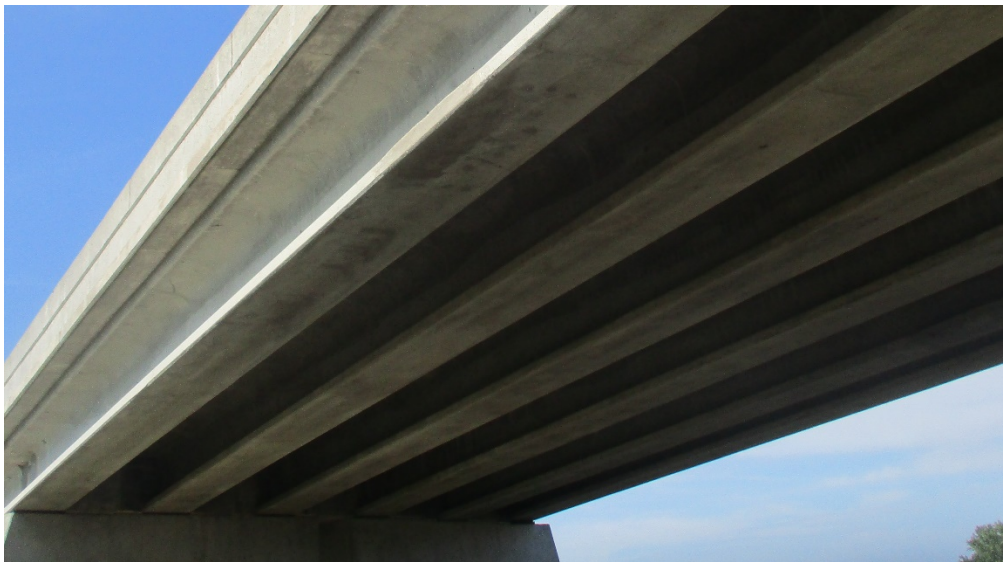
Repair works took place on April 2009. The latest inspection done on August 2017 reported the superstructure NBI condition rate to be 5 with noting that the previous patch was damaged again. A visual inspection visit was done on July 2019. For Girder E, it was noticed that the patched area was damaged with a significant volume of the patching material removed leaving the bottom flange transverse reinforcement exposed as shown in Figure 86. In addition, it was noticed that Girder E had less camber than the neighboring girders. For Girder A there were no notable deficiencies on the repaired girder as shown in Figure 87.

Figure 87: Patched area on Girder A, Wood River Interchange Bridge, courtesy of NDOT

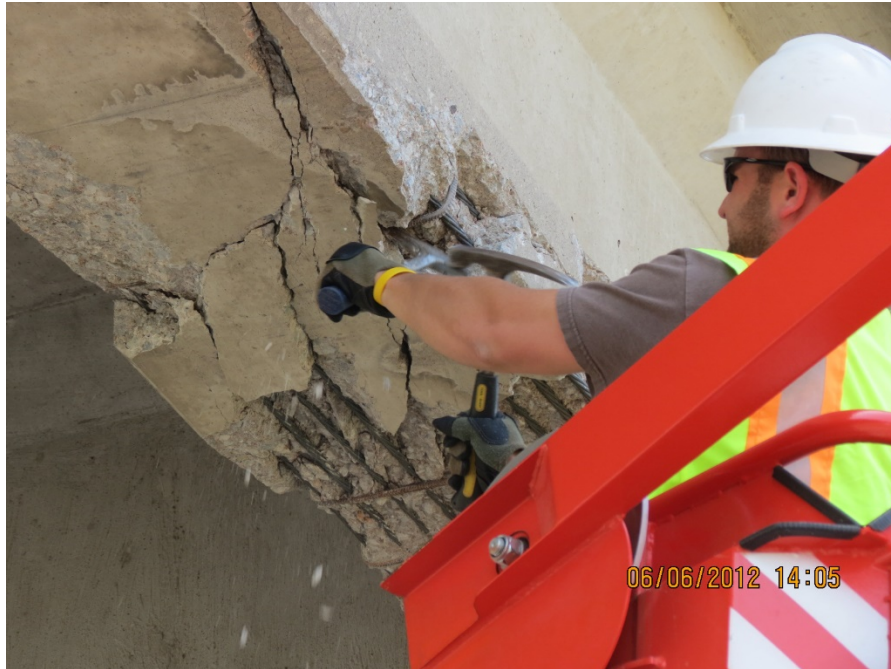
With reference to the accident report, over 40 feet of the exterior girder has been damaged with numerous cracks and spalls as shown in Figure 89. No evidence of any severed strands. No damage was observed on the deck. All loose materials were immediately removed for the safety of I-80 traffic as shown in Figure 90. According to the proposed NDOT damage classification, this damage was classified as Severe II class. However, the bridge girder was replaced since the length of damage was over half of the span length.

Figure 90: Removing all loose concrete immediately from the girder, York East Bridge, courtesy of NDOT

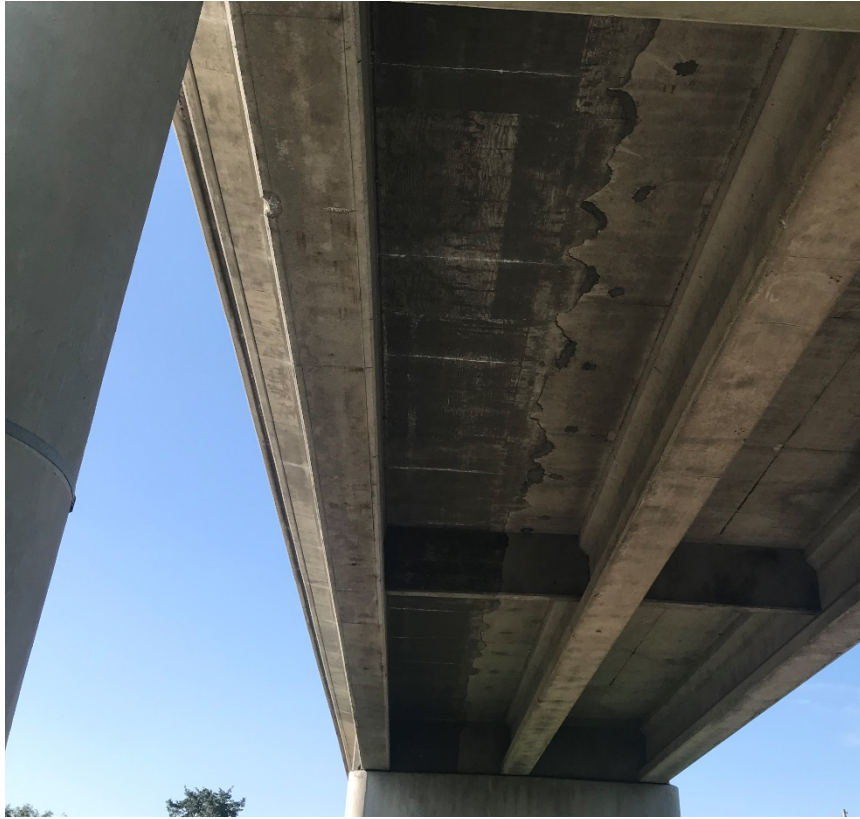
Replacement works took place on July 2012. The latest inspection done on December 2018 reported the superstructure NBI condition rate to be 7 noting minor impact damage to the replaced girder and one other girder with no exposed reinforcement or strands. A visual inspection visit was done on July 2019 noting the minor impact damage as shown in Figure 95 with no notable deficiencies on the replaced girder as shown in Figure 96.

Figure 96: Replaced girder, York East Bridge, courtesy of NDOT

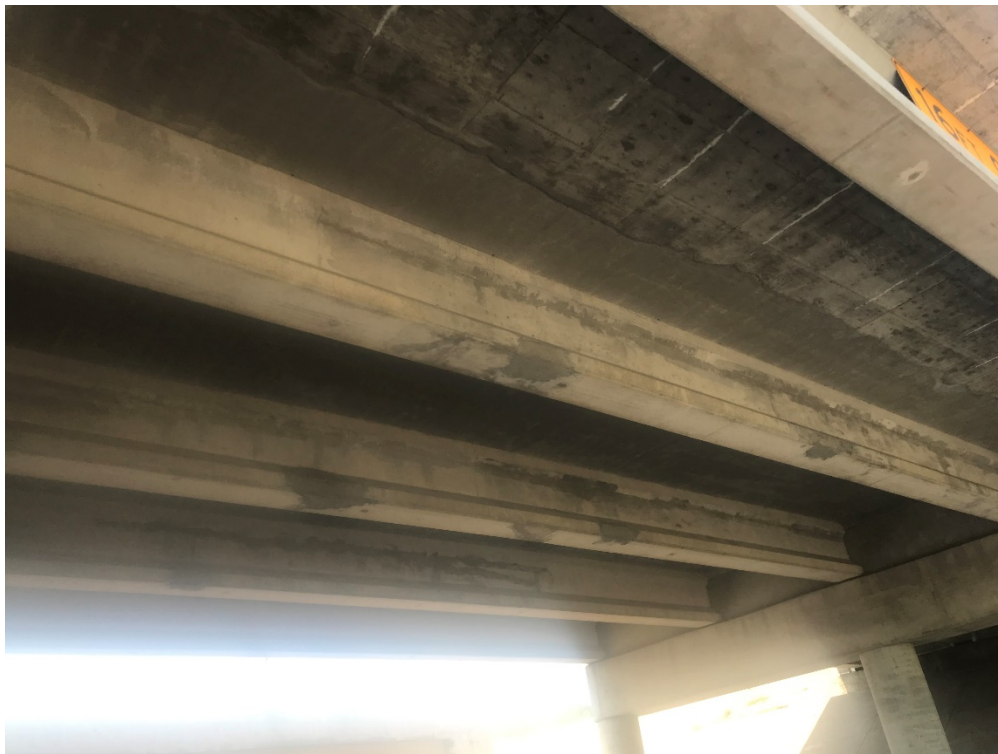
Repair and replacement works took place on August 2012. The latest inspection done on March 2019 reported the superstructure NBI condition rate to be 6 with no notable deficiencies on the replaced girder or the other girder with patching and epoxy injection works. A visual inspection visit was done on August 2019 with no notable deficiencies on the replaced girder or the girders with patching and epoxy injection works as shown in Figure 102 and Figure 103.

Figure 103: Replaced girder and girders with patching and epoxy injection works, I-680 over US-75 Bridge, courtesy of NDOT

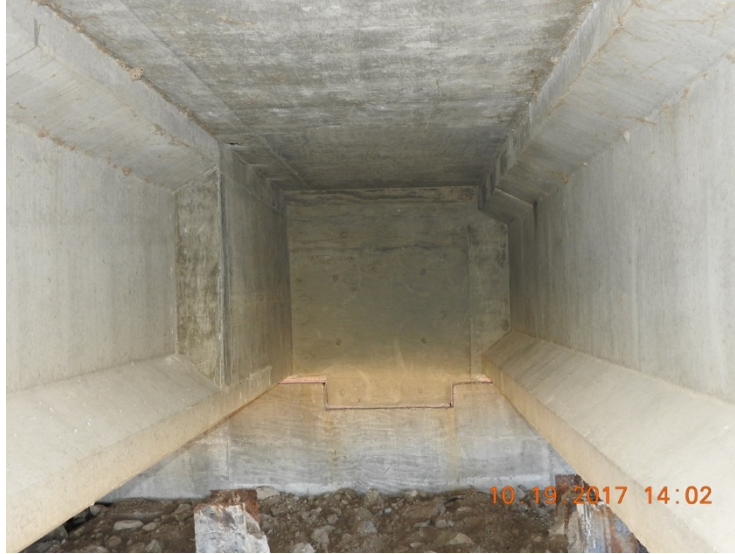
Figure 133: Repaired girder end with a concrete encasement, Alma South Bridge, courtesy of
NDOT

Repair works took place on April 2017. The superstructure NBI condition rate was 6 before repair works and 7 after repair works. Inspection notes before repair works were that one girder had a 0.05" crack at girder end, another girder had a large crack and spall and exposed strands in the bottom flange at girder end. Also, two abutments had considerable spalling with areas of exposed reinforcement. Figures 129 through 132 show deteriorated abutment and girder ends, while Figure 133 shows the repaired girder end after having a concrete encasement.

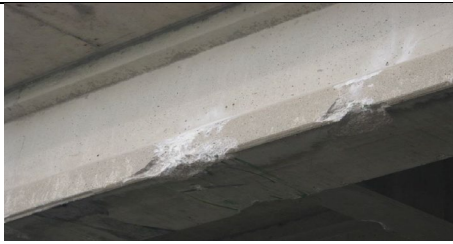
Figure 1: Minor damage, bottom flange spalling, Iowa DOT, 2014

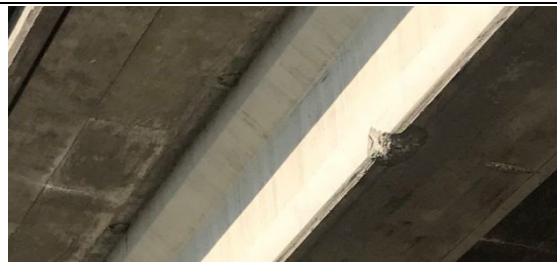
Figure 2: Minor damage, NDOT York Bridge East

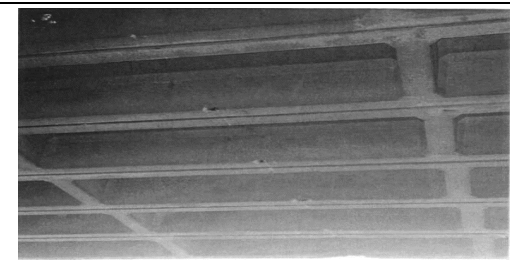
Figure 3: Minor damage, bottom flange cracks, Feldman et al., 1996

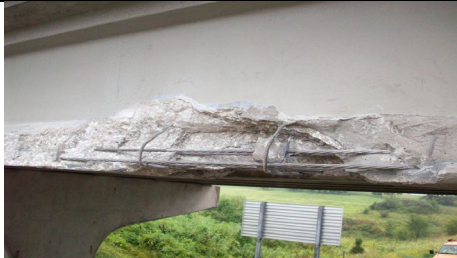
Figure 4: Moderate damage, exposed intact strands, Iowa DOT, 2014

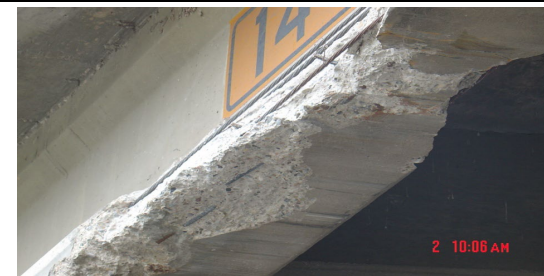
Figure 6: Moderate damage, exposed intact strands, Pantelides et al., 2010

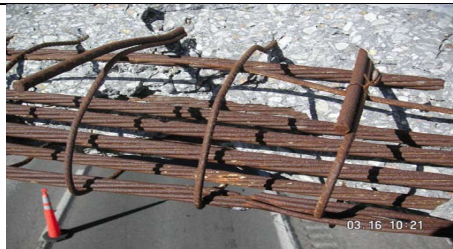
Figure 7: Severe I damage, one severed strand, NDOT Wood River Interchange Bridge Girder (A)

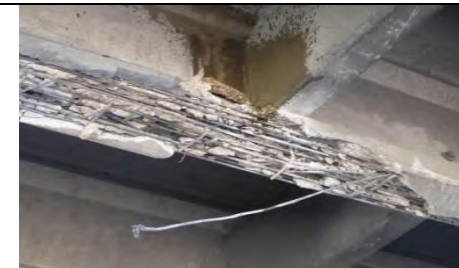
Figure 9: Severe I damage, one severed strand, Harries et al., 2012

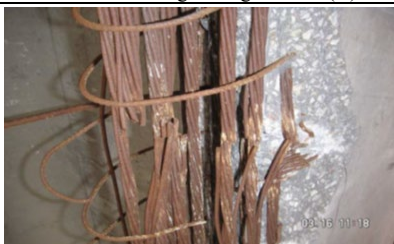
Figure 10: Severe II damage, five severed strands, NDOT Wood River Interchange Bridge Girder (E)

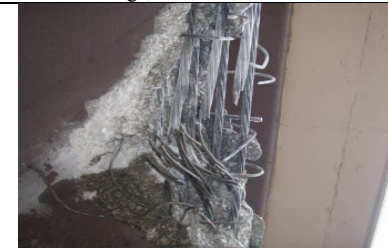
Figure 12: Severe II damage, three severed strands, NDOT Scottsbluff Gering Bypass Bridge

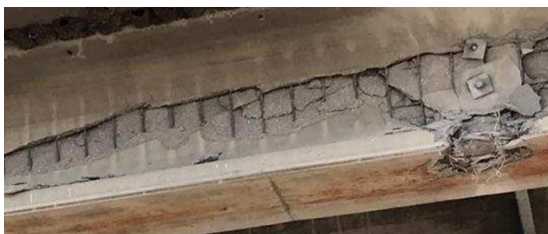
Figure 13: Severe III damage, several damaged strands, NDOT Schuyler Bridge

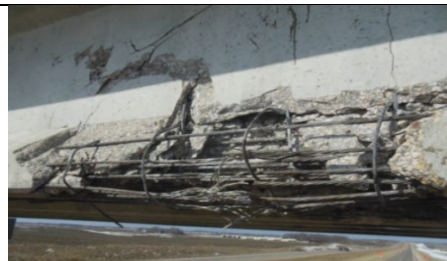
Figure 14: Severe III damage, several damaged strands, Iowa DOT, 2014

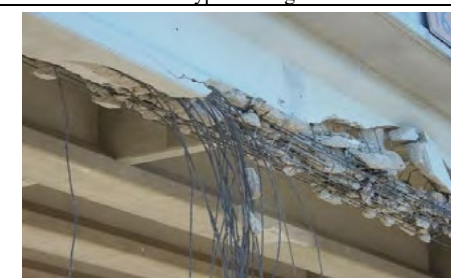
Figure 15: Severe III damage, several damaged strands, Harries et al., 2012

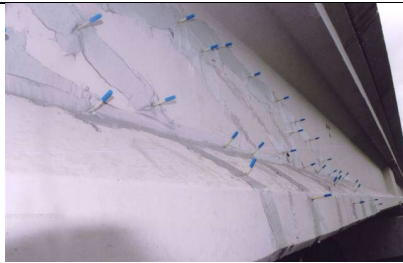
Figure 16: Epoxy injection ports, AIT, 2005

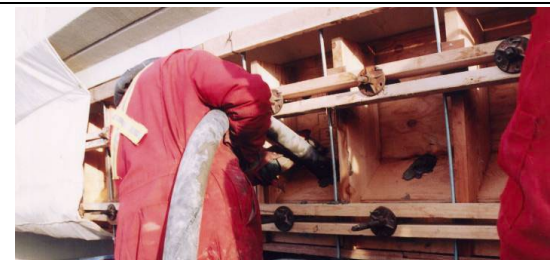
Figure 18: Pumping concrete into plywood formed section, AIT, 2005

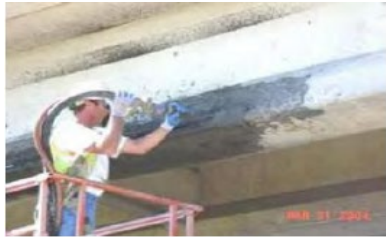
Figure 19: Shotcrete patch, Harries et al., 2012

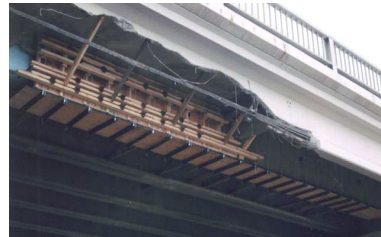
Figure 20: Patching plywood form to restore cross-section, AIT, 2005

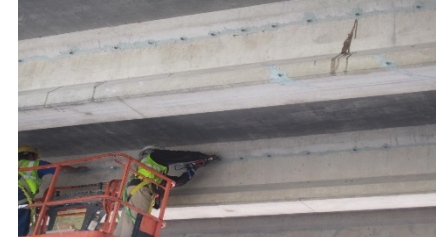
Figure 21: Epoxy injection process done in I-680 over US-75 Bridge

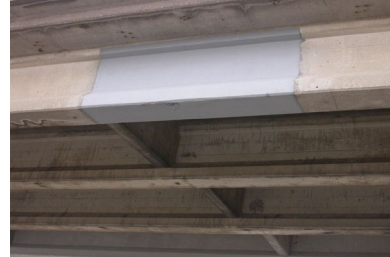
Figure 23: FRP Wrapped Repair, Iowa Dot, 2014

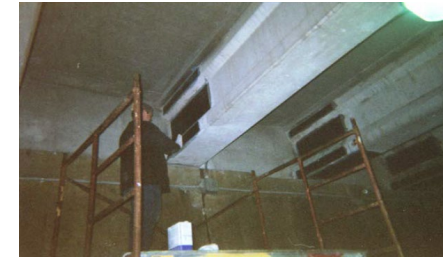
Figure 24: CFRP fabrics installation, Choo et al., 2013

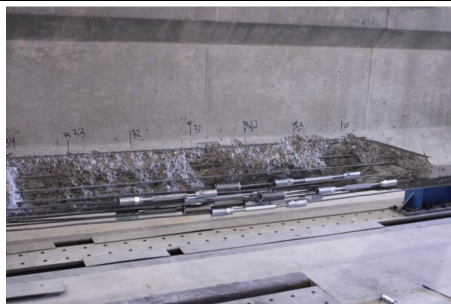
Figure 25: Strand splicing, Jones, 2017

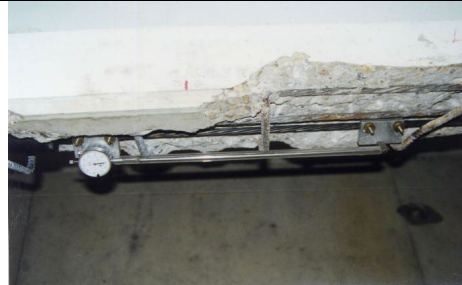
Figure 26: Strand splicing, dial gauges and devices to monitor elongations and strand force, AIT, 2005

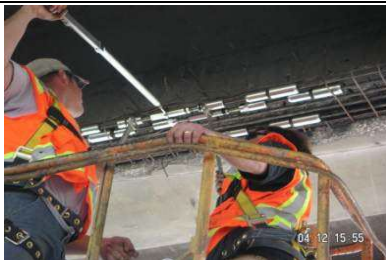
Figure 28: Strand splicing with a torque wrench, Enchayan, 2010

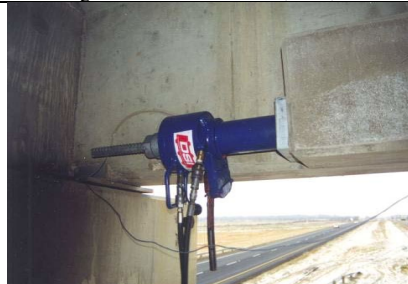
Figure 29: External post-tensioning end block, AIT, 2005

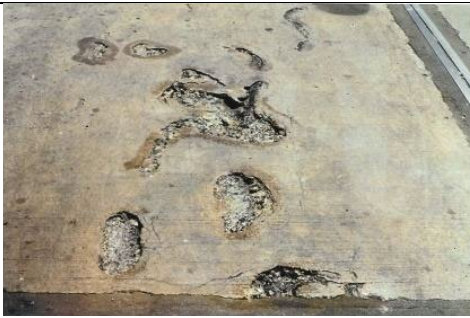
Figure 1: Minor damage, surface spalling with no exposed reinforcement, Naito et al., 2006

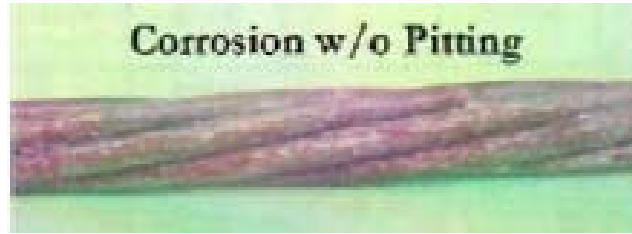
Figure 2: Moderate damage, exposed strands having corrosion without pitting, Naito et al., 2006

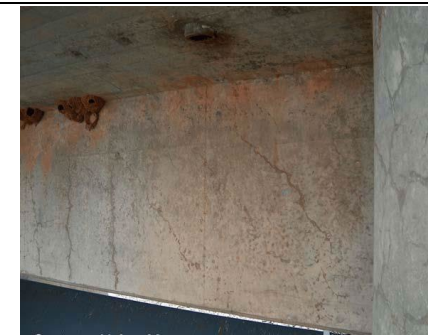
Figure 3: Moderate damage, hairline cracks, WisDOT, 2018

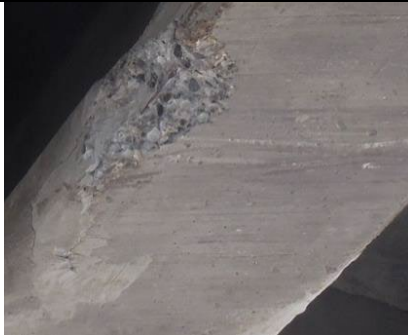
Figure 4: Moderate damage, one exposed strand on concrete bridge girder, WisDOT, 2018

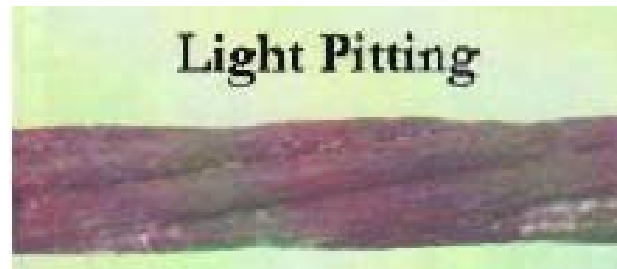
Figure 5: Extensive damage, exposed strands having corrosion with light pitting, Naito et al., 2006

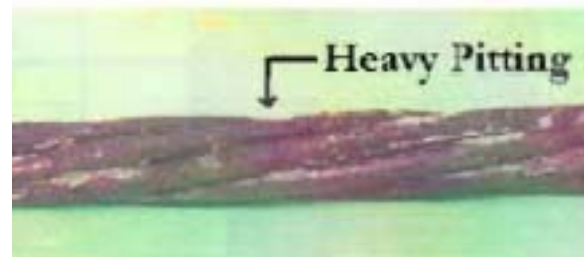
Figure 8: Severe damage, exposed strands having corrosion with heavy pitting, Naito et al., 2006

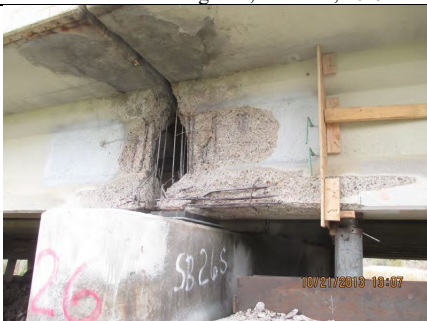
Figure 10: Severe damage, exposed strands > 15 %, MN/RC 2018-07 Report

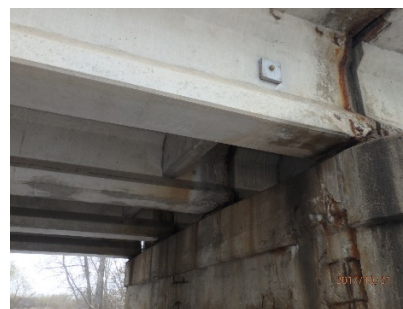
Figure 11: Severe damage, exposed strands, NDOT Platte River South Bridge

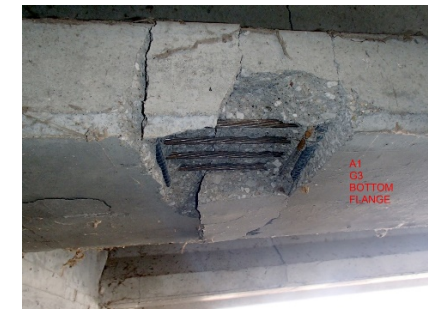
Figure 12: Severe damage, exposed strands, severe cracks or fractures, NDOT Alma South Bridge
