# Non-Cementitious Repair Materials Study

Final Report

WisDOT Project No. 0092-18-02  
June 2019

WISCONSIN HIGHWAY RESEARCH PROGRAM

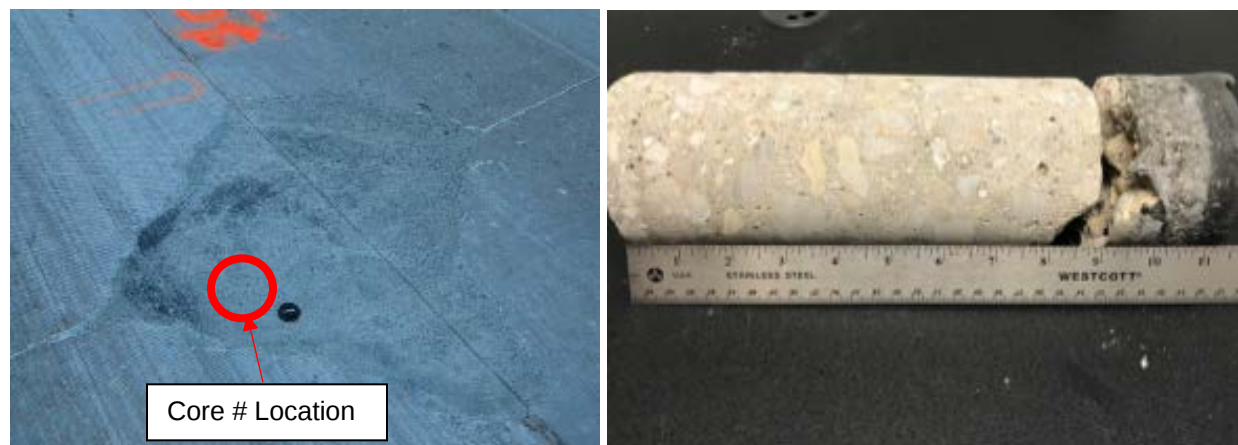
Prior to the replacement of the RM-1 PDRs, the project team had the opportunity to conduct a field visit to document the condition of the PDRs and extract three cores in July 2018. The first core was extracted from an apparently sound PDR on the left most lane, close to a transverse joint. The thickness of the underlying pavement in this location was approximately 8.5 inches and the thickness of the PDR was around 2.5 inches (see figure 3-3).

Figure 3-3. RM-1 core location #1 (left) and extracted core #1 (right).

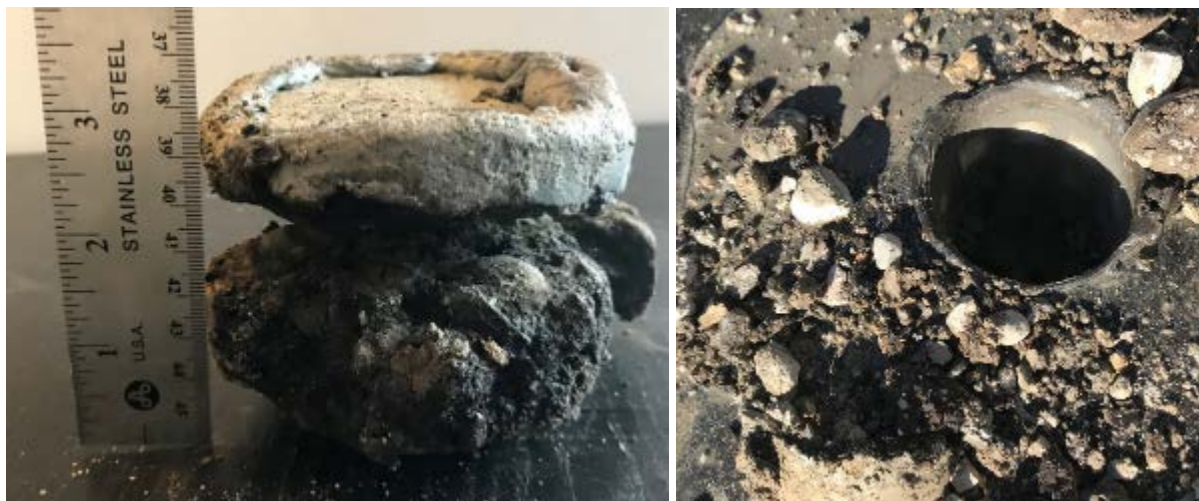
In areas where the cores were extracted (Sites #5 and #8), the underlying concrete pavement was deteriorated to such an extent that only loose material was found beneath the repair material. At Site #5, the extracted repair material deteriorated into multiple pieces even through the repaired

Figure 3-14. RM-3 core from Site #5 (left) and remains of underlying concrete pavement extracted from the core hole (right).

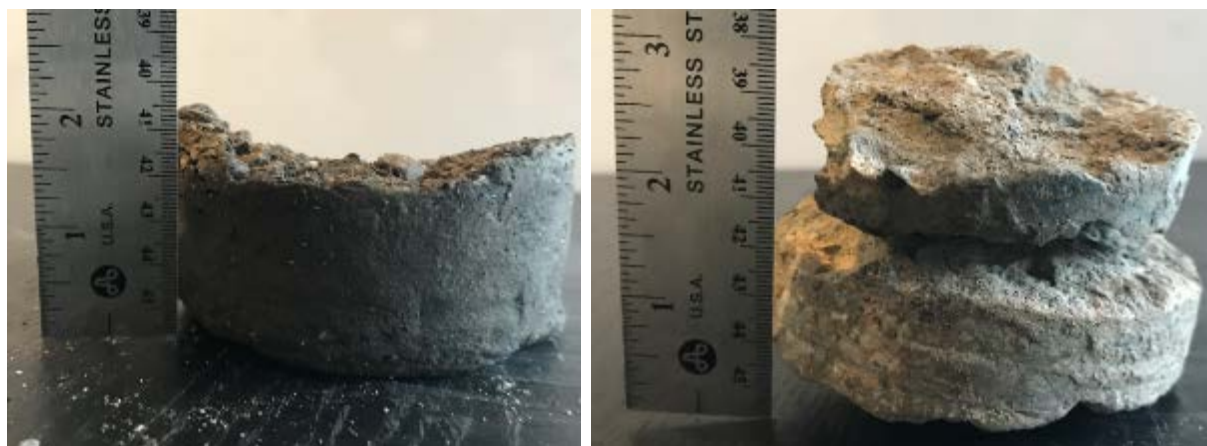
Figure 3-15. RM-3 core from Site #8 (left) and pieces of underlying concrete pavement extracted from the core hole (right).

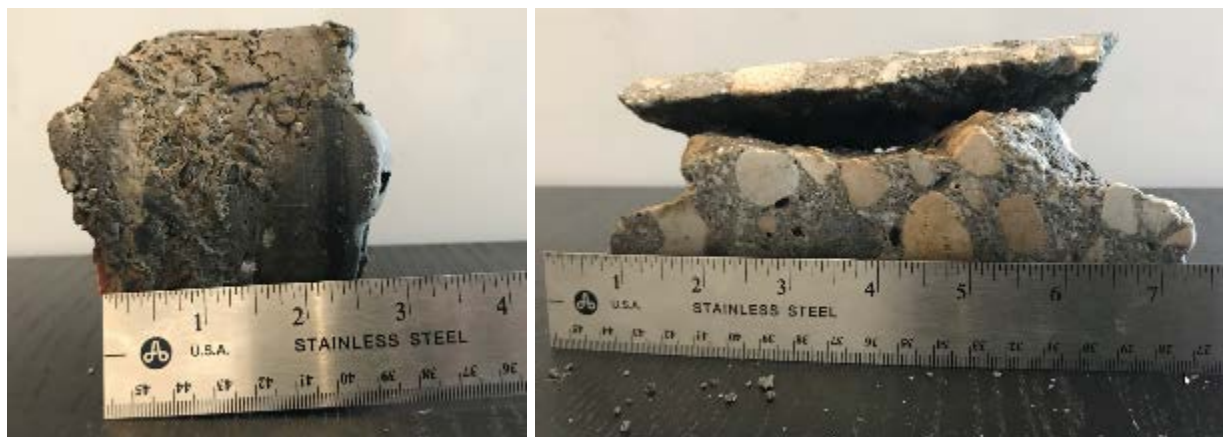
Figure 3-17. RM-4 core from Site #9 (left) and pieces of underlying concrete pavement extracted from the core hole (right).

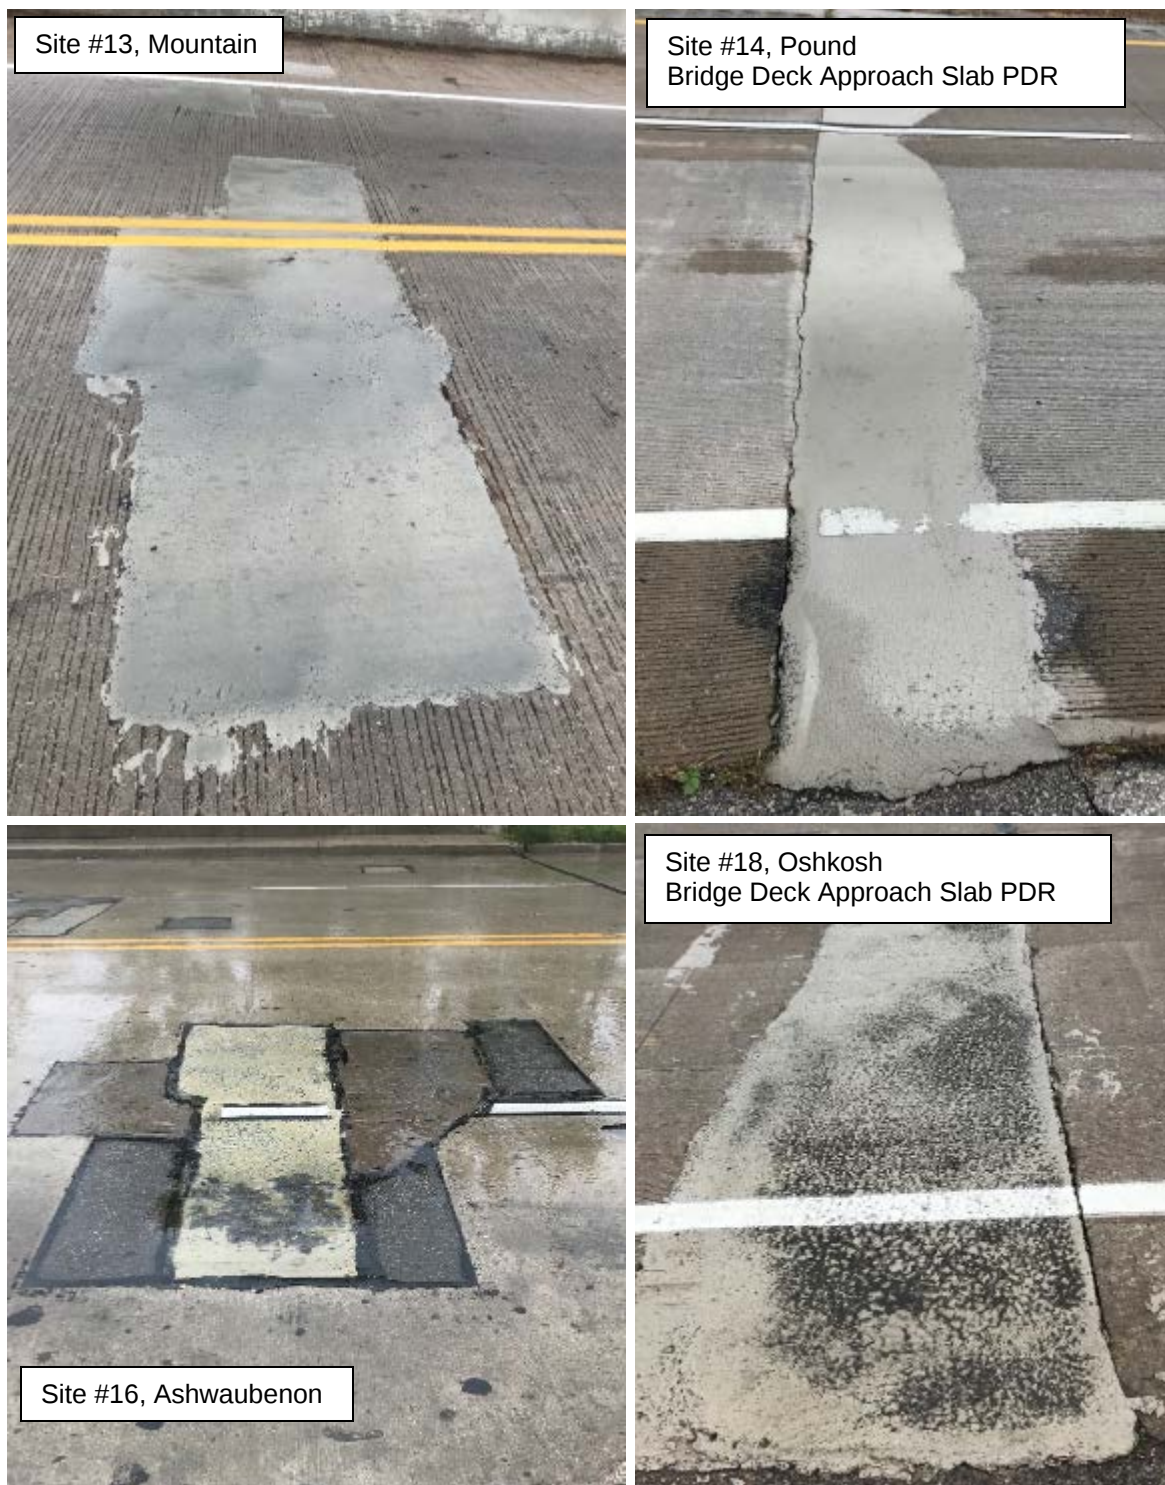
Figure 3-19. RM-4 used in bridge applications.

The RM-4 repairs on bridge decks appear to be performing satisfactorily. In fact, some of the bridge deck PDRs have been in service for over 5 years without any failures. The surface of the PDRs on Site #16 (see figure 3-19, bottom left) have very different tints and appear to have been

performed at different times and the repair boundaries have been sealed with a flexible sealant material. The material manufacturer claims that all the repairs on Site #16 were performed using RM-4 and attributed the difference in color to contaminants from the mixing equipment. The same mixing equipment (see figure 3-20) is used for both RM-3 and RM-4. The material manufacturer noted that if the equipment is not cleaned properly after using it to mix RM-3, the RM-4 mix produced using the same equipment is expected to have a darker shade.

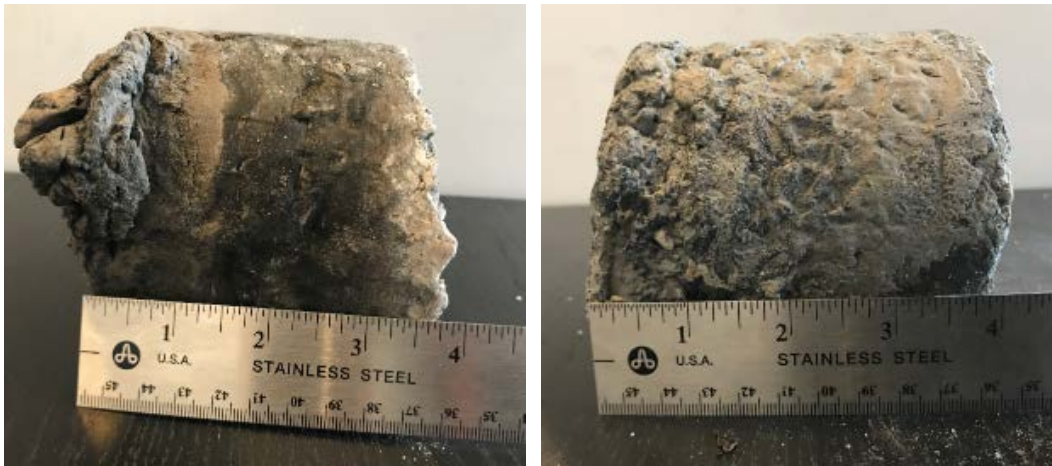
Figures 3-24 show photographs of the extracted cores. At both the sites, the underlying concrete pavement was completely deteriorated and only loose material was found beneath the RM-5 material.

Figure 3-24. RM-5 cores from Site #20 (left) and Site #23 (right).

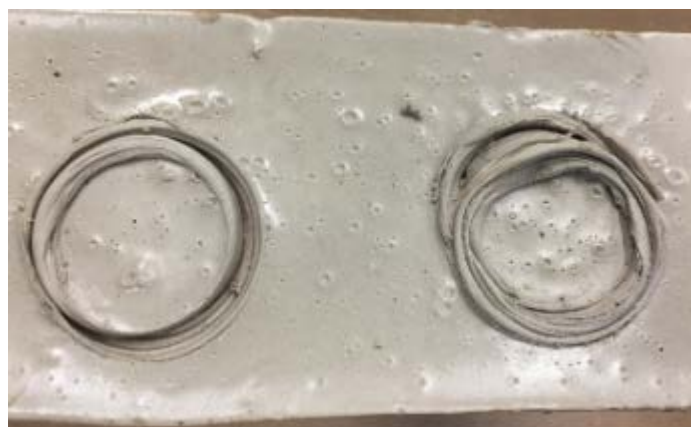
- At -23 °C, the glue used to stick the steel disc to the surface of the repair material failed to hold up during the bond-testing process and the bond between the steel disc and the material failed. Three different cold-temperature resistant glues were tried without any success. After several unsuccessful attempts (on 10 different specimens), eventually one successful test was performed.
- For RM-4 and RM-5, it was not possible to drill the 2-inch core hole successfully. As discussed in the previous chapter, the repair material melted during the coring process. When the core drill was removed from the specimen, the melted material filled up the hole and it was not possible to achieve smooth, uniform top surface which is essential for bond testing process (see figure 4-8).

Figure 4-8. Unsuccessful specimen preparation effort for bond testing.

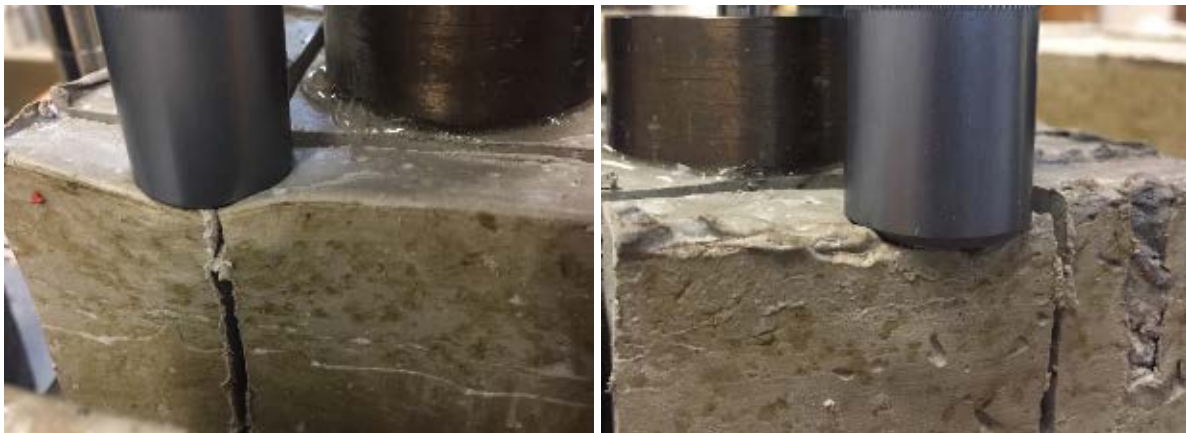
- The bond testing on the RM-4 and the RM-5 specimens using the modified approach described had a number of other issues:
  - At a testing temperature of 23 °C, the material was just too soft and was unable to support the reaction forces during pull-out test (see figure 4-10).

Figure 4-10. RM-4 specimens being crushed by the bond testing equipment at 23°C.

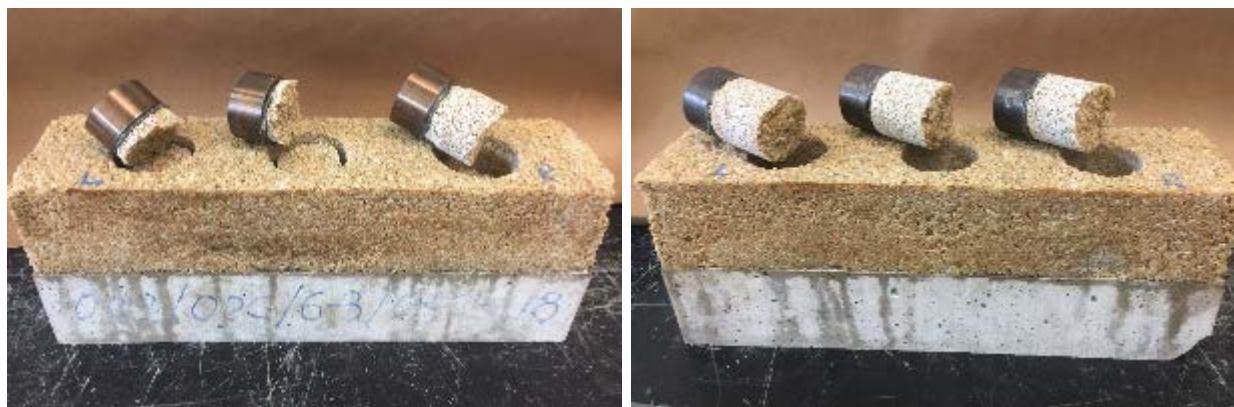
For RM-2, the failure was observed within the repair material and not at the bonding interface for the testing temperatures of 23 °C and -10 °C (see figure 4-12). The bond between RM-2 and the substrate concrete appears to be stronger than the tensile strength of the material at these temperatures. While the failure plane was very close to the surface at a testing temperature of 23 °C, a comparatively deeper failure was observed at -10 °C. At -23 °C, only one successful test could be performed.

Figure 4-12. Failures observed after pull-off testing at 23 °C (left, shallow failures) and -10 °C (right, deep failures).

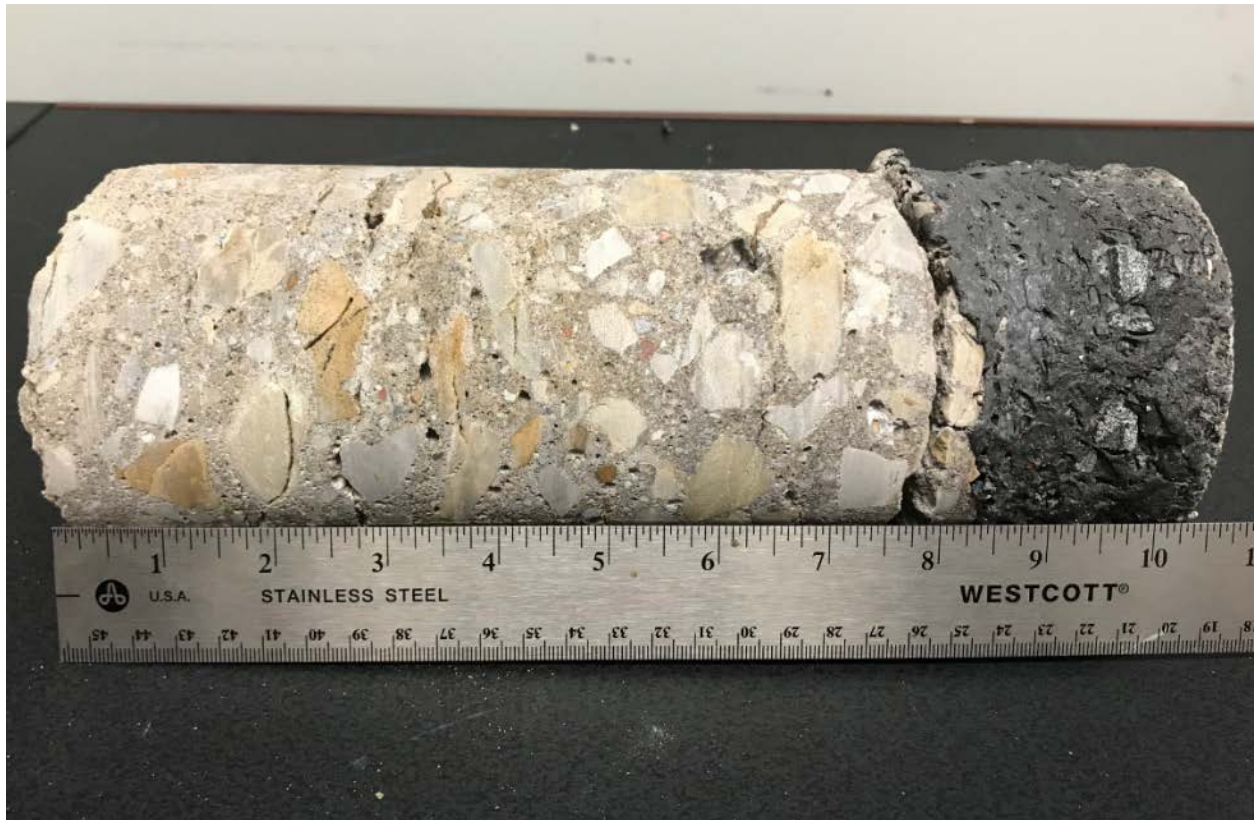
A closer examination of the substrate concrete revealed multiple parallel horizontal cracks through the entire depth of the core (see figure 3-7) and these cracks extend through the coarse aggregates. This potentially suggests freeze-thaw-related damage, however, since petrographic analysis was not performed on the extracted cores, this speculation cannot be confirmed.

One of the core specimens extracted (see figure 3-7; Site #1, Core #2, Madison Beltline) exhibited multiple parallel horizontal cracks through the entire depth of the sample. When this specimen was conditioned at -23 °C for UPV testing, it completely disintegrated. Extremely cold temperatures during the winter seasons could potentially result in deterioration of the substrate concrete in areas where it is already in poor condition. This situation will surely compromise the bond between the repair material and the underlying concrete and can cause the material to pop out of the repair area.

Figure A-5. Site #1, RM-1 Core #2  
(US 12/18, Madison Beltline).

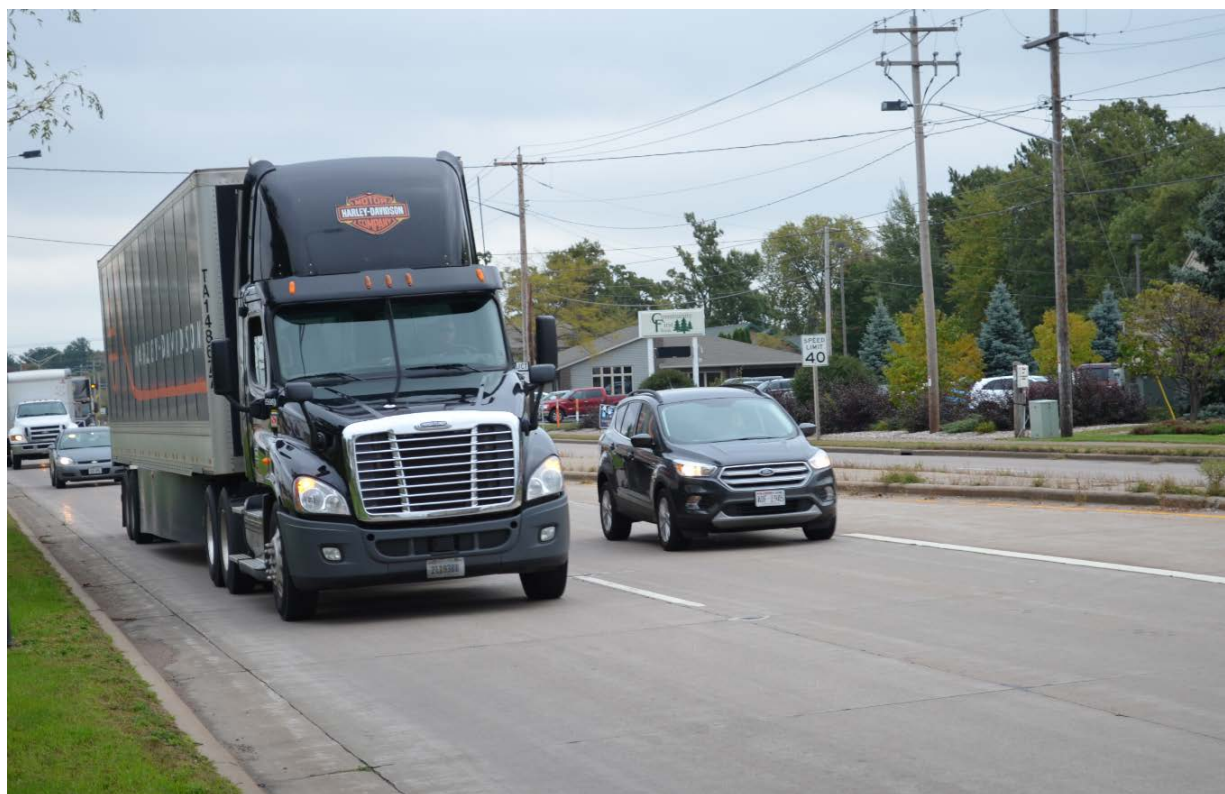
Figure E-7. Typical rush hour traffic  
(Site #11, US 10, Stevens Point).

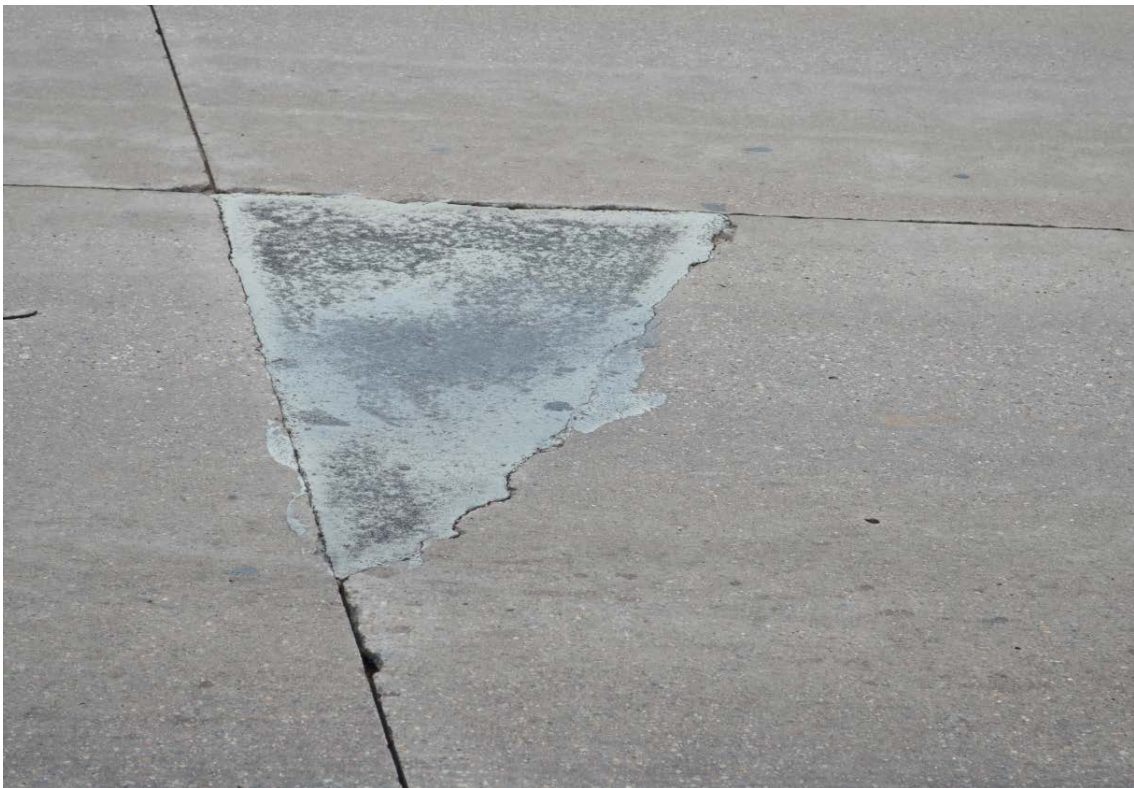
Figure E-13. PDR to address corner break  
(Site #11, US 10, Stevens Point).
