Assessment, Repair, and Replacement of Bridges Subjected to Fire

**Final Report
August 2022**

Sponsored by
Iowa Department of Transportation
(InTrans Project 20-734)
Federal Highway Administration

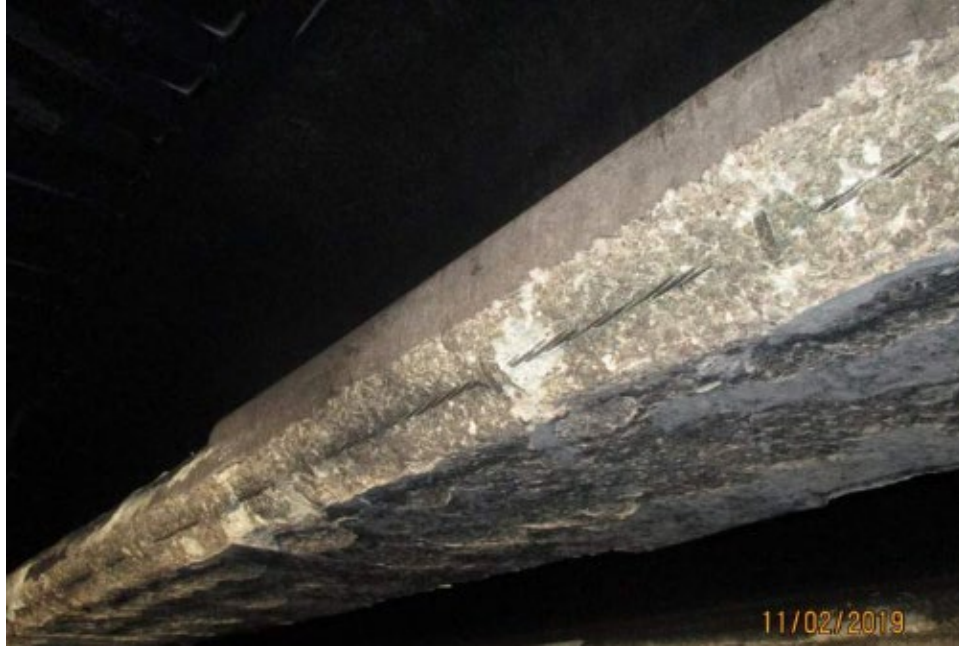
Figure 2. Concrete spalling on concrete girder

Figure 3. Exposed steel reinforcement strands and stirrups on Beam E

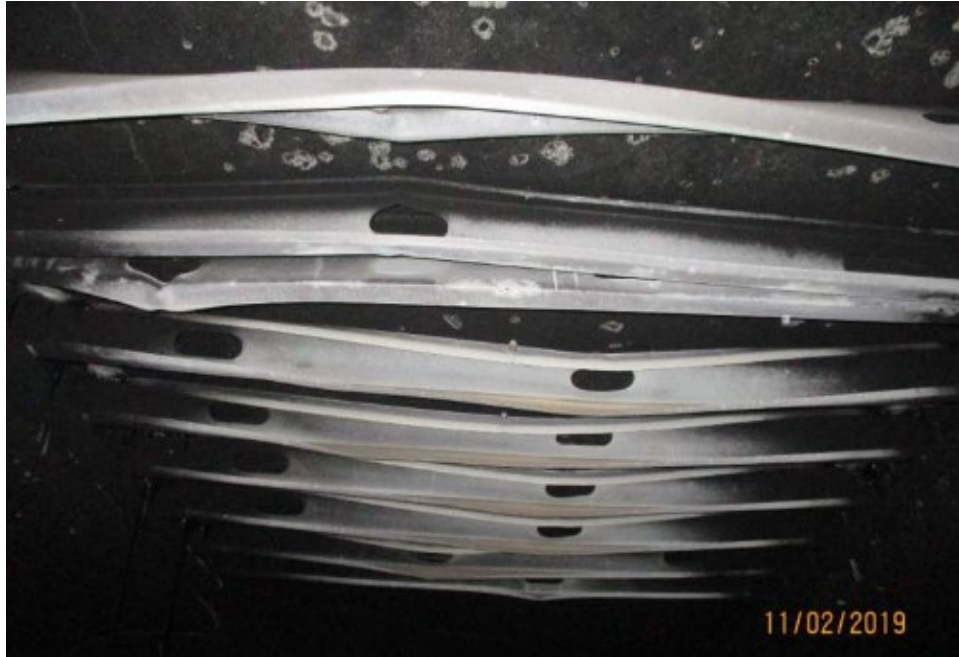
Figure 5. Melted polycarbonate formwork between Girders G and F

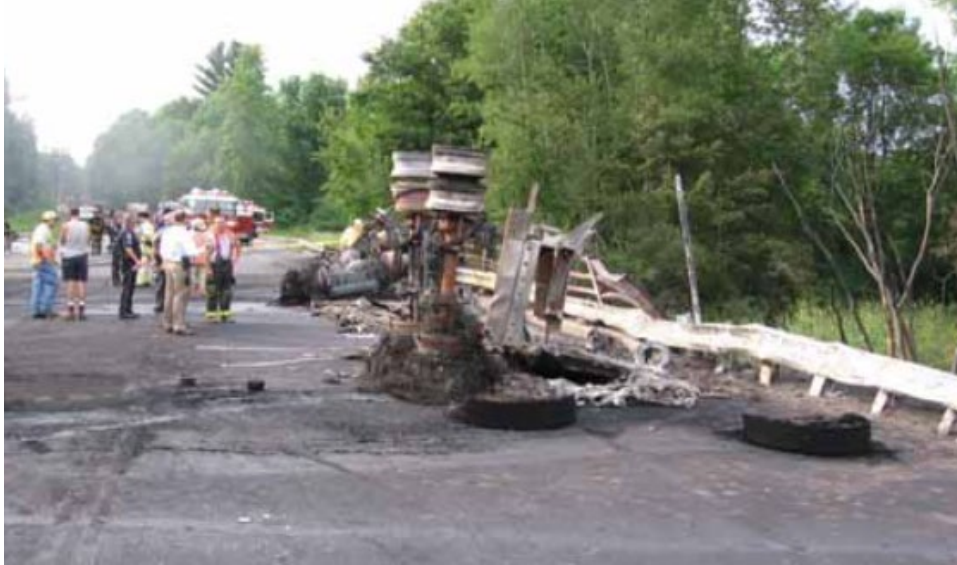
Figure 16. Tanker truck remains on US 7 Bridge in southwestern Connecticut after fire

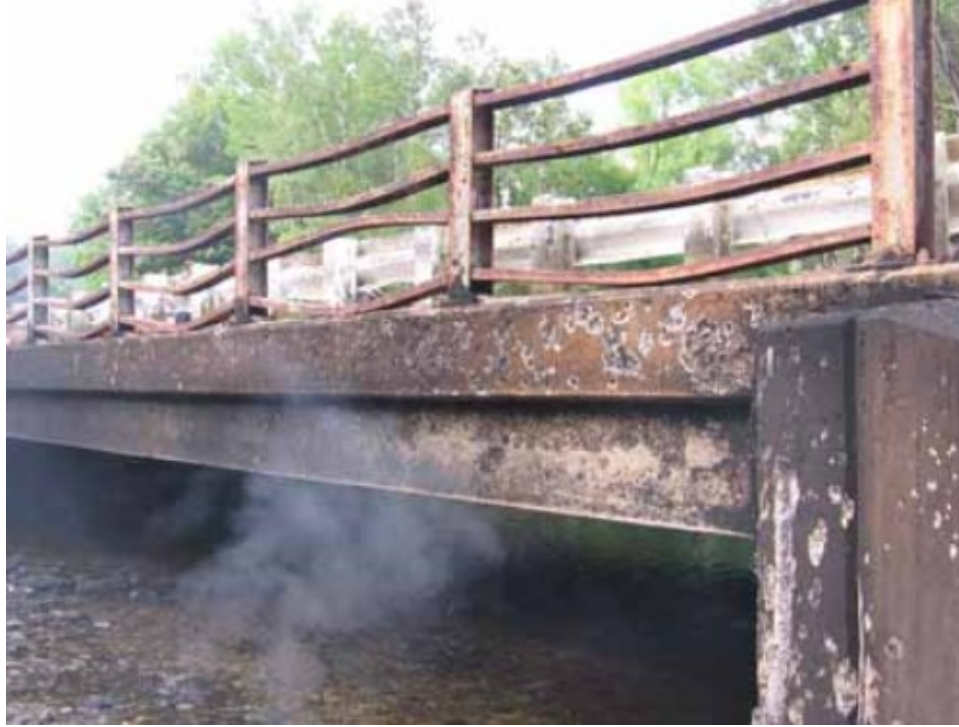
Figure 17. US 7 Bridge fascia after fire
