Summary of Case Studies and Observations on Airport Experience with Pavement Surface Treatments

August 2023

DOT/FAA/TC-TN23/49

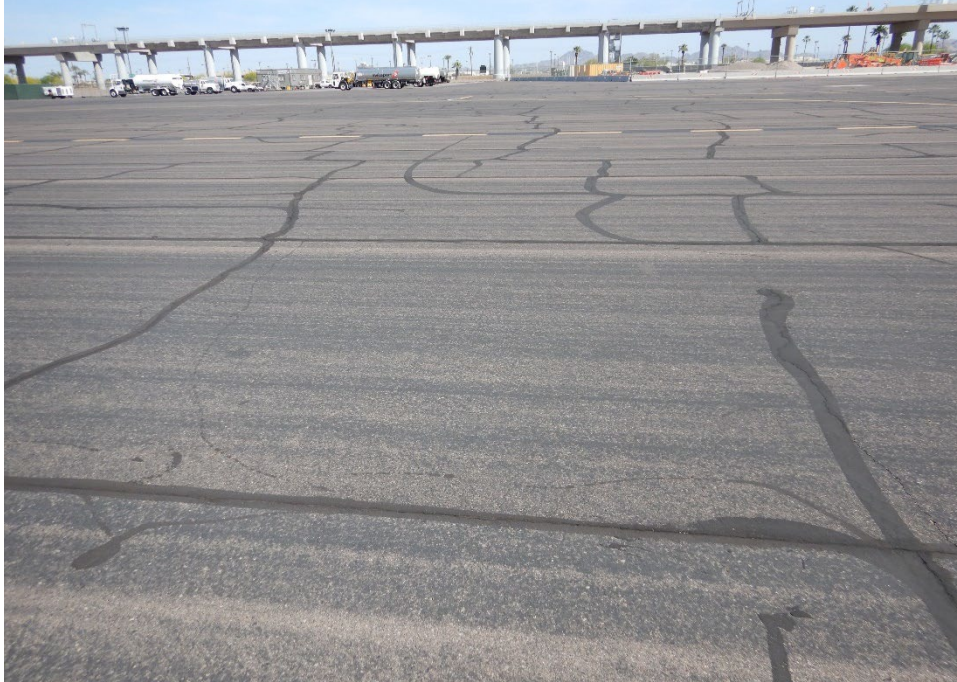
In 2016, PHX used Acrylic Coat, a non-FAA asphalt emulsion surface treatment, on Taxiway A and the East Cargo Apron area, both of which were constructed in 2013. The treatment is an emulsion based on cationic binders and polymers and was introduced to replace RS-44E. This product maintains its color well, delineates different surfaces, and does not produce a strong odor. A cursory visual inspection in 2022 showed that Acrylic Coat had good coverage on the taxiway, with only 5% coarse aggregate exposed, but was near the end of its service life on the apron area, with approximately 75% coarse aggregate exposed. L&T cracking on the East Cargo Apron, which was partially present prior to the treatment application, was extensive. A streaking pattern was present on the surface treatment as seen in Figure 9. New cracks had continued to develop on all pavements. Fading seemed to be the major deterioration mechanism in both locations. FOD production was not a concern as no flaking or chipping was observed for the Acrylic Coat. Overall, the airport has been satisfied with the pavement performance of Acrylic Coat. The longevity of Acrylic Coat is slightly less than RS-44E, but it does not produce the strong, offensive odor of RS-44E.

Figure 7. East Cargo Apron at PHX With Acrylic Coat

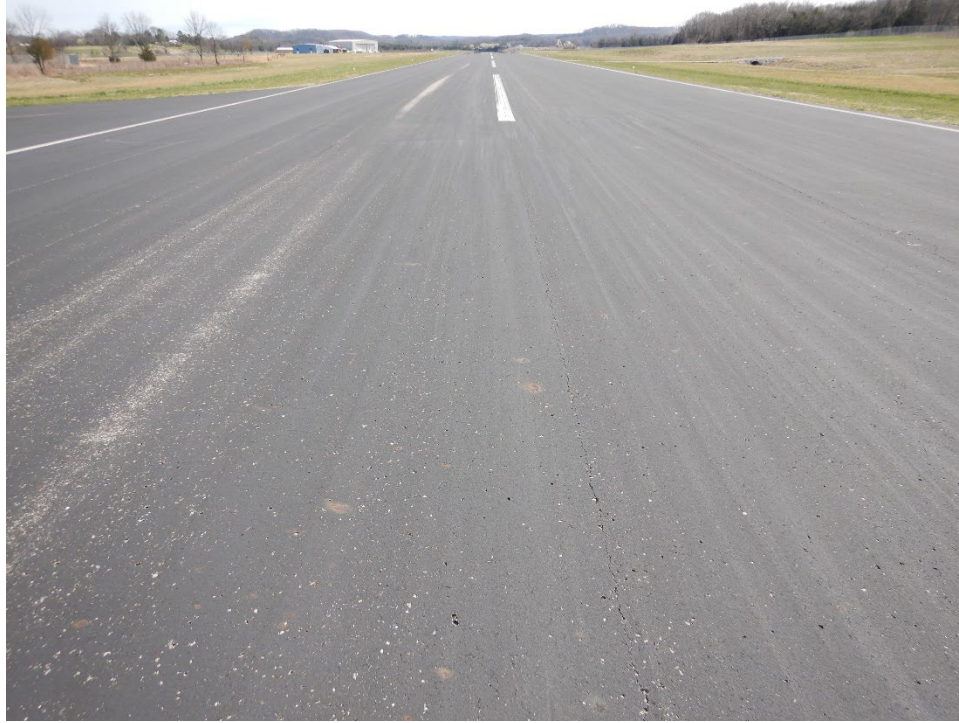
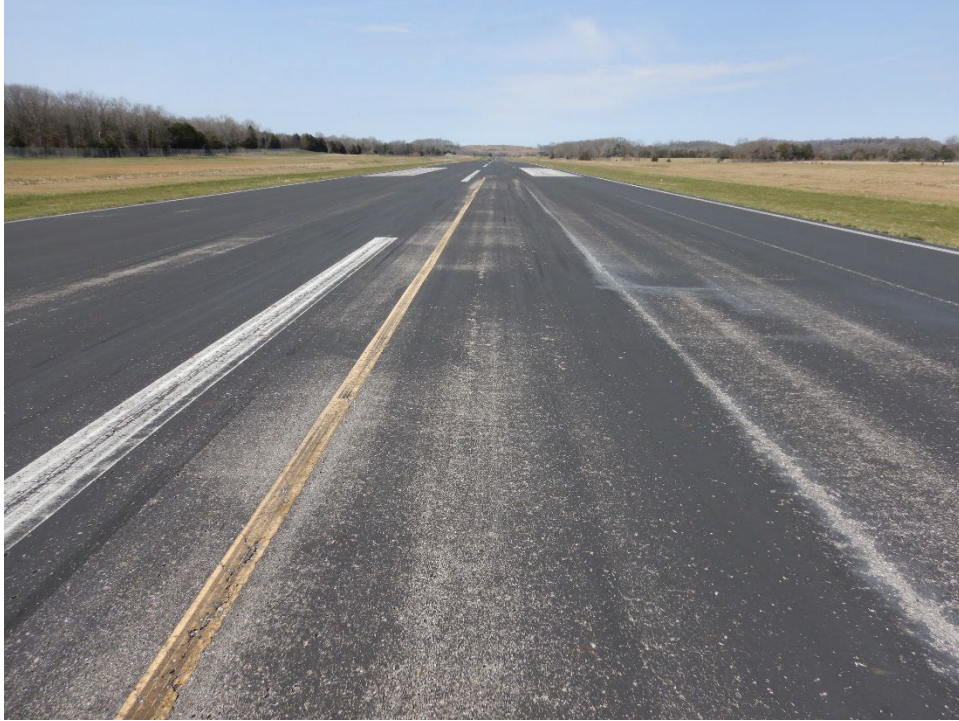
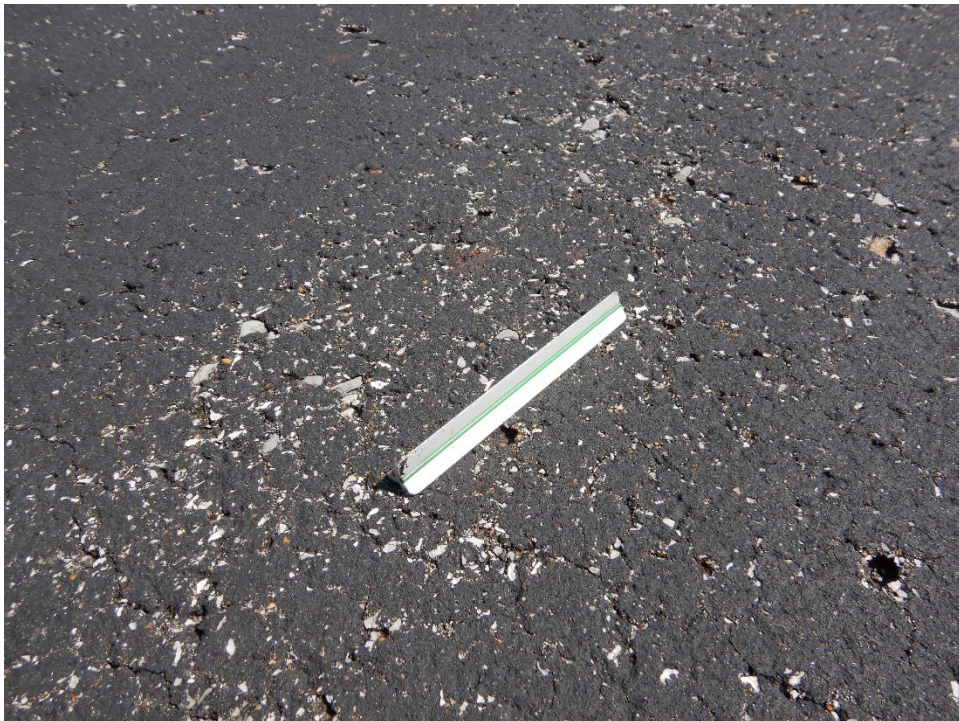
Flaking was present but is not a considerable foreign object debris (FOD) concern. A map cracking pattern was also very apparent in many locations, and a tire wearing pattern was visible longitudinally along portions of Runway 16/34. Longitudinal and transverse (L&T) cracking along the longitudinal paving joints on Runway 16/34 was observed. Additionally, low-severity L&T cracking and medium-severity L&T cracking with spalling and a minor amount of suspected pumping were observed at the end of Runway 34. L&T cracking was common throughout the apron and was approaching the density of block cracking in some areas. The L&T cracking on the apron included a mixture of sealed and unsealed cracks. Most of the L&T cracking was at low severity; some medium-severity L&T cracking was present due to a mixture of failed sealant and minor spalling. Vegetation was also present in some cracks.

The Pavement Condition Index (PCI) of the pavement sections ranged between 72 and 84 in the 2019 inspection. Based on the continued deterioration of the surface treatment and the condition of the cracks, PCIs could have been between 5 and 10 points lower in 2022. In 2022, a project to reapply a coal tar product at GZS is being planned due to the satisfaction with the longevity of the surface treatment. Pictures of the GZS Runway overview, TAD-625 coverage, and tire marks in 2022 are presented in GZS-1 through 13.

Figure GZS-1. Runway 16/34 Overview with TAD-625

Figure GZS-2. TAD-625 Coverage on Runway 16/34

Figure GZS-3. TAD-625 texture on Runway 16/34

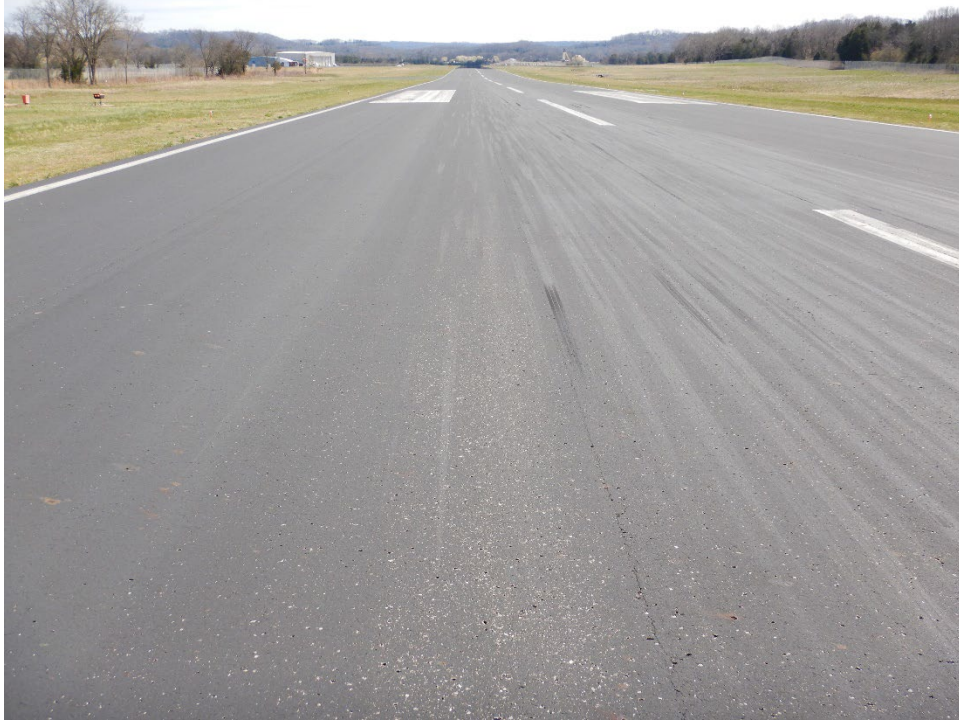
Figure GZS-4. Tire Marks on Runway 16/34

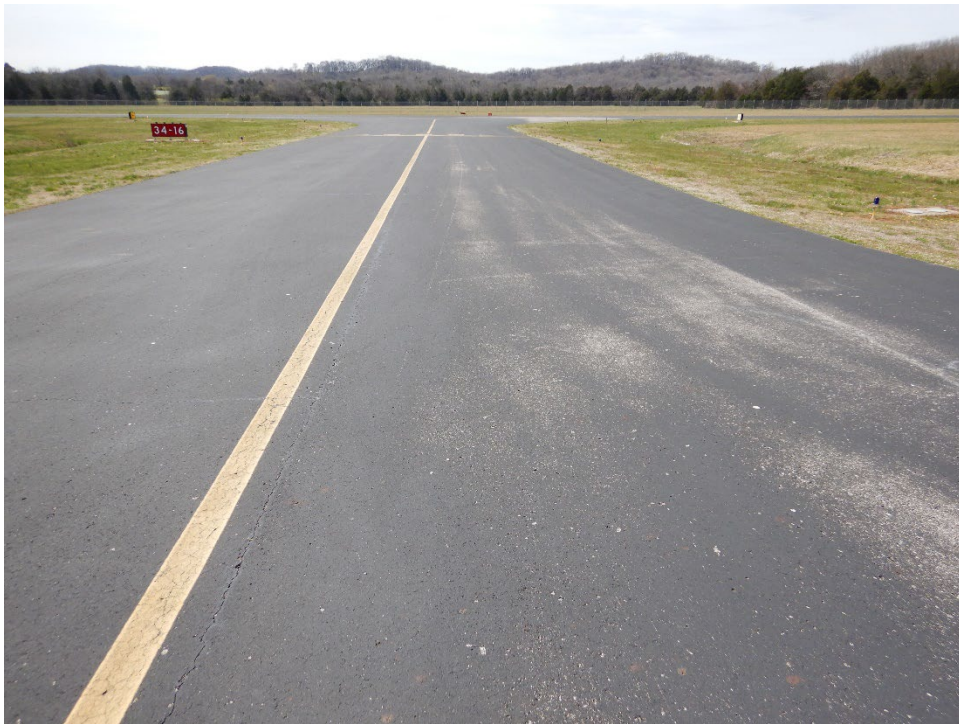
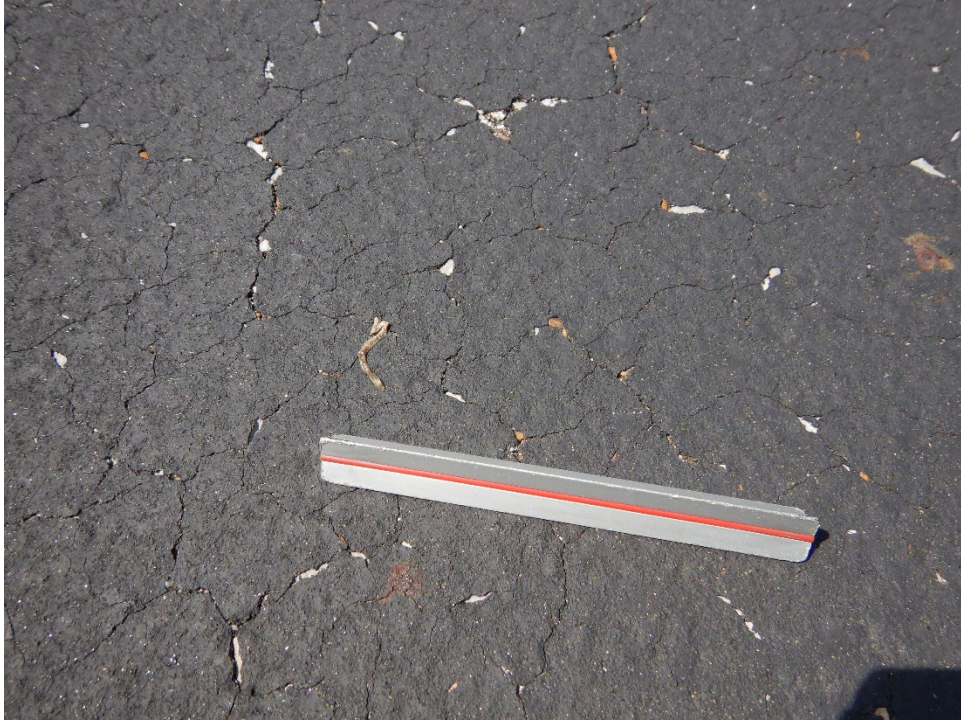
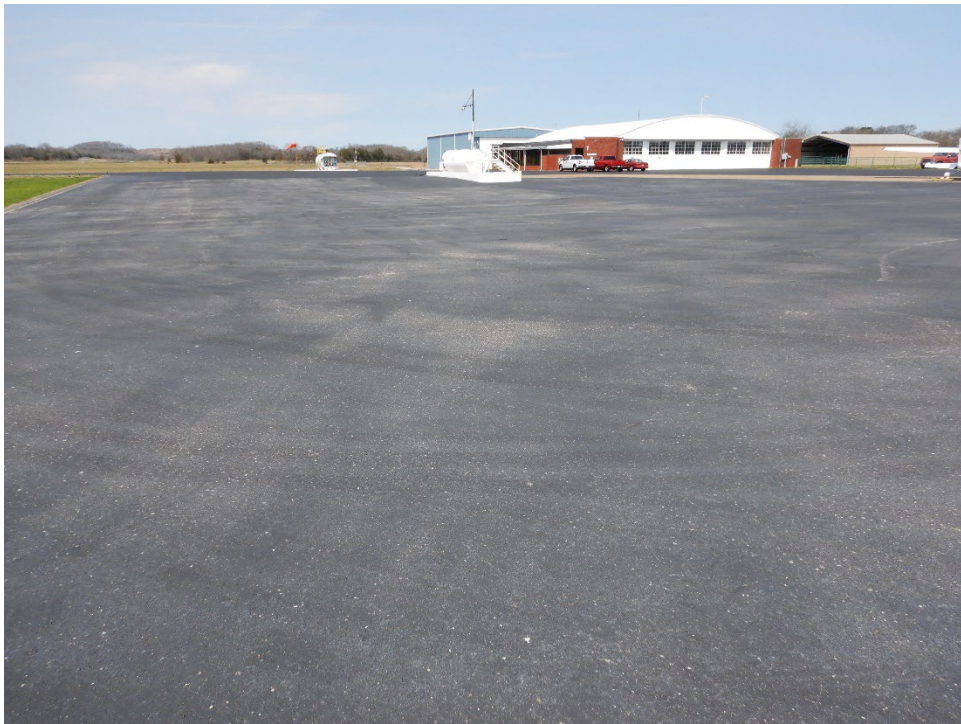
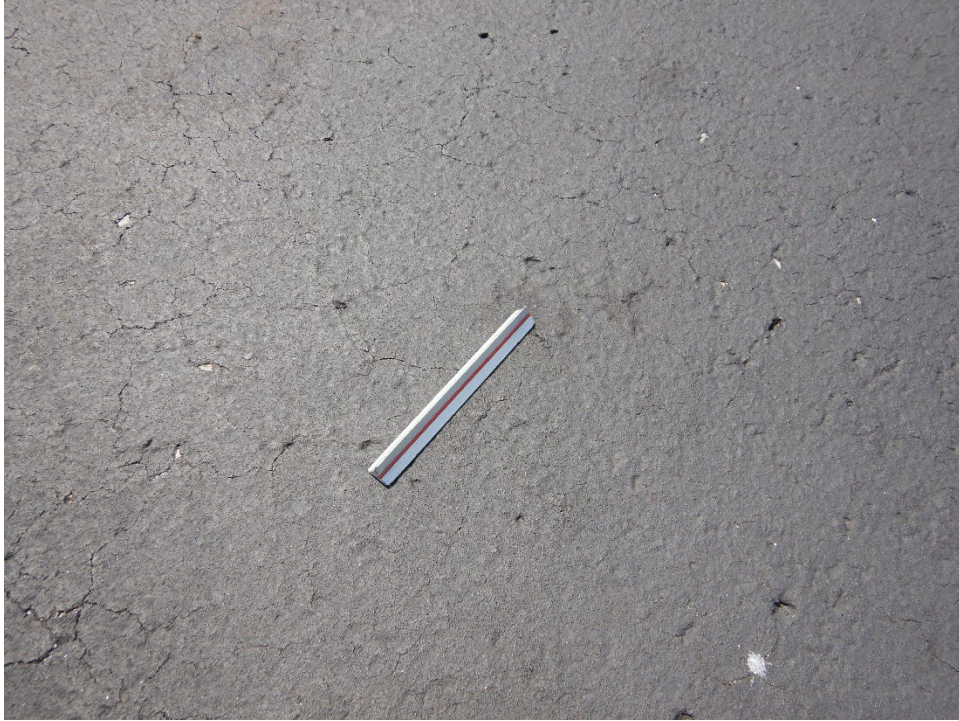
Figure GZS-7. Connector Taxiway Overview with TAD-625.

Figure GZS-8. TAD-625 Texture on Connector Taxiway

Figure GZS-9. Apron Overview with TAD-625

Figure GZS-10. TAD-625 Texture on Apron

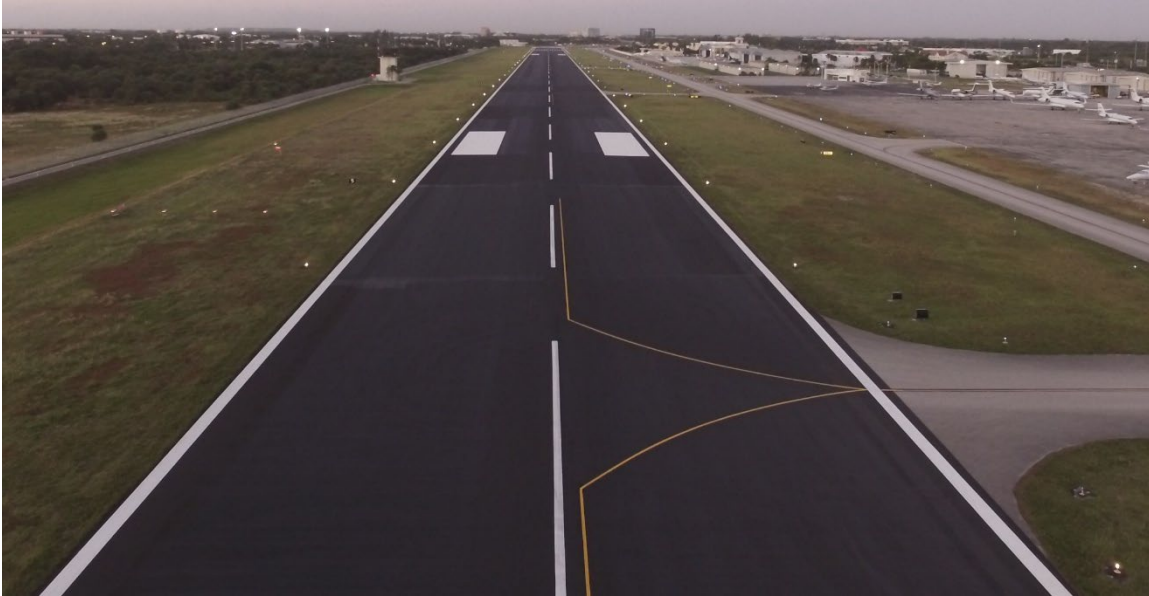
Figure BCT-1. Runway 05/23 Shortly After P-608-R Application

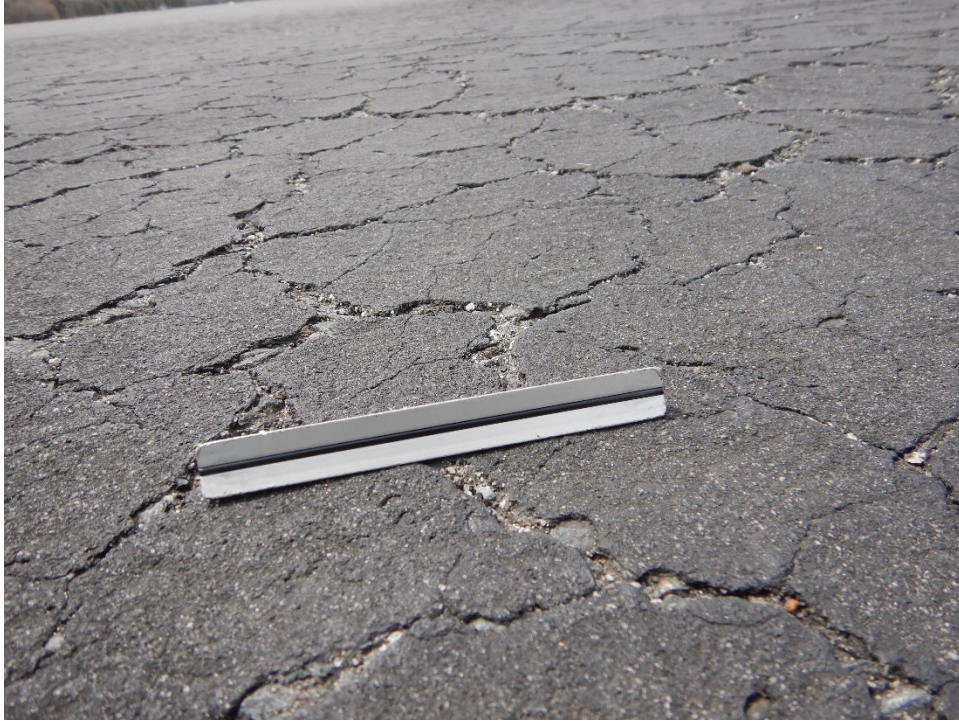
Severe chipping/raveling of the surface treatment was observed on the aprons, which can lead to FOD production. L&T and block cracking with some vegetation were also common on the apron. There was also raveling of the pavement surface where the surface treatment was worn away and the underlying pavement was exposed. Shrinkage of the surface treatment over time resulted in map cracking, which can cause tension on the asphalt concrete pavement surface and may eventually lead to the development of additional L&T cracking. Based on condition and age, the

surface treatment is at the end of its service life. Pictures of the apron condition with the coal tar treatment during visual inspection are presented in figures EQY-1 through EQY-4.

Figure EQY-1. Apron Overview with Coal Tar Slurry

Figure EQY-2. Apron Area Overview with Coal Tar Slurry

Figure EQY-3. Coal Tar Slurry Texture

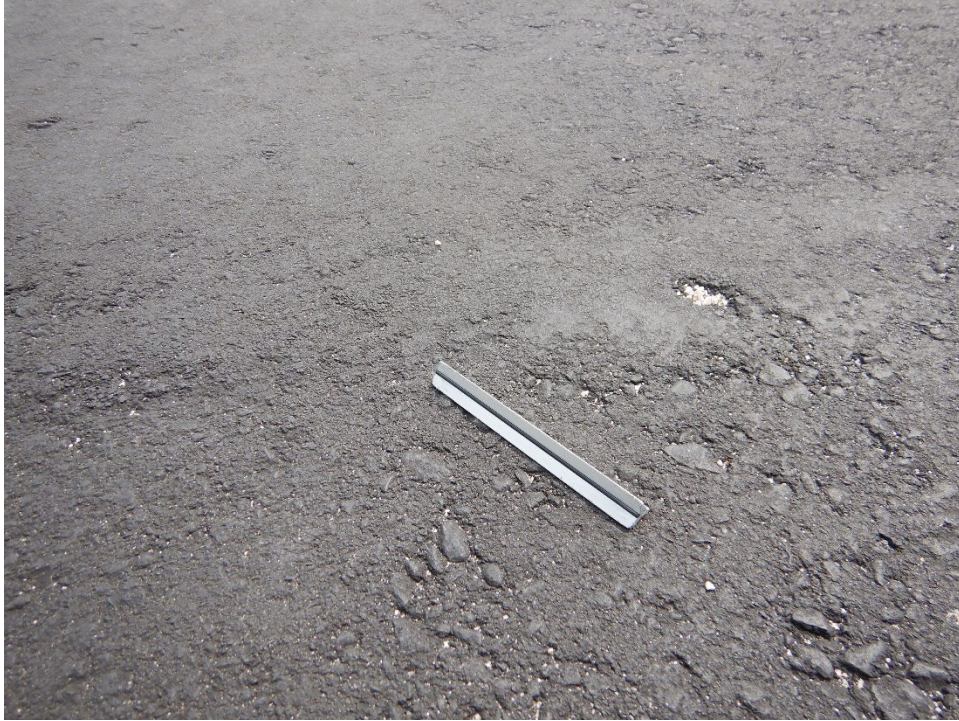
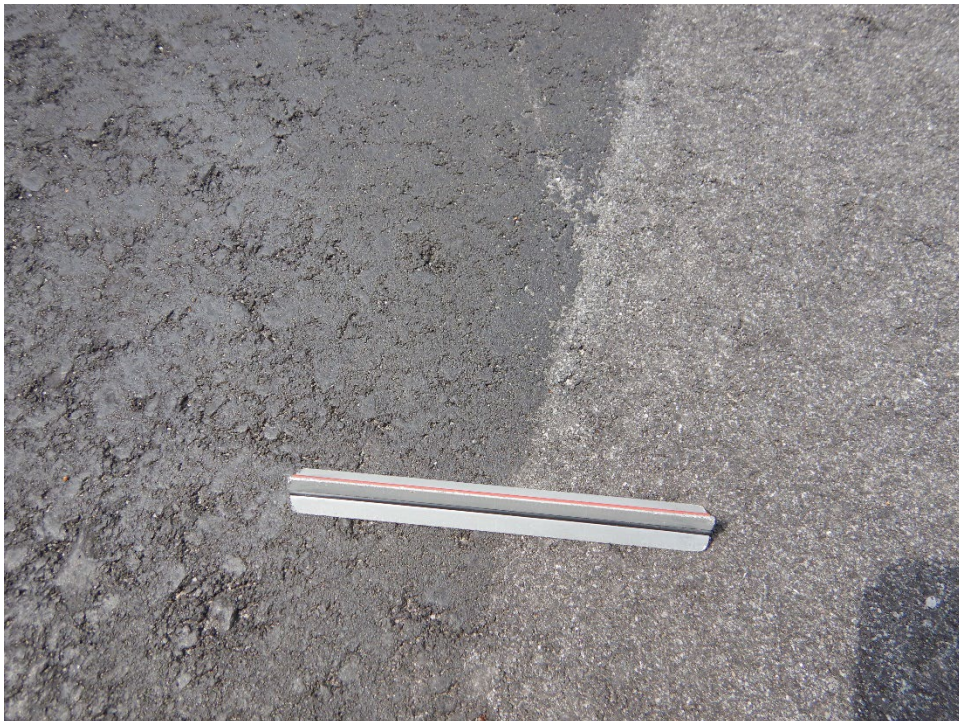
A visual inspection of the condition of the surface treatment was performed in March 2022. Observations at the time of inspection showed that fine and coarse aggregates on the aprons were not exposed and the coverage of P-631 was very good. The uniformity of P-631 was also good. Pavement markings on the P-631 were performing very well with good visual delineation. Minor tire marks were visible on the pavement, although they may not be an imprint on the pavement. Some minor segregation was observed in areas where the underlying asphalt texture was visible. No distresses were observed on the aprons. While there were some oil spills present, they were not significant enough to damage the treatment or the pavement. Overall, the P-631 surface treatment is performing as intended on the aprons. The estimated remaining service life of the treatment appeared to be 3 to 5 years. Photographs of the P-631 on the apron are presented in figures EQY-5 through EQY-8.

Figure EQY-5. Apron Overview with P-631

Figure EQY-6. P-631 Texture on Apron

Figure EQY-7. Apron with (Left) and Without (Right) P-631

Figure EQY-8. Tire Marks on P-631

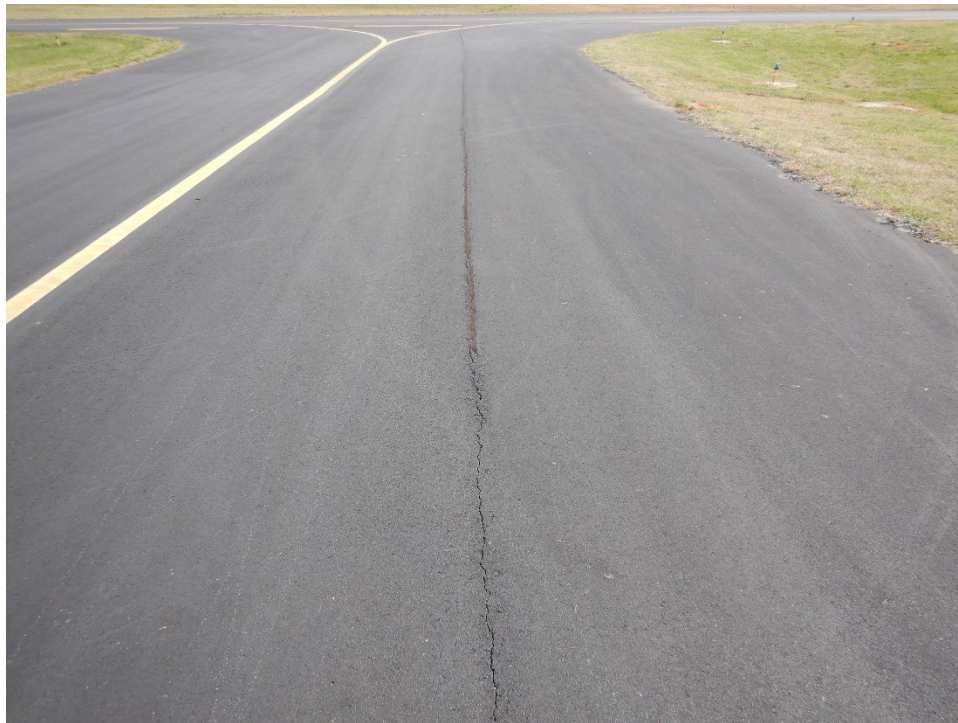
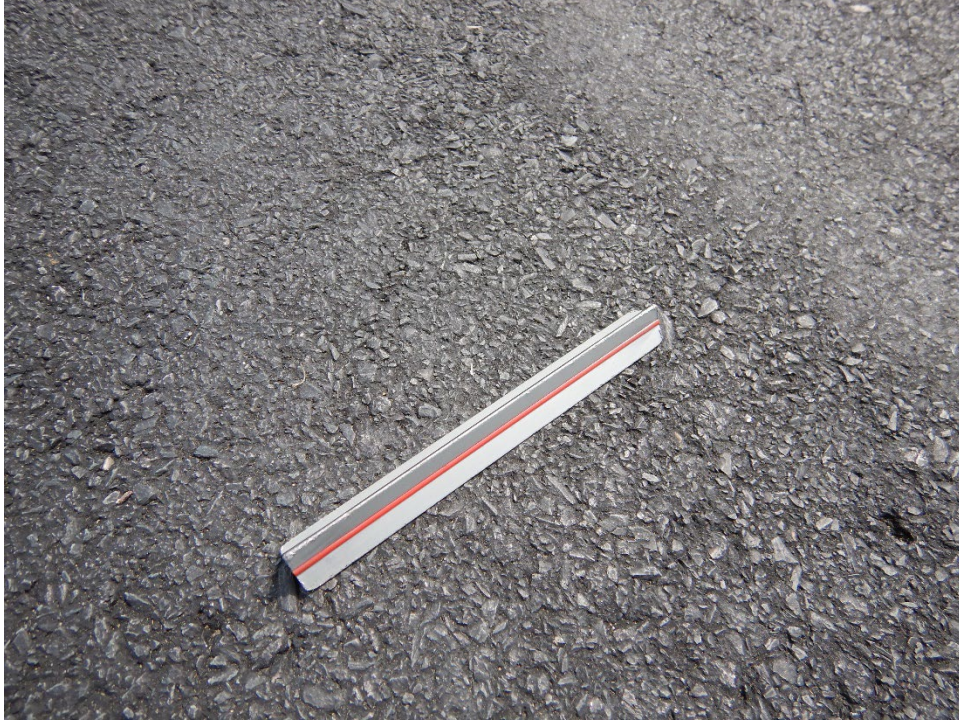
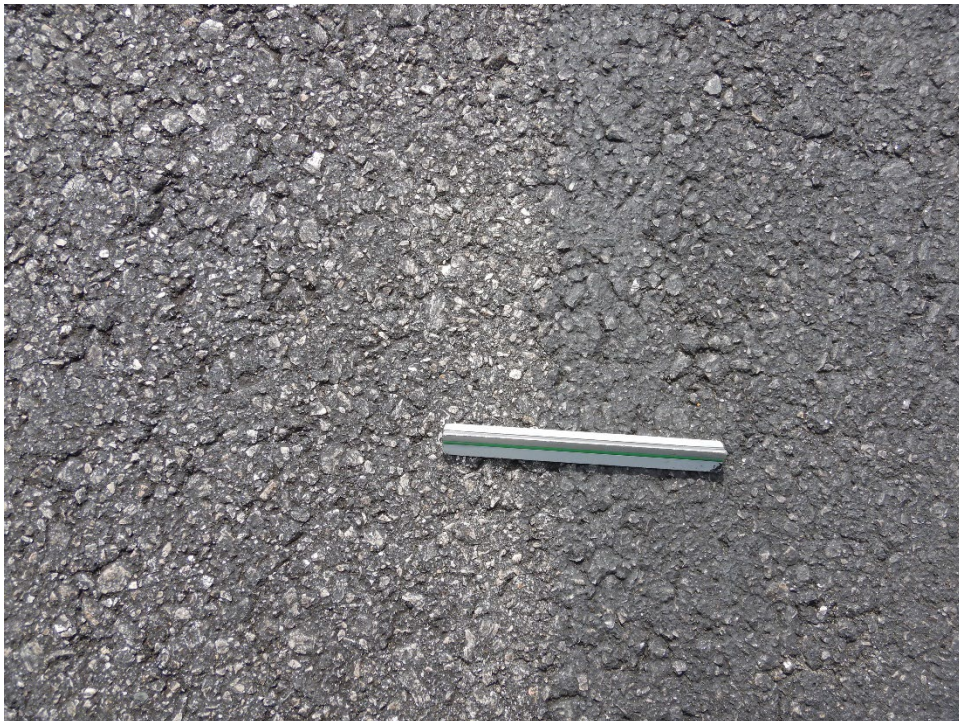
Minor weathering may be present throughout the taxiway pavements where the coverage was lighter. Weathering was not recorded in the previous PCI inspection, which would have impacted the PCI. While the binder still retained a dark appearance from the rejuvenator penetrating the surface, there was a minor loss of fines (low-severity weathering). In high age group taxiways, medium-severity weathering was noted in areas of light P-632 coverage the weathering, which would further impact the PCI. Additionally, some secondary cracking along the longitudinal paving joints had developed on the parallel taxiway. There were a few depressions present and some of these depressions showed fatigue cracking. Fatigue cracking was also starting to develop in some of the wheel paths of Taxiway A.

For the medium age group, the estimated remaining service life of P-632 may be 1 year where coverage is less and 3 years where coverage is adequate. For the high age group, the estimated remaining service life of P-632 is 2-3 years. Pictures of the condition of the P-632 condition are presented in figures EQY-9 through EQY-15 (medium age group) and figures EQY-16 through EQY-23 (high age group).

Figure EQY-9. Medium Age Taxiway Overview with P-632

Figure EQY-10. Surface Texture of P-632 on Medium Age Taxiway

Figure EQY-11. Overview of P-632 Coverage on Medium Age Taxiway

Figure EQY-12. Overview of P-632 Coverage on Medium Age Taxiway

Figure EQY-13. Medium Age Taxiway Without (Left) and With (Right) P-632

Figure EQY-15. Longitudinal Paving Joint on Medium Age Taxiway

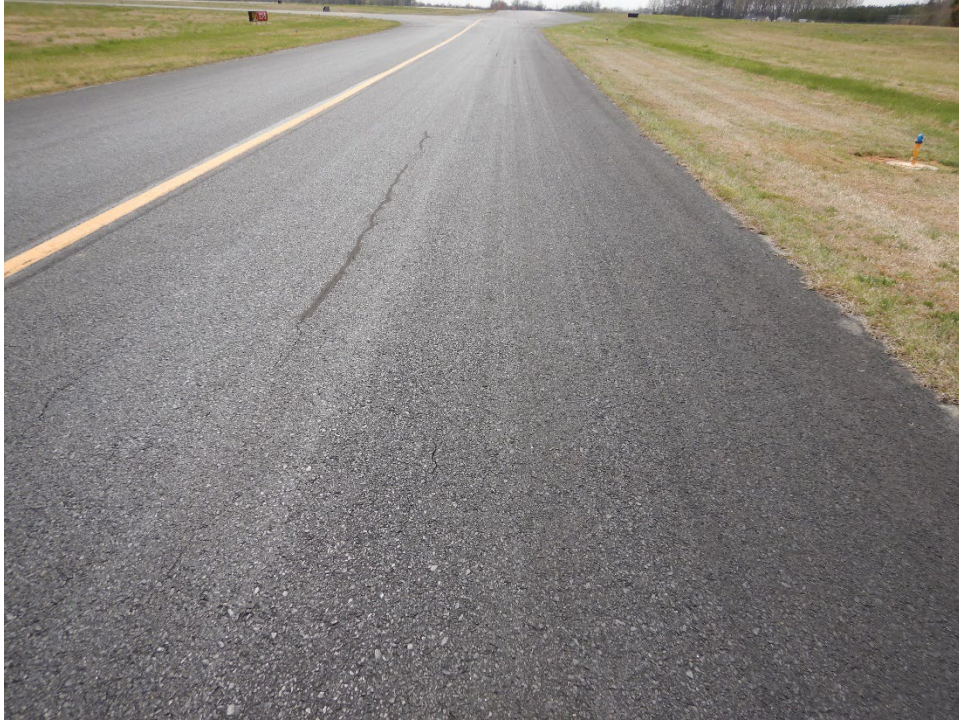
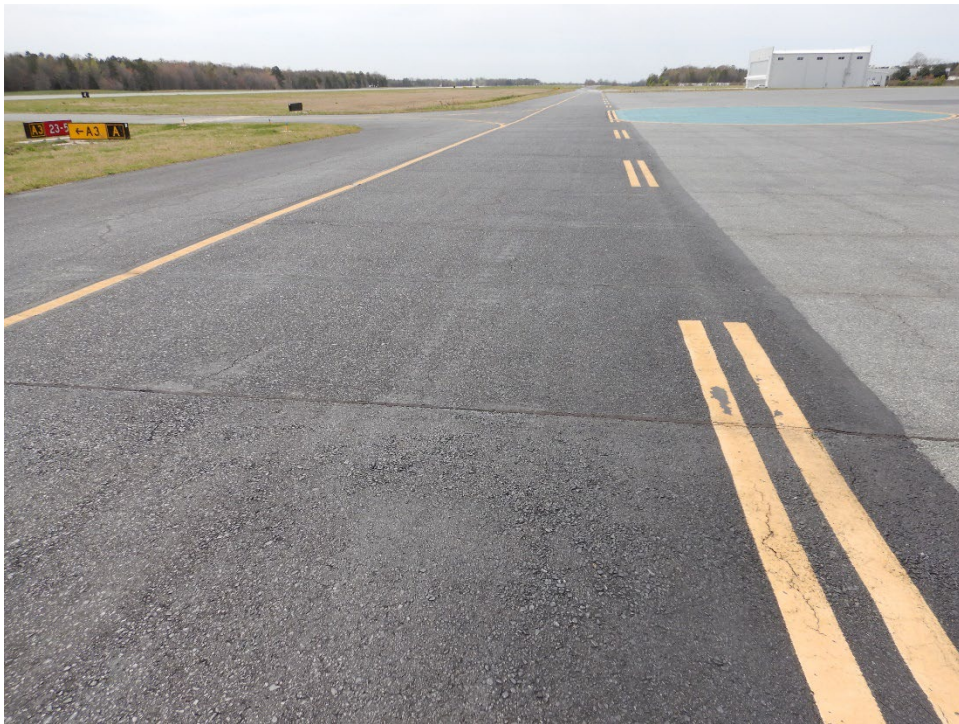
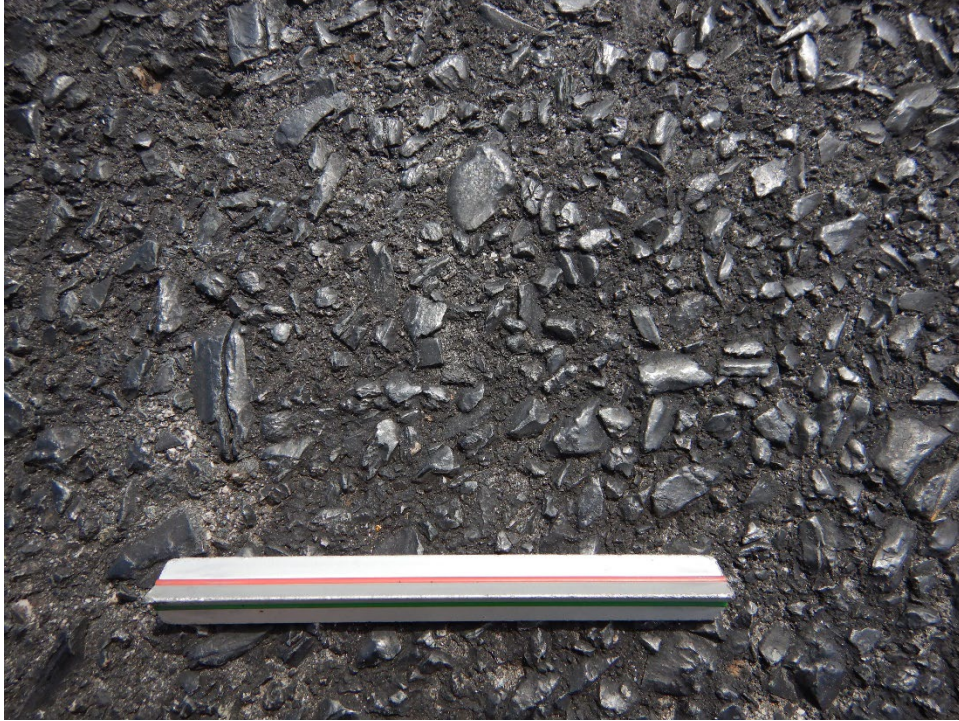
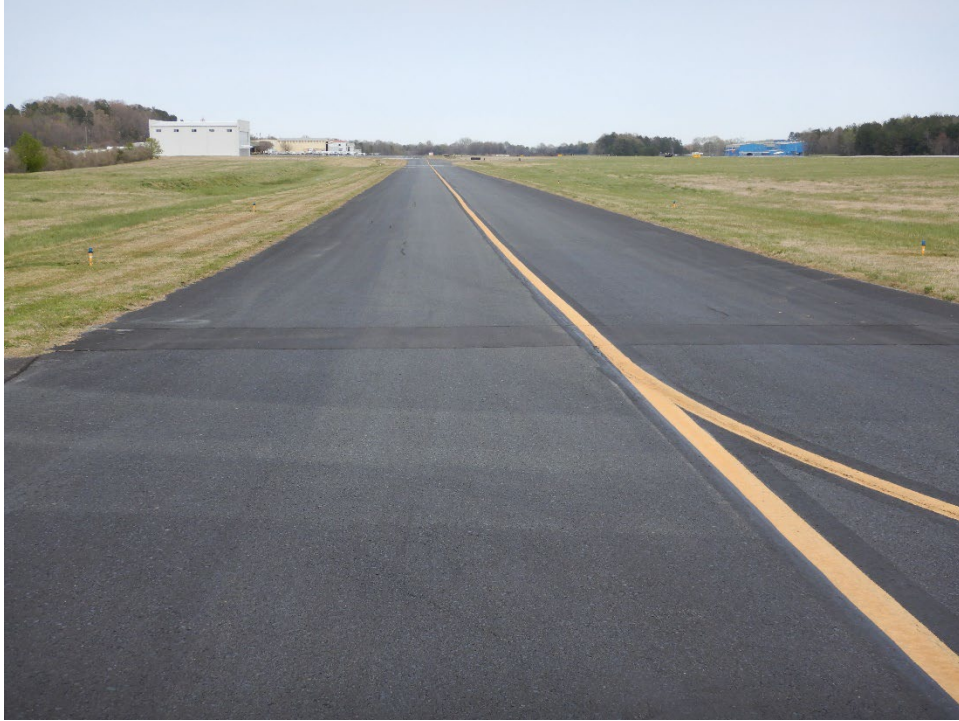
Figure EQY-16. Overview of High Age Taxiway With P-632

Figure EQY-17. Overview of High Age Taxiway With P-632

Figure EQY-18. P-632 Surface Texture on High Age Taxiway

Figure EQY-19. Overview of Edge of P-632 Application on High Age Taxiway

Figure EQY-20. P-632 Coverage on High Age Taxiway

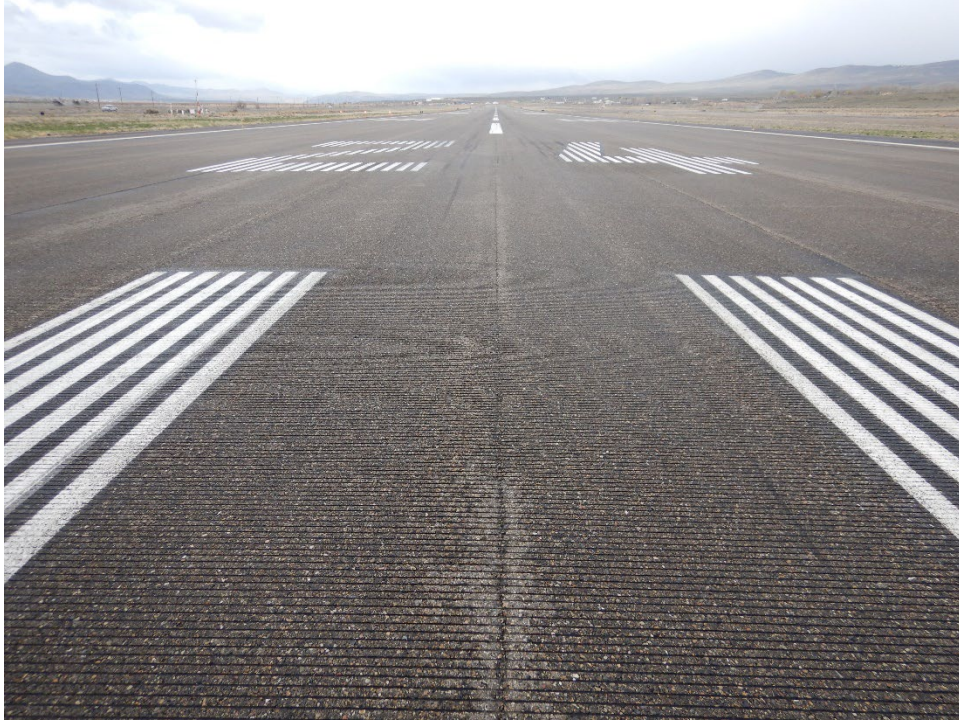
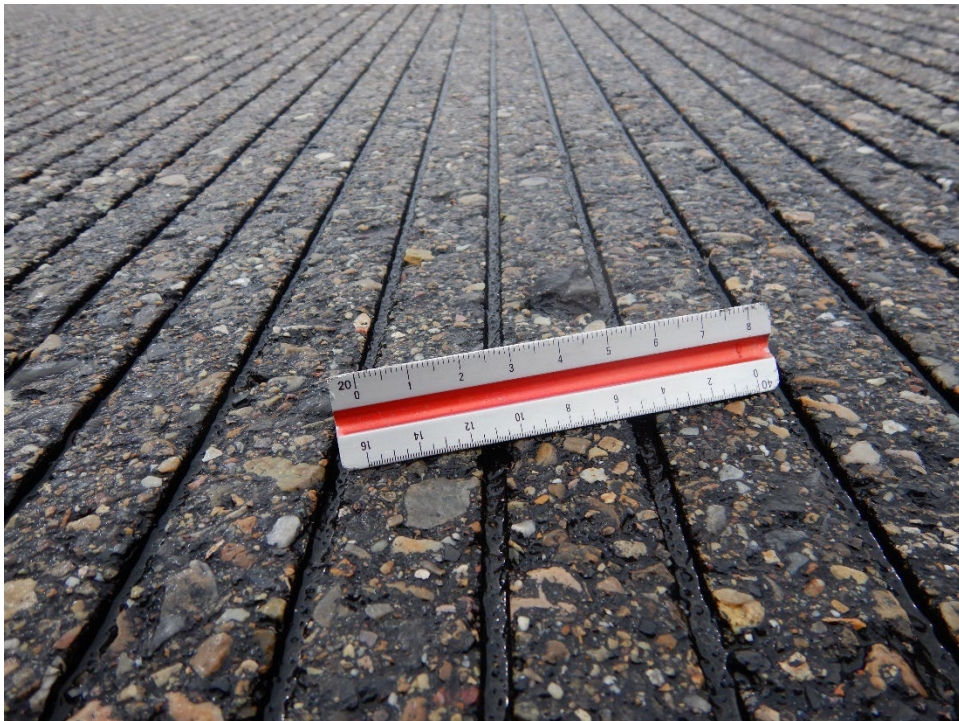
At the current condition, the P-608 surface treatment on Runway 06/24 has no remaining service life. The P-608 material visible within the runway grooves does not help to preserve the pavement. The city commented that the rapid fading of P-608 may have been accelerated by snow removal operations. Figures EKO-1 through EKO-7 showcase the condition of the runway.

Figure EKO-1. EKO Runway 06/24 Overview

Figure EKO-2. EKO Runway 06/24 Texture

Figure EKO-3. P-608 Condition Between and Within Runway 06/24 Grooves

Figure EKO-5. Sealed Longitudinal Paving Joint on Runway 06/24

Figure EKO-7. Transverse Construction Joint on Runway 06/24

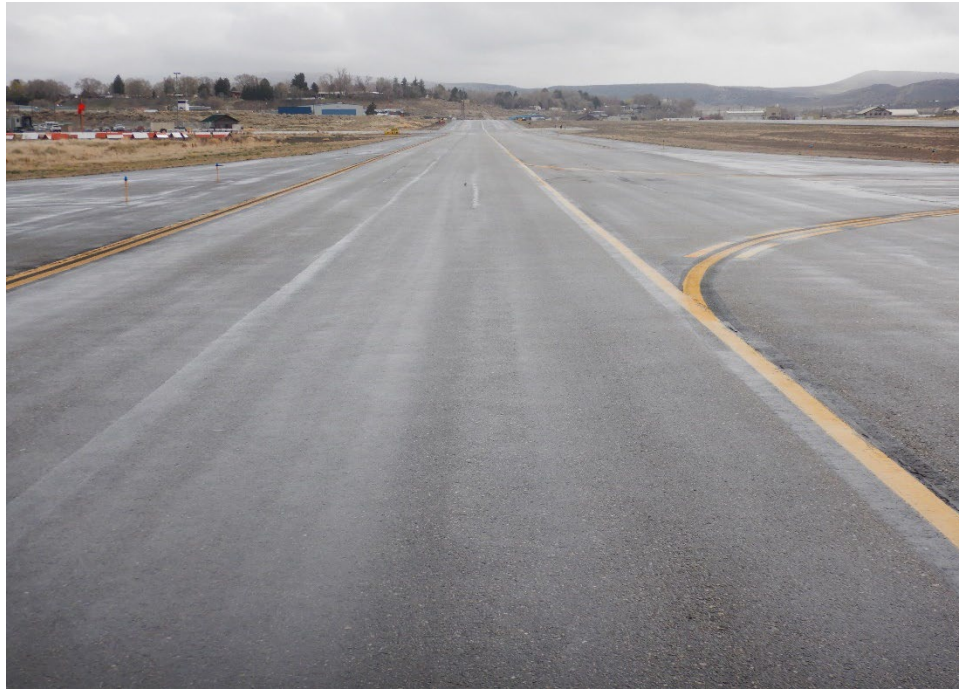
Fading was the major deterioration mechanism observed during the inspection. It may have accelerated due to snow removal operations. No flaking or chipping was observed that may raise concerns for FOD production. Some longitudinal paving joints had opened, and some had been sealed but continued to open. Isolated transverse cracking was observed. Wheelpath cracking was starting to develop on one portion of Taxiway A. The pavements are cleaned by sweepers several times a year after rains. The airport operations use brooms, deicer, and plows (one rubber blade

and two steel blades). Overall, it is estimated that the P-608 has 1 year of service life left on the Taxiway A and apron areas. Pictures of P-608 condition on the Taxiway A and Apron areas are presented in figures EKO-8 through EKO-19.

Figure EKO-8. Taxiway A Overview

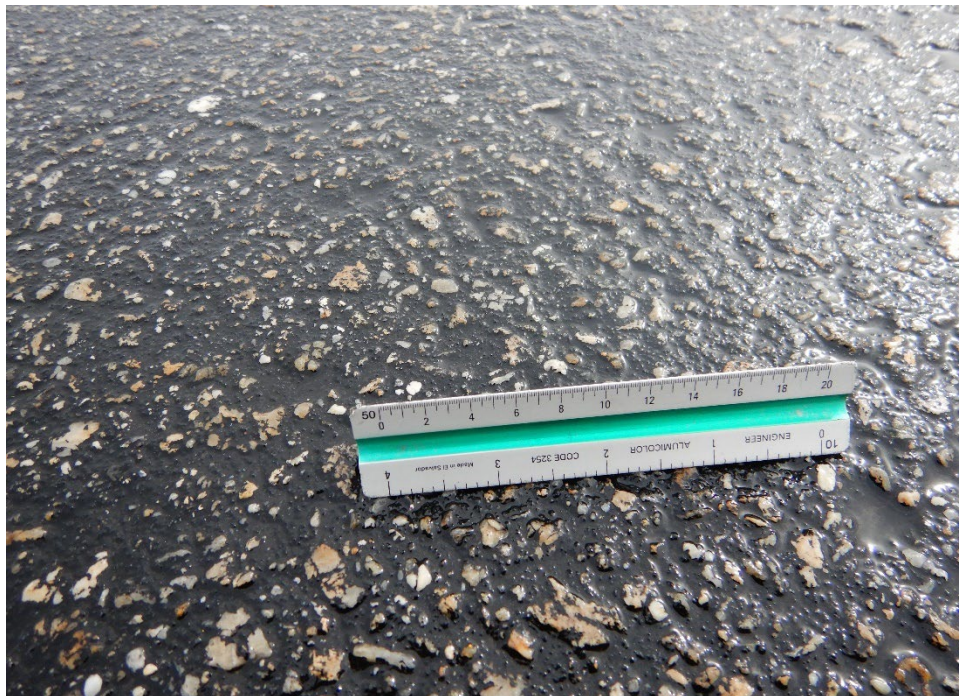
Figure EKO-9. Taxiway A Texture

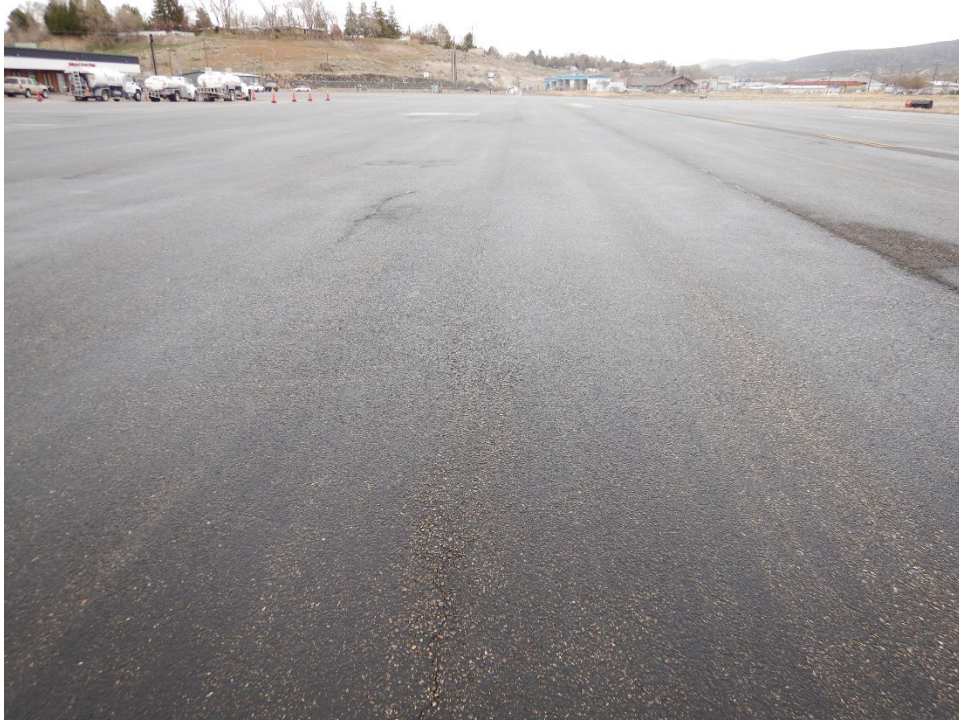
Figure EKO-14. Apron Overview

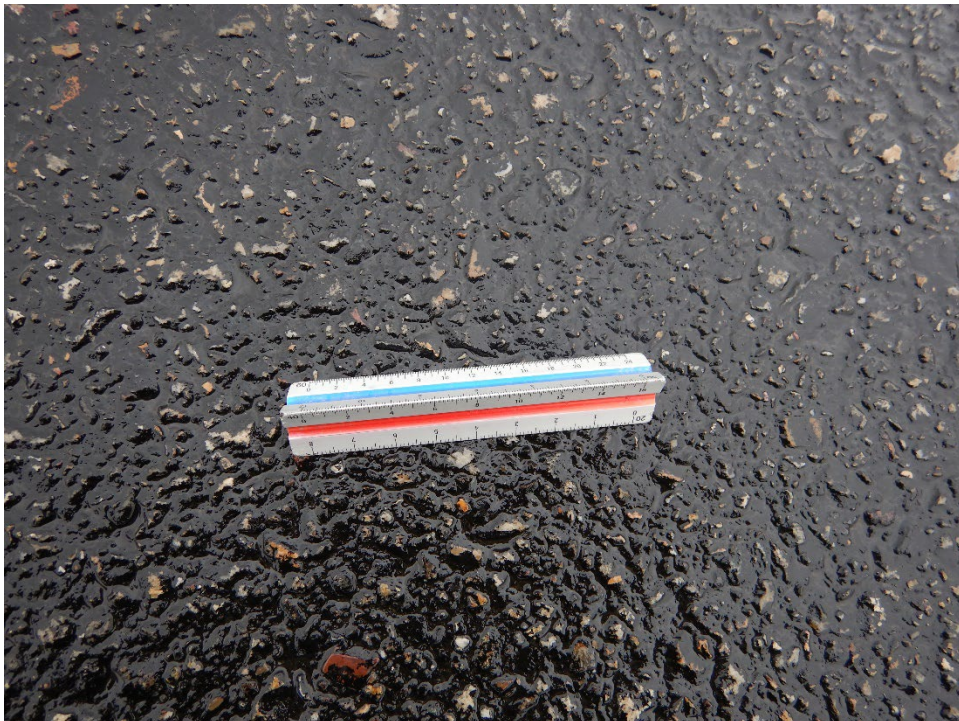
Figure EKO-15. Apron Texture

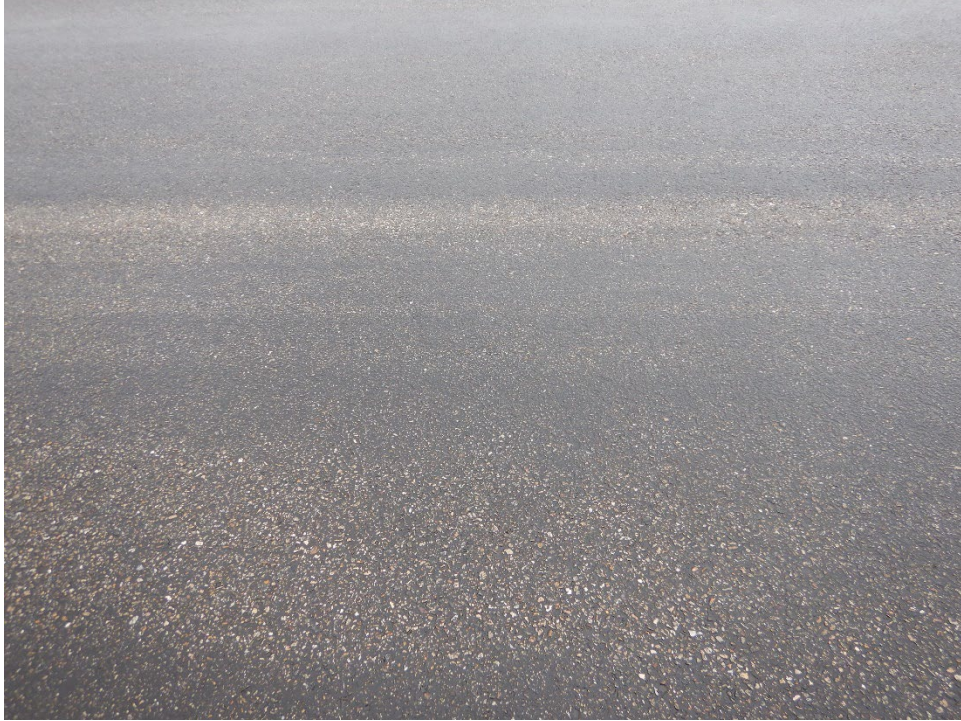
Figure EKO-16. P-608 Coverage on Apron

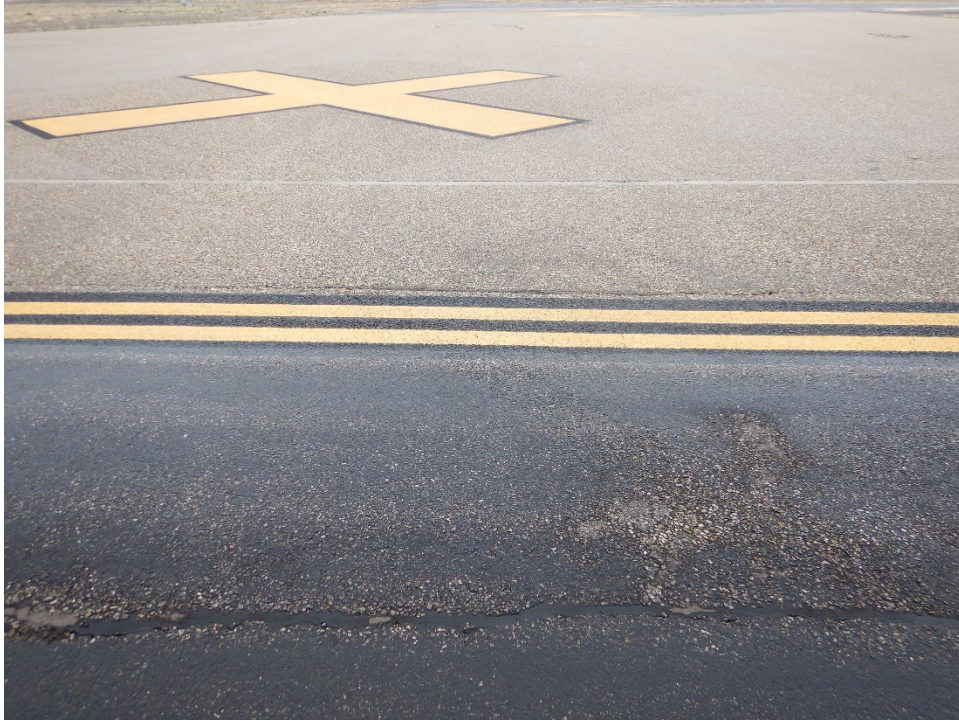
Figure EKO-18. P-608 Treated and Untreated Areas

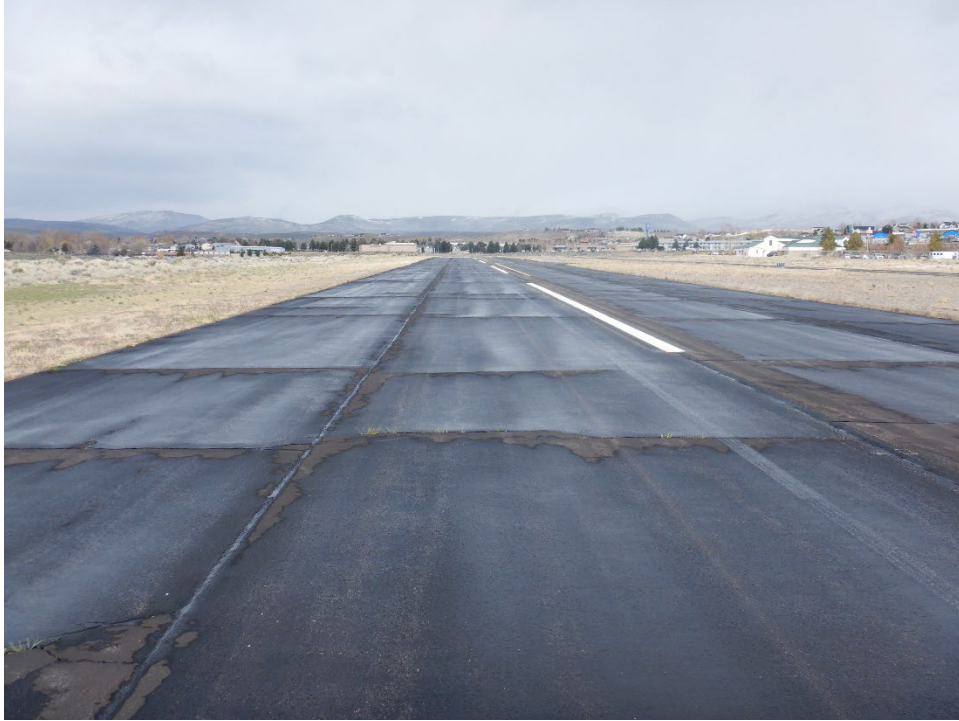
Figure EKO-20. Runway 12/30 Overview

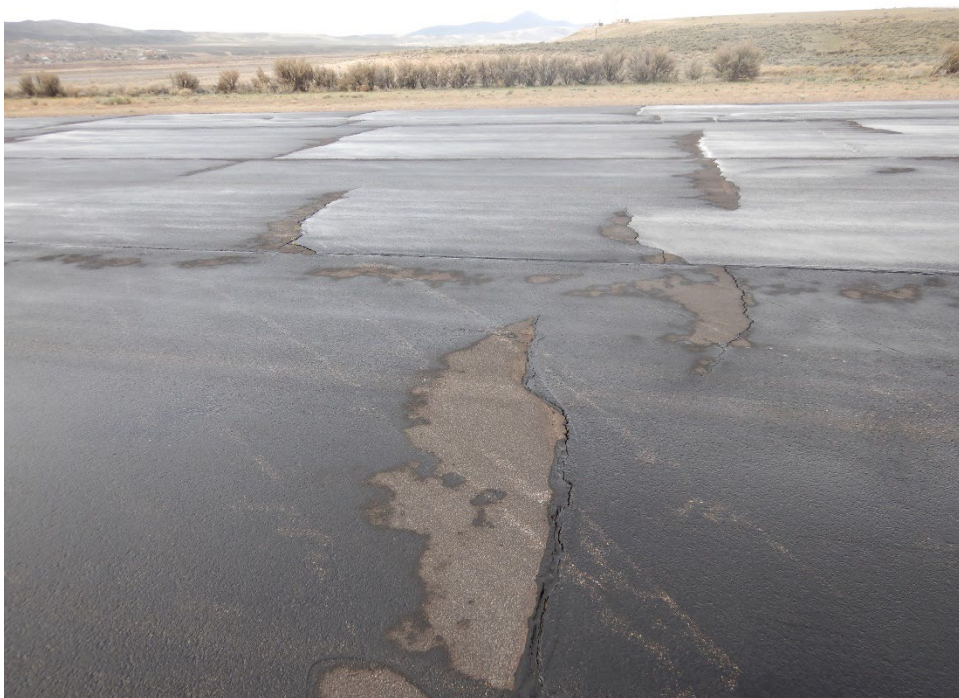
Figure EKO-21. Runway 12/30 Overview
