Summary of Case Studies and Observations on Airport Experience with Pavement Surface Treatments

August 2023

DOT/FAA/TC-TN23/49

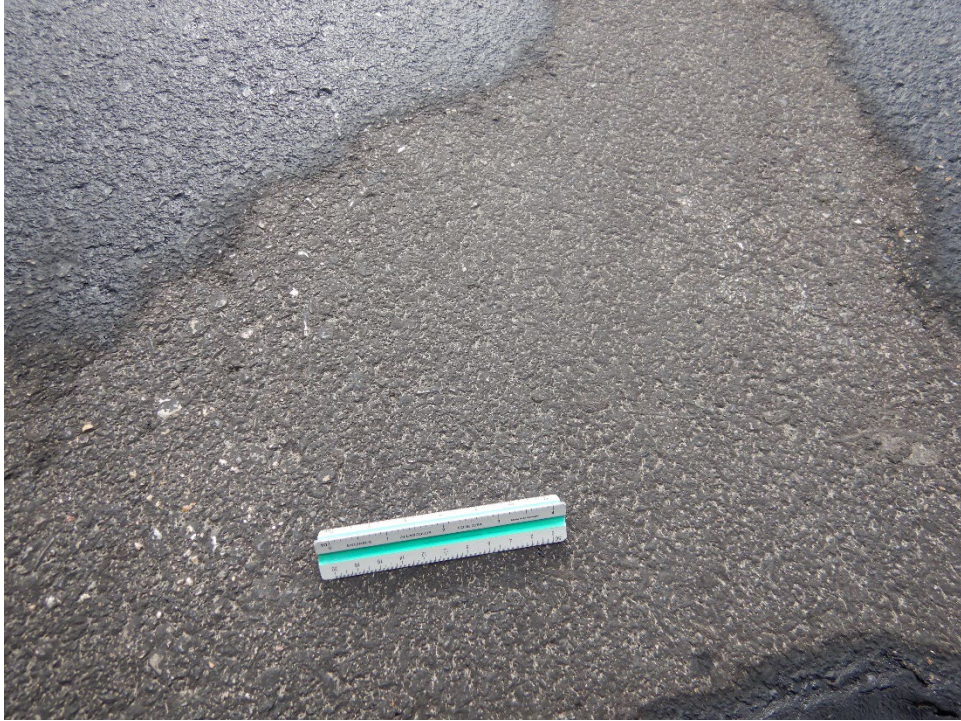
Figure EKO-22. Runway 12/30 Texture

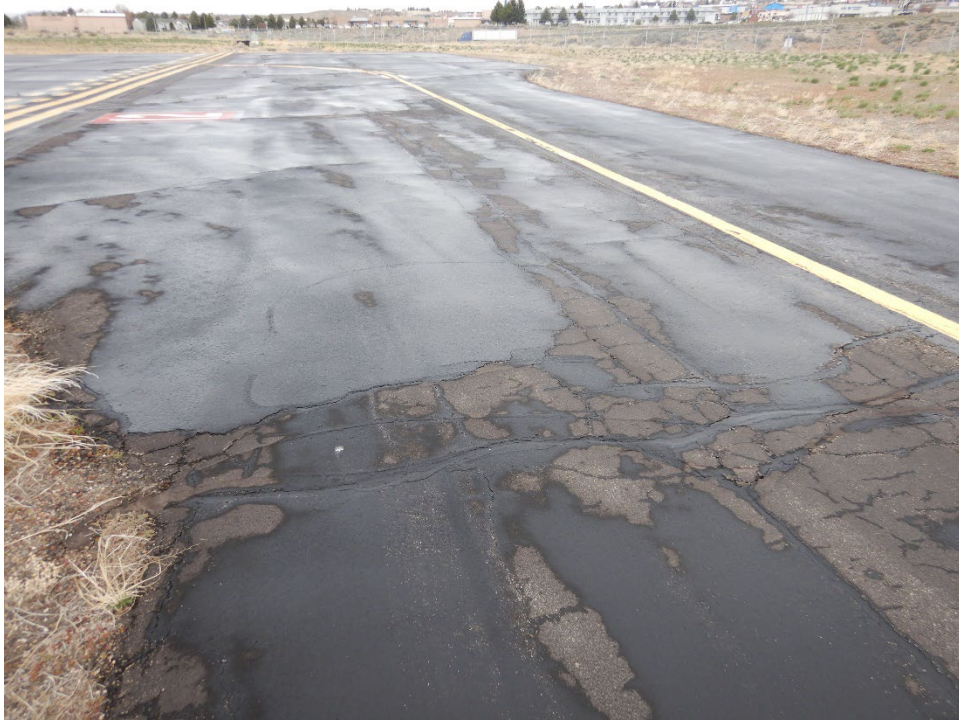
Figure EKO-28. Taxiway B Overview

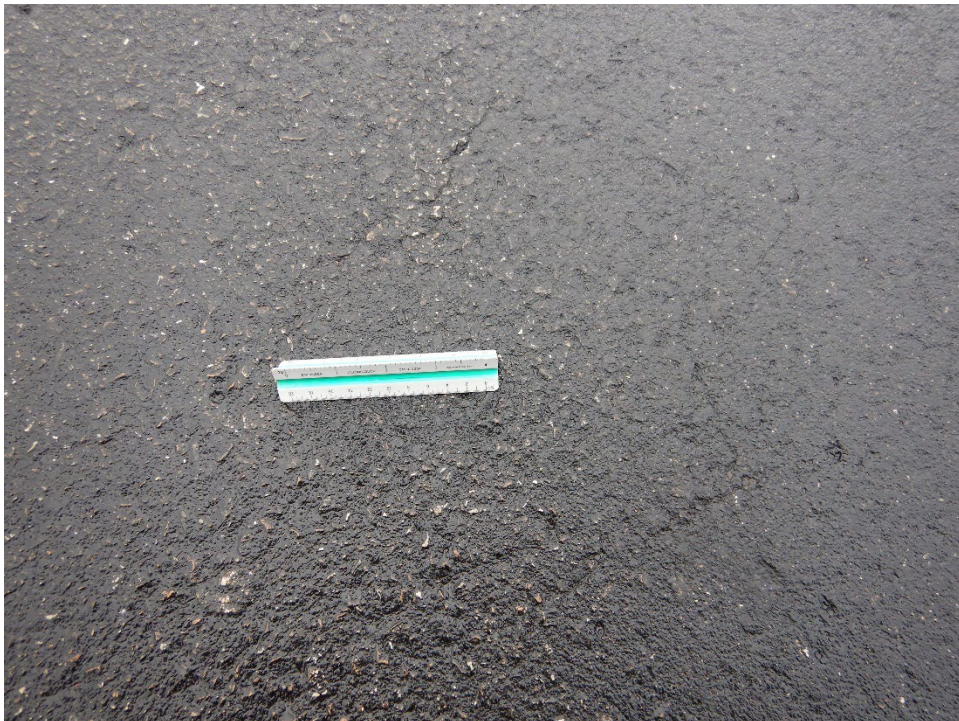
Figure EKO-29. Taxiway B Texture

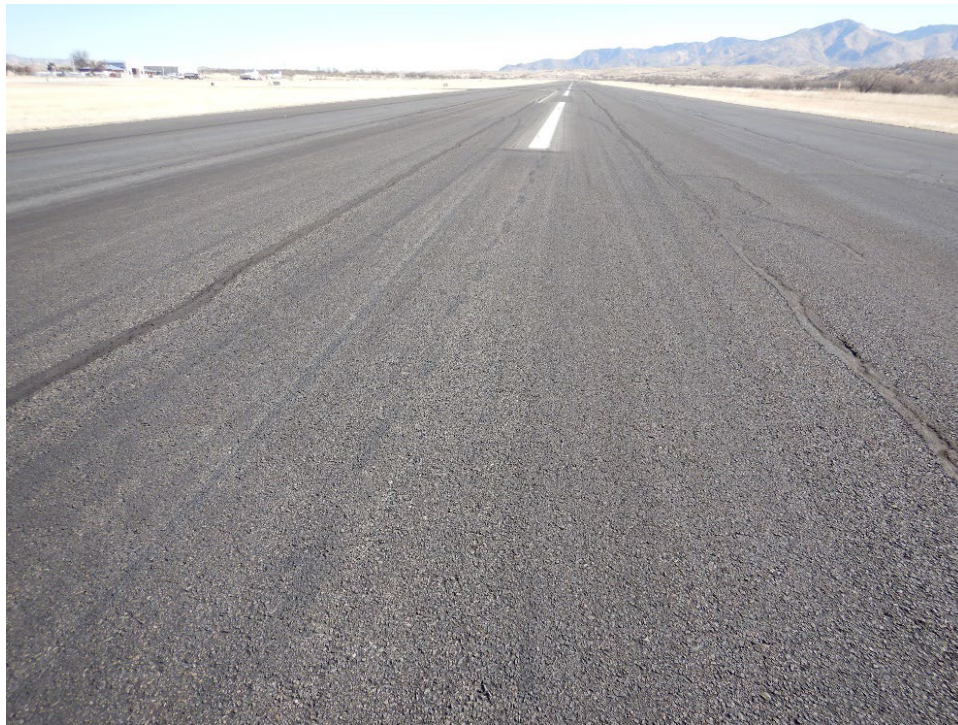
A visual inspection was performed on March 2022 to check the current condition of the P-608 at OLS. The inspection revealed that the P-608 was in acceptable condition with approximately 90% coverage still visible. The P-608 was beginning to wear off along the center wheel path. The P-608 was also getting significantly lighter on high traffic areas, including the impact zone at the end of Runway 04/22. A notable wearing pattern was visible in the high traffic areas. Some connectors close to the 04/22 end had coverage of approximately 30%–50%. The P-608 was in better condition on the parallel taxiway D with approximately 90% coverage. The P-608 coverage was light around the pavement marking areas. Tire marks were visible on the connectors. The P-608 seemed darker at the edges and lighter towards the center of the runway and connectors. Pictures of the P-608 on Runway 04/22 are presented in figures OLS-1 through OLS-6.

Figure OLS-1. Runway 04/22 Overview

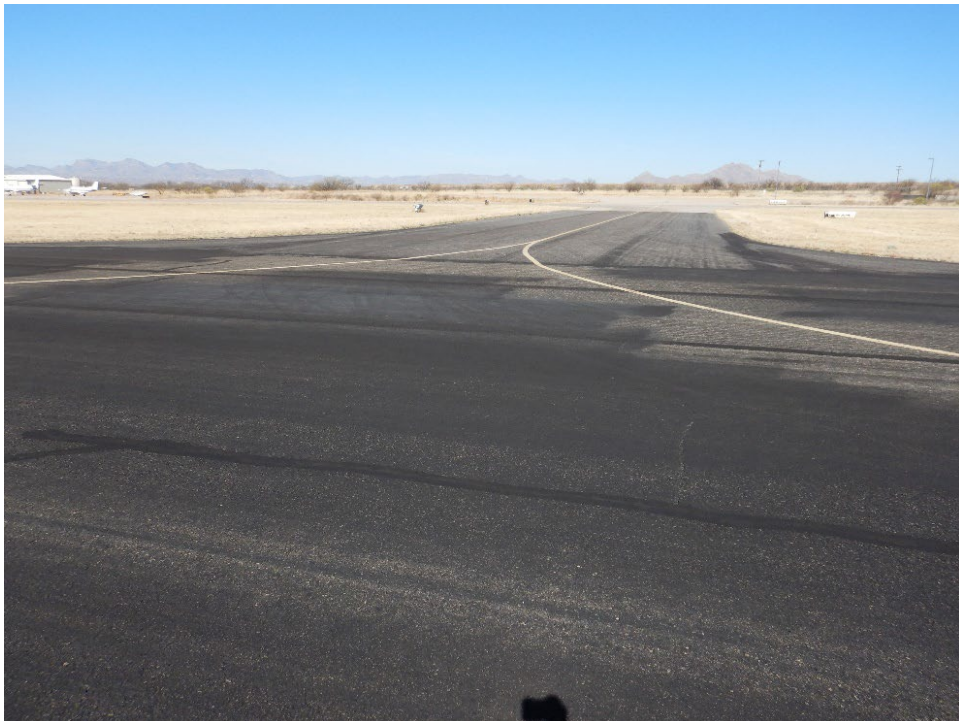
Figure OLS-3. P-608 Coverage on Runway 04/22 and Connector

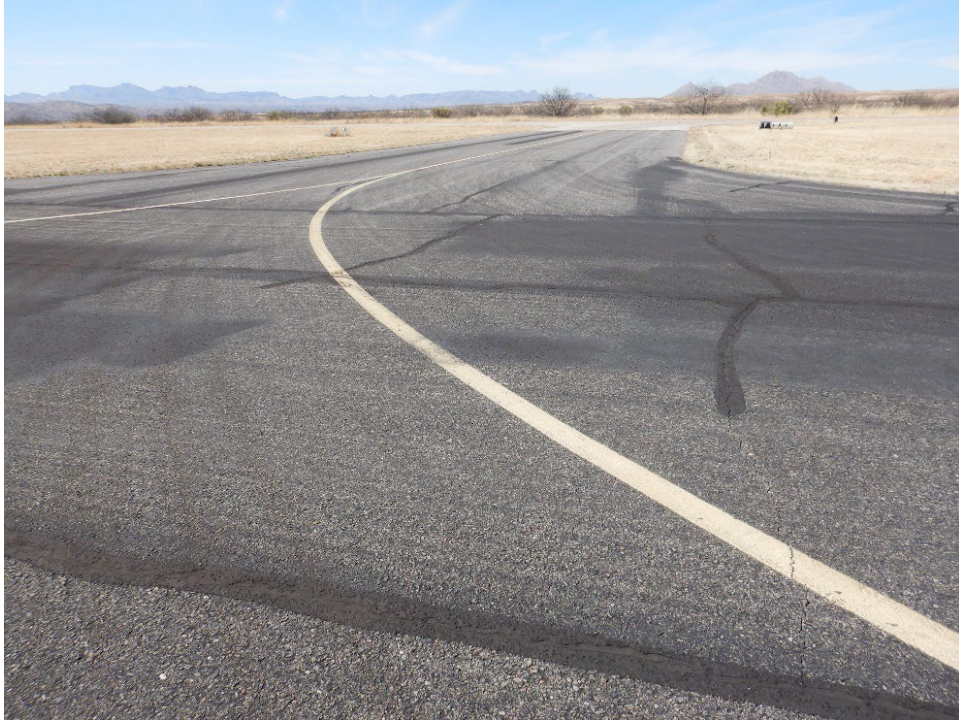
Figure OLS-4. P-608 Coverage on Connector

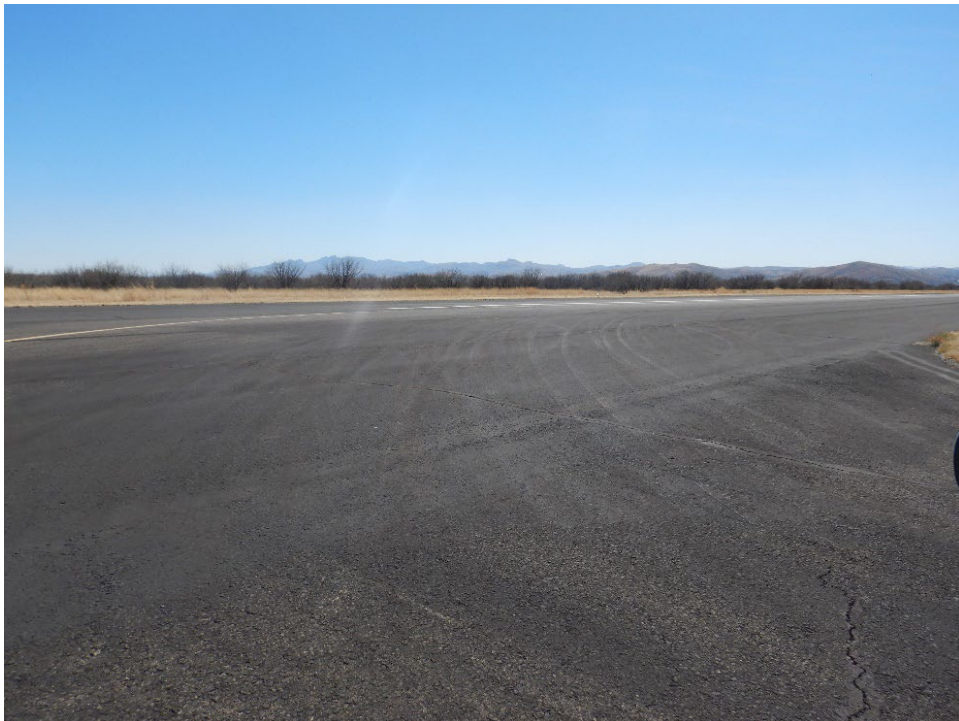
Figure OLS-5. Tire Marks

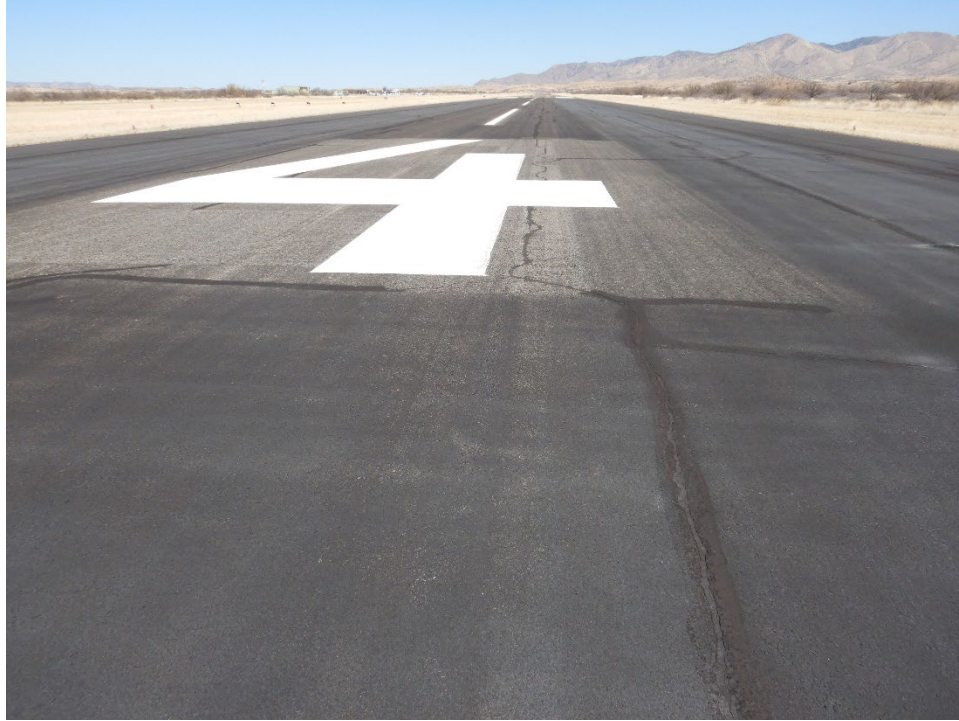
Figure OLS-6. Pavement Designation Marking

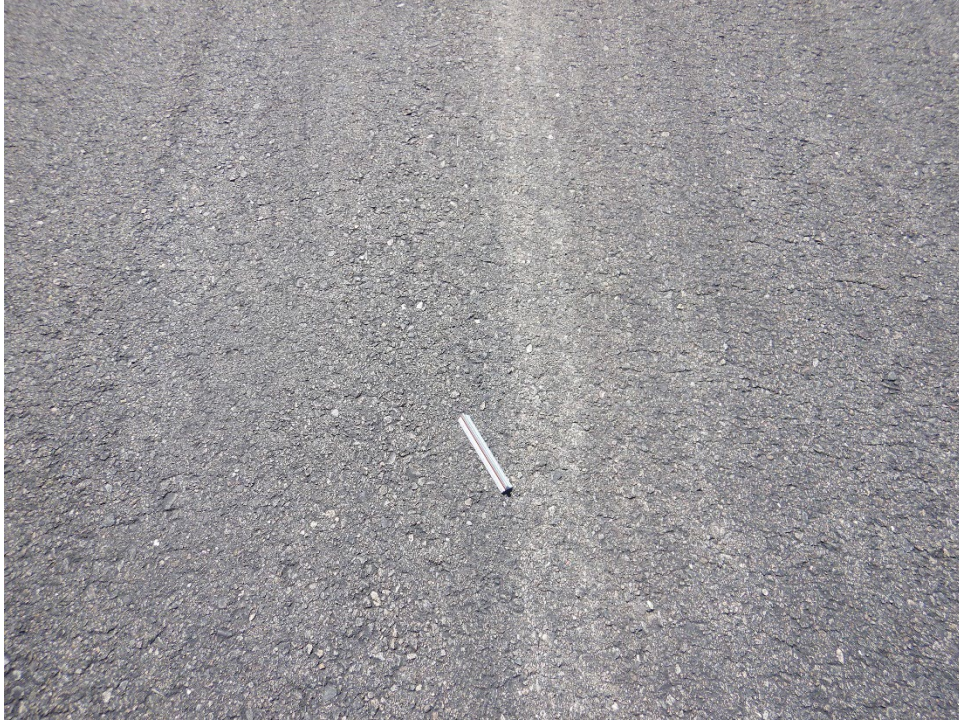
The overall macro texture of the P-608 at OLS appeared uniform. The application of P-608 did not appear to slow new crack formation and existing cracks from widening. The majority of the crack sealants were in satisfactory condition, with some showing signs of oxidation but no FOD potential. Wearing was the major form of deterioration observed on the P-608-treated surfaces. No fading, flaking, or chipping were observed. The OLS operator reported satisfaction with the current performance of the P-608. The estimated remaining service life of the P-608 at OLS is 3 years. Due to the malfunction of the mechanical sweeper, OLS is currently cleaning the surface manually one to two times a month with a broom and shovel. Some pictures of P-608 texture, crack sealant, and cracks are presented in figures OLS-7 through OLS-9.

Figure OLS-7. Runway Pavement Texture

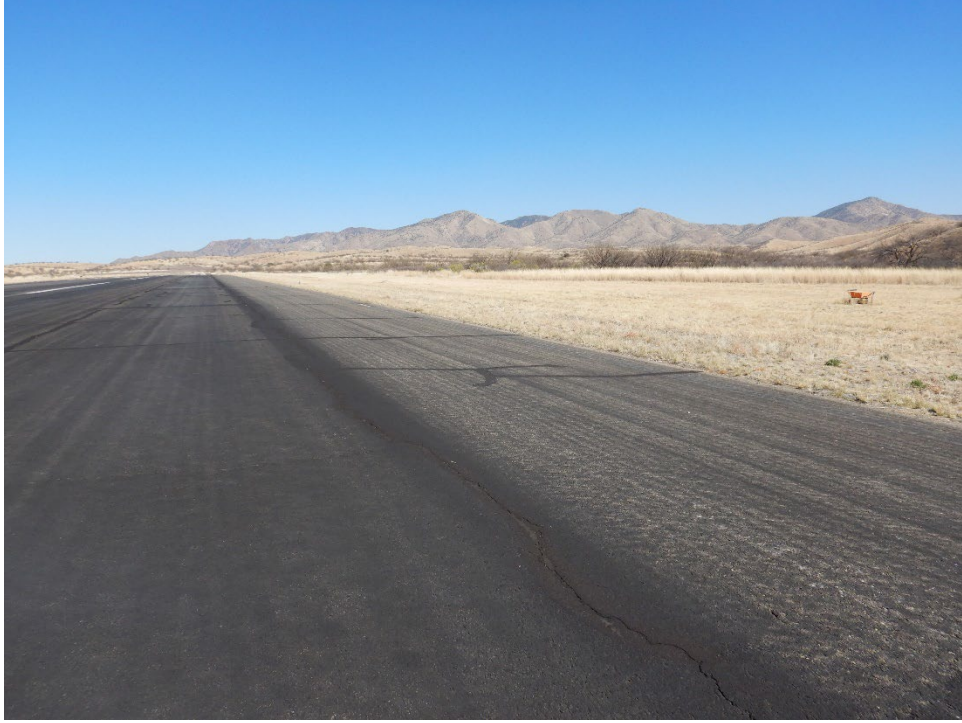
Figure OLS-9. Runway 04/22 Edge

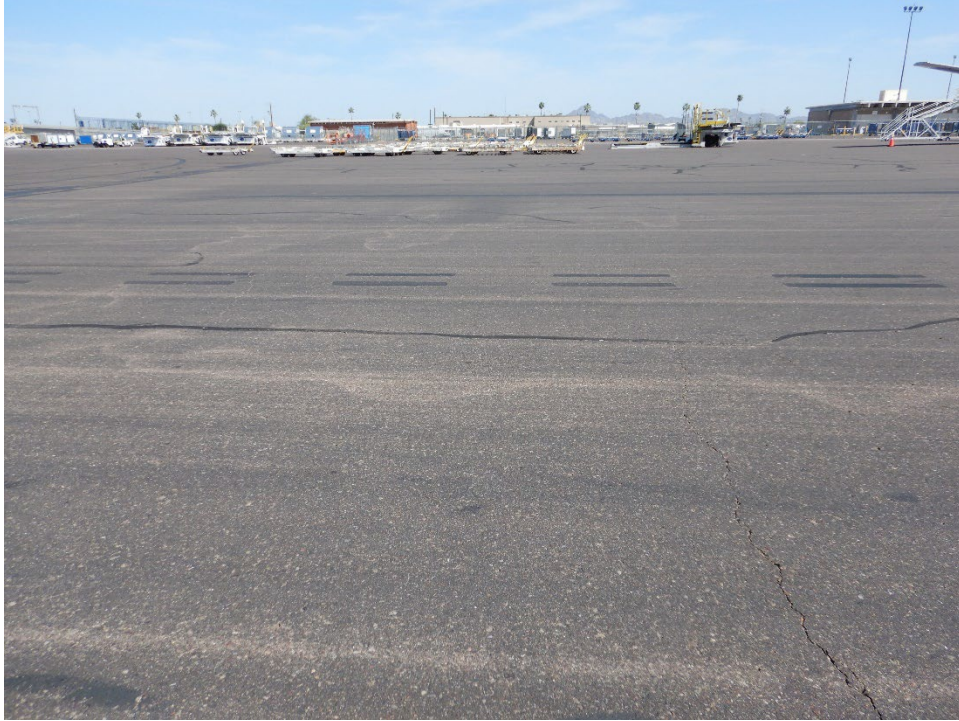
No wearing patterns were observed across the apron pavement areas. Fading was the major deterioration mechanism across all the pavements. FOD production was not a concern, as no flaking or chipping was observed for the RS-44E. In 2022, PHX had re-applied pavement markings on these pavements, so the visual delineation of the markings was very good.

Figure PHX-1. Overview of West Cargo Apron With RS-44E

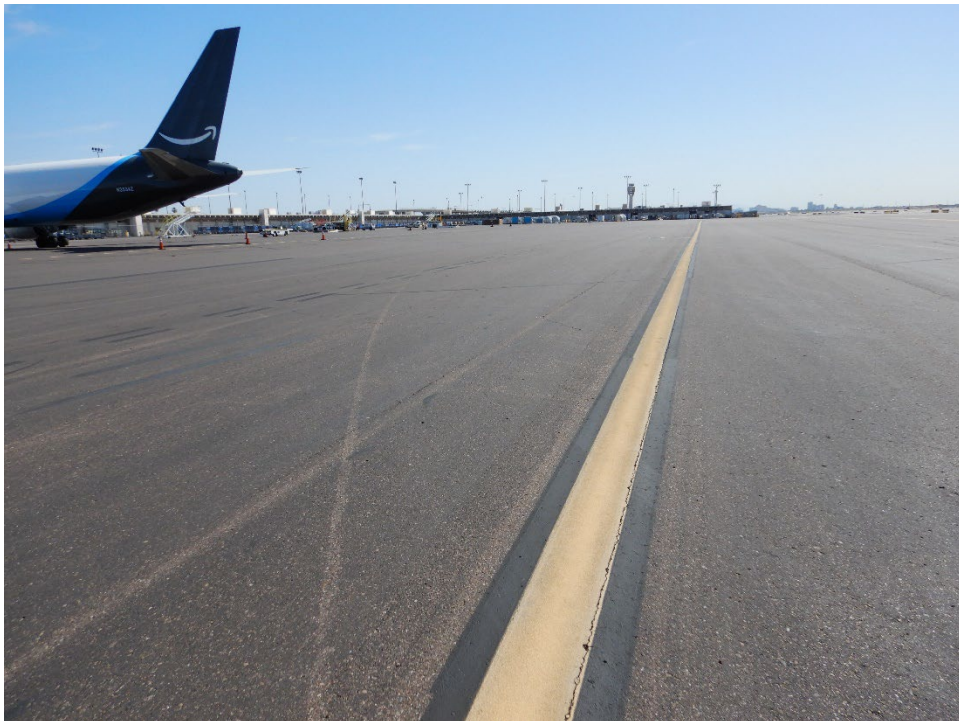
Figure PHX-2. Overview of West Cargo Apron With RS-44E

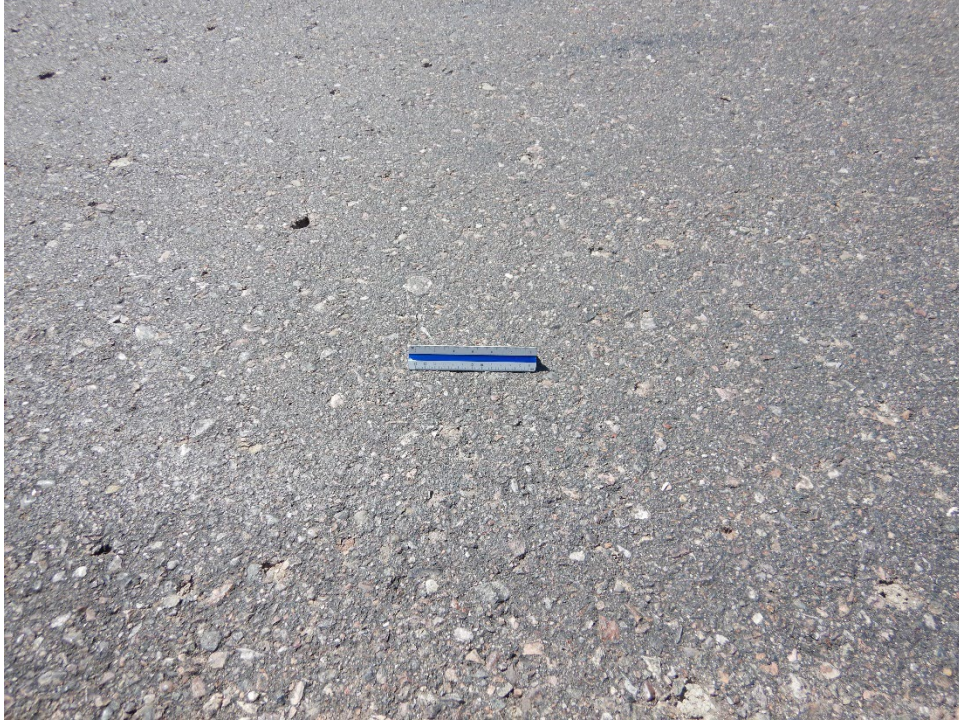
Figure PHX-3. West Cargo Apron Texture

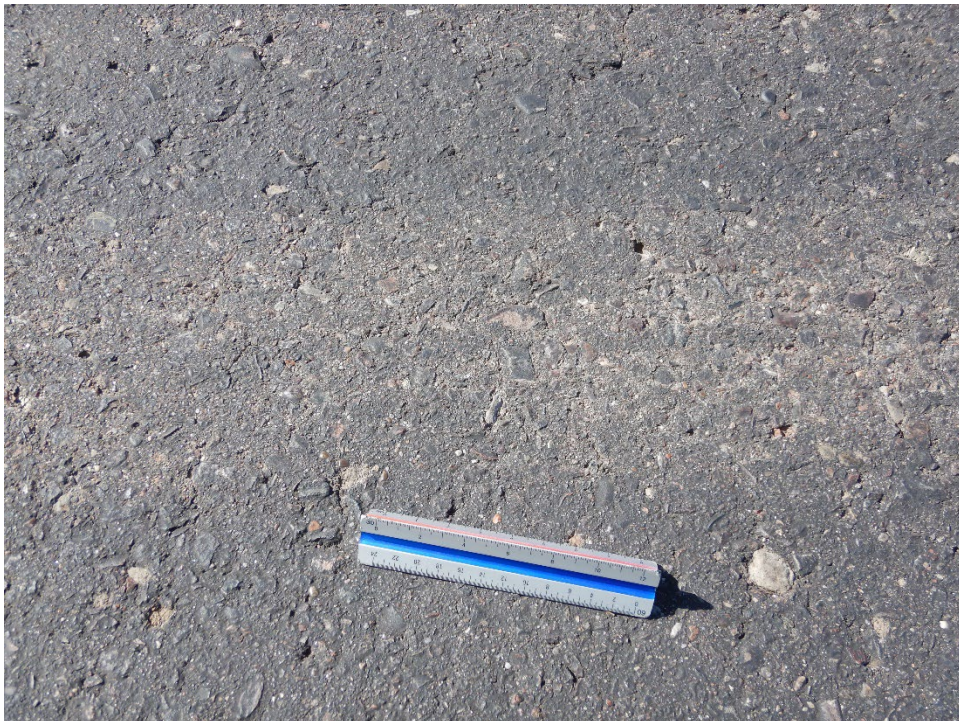
Figure PHX-7. Taxiway A Texture

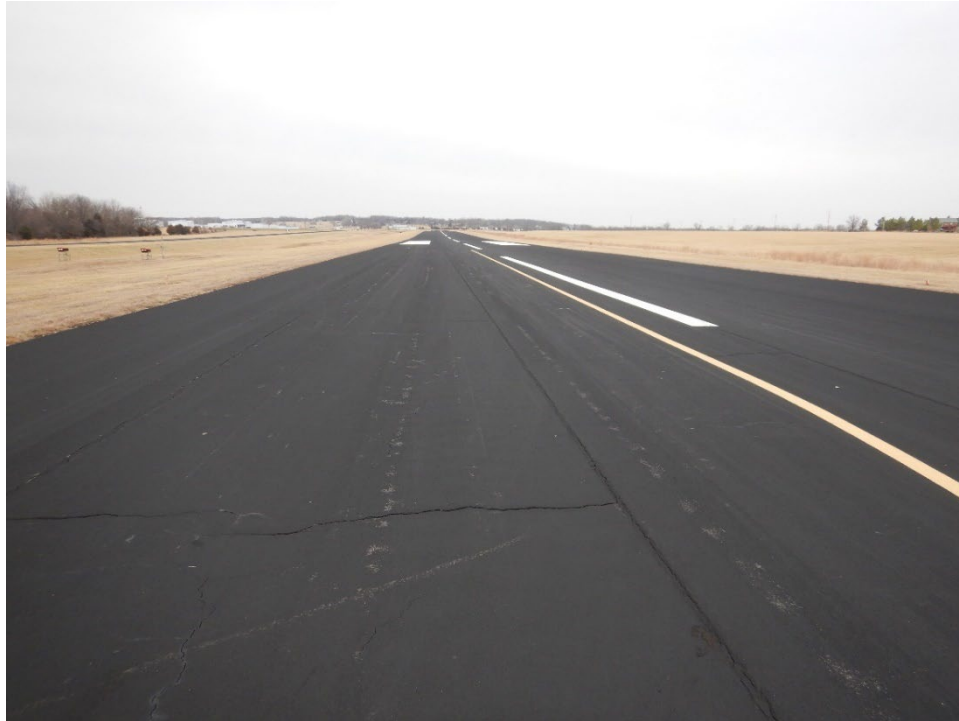
Figure MoDOT-1. Overview of M17 Runway 18/36 With P-629

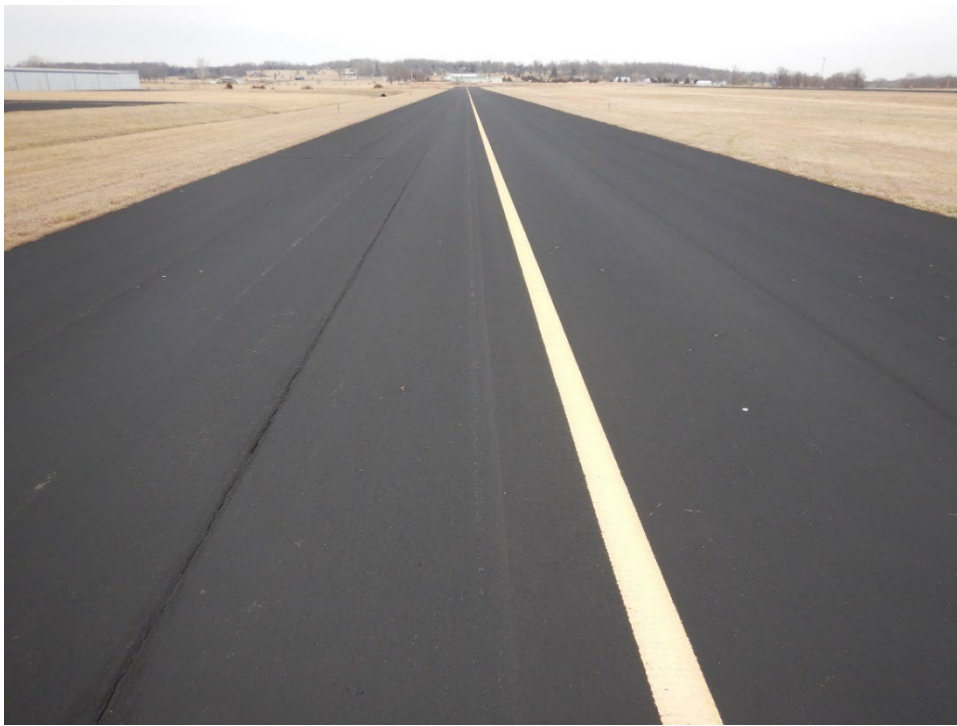
Figure MoDOT-3. Overview of M17 Taxiway With P-629

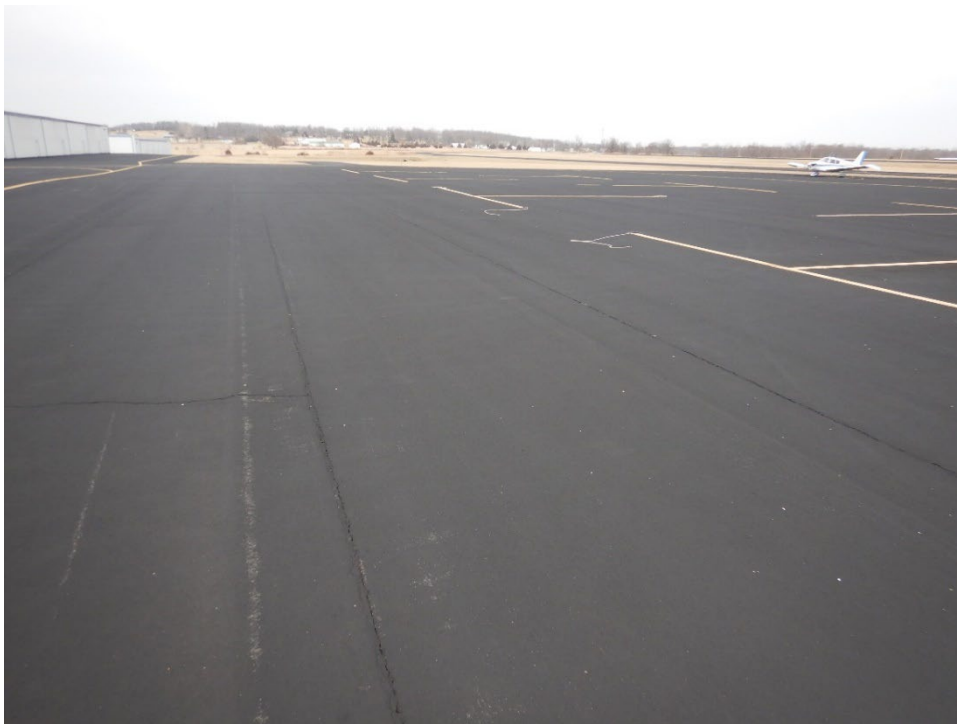
Figure MoDOT-5. Overview of M17 Apron With P-629

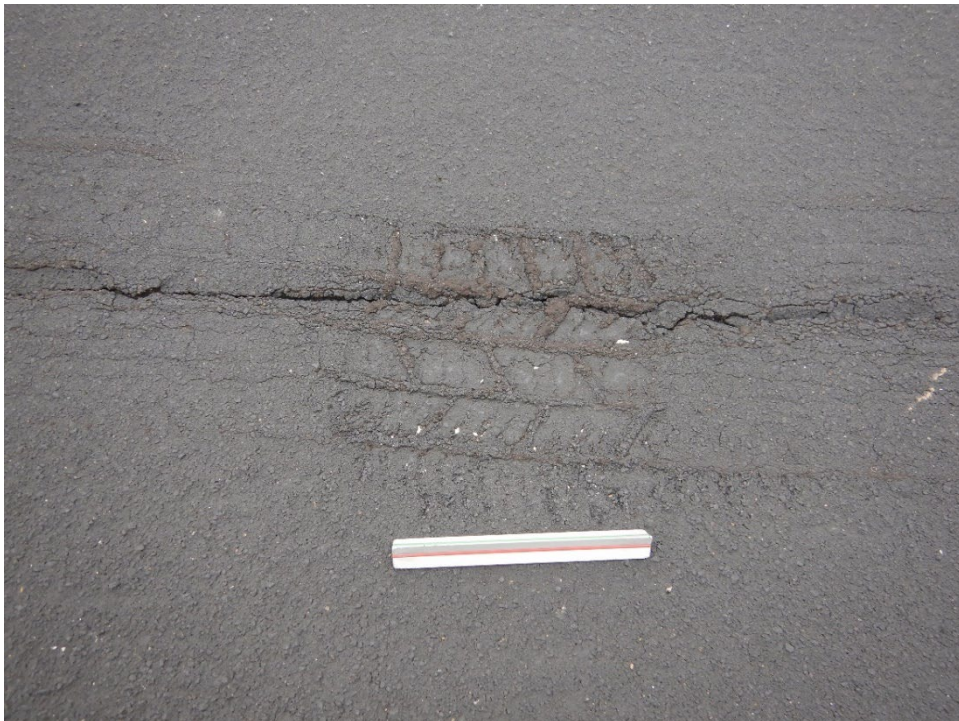
Figure MoDOT-8. Tire Imprint on P-629

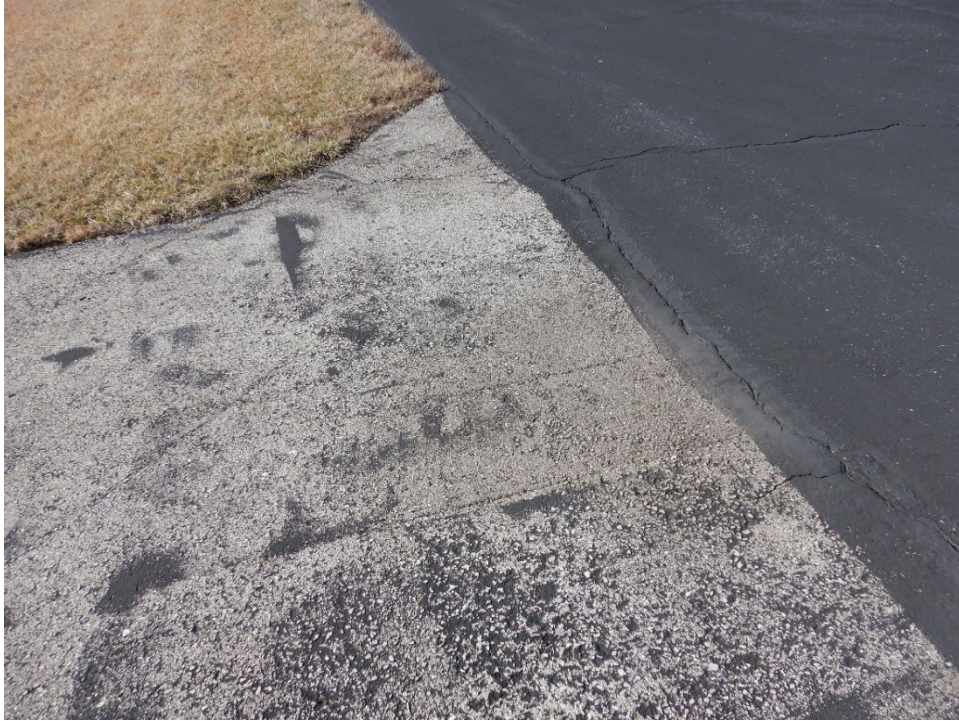
Figure MoDOT-17. Untreated Pavement (Left) and Pavement Treated With MO-623

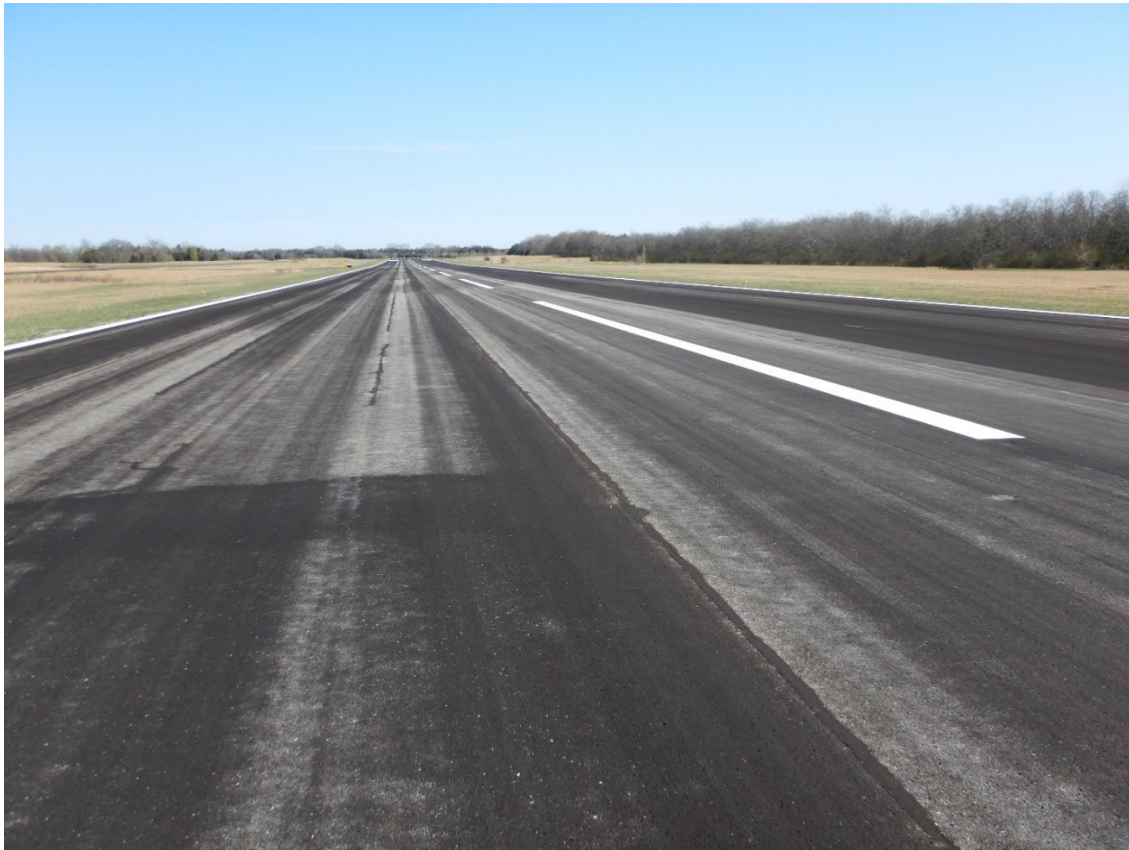
Runway 02/20, Taxiway A1, and T-Hangar 4 are in the low-age pavement group (less than 4 years). In this group, the pavement surfaces were still mostly covered with P-608, but approximately 50% of the coarse aggregate was exposed. Coverage of P-608 on the coarse aggregate was uneven, and the overall coverage of P-608 was not uniform. The variation in the thickness of the P-608 layer could be easily identified, and the underlying pavement was becoming visible. This level of visibility is not expected for a 1-year-old treatment. Pavement markings on the P-608 were performing very well. The visual delineation of the markings was good. Single tire

tracks were noticeable in some areas. Overall, the only deterioration mechanism observed was fading; there was no flaking or chipping, so there were no FOD concerns. Very limited weathering was observed in some areas. L&T cracks were present on the pavement but mostly at low-severity level. Some new cracks had continued to develop along the paving lane joints. Crack sealants were in good condition. Since the last PCI inspection in 2019, it is estimated that these sections remained at the same PCI or increased less than 5 PCI points due to the reduction in the amount of weathering at locations where the P-608 treatment covers the asphalt. The remaining service life of P-608 was estimated at approximately one year, mostly due to its non-uniform thickness and pavement exposure. Pictures of P-608 condition in this pavement age grouping are presented in figures LUG-1 through LUG-10.

Figure LUG-1. Overview of Runway 02/20 With P-608

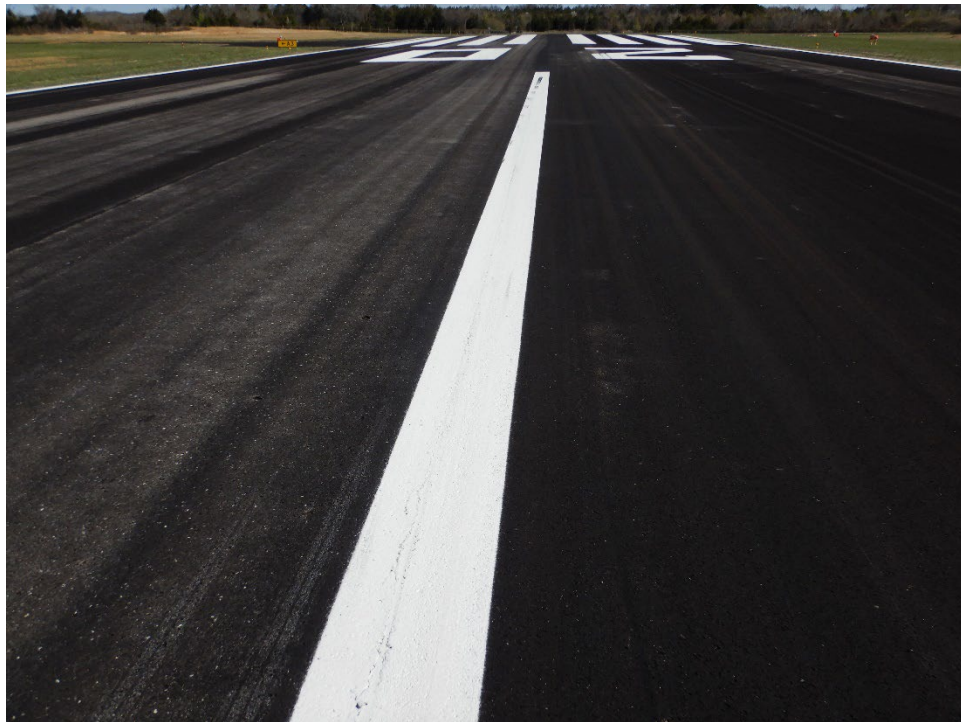
Figure LUG-3. P-608 Coverage on Runway 02/20

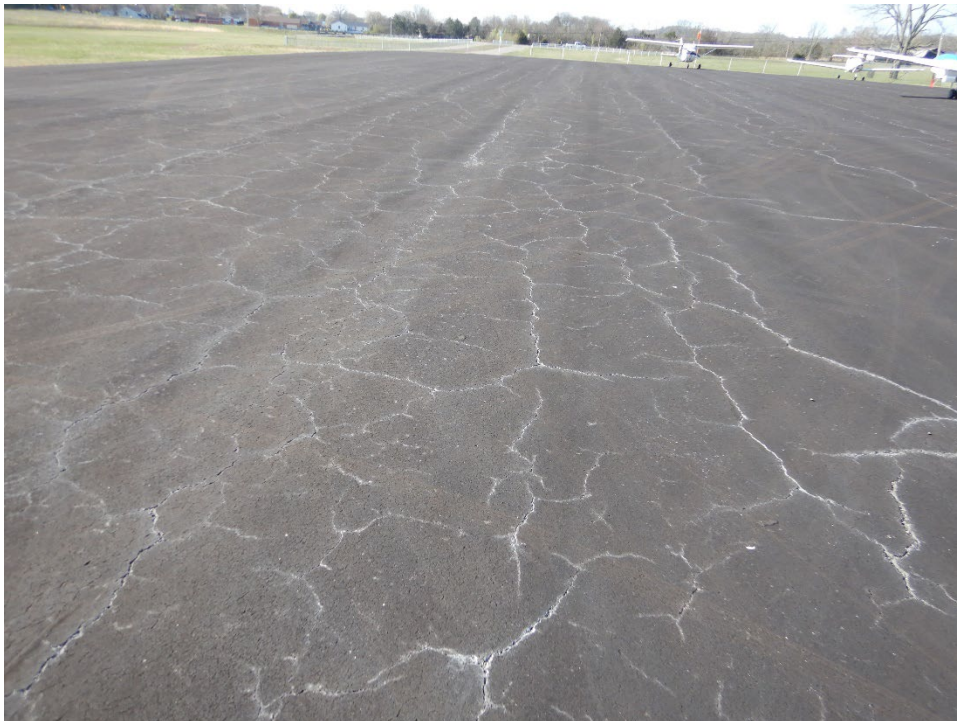
Figure LUG-12. Apron Overview With P-608 With White Precipitate

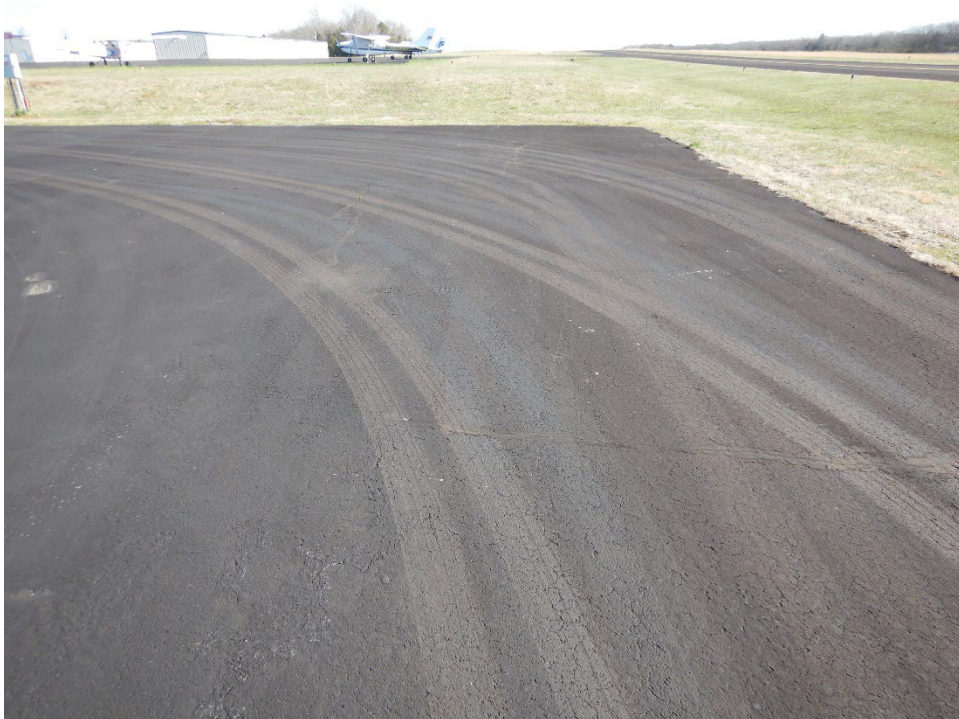
Figure LUG-14. Fuel Truck Track on P-608 Over P-631

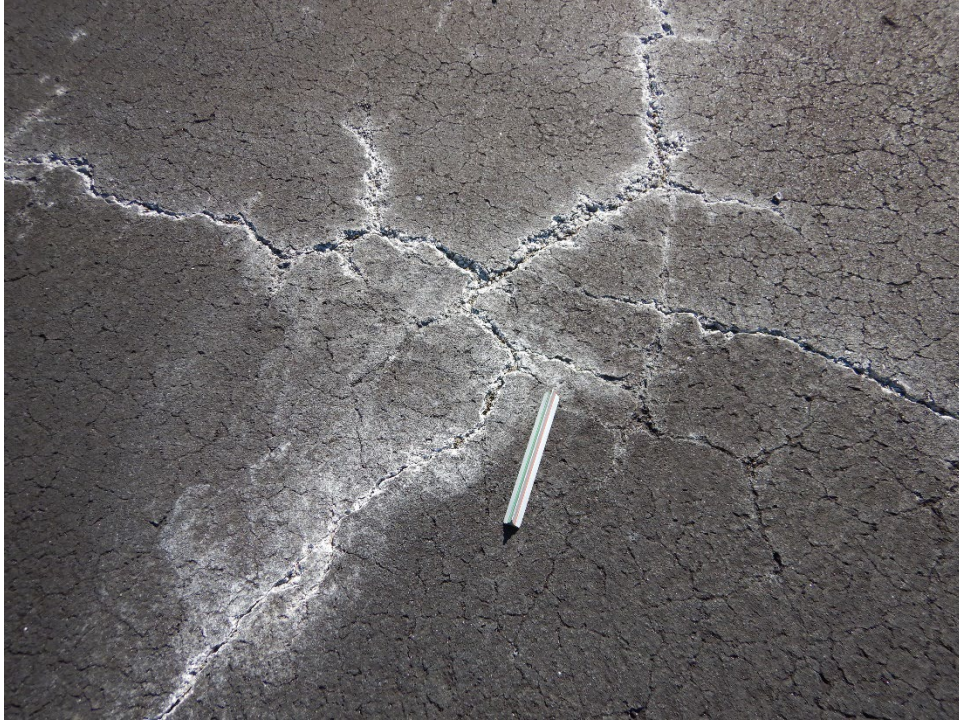
Figure LUG-17. Closeup of White Precipitate on Apron

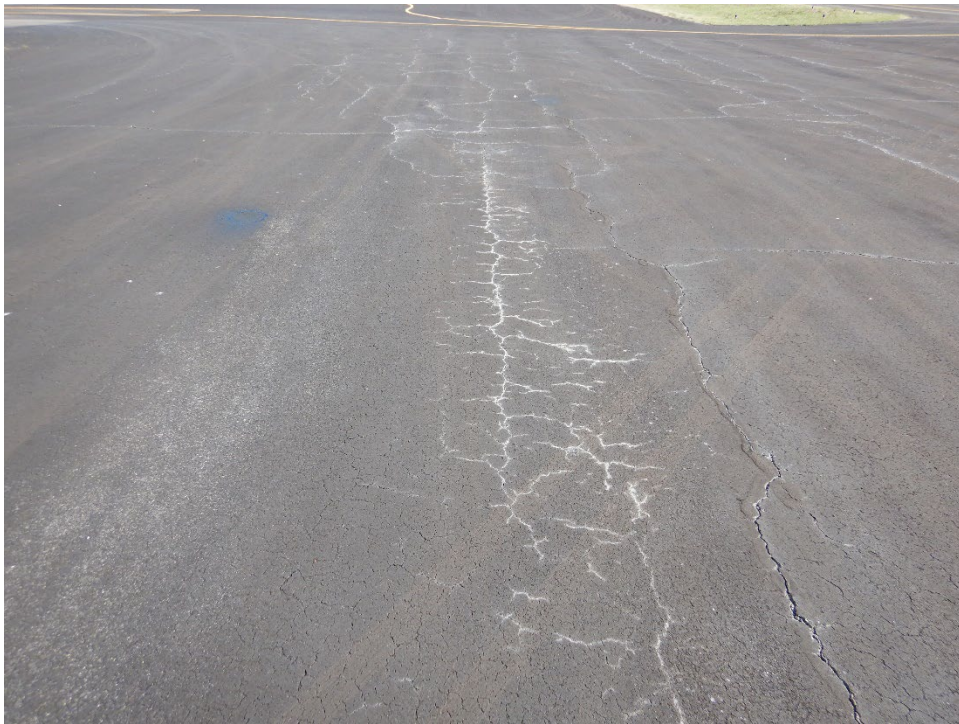
Figure LUG-18. Overview of White Precipitate on Apron

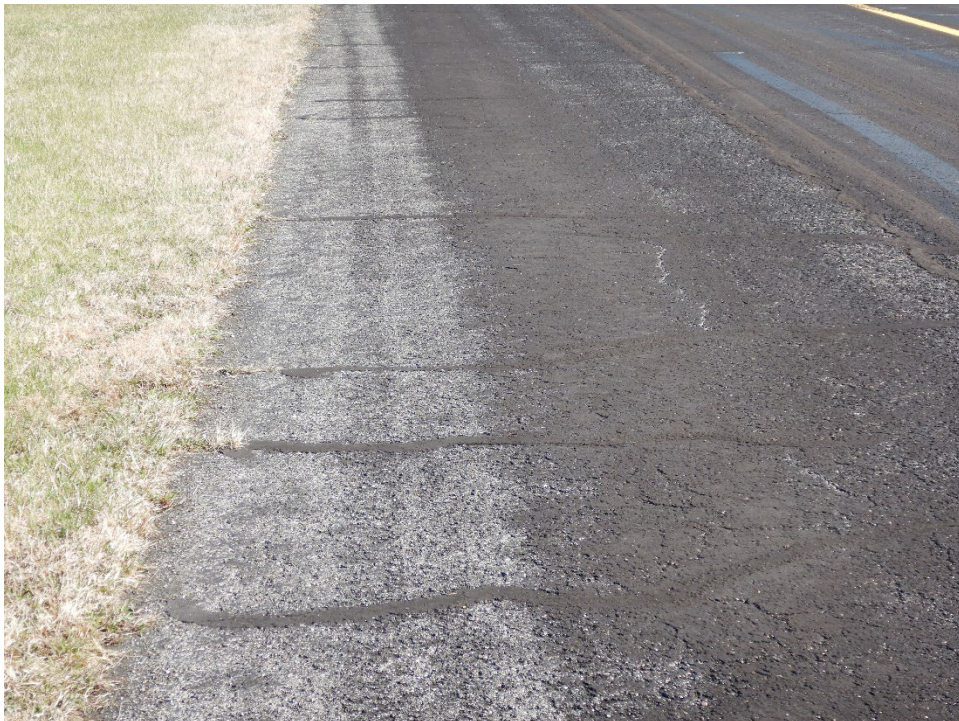
LUG Taxiway A and A2 fall within the high-age pavement group (over 39 years). On these taxiways, P-608 coverage was fair, with 60% of the coarse aggregate exposed. The coverage of P-608 on the coarse aggregate was uneven, and the overall coverage of P-608 was not uniform. Thickness variations of the P-608 layer can be easily identified. The underlying pavement was becoming more visible in areas with a thin P-608 layer. Pavement markings on the P-608 are performing very well. The visual delineation of the markings is good. Single tire tracks were noticeable in some areas. Overall, the primary form of deterioration is fading. No flaking or chipping was observed that would raise FOD concerns. The pavements had cracks with overband sealant. Raveling on the pavement was visible during inspection but had been partially filled in by the P-608 surface treatment. The P-608 surface treatment did not address the raveling due to the thickness of the treatment. FOD concerns were also apparent from the aggregate raveling. The P-608 treatment may not have been appropriate for these pavements based on the amount and severity of the raveling; a slurry seal or micro-surface treatment could have worked better. Since the last PCI inspection in 2019 (PCI in the range of 20–22), it is estimated that the PCI has increased approximately 10–15 PCI points. The amount of raveling recorded during a PCI survey would have likely been reduced based on the difficulty in seeing all areas with aggregate missing. Additionally, the crack sealing had shifted some cracks from medium to low severity. It is difficult to estimate the remaining service life of the P-608 treatment on Taxiway A and A2, as application of this treatment is not typical for the age and deteriorated surface condition of the pavement. Some benefits may remain for approximately one to two more years in specific areas where the treatment is thicker. Pictures of P-608 condition on these pavements are presented in figures LUG-19 through LUG-23.

Figure LUG-23. P-608 Coverage on Taxiway A Edge in High-Age Area

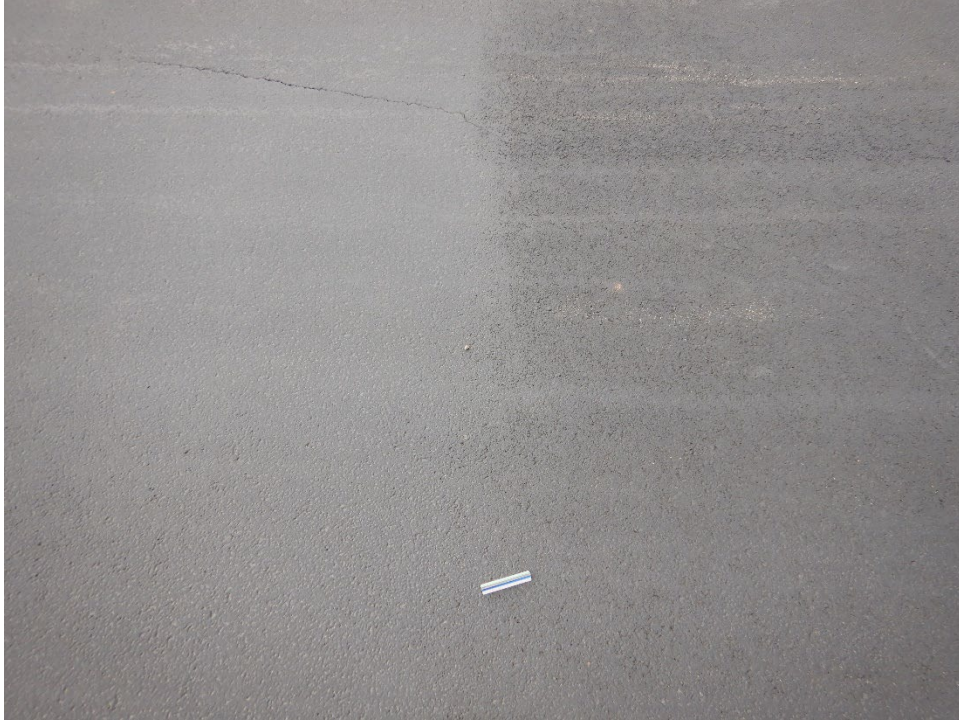
Figure UDOT-23. Onyx Color Difference Due to Application Phase Break
