Methodology for Load Rating Double-Tee Bridges

Study SD2016-01

Final Report

**Department of Civil & Environmental Engineering
South Dakota State University
Brookings, SD 57007**

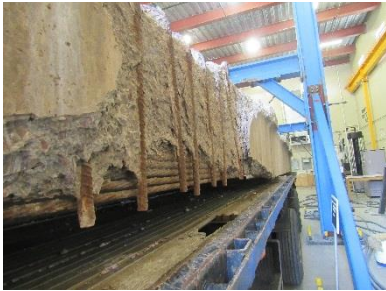
(p) Stem Exposure of Strand (CS-2)

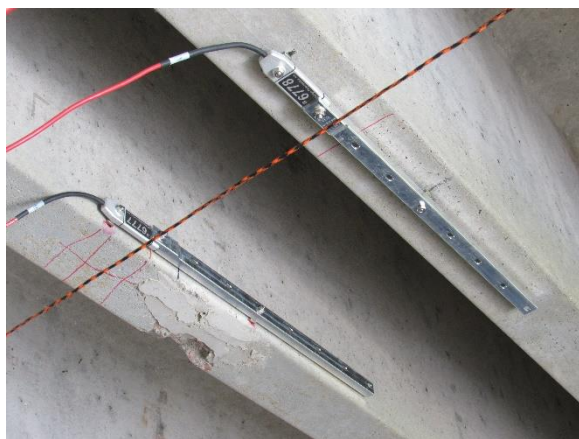
(c) Strain Gauges on Stem Side due to Damage

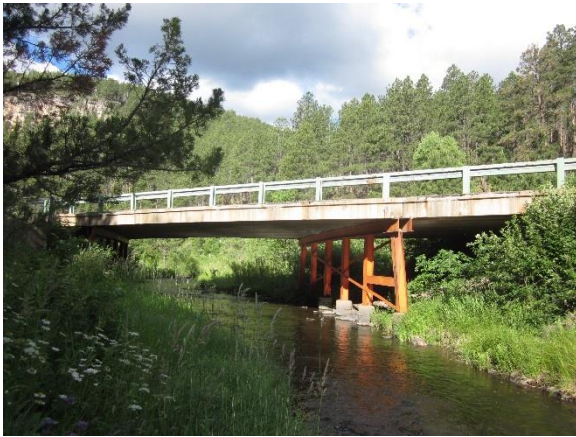
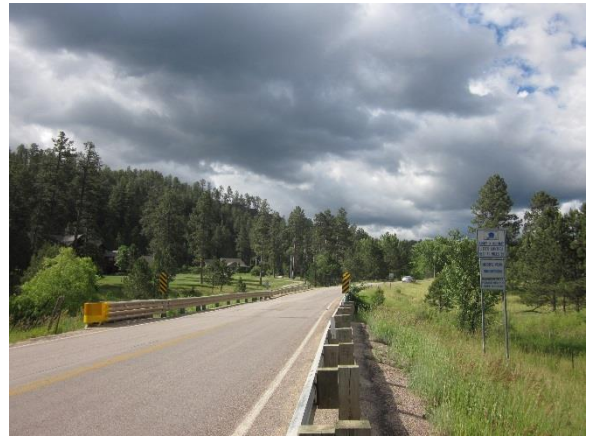
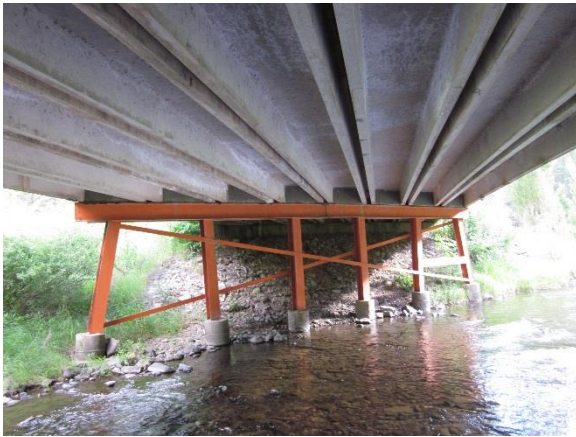
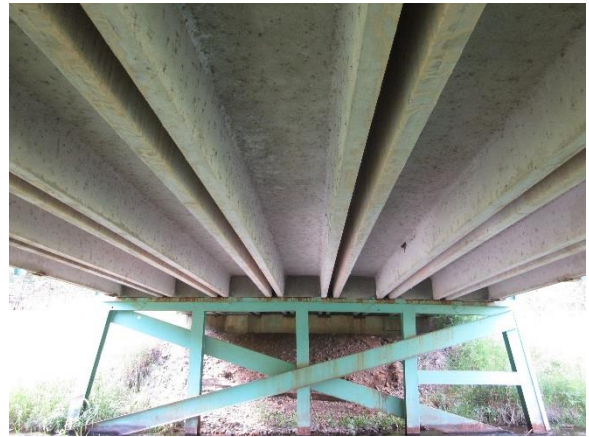
Figure 8.1 – Double-Tee Girder Bridges Inspected for Strength Testing

Two double-tee bridges (Fig. 8.1) close to Rapid City, SD, for which replacement funds became available, were inspected to select girders for lab test. Girders of the Nemo Road Bridge (ID 52-313-265, built in 1972) had more apparent damage compared to those of Norris Peak Road Bridge (ID 52-319-268, built in 1972). Therefore, one 30-ft (9.14-m) long double-tee girder and one 50-ft (15.24-m) long double-tee girder (Fig. 8.2), each 23-in. (584-mm) deep, were selected and extracted from this bridge (Fig. 8.3). The variation in the girder length was to investigate different failure modes. A short and damaged girder may fail in shear even though it was designed for a flexural failure. The two salvaged girders were delivered to the Lohr Structures Laboratory at South Dakota State University (SDSU).

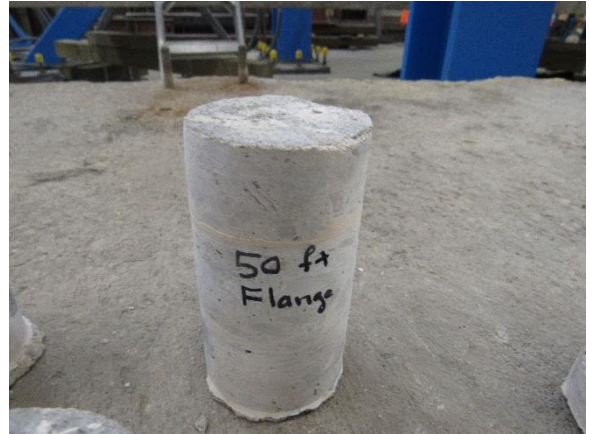
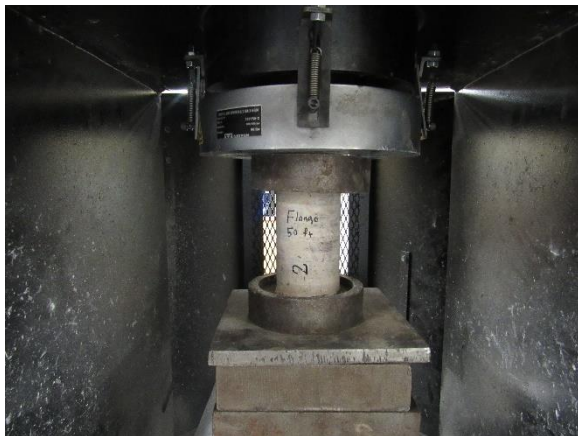
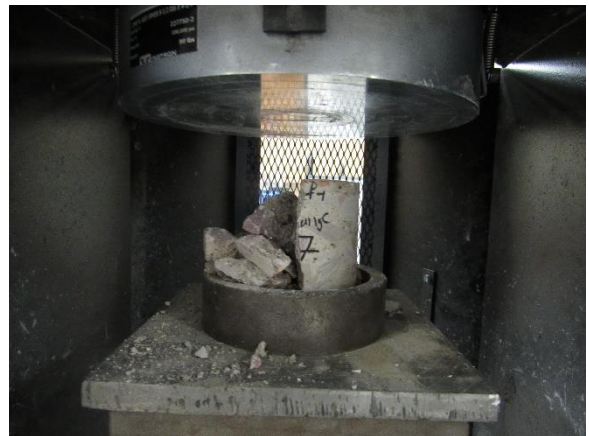
Figure 8.22 – Concrete Coring and Testing for Salvaged Girders

Figure 8.22 shows a sample core, which was obtained following ASTM C42 (2003), and the test setup, which was in accordance to ASTM C39 (2012). Table 8.4 presents a summary of the results. The concrete compressive strength for the 50-ft (15.24-m) long girder stem and flange was 3.15 ksi (21.7

MPa) and 1.92 ksi (13.2 MPa), respectively. Both strengths were significantly lower than that specified in shop drawings found for South Dakota double-tee girders.

Unfortunately, concrete in the 30-ft (9.14-m) long girder was severely deteriorated thus no samples could be obtained (all samples crushed during coring). The only core sample that was extracted from this girder had a short height that was not acceptable by ASTM C42 (2003). Due to a lack of test data, the compressive strength of the 30-ft (9.14-m) long girder is assumed to be the same as that in the 50-ft (15.24-m) long girder.

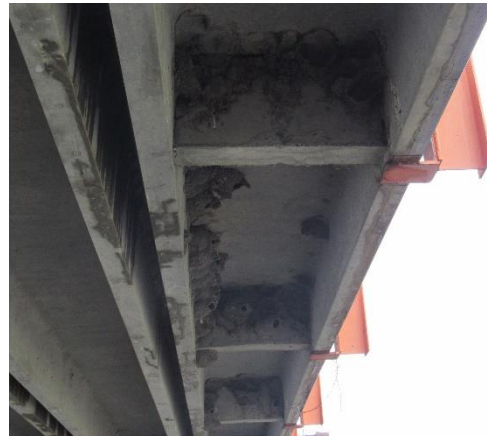
(b) Diaphragm at the exterior girder

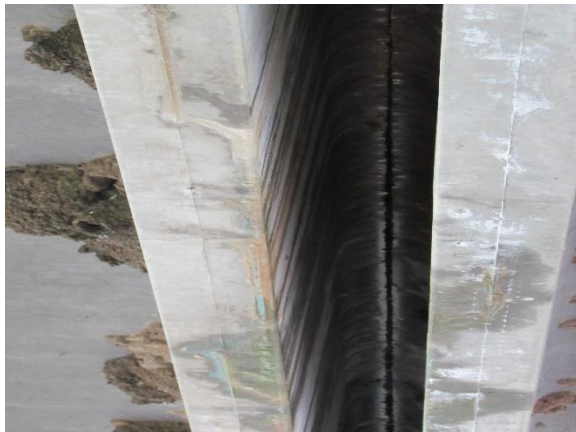
(e) Efflorescence

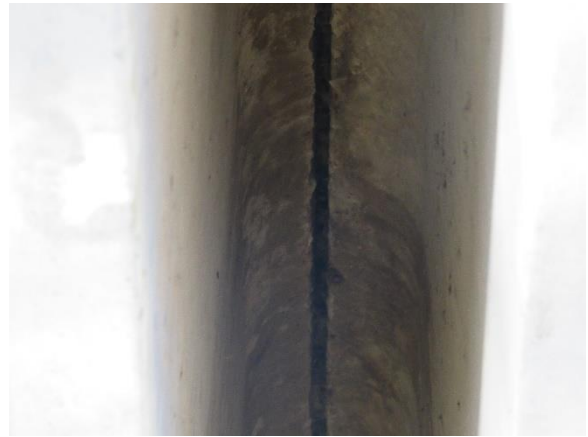
(b) Gap of joint

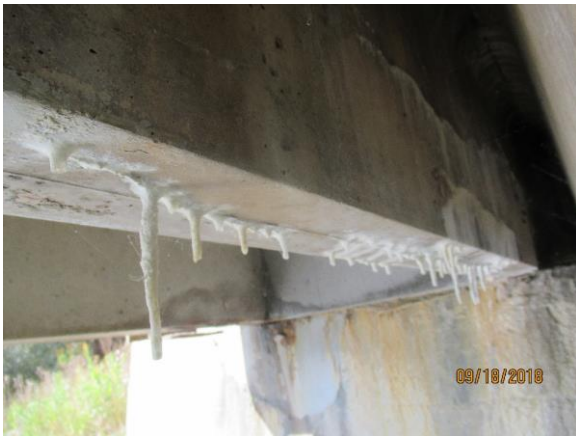
(d) Longitudinal Cracking and Severe Efflorescence- North End of Deck Unit 1
