# Railroad Crossing Study

Study SD90-14  
Volume I: Final Report

Prepared by  
Department of Civil Engineering  
SD School of Mines & Technology  
Rapid City, South Dakota

January, 1992

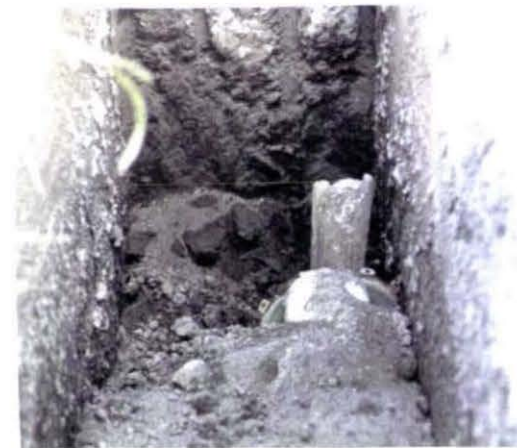
Photo V-4. Summit - Drainage Trench with Drain Pipe.

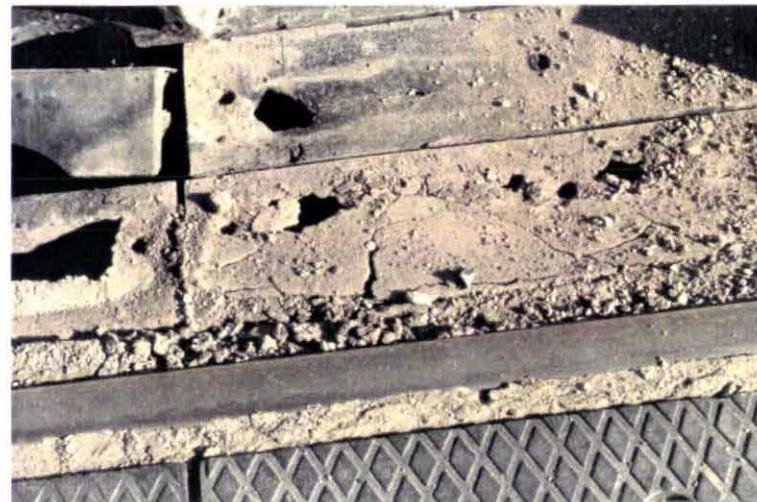
Photo V-6. Summit - Mud between Panels and Spacers.

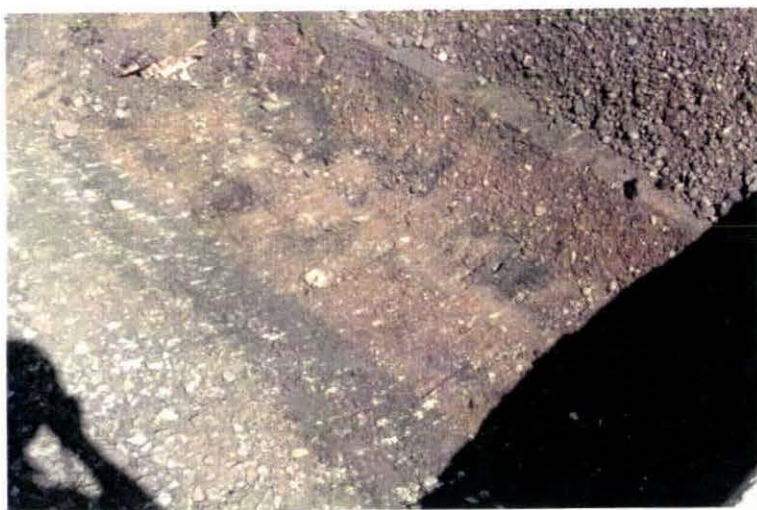
Photo V-7. Summit - Old Ballast, Base Material and Subgrade.

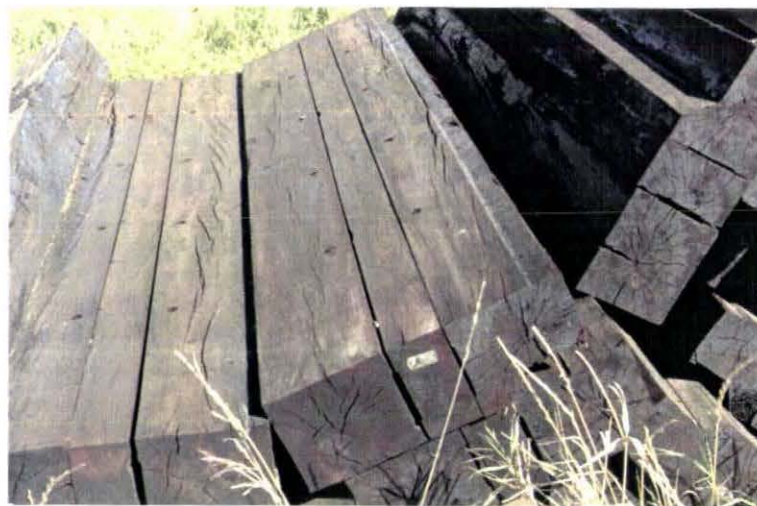
Photo V-8. Summit - New Timber Panels.

Timber panels of the type observed at County 131 and east of Minnehaha County 131 near Sioux Falls were installed in the crossing at Summit. The panels, shown in Photo V-8, are full depth and rest directly on the ties. Each panel is fastened by eight camcar screws. The panels placed next to the rails also are grooved to allow for rail deflection without damage to the panels.

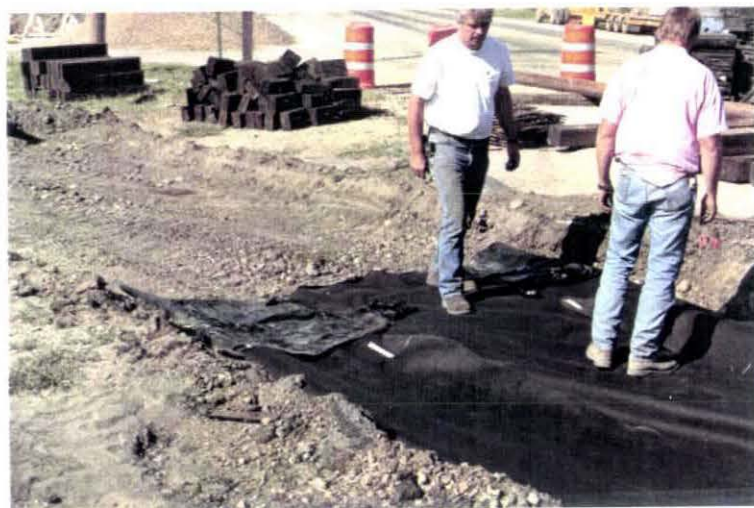
Reconstruction commenced with leveling of the trench bottom. No compaction or proofrolling of the subgrade was performed and the fabric was placed directly on the clay and loose gravel subgrade. The subgrade was not strong, as the backhoe and front loader used in the construction made one to two inch deep ruts when passing over the exposed area. The exposed subgrade is shown in Photos V-13 and V-14. Placement of fabric is shown in Photo V-15. The fabric was 15 feet wide and the excess was folded back into the excavation. New ties were lain directly over the fabric. Ballast was then dumped over the finished track and packed under the ties. Except for the packing of the ballast no compaction

Photo V-15. Aberdeen, Fifth Street - Placement of Fabric.

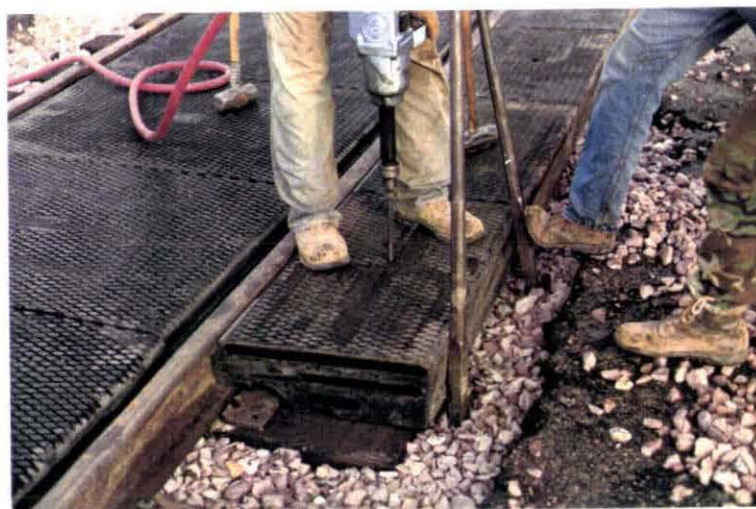
Two types of rubber panels were installed at this location, both previously used and removed from another location. At the portion of the crossing subjected to traffic, Hi-Rail-type panels were installed, while General Tire Gen-Track II were installed at the shoulders. Prior to installation of the panels, the ties and rails were thoroughly cleaned using compressed air (See Photo V-16). Installation of the full depth Hi-Rail panels and the partial depth Gen Track panels with shims is shown in Photos V-17 and V-18. Since the track at this crossing is in an eight degree curve, the contractor had trouble installing the panels such that they matched perfectly. The Gen-Track II panels did not match the Hi-Rail panels in height. In the final product, the shoulder panels were about one half to three quarters of an inch below the Hi-Rail Panels. In order to secure the panels on the outside of the rail, one to two camcar screws were installed in the Hi-Rail panels (See Photo V-18).

Photo V-18. Aberdeen, Fifth Street - Placement of HI-RAIL Panels.

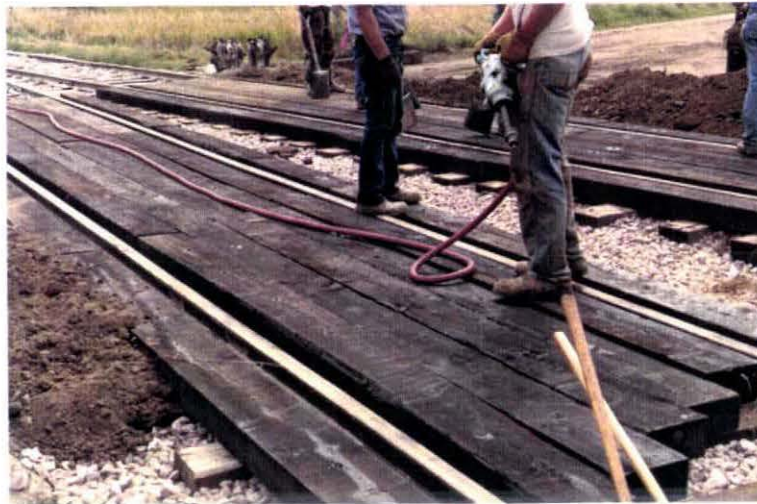
Photo V-22. Aberdeen, 12 Street - Completed Crossing Showing Uneven Timbers.

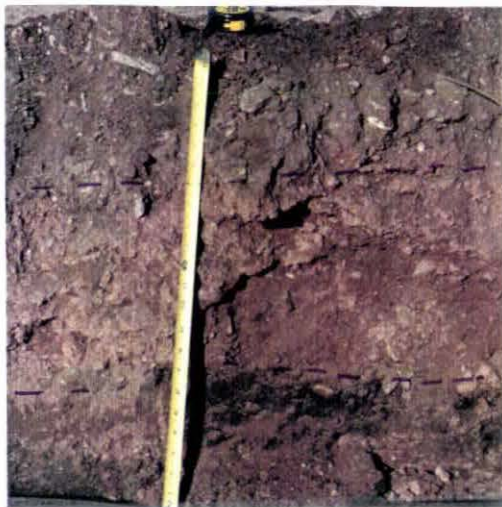
type rubber panels. The crossing, installed in 1981, was not part of the initial survey, nor was it examined during the condition survey. The crossing was replaced in conjunction with the reconstruction of Ball Park Road and, at the time of inspection, the road base was not yet brought to grade. The old track was removed and the ballast and subgrade excavated to a depth of up to 26 inches below the existing grade (See Photo V-25).

Photo V-25. Sturgis, Ball Park Road - Roadbase and Subgrade Exposed in Excavation.

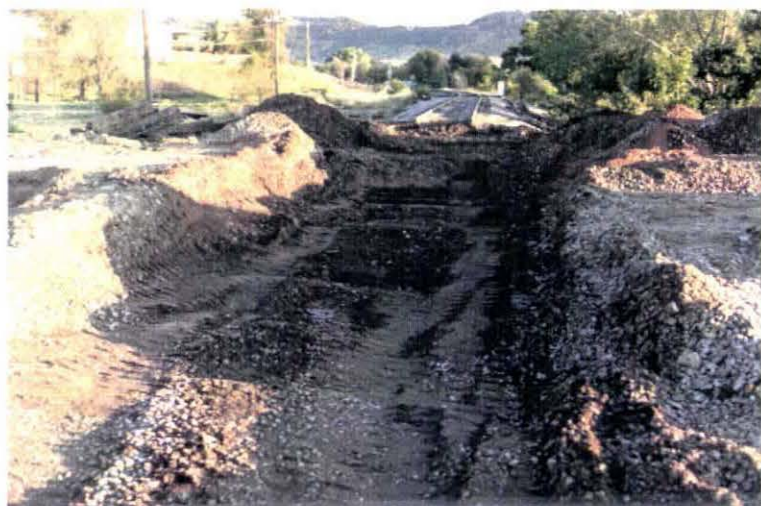
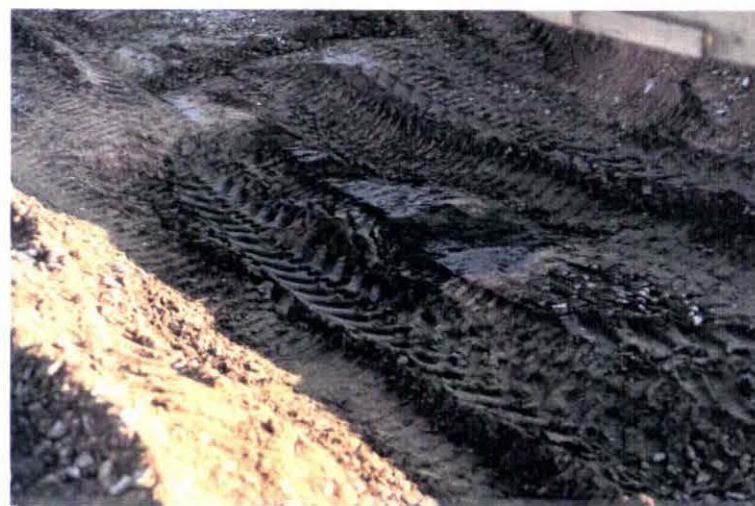
Photo V-27. Sturgis, Ball Park Road - Overall View of Excavation.

Photo V-28. Sturgis, Ball Park Road - Close-up of Rutting from Frontloader Tires.

The removal of the old ballast and excavation of the softened subgrade was performed by a frontloader. The exposed subgrade is shown in Photos V-27 and V-28. The excavation was nearly 2.5 feet deep at the center and tapered down to a depth of approximately 1.5 feet at the north and south ends of the crossing. As can be seen in the photos, the exposed subgrade consisted of dark brown to black, soft, silty clay and was severely disturbed and rutted by the frontloader tires. No proofrolling or compaction of the subgrade was performed and the fabric was rolled out over the subgrade as shown in Photo V-29. No drainage pipe was installed. Ballast was then placed to a depth of approximately 1.5 feet and the preassembled track was lifted into the crossing and bolted to the rails at both ends of the track. No compaction of the ballast was performed. After the placement of the track a ballast car was rolled onto the crossing and further ballast dumped over the track. The track was then jacked to its final grade and the ballast was packed under the ties.

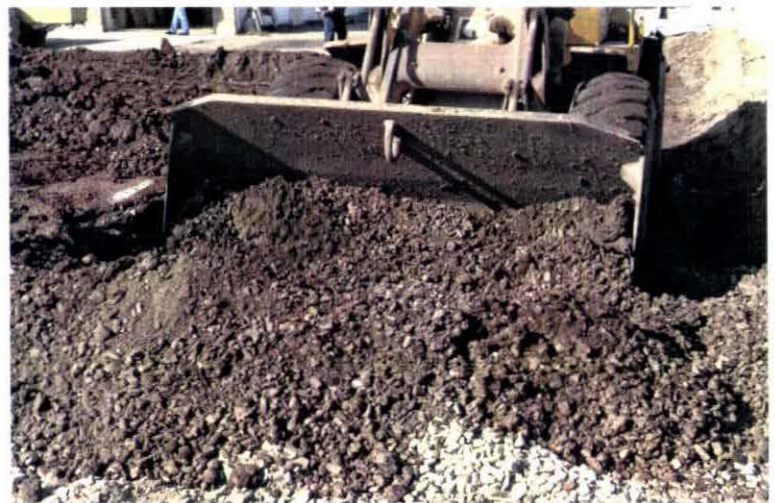
Photo V-36. Rapid City, Second Street - Removal of Old Ballast.

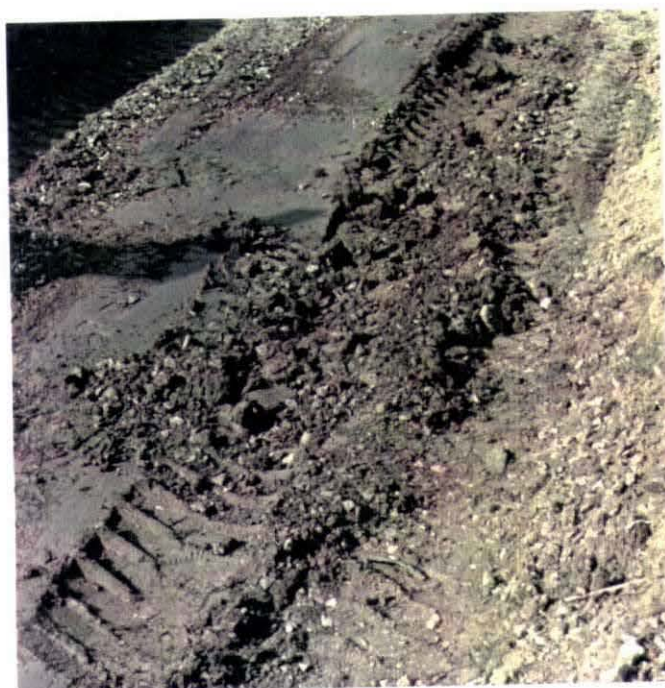
Photo V-37. Rapid City, Second Street - Finished Subgrade and Backfilled Rutting Marks.

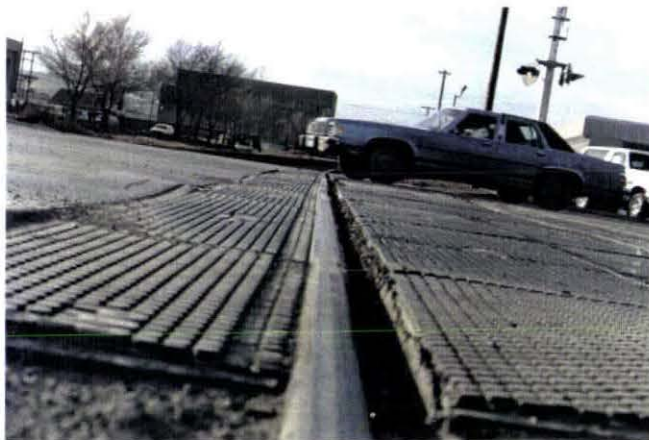
Photo VI-4. Effect of Freeze-Thaw - Mud Squeezing up between Rail and Panel and Outer Panels.

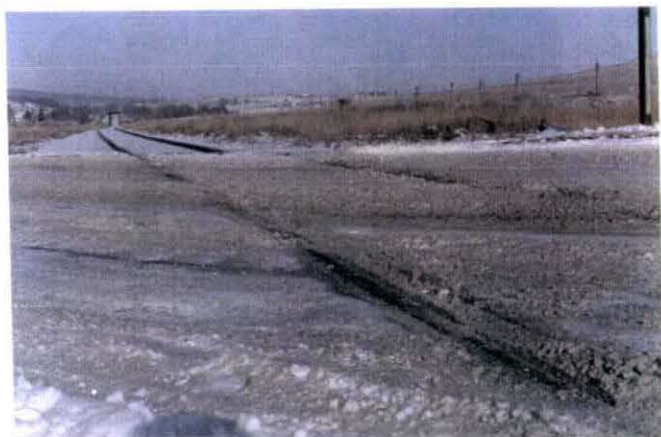
Photo VI-8. Snow Accumulation on Crossing with Cleared Rails.

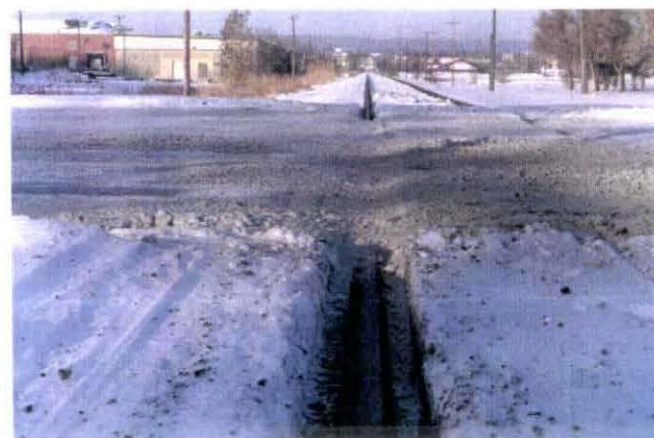
Photo VI-9. Snow Accumulation of Crossing Approaches and Center.

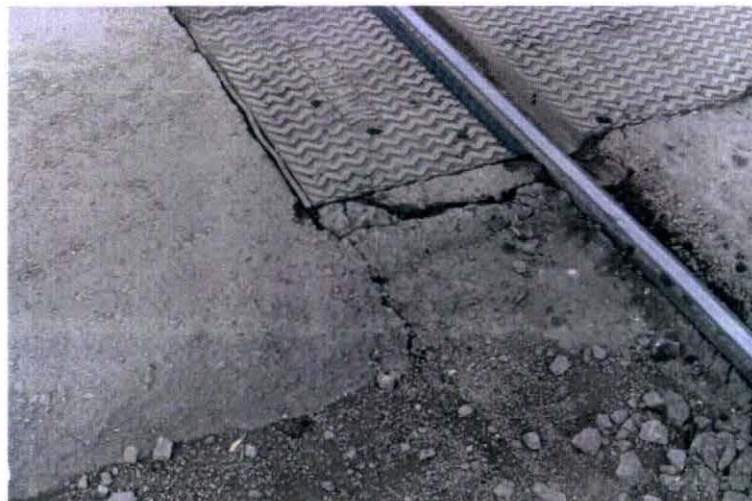
Photo VII-5. Shoulder Settlement.

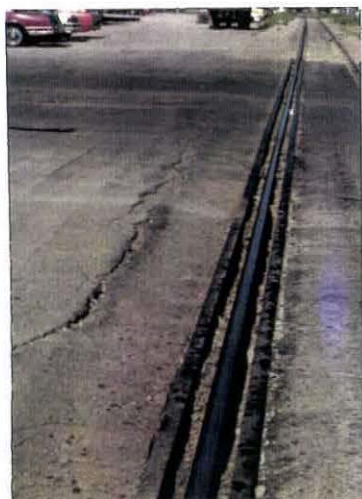
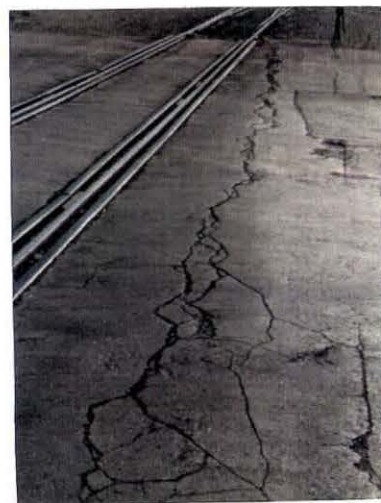
Photo VII-12 and 13. Differential Settlement Between Track and Approaches.

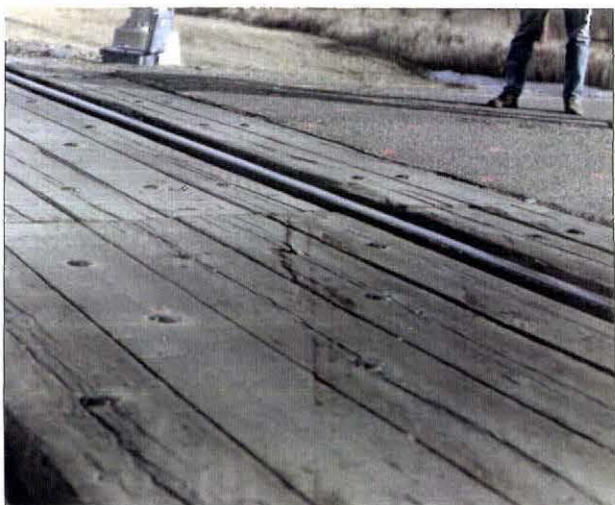
Photo VII-19. Relative Settlement between Crossing and Approach.
